Study of the distribution of temperatures in the windings of a transformer after suffering a short-circuit.

The tests were performed with the dielectric paper of a 800kVA three-phase transformer, manufactured in 1986 with an ONAN cooling system. The total weight of the transformer is 2130 kg, with an insulating liquid mass of 390 kg. The connection of the transformer windings is Dy11 type with a ratio of voltages 30.000/400V. The transformer suffered a short-circuit between turns and it had to be removed from service.

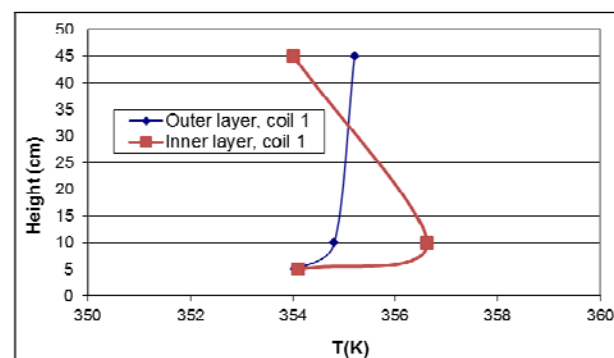
As shown in this table, DP values range from 276.9 to 364.4. If these DP values are plotted as a function of height, differentiating each of the coils and also whether it is an external or internal layer, the figures 1, 2 and 3 can be obtained.

By observing these figures it is found that there is the same aging along the entire height of the coil. It is also observed that the deterioration of paper is similar in both the inner and the outer layer, although overall deterioration of the inner layer is slightly higher than the one of the outer layer.

Fig. 1. Temperature distribution in coil1 (it suffered the short-circuit between turns).

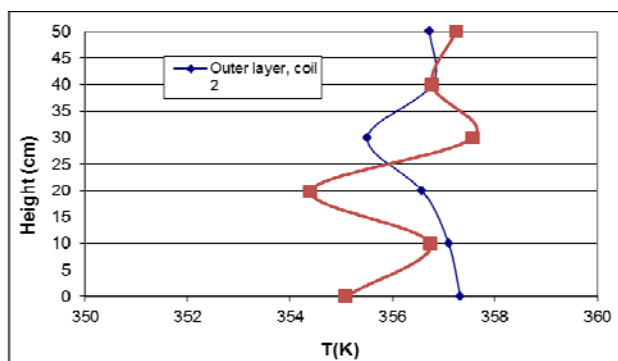
Fig. 2. Temperature distribution in coil2.
