Understanding Poor Seismic Performance of Concrete Walls and Design Implications

Sri Sritharan,[a) M.EERI, Katrin Beyer,[b) M.EERI, Richard S. Henry[c), Y. H. Chai,[d) Mervyn Kowalsky,[e) M.EERI, and Desmond Bull,[f)

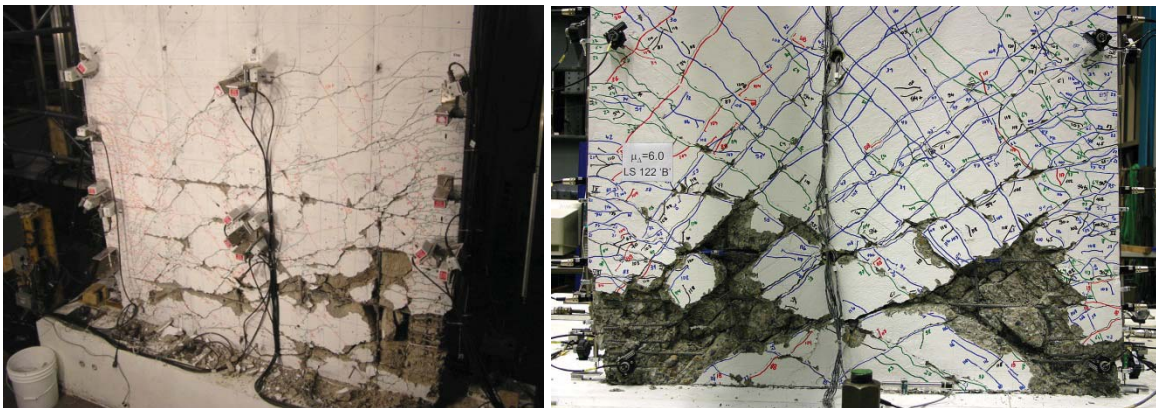
(a) RWN tested by Aaleti et al. (2013)   (b) TUB tested by Beyer et al. (2008)
**Figure 1** Cyclic testing of concrete walls with boundary elements

An important observation from the two tests is that the extent of damage to walls in the boundary elements is relatively less compared to the web regions. Formation of cracks with larger width and wider spacing, crushing and spalling of concrete that began within the cover and penetrated well into the core region, and subsequent reduction of wall thickness beyond that experienced by the boundary elements are direct consequences of using light reinforcement in the web regions. As evidenced from the tests, potential failure modes of walls with heavy longitudinal reinforcement in the boundary elements and light longitudinal reinforcement in the web regions are: (1) Crushing of concrete in the web regions, which can be exacerbated if the axial load in the walls increases due to vertical acceleration and/or framing action resulting from interaction between walls and floors; and (2) Large shear deformation and potential for shear sliding due to the development of wider cracks in the web; and (3) Buckling of boundary elements due to the web experiencing significant damage. Though the aforementioned web crushing occurs under in-plane loading, Paulay and Priestley (1992) noted that out-of-plane response can also increase the possibility of web crushing especially when low amounts of reinforcement presents in the web region.

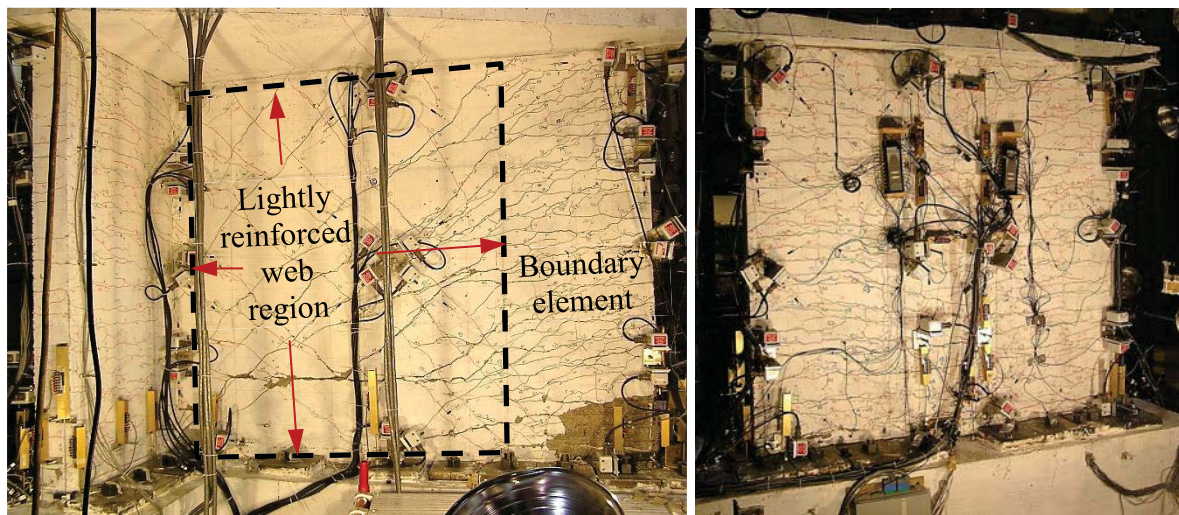
(a) Crack pattern on the web of NTW2   (b) Crack pattern on the back side of flange of NTW2 after web failure

Figure 2 A T-wall test completed by Brueggen with distributed reinforcement in the flange

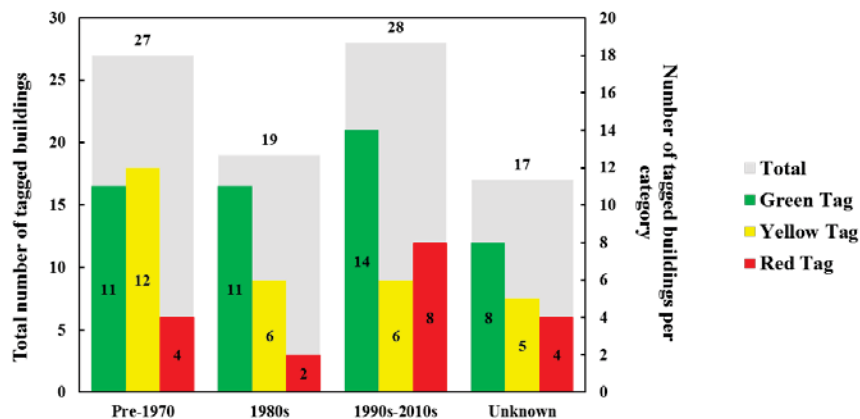
An overview of wall damage in the Christchurch earthquake may be realized from **Figure 4,** which shows the result of rapid building safety evaluations that was conducted during the national state of emergency immediately following the Christchurch earthquake (Kam et al. 2011). This figure shows three categories of damage distribution as a function of design era. Accordingly, red indicated unsafe to enter, yellow corresponded to restricted entry and green

Figure 4   An overview of damage to concrete walls building based on rapid safety evaluation data (after Kam et al. 2011)

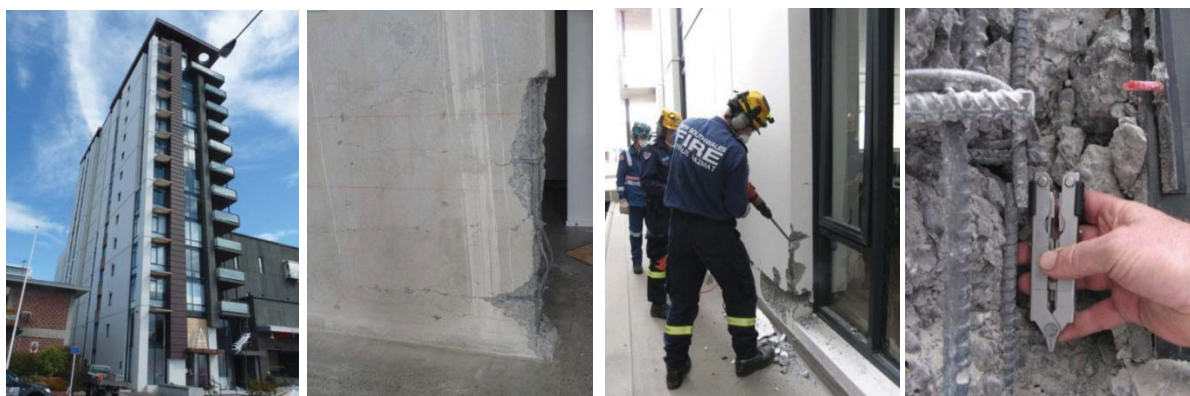
The concrete wall shown in **Figure 5** experienced noticeable distress due to the earthquake motion. Three observations from this figure are: (a) The intensity of ground motion at this site was significant enough to cause cracking but not spalling of cover concrete in the plastic hinge region near the wall base; (b) Use of increased longitudinal reinforcement

in the end regions of wall seems to have controlled the crack width in these regions; and (c) Relatively wider cracks with large spacing apparent on the wall surface in the web regions confirm the use and possible consequence of lightly reinforced concrete in that region. **Figure 6** shows a concrete wall in a 14 story hotel building that had well distributed flexural cracking. As described by Wilson and Lewis (2011), the plastic hinge region in this case was located above level 4 where the building footprint was reduced. The 8 m long and 0.3 m thick wall was designed in accordance with current NZS 3101 standards (2006) and had 1 m long boundary elements with a ρ_l of 2.7% and the web region contained well-distributed longitudinal reinforcement with a ρ_l of 1.0%. The resulting crack widths were between 0.5-0.8 mm and the wall was easily repaired.

**Figure 5** Observed distress to a concrete wall with minimal damage (Photos: Courtesy of Elwood)

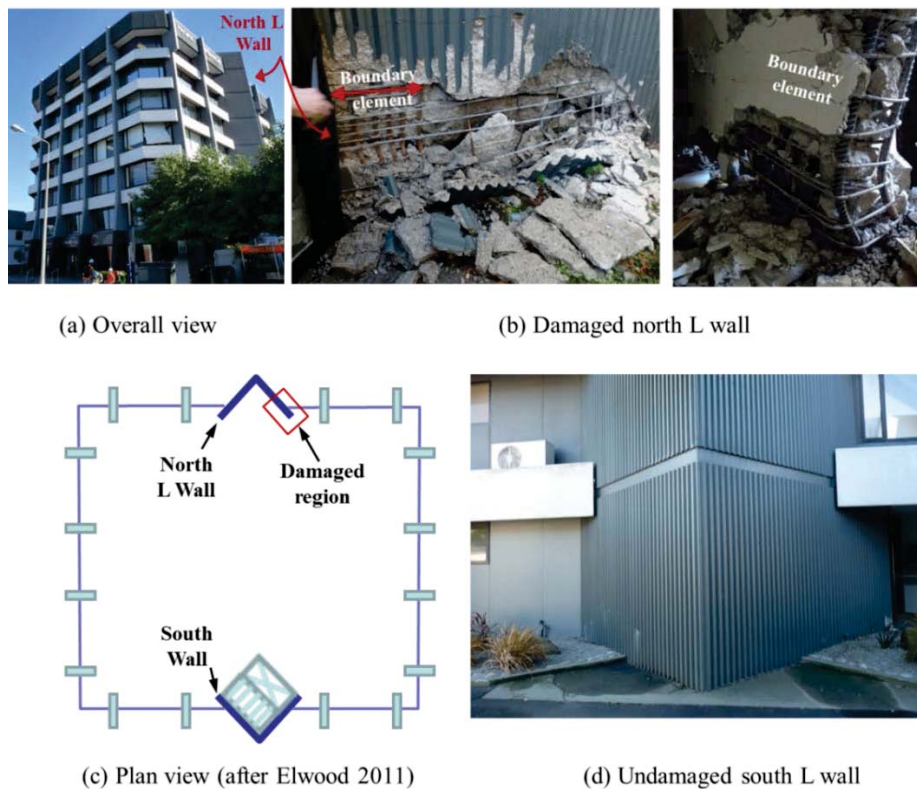
A number of walls, including those that appeared to have good reinforcement details, suffered buckling in the plastic zone. As previously discussed, the cyclic combination of large tension strains and subsequent compression can trigger local wall buckling. This issue is exacerbated when walls are designed with boundary elements and lightly reinforced web regions. **Figure 9** shows a 7-story reinforced concrete wall structure built in 1984, which comprised of two L-shaped walls. The wall on the north experienced significant damage to concrete just adjacent to a boundary element and out-of-plane buckling of the boundary element. The longitudinal steel ratios in the boundary element and outside of the boundary element were estimated to be about 2% and 0.12%, respectively. While 0.12% is lower than the current minimum vertical reinforcement ratio, this amount is consistent with the minimum requirement of the era when the building was designed.

Figure 9 A seven-story office building with wall damage

The lack of damage to the south L wall may be attributed to the building not being as well connected to that wall due to stair and lift shaft penetrating through the diaphragms, adjacent to the wall. In **Figure 9**d, the back of the south L wall is shown, which shows virtually no damage to this wall. A similar observation was made on the inside faces of this wall.

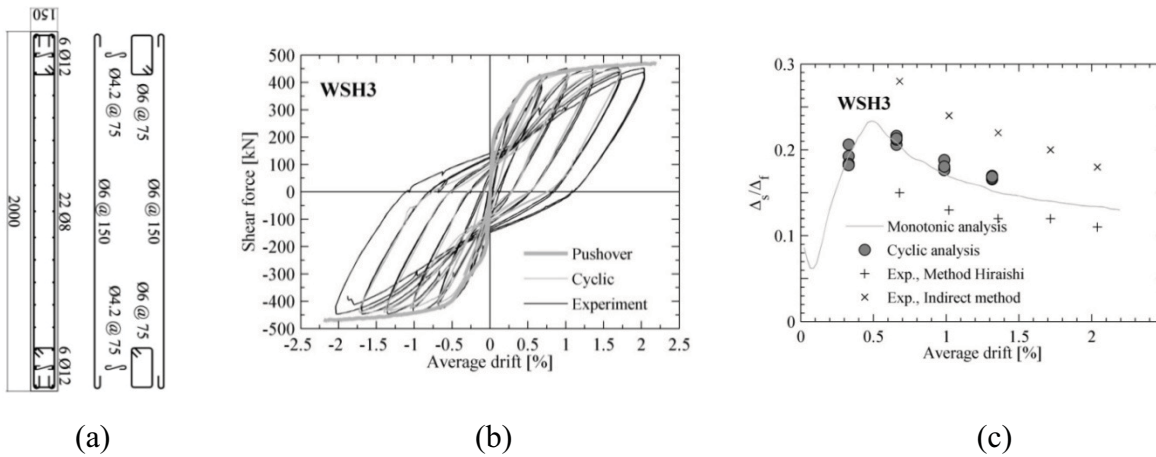
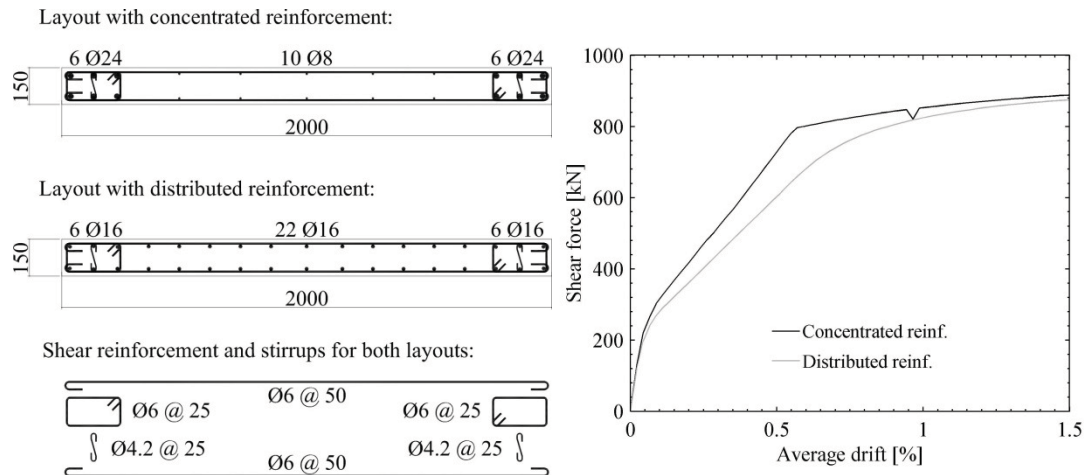
Figure 11b compares the numerical force-displacement response to that obtained during testing, which confirms that the numerical model captures both the overall force-displacement response and the cyclic hysteretic behavior with good accuracy. **Figure 11**c compares the ratio of shear to flexural deformation components, which shows appropriate representation of flexure and shear components in the numerical model when compared to the experimentally determined shear to flexural deformation ratios using two different methods (i.e., Hiraishi's method (1984) and indirect method in Beyer et al., 2011), which also confirms satisfactory behavior of the analytical model.

Figure 11 Wall WSH3 tested by Dazio et al. (2009) and comparison of its simulated response using a VecTor 2 model to experimental data: (a) Reinforcement layout (b) Force-displacement response (c) Ratio of shear to flexural deformations

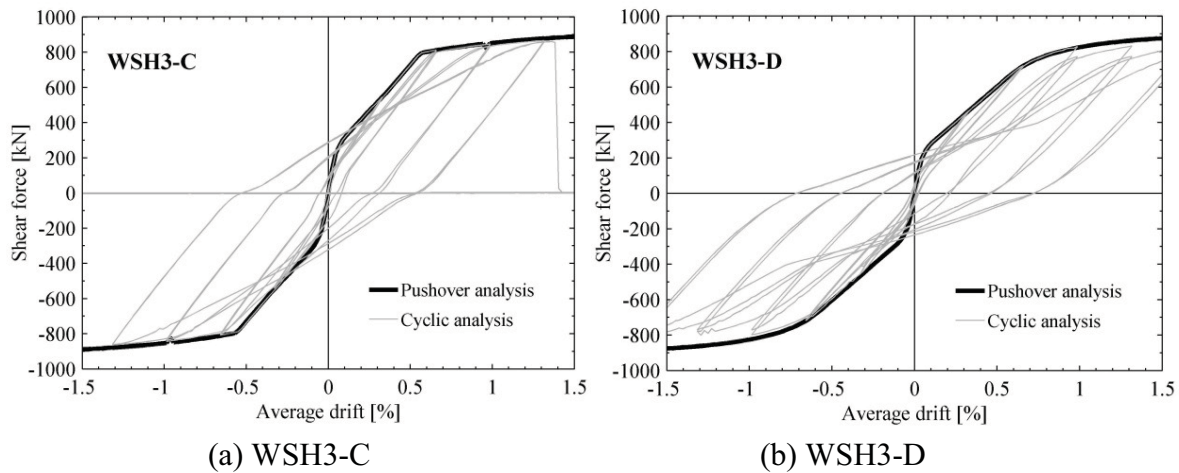
As targeted, both walls provided a similar shear and base moment resistance (see **Figure 12**b, **Table 1**). **Figure 13** shows the force-displacement responses obtained for the two hypothetical walls subjected to both monotonic and cyclic loading. While both cyclic analyses appear to produce stable hysteretic responses up to 1.3% drift, WSH3-C failed at this point due to sliding failure at the large base crack. This failure mode was preceded by short branches of almost zero lateral stiffness during unloading and reloading response of WSH3-C in the previous load cycles. When compared to WSH3-D, WSH3-C resulted in somewhat broader hysteresis loops, indicating development of larger inelastic steel strains and therefore a small increase in energy absorption capacity at a given drift. This difference in energy absorption will have, however, only relatively small impact on the peak displacement demand during an earthquake (Priestley, 2003).

Figure 13 Comparison of simulated force-displacement responses

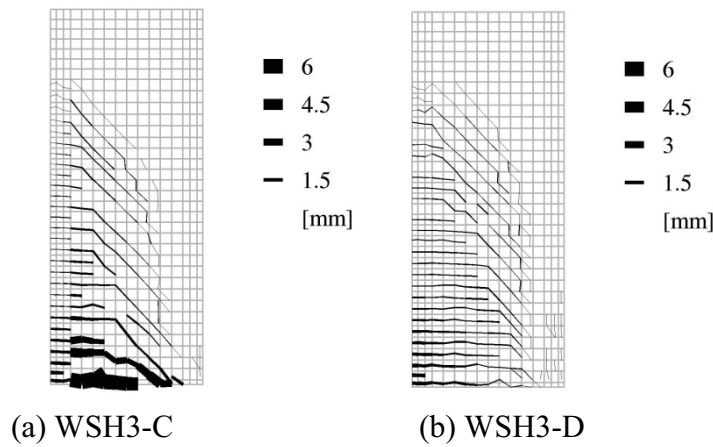
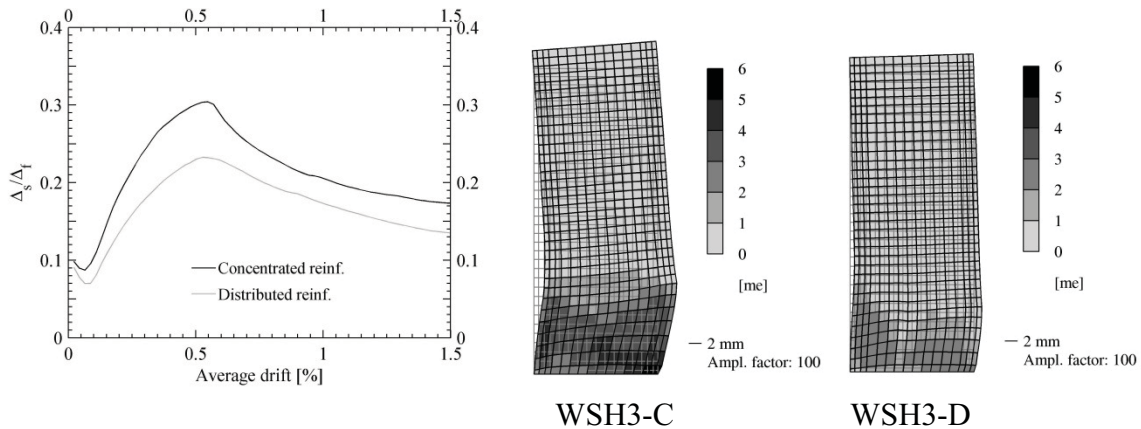
Similar to the damage pattern shown in **Figure 1**, formation of wide cracks in the lightly reinforced web region is observed for WSH3-C at the base in **Figure 14**a. In the boundary elements with a large ρ_l, the crack widths are much smaller. For the same top lateral displacement, the maximum crack width in WSH3-D is about one third of the maximum crack width observed in the web of WSH3-C (**Figure 14**b). As a result, the wall will be less prone to sliding shear failure, rupture of the longitudinal reinforcement bars, web crushing and separation of boundary elements from the web. A concentration of damage to the web for walls with heavily longitudinal reinforcement in the boundary elements and lightly reinforced webs was also observed in the field (e.g., **Figure 9**) and in experimental research (**Figures 1** and **2**a).

Figure 14 Observed crack pattern at 1% lateral drift

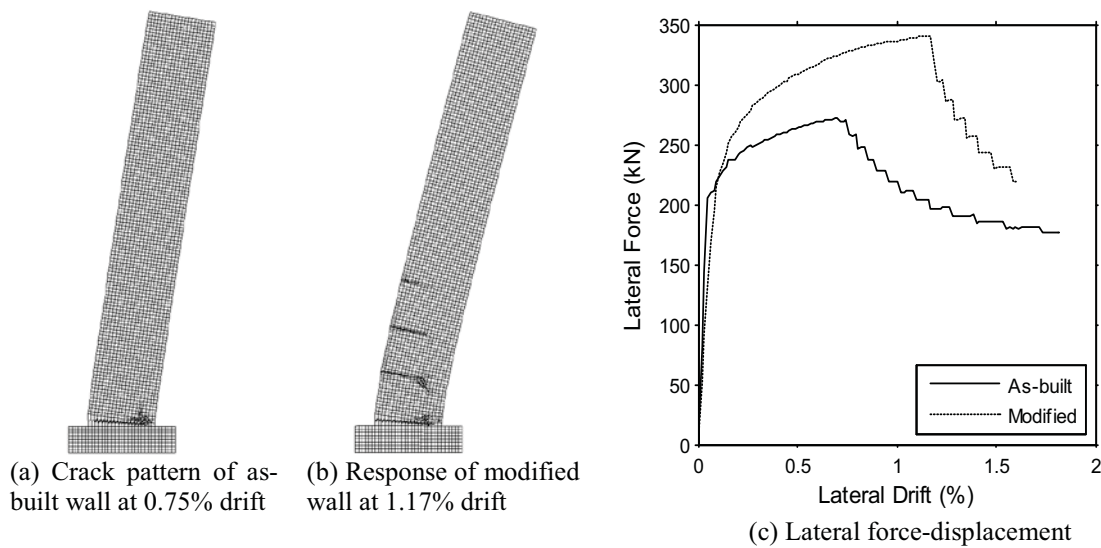
The crack pattern and lateral force-displacement response from the finite element analyses of the as-built grid-F wall are shown in **Figure 17**. The analytical crack pattern correlated well with the observed performance of the wall, with cracking concentrated at a single primary crack at the wall base with no secondary crack formation. The wall response was elastic until the first crack developed at a lateral force of 205 kN and the peak strength was reached at a lateral drift of 0.7% before fracture of the vertical reinforcement occurred. The analysis confirms the findings of other reports that concluded based on section analyses that the vertical reinforcement content in the grid-F wall of the Gallery Apartments building was insufficient to initiate secondary cracking, resulting in a concentration of inelastic actions at the wall base (CERC 2012; Henry 2013).

(a) Crack pattern of as-built wall at 0.75% drift

(b) Response of modified wall at 1.17% drift

A further analysis of the grid-F wall was conducted with an increased vertical reinforcement to comply with the current limits in NZS 3101:2006 (i.e., Eq. 5). Using the specified concrete strength of 30 MPa, the resulting vertical reinforcement content of 0.274% was used. Additionally, the 30 MPa specified concrete strength with a corresponding tensile strength of 2.9 MPa was used. The resulting crack pattern and lateral force-displacement results of the modified grid-F wall are also shown in **Figure 17**. Instead of a single crack at the wall base, four primary flexural cracks were obtained for the modified grid-F wall with minimal secondary cracking. Both the lateral strength and drift capacity increased with the additional reinforcement before fracture of the vertical reinforcement occurred. These results confirm that although the wall performance would have been improved if current levels of
