CRACK ORIGIN AND DETECTION IN THIN CRISTALLYNE SOLAR CELLS IN A PRODUCTION LINE

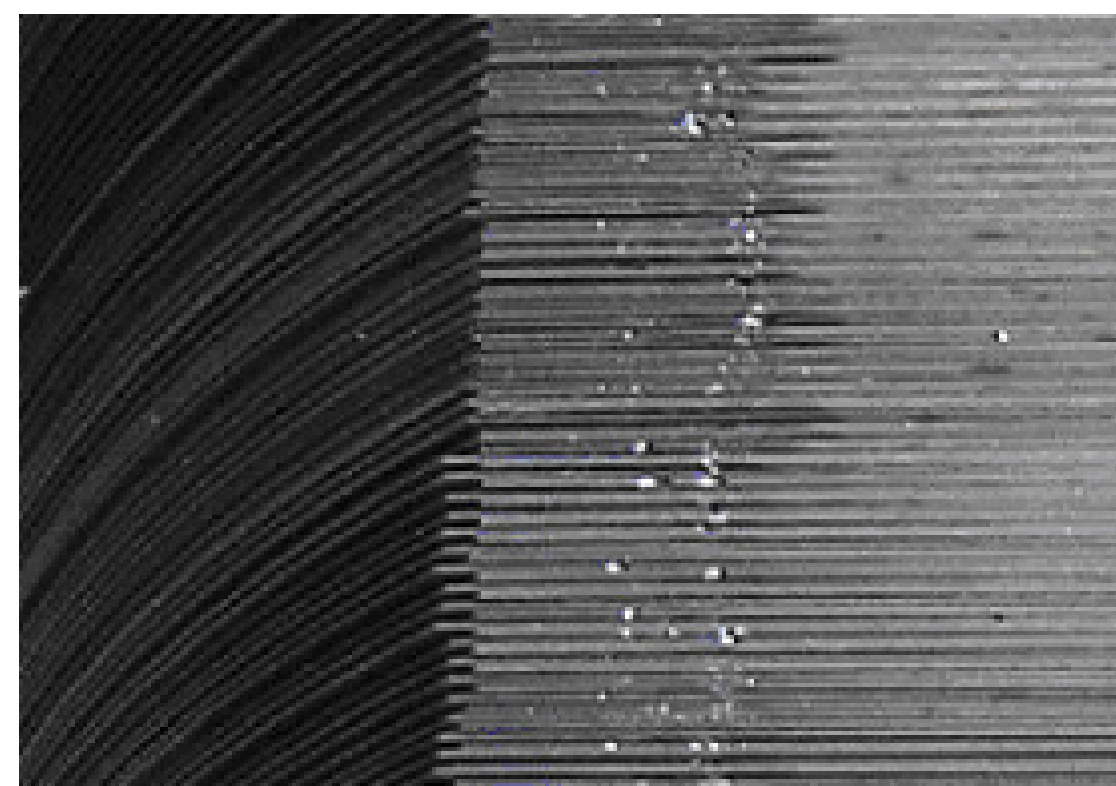
To measure the extrinsic damage generated during the solar cell process, two sets of thin 125x125mm^2 monocrystalline silicon wafers were introduced in a standard production line. These sets of wafers were 125µm and 150µm thick, respectively, whereas the production line was prepared for 240µm thick wafers. Results show that crack formation is related more to the wafer handling process (fig.1) rather than the cell processing.

Thin wafers must be handled with special care so that optical aligning and vacuum handlers are capable of carefully managing them. Pushers, lateral friction points, mechanical positioners and any strike in the edge of the wafer could be a crack source that leads to breakage.

Figure 1: Wafers damaged by handling tools

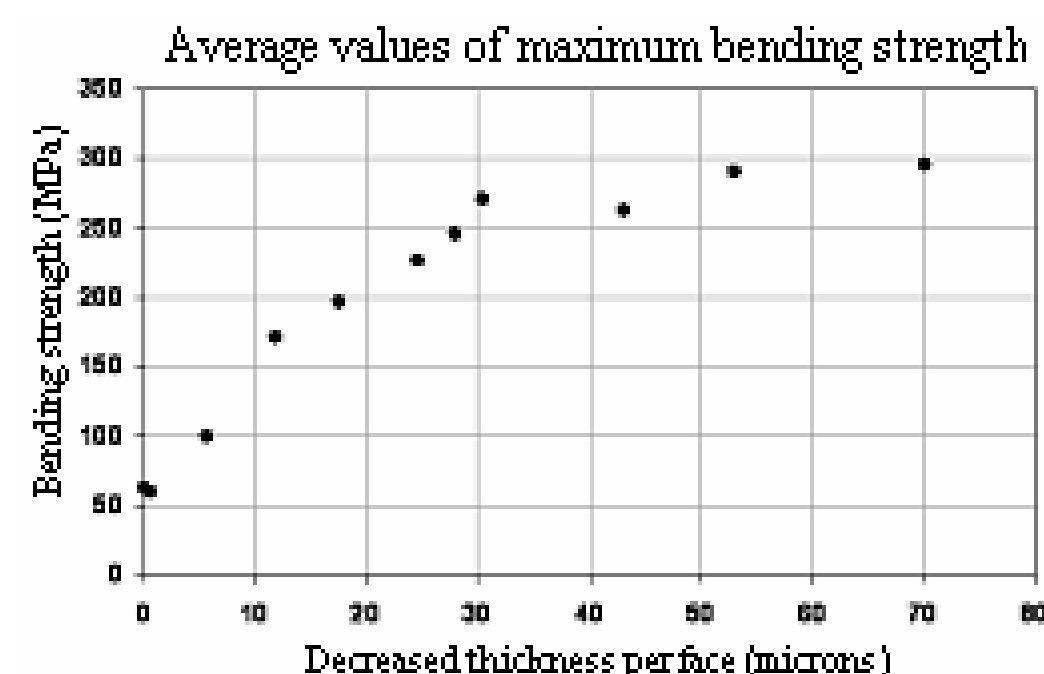
Test results show dependence between decreased thickness and mechanical strength of the wafer, but this dependence changes form one etching method to another. The best results are obtained with chemical etching (NaOH) and the mechanical strength of the wafer is enhanced with a longer etching process. Above a certain value of decreased thickness, around 30 microns per face, the bending strength remains constant (fig.5). With this decrease, the surface cracks caused by the sawing process have been eliminated. Any other type of etching like mechanical etching or chemical etching with acid $HF\text{-}HNO_3$ shows worse results.

Figure 5: Bending strength with decreased thickness

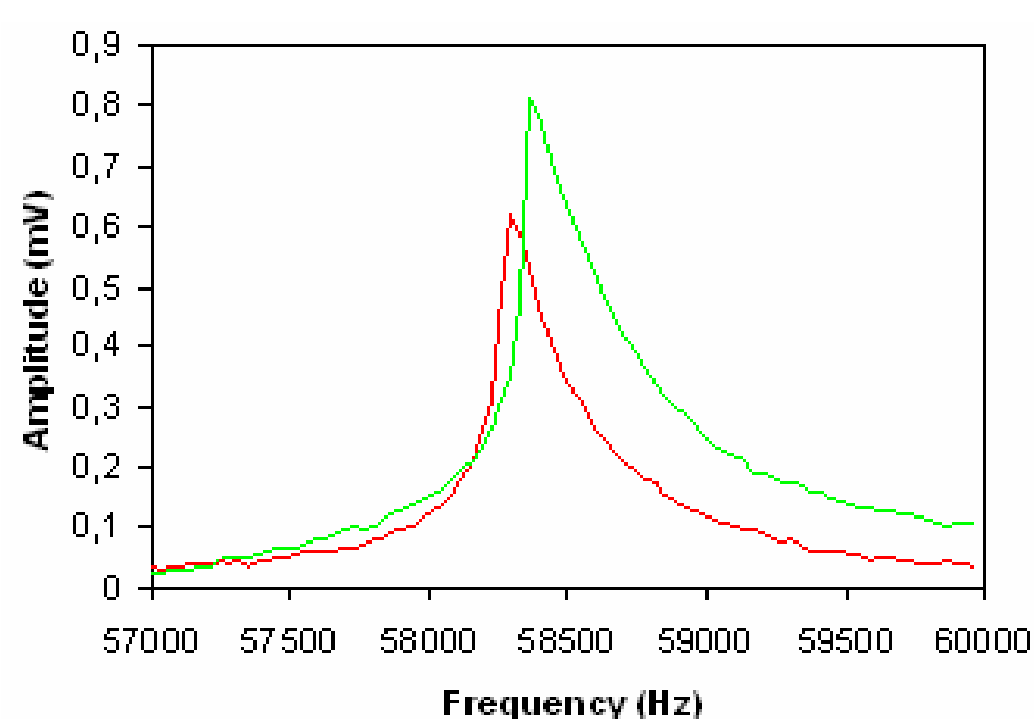
If a wafer has a crack its resonance peak frequency shifts down, the peak becomes wider, and its amplitude decreases. The responses of an undamaged wafer and a wafer with a crack can be seen in figure 7.

Figure 7: Resopnse of two 125x125mm monocrystalline silicon wafers. The red trend shows a damaged wafer.
