250TH ANNIVERSARY OF THE 1755 LISBON EARTHQUAKE

Structural Monitoring of the Monastery of Jerónimos

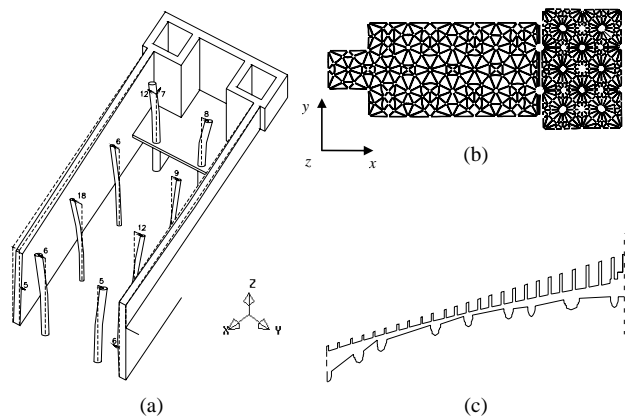
The nave is divided by two rows of columns, with a free height of about 16.0 m. Each column possesses large bases and fan capitals. The transverse sections of the octagonal columns have a radius of 1.04 m (nave) and 1.88 m (nave-transept). The columns seem to be made of a single block or two blocks, for the nave, and four blocks, for the transept. The topographic survey of the columns presented by Genin (1995) demonstrates the vertical unaligned for all the columns and the external walls, with a maximum of 0.18 m, as it can be observed in Figure 3a.

Fig. 3. Aspects of the geometry: (a) topographic survey of the columns and external walls; (b) and (c) plan and transversal cross-section of the nave, respectively.

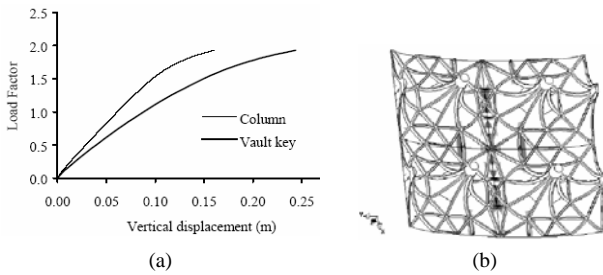
Fig. 5. Results of the nave analysis: (a) load-displacement diagram; (b) maximum principal strains (equivalent to cracks).

Figure 5a illustrates the load-displacement diagrams for the vault key and top of the column. Here, the load factor represents the ratio between the self-weight of the structure and the applied load, meaning that the ultimate load factor is equivalent to the safety factor of the structure. It is possible to observe that the response of the structure is severely non-linear from the beginning of loading, for the nave, and from a load factor of 1.5, for the column. The behaviour of the nave is justified by the rather high tensile stresses found in the ribs, using a linear elastic model. The collapse of the columns is due to the normal and flexural action. The safety factor is 2.0, which is rather low for this type of structures.

The stresses are bounded in tension and compression, meaning that cracking and crushing occurs. Figure 5b illustrates the maximum principal strains, which are related to cracking of the structure. The pairs of transverse ribs that connect the columns (in the central part of the structure) exhibit significant cracking, as well as the infill in the same area. Additional cracking, less exuberant and more diffused, appears in the central octagon defined by the capitals of the four columns. Such cracking occurs at the key of the octagon and in the longitudinal ribs, which confirms the larger displacements of the vault and the bidirectional behaviour of the vault. Finally, the columns exhibit also very high compressive stresses, which lead to the collapse mechanism described before.

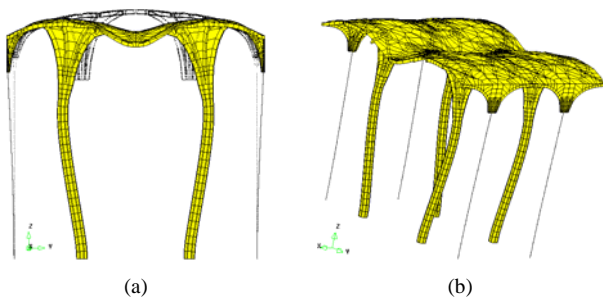
The deformed mesh at failure, see Figure 6, indicates that the structural behaviour is similar to a two-dimensional frame, with a collapse mechanism of five hinges (four hinges at the top and base of the columns and one at the key of the vault. Nevertheless, there is some vault effect with slightly larger displacements at the central octagon, formed between the four capitals.

Fig. 6. Deformed mesh failure: (a) cross-section; (b) perspective view.

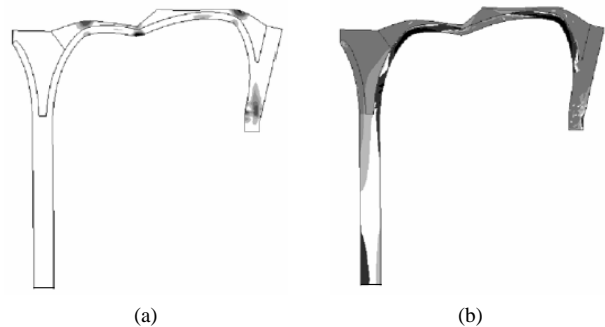
Fig. 7. Results of transept analysis at collapse: (a) maximum principal strains (equivalent to cracks); (b) minimum principal stress (compression), depicted on deformed meshes.

Collapse occurs with a typical four hinges mechanism; being three hinges located in the vault and one hinge located in the right support, see Figure 7. The collapse involving the right wall occurs due to the consideration that the nave prevents inwards movement of the (left) column. Figure 7a indicates that the arch is cracked at the key (intrados) and both quarter spans (extrados). Significant cracking is also present in the right support. Figure 7b demonstrates that high compressive stresses are found in the arch and in the base of the right wall. The compressive stresses in the left column are moderate and do not govern collapse.

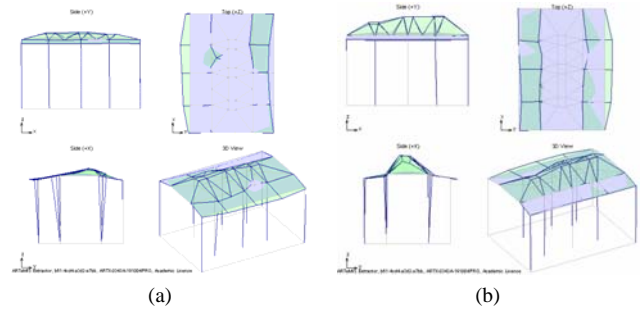
Figure 11 shows the mode shape configuration for the first two modes. As it was observed in the preliminary numeric analysis, the dynamic response of the main nave is influenced by the dynamic response of the slender columns. The first mode shape is not a global mode of the church, because the nave boundaries do not suffer significant deformations as can be observed in its central part. The mode configurations are essentially composed by components in y (North-South) and z (vertical) directions.

Fig. 11. Experimental mode shape results from EFDD method: (a) first mode shape at 3.7 Hz; (b) second mode shape at 5.1 Hz.

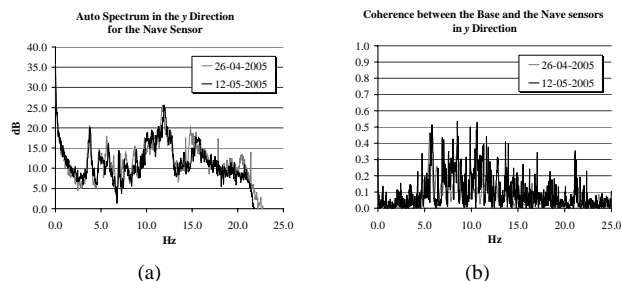
For the same dates and direction y, Figure 15a shows the auto spectrum of the sensor A2, where the shifts between the two time records are very small and can be only perceptible for the frequencies peaks below 5 Hz. Detail analysis of this shifts are premature at this stage, because it is necessary to have more

Figure 15b presents the coherence between the base and the nave sensor in the y direction. It is possible to observe small coherence values between the signals, with a maximum of 0.5 for frequencies below 5 Hz. These values can be justified by the distance between the two measured points, which can reduce the signal correlation, or by the fact that these events were programmed and they do not correspond to a site tremor.

Fig. 15. Events comparison in y direction: (a) auto spectrum; (b) coherence values.
