3rd International Symposium on Fatigue Design and Material Defects, FDMD 2017, 19-22 September 2017, Lecco, Italy

# Experiments on crack propagation and threshold at defects in press-fits of railway axles

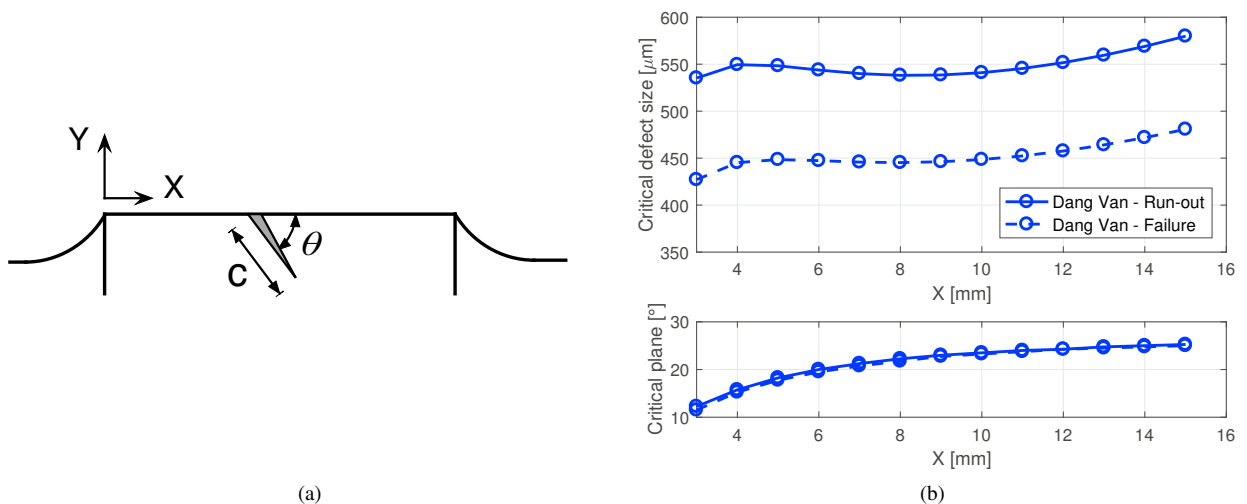
In Figure 1b, results showing the non-propagating crack size for F4 axle under the two different loading conditions, failure and run-out, are presented. Due to the numerical stress singularity at the seat edge where the transition to the axle body starts, the proposed method can be applied starting from 2-3 mm away from the transition edge. As shown in Figure 1b, the predicted region susceptible to crack propagation is found to be located at a distance of 4-10 mm away from transition edge. When a nominal stress of 132 MPa (dashed line corresponding to a failure condition in Figure 1b) is applied, allowable crack size is predicted to be $c = 450 \, \mu m$ in length. This limitation increases to a level of $c = 540 \, \mu m$ for an applied stress $\sigma_{nom}$ = 120 MPa, which is the loading condition for run-out axles. The critical plane orientation $\theta$, presented in Figure 1b and independently from the applied nominal stress, was estimated to be in the range $20 - 25°$.

Fig. 1. Prediction of allowable defect sizes under fretting fatigue by a modified Dang Van criterion: a) problem statement; b) predictions by Foletti et al. (2016).

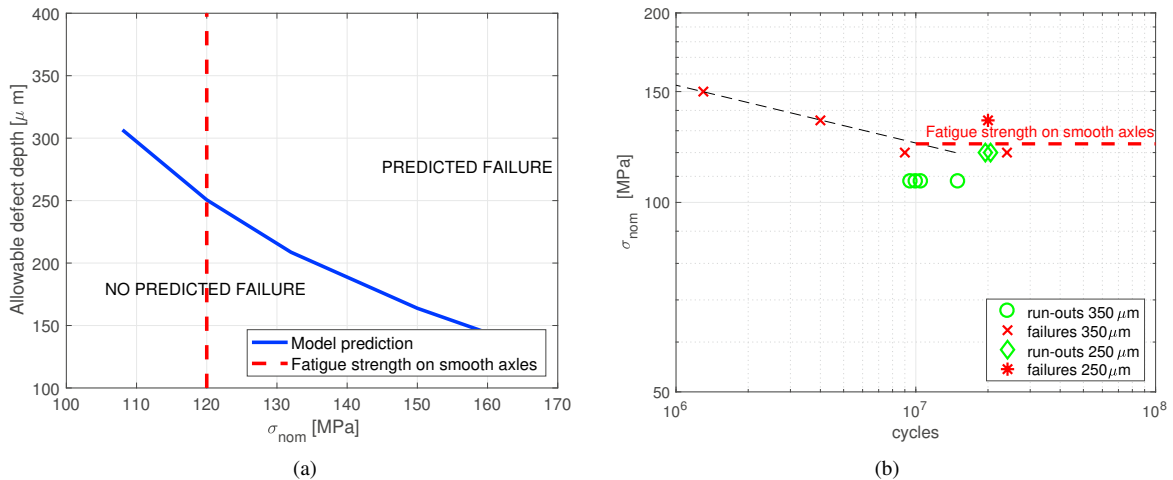
Micronotches were located at the distance x = 10 mm from the transition edge, close to the minimum allowable crack size predicted by the model, see Figure 1b. At this distance, the maximum allowable defect depth predicted by the criterion for the axle's geometry under investigation is shown in Figure 3a. The fatigue strength is decreasing with respect to the one of a smooth axle only if a defect with a depth greater than $250\mu m$ is present.

Fig. 3. a) Prediction of the allowable defect depth under fretting; b) S-N diagram of the fretting tests on full-scale axles containing circumferential micronotches.

Experimental results are reported in details in Table 1 and Figure 3b in terms of a prospective S-N diagram for axle press-fits. For a defect depth of $350\mu m$, the full-scale fatigue strength is slightly lower than the one of smooth axles, while the presence of a defect with a depth of $250\mu m$ seems not to affect the fatigue strength.

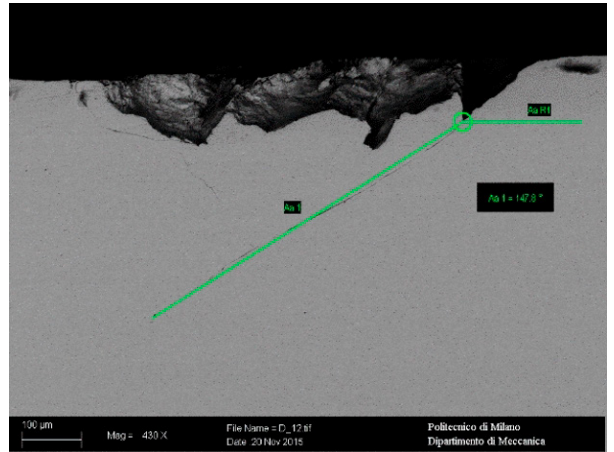
The fractographies are reported in Figure 4. Considering Axle #1, it presented no UT indications at the end of the first load step (110 MPa), while it failed rapidly, as expected, during the second one (150 MPa). Final failure originated at micronotches with a maximum crack depth of 25mm. Multiple cracks originated in the free side at a distance from the edge of the seat ranging from 5 to 15 mm, see Figure 4a and 4b.

(a) Axle #1. Final failure at a micronotch. Maximum crack depth: 25mm

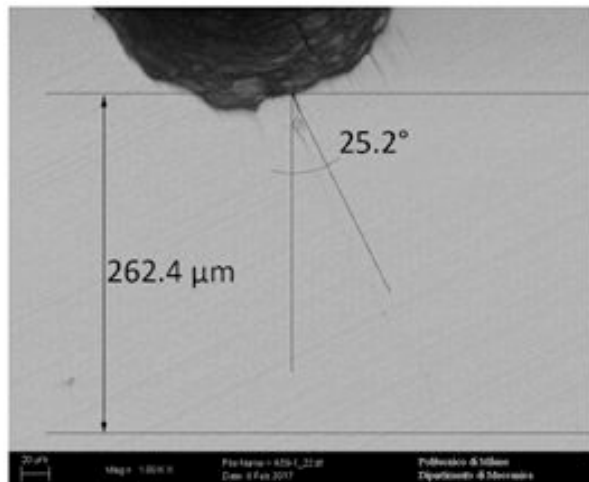
Finally, Axle #4 was first tested at 110 MPa without showing any UT indications and, then, at 135 MPa, which it failed at (Fig. 4f). Failure originated at micronotches with a final crack depth of 24mm.

(d) Axle #2. Multiple cracks at the press-fit region

(e) Axle #3. Crack at a micronotch

(f) Axle #4: Final failure at a micronotch. Maximum crack depth: 24mm

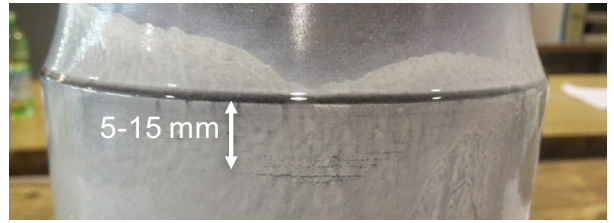
(b) Axle #1. Multiple cracks at the press-fit region

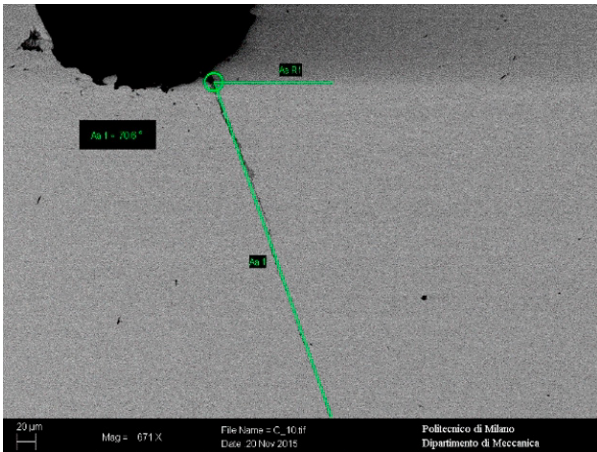
In the case of Axle #2, the first load step (110 MPa) didn't show, again, any UT indications, while, during the second one (120 MPa), some were detected after about $9 \cdot 10^6$ cycles. The test was, then, interrupted in order to investigate the indications without reaching the final failure of the axle. The indications were confirmed by MPI and the relevant regions sectioned and lapped. Figure 4c and 4d show that fretting fatigue cracks originated at both micronotches and the press-fit region. Axle #3 was tested repeating the same load program used for Axle #2, getting very similar results (Fig. 4e).

(c) Axle #2. Crack at a micronotch

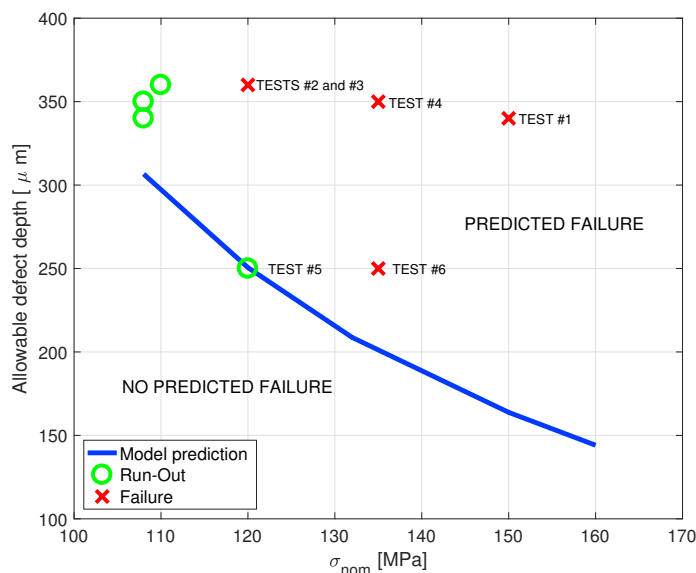
The summary of the experimental results is shown in Figure 5 together with the comparison with the predicted failure locus. The results show that the proposed model based on the Dang van criterion is slightly conservative in predicting the fatigue strength in presence of a defect with a depth of $350\mu m$.

On the other hand, as predicted by the model, an artificial defect with a depth of $250\mu m$ is competitive with naturally propagating cracks originated from surface scars and surface damage, leading to an unchanged fatigue strength.

Nevertheless, the failure condition is always well predicted by the model for both defect sizes.

Fig. 5. Comparison between experimental results and the failure locus according to the Dang Van modified criterion.
