Seismic Vulnerability Assessment and Evaluation of High Rise Buildings in Islamabad

SUMMARY

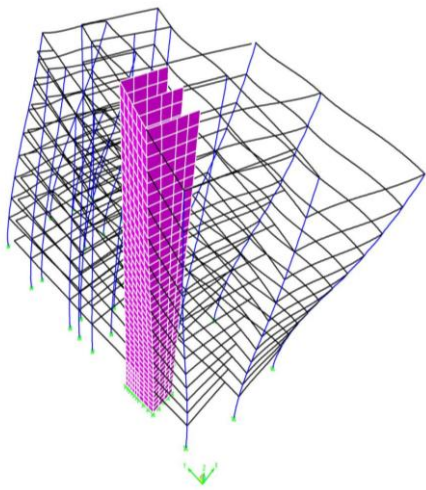
Photo 1. Collapse of Margalla Tower during Oct 8, 2005 Earthquake
