Investigation of short-circuit failure mechanisms of SiC MOSFETs by varying DC bus voltage

Masaki Namai*, Junjie An, Hiroshi Yano, and Noriyuki Iwamuro*

Graduate School of Pure and Applied Sciences, University of Tsukuba,

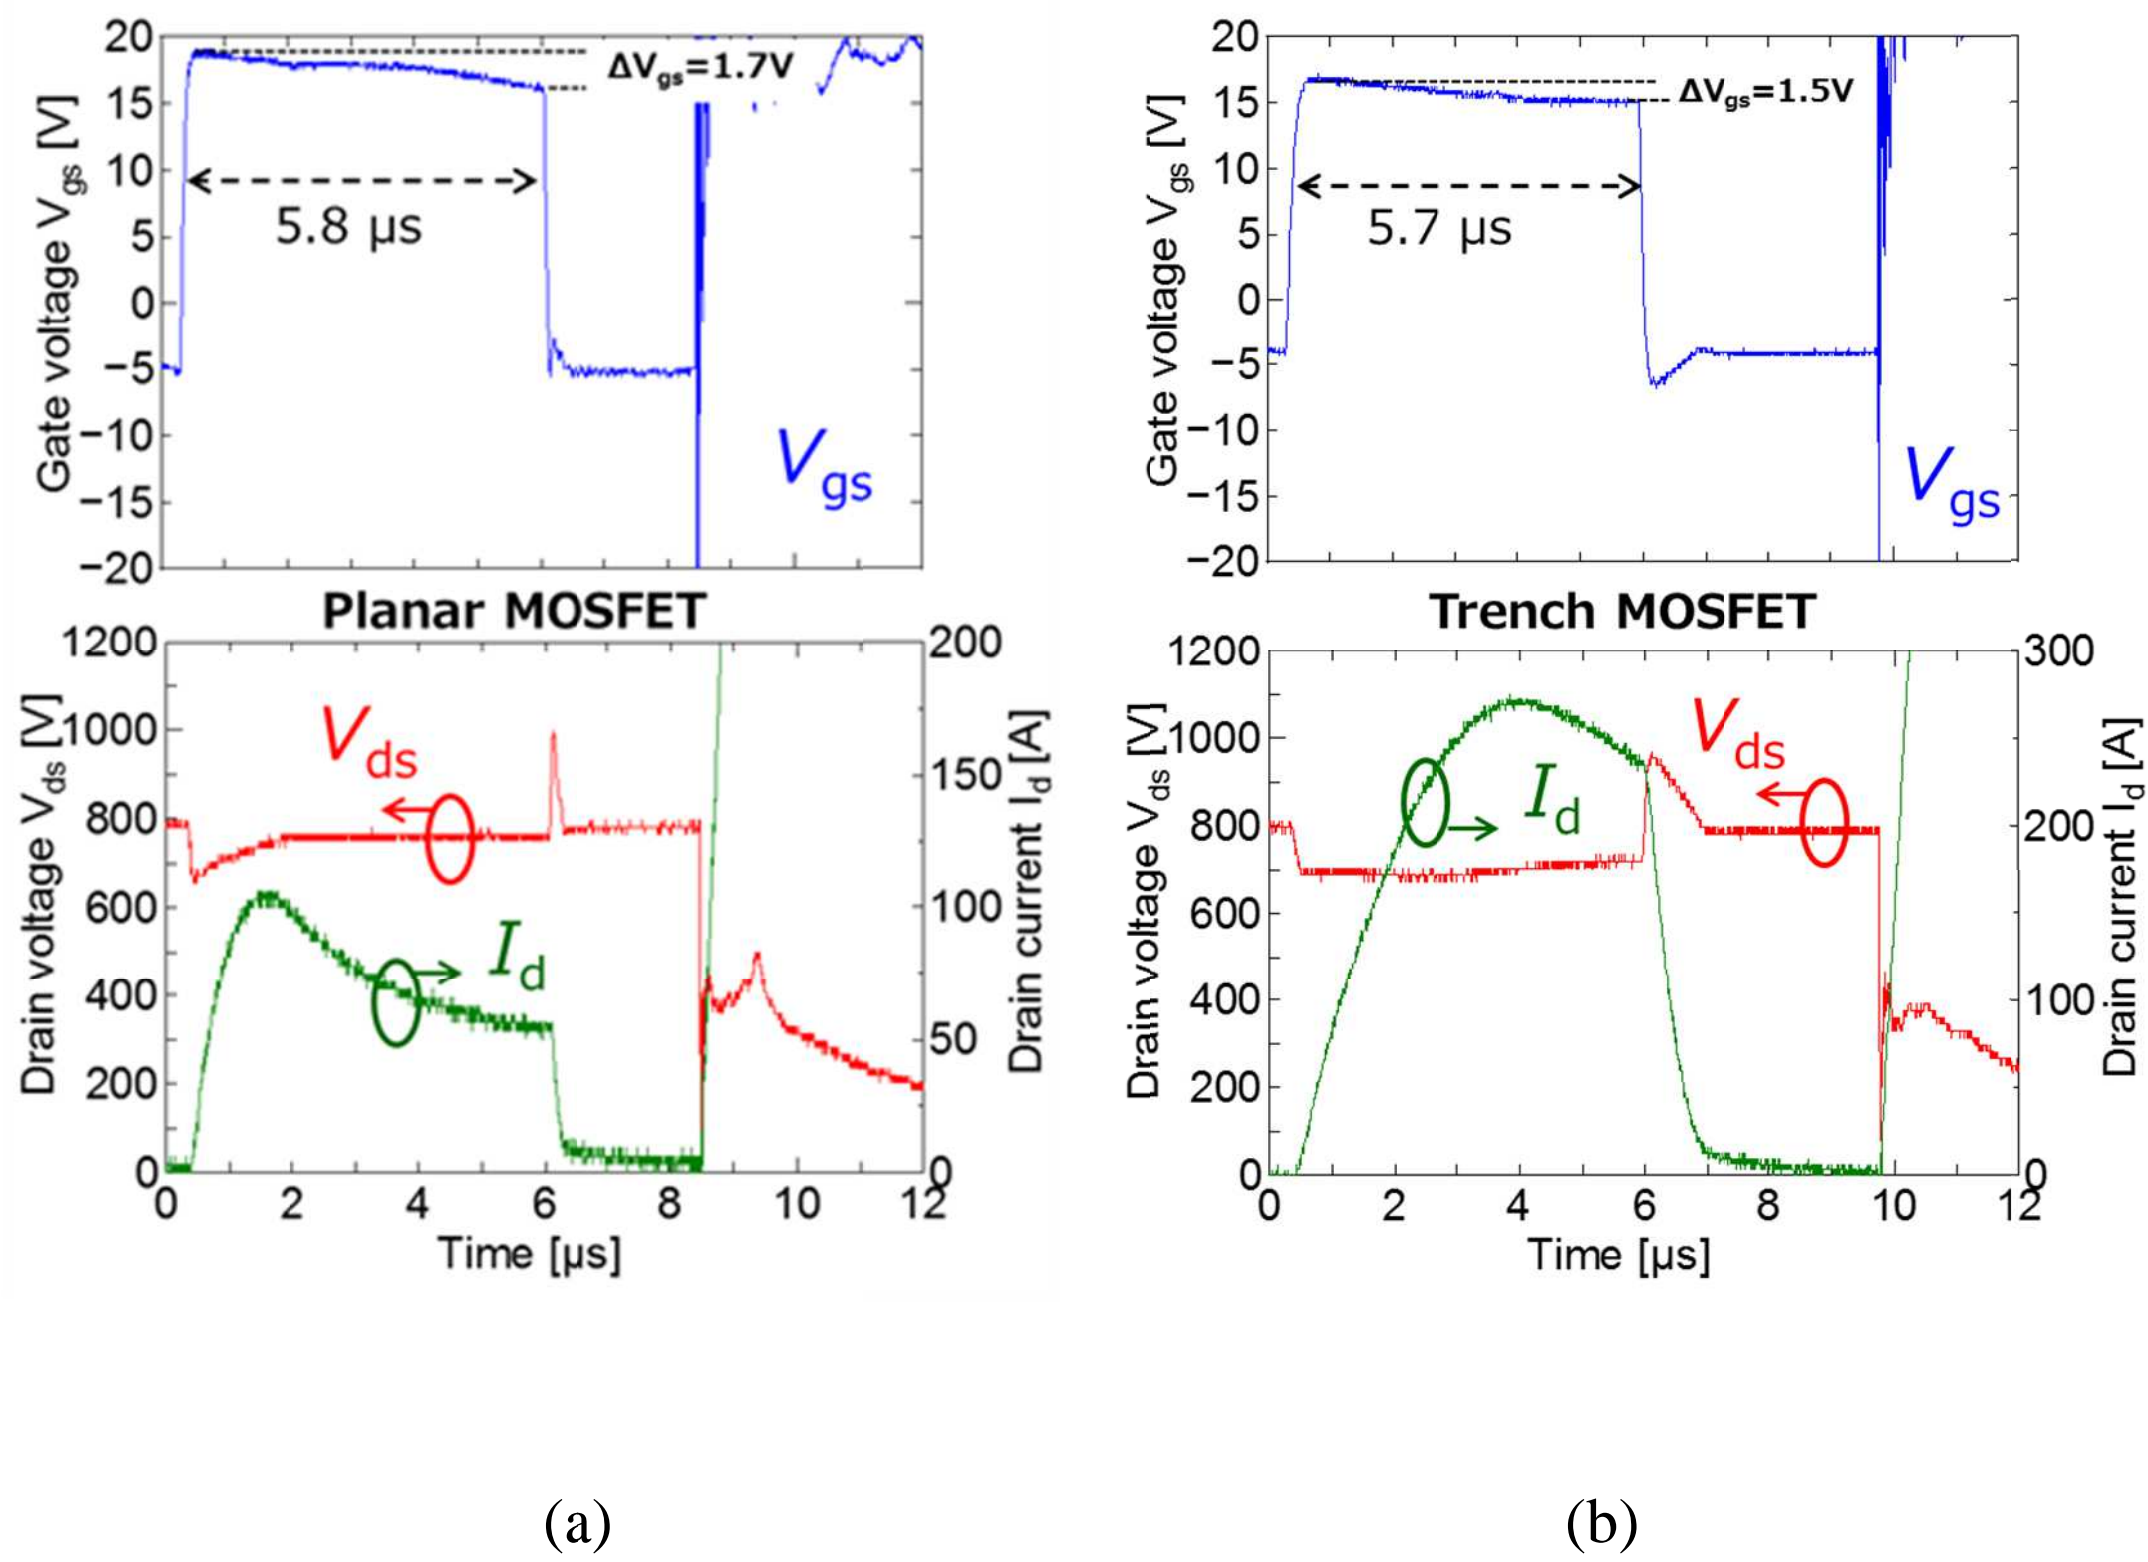
Figure 5 (Color Online)

The measured $t_{\mathrm{SC_CR}}$ values were 5.8 and 5.7 μs and the measured E_{SC} values were 10.4 and 9.9 J/cm^2 for the SiC planar and trench MOSFETs, respectively. At device turn-off, the device failures had not occurred; however, at 2.6 and 4.0 μs after device turn-off, for the planar and trench MOSFETs, respectively, delayed failures were observed. In addition, an increased leakage current appeared as a tail current after device turn-off, despite the fact that such a tail current should not be present in unipolar devices. The tail current occurred primarily because the combination of high voltage and increased hole current generated a severe power dissipation in the device, despite the short-circuit conditions no longer being present. If the dissipated power exceeds the power being transferred away from the device, the hole current will further increase and temperatures will increase, leading to a positive feedback process known as thermal runaway.[3)]

As seen in the measured waveforms shown in Fig. 5, the gate voltages in both types of MOSFET decreased gradually as the short-circuit transient increased. This change in the gate voltage ΔV_{gs} was caused by gate oxide degradation caused by an increase in gate leakage current due to high gate electric field and lattice temperature. This gate leakage current, which is caused by Fowler-Nordheim tunneling and Poole-Frenkel emission,[32, 33)] increased as a result of the higher temperature, resulting in damage to the gate oxide layer. Note that this damage to the gate oxide layer was encountered during the gate turn-on (V_{gs_on}) period. Figure 11 shows the measured short-circuit waveforms of the trench MOSFET at a reduced V_{gs_on} of 12 V. It can be seen that ΔV_{gs} becomes lower than 0.8 V, indicating that the gate leakage current was successfully reduced. However, the values of E_{SC} remain almost identical (9.9 J/cm^2 at a V_{gs_on} of 15 V, and 10.0 J/cm^2 at a V_{gs_on} of 12 V). These results indicate that neither increased gate leakage current nor gate oxide rupture was the principal cause of device failure under the specified conditions.

Fig. 5. (Color online) Measured short-circuit waveforms of the (a) planar and (b) trench MOSFETs at a DC bus voltage of 800 V. Turn on- and turn off-gate voltages were set from (a) +18 to -5 V and (b) +15 to -4 V.

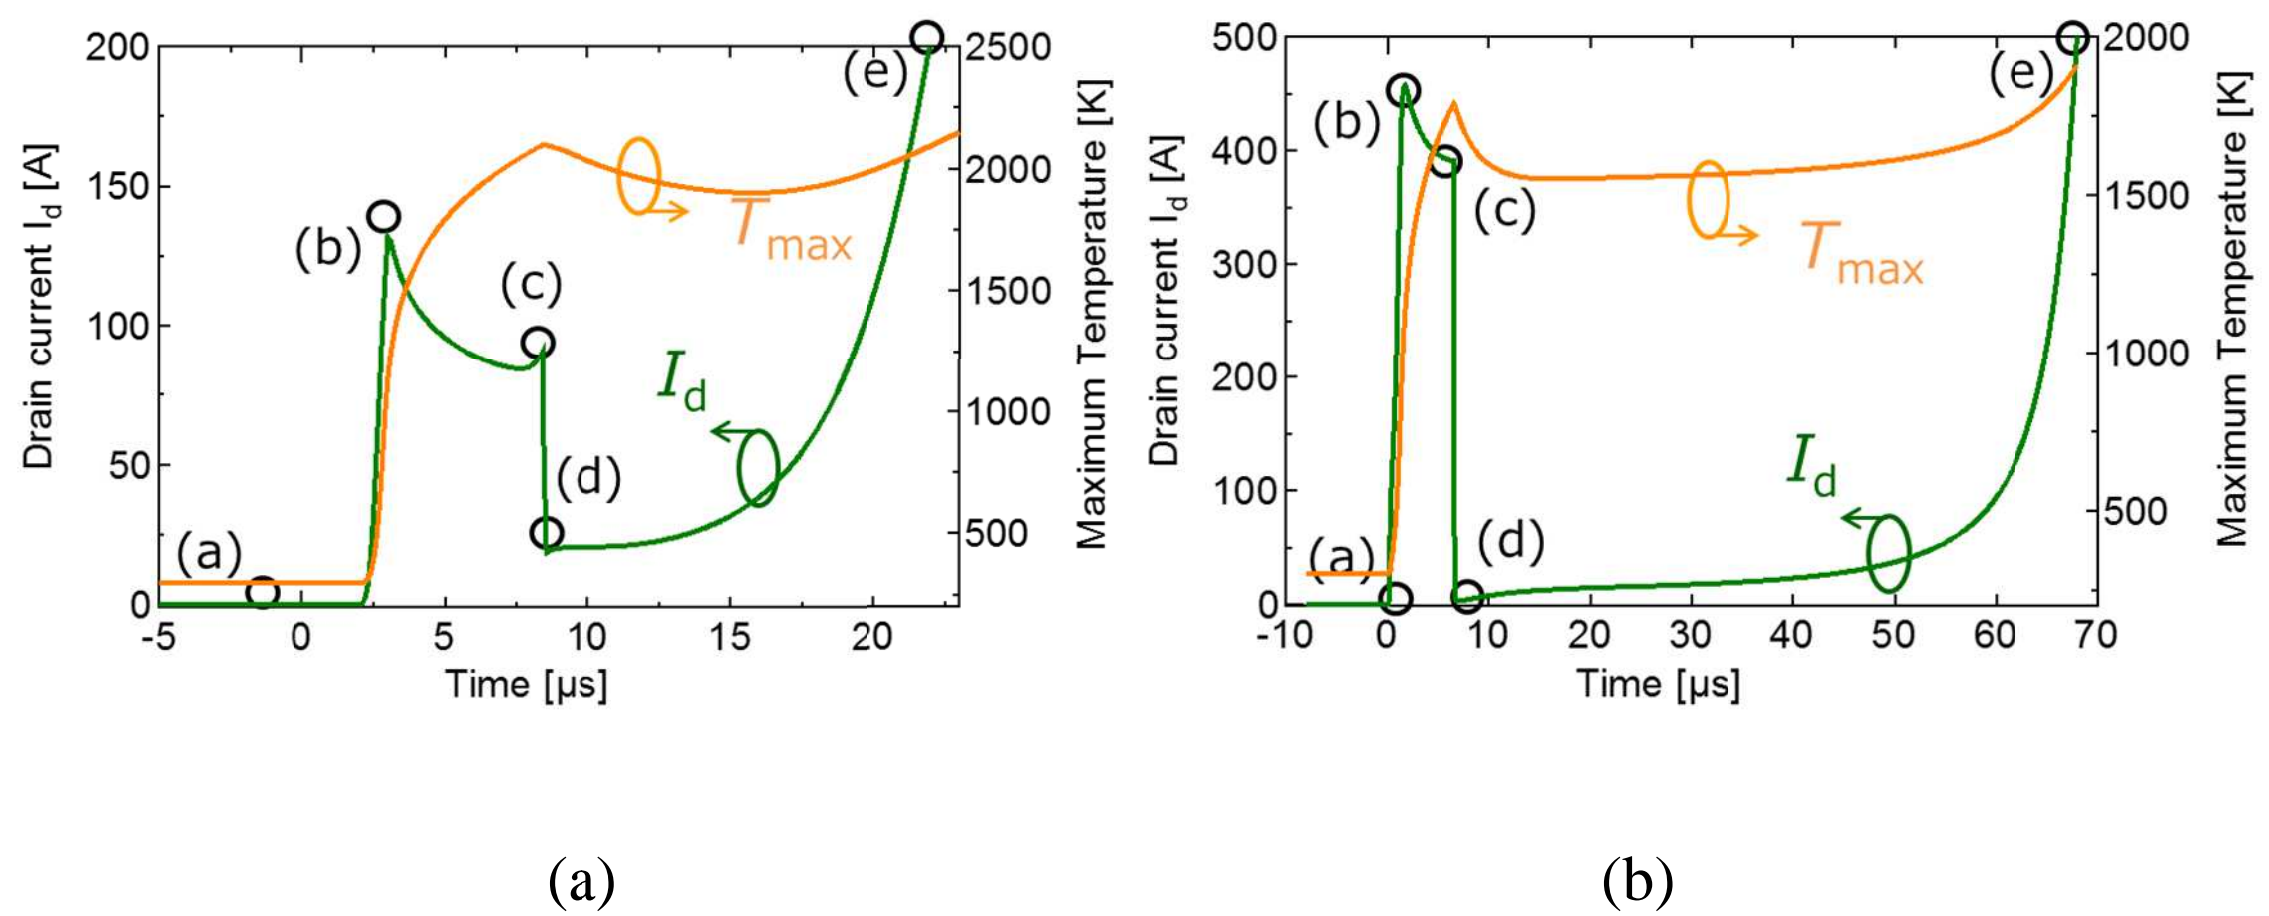
Figure 6 (Color Online)

Fig. 6. (Color online) Simulated drain current and maximum temperature in the SiC (a) planar and (b) trench MOSFETs at a DC bus voltage of 800 V and gate voltages from +15 to -4 V.

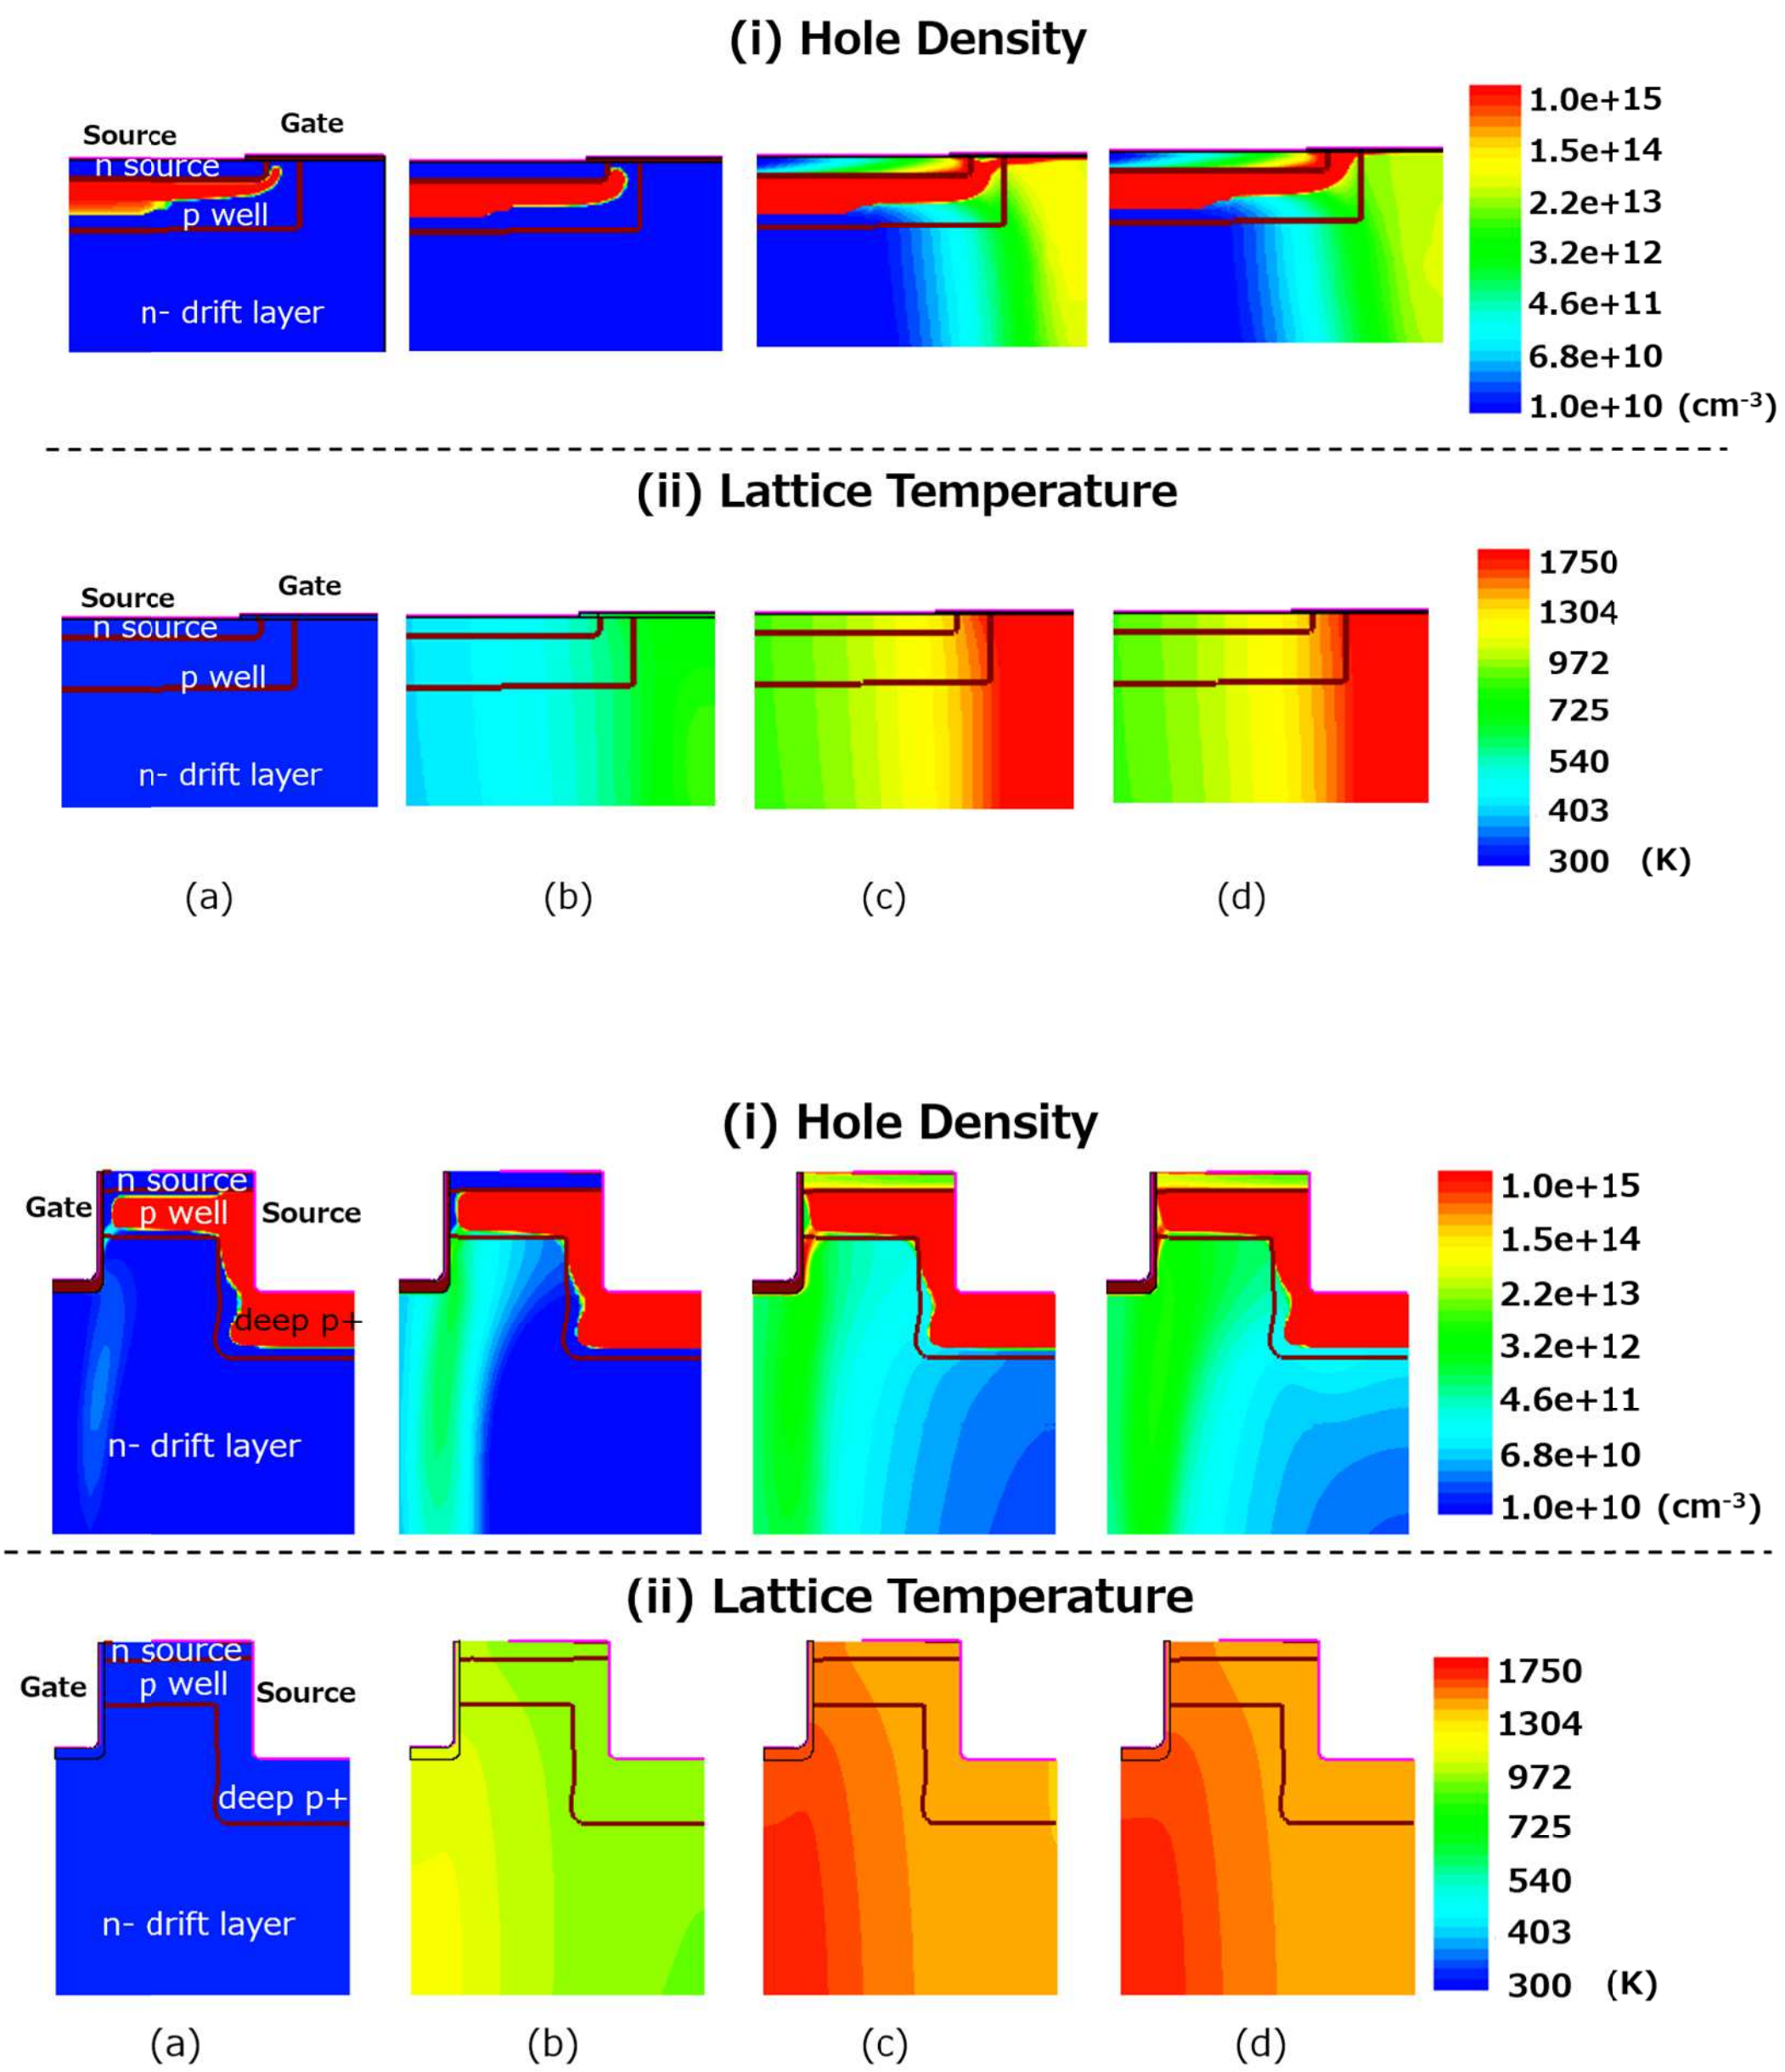
Figure 7 (Color online)

Fig. 7. (Color online) Simulated results for (i) hole density and (ii) temperature distribution in the SiC planar and trench MOSFETs at a DC bus voltage of 800 V and V_{gs} from +18 to -5 V and V_{gs} from +15 to -4 V, respectively, during the short-circuit transient. Graphics (a) - (d) correspond to the points shown in Fig. 5.

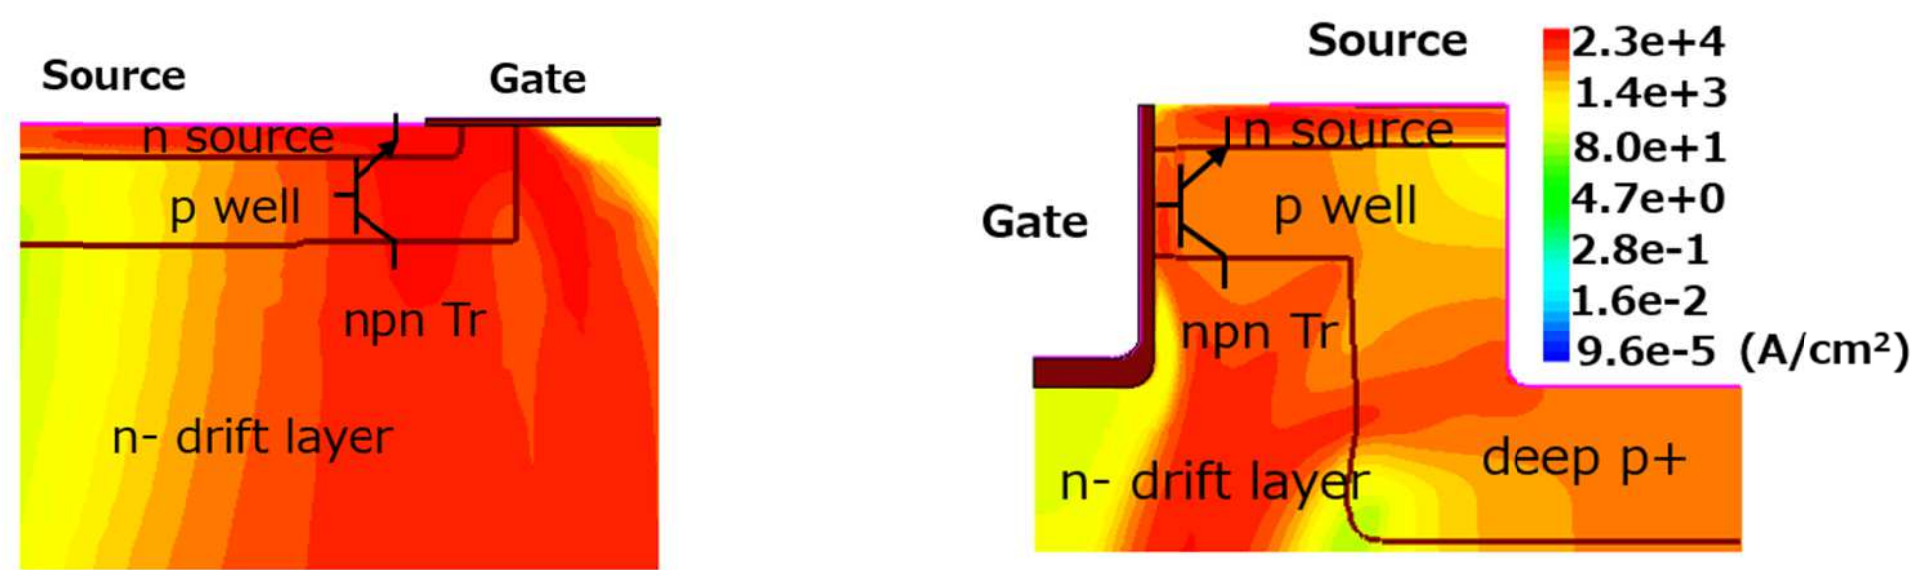
Figure 8 (Color online)

Fig. 8. (Color online) Simulated total current density distribution of the SiC planar and trench MOSFETs at point (e) in Fig. 5. The parasitic npn transistor was activated.

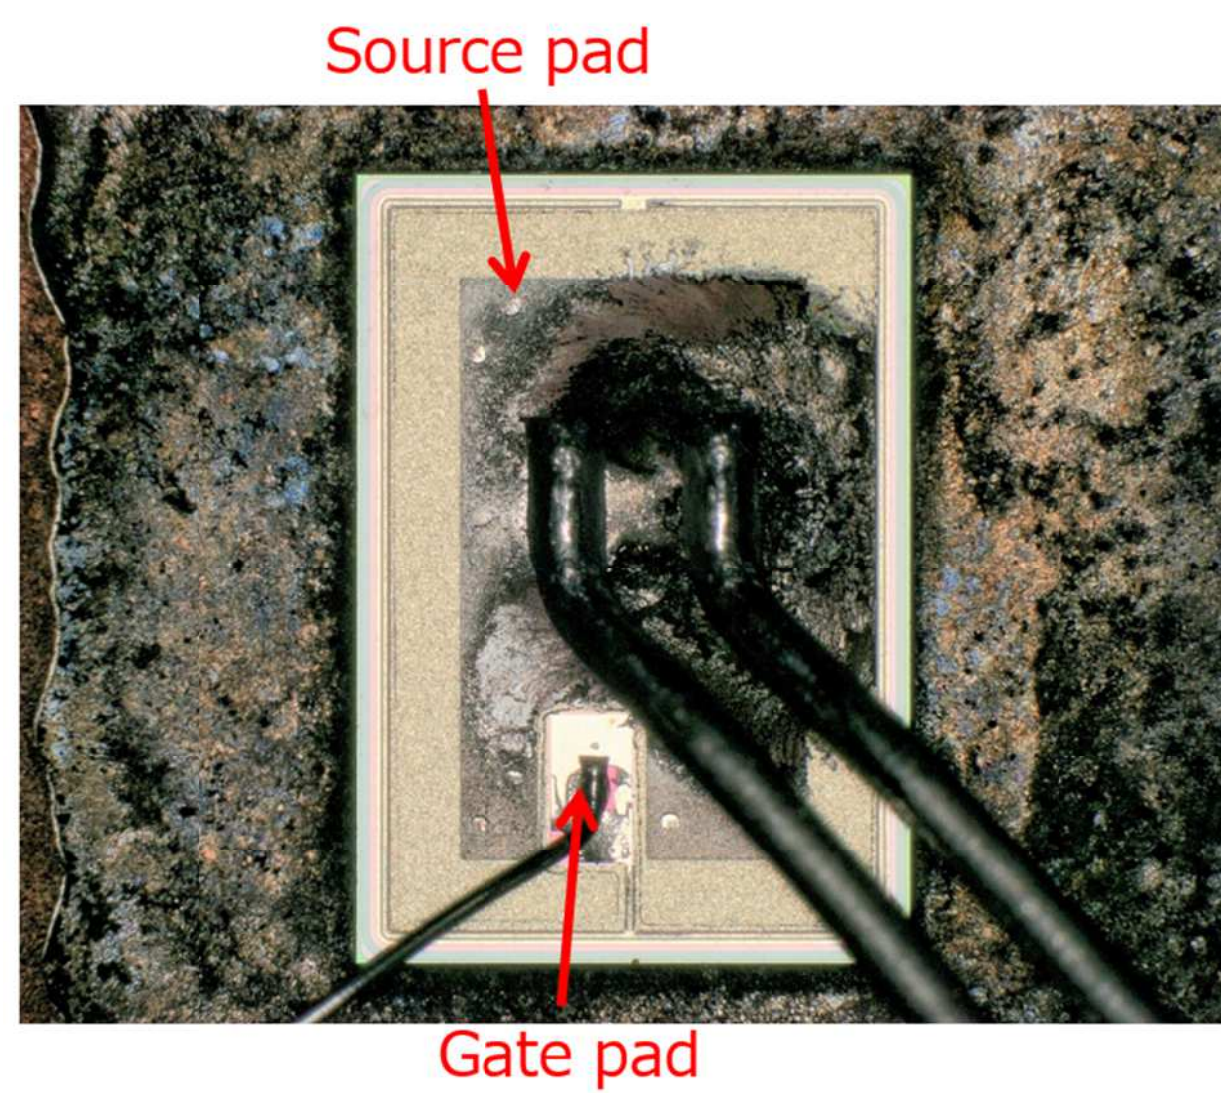
Figure 9 (Color online)

Figure 9 shows a top view of one of the SiC trench MOSFETs after a short-circuit test at a DC bus voltage of 800 V. It is clear that the source electrode near the bonding wires melted as a result of a sudden marked increase in drain current immediately after the aforementioned activation of the parasitic npn transistor. Table I shows the measured resistances between three terminals (R_{gs}, R_{gd}, and R_{ds}) of the failed SiC planar and trench MOSFETs after the short-circuit test. It is apparent that the extremely low resistances between the electrodes resulted in all of them becoming completely shorted.

Fig. 9. (Color online) A top view of one of the SiC trench MOSFETs following a short-circuit failure. The DC bus voltage was 800 V and V_{gs} values were from +15 to -4 V.

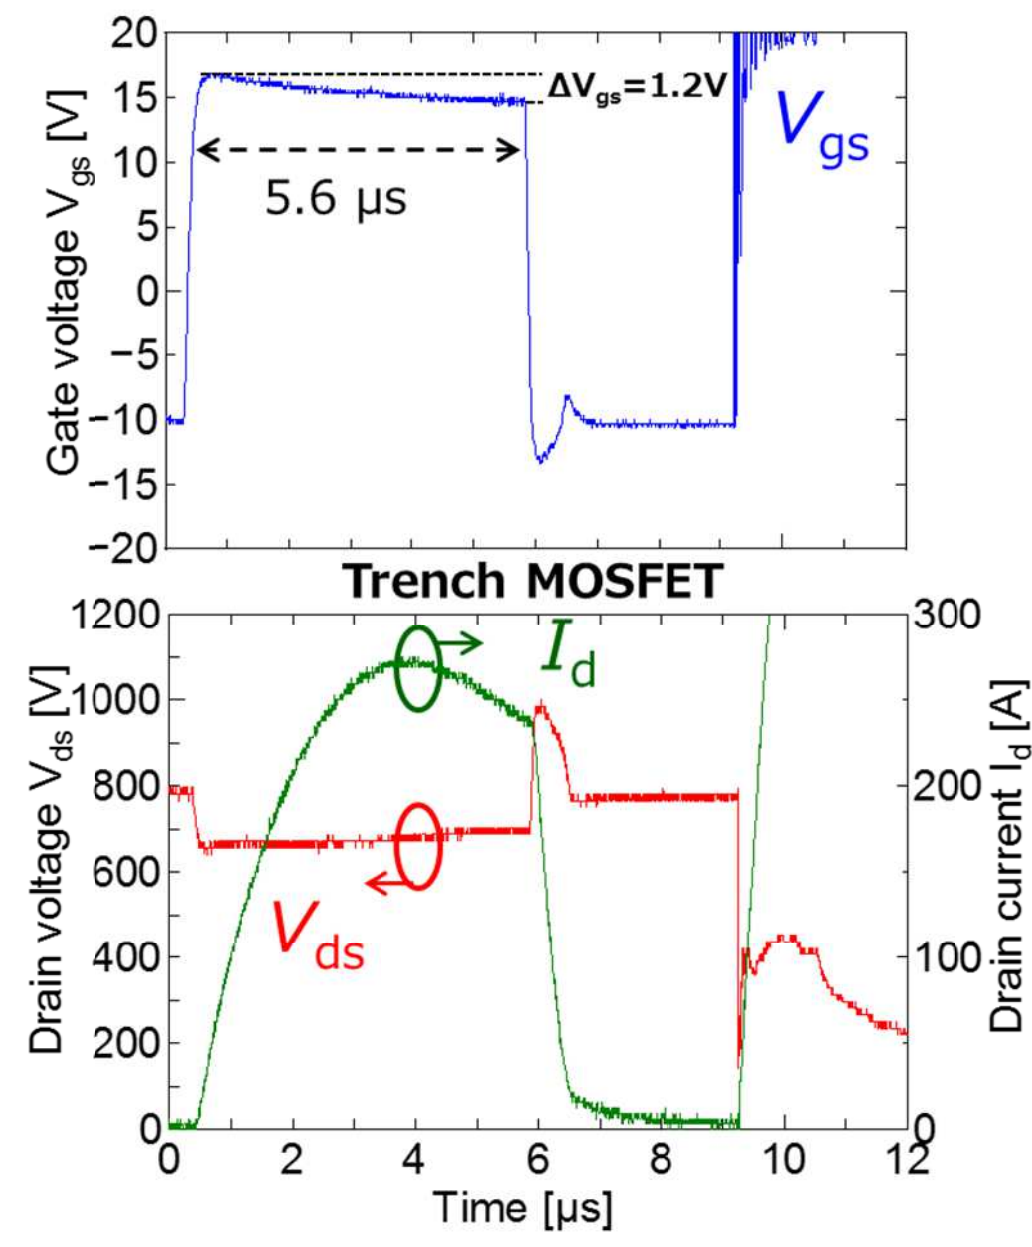
Figure 10 (Color online)

Fig. 10. (Color online) Measured short-circuit waveforms of the SiC trench MOSFET at a DC bus voltage of 800 V and gate voltages from +15 to -10 V.

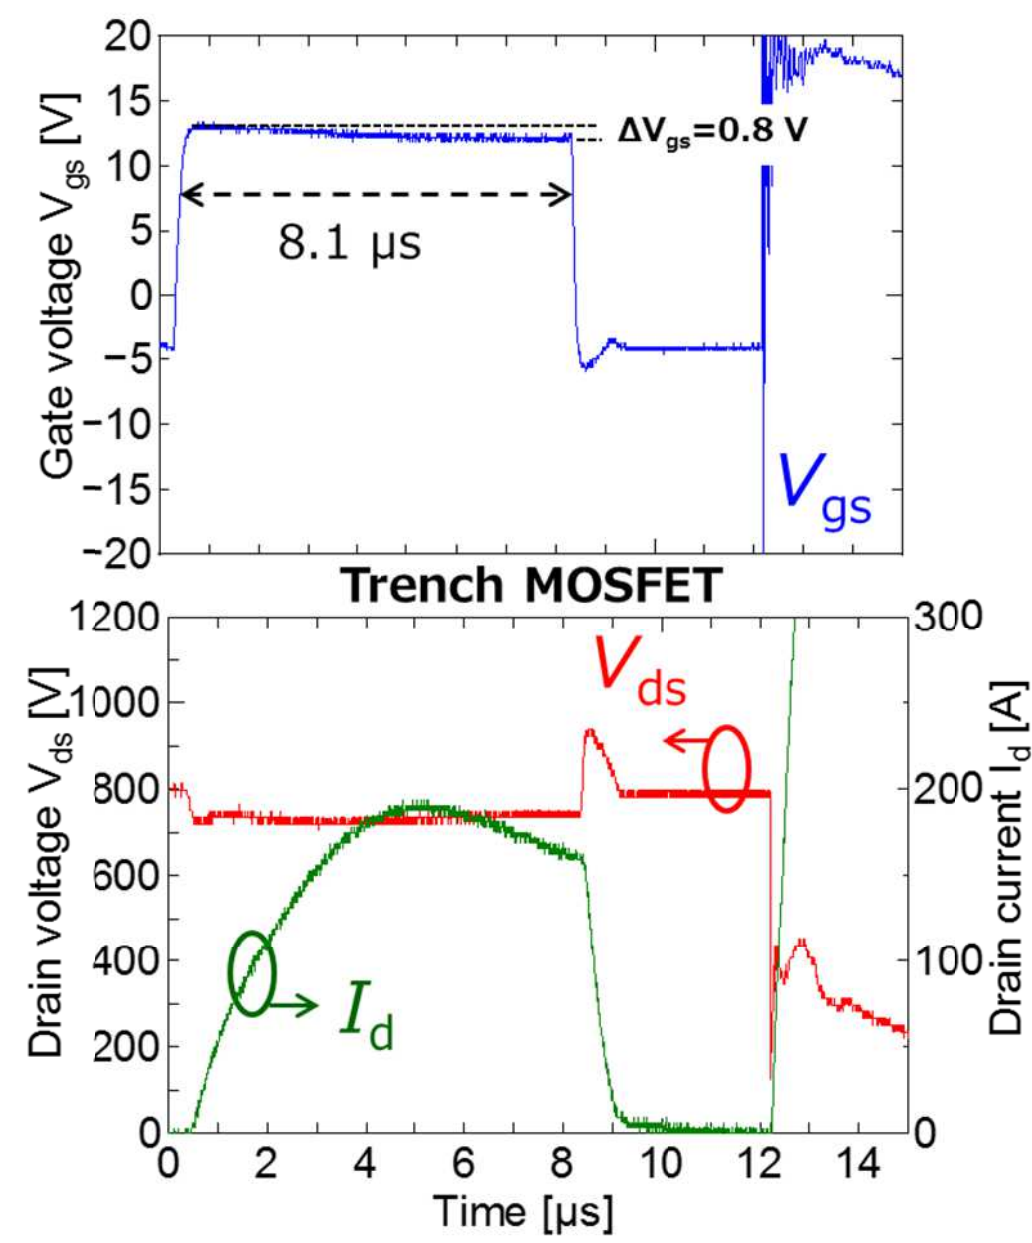
Figure 11 (Color online)

Fig. 11. (Color online) Measured short-circuit waveforms of the SiC trench MOSFET at a DC bus voltage of 800 V and gate voltages from +12 to -4 V.

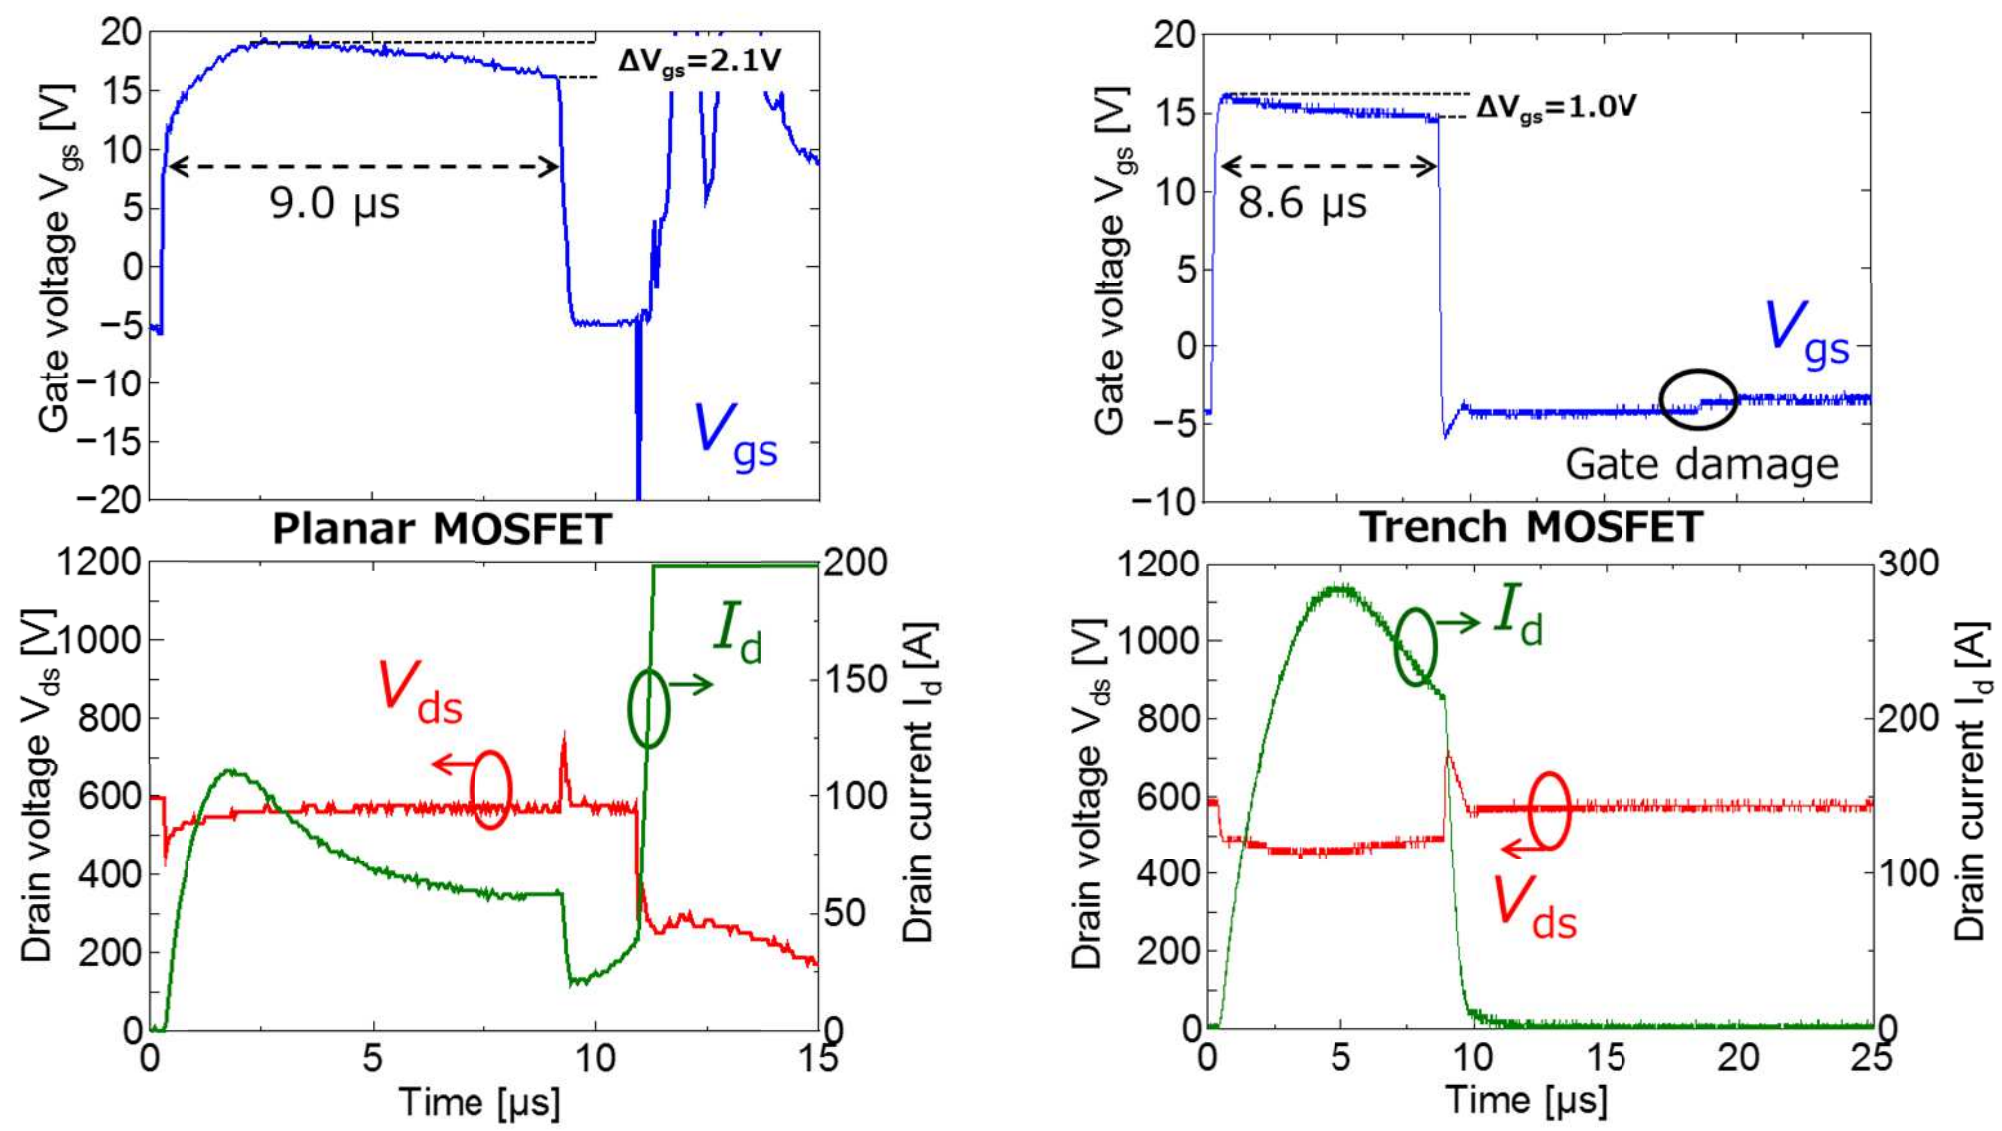
Figure 12 (Color online)

From Fig. 12(a), the drain current kept flowing after device turn-off. It was suggested that the planar MOSFET cannot be turned off completely even after gate turn-off because of the high temperature (as described in the previous section). The planar MOSFET has a lower threshold voltage (2.5 V) than the trench MOSFET (4.7 V). A device with a lower threshold voltage is easy to operate during normally-on operation, but the trench MOSFET is not easy to operate during normally-on operation owing to its higher threshold voltage.

Fig. 12. (Color online) Measured short-circuit waveforms for the (a) planar and (b) trench MOSFETs at a DC bus voltage of 600 V. The on- and off-gate voltages were set at (a) +18 to -5 V and (b) +15 to -4 V.

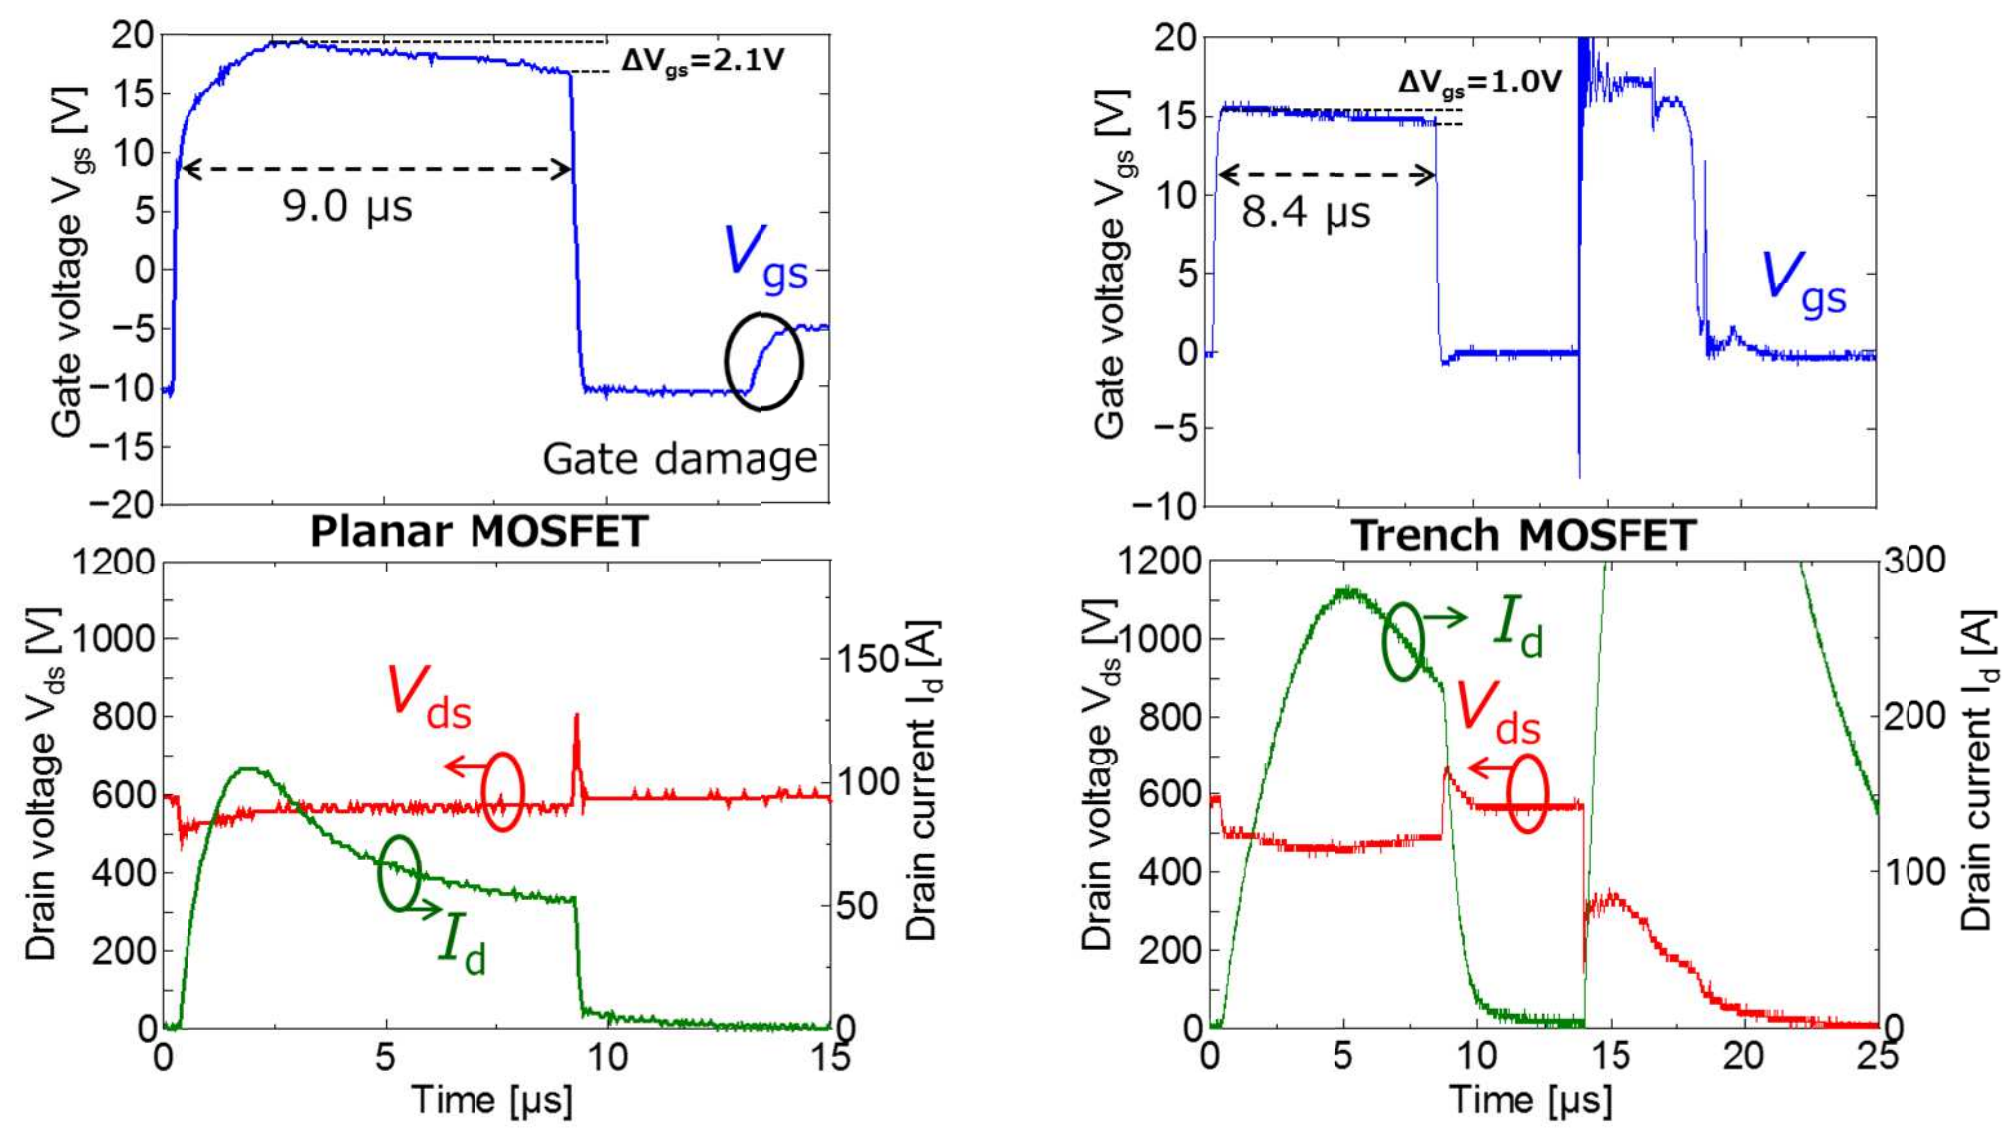
Figure 13 (Color online)

Figure 13 shows the measured short-circuit current and voltage waveforms at an increased V_{gs_off} of -10 V in the planar MOSFET and at the decreased V_{gs_off} of 0 V in the trench devices. Unlike the results in Fig. 12, it can be clearly seen that the current and voltage waveforms were markedly different whereas t_{SC_CR} was almost independent of V_{gs_off}. As V_{gs_off} was set at an increased value of -10 V, the sudden increase in drain current ended abruptly in the planar MOSFET. Device failure was characterized by a collapse in the gate voltage waveform from -10 to -5 V in the planar MOSFET. On the other hand, in the trench MOSFET, the drain current increased immediately after device turn-off.

Fig. 13. (Color online) Measured short-circuit waveforms for the (a) planar and (b) trench MOSFETs at a DC bus voltage of 600 V. The on- and off-gate voltages were set at (a) +18 to -10 V and (b) +15 to 0 V. The sudden increase in drain current ends abruptly in both the planar and trench MOSFETs.

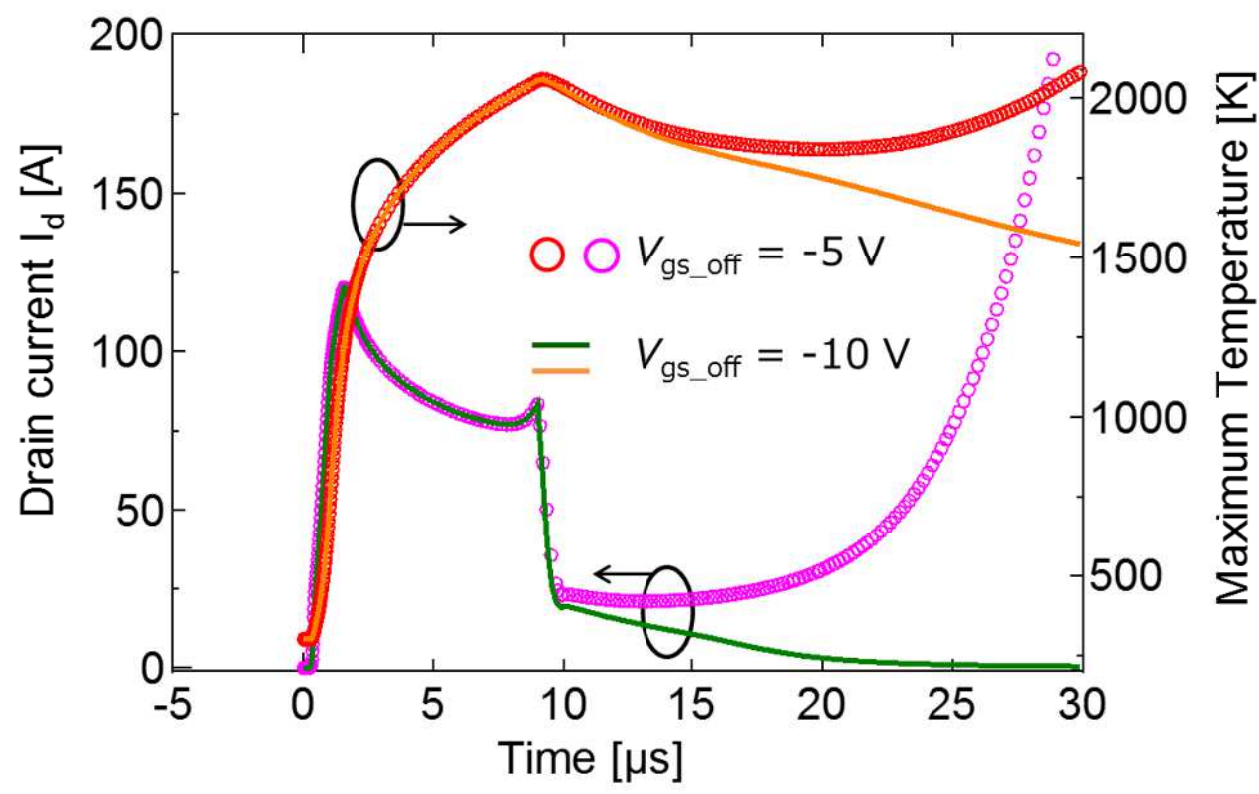
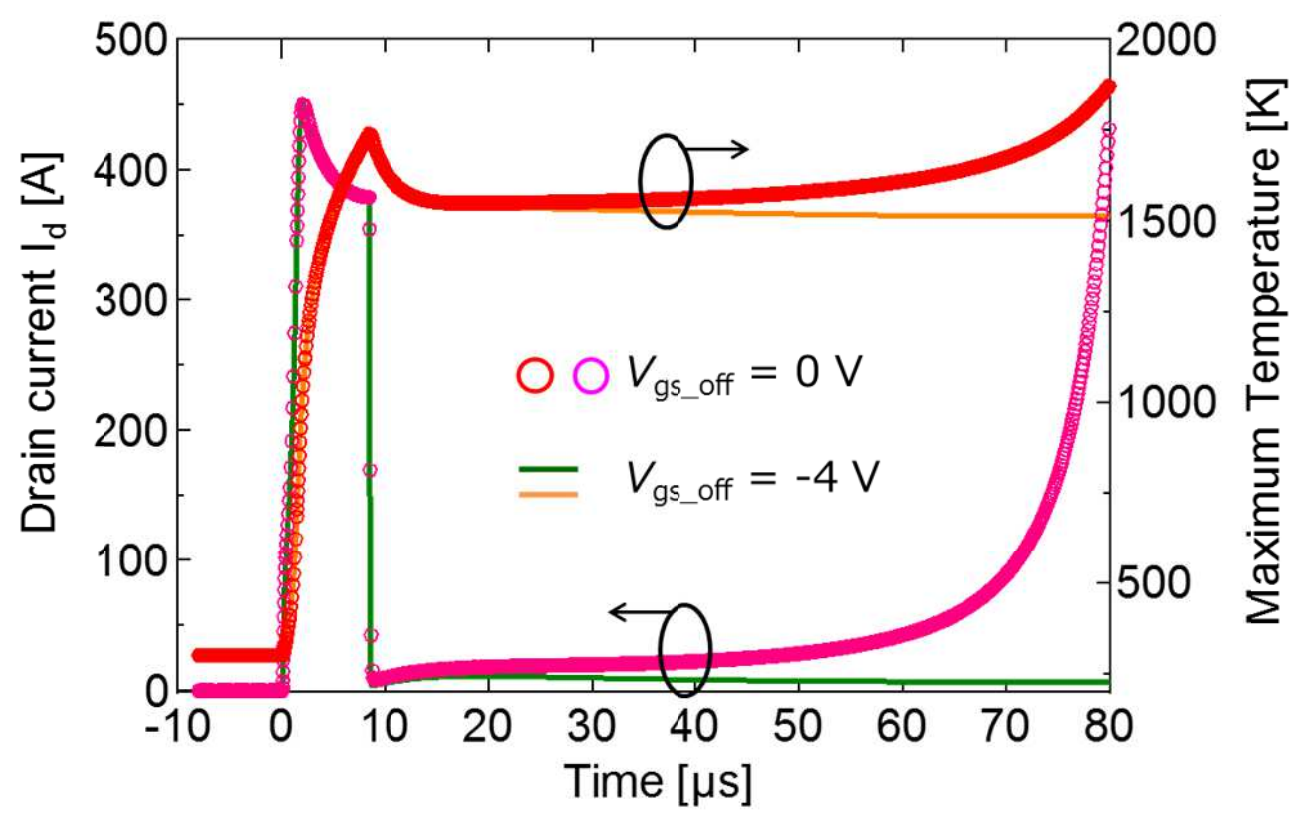
Figure 14 (Color online)

Fig. 14. (Color online) Simulated drain current and temperature waveforms, with a DC bus voltage of 600 and V_{gs_off} set at -5, -10 and 0 V, -4 in the (a) SiC planar and (b) trench MOSFETs, respectively.
