Investigation of short-circuit failure mechanisms of SiC MOSFETs by varying DC bus voltage

Masaki Namai*, Junjie An, Hiroshi Yano, and Noriyuki Iwamuro*

Graduate School of Pure and Applied Sciences, University of Tsukuba,

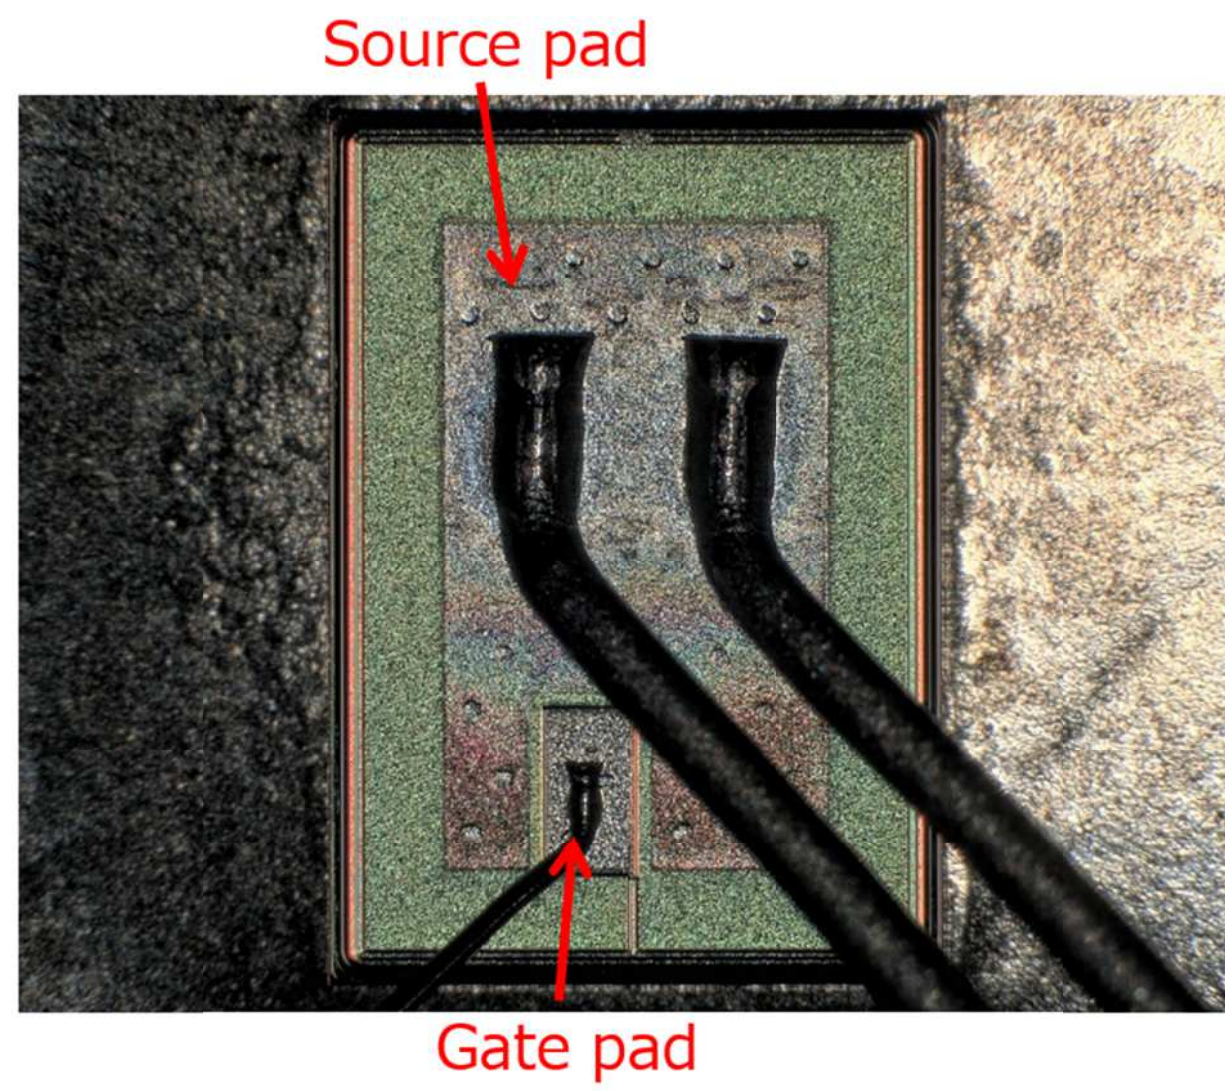
Figure 15 (Color online)

Fig. 15. Top view of one of the SiC trench MOSFETs following a short-circuit failure. The DC bus voltage was set at 600 V and V_{gs} was +15 to -4 V.

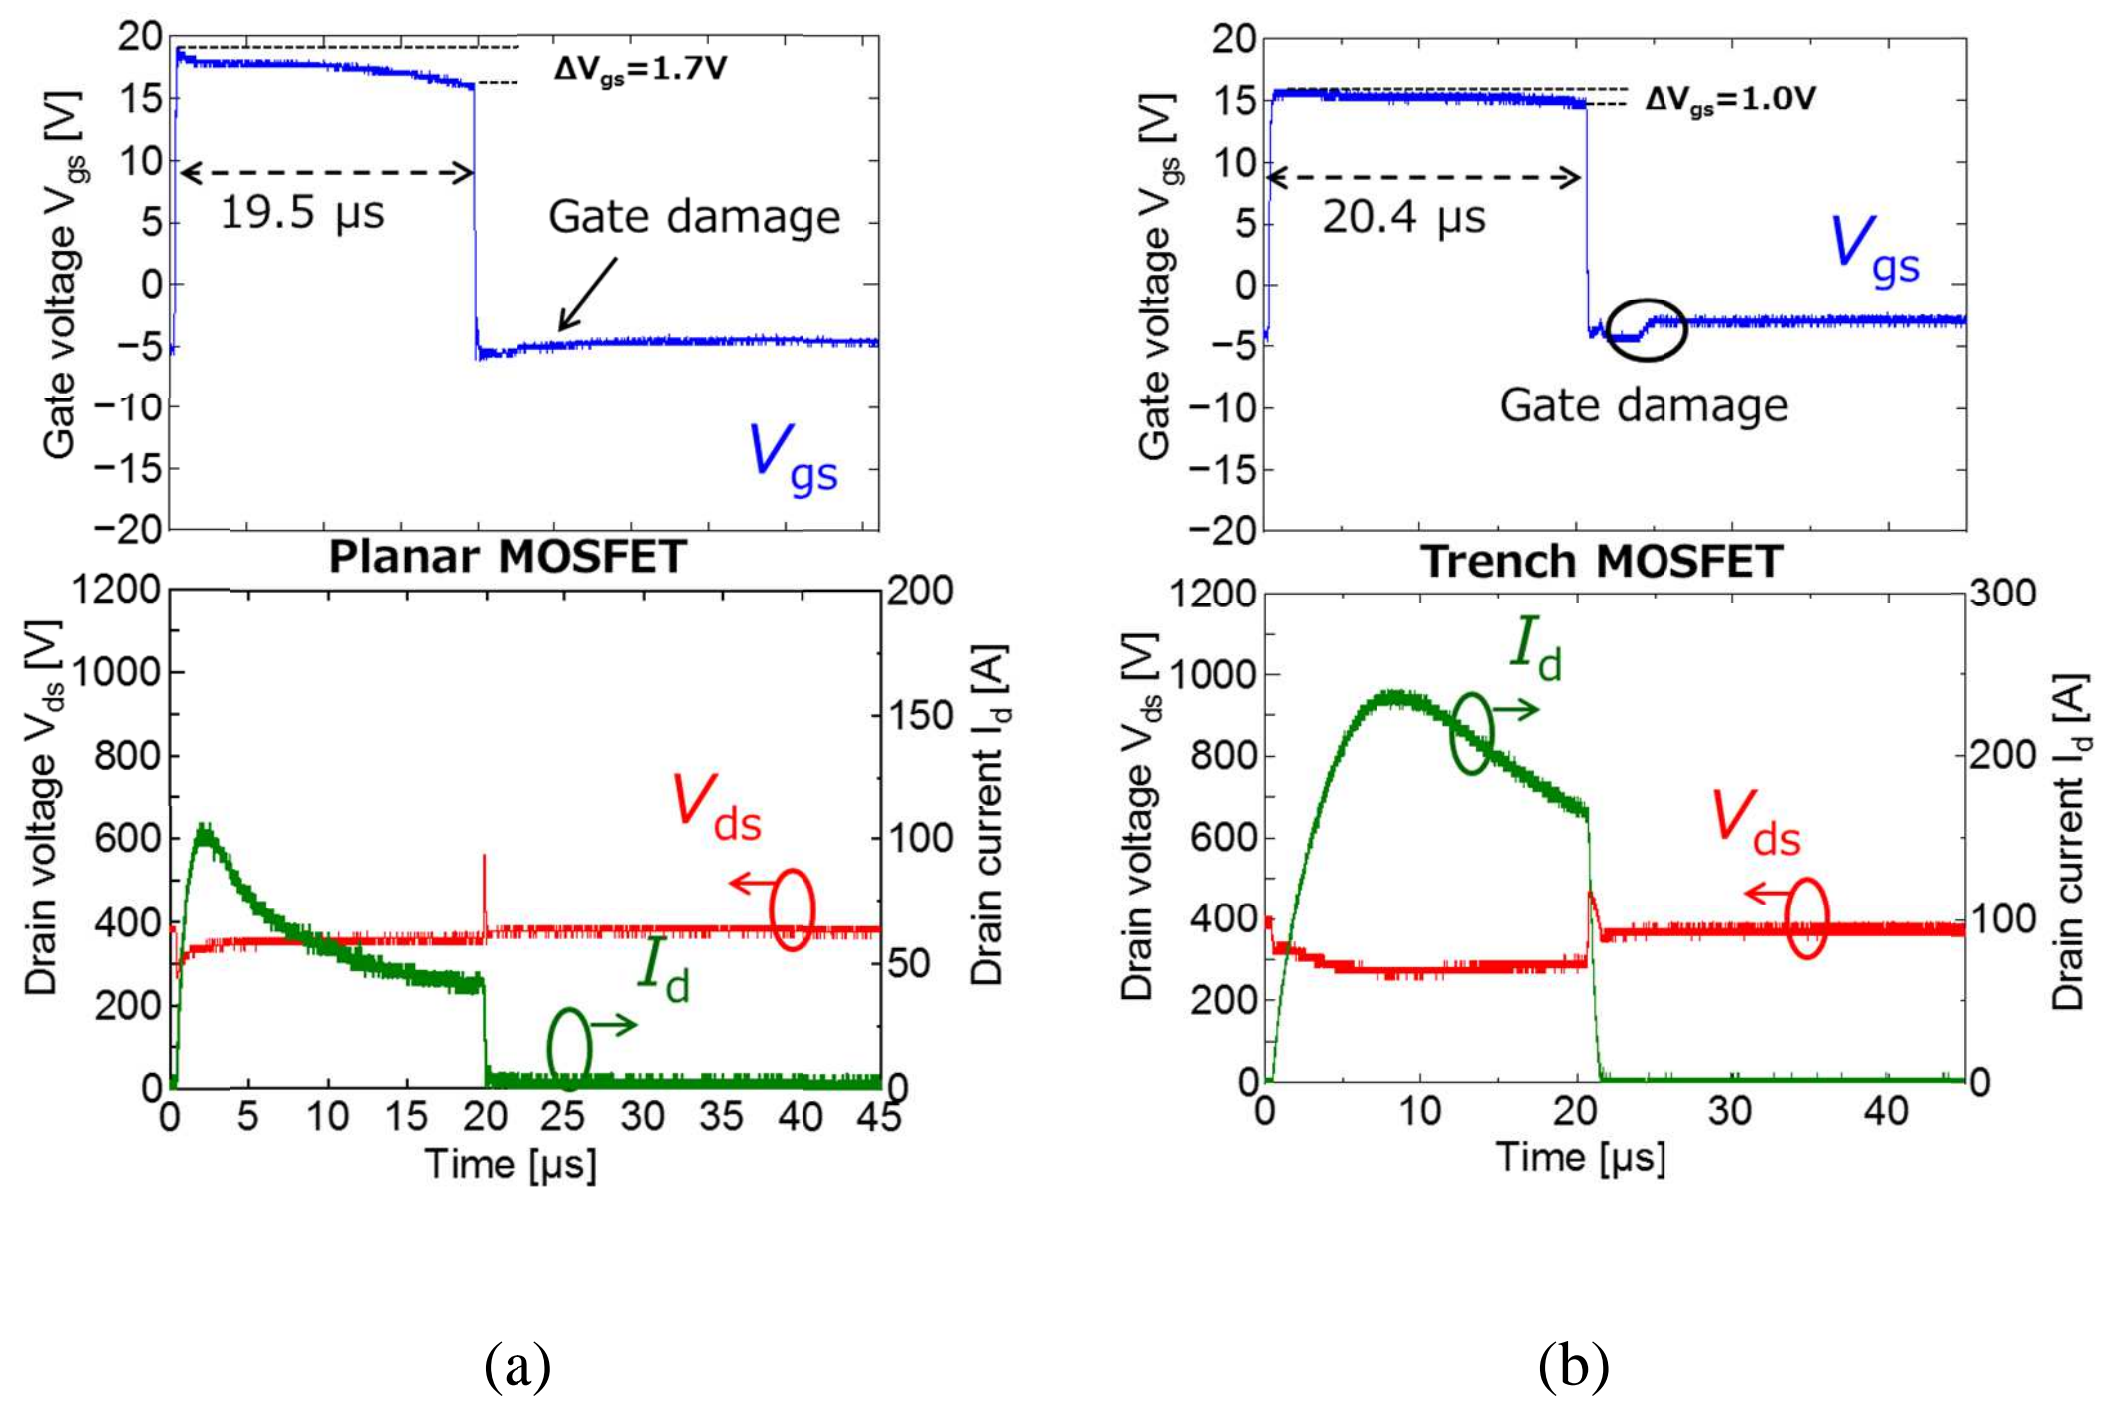
Figure 16 (Color online)

Fig. 16. (Color online) Measured short-circuit waveforms for the (a) planar and (b) trench MOSFETs at a DC bus voltage of 400 V. The on- and off-gate voltages were set from (a) +18 to -5 V and (b) +15 to -4 V.

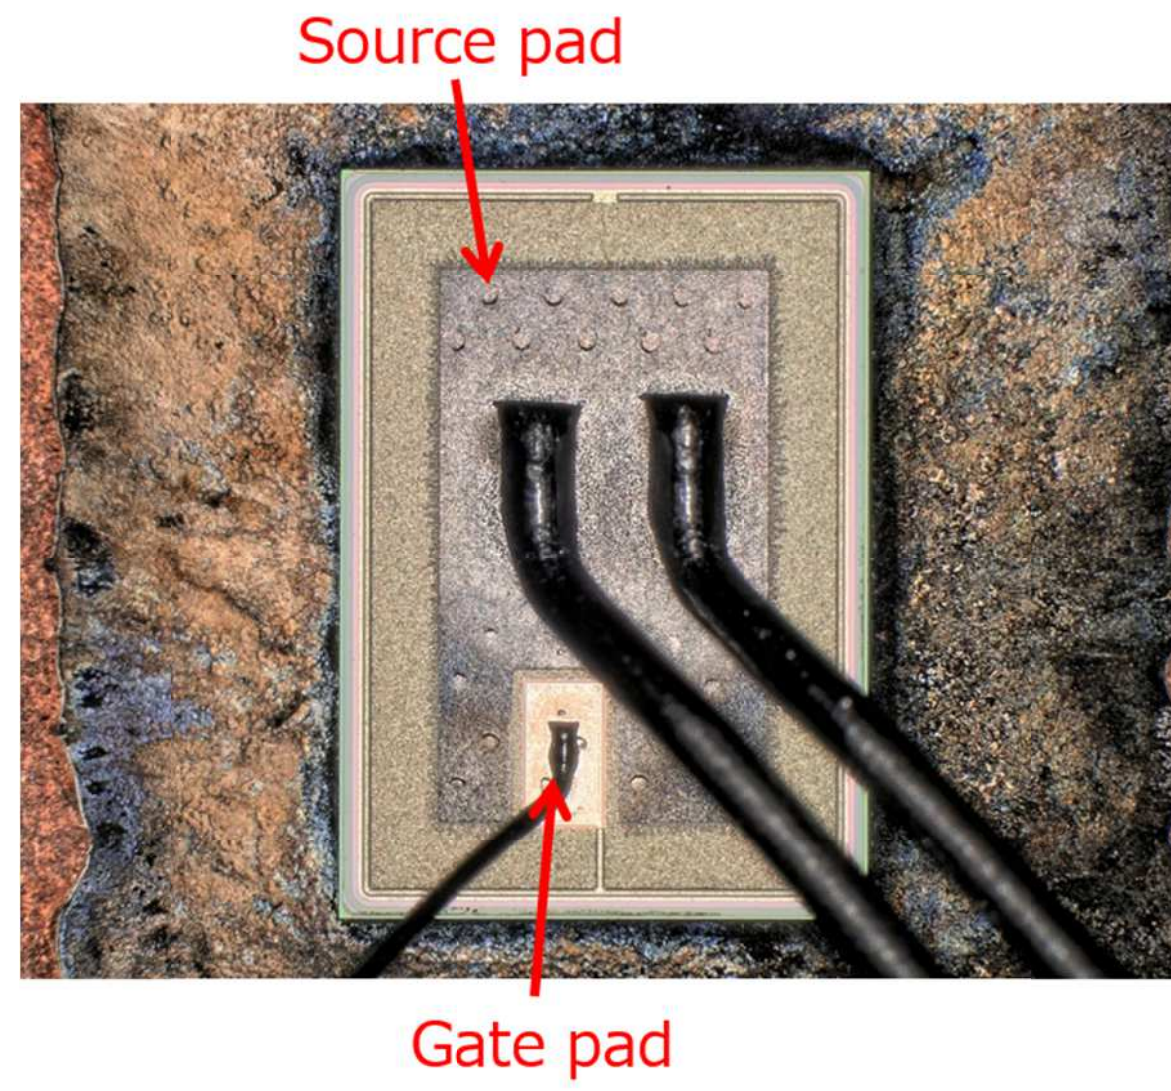
Figure 17 (Color online)

collapse in the gate voltage waveform from -5 to -4.4 V at 6.0 μs after device turn-off (planar MOSFET) and from -4 to -2.8 V at 4.3 μs after device turn-off (trench MOSFET). No significant differences between the failure mechanisms of the respective devices could be seen. Furthermore, unlike the results at 800 V, the drain current did not increase at all, and a tail current could hardly be detected. As no tail current was seen after the devices were turned off, it is clear that there were few thermally generated holes in either of the SiC MOSFETs. Table IV shows the measured resistances between three terminals of the failed SiC planar and trench MOSFET (R_{gs}, R_{gd}, and R_{ds}). The resistance between the gate and source electrodes became very low, whereas the blocking characteristics between the drain and source terminals were not altered, indicating that device failure was due to damage of the gate oxide layer, similarly to the events described in Sect. 3.2 (which occurred under higher negative gate bias conditions at V_{dd} of 600 V). As device failure occurred in the gate oxide layer, the metal layers on the gate and source electrodes were completely undamaged, as shown in Fig. 17.

Fig. 17. Top view of one of the SiC trench MOSFETs following a short-circuit failure. The DC bus voltage was set at 400 V and V_{gs} was from +15 to -4 V.

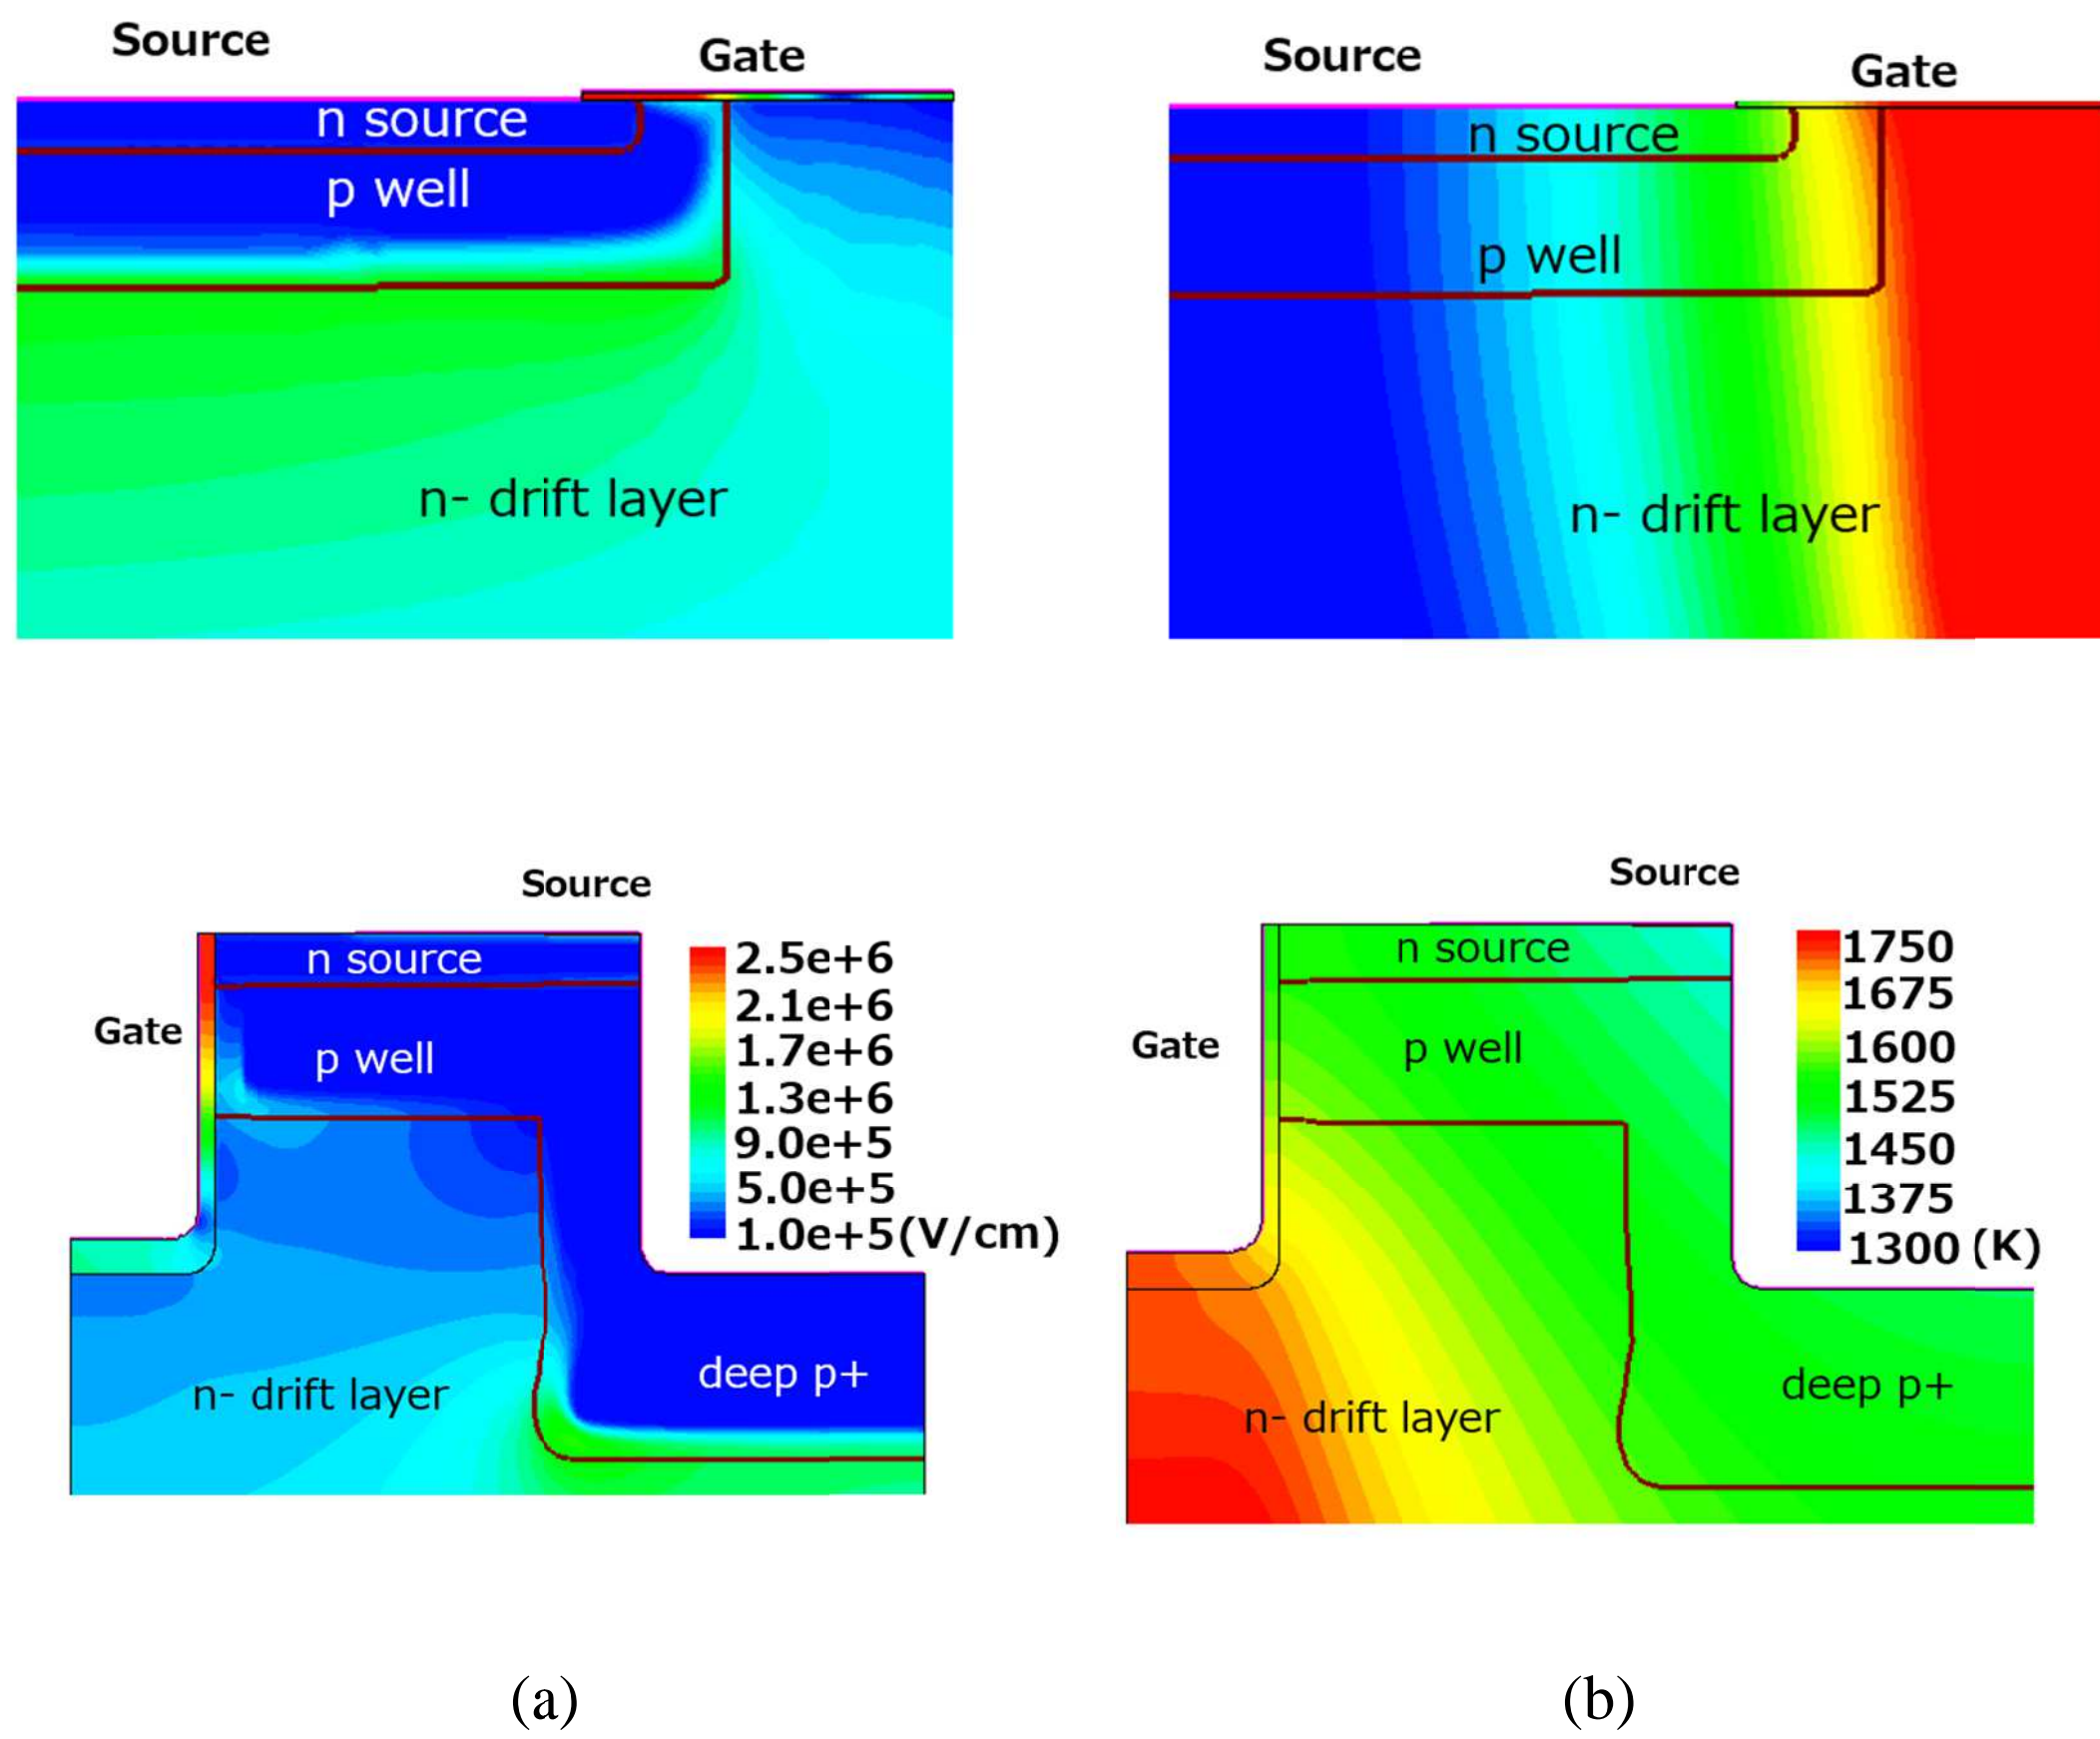
Figure 18 (Color online)

Fig. 18. (Color online) Simulated (a) electric field and (b) lattice temperature distribution in SiC planar and trench MOSFETs immediately before device turn-off. The DC bus voltage was at 400 V and V_{gs_on} was set at +18 and +15 V.
