Erosive wear failure of spool valves

Erosive Wear Failure of
Spool valves

Submitted by Paul E Pomeroy

1995

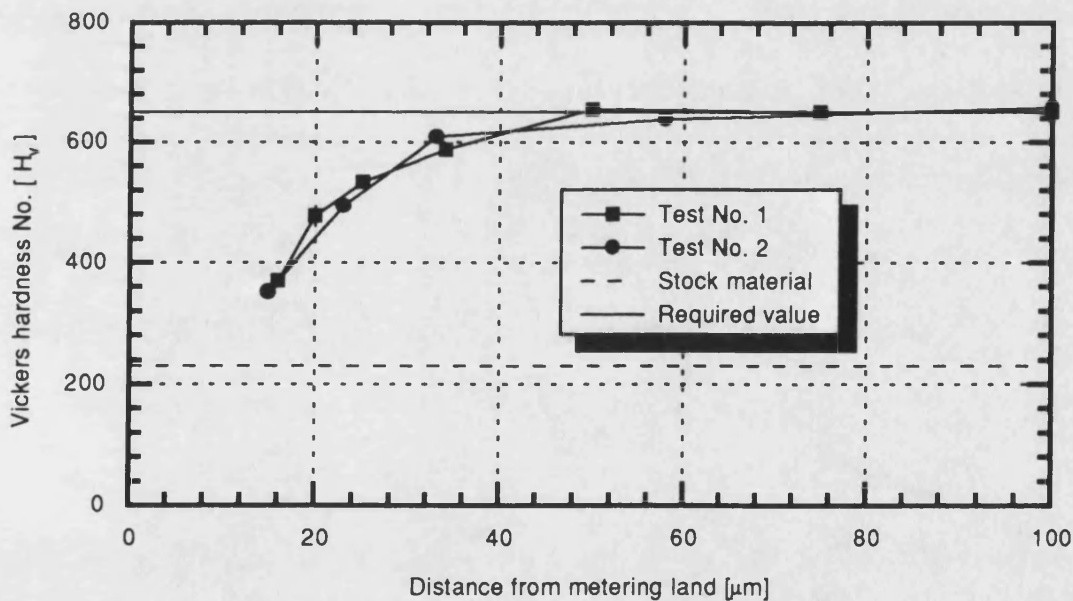
Figure 5.1 - New bushing hardness profile.

However, when considering the EDM of the metering slots within the bushing, the author considered that local tempering effects may occur, reducing the hardness of the metering corner. To verify this, a new spool and bushing was sectioned longitudinally, resin mounted and highly polished to produce a scratch free surface. Testing the specimens in a micro hardness testing machine with a Vickers pyramid diamond, it was found that both components had a bulk

hardness of $H_v \approx 650$ (6.4 GPa) as specified on the manufacturing drawings. However, when the material adjacent to the bushing metering edge was tested, there appeared to be a marked reduction in hardness in the 10 to 40 µm band from the edge, as shown in Figure 5.1. To ensure that this reduction was not just an edge effect phenomenon, other hardness tests were carried out on a different ground edge of the component. Although the results indicated a reduction in the hardness at the edge, this was not as marked as obtained at the EDM edge.

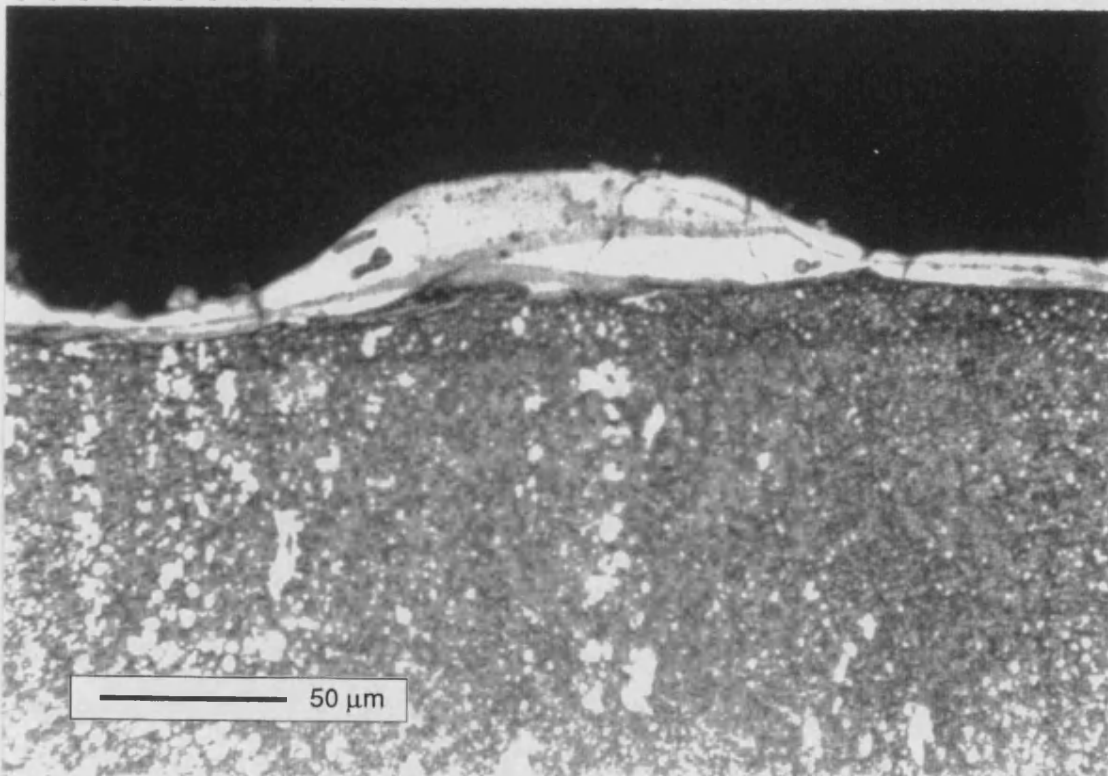
Figure 5.2 - Metallurgical structure of a new bushing.

To verify the micro-hardness results, a second bushing specimen was mounted and etched as a normal section for metallurgical examination. By using an optical microscope it was then possible to examine the material grain structure around the EDM face. It can be seen in Figure 5.2 that a boundary layer exists of about 10 to 20 µm which appears to contain no carbides as evident in the bulk material structure. To verify this finding, the specimen was subjected to an element intensity trace across the bulk of the specimen to the metering edge, Figure 5.3 shows how the composition of carbon and chromium varies with position. It can be seen that for about 20 µm from the EDM face the structure has an increase in carbon and a constant chromium content, this suggest that the bulk material matrix is tempered by the EDM process to reduce the chromium carbides and hence reduce the material hardness.

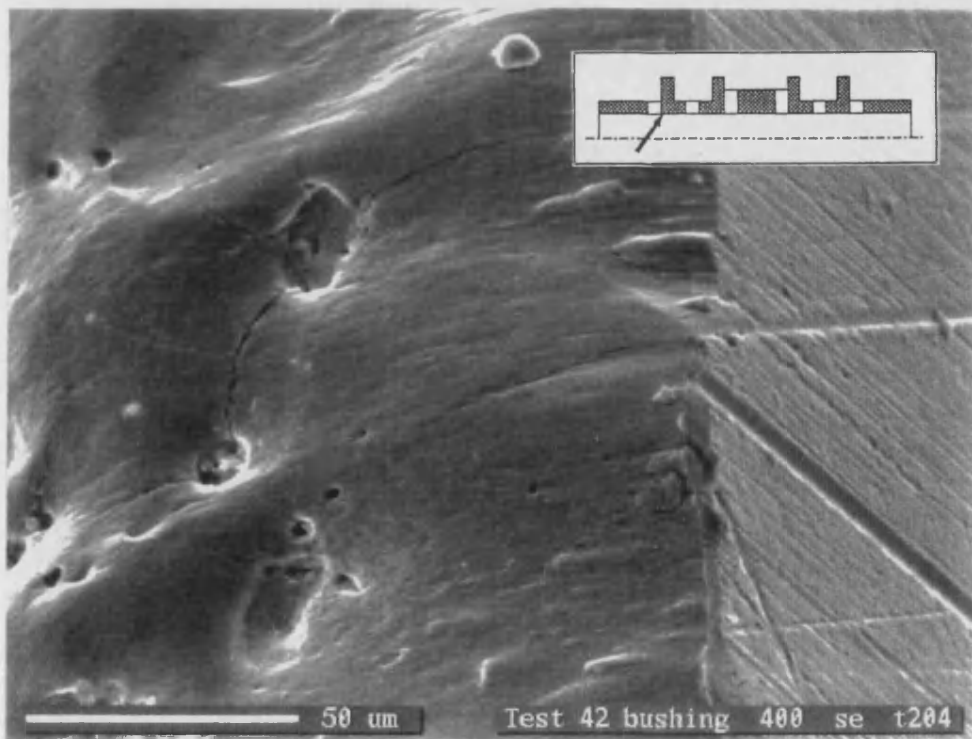
Figure 5.4 - SEM micrograph showing surface cracks in the bushing EDM face.

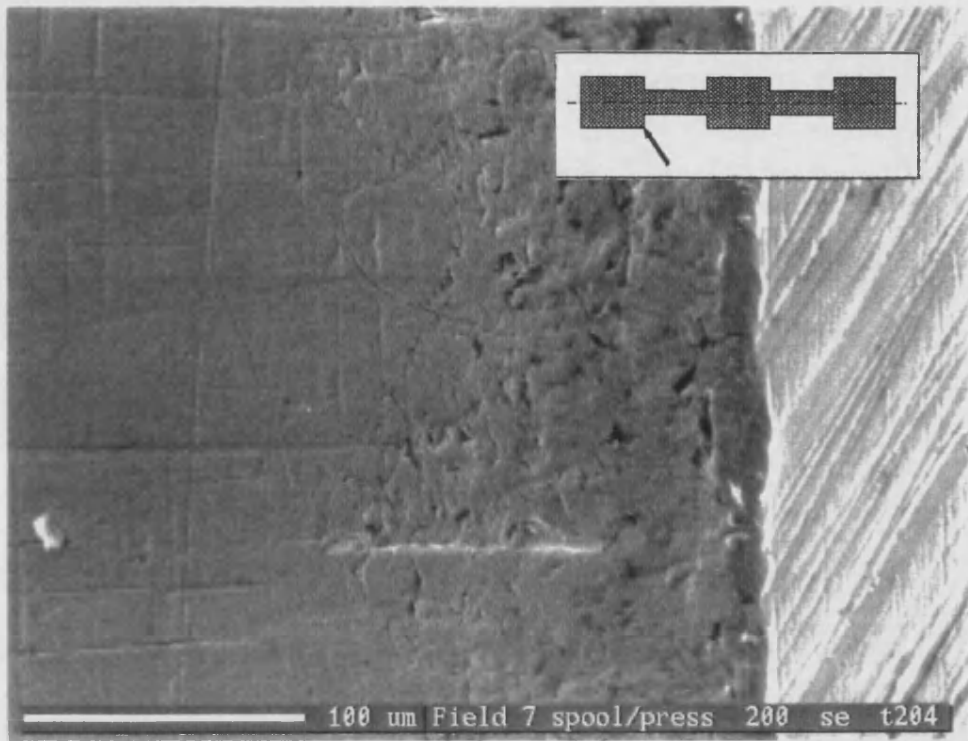
Figure 5.9 - Typical SEM micrograph of an in-service spool metering edge (pressure land).

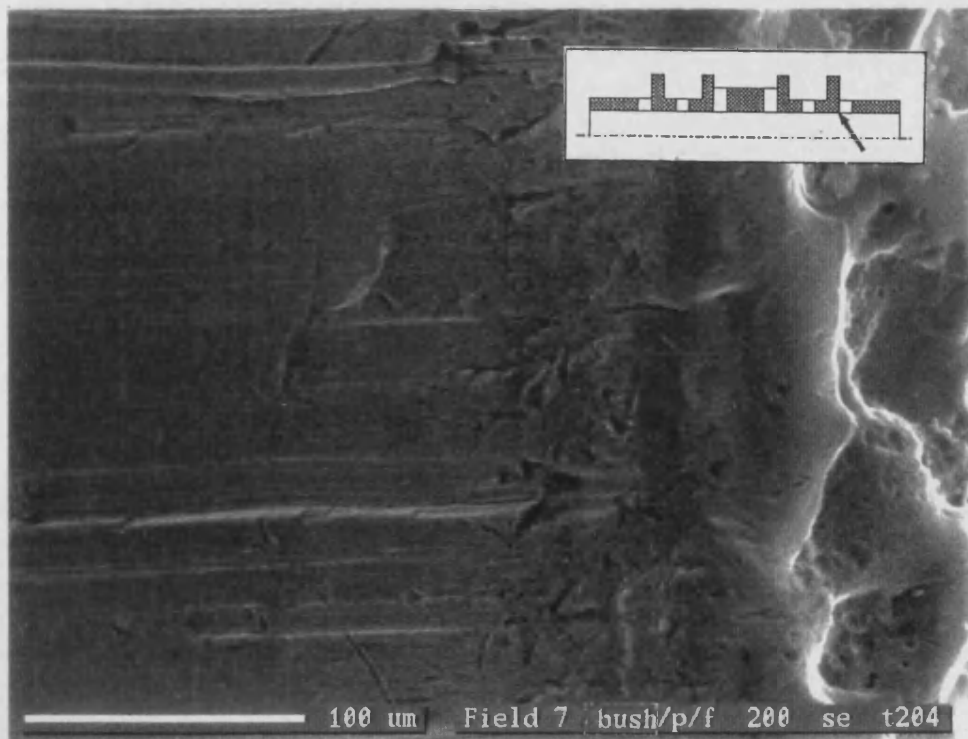
Figures 5.9 to 5.12 contain SEM micrographs of the pressure port (P→S) and the tank port (S→T)
metering lands from a typical in-service specimen. From the two spool micrographs it can be
seen that the outside diameter has been damaged but the side face appears to unaffected. This
result is surprising for the tank port (S→T) because the fluid flow will tend to impinge onto the side
face causing erosion damage. Since this result is common with all the field samples examined
to date, it may be concluded that if particle erosion occurs on this face, it must be concentrated
at the metering corner. Also, since both spool metering lands are subjected to an identical duty
cycle (amplitude and frequency) during the valve operation, it may be expected that similar
amounts of abrasion damage would be seen at both locations. However, this result is not the
case and the spool has more damage on the pressure port than the tank port. This difference is

Figure 5.10 - Typical SEM micrograph of an in-service bushing metering edge (pressure land).

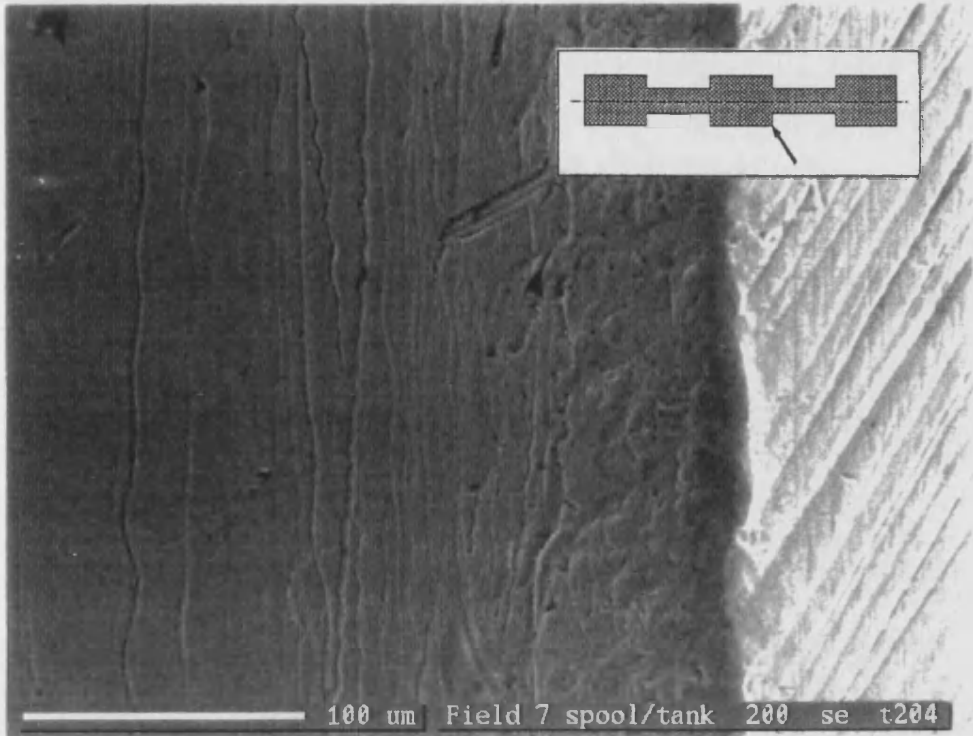
Figure 5.11 - Typical SEM micrograph of an in-service spool metering edge (tank land).

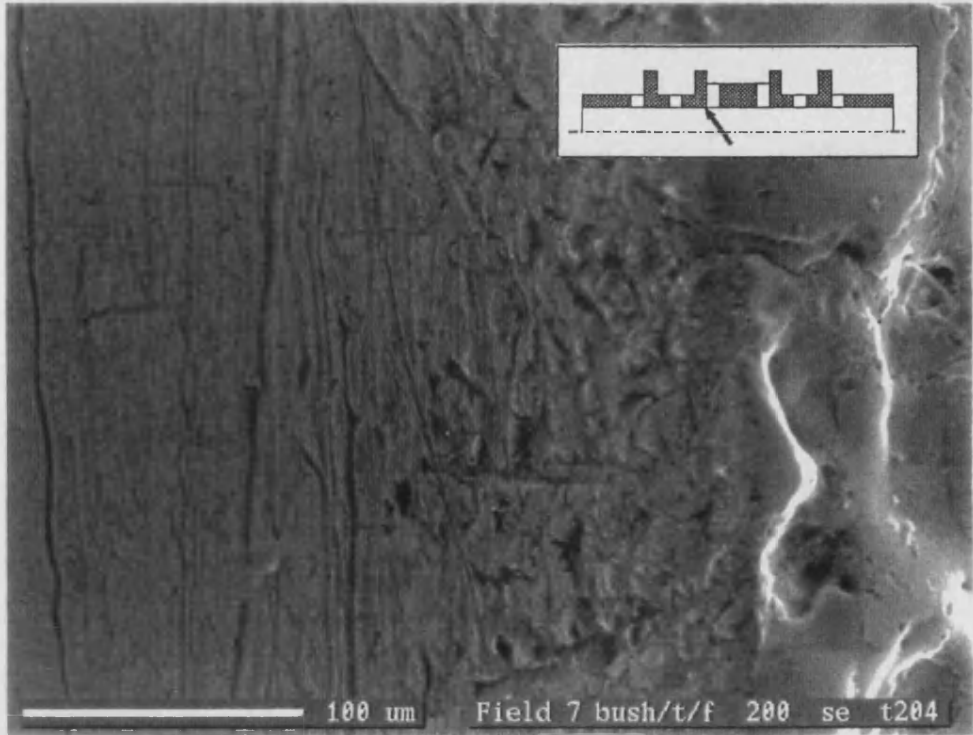
From Figures 5.9 to 5.12 it is evident that the wear patterns are irregular and that the reliability
of a single trace being representative of the complete circumference is poor. Therefore, to
eliminate this error and to provide an additional insight into the field components, four 3-D contour
maps have been included. Figures 5.13 to 5.16 have been constructed over a 3° arc using a
circumferential step size of 3.5 μm.

Figure 5.12 - Typical SEM micrograph of an in-service bushing metering edge (tank land).

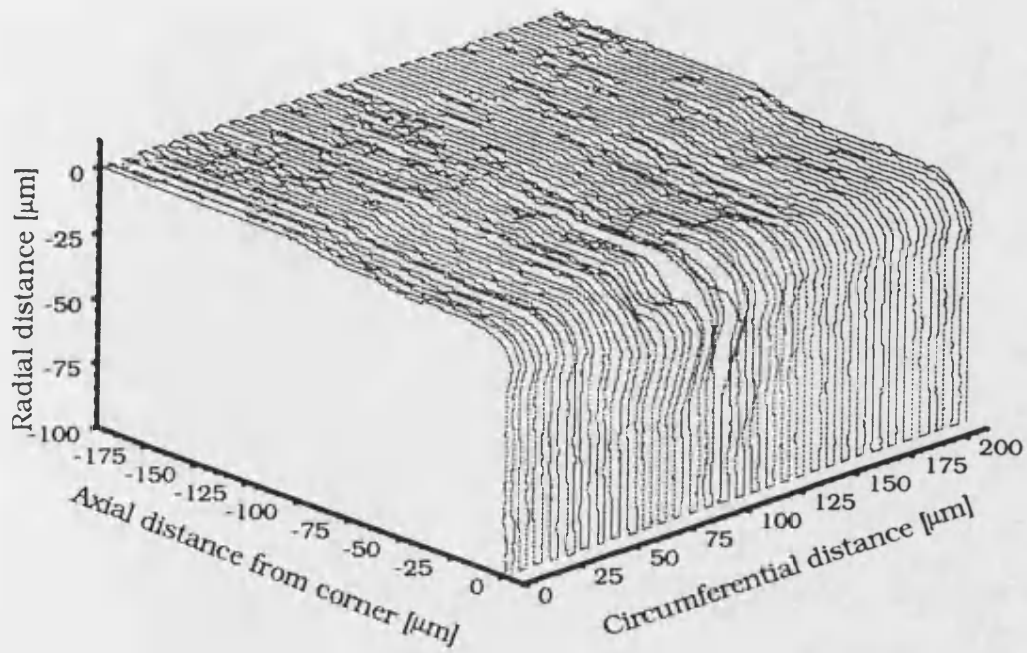
Comparing the two spool corner profiles Figure 5.13 & 5.15, it can be seen that the pressure port
has greater damage as suggested by the SEM micrographs. Figure 5.13 indicates that a definite
step change (approximately 7 μm) in the outside diameter of the spool occurs before a general
rounding of the metering corner. In addition to material removal, it is also evident that the material
has been deformed in the direction of the fluid flow to produce a 2 to 3 μm overhang on the side
face. In comparison, the tank land has material removed from the side face due to particle

Figure 5.13 - Typical 3-D profile map from a worn spool pressure port metering land.

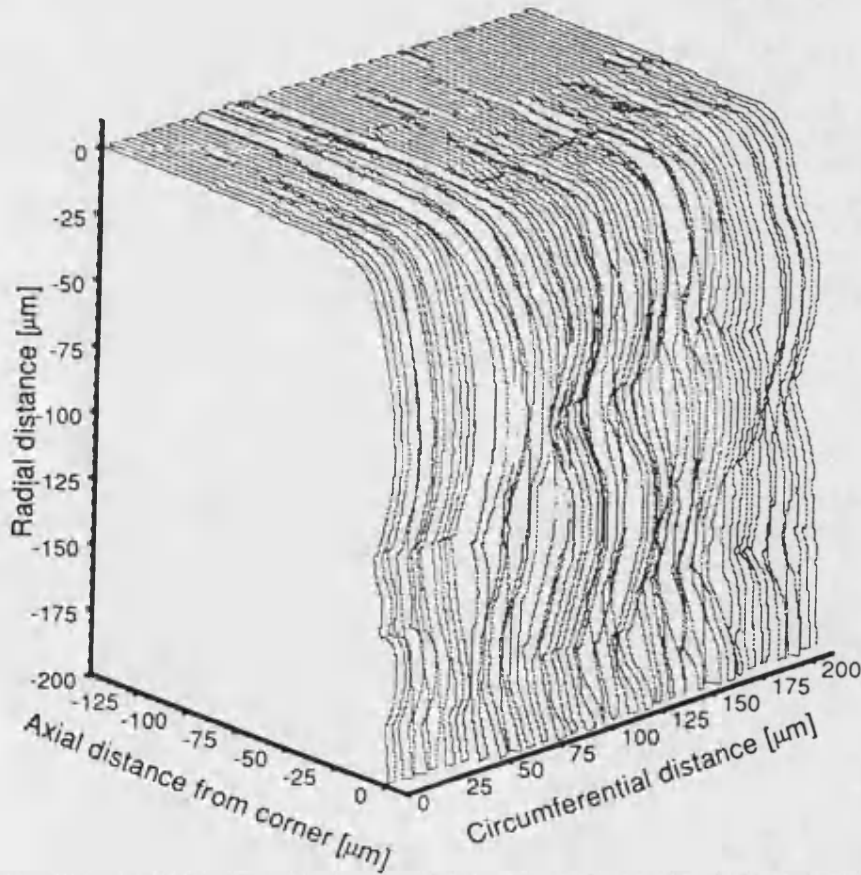
Figure 5.14 - Typical 3-D profile map from a worn bushing pressure port metering land.

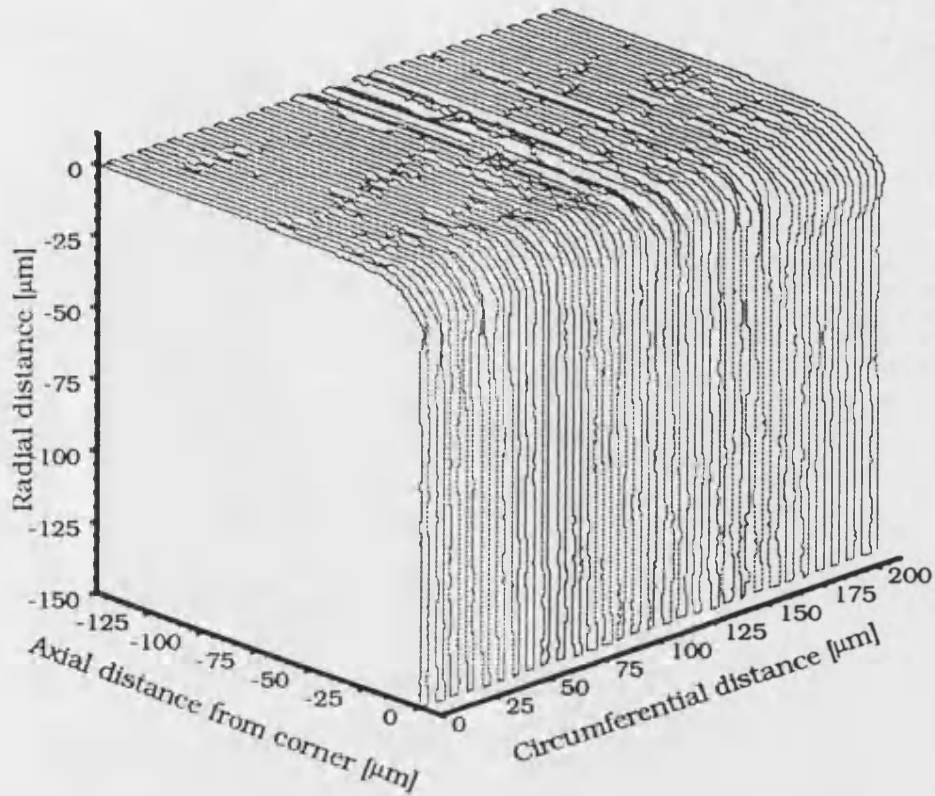
Figure 5.15 - Typical 3-D profile map from a worn spool tank port metering land.

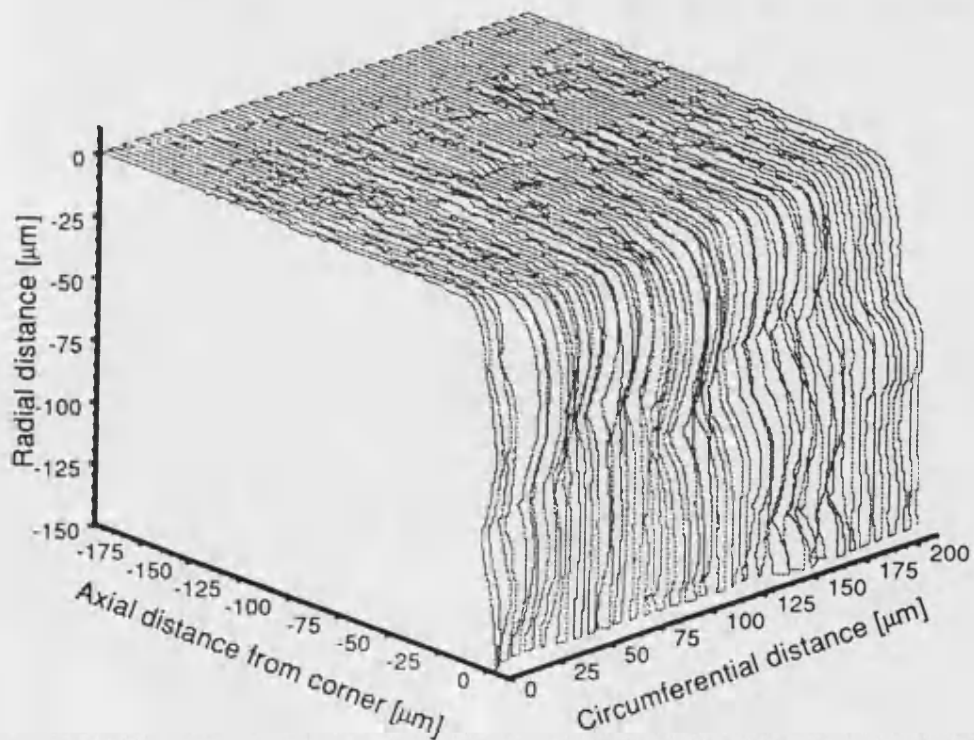
Figure 5.16 - Typical 3-D profile map from a worn bushing tank port metering land.

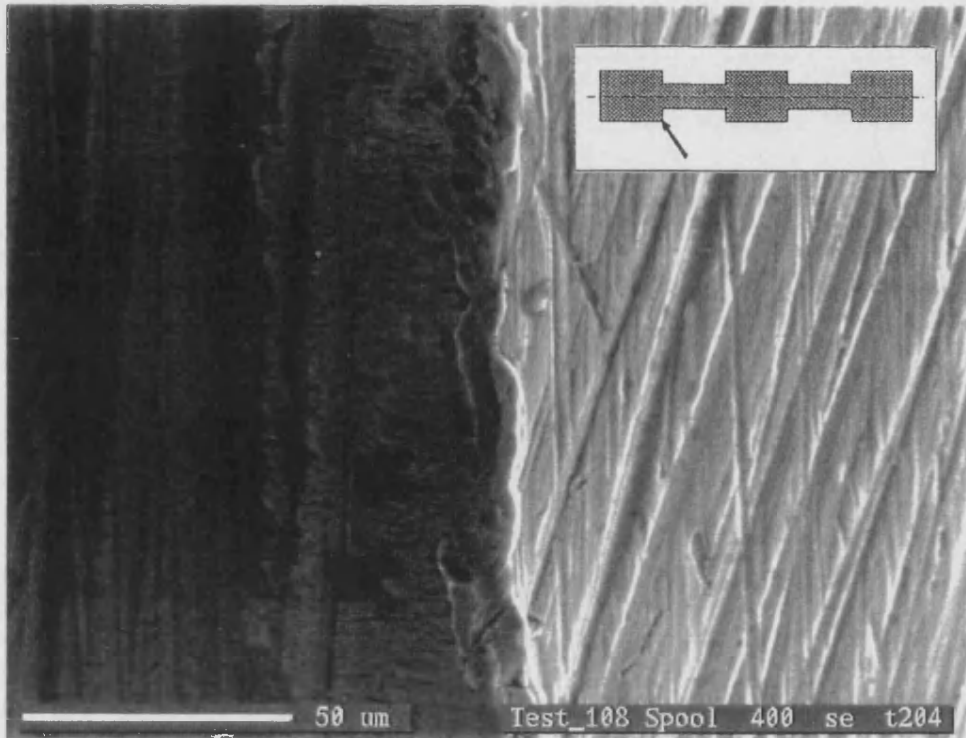
After completing the 48 hour test, no increase in the flow rate (t = 48 hours, $\Delta Q = 0$ L min^{-1}) could be detected. However, from the SEM micrographs of the spool and bushing metering edge, Figures 5.20 & 5.21, it can be seen that very slight damage has occurred on the corner. Therefore, this result implies that liquid impact or cavitation erosion [57] has no influence on the test results and any changes if flow rate must be attributed to the solid particles. This result also supports the general opinion that wear in servo valves is not a problem for systems with low contamination levels.

Figure 5.20 - SEM micrograph of the spool metering edge following a *clean oil* test.

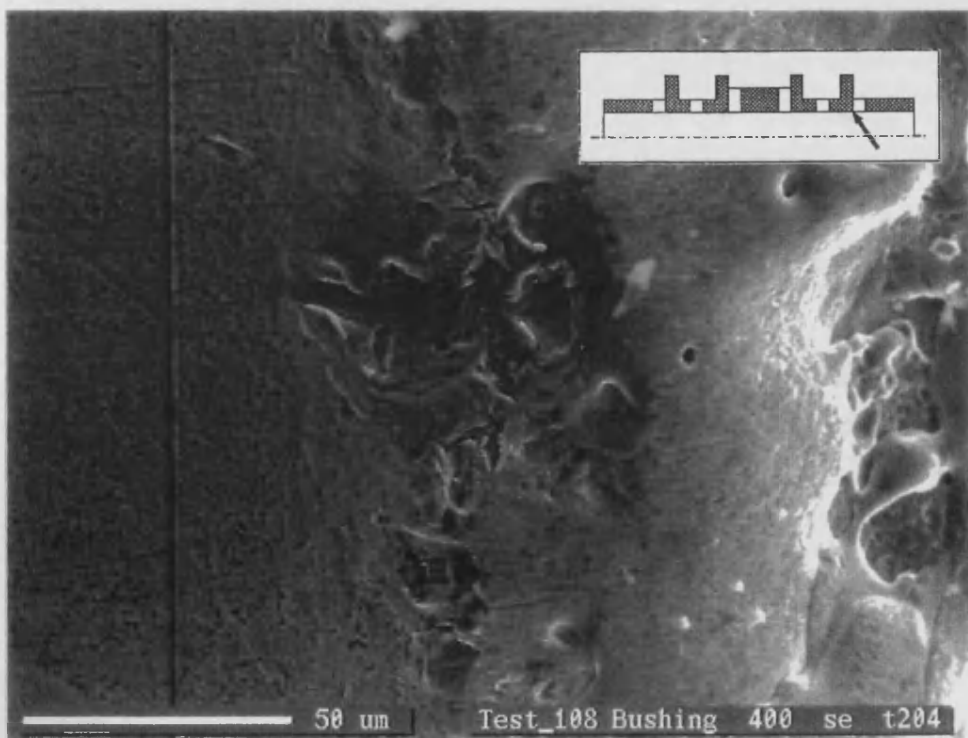
Figure 5.21 - SEM micrographs of the bushing metering edge following a *clean oil* test.

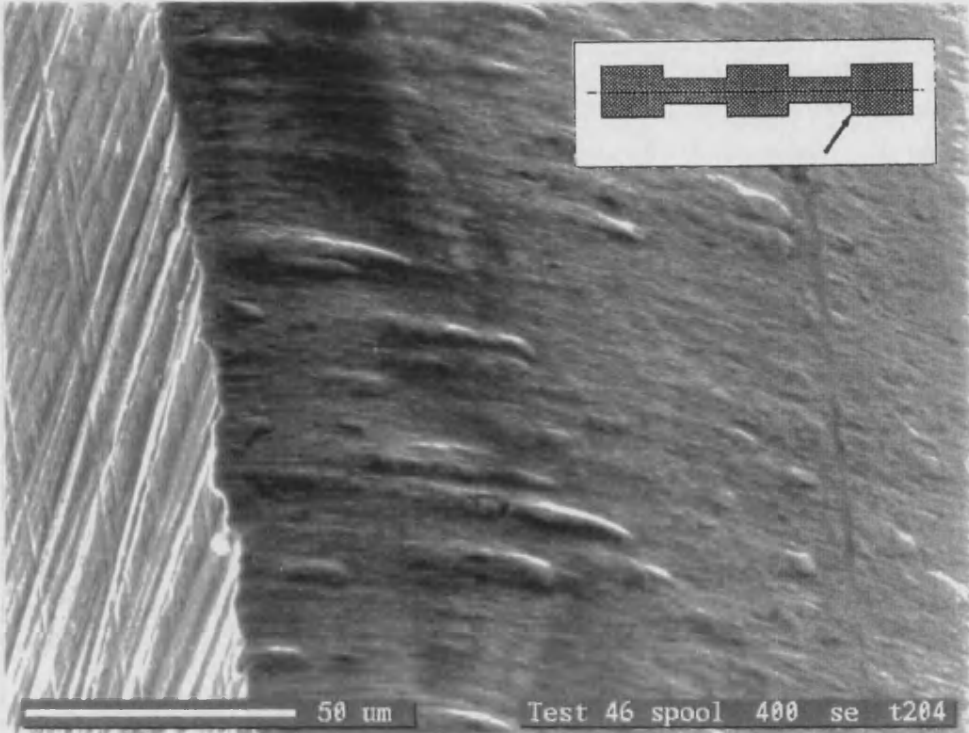
Figure 5.23 - SEM micrograph of the spool metering edge for a 70 bar uncut quartz test (P→S).

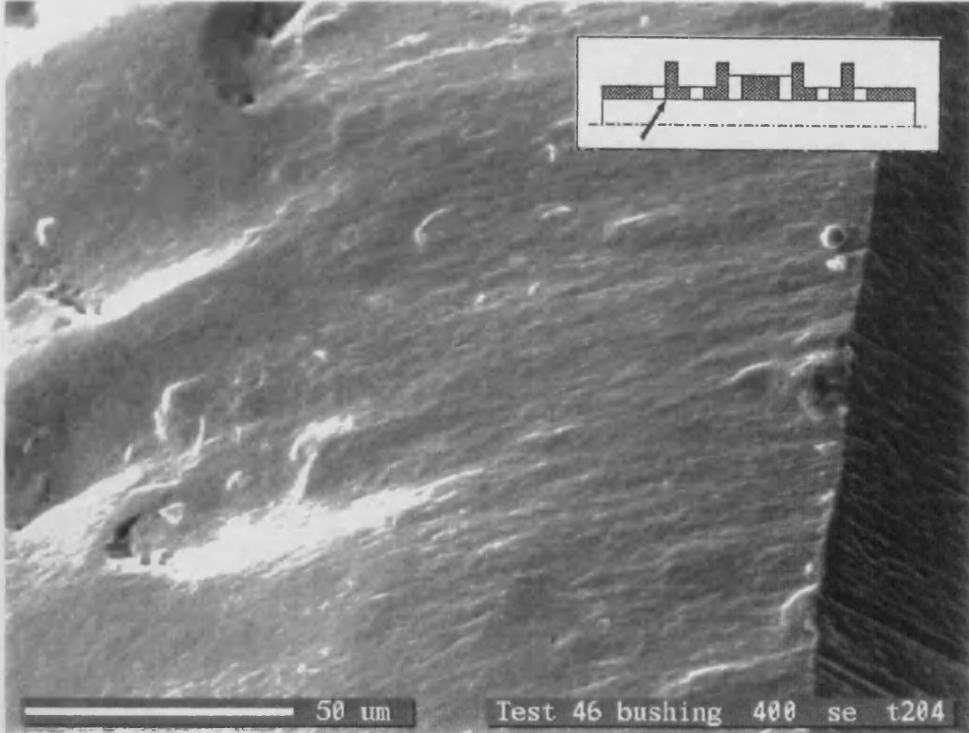
Figure 5.24 - SEM micrograph of the bushing metering edge for a 70 bar uncut quartz test (P→S).

in Figures 5.23 to 5.26, it can be seen that both tests produce metering surfaces having a columnar appearance in-line with the fluid flow. A variation between the two results can be seen by the nominal length of the surface damage extending from the metering corner. This observation confirms that the uncut quartz is more severe than the ACFTD even though it has been found to contain fewer larger particles. However, since the density of quartz is higher than ACFTD, it is thought that the particle mass is the significant difference between the two contaminants.

From the spool/bushing SEM micrographs it is difficult to judge if there is any difference in the surface damage between the different cuts. However, it is possible to determine a variation between the uncut and 0-10 μm quartz, the results of which are contained in Figures 5.23, 5.24, 5.28 & 5.29. From Figures 5.28 & 5.29, it can be seen that the columnar structure is still present, but when compared with the uncut results, it appears to be more pronounced and localised at the metering corner.

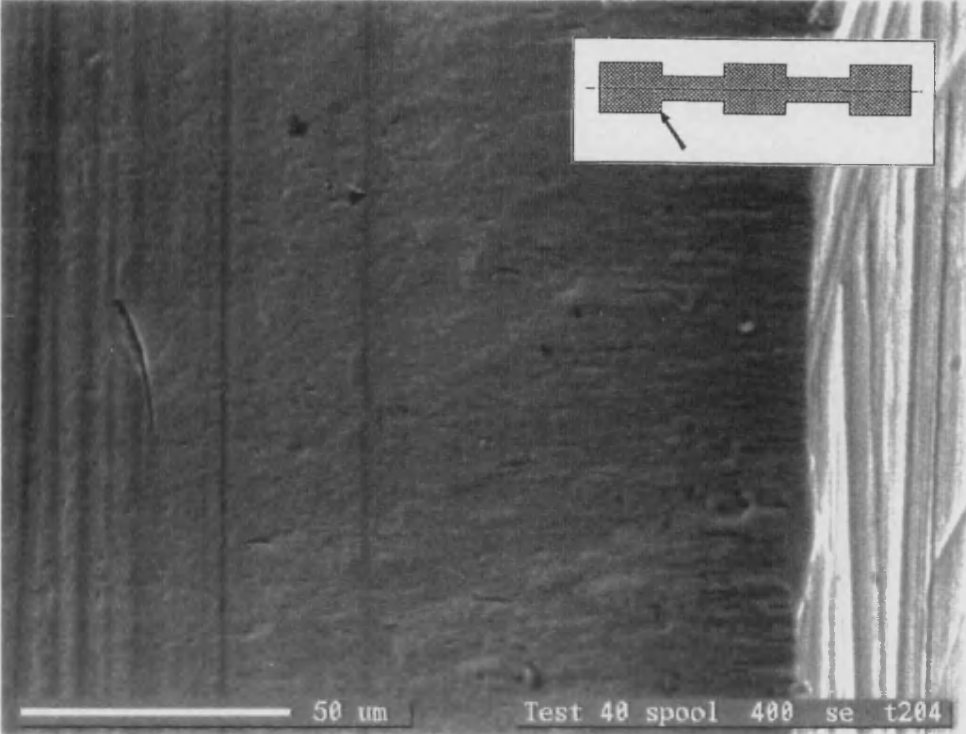
Figure 5.25 - SEM micrograph of the spool metering edge for a 70 bar ACFTD test (P→S).

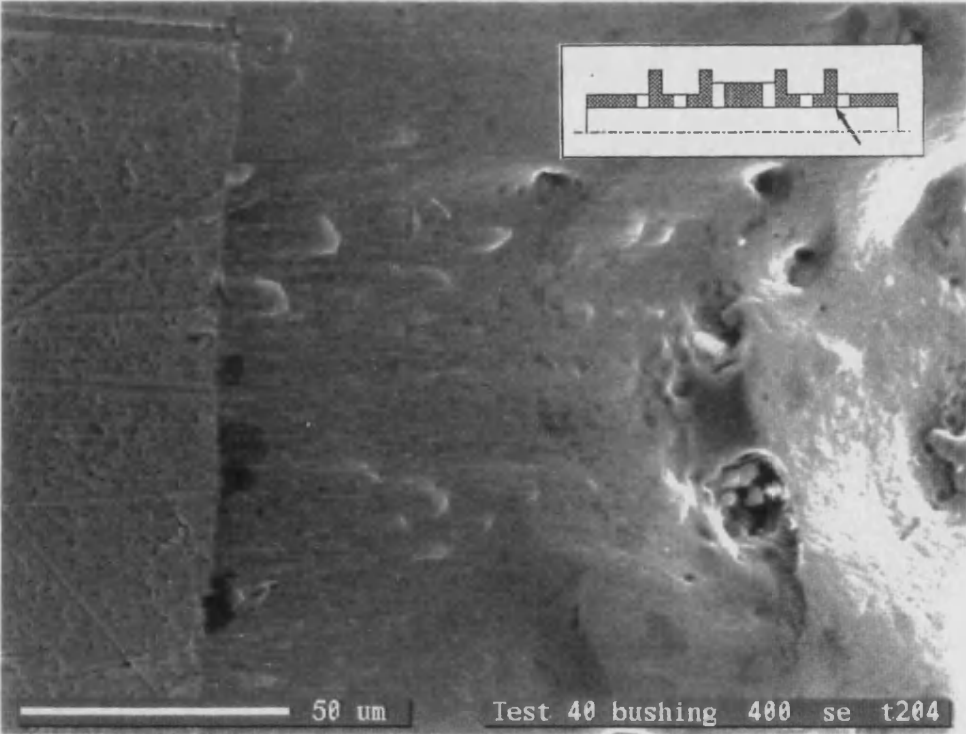
Figure 5.26 - SEM micrograph of the bushing metering edge for a 70 bar ACFTD test (P→S).

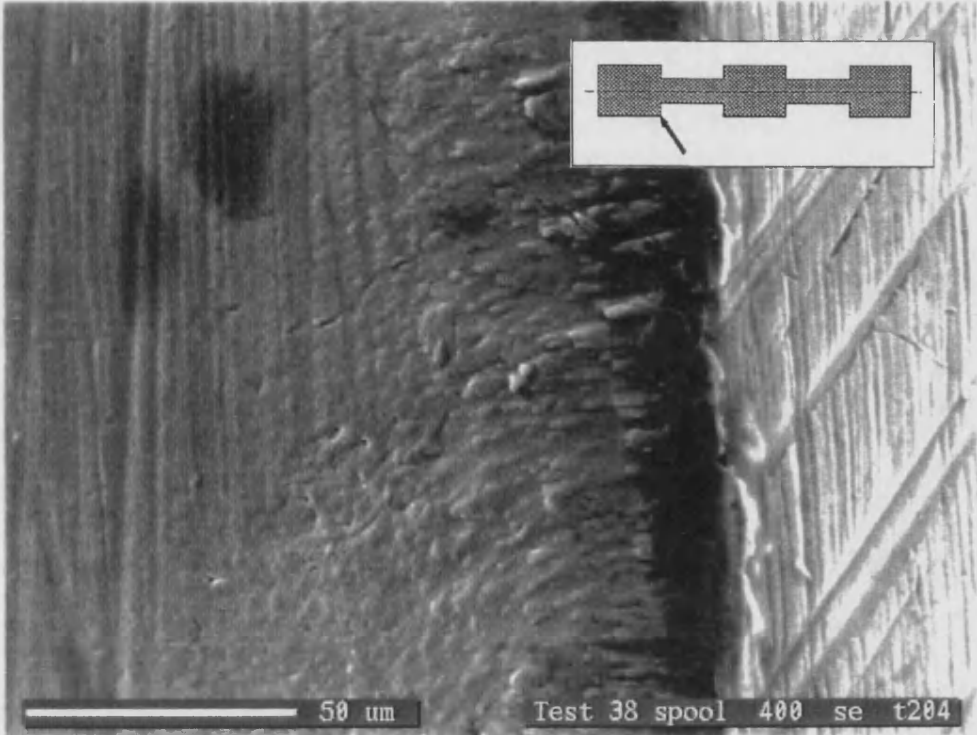
Figure 5.28 - SEM micrograph of the spool metering edge for a 70 bar 0-10 μm quartz test (P→S)

The SEM micrographs for the P→S condition, operating with uncut and 0-10 μm quartz at 70 bar are shown in Figures 5.23, 5.24, 5.28 & 5.29, equivalent micrographs for the S→T condition are contained in Figures 5.36 to 5.39. From these results, a similar trend for both flow directions can be seen. For example, the columnar structure is again more prominent on the 0-10 μm test and secondly, the surface damage extends further from the corner as the leakage flow increases.

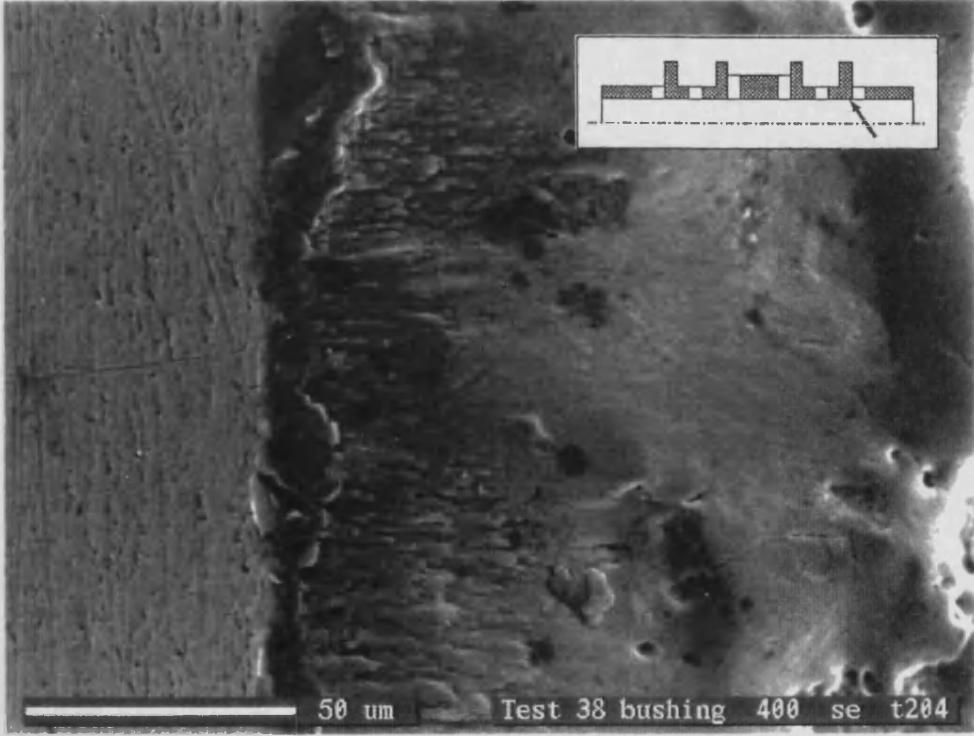
Figure 5.29 - Micrograph of the bushing metering edge for a 70 bar 0-10 μm quartz test (P→S).

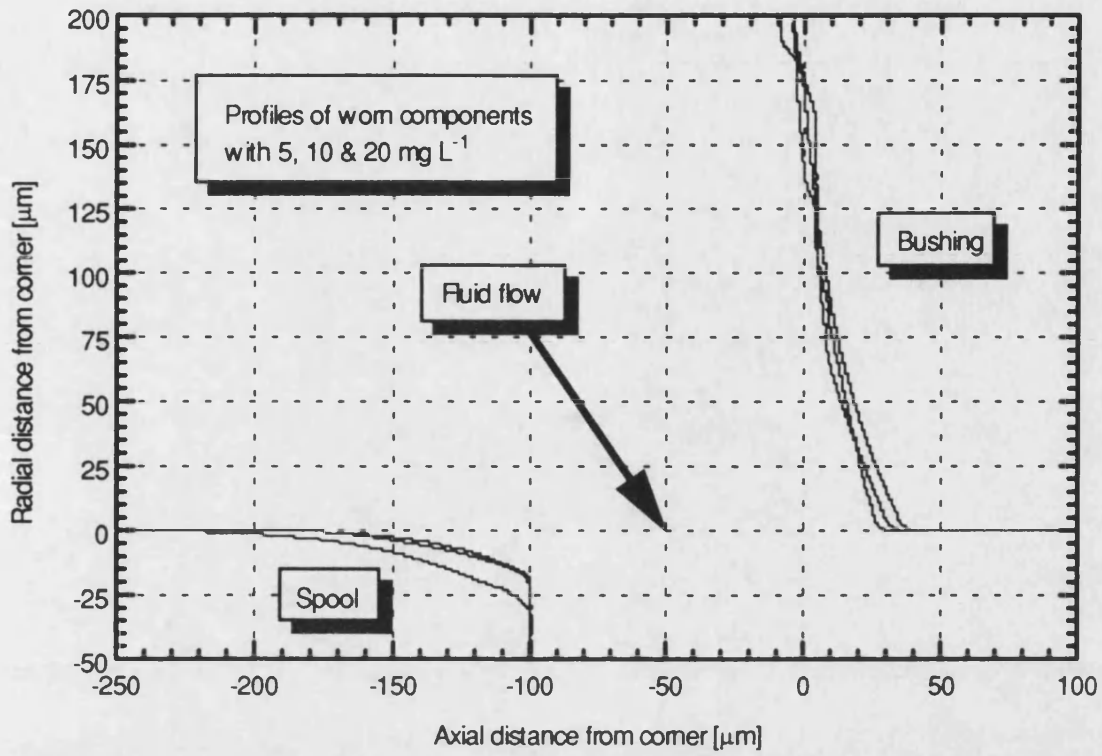
In order to quantify the amount of material removal occurring at each test condition, a profile measurement has been conducted on each component, the results of which are shown in Figures 5.32 & 5.33. Unfortunately, the measurements are taken at the end of the test (t = 48 hours) and not at the maximum confidence interval $\bar{t}$. The profiles confirm that the flow area increases with concentration and clearly the uncut quartz removes more material. By integrating each profile using the trapezoidal rule, it is possible to calculate the area of material removed for each test condition as shown in Table 5.1. Due to the surface topography of the bushing metering slot, significant errors can be introduced in the computation if the complete

From Table 5.1, the combined wear results indicate that the amount of material removed is not linear with contaminant concentration. Therefore, both the flow plots and the component profiles confirm that a linear relationship between concentration and wear does not exist. Also, the results indicate that more material has been removed from the bushing than the spool. This variation is considered to be due to the combined effects of different material properties and the flow pattern as the oil enters the vena-contracta. Further details on the influence of flow direction on the wear rate are presented in Section 5.7.

Figure 5.32 - Effects of uncut quartz concentration on spool/bushing profiles.

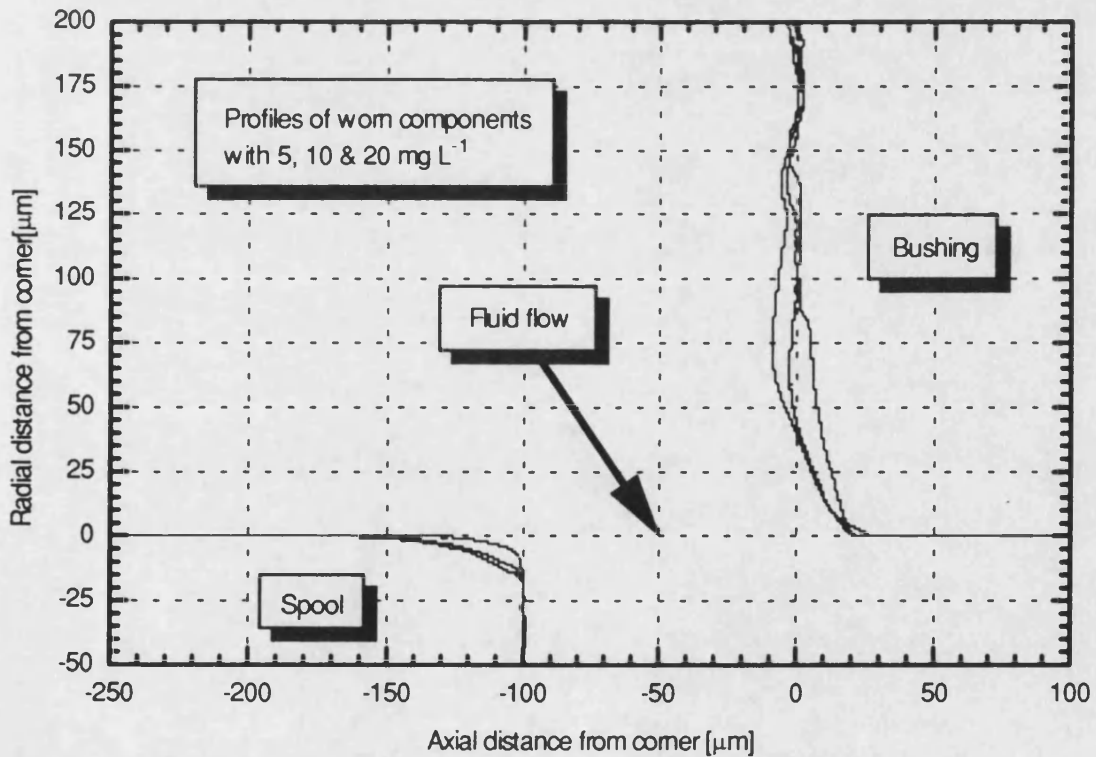
Figure 5.33 - Effects of 0-10 μm quartz concentration on spool/bushing profiles.

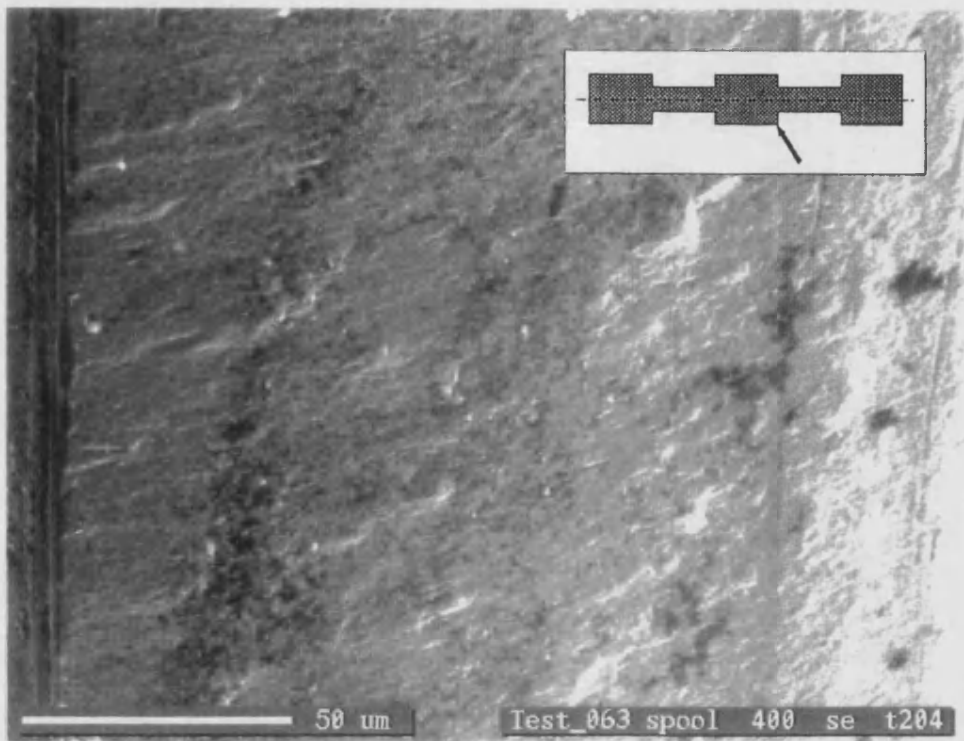
Figure 5.36 - SEM micrograph of the spool metering edge for a 70 bar uncut quartz test (S→T).

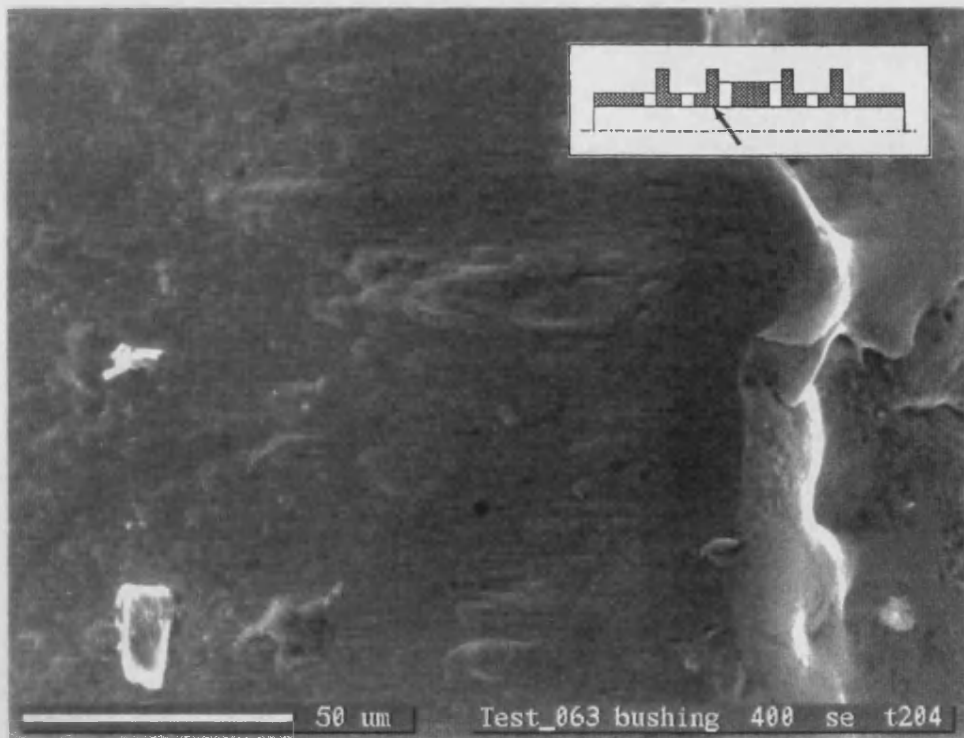
Figure 5.37 - SEM micrograph of the bushing metering edge for a 70 bar uncut quartz test (S→T).

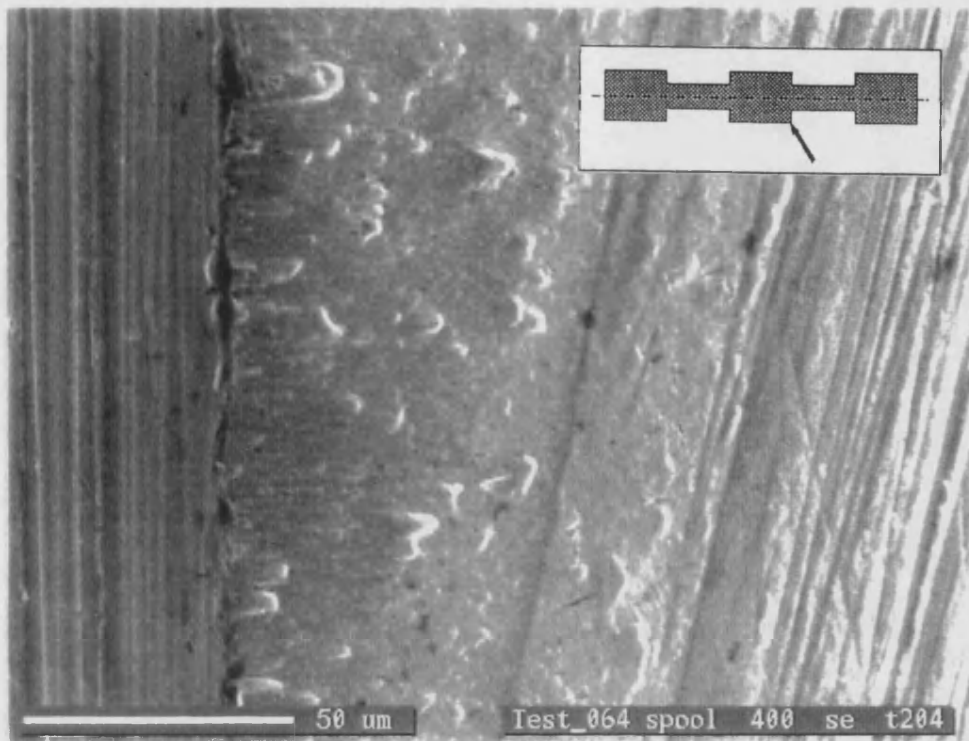
Figure 5.38 - SEM micrograph of the spool metering edge for a 70 bar 0-10 µm quartz test (S→T).

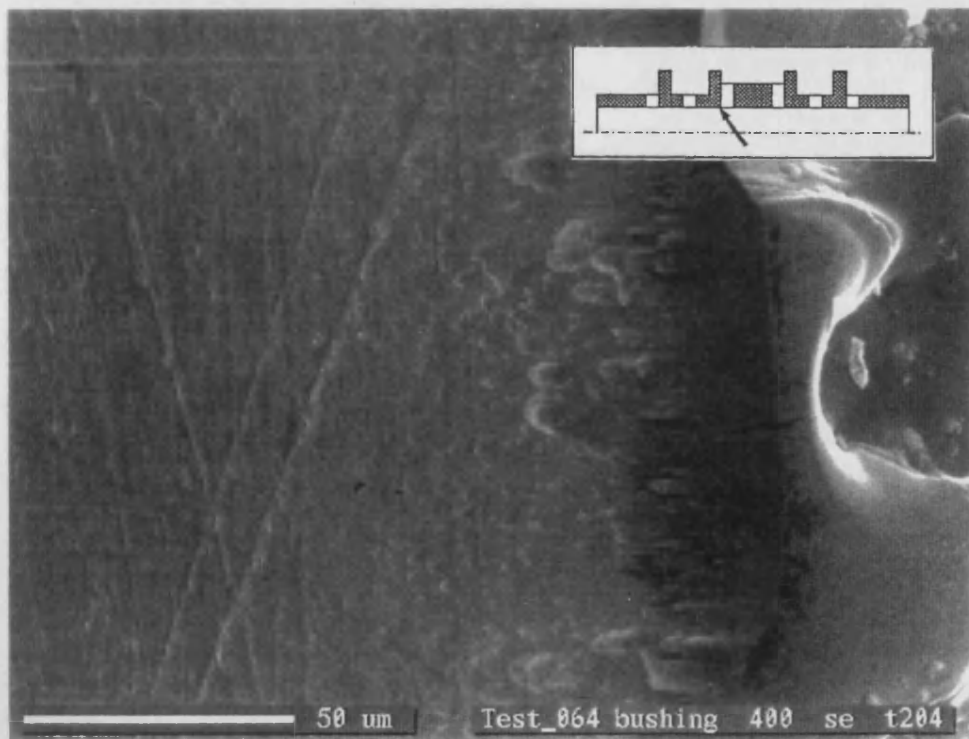
Figure 5.39 - SEM of the bushing metering edge for a 70 bar 0-10 µm quartz test (S→T).

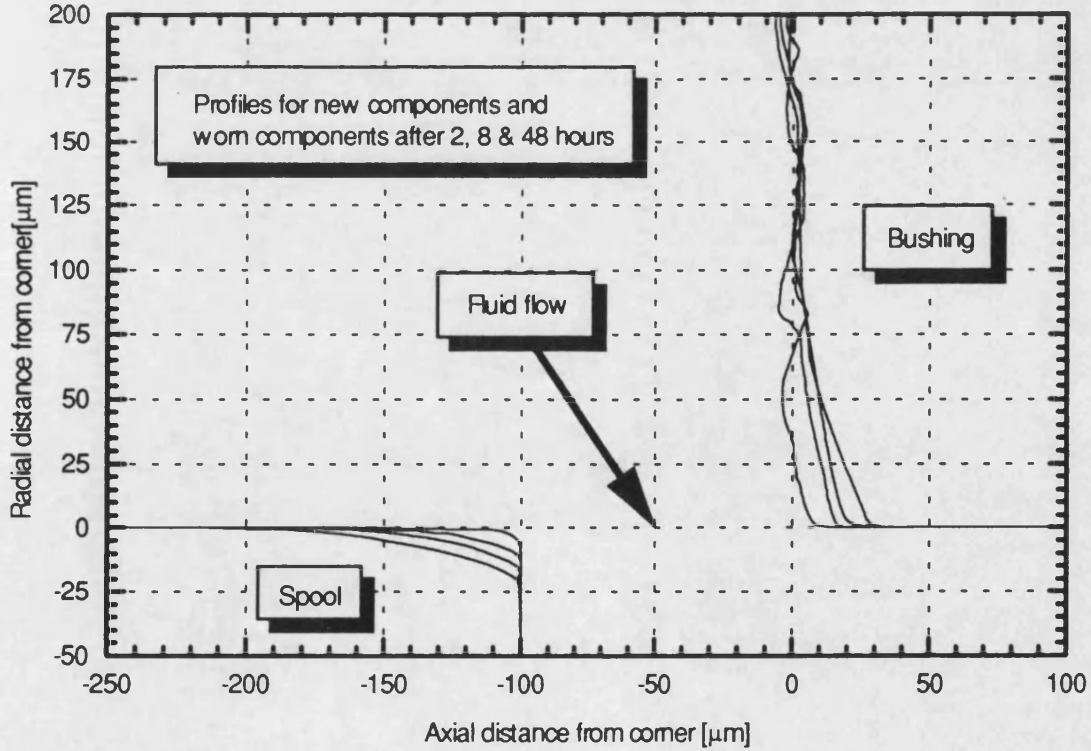
Figure 5.41 - Spool/bushings profiles, flow P to S with uncut quartz at 70 bar.

As described is Section 5.6.4, the quantity of material removed at each test condition can be found by integrating the component profile. The results are presented in Table 5.2. In line with the results presented earlier, a subtracted correction allowance for the new spool and bushing of 46 and 107 μm^2 respectively has been applied. From Table 5.2 it can be seen that for the same test conditions, the quantities of material removed (combined wear) in the P→S is greater than the S→T flow direction. This result is surprising since the flow plots suggest that more wear occurred in the S→T direction. However, it can be seen from the S→T SEM micrograph results that material is deformed in the direction of the fluid flow as well as being removed. It is thought that this feature may be due to the softer material on the side wall of the metering slot (see Section 5.2.1), although this is difficult to verify.

In addition to the variation in the combined value, the contribution of each individual component varies significantly with the flow direction. For example, in the P→S direction the bushing wears significantly more than the spool and the opposite occurs in the S→T flow direction. This result implies that the wear profiles may be dependent upon the fluid flow patterns and/or the jet angle as fluid enters the flow restriction. However, it is beyond the scope of this thesis to determine exactly what flow patterns exist as the fluid enters and leaves the valve, although some computational fluid dynamic (CFD) predictions are included in Chapter 8
