Erosive wear failure of spool valves

Erosive Wear Failure of
Spool valves

Submitted by Paul E Pomeroy

1995

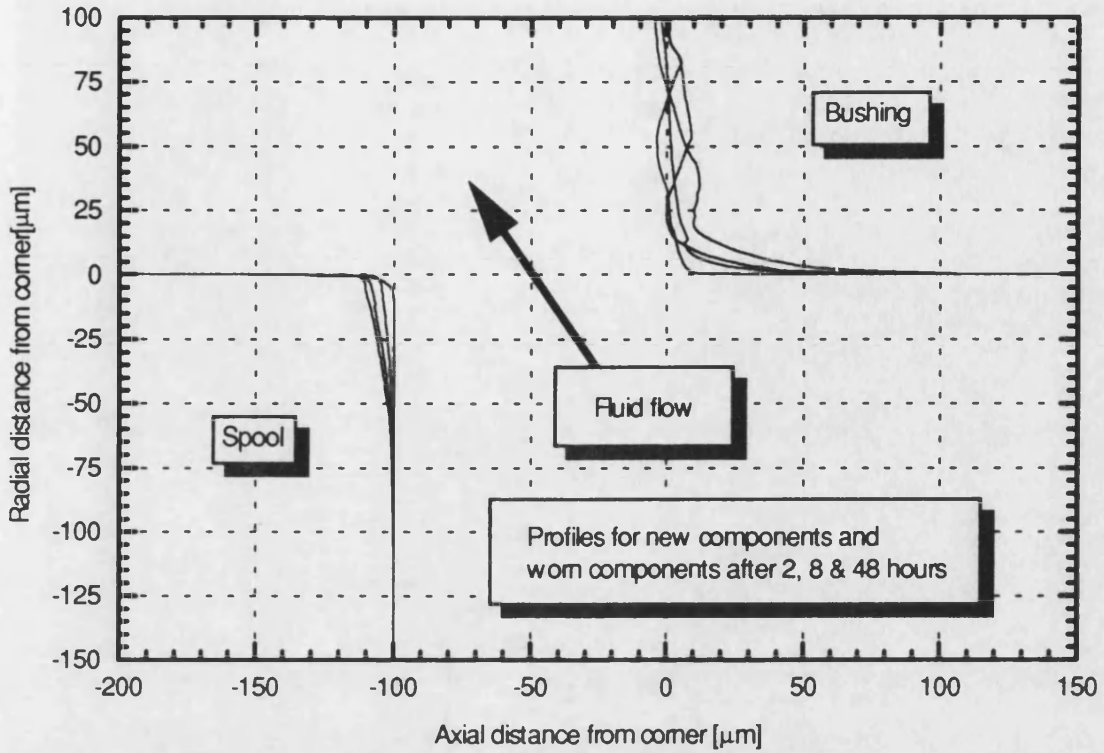
Figure 5.42 - Spool/bushings profiles, flow S to T with uncut quartz at 35 bar.

As described is Section 5.6.4, the quantity of material removed at each test condition can be found by integrating the component profile. The results are presented in Table 5.2. In line with the results presented earlier, a subtracted correction allowance for the new spool and bushing of 46 and 107 μm^2 respectively has been applied. From Table 5.2 it can be seen that for the same test conditions, the quantities of material removed (combined wear) in the P→S is greater than the S→T flow direction. This result is surprising since the flow plots suggest that more wear occurred in the S→T direction. However, it can be seen from the S→T SEM micrograph results that material is deformed in the direction of the fluid flow as well as being removed. It is thought that this feature may be due to the softer material on the side wall of the metering slot (see Section 5.2.1), although this is difficult to verify.

In addition to the variation in the combined value, the contribution of each individual component varies significantly with the flow direction. For example, in the P→S direction the bushing wears significantly more than the spool and the opposite occurs in the S→T flow direction. This result implies that the wear profiles may be dependent upon the fluid flow patterns and/or the jet angle as fluid enters the flow restriction. However, it is beyond the scope of this thesis to determine exactly what flow patterns exist as the fluid enters and leaves the valve, although some computational fluid dynamic (CFD) predictions are included in Chapter 8

- Testing in the S→T direction, suggests that the bushing metering corner is subjected to both material removal and a deformation process. Again this could be due the flow patterns, but the softer material properties found adjacent to the sides of the metering slots may be a factor.

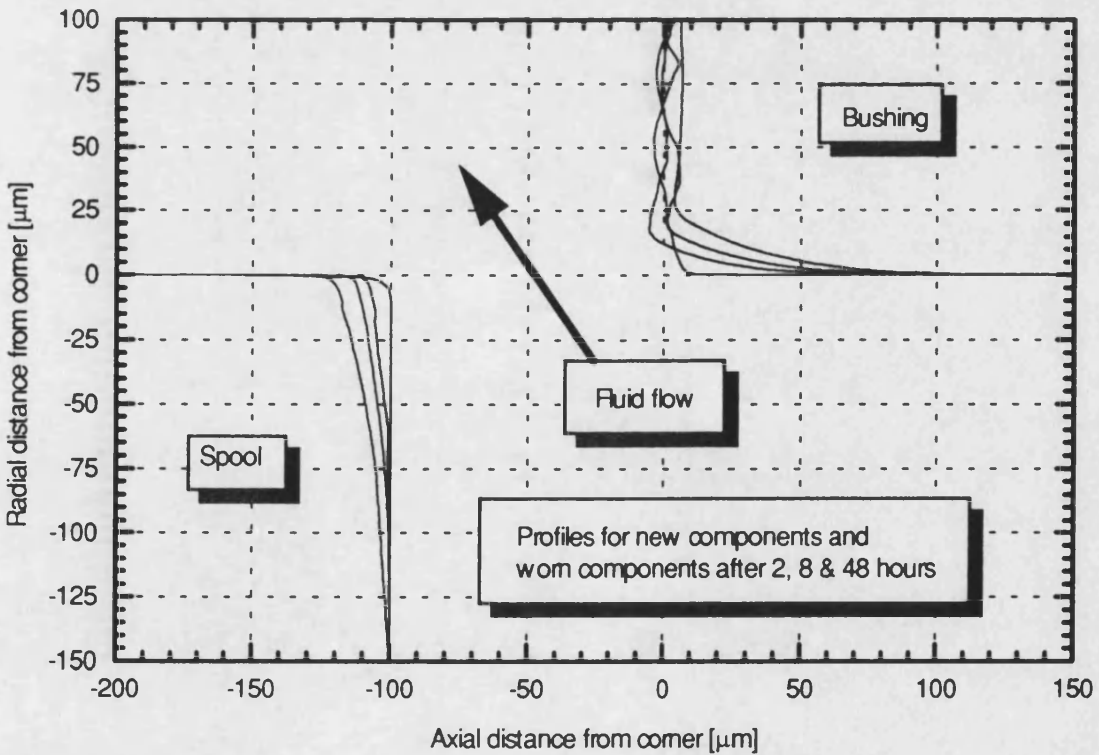
Figure 5.43 - Spool/bushings profiles, flow S to T with uncut quartz at 70 bar.

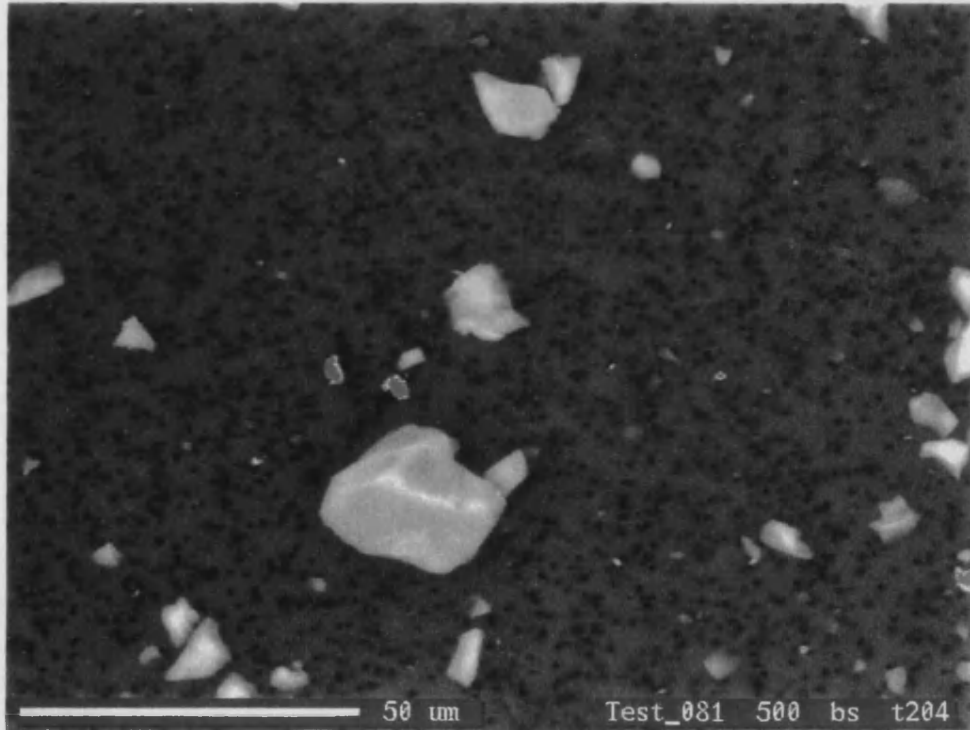
Figure 5.44 - Example of uncut quartz and steel wear debris from an erosion test.

The experimental approach worked well with the RPD slides, although a small quantity of quartz particles were also present with the steel wear debris. This suggests that the quartz particles are statically charged or have magnetic material attached (para-magnetic). Since the LCM II particle counts are combined readings for quartz and steel, a particle size/composition ratio is required. For this, membrane filters are used in preference to RPD slides. Figure 5.44 shows a typical SEM examination of a filter where the steel particles are highlighted in red.

From the samples tested, the steel wear debris has been found to be smaller than 6 µm and, consequently, only the >5 µm particle counts will be affected. Typical quartz/steel ratios for uncut and 0-10 µm quartz dust following a 48 hour test with a 70 bar differential pressure are shown in Table 5.4.

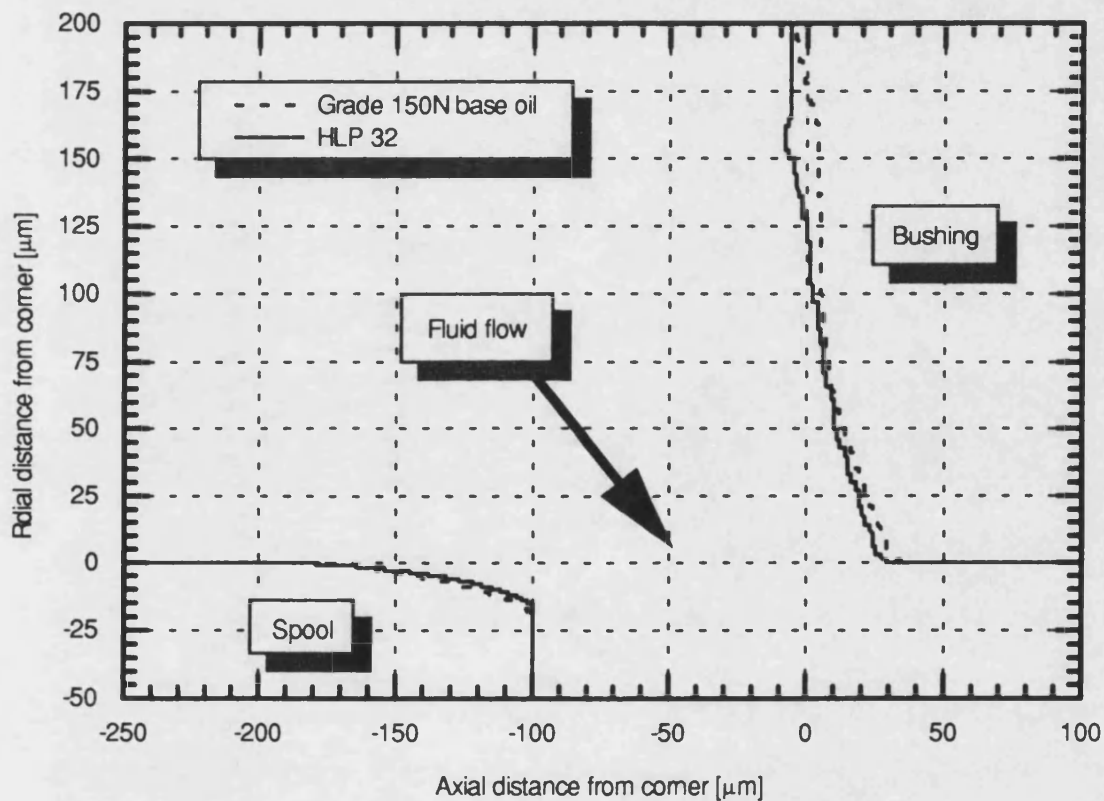
Figure 6.7 - Component profiles for a base oil and a HLP test.

To confirm these results, profile measurements have been conducted on the components from the 70 bar, uncut quartz tests. From Figure 6.7, the results confirm that more material has been removed from the spool and bushing during the base oil test. Although, the variation between the two profiles does not appear to be significant, this small difference will affect both the flow area and the orifice flow coefficient (C_q). In addition to the component profiles, SEM micrographs have been examined for the different test conditions. Unfortunately, the two test conditions cannot be visually separated. Therefore, the SEM micrographs in Chapter 5 can be used for the HLP tests.

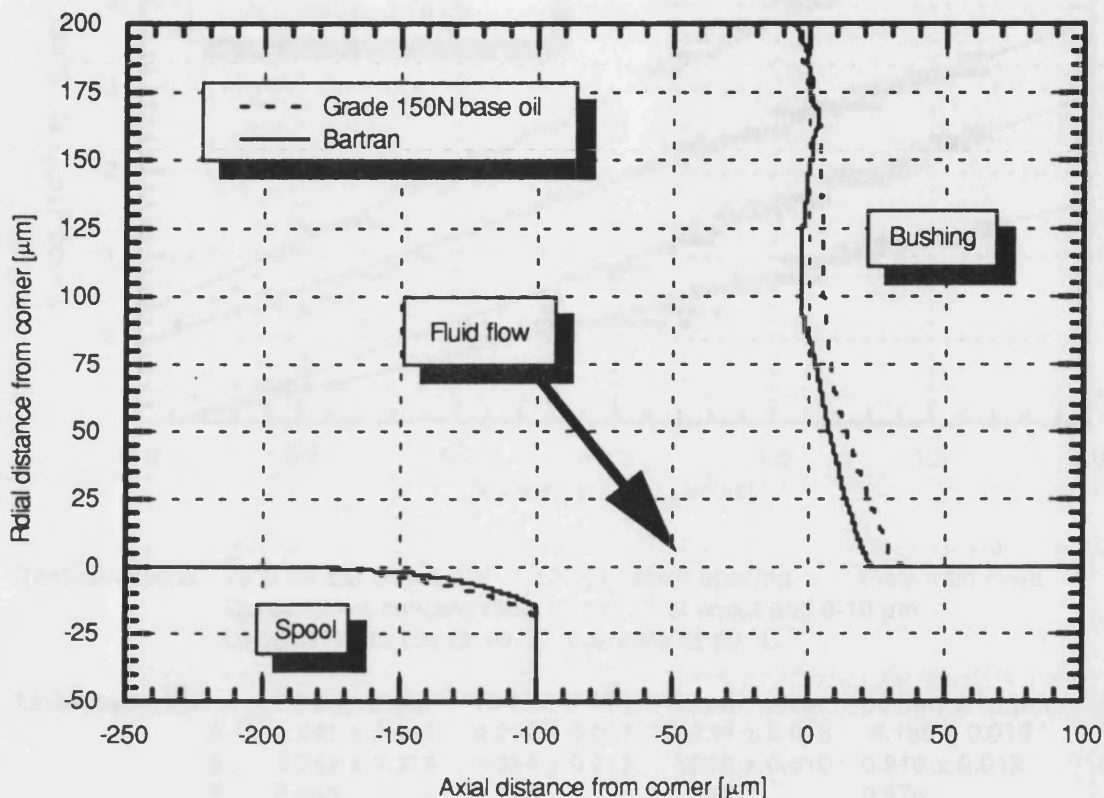
Figure 6.9 - Component profiles for a base oil and Bartran test.

As with the HLP results, component profiles for the Bartran tests have been used to verify the flow plot. From Figure 6.9, a difference between the base oil and the Bartran tests can be detected. However, when compared to the HLP results, Figure 6.7, it appears that the difference is slightly larger in the Bartran case. This supports the findings that Bartran gives improved performance over the HLP.

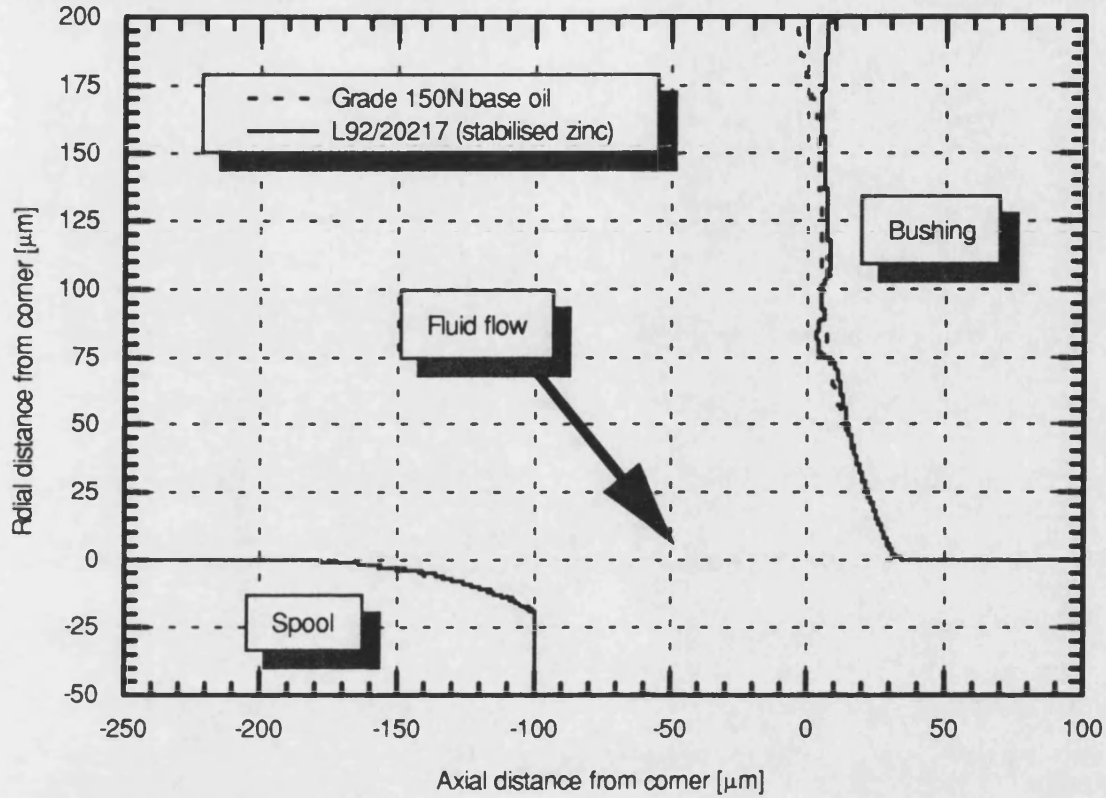
Figure 6.11 - Component profiles for a base oil and a L92/20217 test.

This result can be verified from the profile measurements presented in Figure 6.11, where it is impossible to discriminate between the base oil and the L92/20217 test.

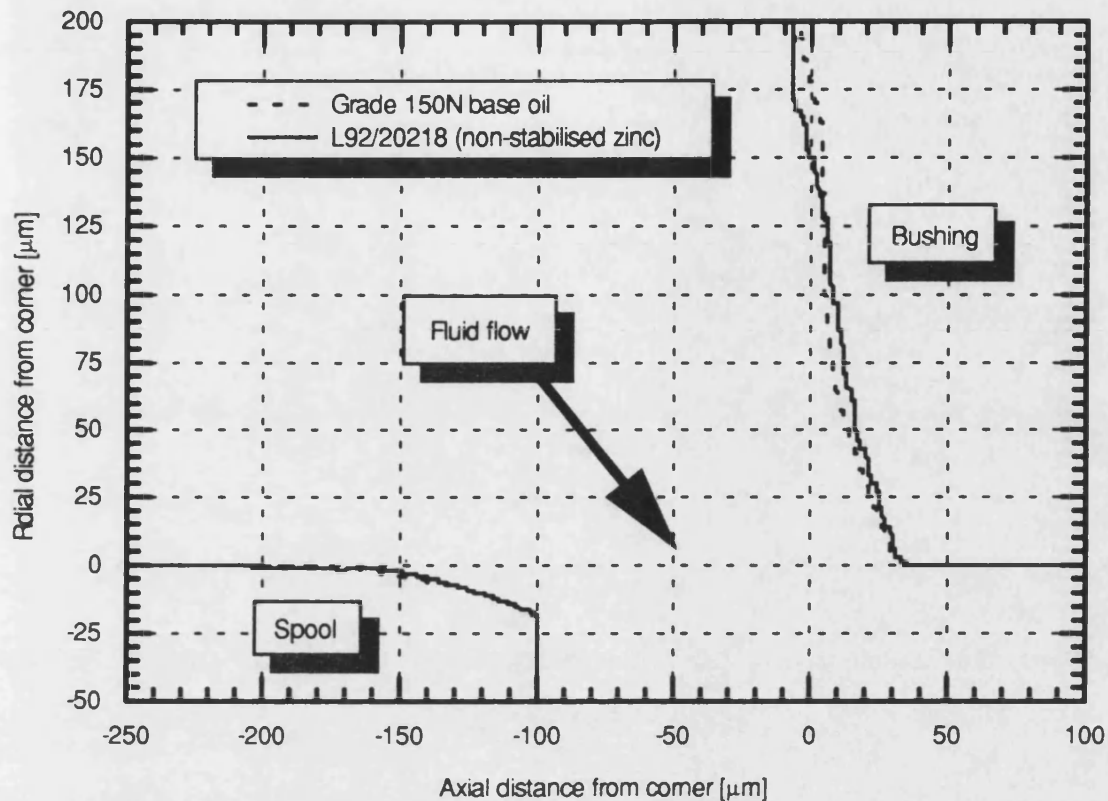
Figure 6.13 - Component profiles for a base oil and a L92/20218 test.

This result can be verified from the profile measurements Figure 6.13, where it is impossible to discriminate between the base oil and the L92/20218 test.

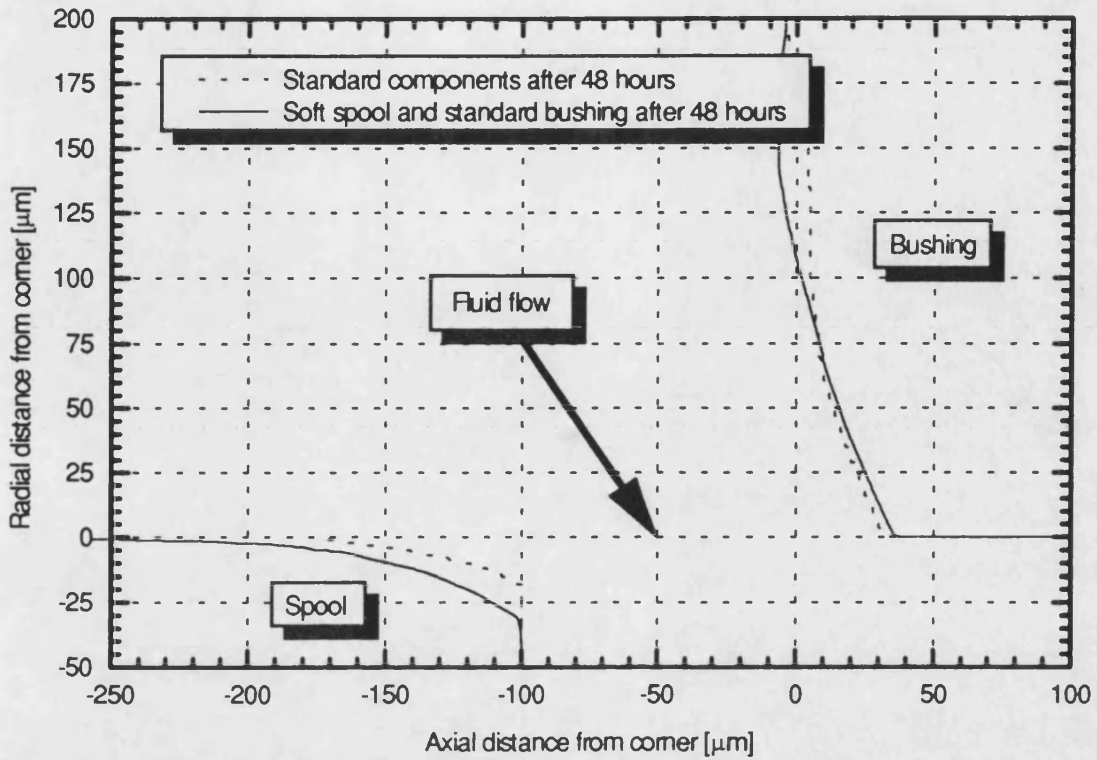
Figure 7.4 - Soft spool/bushing profiles, flow P to S with uncut quartz at 70 bar.

From Figures 7.4 & 7.5 it can be seen that the spool wear profile has changed as suggested by the flow plots. It is interesting to see that little or no change has occurred with the bushing wear profile and therefore any flow change can be directly attributed to the spool properties.

By integrating the wear profiles, it is possible to calculate the area of material removed for each test condition as shown in Table 7.1. These are presented with a subtracted correction allowance of 46 μm^2 for a new spool. The results show that almost a complete reversal in the amount of material removed occurs between the two flow directions. At present this result cannot be explained using published literature.

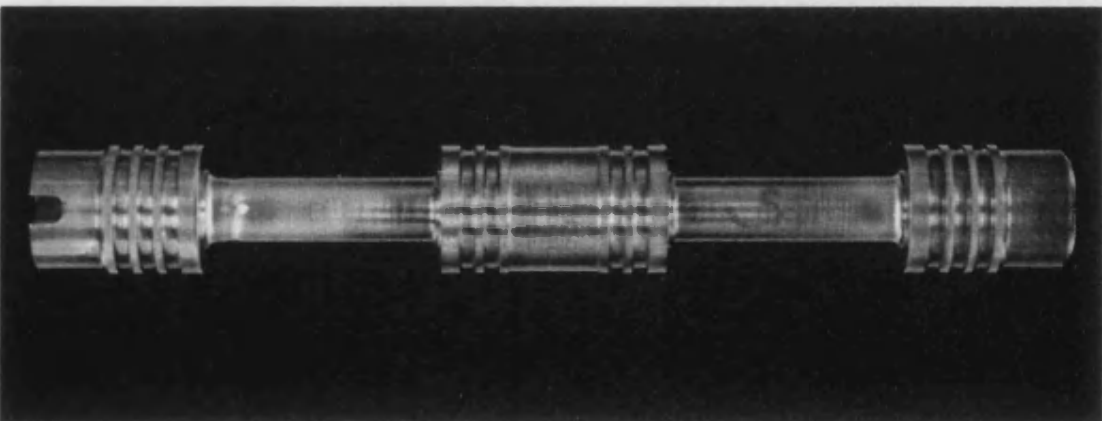
Figure 7.8 - Overall view of soft spool after the completion of all four tests.

From the SEM micrographs, it is impossible to discriminate between the soft and the standard spools, hence they have been omitted from this chapter to prevent duplication. However, low magnification micrographs of the spool are included in Figures 7.6 to 7.8. These clearly illustrate the effects of contaminant in the P→S direction by the removal of the temper colours along the spool stems. In addition, excessive damage has been caused by the uncut quartz on the spool stem. This result gives a good indication of the flow jet angle through the metering orifice in the P→S direction.

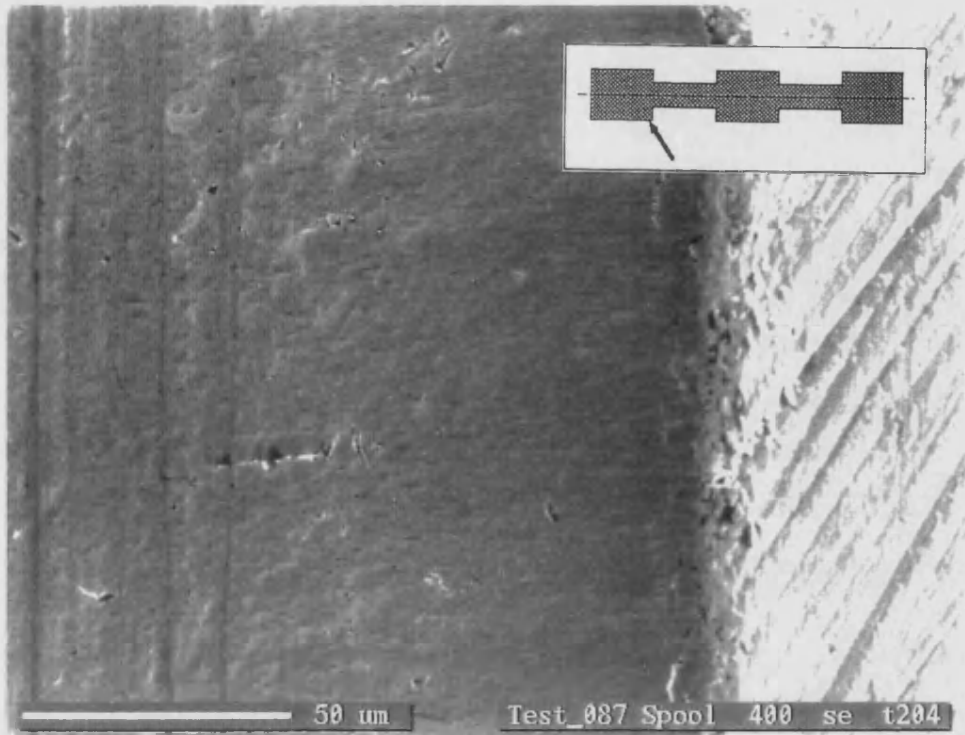
Figure 7.10 - SEM micrograph of nitrocarburised spool pressure land, uncut quartz.

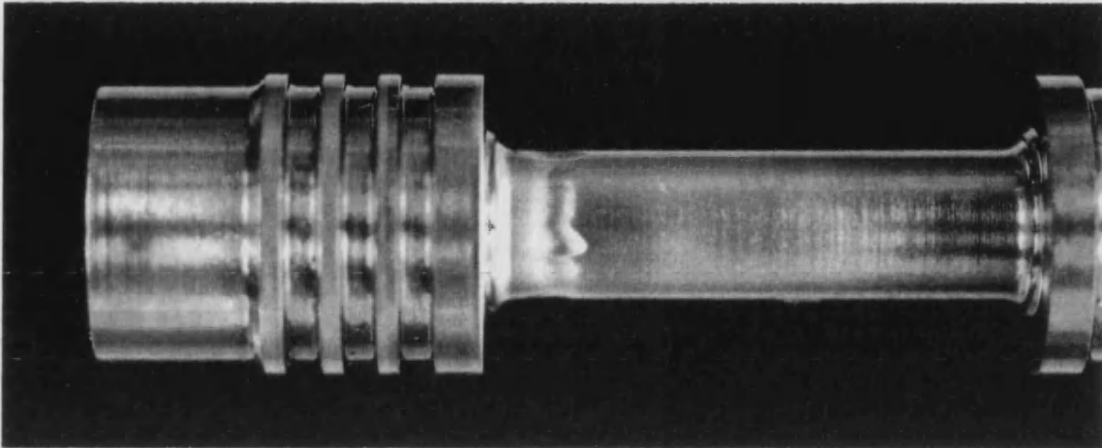
Figure 7.14 - Nitrocarburised spool pressure land following a uncut quartz test.

Figures 7.10 to 7.13 contain a SEM micrograph for each of the spool metering edges. As previously discussed in Chapter 5, the columnar structure is present in the direction of the fluid flow, although the damaged area extends a smaller distance from the corner when compared with the standard components. This visually confirms the increased performance. However, the most interesting point can be seen in the 0-10 μm quartz, pressure land test, Figure 7.11, and to a less extent in the uncut quartz test, Figure 7.10. Here it can be seen that a layer of material has been effectively removed from the surface. It is not clear how or why this has occurred, but it is not unreasonable to assume that this is the hard nitrocarburised layer. For completeness, the low magnification micrographs of the spool are shown in Figures 7.14 to 7.16. Again many of the features described in Section 7.3 for the soft spool apply.

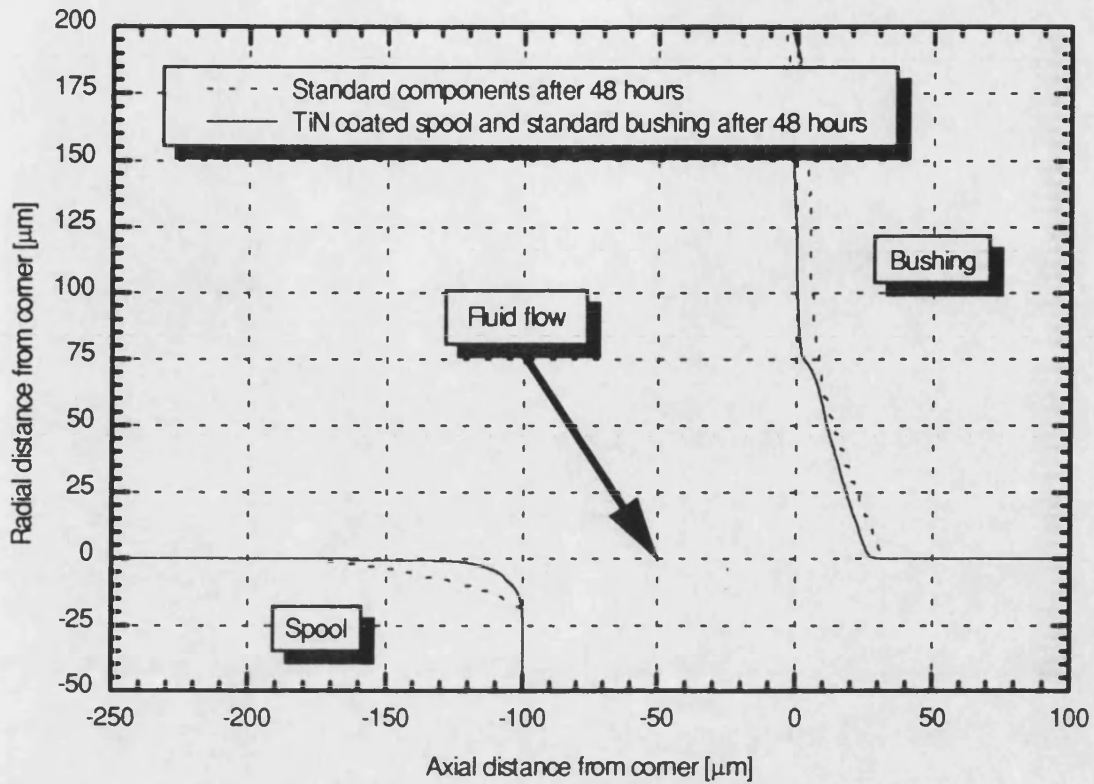
Figure 7.18 - TiN spool/bushings profiles, flow P to S with uncut quartz at 70 bar.

From Figures 7.18 & 7.19 it can be seen that the spool wear profile has changed as suggested by the flow plots. The area of material removed for each test condition is shown in Table 7.2. The results indicate an improvement in the resistance of the surface to particle erosion, especially in the S→T case, where a 10:1 reduction has occurred.

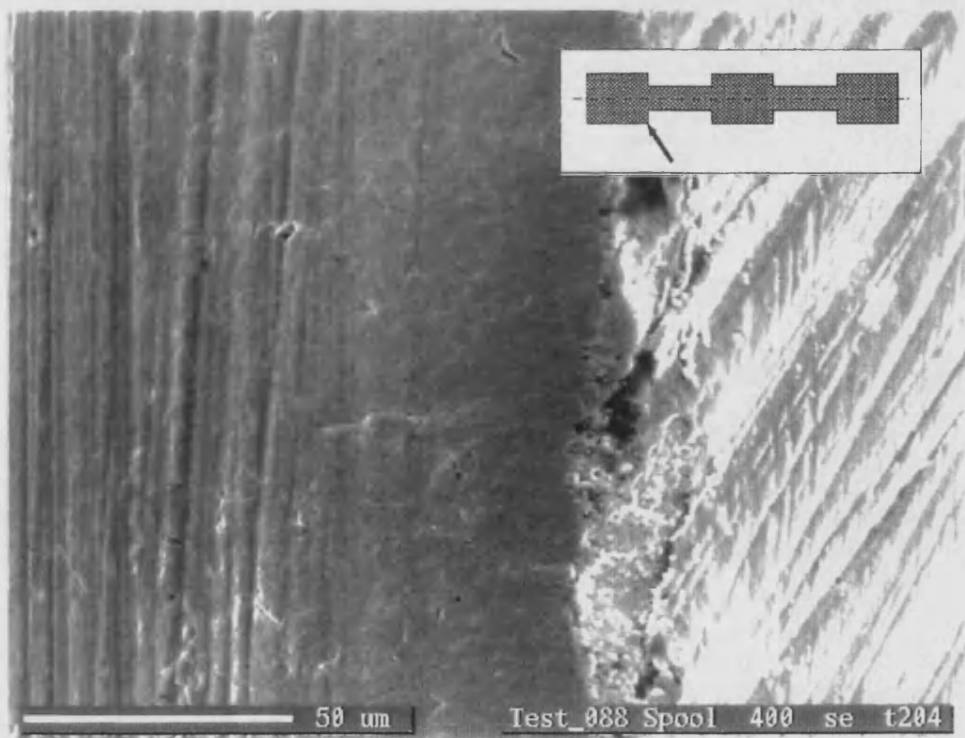
**Figure 7.20 -** SEM micrograph of TiN coated spool pressure land, uncut quartz.

Figures 7.20 to 7.23 contain a SEM micrograph for each of the spool metering edges. Unlike all the spools examined to date, the columnar wear patterns have been replaced by a ploughed surface localised at the corner. This confirms the profile maps which indicated that a slight rounding of the metering corner has occurred. When the corners were examined using EDX (energy dispersive analysis), the results indicated that a layer of TiN coating was still present.

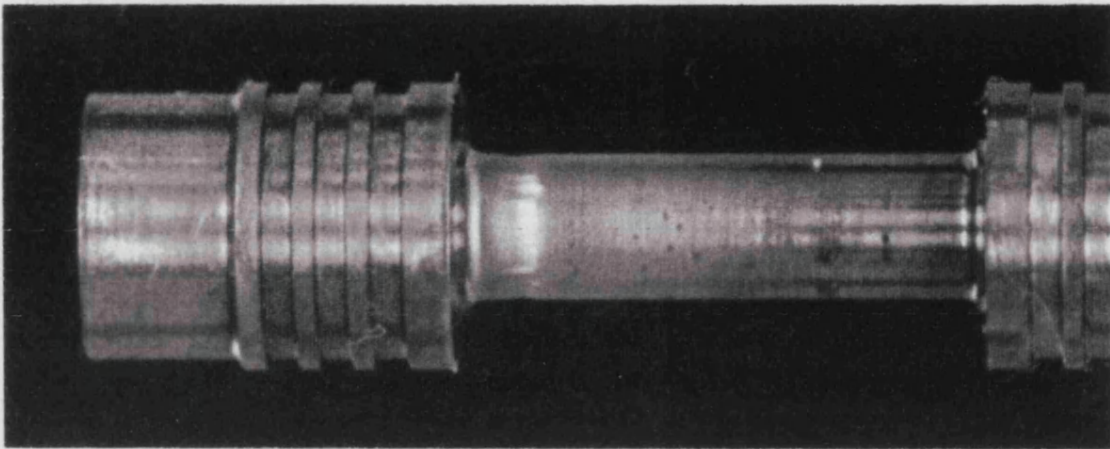
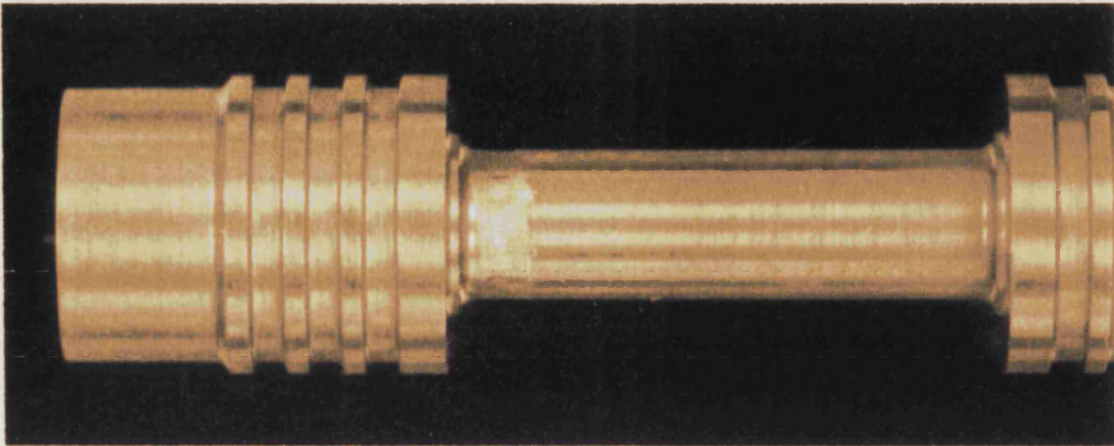
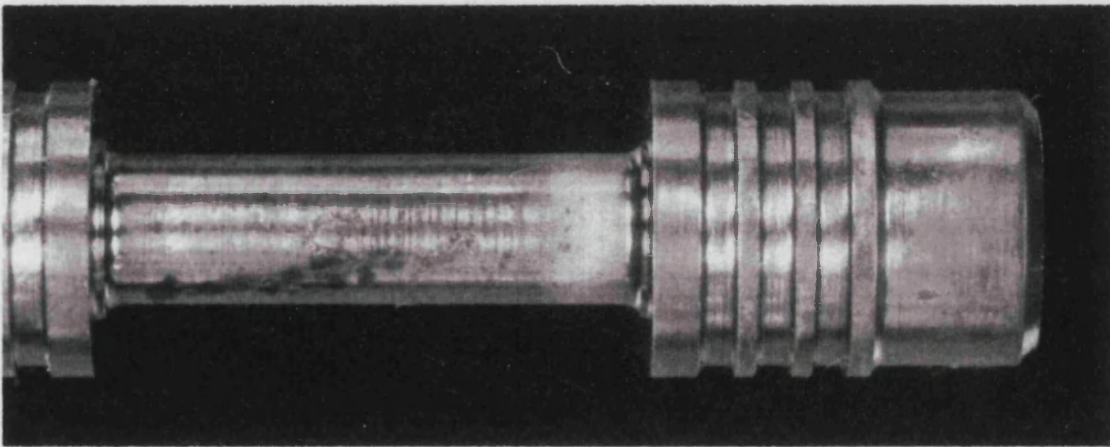
The low magnification micrographs of the spool are shown in Figures 7.24 to 7.26. Unlike the soft and nitrocarburised spool, the spool appearance is unchanged except for a small area on the stem arising from the uncut quartz test on the pressure land. This area is assumed to be caused by the momentum of the large particles carried in the exit jet flow. This is shown pictorially in Figure 7.27, where assuming that the particles are carried by the fluid streamlines, a mean jet or impact angle has been calculated at 54° (total range of damage is between 45 and 70°). These angles are not unreasonable when compared to the classic 69° Von-Mises jet angle for a spool valve [54]. However, the optimum impact angle for maximum erosion will be 20 to 30° for a ductile material and therefore it is surprising that damage has resulted.

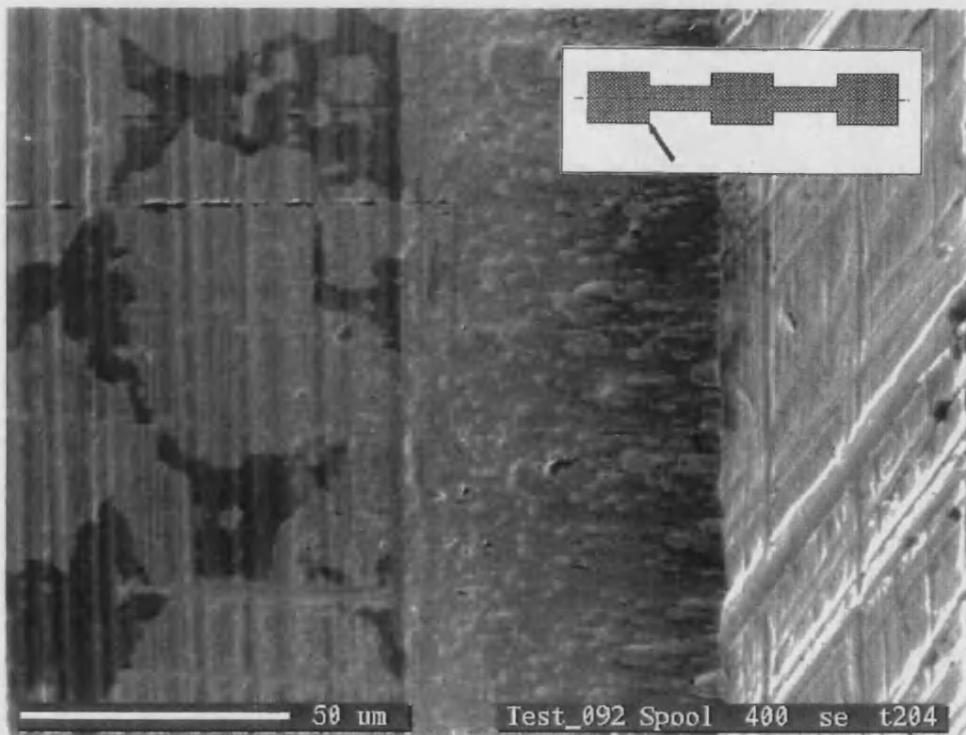
From the SEM micrographs Figures 7.29 to 7.32, and the low magnification micrographs Figures 7.33 to 7.35, the surface topography of the worn spool appears to be very similar to the standard material. However, the length of the wear scar extending from the corner is reduced as expected from the improvement in the flow plots.

Figure 7.29 - SEM micrograph of ion implanted spool pressure land, uncut quartz.

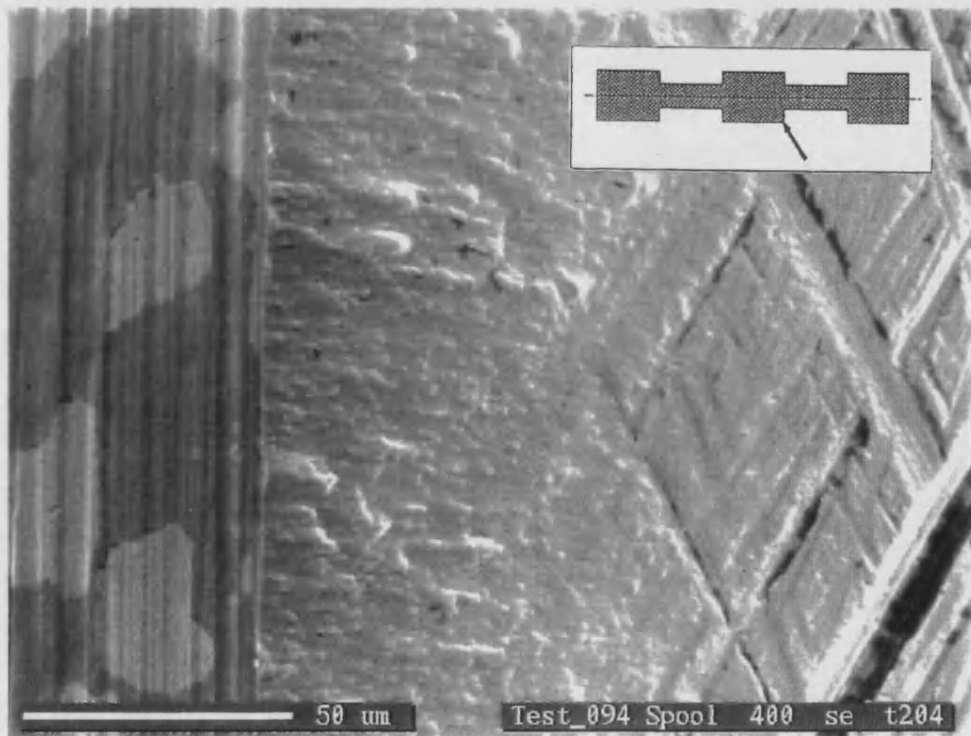
Figure 7.30 - SEM micrograph of ion implanted spool pressure land, 0-10 μm quartz.

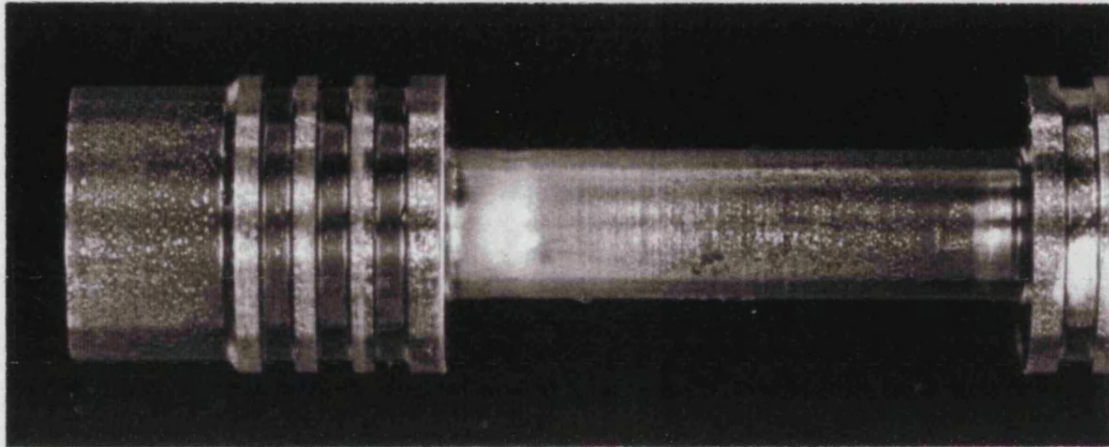
Figure 7.33 - Ion implanted spool pressure land following a uncut quartz test.

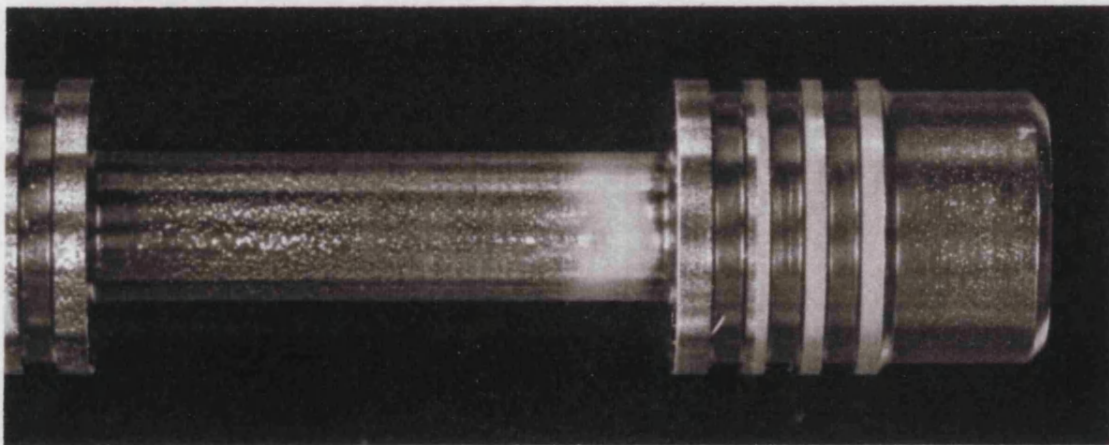
Figure 7.34 - Ion implanted spool pressure land following a 0-10 µm quartz test.

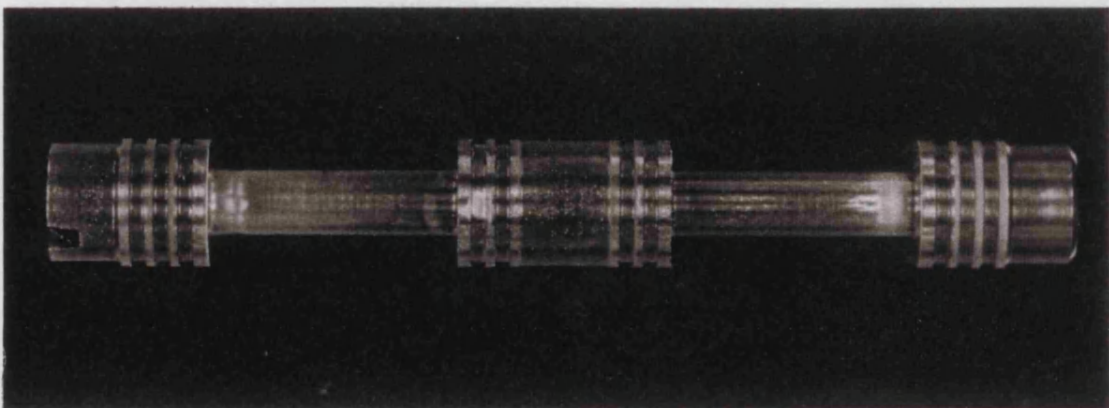
Figure 7.35 - Overall view of ion implantation spool after the completion of all four tests.

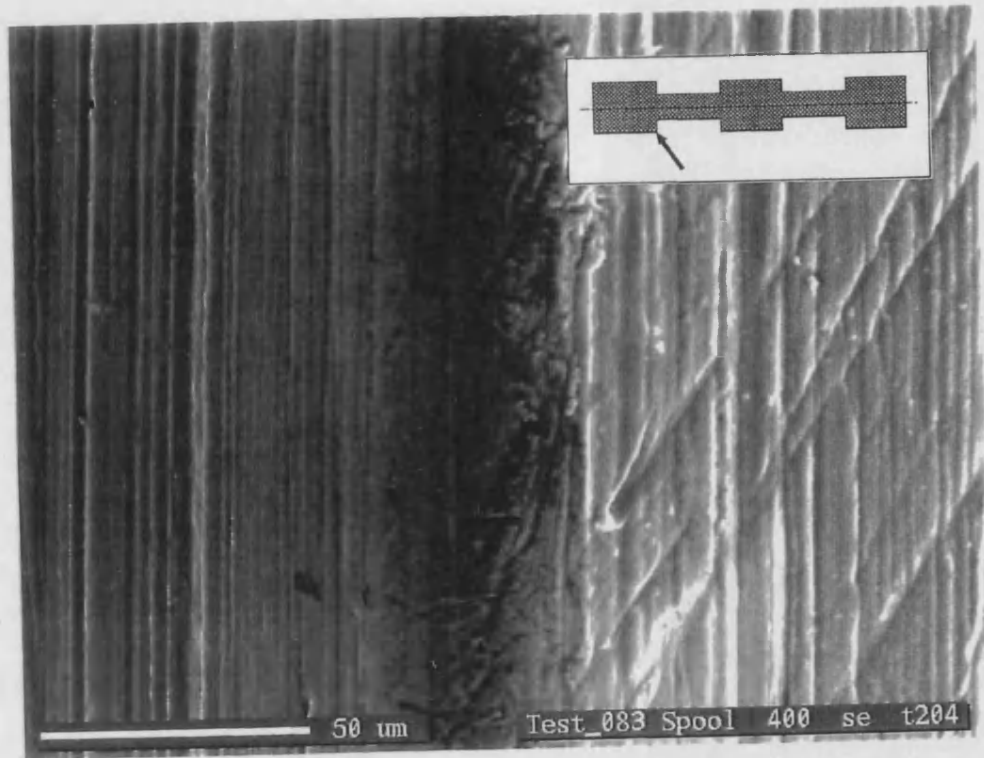
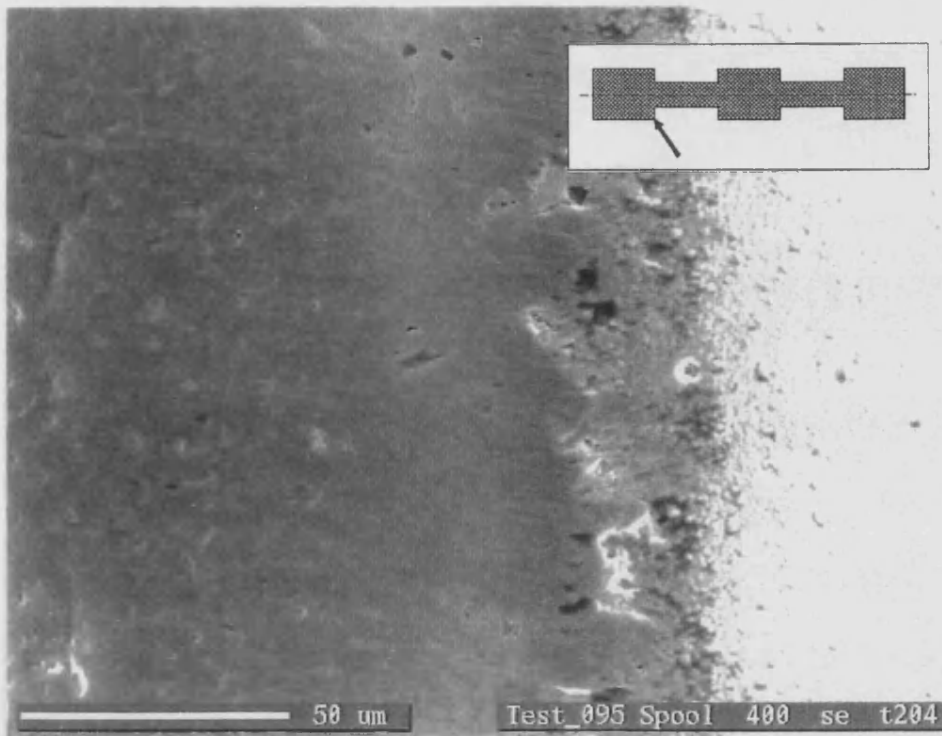
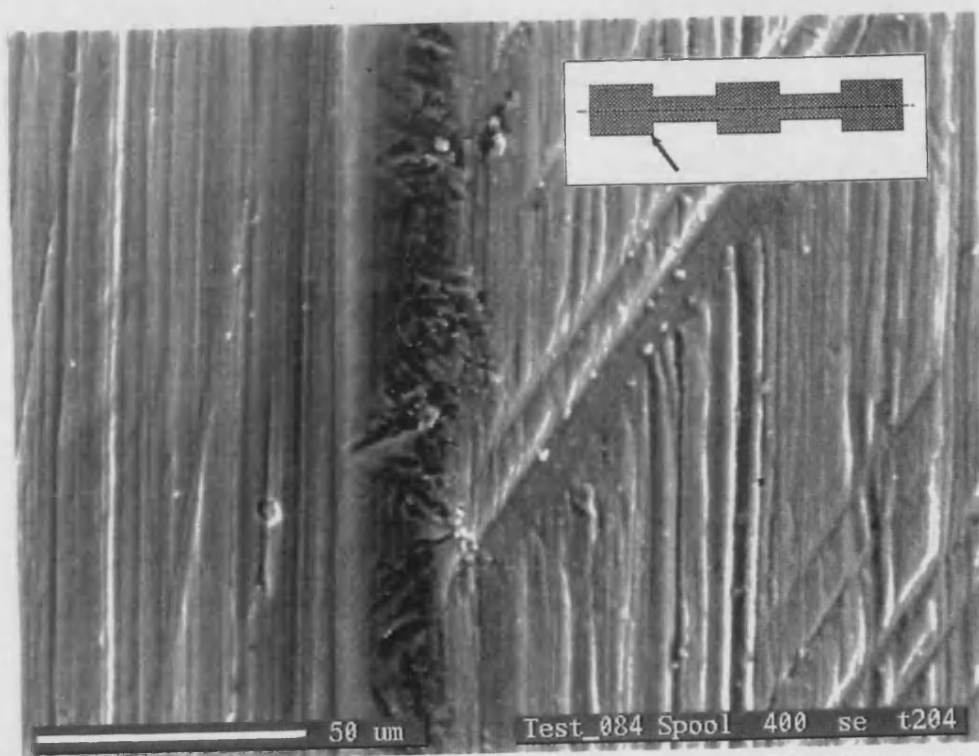
**Figure 7.37** - SEM micrograph of WC/C coated spool pressure land, uncut quartz.

From the tungsten carbide/carbide coated spool results included in Section 7.7, an initial increase in the erosion resistance was found. However, after a given test period a step change in the results was obtained. From the spool SEM analysis (Figures 7.37 to 7.40) it can been seen that the coating has been removed from the parent material. Unfortunately, this highlights a common problem associated with surface coatings, where often the performance is dependent on the bonding between the coating and the parent material and not on the properties of the surface coating alone. Further evidence on this effect has been reported by Stidh et al. [85] who studied the effects of particle erosion on thin ceramic coatings. From their results it was suggested that a strong relationship exists between erosion resistance and the coating thickness. Surprisingly the thin coatings performed better than the thicker ones. They conclude that low porosity, fine grain size, low residual stresses and good adhesion are desirable for good erosion resistance.

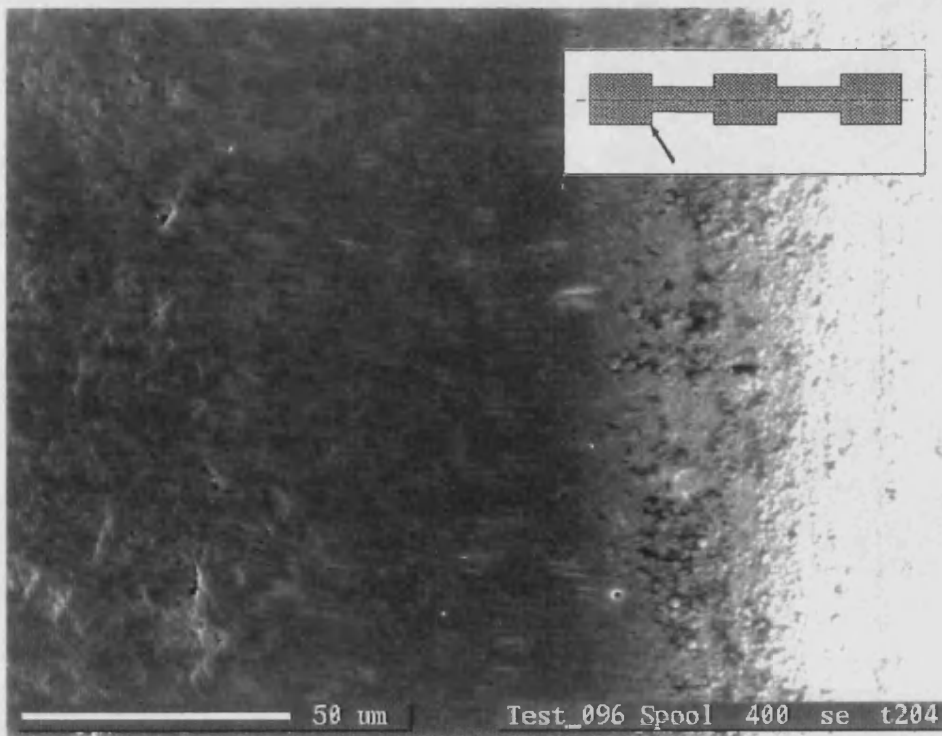
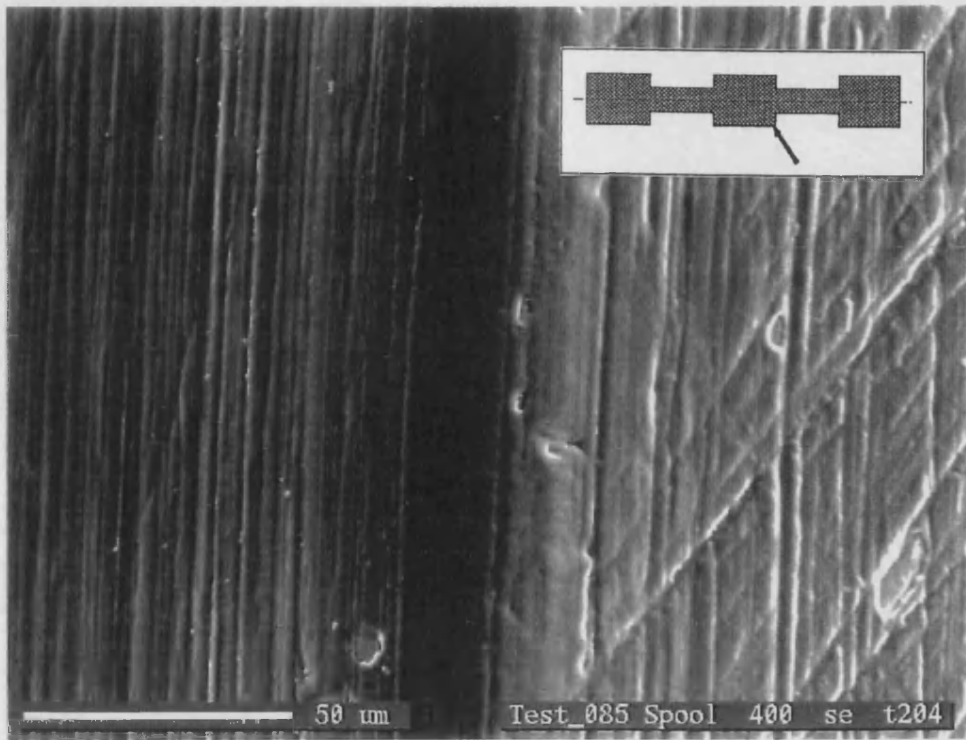
**Figure 7.38** - SEM micrograph of WC/C coated spool pressure land, 0-10 μm quartz.

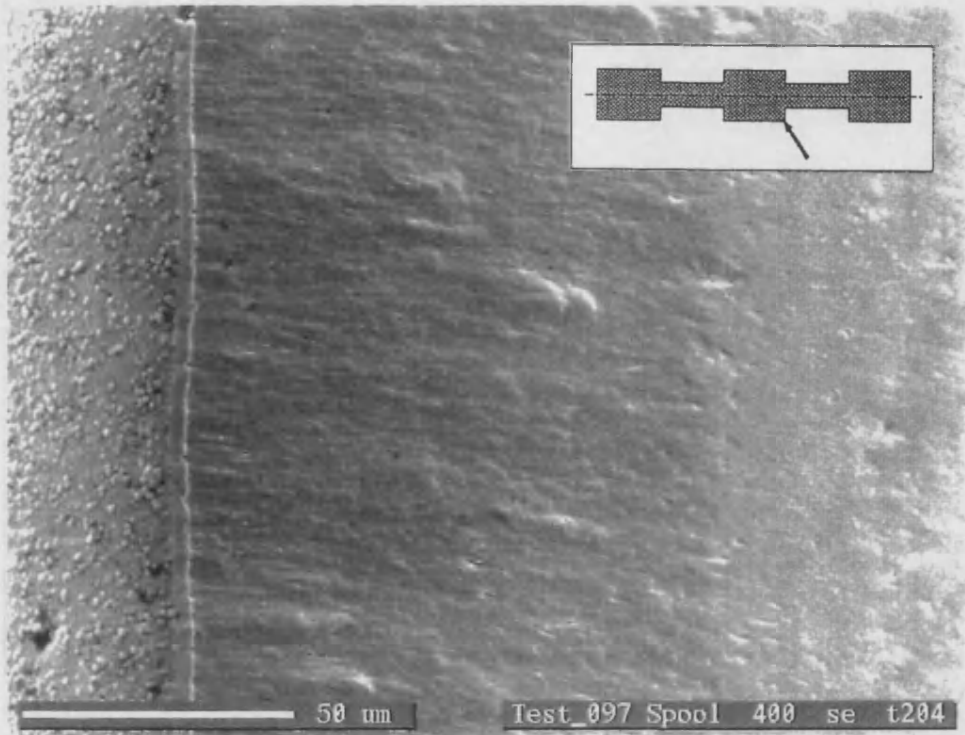
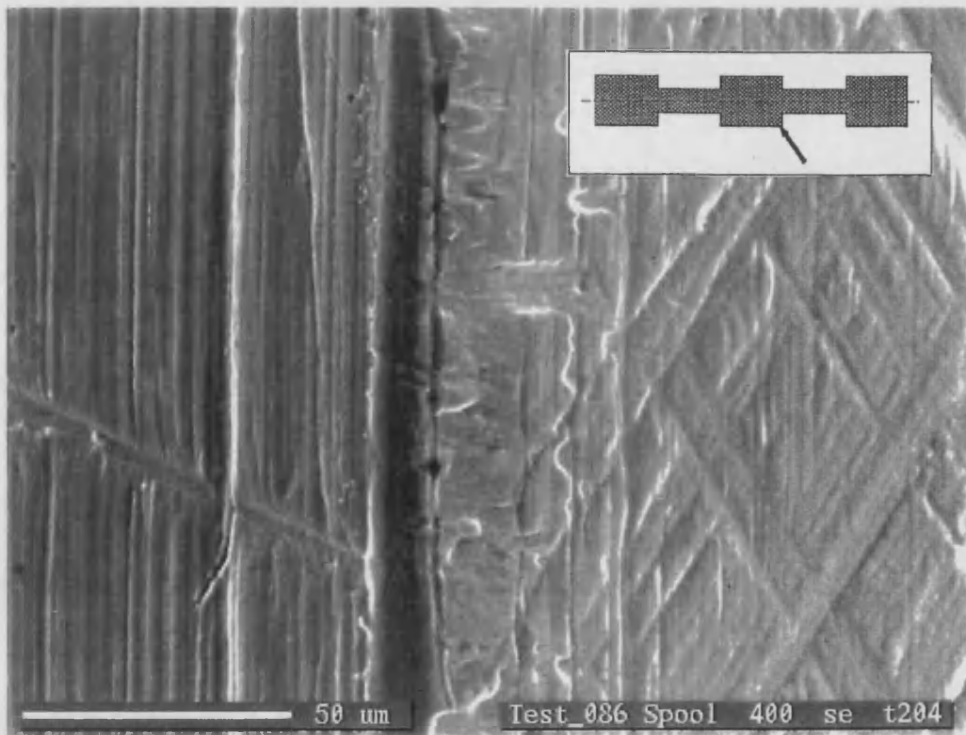
**Figure 7.39** - SEM micrograph of WC/C coated spool tank land, uncut quartz.
