Erosive wear failure of spool valves

Erosive Wear Failure of
Spool valves

Submitted by Paul E Pomeroy

1995

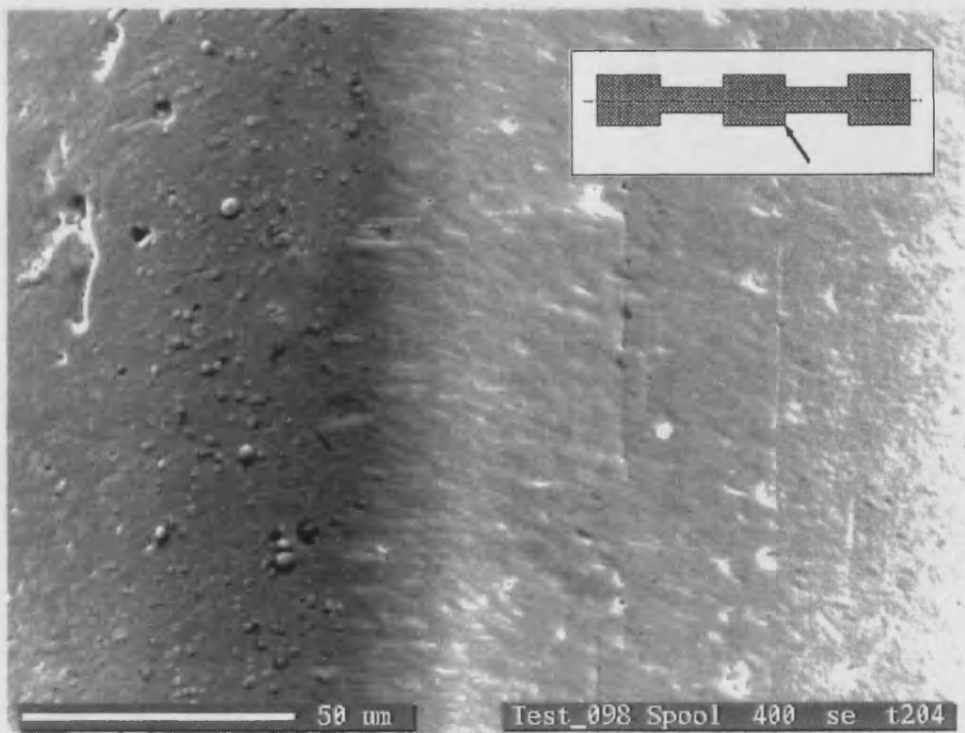
**Figure 7.40** - SEM micrograph of WC/C coated spool tank land, 0-10 μm quartz.

From the tungsten carbide/carbide coated spool results included in Section 7.7, an initial increase in the erosion resistance was found. However, after a given test period a step change in the results was obtained. From the spool SEM analysis (Figures 7.37 to 7.40) it can been seen that the coating has been removed from the parent material. Unfortunately, this highlights a common problem associated with surface coatings, where often the performance is dependent on the bonding between the coating and the parent material and not on the properties of the surface coating alone. Further evidence on this effect has been reported by Stidh et al. [85] who studied the effects of particle erosion on thin ceramic coatings. From their results it was suggested that a strong relationship exists between erosion resistance and the coating thickness. Surprisingly the thin coatings performed better than the thicker ones. They conclude that low porosity, fine grain size, low residual stresses and good adhesion are desirable for good erosion resistance.

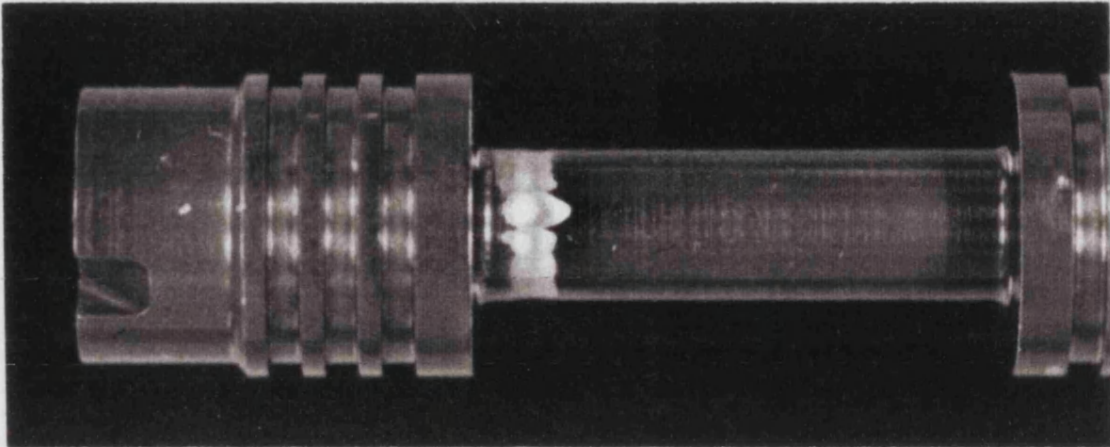
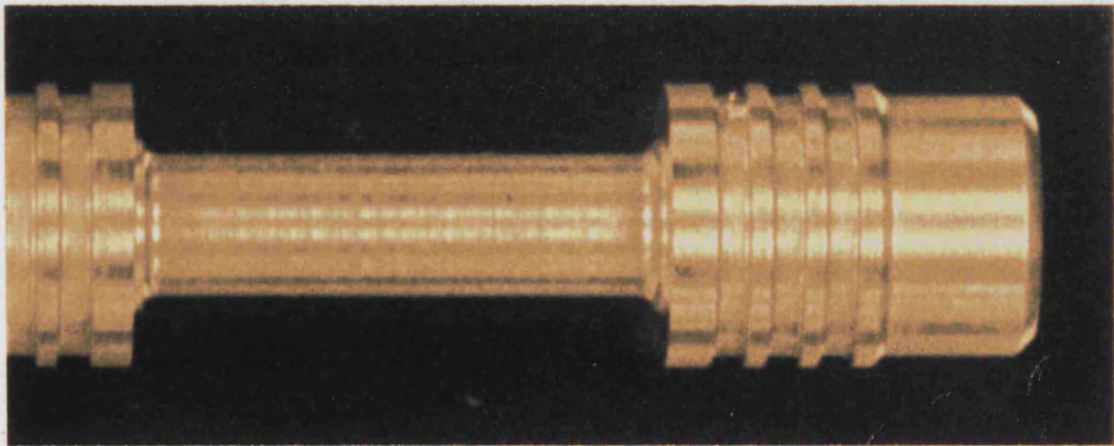
**Figure 7.41** - WC/C coated spool pressure land following a uncut quartz test.

Finally, the low magnification micrographs for the WC/C coated spool are included in Figures 7.41 to 7.43. The salient features of the worn spool are similar to the TiN coated spool, where the only visible damage occurs on the spool stem after completion of the uncut quartz test.

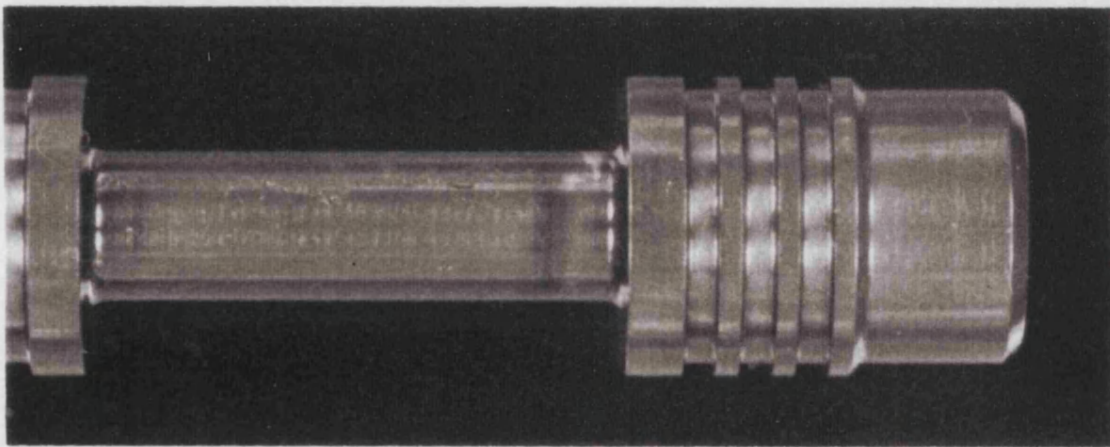
**Figure 7.42** - WC/C coated spool pressure land following a 0-10 μm quartz test.

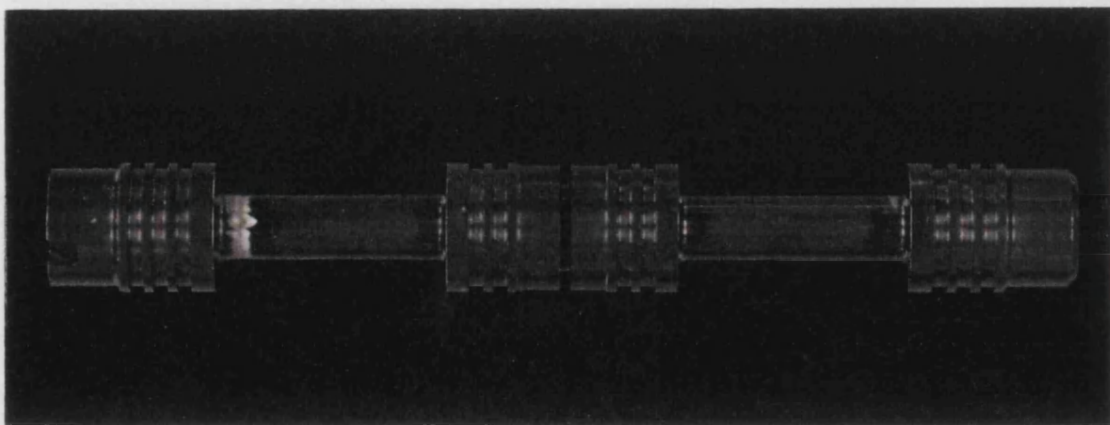
Figure 7.43 - Overall view of WC/C coated spool after the completion of all four tests.

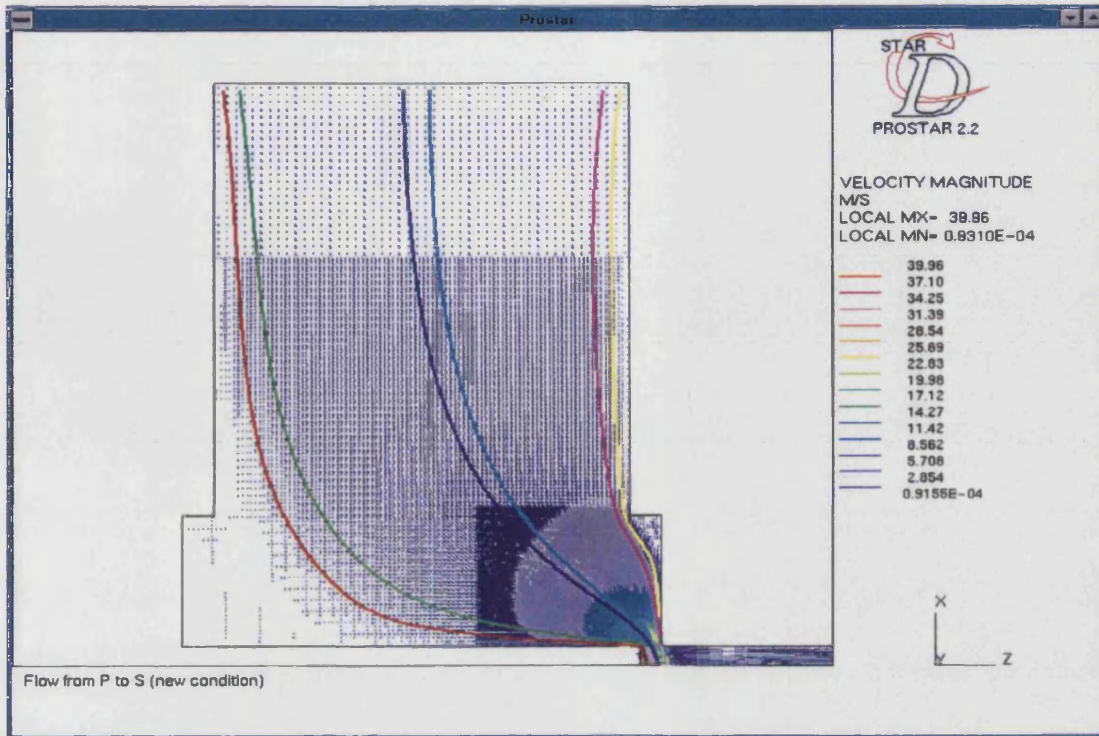
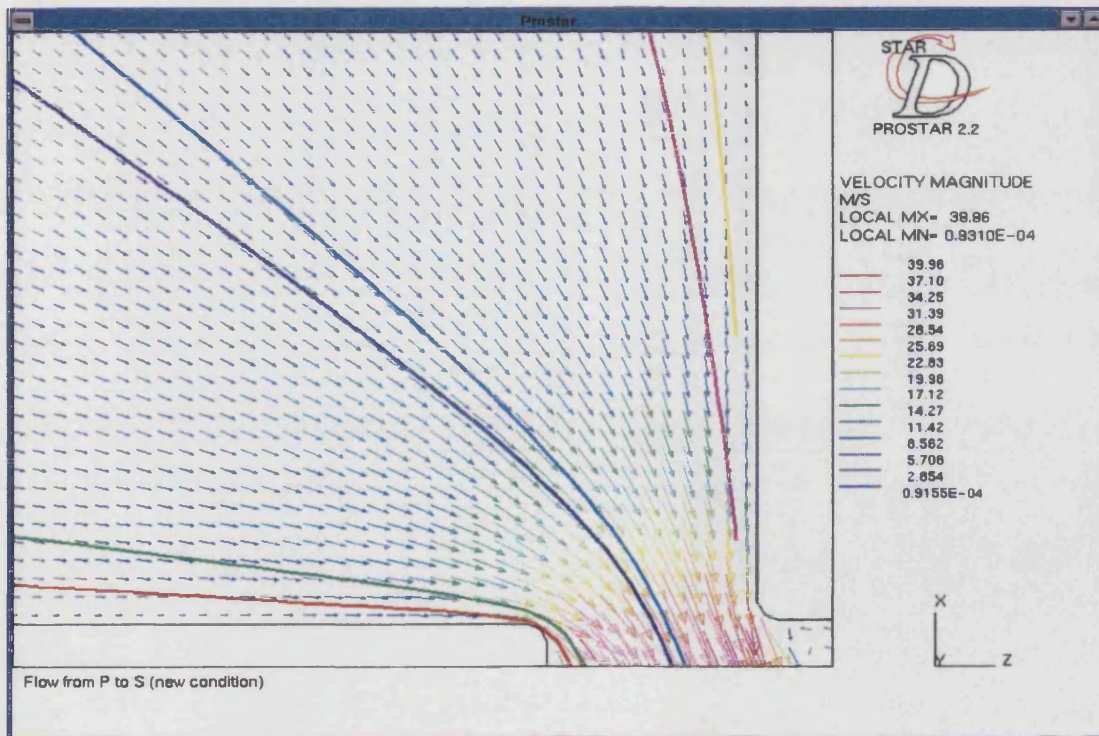
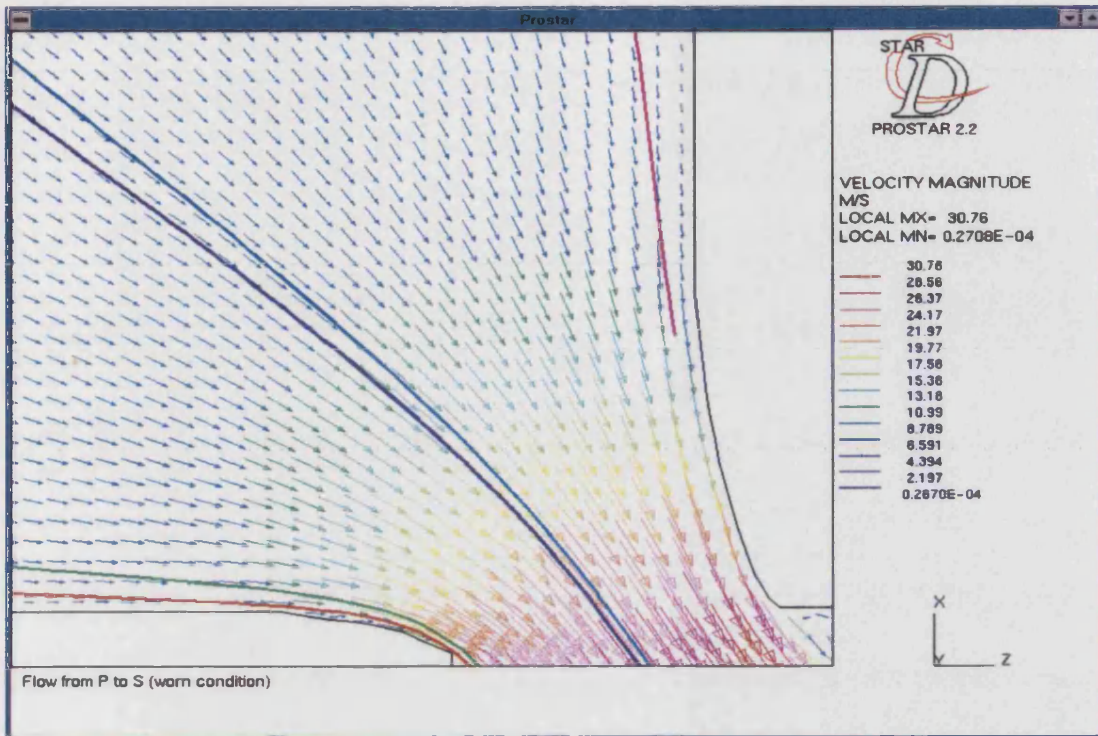
Confirmation of this phenomenon, together with the particle tracking information for a worn orifice in both directions, is shown in Figures 8.15 & 8.16. Here, the particles appear to follow the actual wear profile, therefore supporting an abrasion/micro-machining type process.

Figure 8.15 - Particle tracking results, worn metering orifice with the flow from P→S.

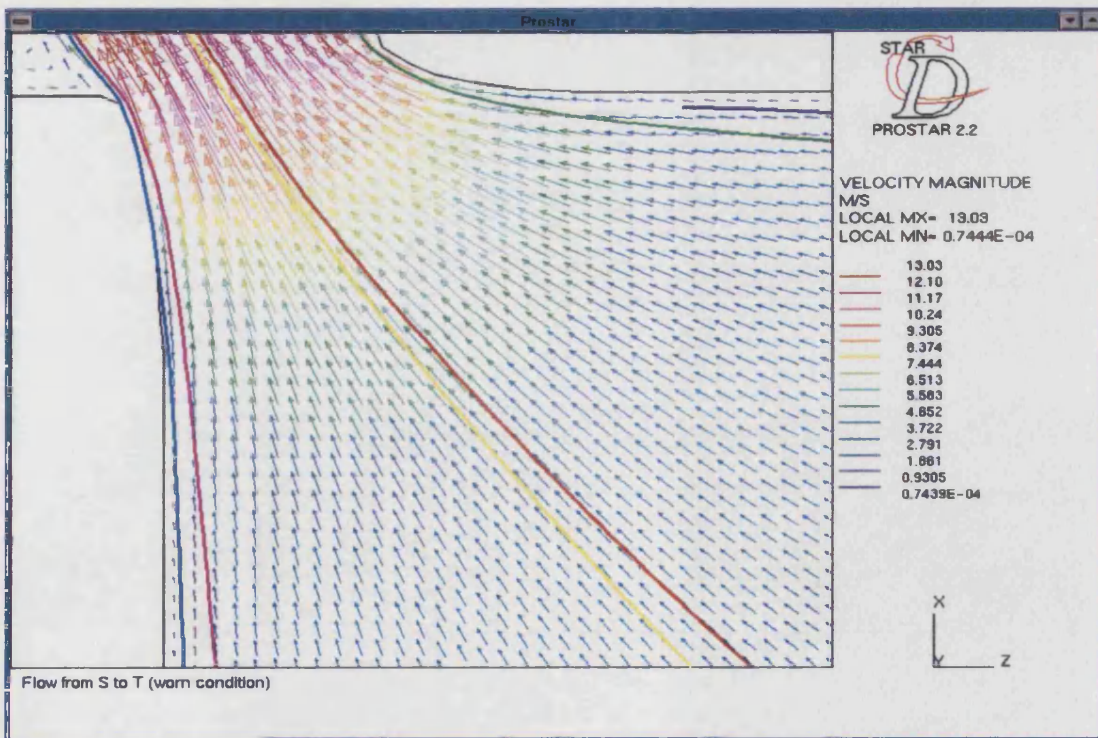
Figure 8.16 - Particle tracking results, worn metering orifice with the flow from S→T.
