Improving the reliability of industrial multi-MW wind turbines

Zhou, Jun; Roshanmanesh, Sanaz; Hayati, Farzad; Jantara Junior, Valter Luiz; Wang, Taoran; Hajiabady, Siavash; Li, Xiaoying; Basoalto, Hector; Dong, Hanshan; Papaelias, Mayorkinos

Document Version
Peer reviewed version

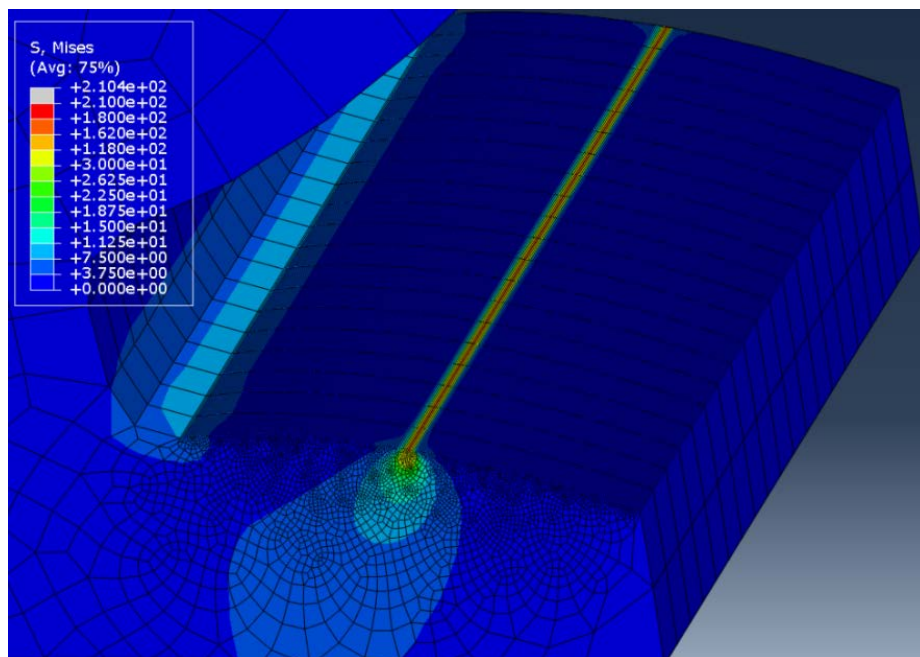
The highest stresses are concentrated in the contact area between two rolling elements, e.g. two gears. The contact and bending stresses between two gear teeth in contact can be seen in figure 2. For this gear pair and input torque, the bending stress is much lower than the contact stress, as observed in the contour plot.

Figure 2: Von Mises contour plot for gear pair, lateral view. The mating gear was removed for better visualisation.

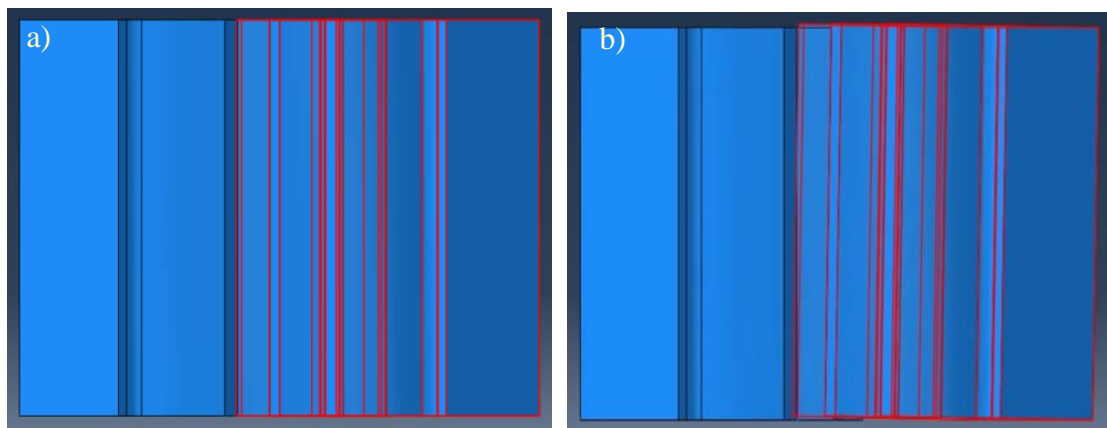
Figure 4: a) Gear pair in perfect alignment (left); b) Gear pair in angular misalignment (1°) (right).

Angular misalignment has a significant effect on the amplitude of the contact stress. Even a small amount of misalignment, such as 0.20° can produce contact stresses as high as 692.7 MPa, which is almost 3.3 times the contact stress level obtained from two gears in perfect alignment. At 1° of angular misalignment, the contact stress can be almost 18 times higher than the initial contact stress. Such high contact stresses could lead to severe plastic deformation, causing initiation and subsequently rapid propagation of damage.
