Evaluation of the Midwest Guardrail System stiffness transition with curb

Jennifer D. Schmidt, Scott K. Rosenbaugh, and Ronald K. Faller

Midwest Roadside Safety Facility, University of Nebraska-Lincoln, Lincoln, NE, USA

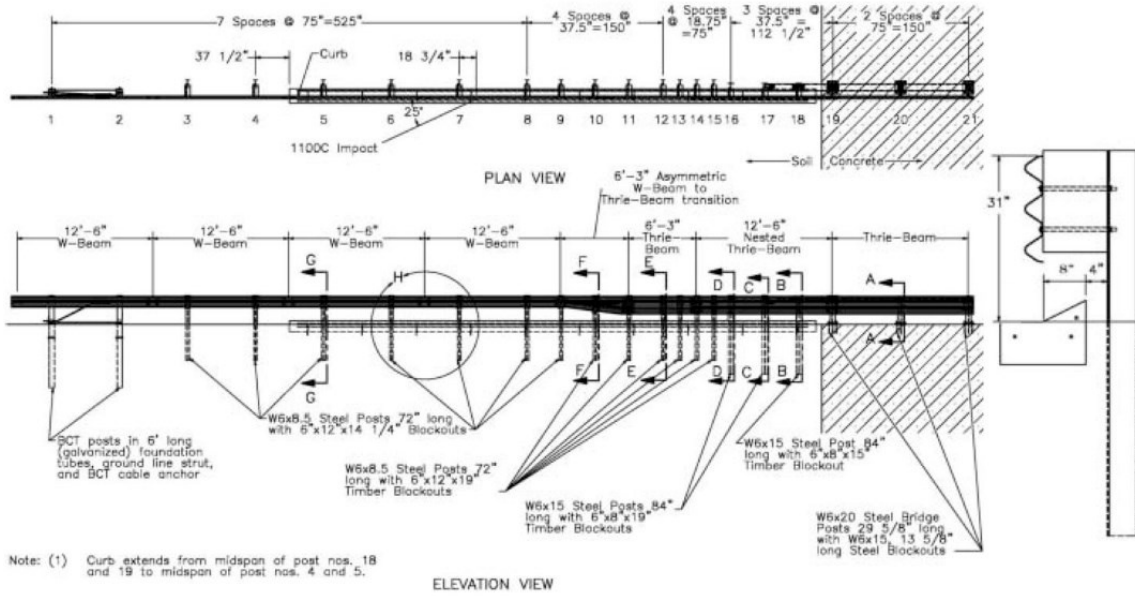
Fig. 6. Summary of test results, Test No. MWTC-2 (Winkelbauer et al., 2014).

Upon impact, the left-front corner of the vehicle under-rode the rail, and the vehicle pitched down. The left-front tire proceeded to override the curb and contact Post Nos. 8 and 9. This time, the rail and splices held together and contained the vehicle as it continued to contact posts within the system. The vehicle was eventually redirected and exited the system 0.312 sec after impact at an angle of 11 degrees. The vehicle came to rest 13.1-m (43.0-ft) downstream of impact and 1.2-m (3.8-ft) laterally in front of the system. The vehicle trajectory and final position are shown in Figure 6.

The calculated OIVs and ORAs in the longitudinal and lateral directions were within the suggested limits provided in *MASH*, as shown in Figure 6. Also, deformations to the occupant compartment were minor. Therefore, Test No. MWTC-2, conducted on the MGS upstream stiffness transition with curb, was determined to be acceptable according to the *MASH* safety performance criteria for test

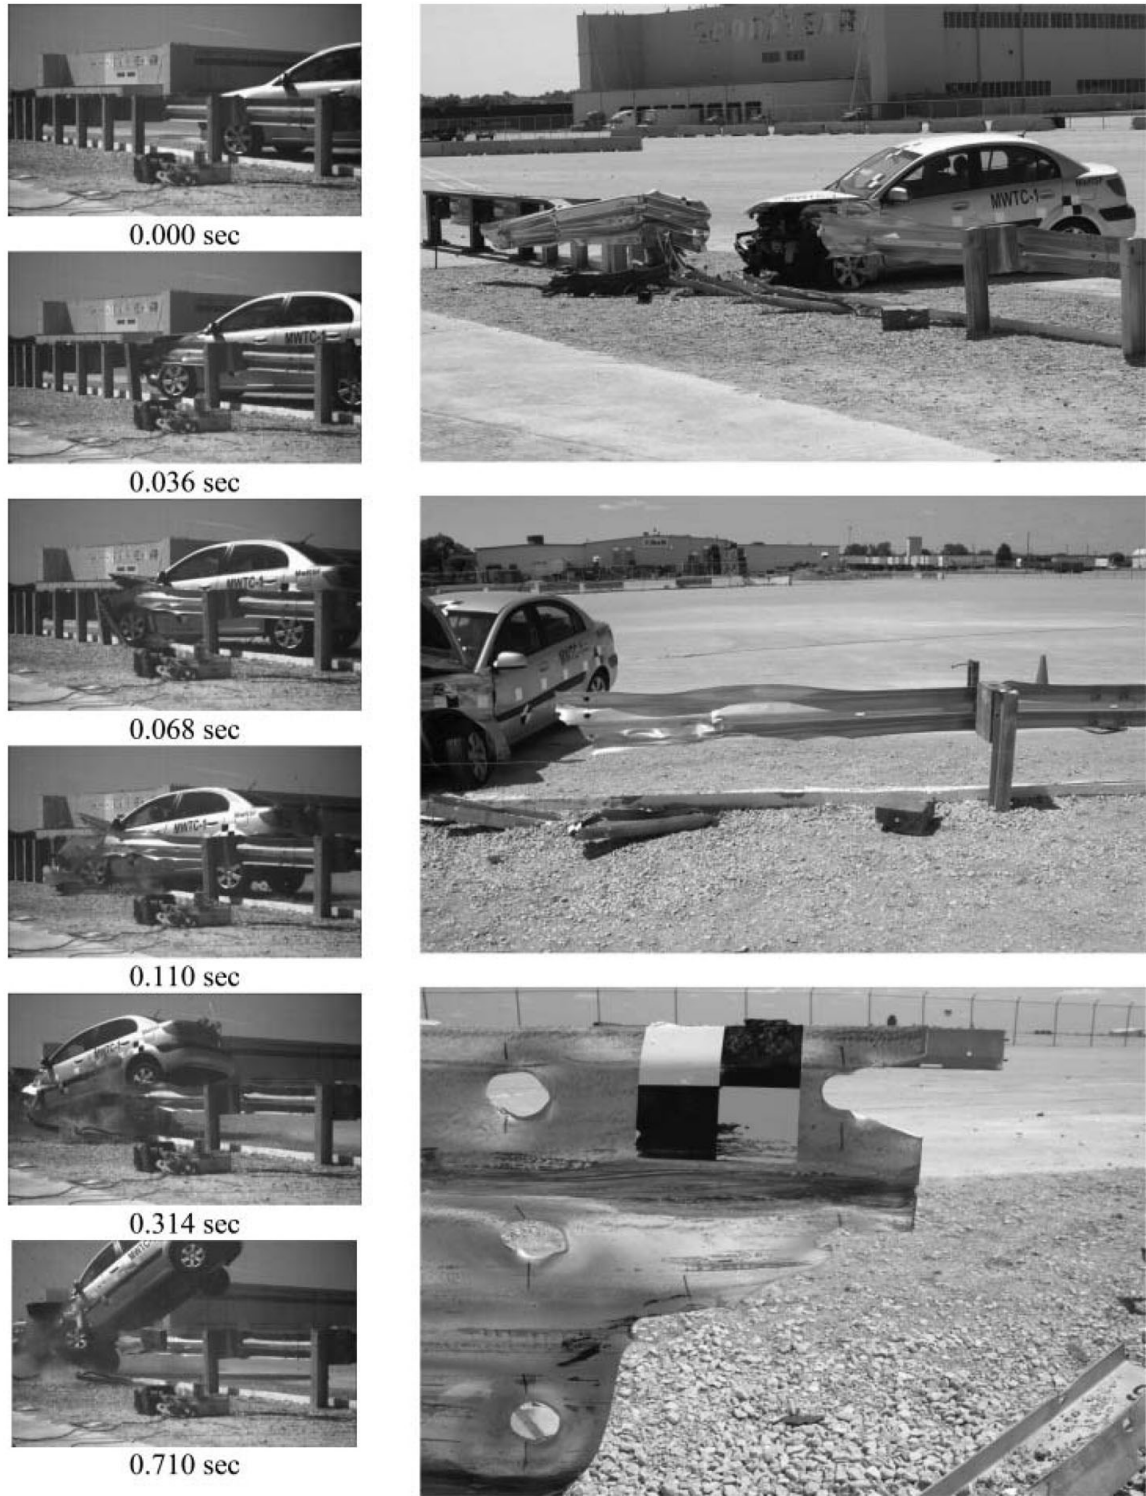
Fig. 4. Sequential photos and system damage, Test No. MWTC-1 (Winkelbauer et al., 2014).

Damage to the barrier was severe, as shown in Figure 4. The rail was kinked and flattened throughout the impact region, and Post Nos. 8 through 12 were bent and twisted. The 12-gauge W-beam rail ruptured at the splice at Post No. 9 with all bolts remaining on the downstream end of the ruptured rail, or on the 10 gauge W-to-thrie segment. The guardrail tore from the top, downstream corner of the splice diagonally to the bottom, upstream corner. The downstream edge of the Wbeam remained attached to the W-to-thrie segment. The downstream end of rail folded back and behind the system at Post No. 12. Additionally, a 38-mm ($1^1/_2$-in.) vertical tear occurred in the thrie beam at the bottom post bolt of Post No. 12. Finally, the top of the curb was gouged in several places from contact with the vehicle bumper and undercarriage.

Due to the W-beam rail rupture, the loss of vehicle containment, and the excessive ORA values recorded by the accelerometers, Test No.

MWTC-1 on the MGS upstream stiffness transition with curb was determined to be unacceptable according to the *MASH* safety performance criteria for test designation no. 3-20. More comprehensive test results are detailed in the test report "Dynamic Evaluation of MGS Stiffness Transition with Curb" (Winkelbauer et al., 2014).

Because the presence of a curb within the transition caused increased loading to the guardrail segments and lead to rail rupture and excessive occupant risk measures, design modifications were required to strengthen the rail upstream of the W-to-thrie segment. Thus, an additional 12-gauge W-beam segment was incorporated into the system such that 3.8-m (12.5-ft) of nested W-beam guardrail preceded the 10-gauge W-to-thrie segment. This minor modification was believed to be sufficient to prevent rail rupture observed during a small car impact just upstream from the asymmetrical element and in combination with a concrete curb.

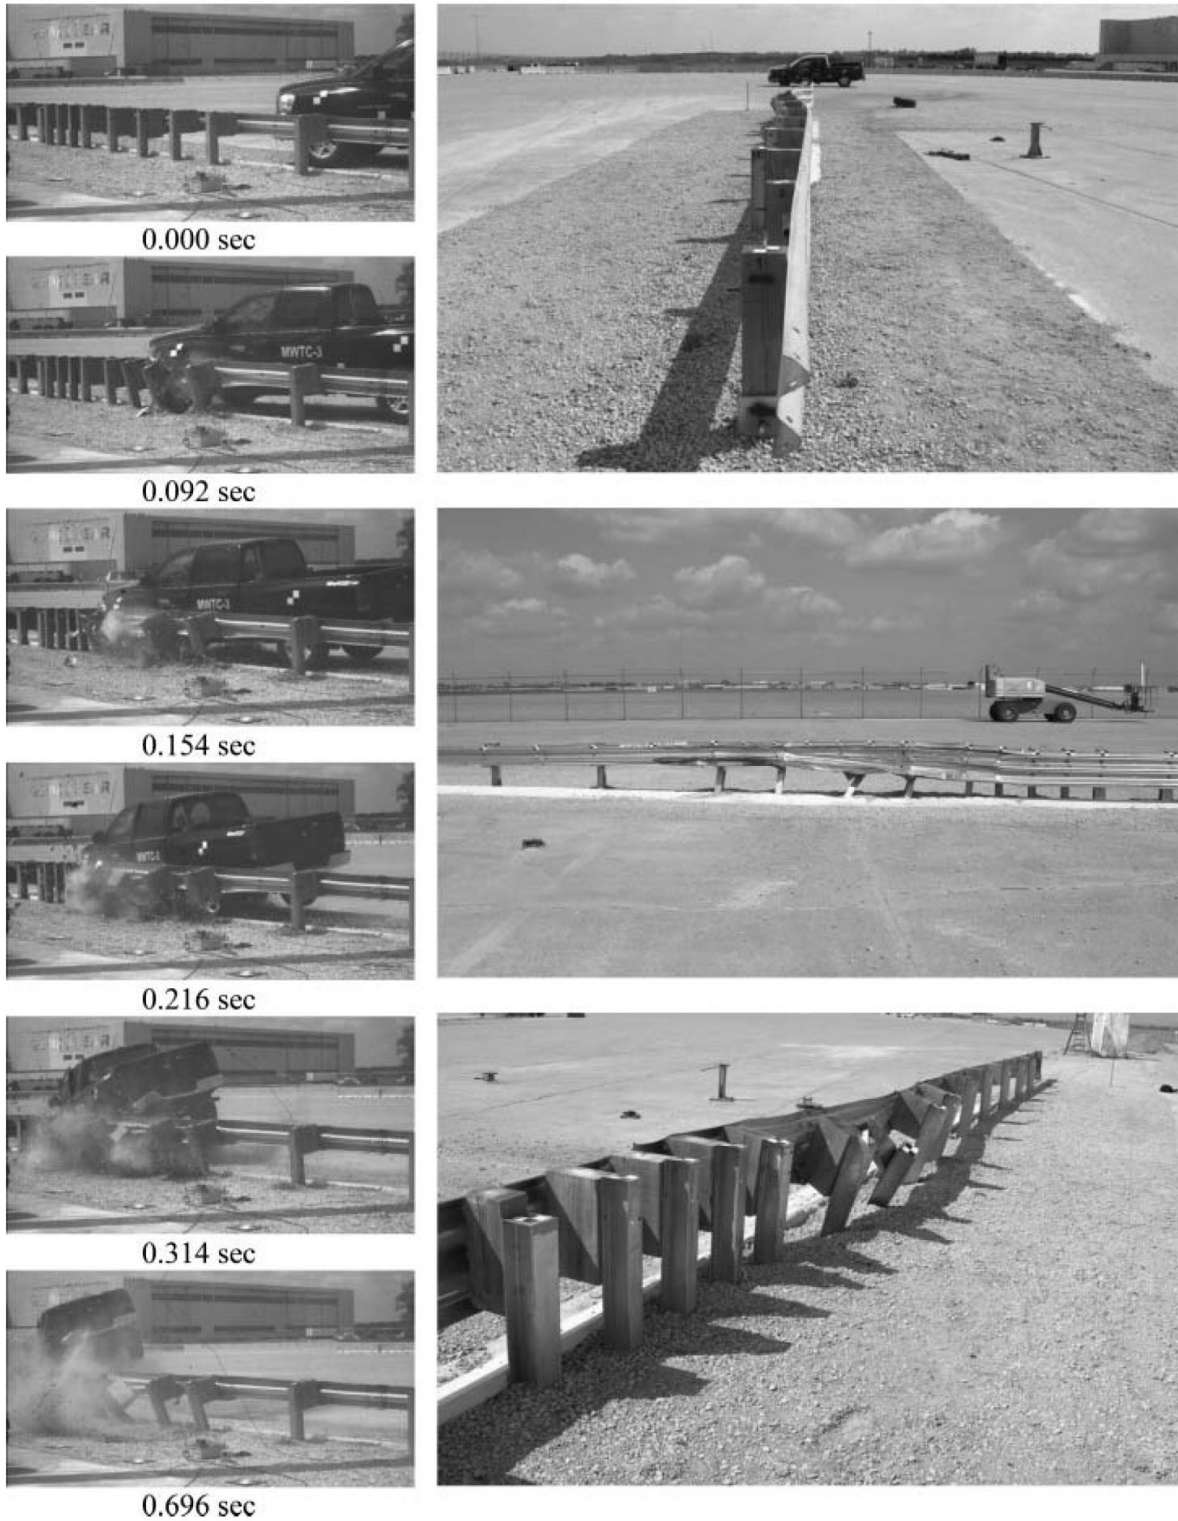
Fig. 9. Sequential photos and system damage, Test No. MWTC-3 (Winkelbauer et al., 2014).

Damage to the barrier was moderate, as shown in Figure 9. The guardrail was kinked and flattened throughout the impact region and disengaged from Post Nos. 6, 8, and 10 through 12. Post Nos. 7 through 12 were bent back and downstream. The maximum lateral dynamic post and rail deflections were 607-mm (23.9-in.) and 559-mm (22.0-in.), respectively, at Post No. 10. The working width of the system was found to be 1,036-mm (40.8-in.).

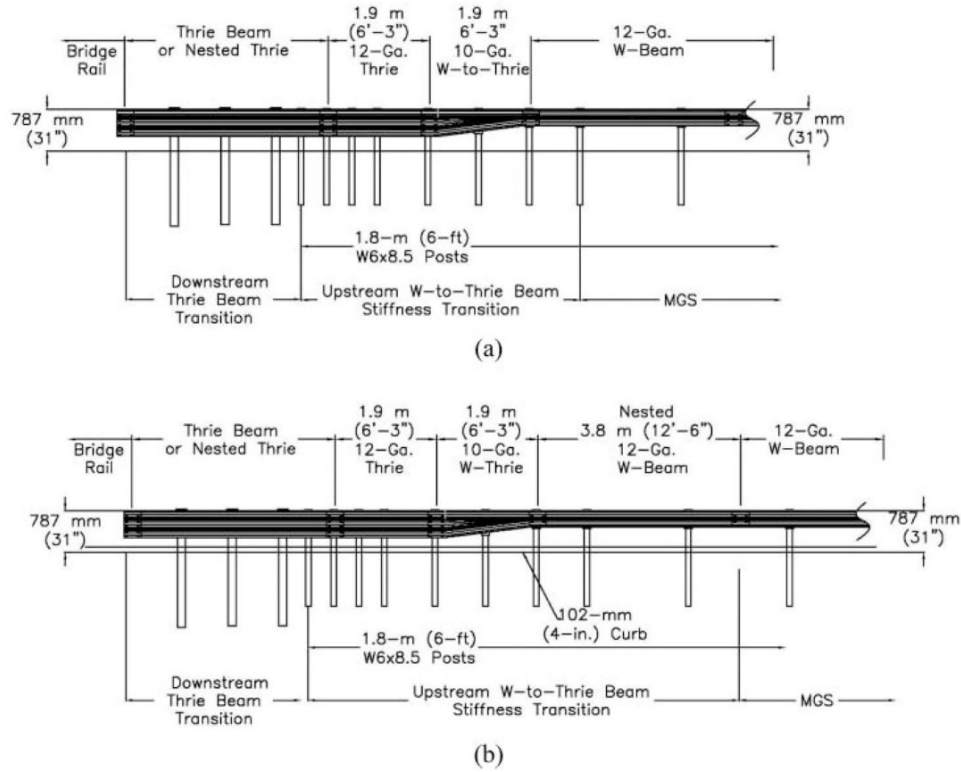
Fig. 10. Midwest Guardrail System to thrie beam stiffness transitions details (a) without a curb and (b) with or without a curb, 102-mm (4-in.) maximum curb height (Winkelbauer et al., 2014).

After the failed crash test, the design was modified to incorporate an additional 12-gauge W-beam segment such that 3.8-m (12.5-ft) of nested guardrail preceded the asymmetric W-to-thrie segment, as shown in Figure 10b. Subsequently, *MASH* Test Designation 3-20 was repeated, and the 1100C small car was safely contained and redirected. A second test was then conducted on the modified transition according to *MASH* Test Designation 3-21, and the 2270P pickup truck was also safely contained and redirected. Upon the successful completion of the *MASH* TL- 3 Testing Matrix, the modified upstream stiffness transition (between the MGS and thrie beam guardrail transition) with curb was found to satisfy current safety standards.

The use of nested W-beam rail at the upstream end of the W-to-thrie segment will be required for transition installations that utilize curbs. The use of nested rail was shown to sufficiently increase the

To ensure the safety performance of the transition, the 102-mm (4-in.) tall curb should be placed through the entire length of the stiffness transition. Thus, the curb should be extended from the bridge and through the nested W-beam section before either being terminated or transitioning to another curb type. Curbs taller than 102-mm (4-in.) are not recommended to be utilized with approach guardrail transitions without further evaluation. Additionally, it is recommended to utilize a minimum length of 0.9-m (3-ft) for any curb shape transitions or terminations (e.g., transitioning from 102-mm [4-in.] curb to no curb).

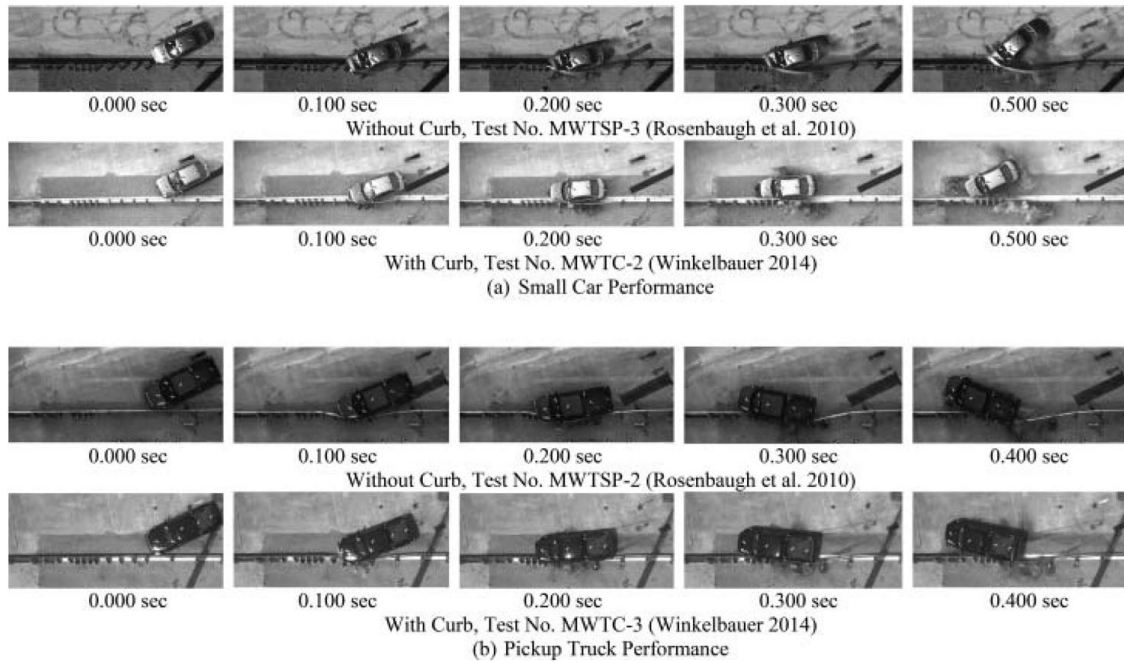
Fig. 11. Comparison of Midwest Guardrail System upstream stiffness transition performance.

strength of the system and prevent rail tearing. Additionally, rail nesting adjacent to the upstream end of the W-to-thrie segment aided to decrease vehicle pocketing and snag. These same benefits could also be gained if the modified (nested) version of the upstream stiffness transition was utilized for installations without curbs. The system performance during crash tests without curbs (Test Nos. MWTSP-3 and MWTSP-2) and with curbs (Test Nos. MWTC-2 and MWTC-3) were similar, only the system tested with a curb was stiffer with the nested section and curb and had lower dynamic deflections (Rosenbaugh et al., 2010; Winkelbauer et al., 2014). The upstream stiffness transitions were impacted by 1100C small cars at the same impact location and dynamically deflected 470-mm (18.5-in.) in Test No. MWTSP-3 and 417-mm (16.4-in.) in Test No. MWTC-2. The upstream stiffness transitions were impacted by 2270P pickup trucks at the same impact location and dynamically deflected 833-mm (32.8-in.) in Test No. MWTSP-3 and 607-mm (23.9-in.) in Test No. MWTC-2. A graphical comparison of the transition systems' performance when impacted by small cars and pickup trucks is shown in Figure 11. Thus, system installations without curbs have the option to use either the original MGS upstream stiffness transition design or the modified (nested) MGS upstream stiffness transition. The final configurations of the stiffness transitions with and without a curb are shown in Figure 10.
