# Phase II: Chulitna River Bridge Structurally Health Monitoring

## Alaska Bridge 255 – Chulitna River Bridge

**January 2015**

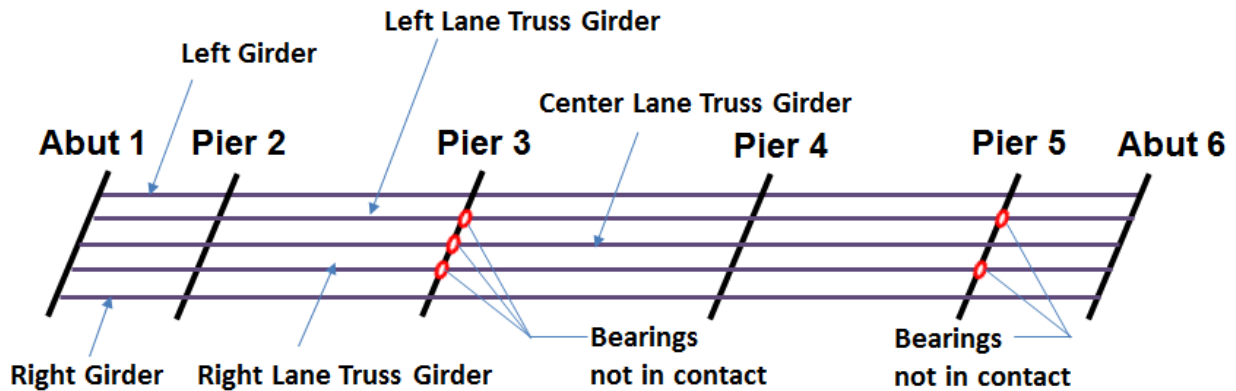
Figure 1.2 Plan view: Bearings that are not in contact with masonry plates

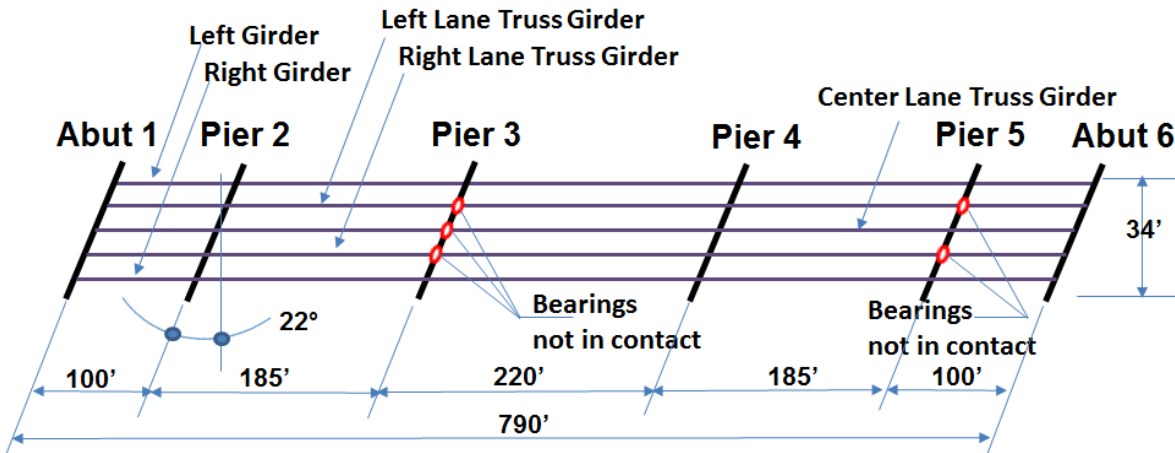
Figure 2.7 Plan: Bearing issue locations

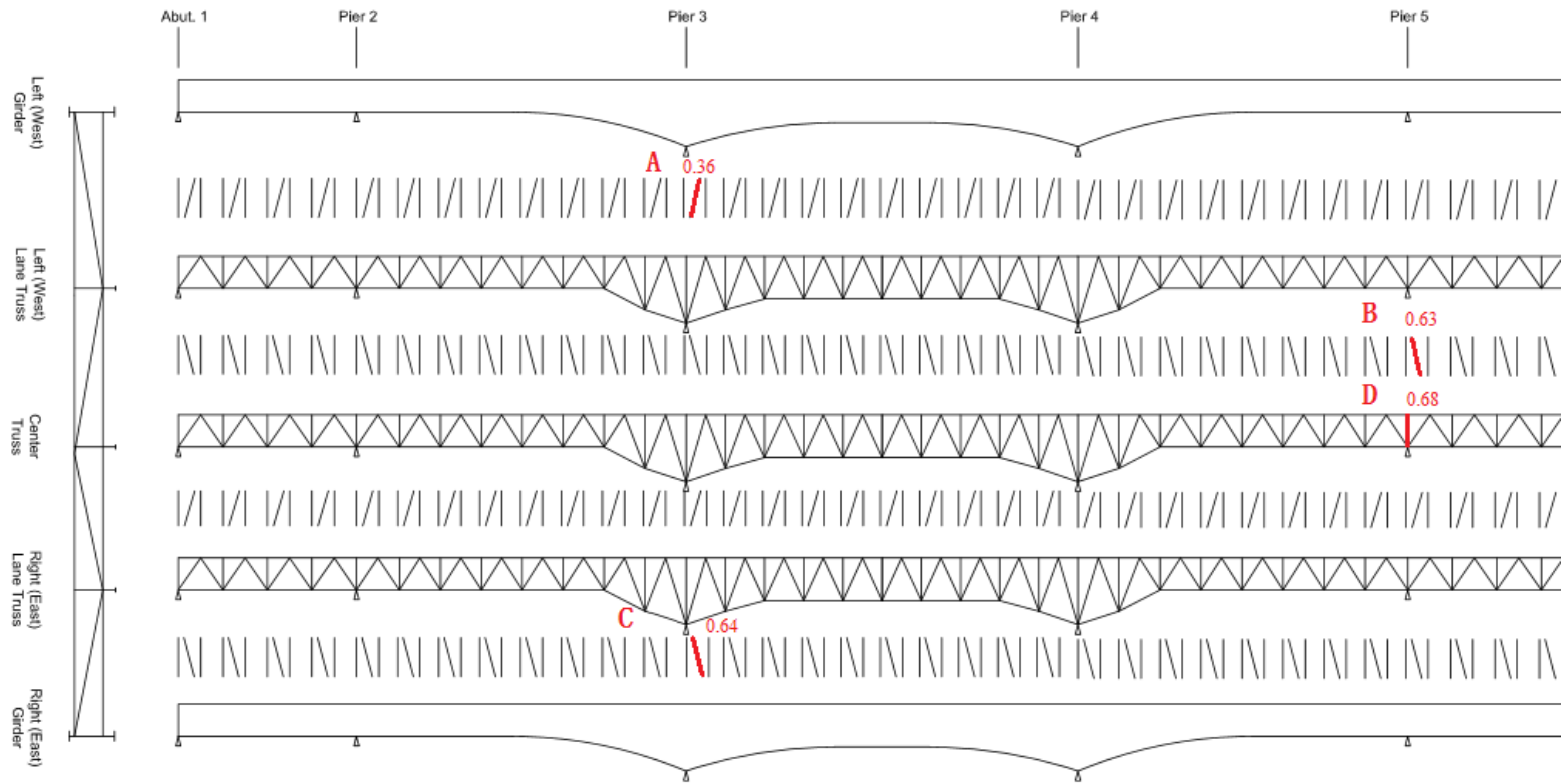
In accordance with AASHTO, the operating load rating for the "as-is" structure was evaluated for HL-93 loading on three (3) traffic lanes. Results showed four (4) members had an operating load rating less than 1; therefore, without strengthening or other alternatives the as-is bridge did not pass. Evaluation of the cause of the unsatisfactory load rating showed that members with less than satisfactory performance were secondary type members.

LRFR HL-93 Operating Rating Factors (<1.00)

(Updated Model - As is Condition for Three Lanes)

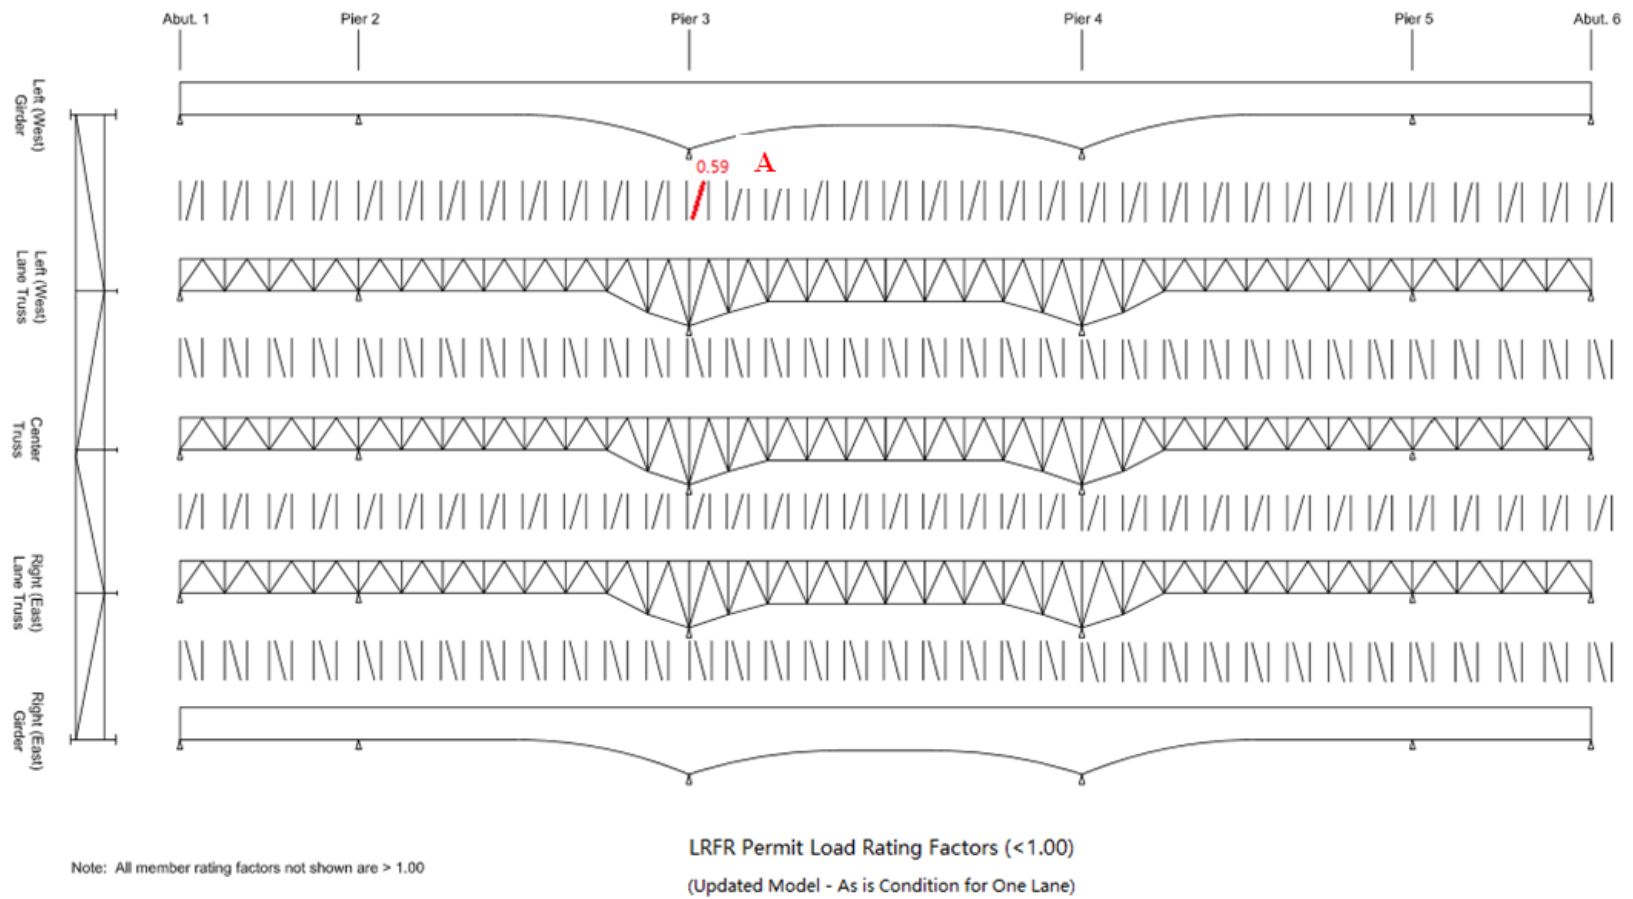
Figure 2.11 Operating Load Rating; One lane, permit load, as-is condition

- Permit loading on one traffic lane (truck is on the bridge centerline) produced an operating load rating below 1 ($RF < 1$) (see Figure 2.11, Figures 2.23, and Tables 2.1 and 2.2).

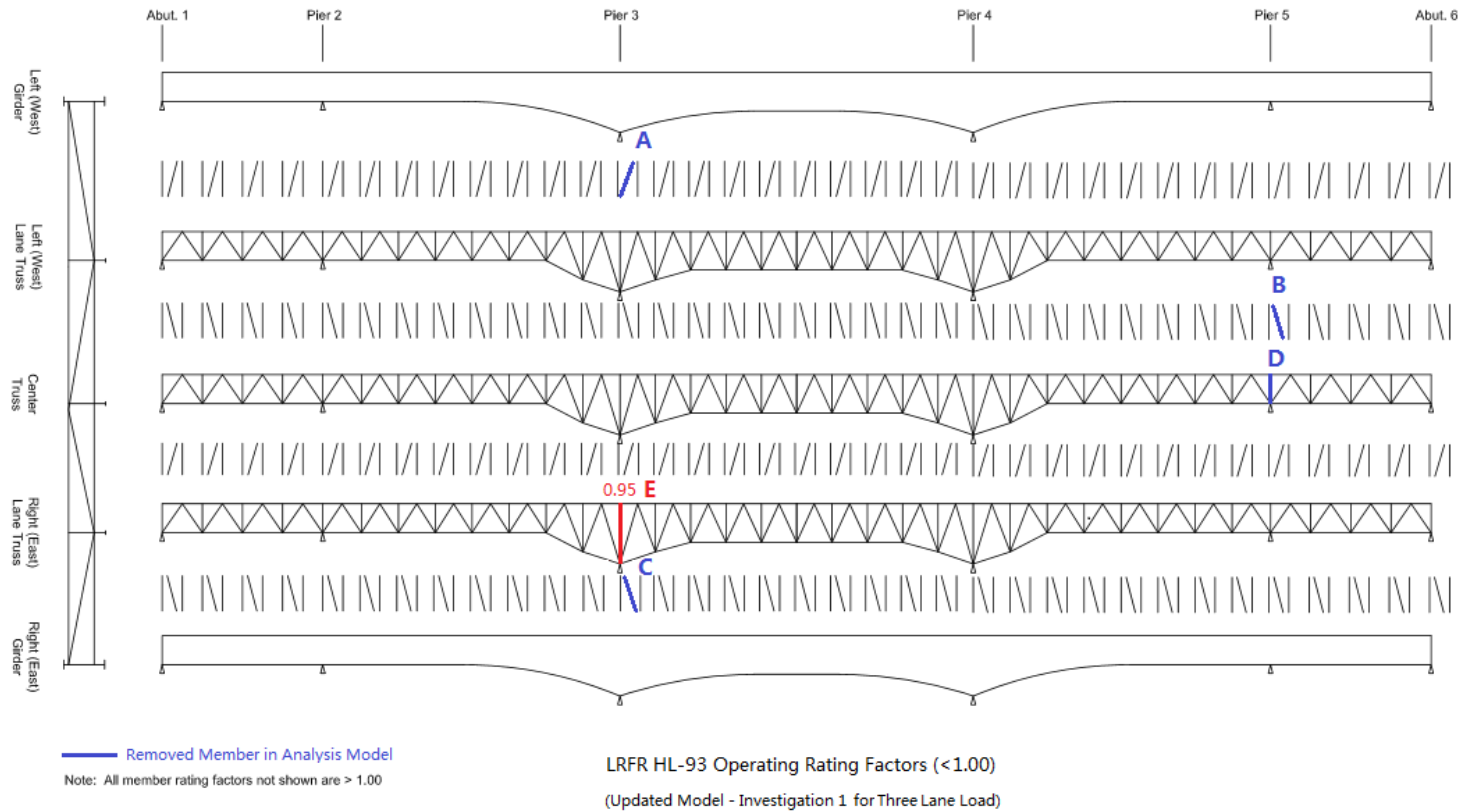
Figure 2.12 Operating Load Rating, Three lanes, HL-93, Model 1 (4 members removed)

- HL-93 loading on three traffic lanes: Results showed an additional member (E) had a load rating below 1 (see Figure 2.12, Figures 2.23–2.24, and Table 2.3).

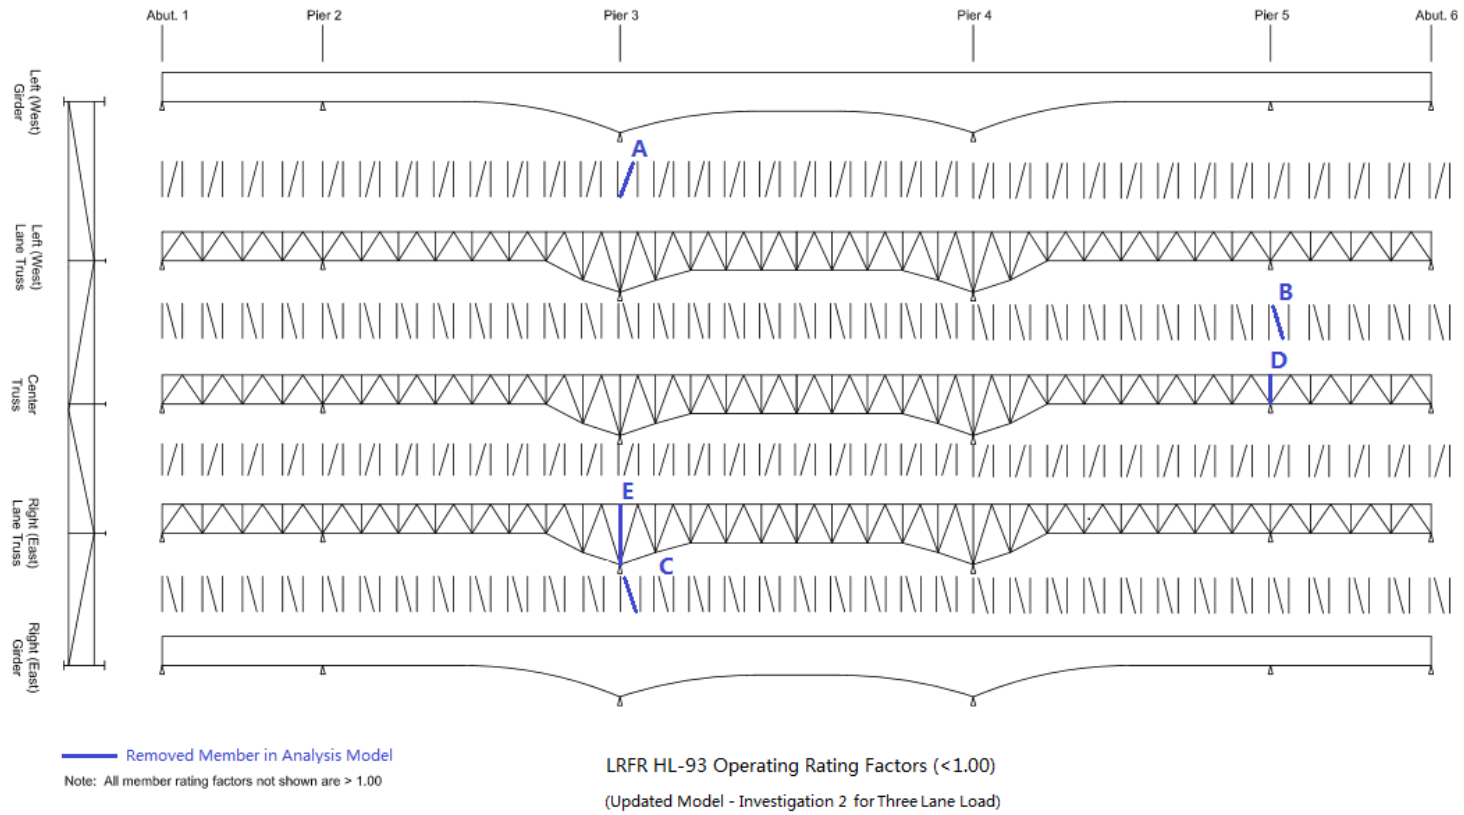
Figure 2.13 Operating Load Rating, Three lanes, HL-93, Model 2 (5 members removed)

- HL-93 on three traffic lanes: The operating load rating passed (see Figure 2.13, Figures 2.23–2.24, and Table 2.3).

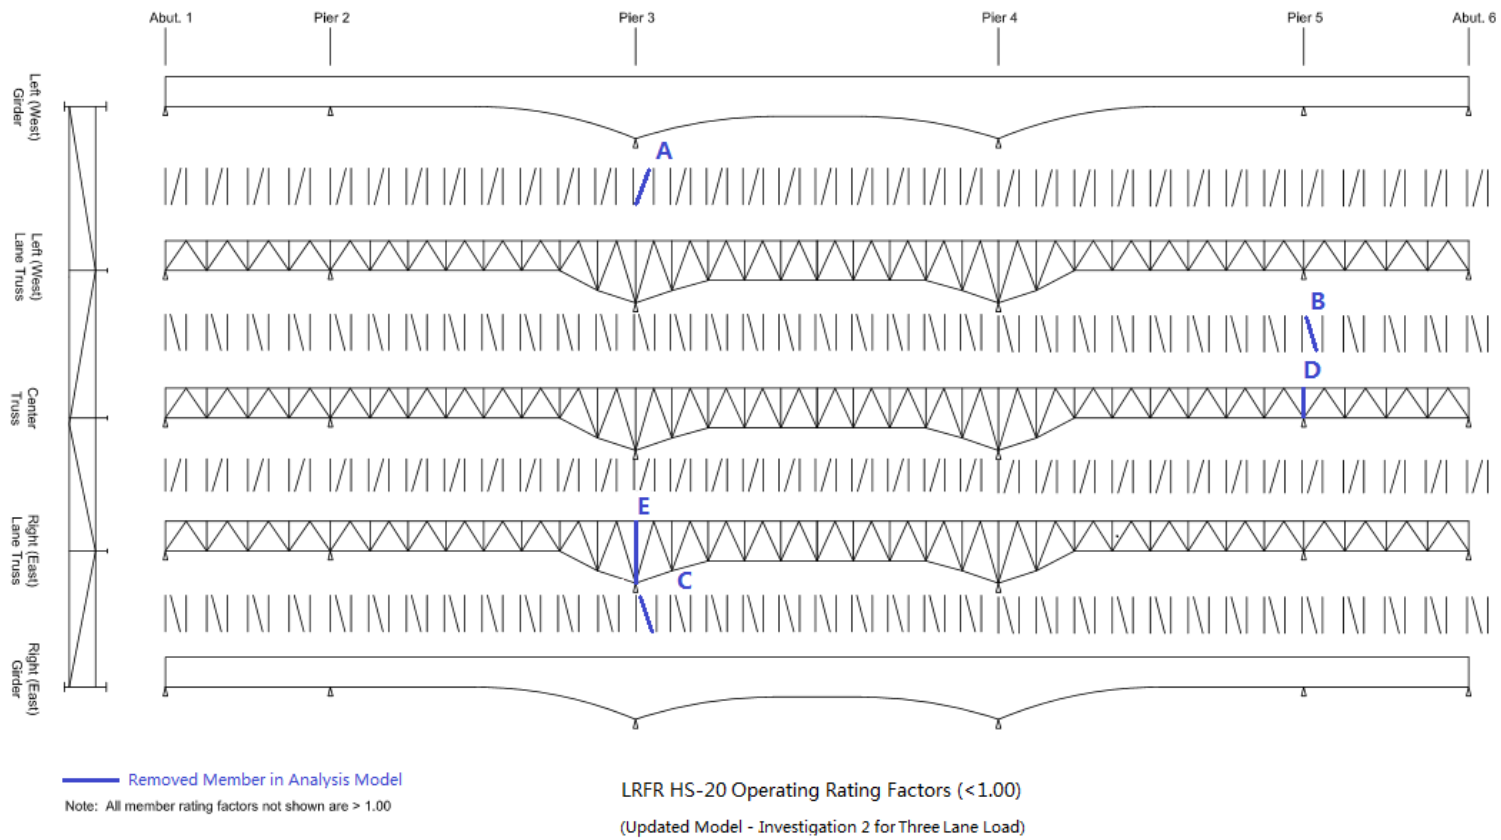
Figure 2.14 Operating Load Rating; Three lanes, HS20-44, Model 2 (5 members removed)

- HS20-44 loads on three traffic lanes: The operating rating passed (see Figure 2.14, Figures 2.23–2.24, and Table 2.3).

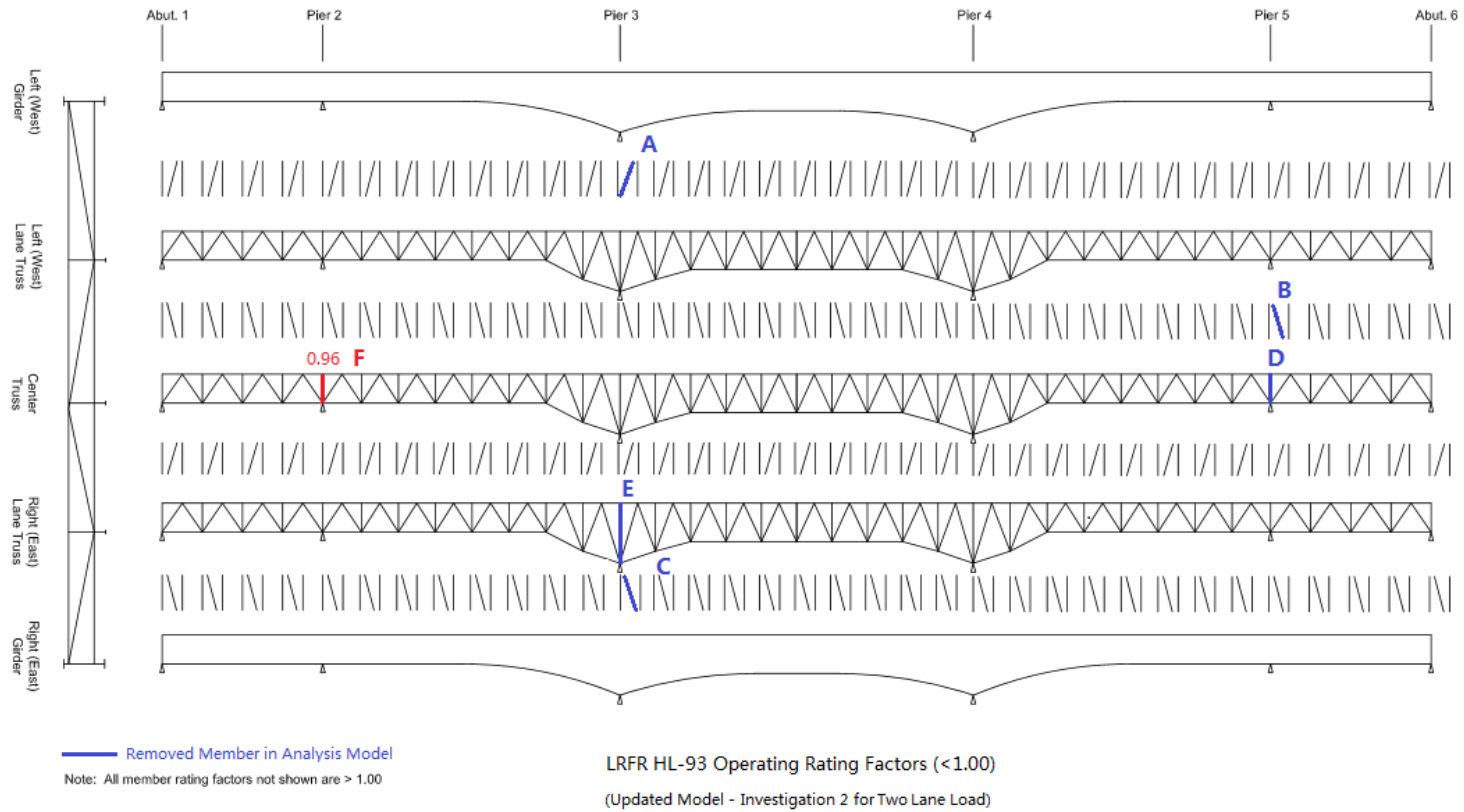
- HL-93 on two traffic lanes: Secondary member (F) had a rating of less than 1 (see Figure 2.15, Figures 2.22–2.24, and Table 2.3).

Figure 2.15 Two lanes loaded, HL-93, Model 2 (5 members removed), RF<1

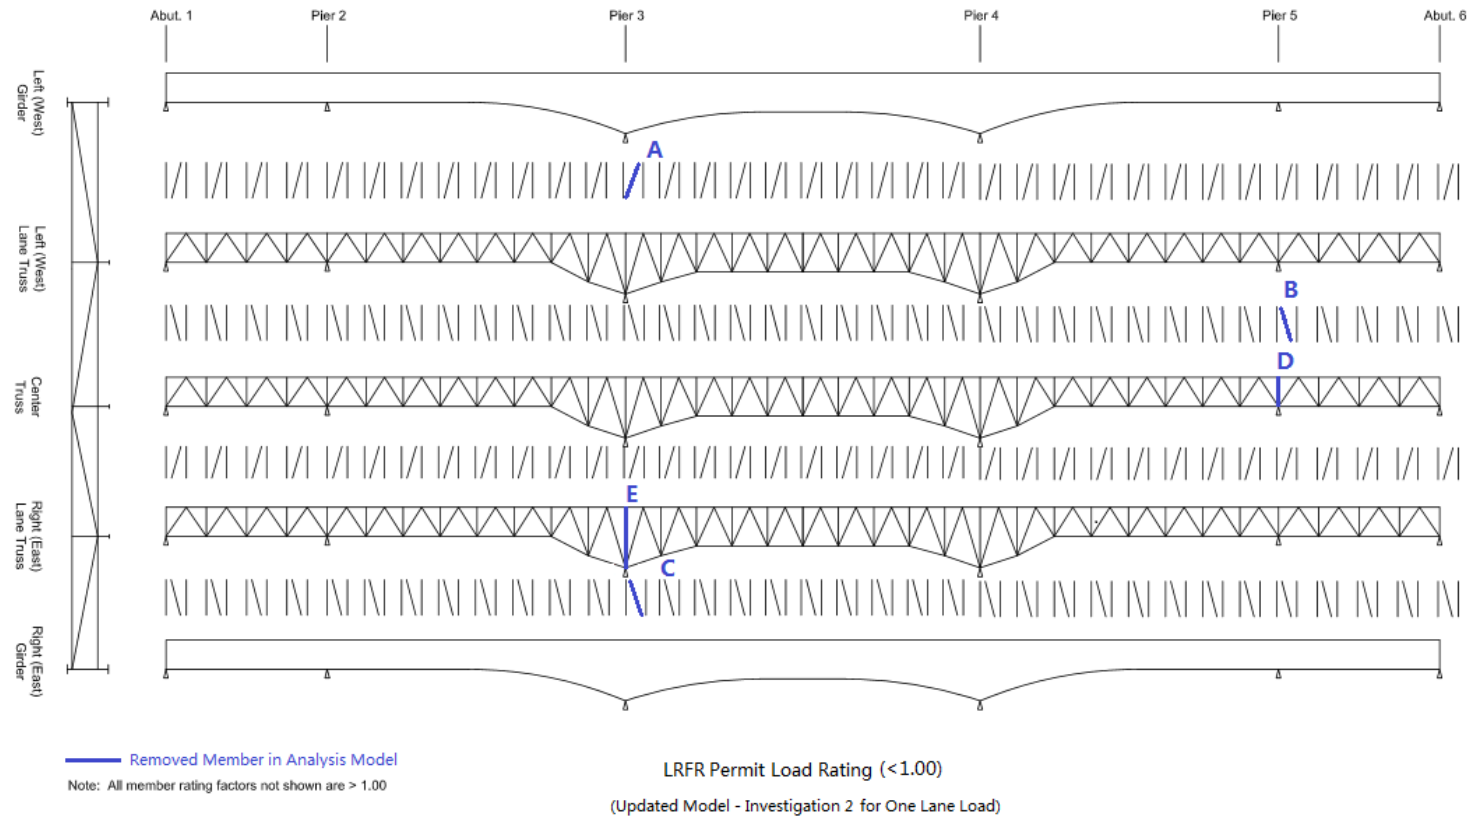
- Permit loading on one traffic lane (truck is on the bridge centerline) passed the load rating test (see Figure 2.16, Figures 2.23–2.24, Tables 2.2 and 2.3).

Figure 2.16 One Lane Loaded, Permit load, Model 2 (5 members removed) passed

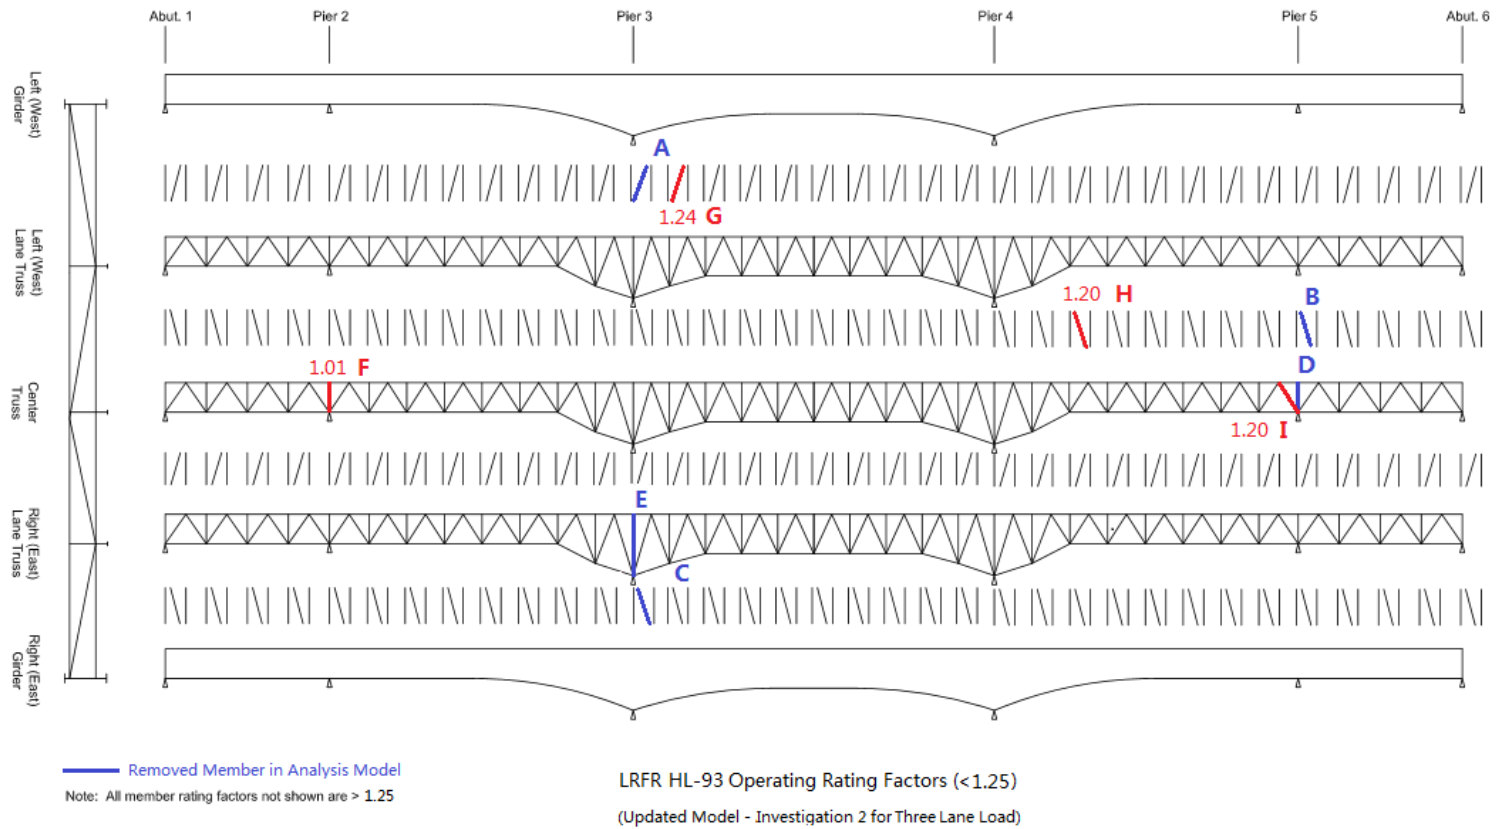
- The bridge was analyzed using Model 2 (five removed members, A–E) for HL-93 loading on three traffic lanes. Sensitivity of the structure was examined; that is, $1 \le RF < 1.25$ was used to evaluate truss member sensitivity for this structure. Four members (F–I) were found to meet this criteria. Member F had a load rating slightly larger than 1 ($RF = 1.01$) (see Figure 2.17, Figures 2.22–2.24, and Table 2.4).

Figure 2.17 Three lanes, HL-93, Model 2 (5 members removed) results for $1 \le RF < 1.25$

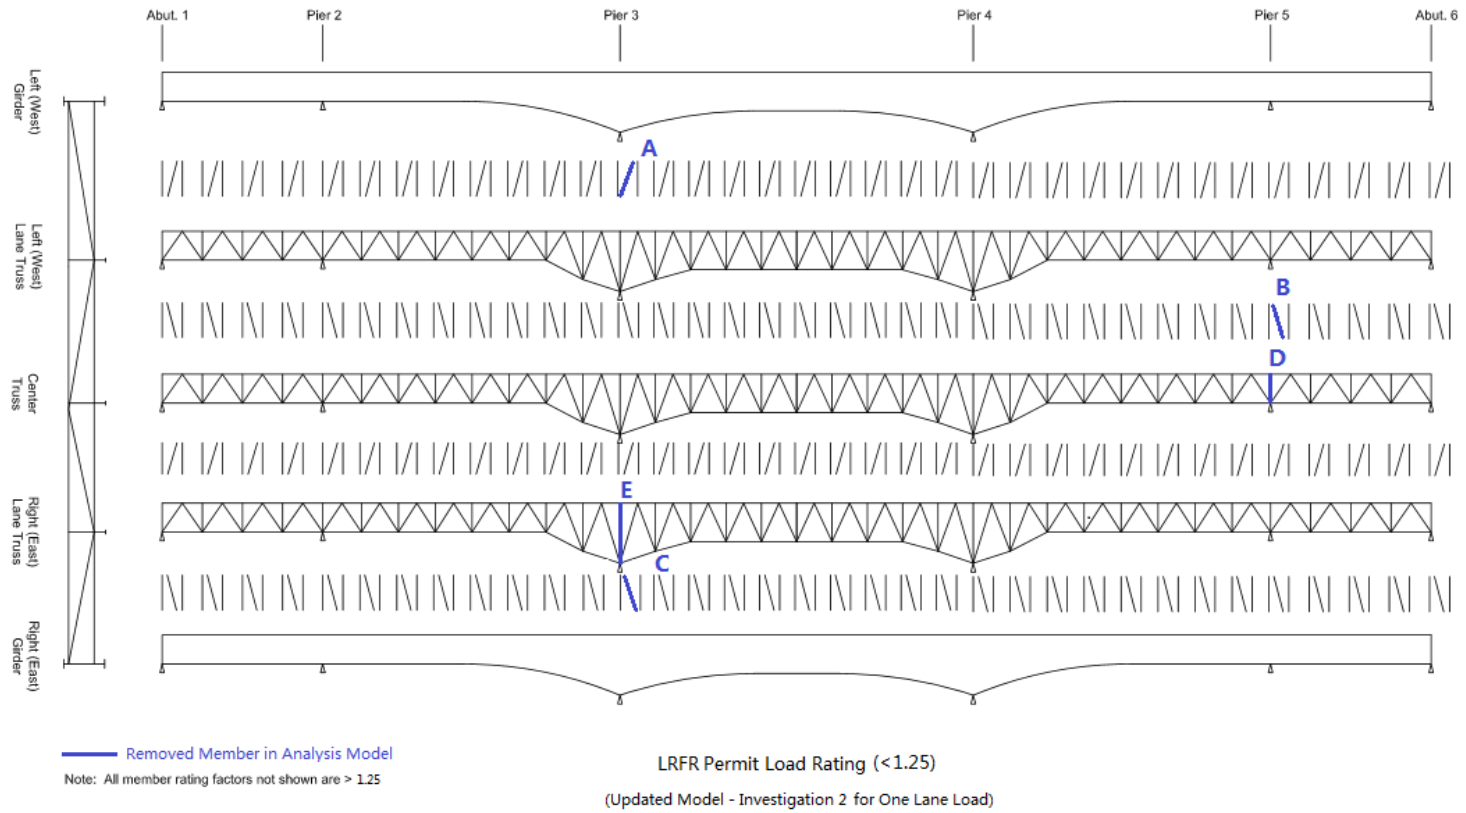
- The bridge was analyzed using Model 2 (five removed members, A–E) for permit loading on one lane (truck on the centerline of the bridge) (see Figure 2.18, Figures 2.23–2.24, and Tables 2.2 and 2.4).

Figure 2.18 One lane, permit load, Model 2 (5 members removed) results $1 \le RF < 1.25$

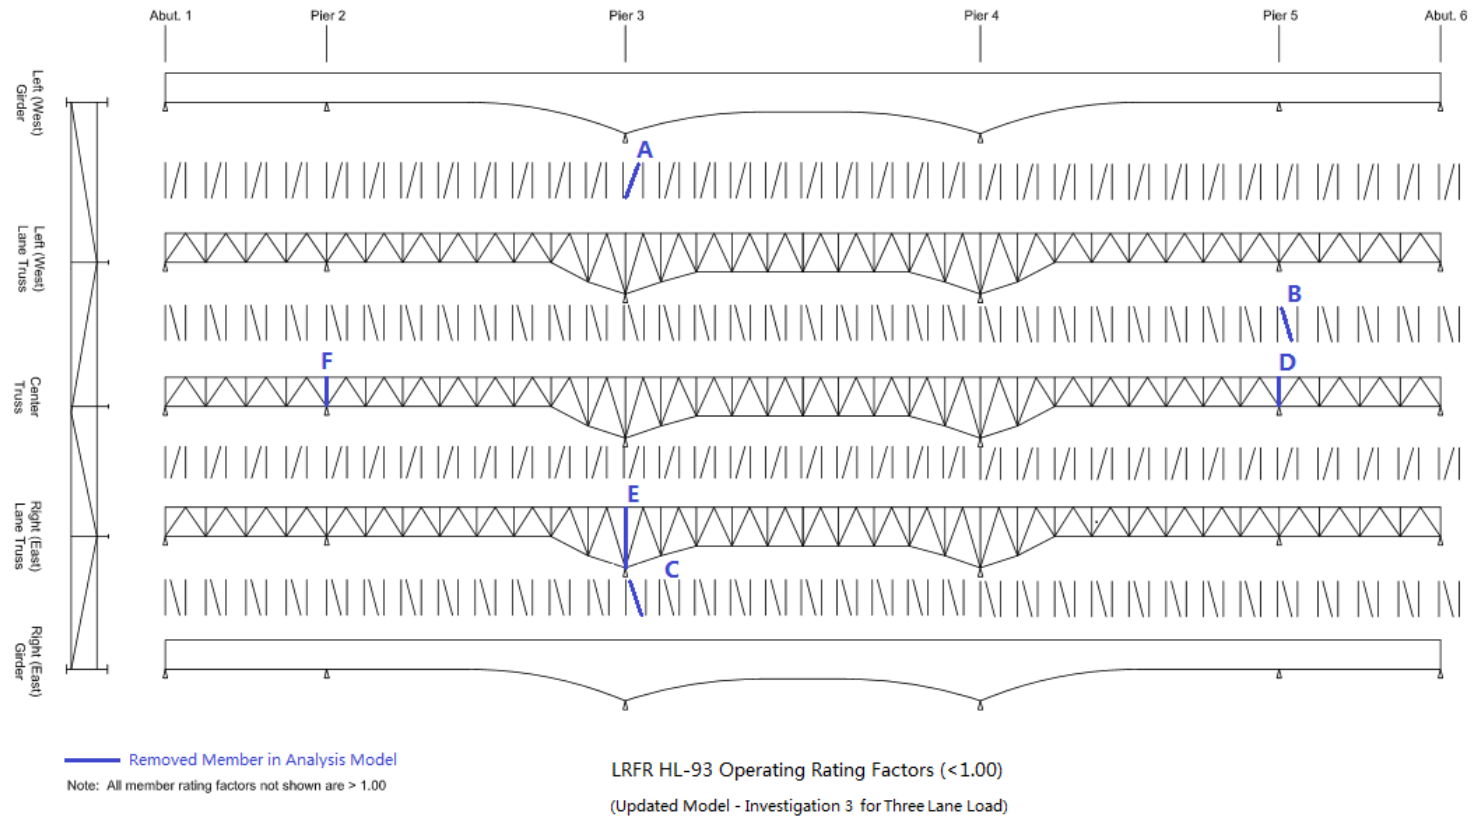
- The bridge was analyzed for HL-93 loading on three lanes of traffic using Model 3 (six members removed, A–F). The load rating passed (see Figure 2.19, Figures 2.22–2.24, and Table 2.4).

Figure 2.19 Three lanes, HL-93, Model 3 (6 members removed), load rating passed

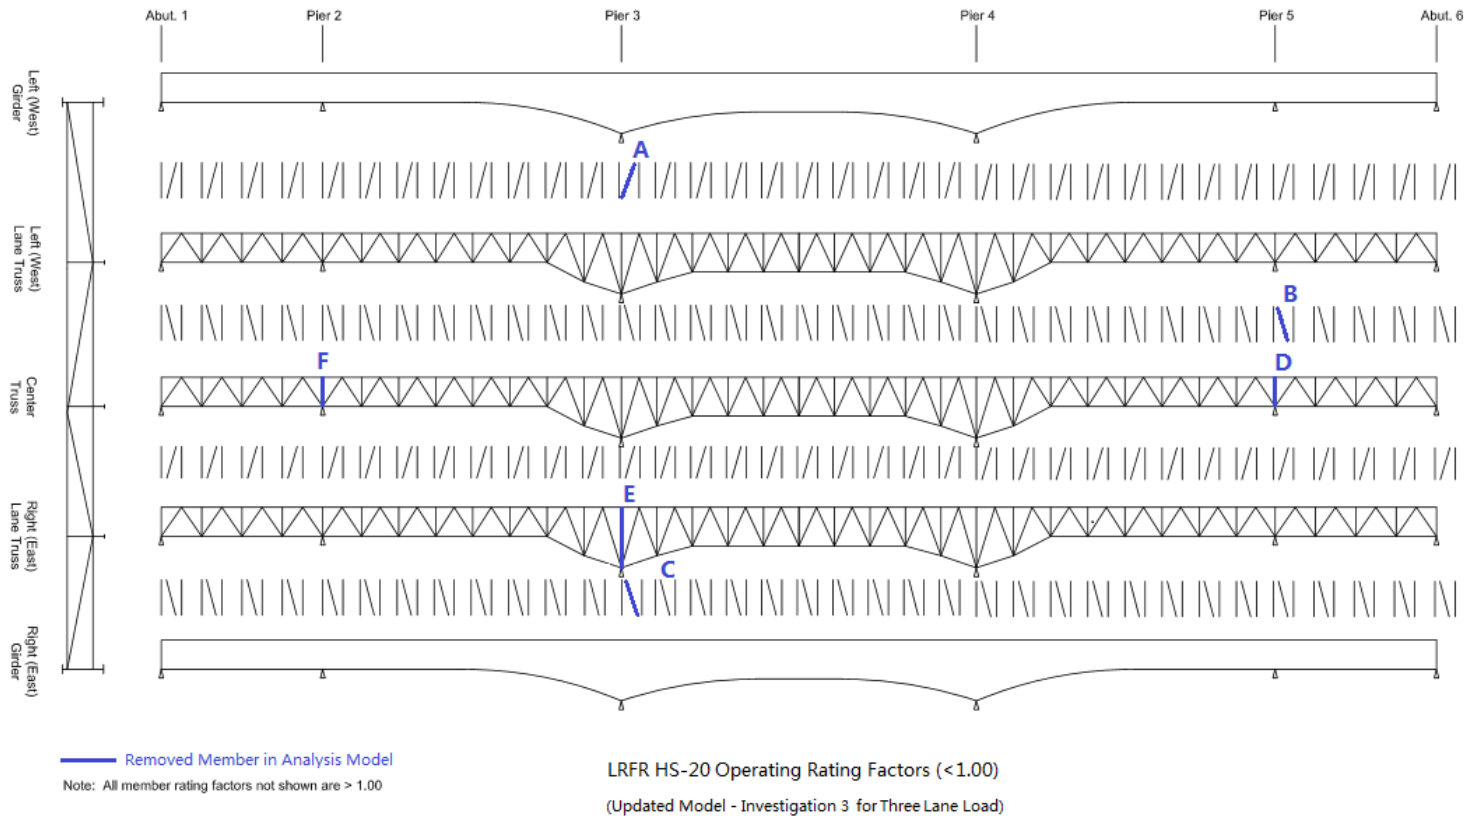
- The bridge was analyzed for an AASHTO HS20-44 load on three lanes of traffic using Model 3 (six members removed, A-F).   The load rating passed (see Figure 2.20, Figures 2.22-2.24, and Table 2.4).

Figure 2.20 Three lanes, AASHTO 20-44, Model 3 (6 members removed), load rating passed

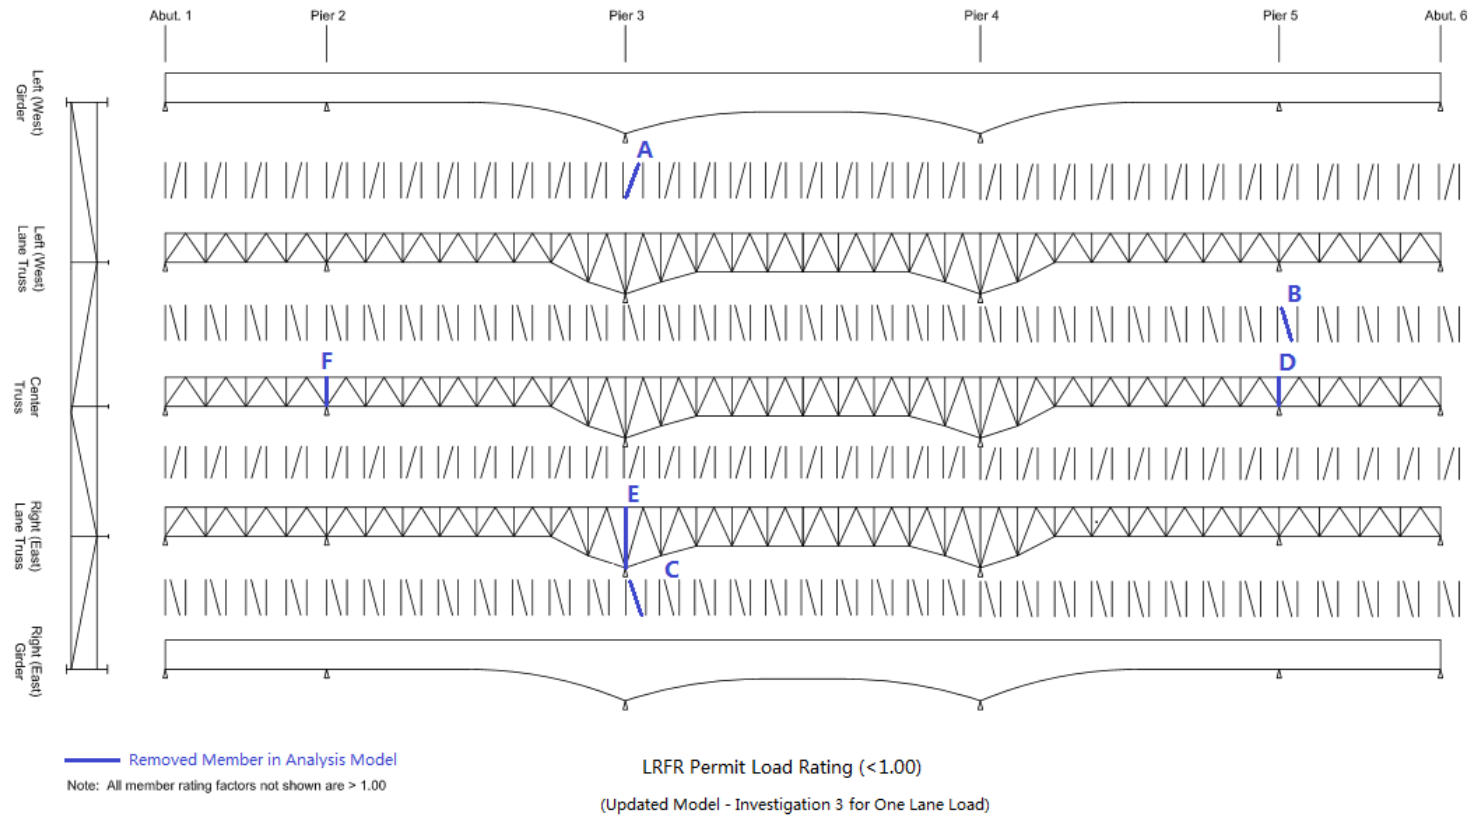
- The bridge was analyzed for a permit load on one lane using Model 3 (six members removed, A–F). The structure passed this load rating (see Figure 2.21, Figures 2.22–2.24, Tables 2.2 and 2.4).

Figure 2.21 One Lane, Permit Load, Model 3 (6 members removed), load rating passed

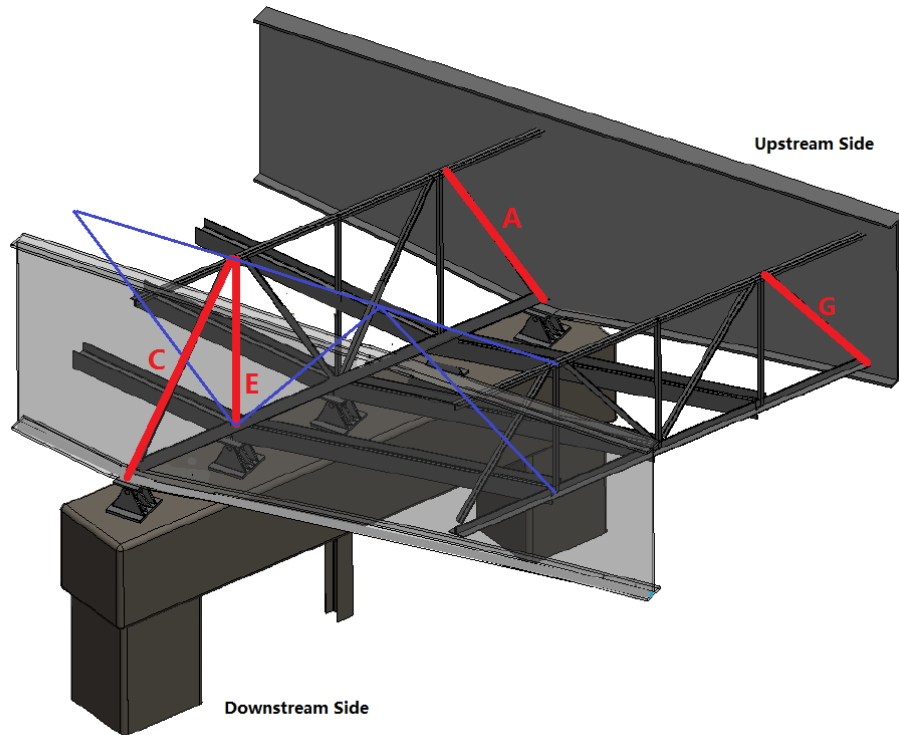
Figure 2.23 Three-dimensional view of showing members A, C, E, and G

- HL-93 loading on three traffic lanes had four members with an operating load rating below 1 ($LR < 1$). Four secondary members A, B, C, and D had load ratings below 1. These secondary members are not crucial to bridge safety (see Figure 2.8, Figures 2.23–2.24, and Table 2.1).

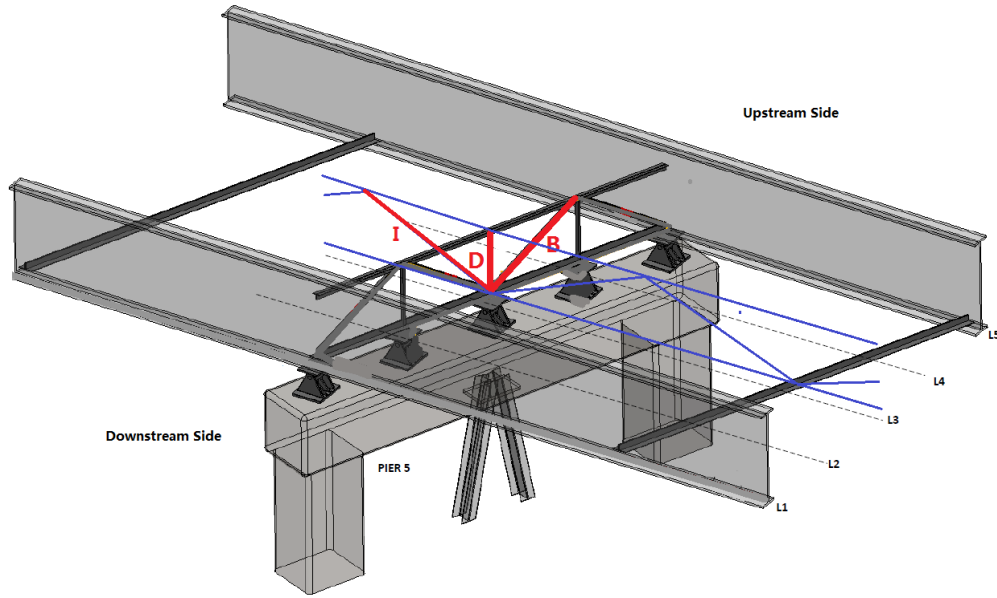
Figure 2.24 Three-dimensional view showing members B, D, and I

- HL-93 loading on two traffic lanes with all bearings in contact. One member, D, had an operating load rating below 1 (see Figure 2.10, Figure 2.24, and Table 2.1).

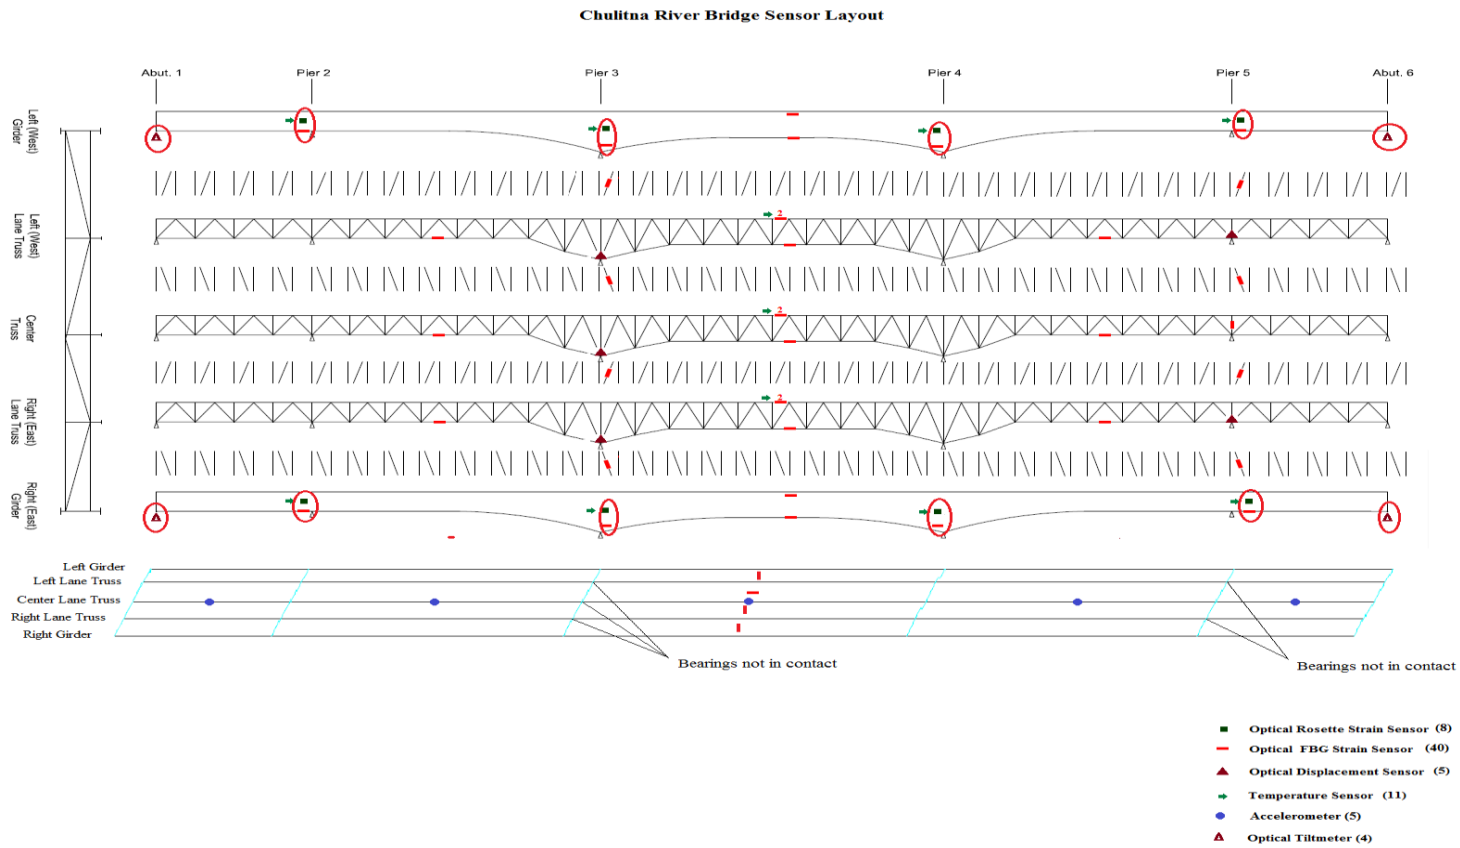
Figure 4.1 Sensors used for evaluating the bridge response

A total of 20 data sensors were not needed to update and calibrate the computer model. The resulting computer model was then used to load rate the bridge. The unused sensors included 8 rosettes (on the girders); 8 strain sensors (on the girders); 4 tilt meters (on the roller supports). Unused sensors are shown in Figure 4.1 by marked red circles around the sensor.

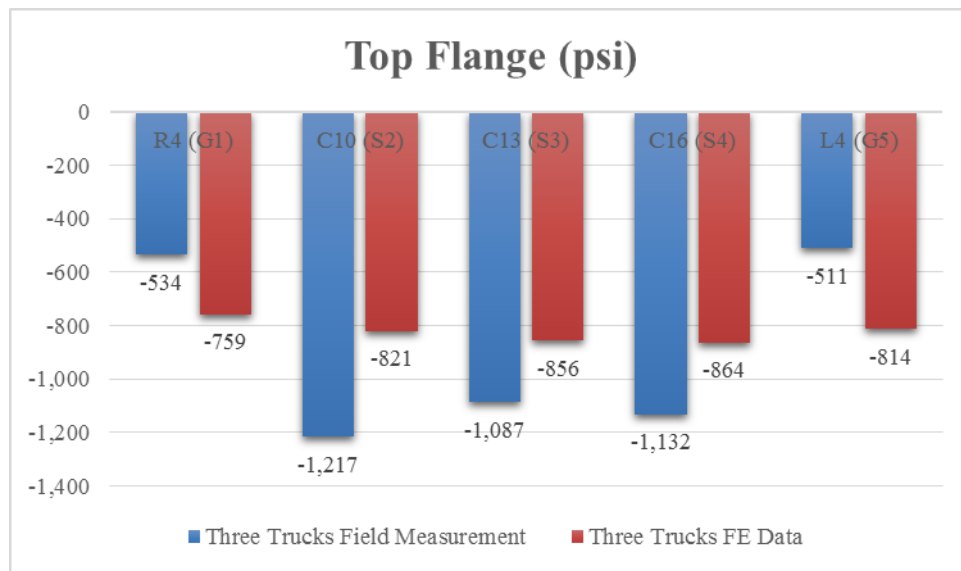
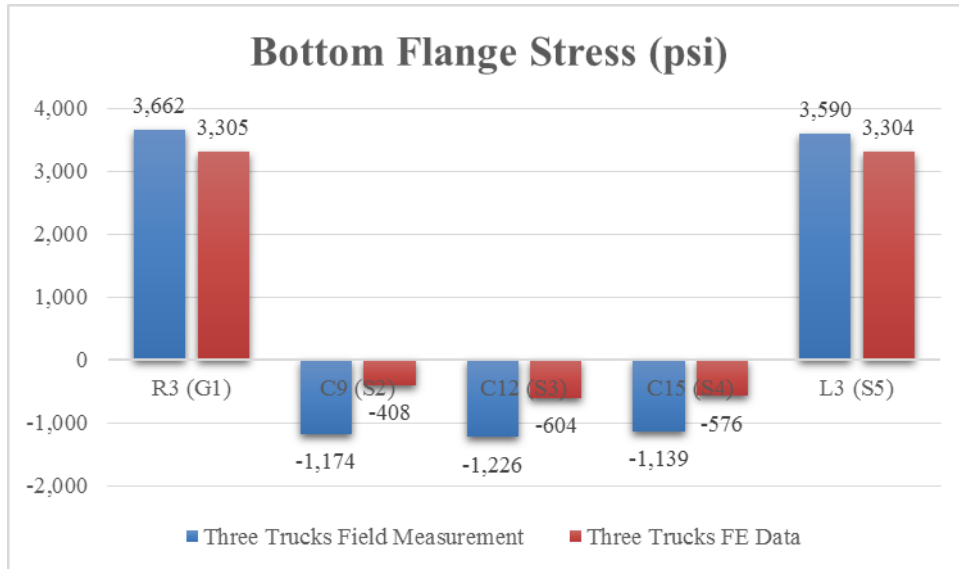
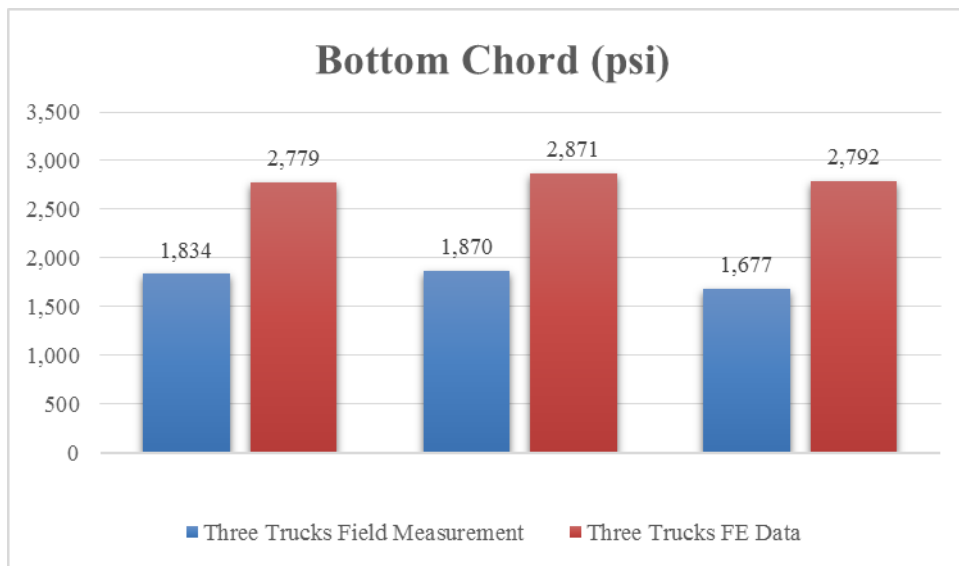
Figures B.1, B.2, and B.3 show a comparison between stresses obtained from measured strain data and the "before modification" HDR FEM calculated mid-span stresses. Results indicate that the FEM-calculated stresses carried by the composite trusses are higher than measured; that is, calculated lower chord stresses are higher than measured (Hulsey and Xiao, 2013). This finding illustrates that the FEM does not properly represent the distribution of stiffness between the bridge composite stringers and the girders. In consideration of these problems, 14 objective functions (variables) were selected for study. Modifications to the objective functions affected load distribution for the composite trusses and girders.
