# Phase II: Chulitna River Bridge Structurally Health Monitoring

## Alaska Bridge 255 – Chulitna River Bridge

**January 2015**

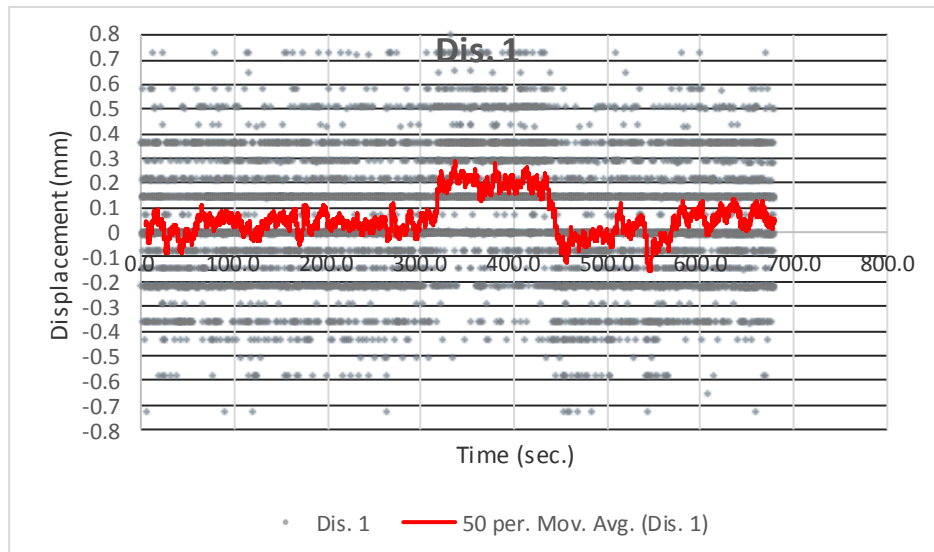
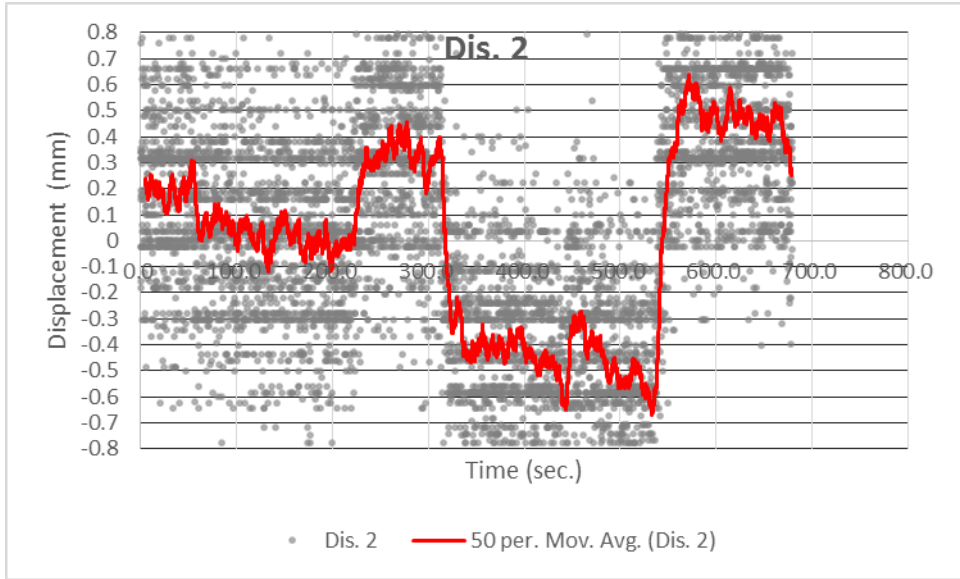
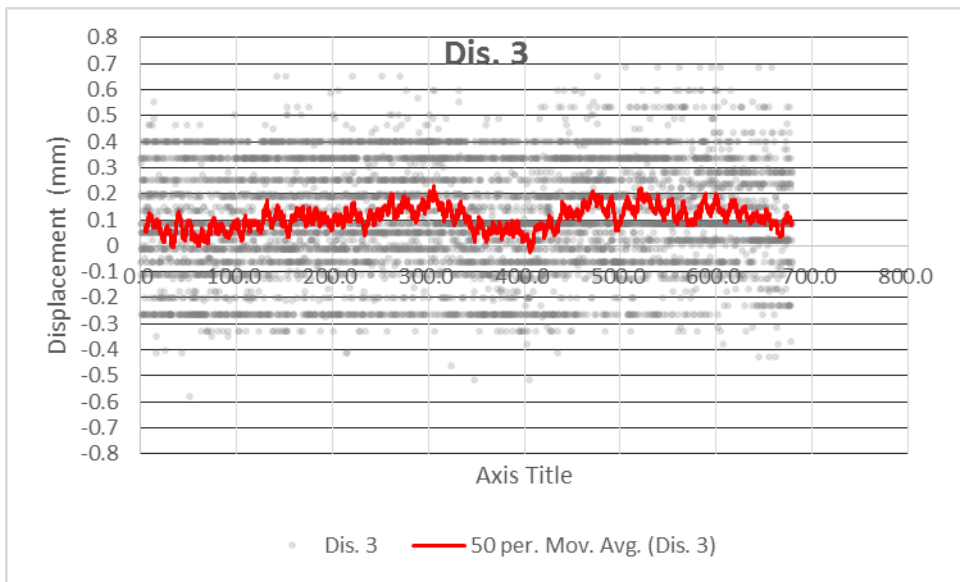
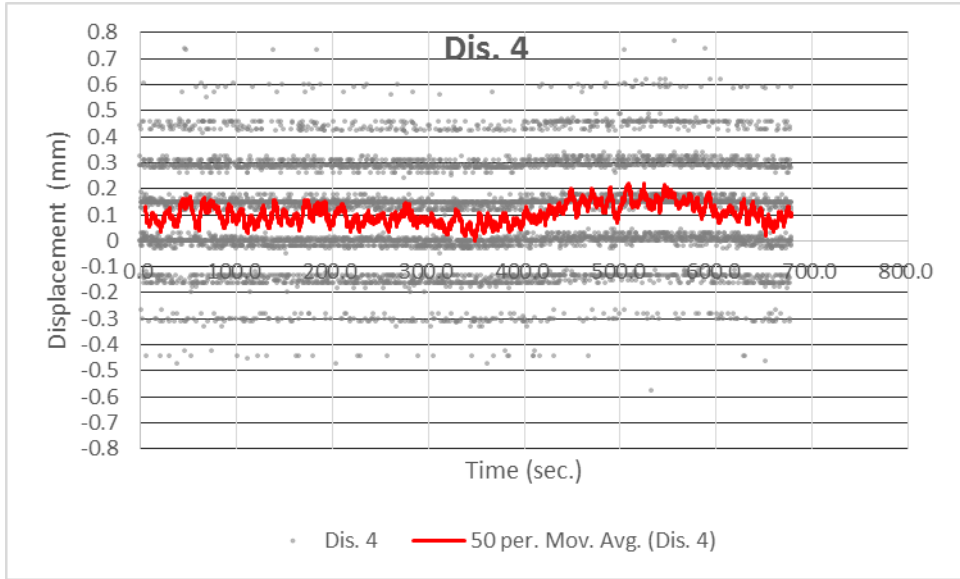
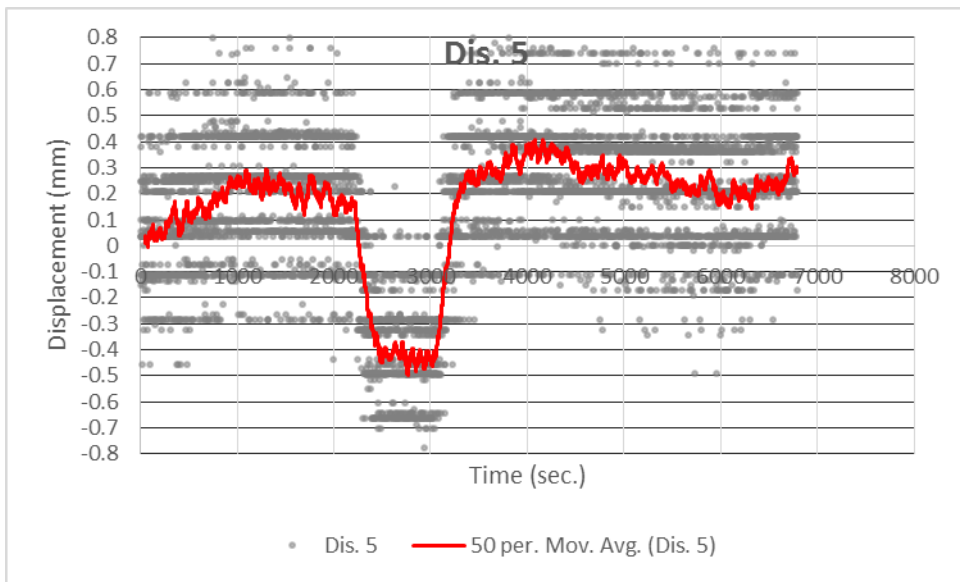
Figure D.1 Vertical movement at 5 unconnected bearing supports

According to the displacement sensor results, roller bearings 1, 3, and 4 have limited movement in the vertical direction. When compared with the other roller bearings, bearings 2 and 5 are more flexible in the vertical direction than the others are (Xiao and Hulsey, 2015).
