Integrity and Reliability Testing of a HDPE Taut Mooring System Belt

Philipp R. Thies, Peter Halswell, Marcus Lehmann and Lars Johanning

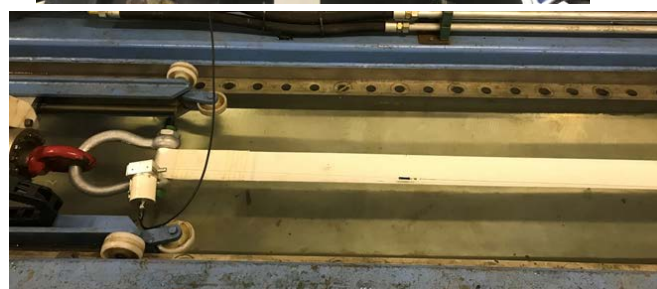
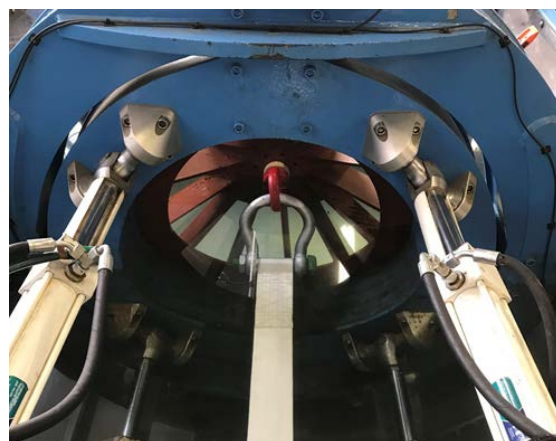
Fig. 5. Experimental setup – connections. Top: Headstock connection. Bottom: Tailstock connection of the belt sample with draw wire potentiometer attached to belt.

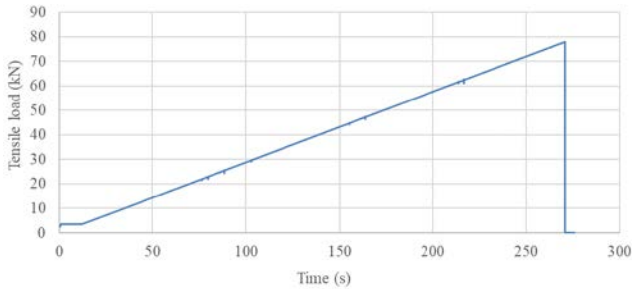
Sample 1-TTS failed at 78.0 kN load, see Fig. 6. The stitching on the belt loop started to fail as low as 21.9 kN, indicated by the small load decreases in the time history. Sample 3-SKB failed at 144.9 kN MBS, see Fig. 7, and sample 3-SKB failed at 205.9 kN MBS, see Fig. 8.

Fig. 6. Time series of tensile load test, sample 1-TTS failure at 78.0 kN. The small load slips indicate the onset of loop failure.

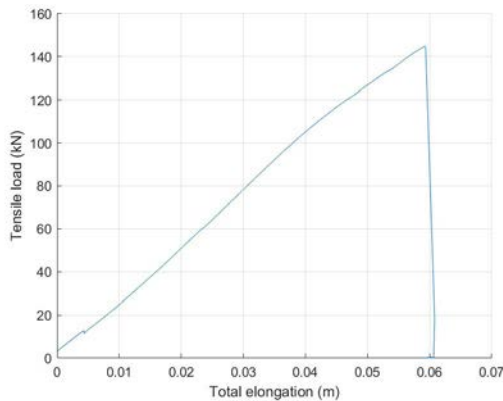
Fig. 7. Sample 3-SKB - load extension plot, with MBS of 144.9 kN.

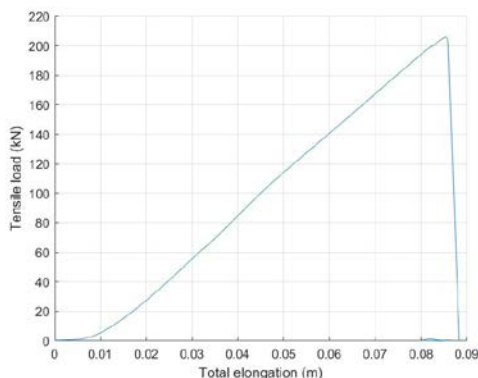
Fig. 8. Sample 4-SKB - load extension plot, showing MBS of 205.9 kN.

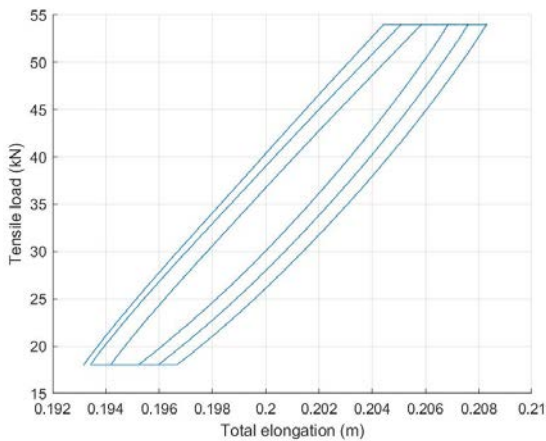
Fig. 12. Sample 3-SKB - Load vs total elongation of quasi-static stiffness test [ISO19336:2015 B.3.5.2].

Fig. 12 and Fig. 13 show the bedding in of the samples, with increased elongation for repeated cycles. The stiffness remains relatively steady and can thus be calculated as the slope of a single-cycle.

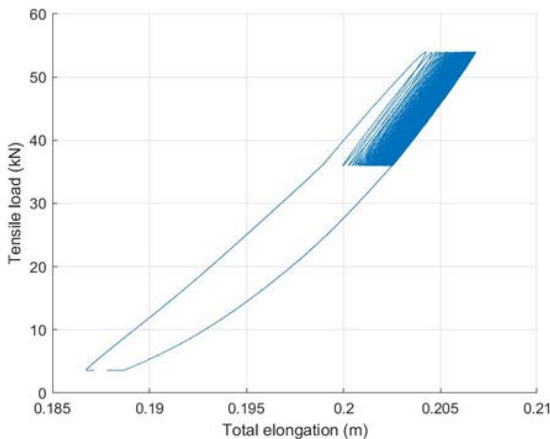
Fig. 13. Sample 3-SKB - Load vs total elongation of dynamic stiffness test [ISO19336:2015 B.3.5.3.A].

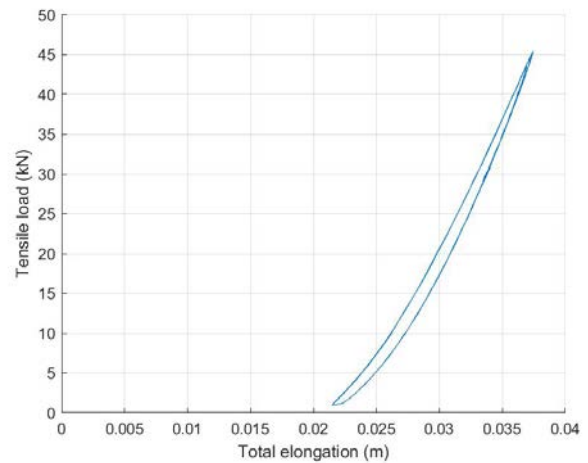
Sample 4-SKB was also subjected to the repeated shock load signal (comp. Fig. 4). The mooring belt response is plotted in Fig 14. The hysteresis of the load extension response is relatively low, as the sample has been fully bedded in for this test, being close to a linear stiffness response.

Fig. 14. Sample 4-SKB - Load vs total elongation of last three cycles of shock loads.

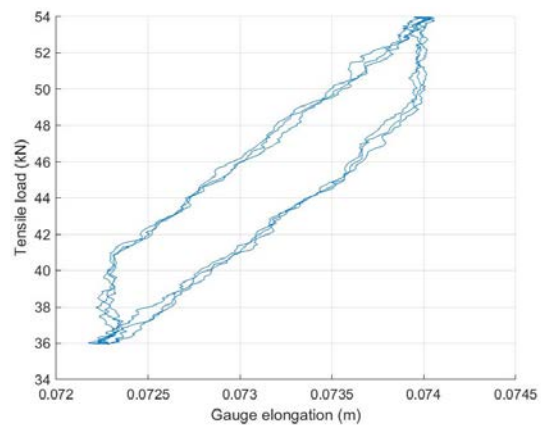
The load versus gauge elongation (draw-wire transducer) measurements (B.3.1) are shown in Fig. 15. The draw-wire transducer data is plotted using a 0.2s rolling average to reduce noise.

Fig. 15. Sample 3-SKB - Load vs gauge elongation of dynamic stiffness test (last 3 cycles) [ISO19336:2015 B.3.5.3.A].
