Foundation Work of High TV Tower in Collapsible Loess

Dimcho Evstatiev
Geological Institute of the Bulgarian Academy of Sciences, Sofia, Bulgaria

FOUNDATION WORK OF HIGH TV TOWER IN COLLAPSIBLE LOESS

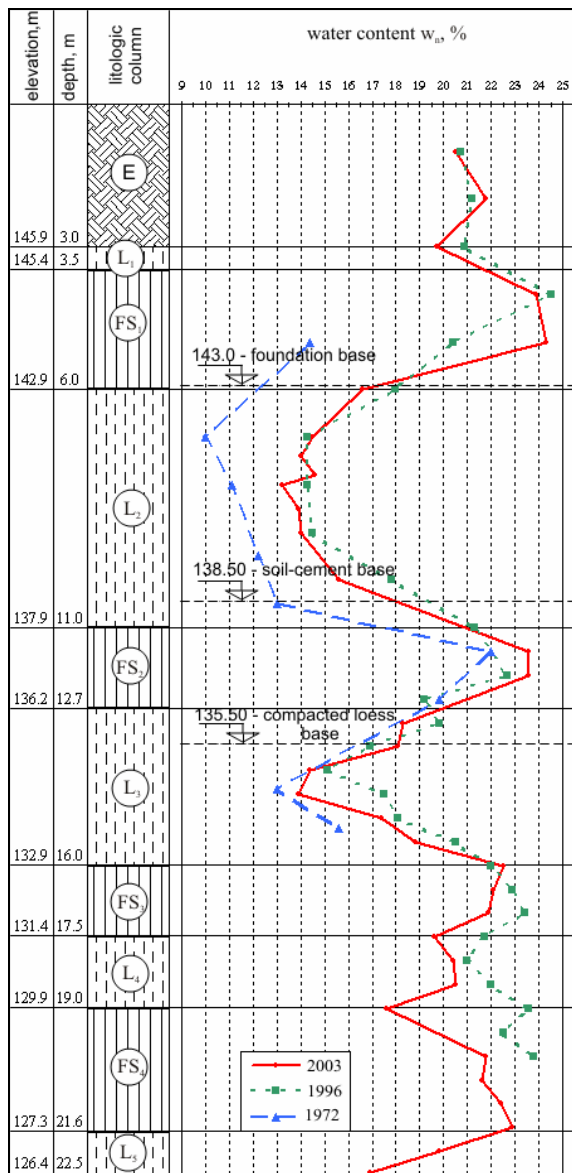
The 7-16 m interval (layers L_2, FS_2 and L_3 in Fig. 2) possesses collapsibility under geological burden (unloaded collapsibility) of 2-3 %. Non-collapsible loess is found at a depth of 16 m with collapsibility tending to δ_{cv} = 0.00 % under geological burden $p_{B\ v}$ = 0.3 MPa.

Fig. 2. Geological structure of the soil base
The curves of the moisture content investigated in 1972, 1996 and 2003 are presented in the right

It increased with another 1 cm till 1987 and then slow attenuation started, increasing only with 0.5 cm in the course of 8 years, i.e. with about 0.62 mm annually till 1995. It may be presumed that this fading rate would have continued in the next years too, if the accidents in the WSS system did not occur. As a result of them, the non-compacted backfill embankment (Fig. 3) was over-moistened and irregular settlement of the built on it contiguous to the tower low structures occurred. Part of the water had permeated into the non-compacted part of the soil base (loess horizon L_3), provoking certain increase in its moisture content (Fig. 2).

The establishment of the degree of moistening of the loess base under the tower foundation and the tracing of these changes in the course of time is an important element of the monitoring (Fig. 2). As already mentioned, 2.60 m of collapsible loess remained under the heavy tamper compacted loess. The moisture content in it had increased from to 2 to 4 % till 1996 (with respect to the recorded one in 1972), with a maximum in the lower part of the layer. Due to this moistening the settlement of the tower has not attenuated entirely. The main sources of moistening are the permeating surface water via the deformed vertical planning and the damaged WSS networks.

The effect of activities undertaken to 2003 consisted in reducing the moisture content of the collapsible layer with 1-2 % (Fig. 2). The entire stabilization of the backfill embankment completed in 2006 will lead to further attenuation of the settlement.

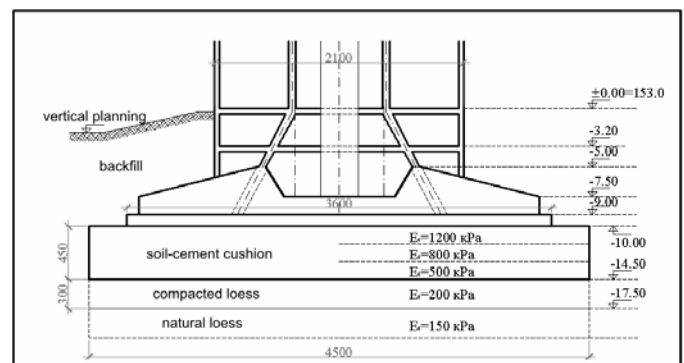
Fig. 3. Foundation scheme of the TV tower in Rousse city

The method described so far prevents the hazard of collapsibility for the layers L_1, FS_1, L_2 and FS_2 and the top part of L_3. In fact the lower 2.6 m of L_3 remained unchanged, its w_n being increased at the transition to FS_3. The small thickness of the potentially collapsible layer, its situation at a great depth and the absence of a project for buildings in the tower vicinity – the surrounding space being intended to be a lawn, as well as the envisaged network for geodetic control, were the most important motivations for the absence of apprehensions about this thin collapsible layer. The eventual deformations in it would have been expressed in additional settling instead of collapsing.

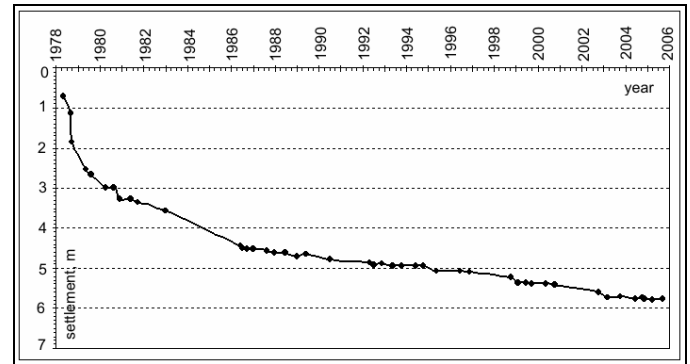
Fig. 4. Averaged graph "time – settlement" of the leveling marks

During the construction of the tower the settlement was relatively more intensive, reaching 3.57 cm after its completion in 1983.

The over-moistening of the backfill had caused cracking of the sidewalk and a 20-cm wide gap appeared between the sidewalk and the tower, allowing the permeation of precipitation water flowing down the tower body into the soil base. This rise of water content caused slight increase in the settlement – up to 1 mm annually and very slight, rather below the admissible, inclination of the tower, these processes being interrupted after the repair of the sewerage system in 2003 and the drying of the backfill in 2005.
