Performance and reliability of PZT-based piezoelectric micromirrors operated in realistic environments

R. P. Dahl-Hansen[1,2*], T. Tybell[1]
[1]Norwegian University of Science and Technology
Department of Electronic Systems,
7491, Trondheim, Norway

Keywords: PiezoMEMS reliability, lifetime, fatigue, temperature, humidity

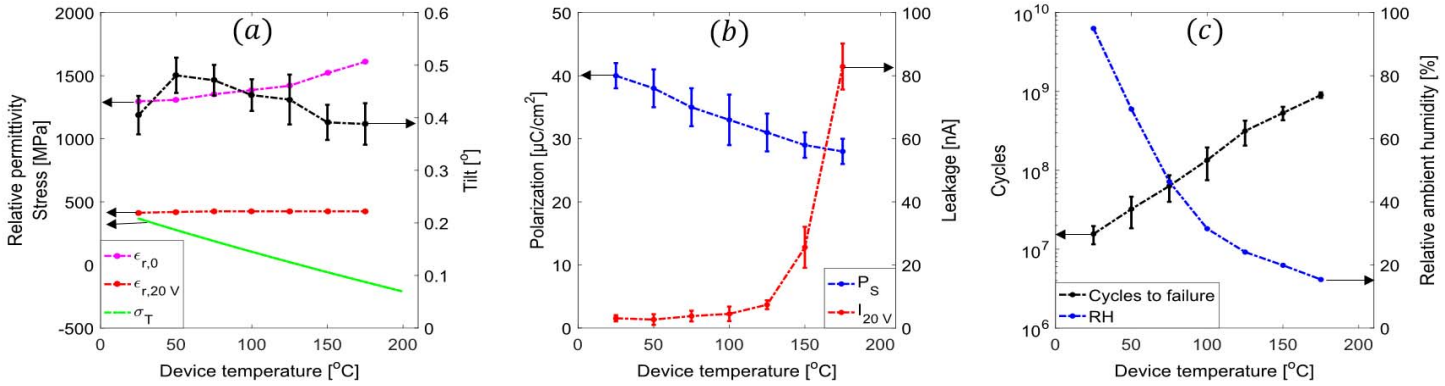
Figure 2: (a): Measured relative permittivity at 0 V, $\varepsilon_{r,0}$, and 20 V, $\varepsilon_{r,20\,V}$, calculated thermal stress, σ_T, and deflection tilt as a function of device temperature. (b): average polarization and leakage as a function of device temperature. (c): Average cycles to failure, and relative humidity due to heated ambient as a function of device temperature.

Fig. 2 (a) show the measured average angular tilt, relative permittivity at 0 V ($\varepsilon_{r,0\,V}$) and 20 V ($\varepsilon_{r,20\,V}$) and calculated total thermal stress in the device stack (σ_T) plotted as a function of T_{sub}. The measured average saturation polarization (P_S) and leakage at $20\ V$ ($I_{20,V}$) is shown in *Fig. 2* (b) and the values summarized in *Table I*. $\varepsilon_{r,0}$, $\varepsilon_{r,20\,V}$ and $I_{20\,V}$ increases, while P_S decreases with increasing T_{sub} and is consistent with literature on ferroelectrics [5]. As shown in *Fig. 2* (a) the measured average tilt increases with T_{sub} and peaks at 50^oC before it decreases for $T_{sub} > 50\ ^oC$. Such electromechanical behavior has also been reported for similar PZT-based ceramics in literature [7]. Thin-film devices such as the present micromirror, are particularly sensitive to the in-plane circumstances. Hence in-plane stress, excitation field and device geometry are important for the final electromechanical response. The bending moment moving the current device structure originates from the total in-plane stress (σ_{tot}) and has three main contributions: the residual stress (σ_R) applied stress (σ_A) and piezoelectric stress (σ_P). The latter being the controllable stress, relates to the

These literature findings correlate well with the current measured increasing cycles to failure with increasing T_{sub} (see *Fig. 2* (c) and *TABLE I*). This may suggest that other factors such as the absolute humidity ambient humidity rather than the relative ambient humidity, the relation between the device temperature and the ambient temperature as well as the cleanliness of the device being tested are important to consider during lifetime and reliability tests. It can be noted that no local breakdown-events was observed for devices operated in $RH = 35\ \%$ at $T_{sub} = 25\ ^oC$, and $T_{atm} = 25\ ^oC$ for up to $1.5x10^{11}$ cycles. At $T_{sub} = 175\ ^oC, T_{atm} = 62.3\ ^oC$ and $RH = 15.4\ \%$ on the other hand, failure occurred after $9x10^8$ cycles which further support the abovementioned claim.

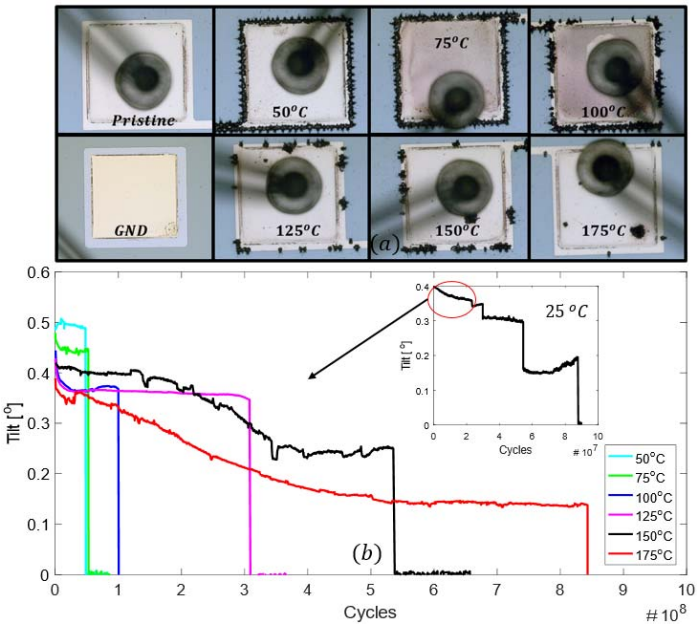
Micrographs of the bonding pads after device failure is shown in *Fig. 3* (a). Humidity-related degradation was primarily manifested as local breakdown-events and pinhole-formation along the edges and on top of all utilized top electrodes. The ground pads and unused electrodes, however, remained unaffected. As shown in *Fig. 3* (a), the relative pinhole concentration appeared to be considerably larger along the electrode edges than on top of the electrode surfaces. Also, the total number and relative portion of pinholes along the edges compared to the electrode surface was significantly larger at lower T_{sub} than at higher T_{sub}. Since for the present experiments the applied voltage was above the standard potential for catalytic water-splitting of $1.23\ V$, we speculate that water-splitting catalysis can facilitate the observed degradation. During testing, the Ti/W-layer used as an adhesion-layer between Au and PZT is exposed to the ambient along the electrode edges and can hence form catalytically active oxides such as TiO_2 and WO_3 in the presence of humidity. If water-splitting is indeed occurring, hydrogen will evolve on the top electrode and may quickly diffuse into PZT along the electrode edges. If e.g. hydrogen-induced hardening reduces the critical stress - the maximum stress the PZT-films can accommodate before cracking - so that the application of σ_P results in cracks, the edges should be the first area to be affected by such degradation. The fact that the unused and bottom electrodes remains unaffected may indeed further support this claim and similar observations have been reported for PZT under DC-bias [9], [10] and in the FERAM-literature [11].

For water splitting to occur on the electrode surface, PZT should either be exposed through the top electrode or catalysis should occur on Au. The former can be true in the presence of pinholes, large local defects such as sputtered particles or cracks appearing during operation. The latter have recently caught interest in literature due to the catalytic activity of gold [12]. To understand the connection of the observed degradation to elevated temperatures, the adsorption of water on the device

Figure 3: (a): micrographs of bonding pads after failure at $25 - 175^oC$ in humid ambient and (b): measured deflection as a function of cycles.

The measured amplitude degradation in high humidity was typically characterized by four sudden drops during operation, as shown in the inset of *Fig. 3* (b). Each drop was associated with the breach of an electrode routing connecting the wire-bonding pads to the actuating membrane. Hence, device failure was defined as the breach of the first electrode. The tilt relative to the tilt at $25\ ^oC$ as a function cycles until the first routing breach is plotted vs T_{sub} in the main graph of *Fig. 3* (b). As seen, the deflection amplitude declines by cycling for all devices. But, even though the rate of decline was significantly higher at elevated temperatures, as to be expected [5], the lifetime was indeed longer. However, the electromechanical degradation by cycling was found to exceed the expected contribution from pure ferroelectric fatigue. E.g. at $175\ ^oC$ the average decrease in tilt was $65\ \%$ opposed to a $10\ \%$ decrease in P_S after $5x10^8$ cycles (not shown here). ε_r remained approximately constant throughout the experiments. Again, this points towards the in-plane sensitivity to film-substrate stress transfer and other factors of such devices. Lastly it can be mentioned that no short-circuiting was detected prior to the shown routing breaches.
