Photogrammetric evaluation of geometrical tolerance standards: a DARPA suboff model case study

Fillipe R. Esteves [1]
Hélio C. S. Júnior [2]
André M. Kogishi [3]
Bernardo L. R. de Andrade [4]

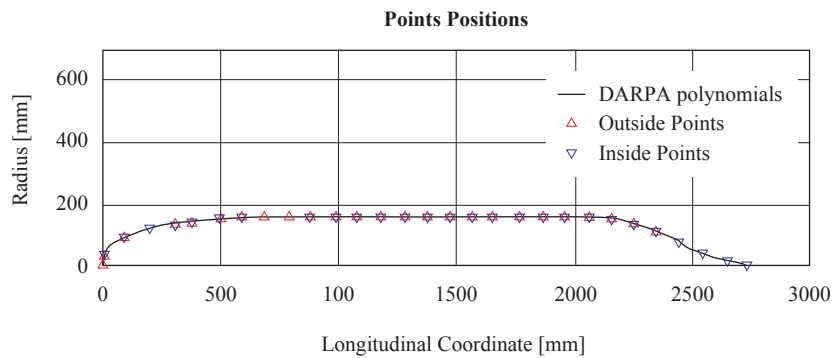
Fig. 5. Bias comparison of measured points over the reference polynomial curve.

A useful way to evaluate the deviations of this model is its arrangement as a function of the longitudinal coordinate of the hull. Figs. 5 and 6 show distinct ways to visualize deviations: The first one plots the radii measured by photogrammetry over the DARPA Suboff hull reference curve.

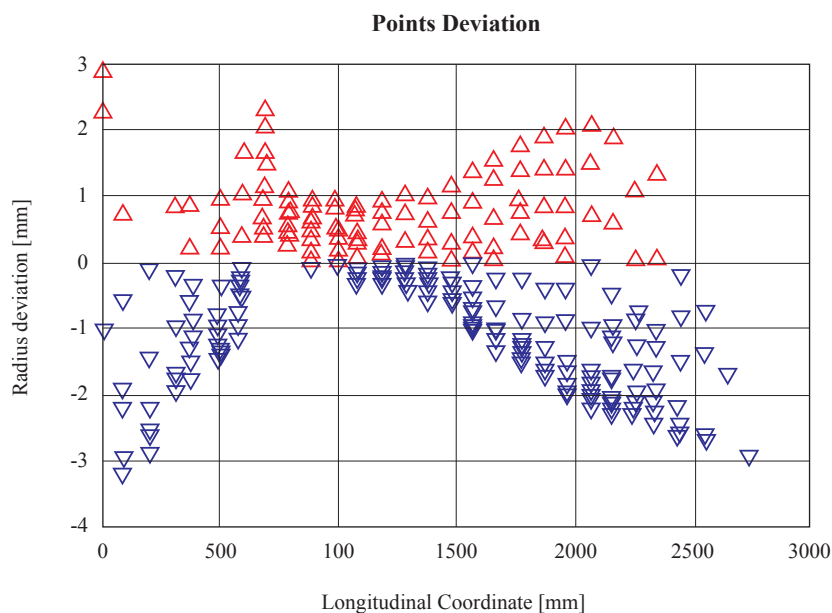
Fig. 6. Radii deviations, as function of the longitudinal coordinate of the hull.

The Figure 6, in turn, shows only the deviations as a function of the longitudinal coordinate. It is possible to observe, qualitatively, greater deviations in the two extremities. In the bow, near the zero coordinate, there is greater concentration of negative amplitude big deviations. This means that the surface of the bow has a slightly smaller radius than the reference. The red markers highlight positive deviations (outside points), while the blue markers highlight the negative ones (inside points).

The region of the parallel middle body fits reasonably to the reference geometry, in the longitudinal coordinate close to 1000 millimeters. Starting

from 1500 millimeters, there is a deviation increase to both positive (external) and negative (internal) values. The average value for the whole sample is -0.438 mm, showing a slight tendency for smaller radii than the design. In absolute values, the mean deviation is 0.968 mm.

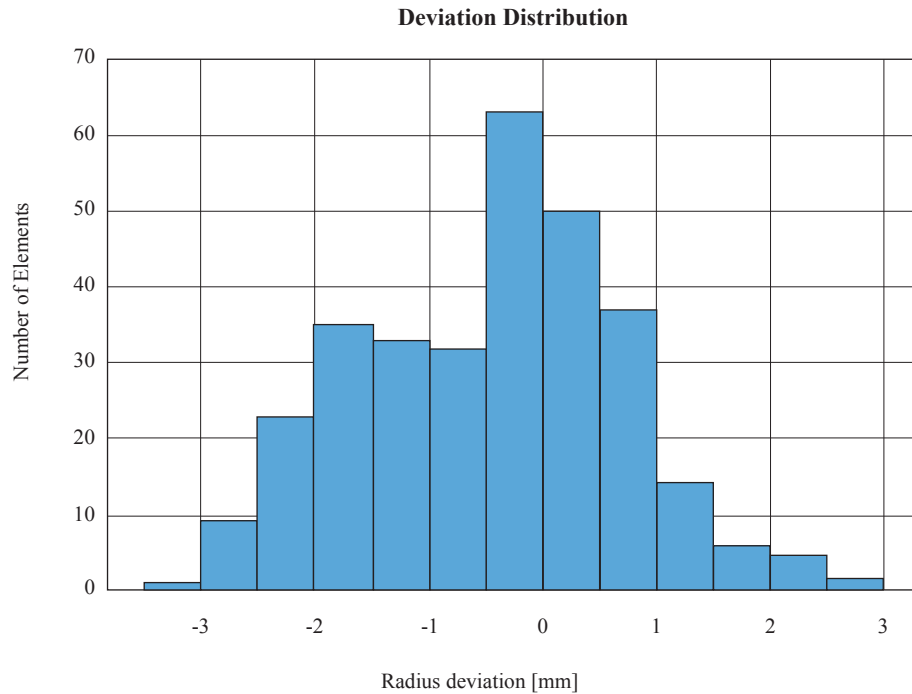
Fig. 7. Distribution of deviations.

The distribution of deviations is shown in Fig. 7. This distribution makes it clear that there is a greater density of points in the negative part of the graph, illustrating the value expressed by the simple mean. The variance for this distribution is 1.314 mm.

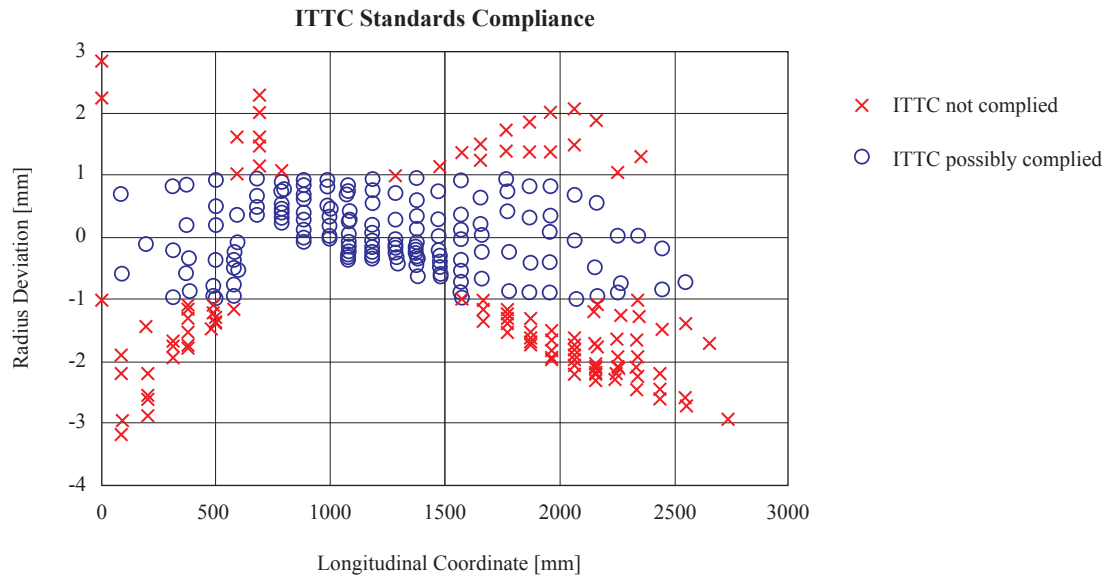
Fig. 8. ITTC Recommended Procedures compliance to ship models manufacturing.

The recommendation for depth and beam, dimensions relevant to this work, once the radius is being checked at each point (Fig. 8), is that the principal dimensions deviations should be less than 1 millimeter. In a conservative approach, the points whose radius deviation exceeds this value were highlighted. In practice, it is verifiable that, at least due to radial symmetry, it is not possible to comply the standard with local deviation values close to 1 millimeter, since the great majority of the point's sections present values in the positive and negative half-planes of the graph. A total of 127 points (41.1%) with absolute deviation greater than 1 mm were observed and 182 (58.9%) presented deviations less than 1 mm. The first group had an absolute mean of 1.734 mm and a variance of 0.255 mm, while the second one had an absolute mean of 0.434 mm and a variance of 0.087.

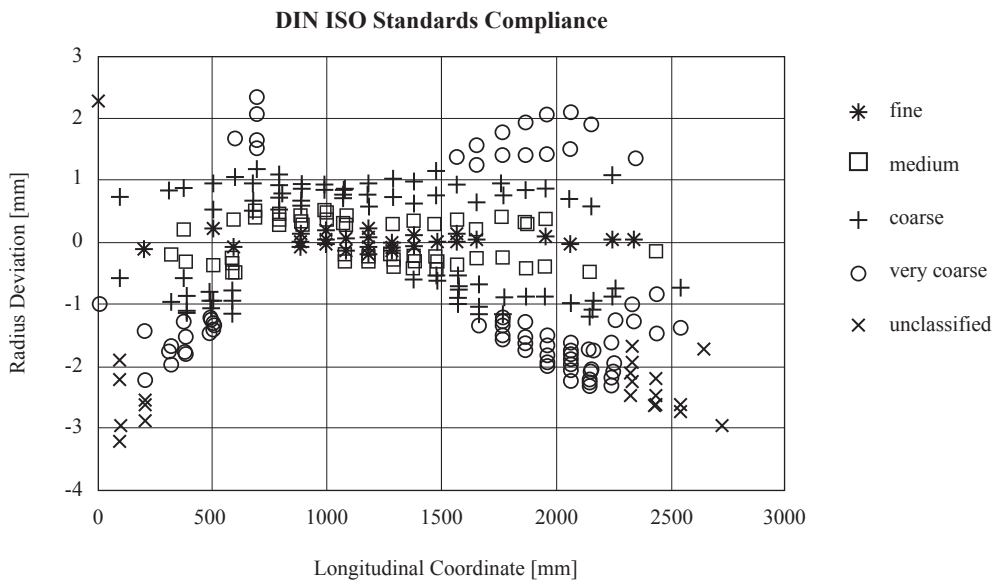
Fig. 9. DIN ISO Compliance.

The Fig. 9 shows the same distribution of deviations as a function of the longitudinal coordinate, but the points were grouped according to the class in which they fit the norm *(DIN ISO, 1989)*: "Fine" adjustment, "Medium" adjustment, "Coarse" adjustment, "Very Coarse" and points that do not fit the rules in any range of values, i.e., no class. It is possible to observe that in some cases, there may be up to three classes of deviation in the same arbitrary section at most.

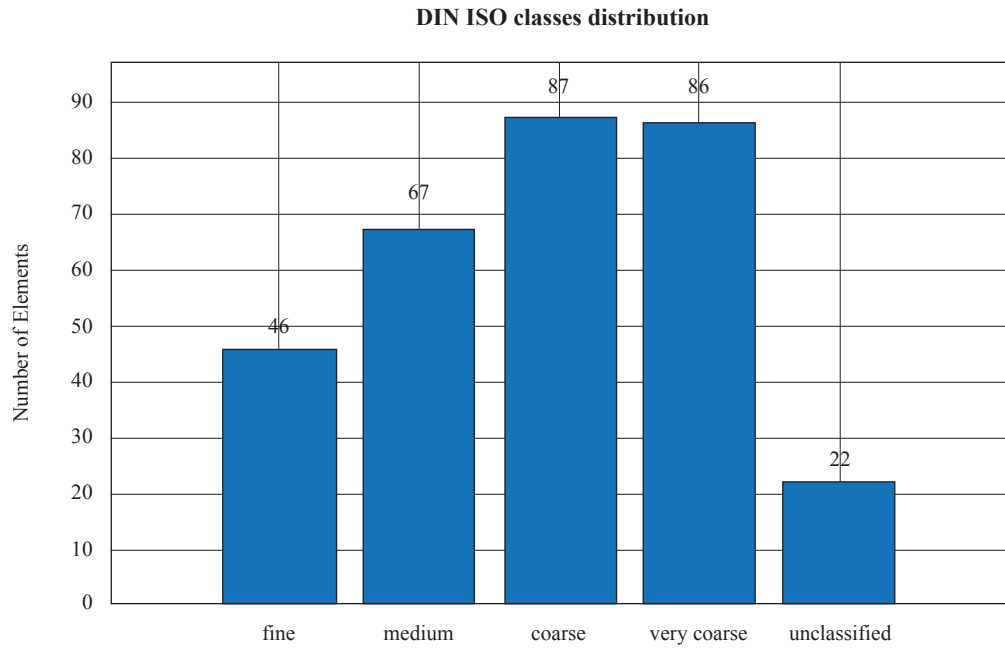
Fig. 10. DIN ISO classes distribution.

The distribution among the classes can be better studied in the Fig. 10 which shows 46 points in "Fine" adjustment, 67 points in "Medium" setting, 87 "Coarse", 86 "Very Coarse" and 22 out of standard ranges.

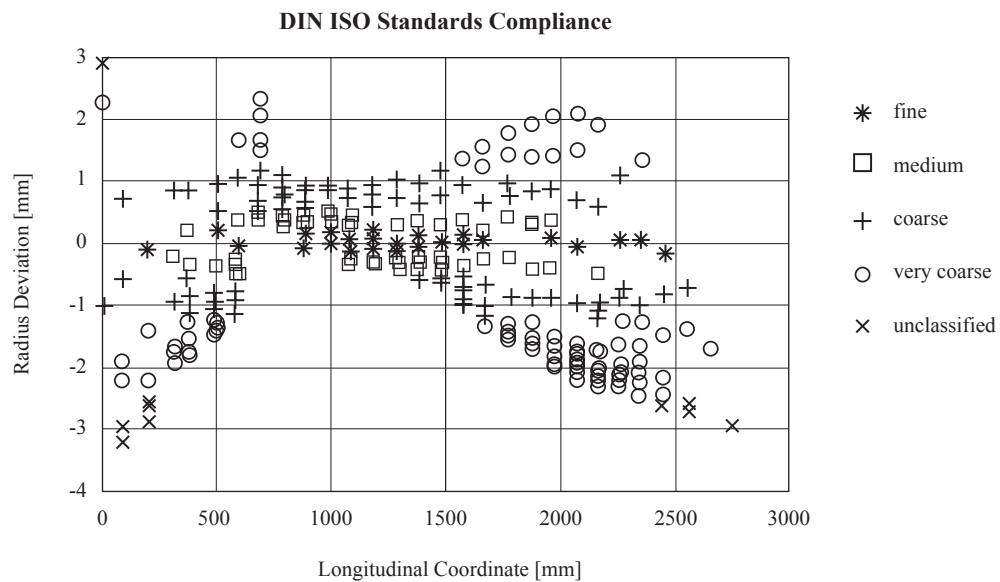
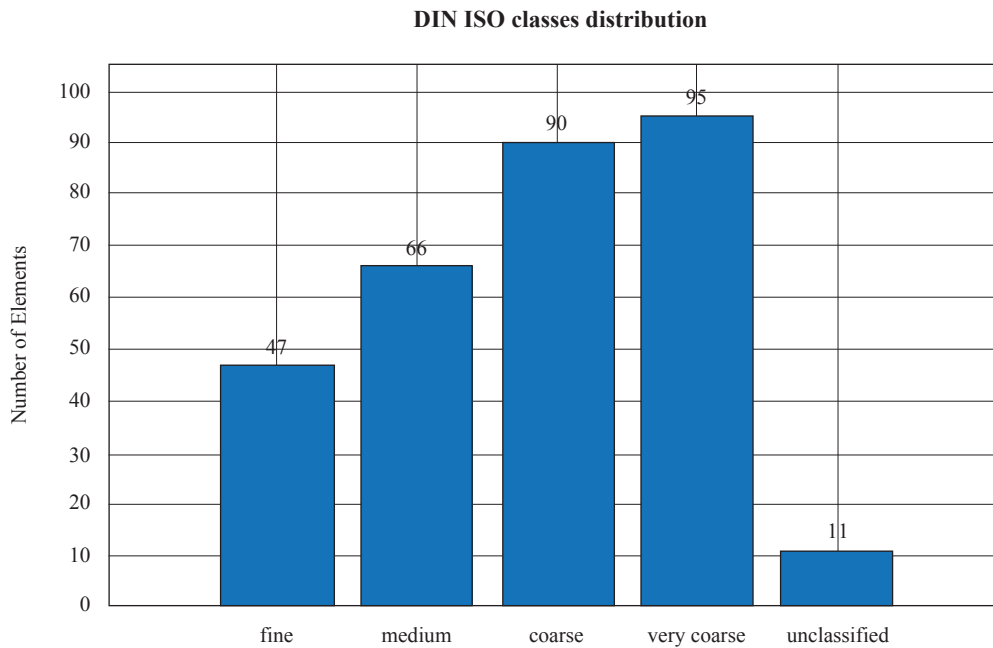
The same procedure can be verified in the Fig.11 and Fig. 12, this time with the loosening of the rule, in order not to penalize too much the bow and stern end points, where the reference becomes smaller and smaller. In this case, it was decided to adopt the maximum radius R_{max} as nominal size for all analyzes. With this hypothesis, several points have undergone class improvement, resulting in 47 "Fine" adjustment points, 66 "Medium" adjustment, 90 "Coarse", 95 "Very Coarse" points and only 11 unclassified points, according to table presented by the standard.

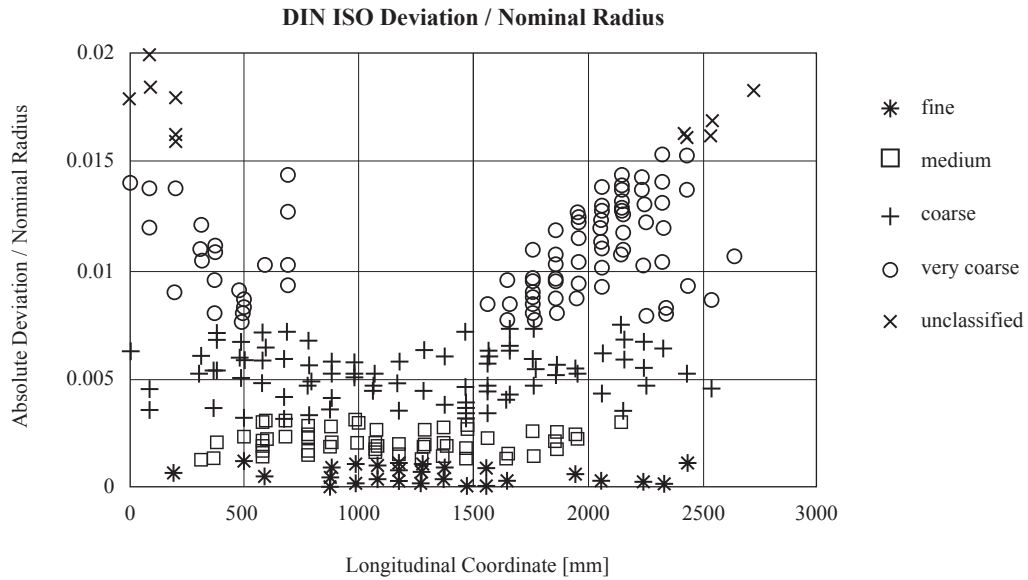
Fig. 13. Deviation / Maximum Radius dimensionless, as function of longitudinal coordinate.

In this sense, the Fig. 13 shows the dispersion of the deviations as a function of the longitudinal coordinate, showing the classification of each point, according to the criterion *(DIN ISO, 1989)*, in the same color scale previously used. It is possible to observe very clear levels between the

different classes, which is the advantage of having a single nominal size. In absolute values, it is possible to verify the mean of this dimensionless equal to 0.006, median equal to 0.005, maximum value 0.020 and minimum value equal to zero. The maximum value of the dimensionless, which still complies the rule, is 0.015.

In relation to the real values, were obtained the mean equal to -0.003, median equal to -0.002, maximum value 0.018 and minimum value -0.020. The maximum value of the dimensionless, which still complies the standard, is 0.014 and the minimum that obey the same rule is -0.015.

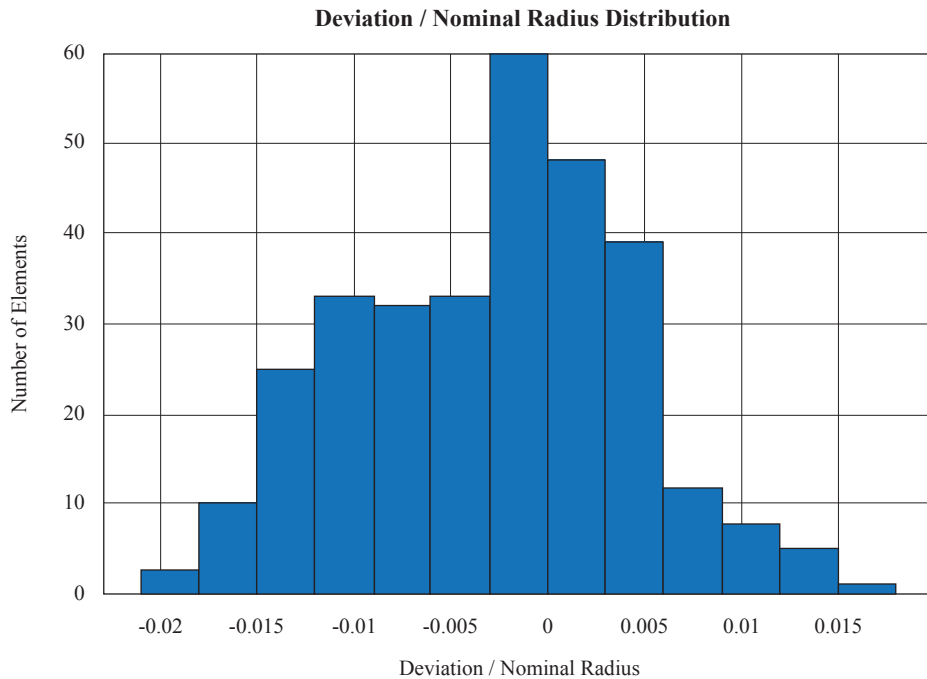
Fig. 14. Deviation / Maximum Radius dimensionless distribution.

Fig. 14 shows the distribution of the dimensionless deviations in absolute values. Due to the use of the maximum radius, the shape of this distribution was preserved as in Fig. 7.
