Rainfall induced residual soil slope instability: building cracked and slope failure

L J Yue[1], M F Ishak[1], M S I Zaini[1] and M F Zolkepli[1]

[1] Faculty of Engineering Technology, Universiti Malaysia Pahang, Malaysia

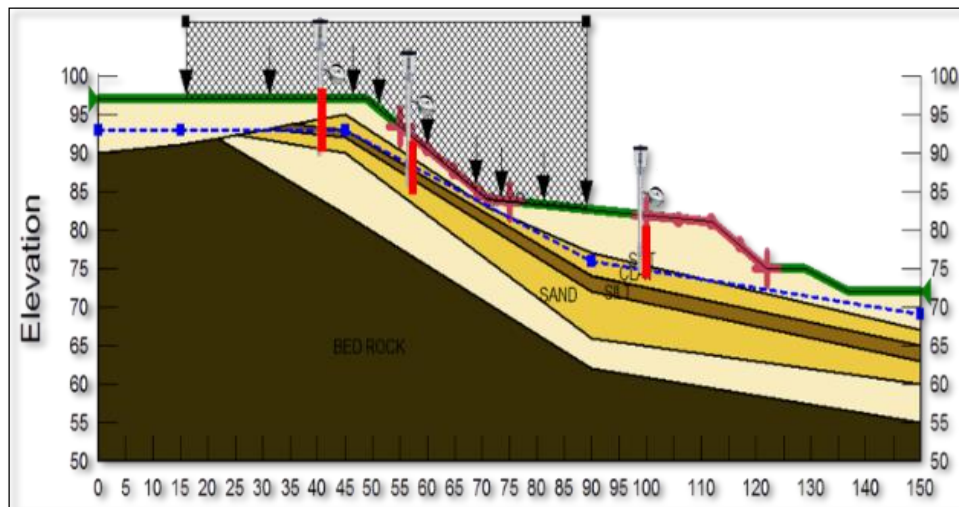
Figure 3. Location of tensiometer

The slope was divided into three parts which are top, middle and toe of slope for suction testing with three different tensiometer depth (0.3 m, 0.45 m and 0.9 m below the ground surface). The location of tensiometer was shown in Figure 3. Rain gauge was placed at the open area of the site or installed it at the centre of research area.

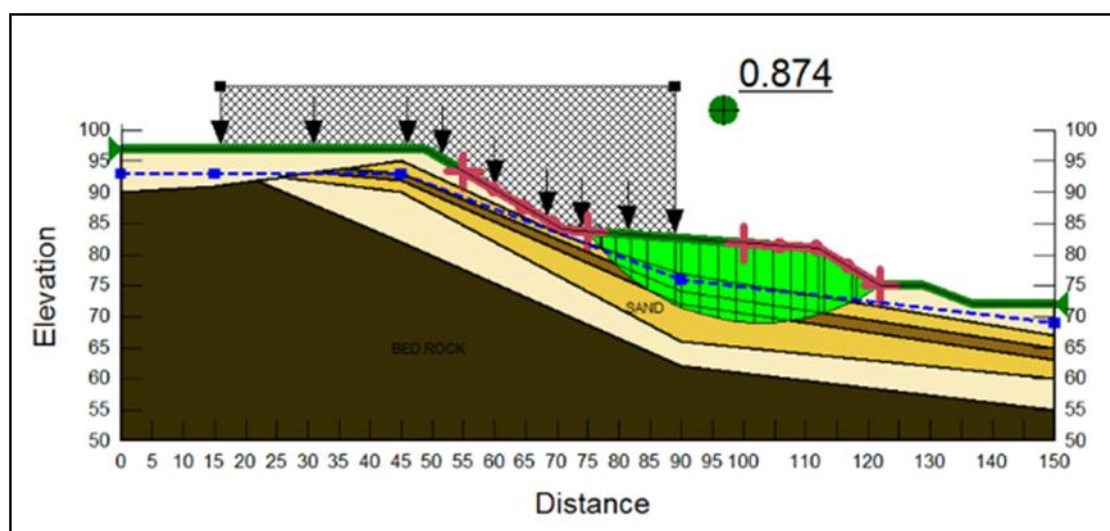
Figure 6. SLOPE/W analysis

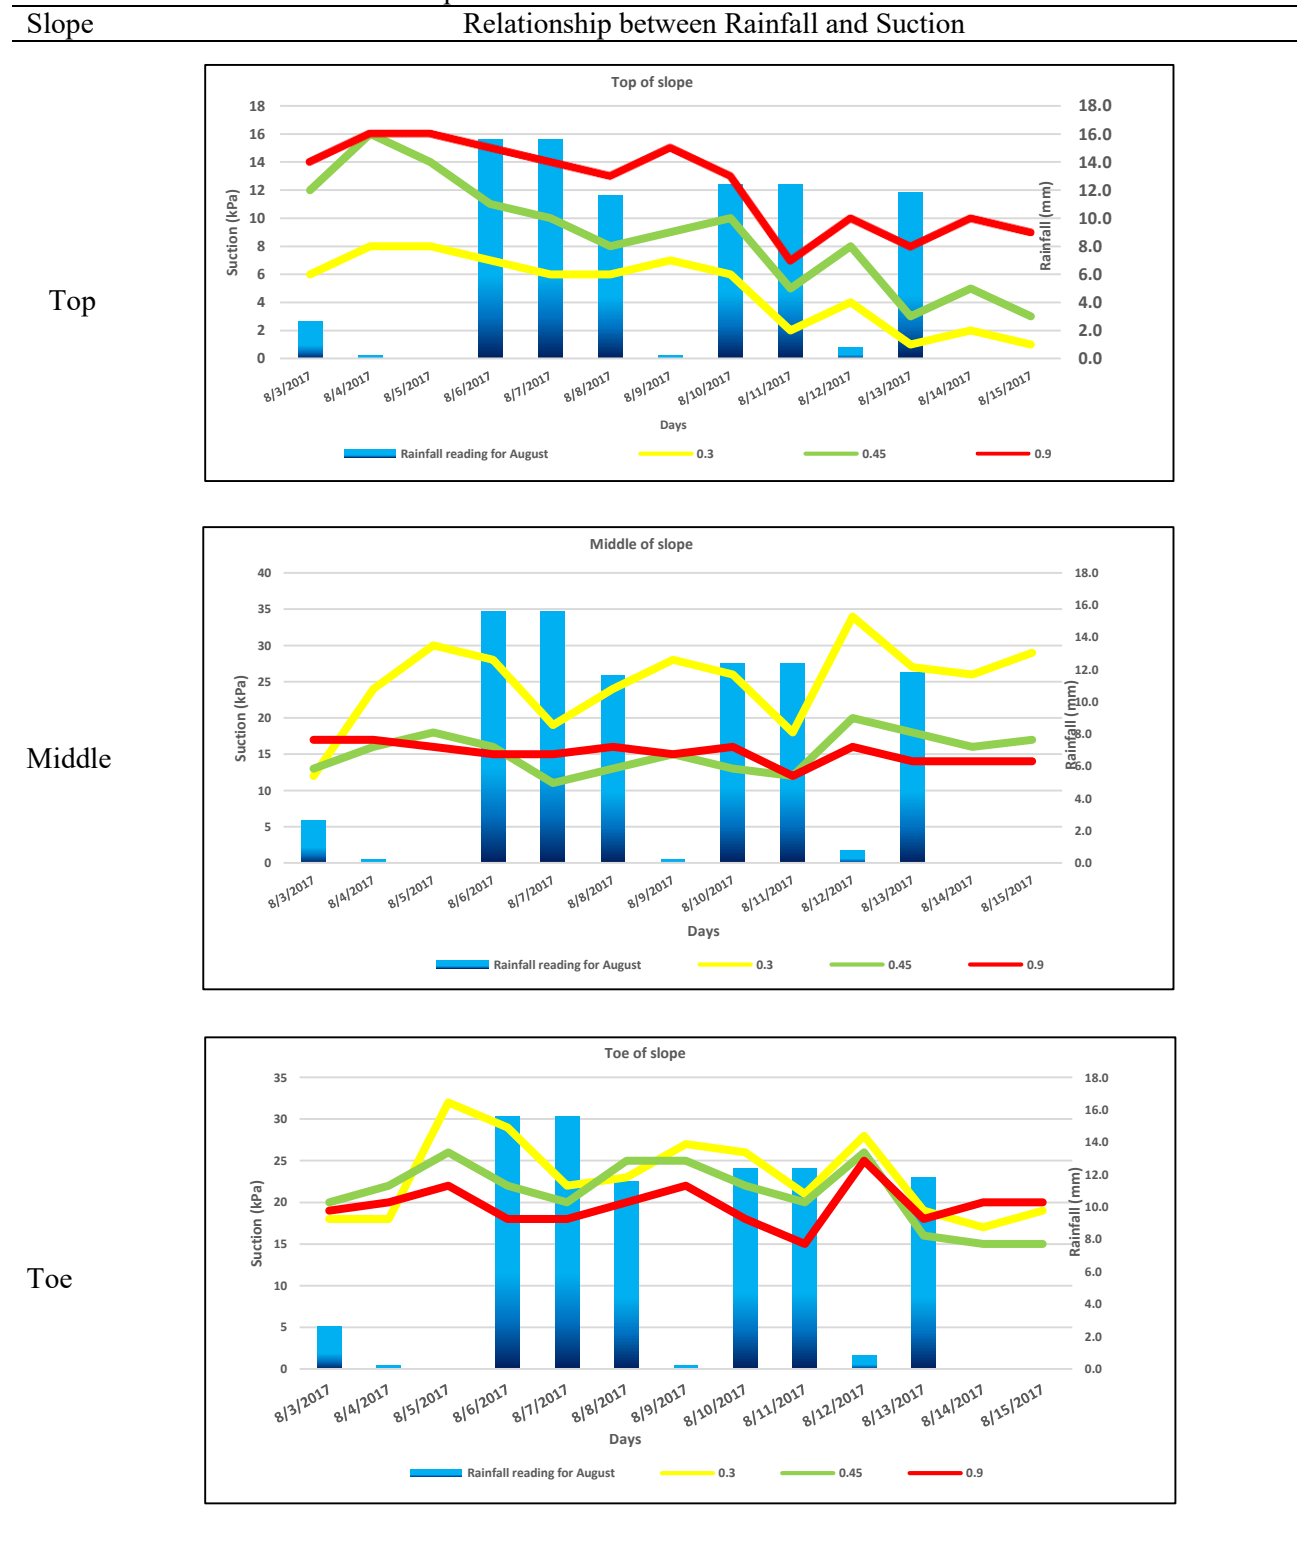
Table 4. Relationship between rainfall and suction at different location

According to Table 4, it was found that the suction value decreased due to increase of water content in soil during the high rainfall and number of precipitation.

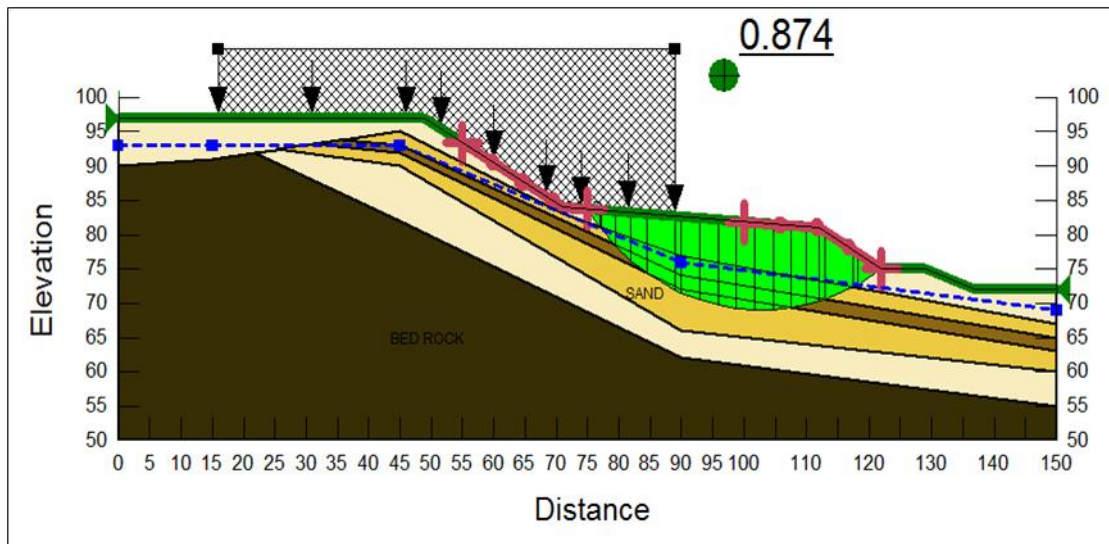
Figure 7. Analysis result of critical FOS with building surcharged on toe of slope

From the analysis by using Slope/w software, on top of slope, the factor of safety on the top of the slope is higher than factor of safety at middle and toe of slope. It was found that slope was not stable due to the factor of safety value of less than 1.3 at toe of the slope studied. This may happen Due to the seepage force in the sloping alignment together with the gravity force thus promoting to the slope instability. The factor of safety at middle of slope was determine by 1.963 via Slope/W analysis. Since at the middle of slope present a building structure the factor of safety may higher than expected factor of safety due to the disturbance of soil structure via earthwork (cut, fill and compaction of soil).

The paper had shown the relationship between suction, rainfall and FOS. FOS was determined using SLOPE/W and Fellenius' Method with Microsoft Excel formula. Matric suction was influenced by rainfall because when rainfall intensity increased, matric suction of soil decreased. Factor of safety is interrelated with rainfall and suction of soil. Suction of soil increased and thus influence the increasing of the factor of safety. The factor of safety at specific slice was analysed using the suction which affected by rainfall. Finally, the changes of rainfall intensity caused the factor of safety to reduce, the lower factor of safety had caused the instability of slope. Hence, the constructed slope was suggested to be redesign to improve its safety factor.

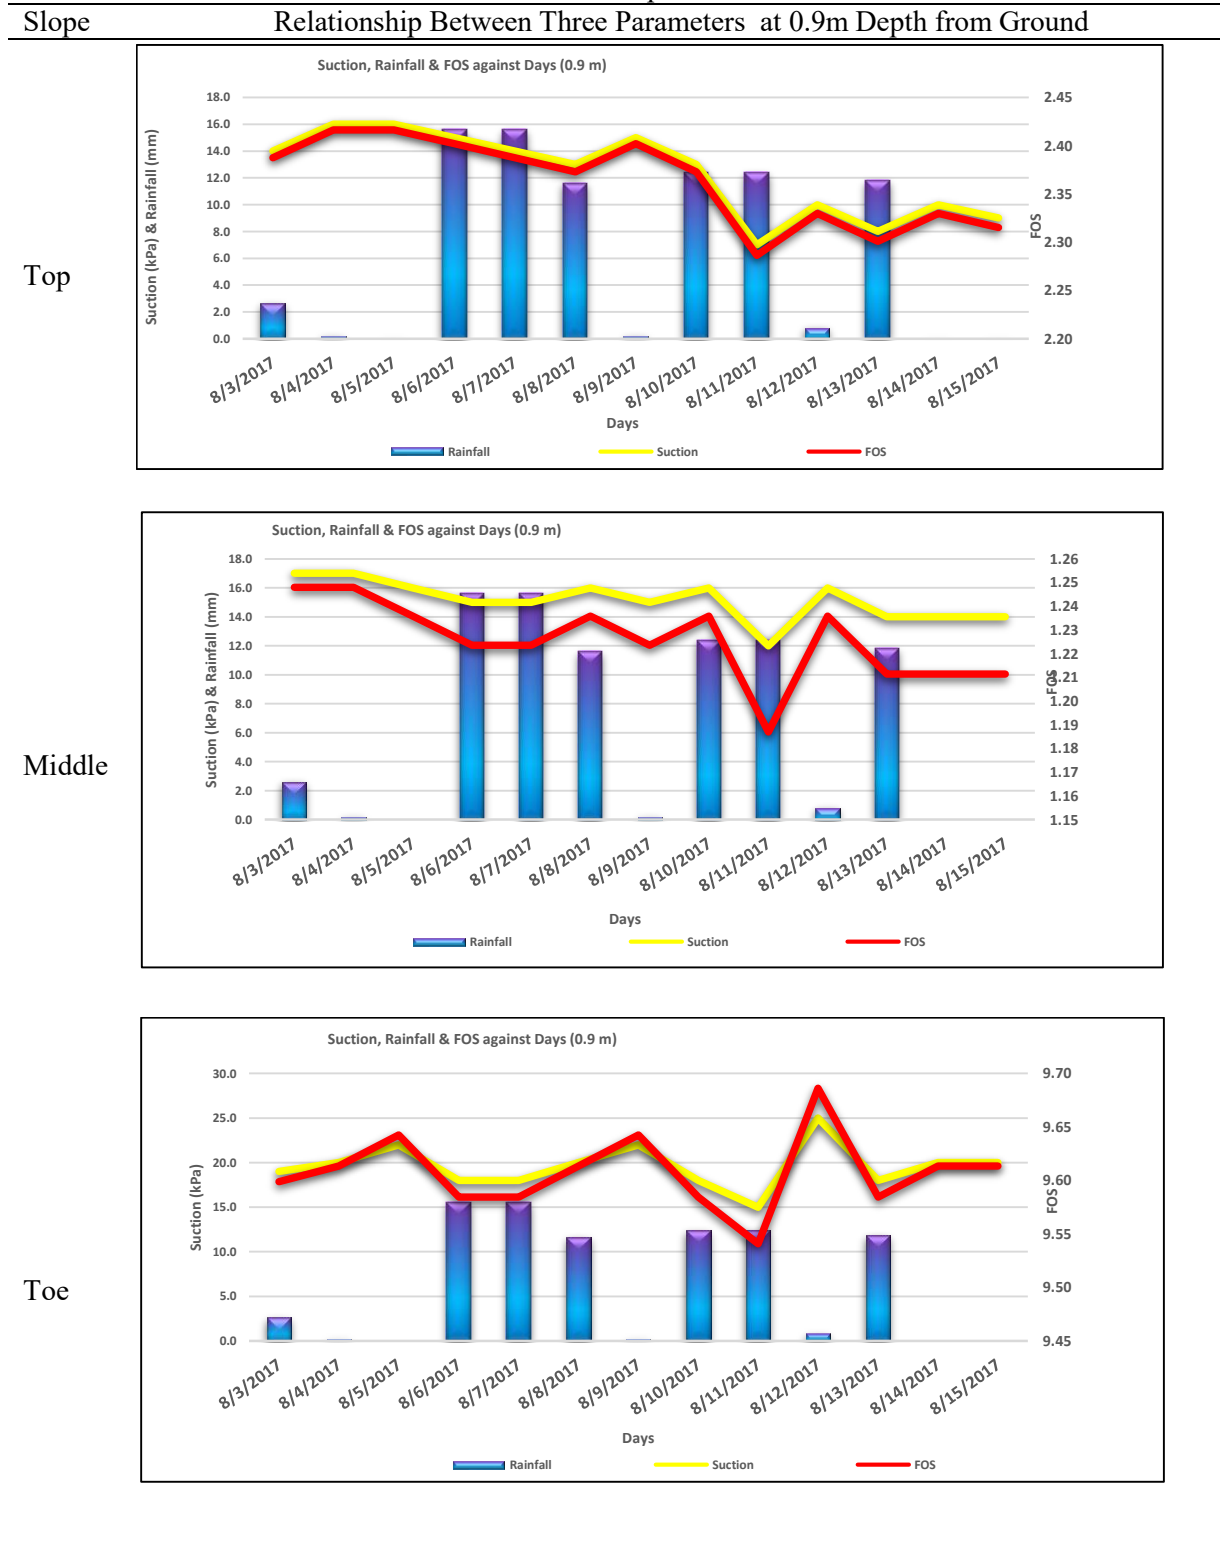
Table 7. Relationship between factor of safety, suction and rainfall at three different location with 0.9m depth

It was found that the trend line for suction and FOS at toe of slope is most critical compared to FOS at middle and top of slope shown in Table 7. The trend line for suction and FOS in these three graphs are having same extent. On 11th August, the volume of the rainfall is same as 10th August for three locations and the FOS and Suction had dropped gradually. While on 12th August, value of FOS and suction at toe of slope had rose rapidly compared to FOS and suction at middle and top of slope. Different location and depth of soil had different suction and FOS due to infiltrate of rainwater with different type of soil and groundwater. In conclusion, the rainfall had influenced the changes of suction and FOS. The suction of soil and FOS are interrelated affect each other.
