A POST-OCCUPANCY EVALUATION OF WAYFINDING IN A PEDIATRIC HOSPITAL: RESEARCH FINDINGS AND IMPLICATIONS FOR INSTRUCTION

Barbara Brown
Holly Wright
Craig Brown

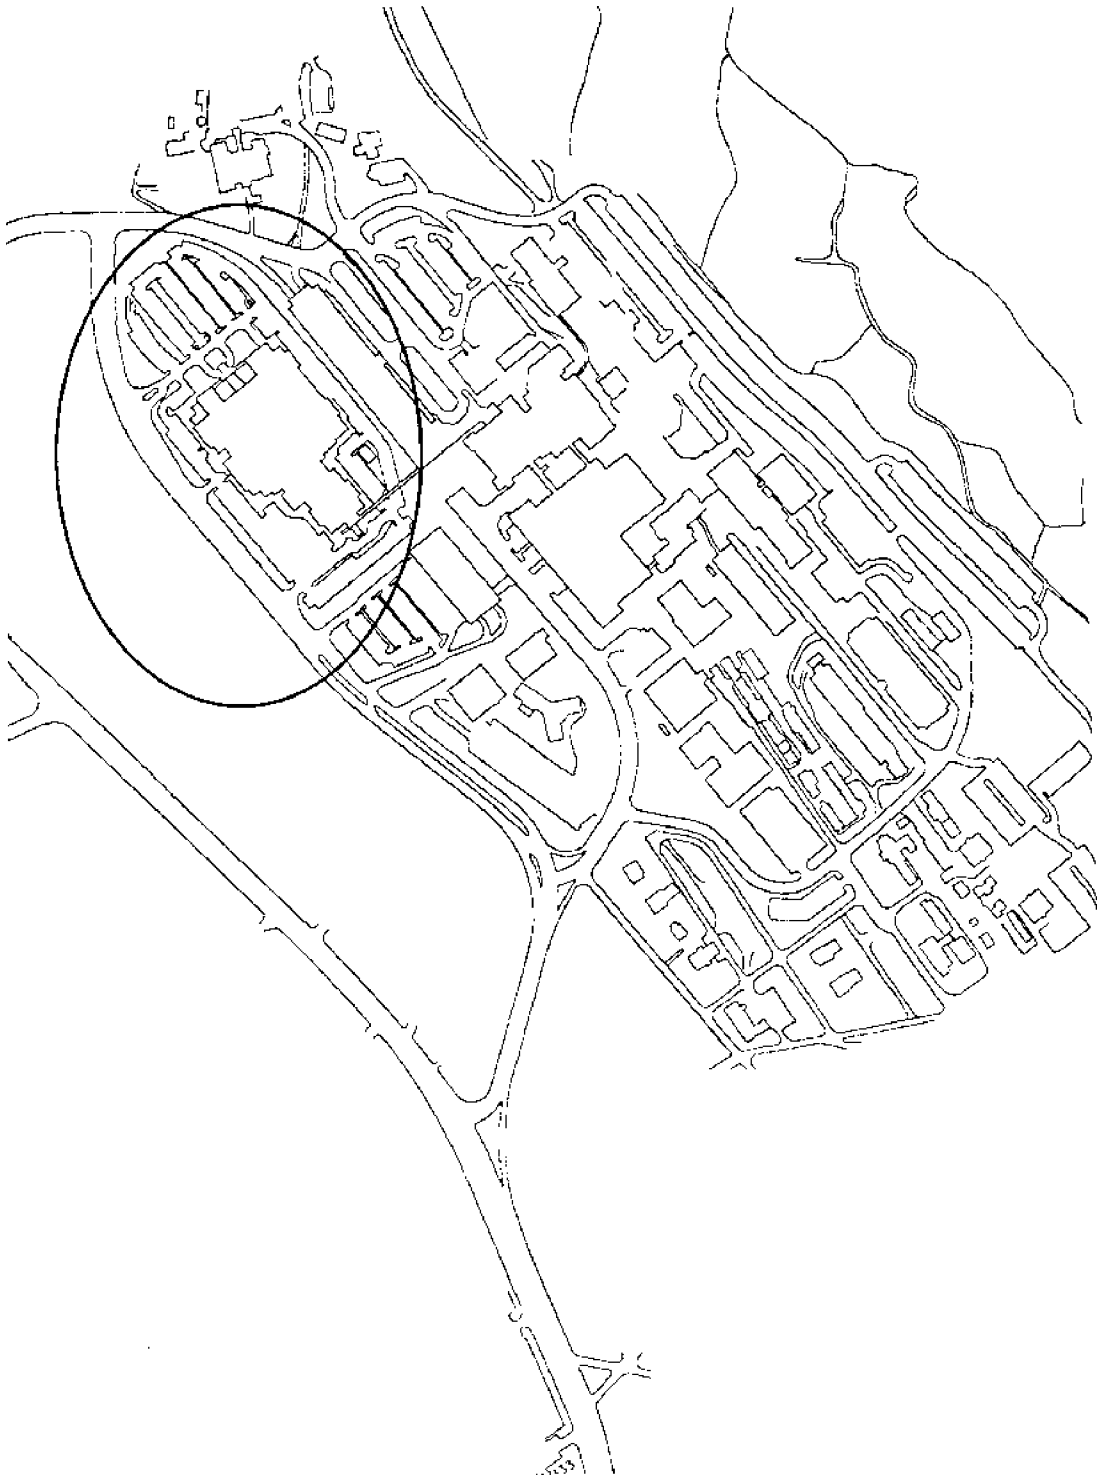
FIGURE 1. Hospital site.

In contrast, management and the research team agreed that the exterior was likely to prove more confusing. The pediatric hospital was adjacent to a larger research and teaching hospital that sprawled to the south and east of the new facility (see Figure 1). Drivers approaching from the south had to pass the larger adjacent facility and a large number of directional signs; drivers approaching from the north had to pass directional signs indicating both facilities. Consequently, the information processing demands and therefore potential for confusion outside the facility was high.

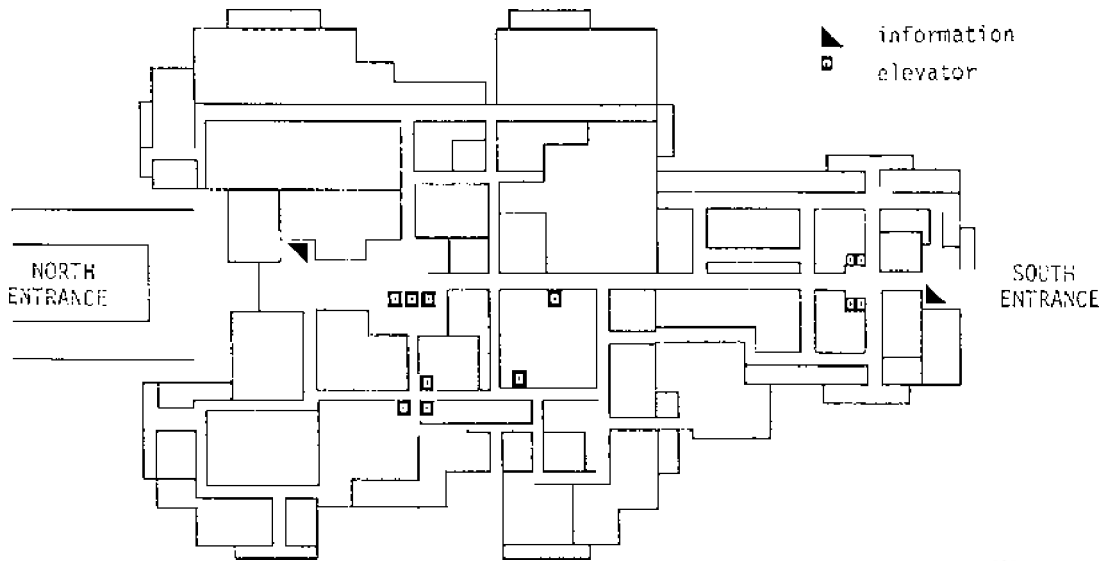
FIGURE 2. Level 1 plan.

Finding the right elevator: It was also apparent that the outpatient (south) wing and inpatient (north) wing look more distinctive when viewed in plan in Figure 2 than when experienced on a walk into the facility. Once inside, a visitor would see the outpatient area blending into the inpatient area. The view down the central corridor shows one long hall with no visible distinctions between outpatient and inpatient ends. The boundaries between the two areas are not marked by thresholds or any differentiation in color, lighting, surfaces, or textures.

The lack of distinction in the appearance of outpatient and inpatient ends of the hospital on level 1 can mislead visitors into choosing the wrong elevator. Although 86% of visitors said the elevators were easy to find, it was not clear to visitors that elevators gave access to a limited number of destinations. If a visitor enters the hospital from the inpatient (north) side for an appointment with an outpatient (south) clinic on levels 2 or 3, the north elevators will be encountered first. A glance at the layout would suggest to the visitor that the hospital is organized around a long central corridor, making the choice of the north elevator an appropriate one for all destinations above level 1. But if visitors ride the north elevator up for outpatient appointments on levels 2 or 3, they will find that the central corridor terminates only halfway to the south end. Visitors must then return to level 1 and walk to the south elevator, which does access outpatient areas on levels 2 and 3. Finally, additional difficulties are noted in staff comments in Table 2.

New north elevator sign: "To Inpatient Areas. For Outpatient Doctor Visits, use South Elevators."

New south elevator sign: "To Outpatient Areas. For Inpatient Areas, use North Elevators."

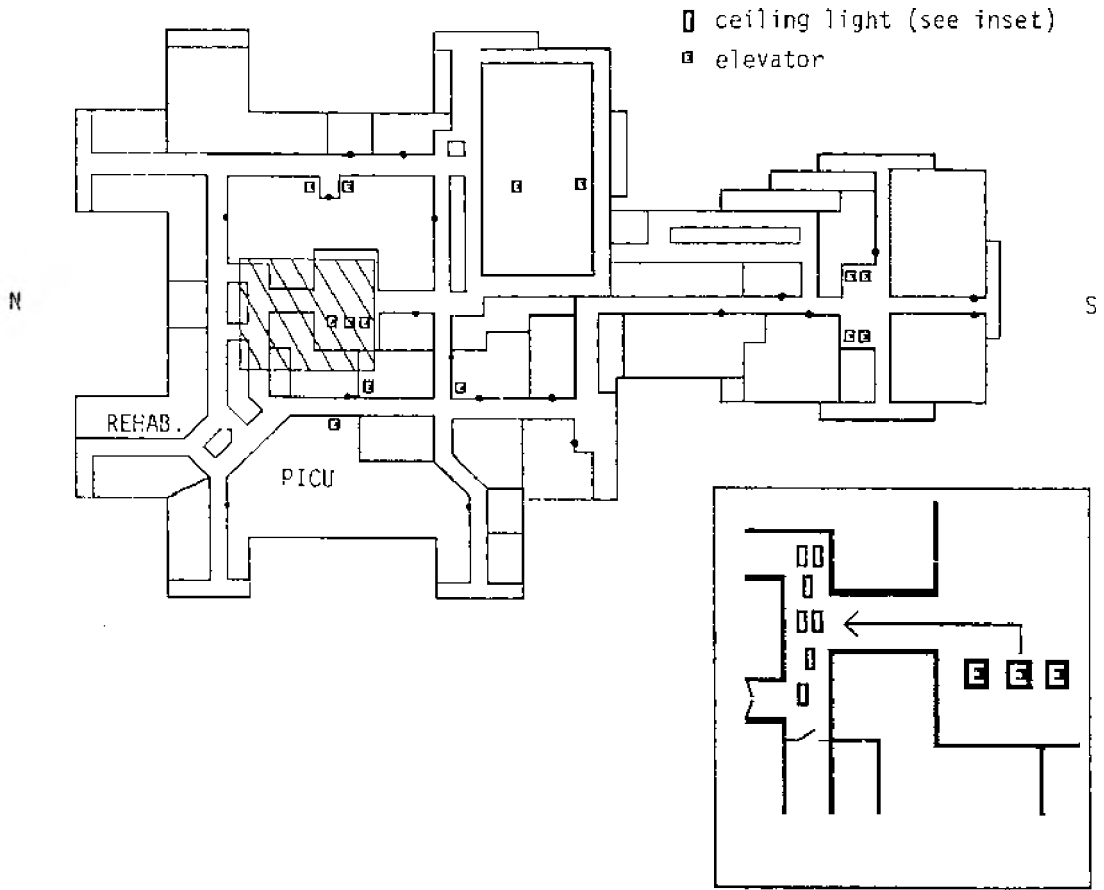
FIGURE 3. Level 2 plan.

The PICU (Pediatric Intensive Care Unit) was the most difficult area for visitors to locate, generating 223 requests for assistance. The PICU waiting room elicited 37 additional requests for directions. Recall that a visitor's initial glance at the floor layout from the lobbies on level 1 suggests a simple, central, double-loaded corridor, with all halls crossing at right angles. But on levels 2 and 3, the floor layout on the north end changes radically, with many diagonal halls radiating from decentralized nurse stations. Previous research emphasized that simple floor layouts provide easiest wayfinding (Weisman, 1981) and that navigational choice points require signs or other wayfinding aids (Carpman *et al.*, 1986). The angled halls on levels 2 and 3 north are not long, but they are not simple and they present visitors with many choice points.

A good example involves the first left turn required of visitors walking north from the north elevators toward PICU (see inset detail in Figure 3). First, it is important to consider the state of mind of visitors

tion (i.e., in front of the arrow on the Figure 3 inset), seeking additional reassurance that a left turn is indicated, sees a large sign to the left of the door leading to PICU, but the lettering is small, too small to read given the distance, the colors, and the lighting. Finally, elements of lighting and size suggest that the correct door to PICU is not a major entrance. The door to PICU is single, poorly lit, and the ceiling is dropped a few inches in front of the door, contributing to the appearance of a small narrow entryway. In contrast, visitors often make a wrong turn into the Rehabilitation unit, which does look like a main entrance; specifically, this entrance has double doors, with a large sign with large letters (larger than the letters on the PICU sign), and a ceiling light panel illuminating the area right in front of the entrance. Lighting placement and amount both seem to be critical cues. If a visitor is deciding whether to turn left

at the intersection, a glance to the right shows a hall of about 8 paces illuminated with 3 light panels; a glance to the left shows a hall of about 11 paces illuminated with 2 light panels. One staff member commented, "People don't walk down dim hallways." Consequently, many visitors go through the Rehabilitation entrance where they require additional guidance to locate PICU, which explains the numerous signs erected by the Rehabilitation staff. This extended example illustrates how important the entire wayfinding system is to the diagnosis and remediation of wayfinding problems. It is quite possible that the unusual floor layout could have been easier to negotiate if a variety of cues could be used to draw visitors to the entrance.

Use color, lighting, and signs to distinguish PICU from rehabilitation areas, areas easily confused because they are not separated by barriers.

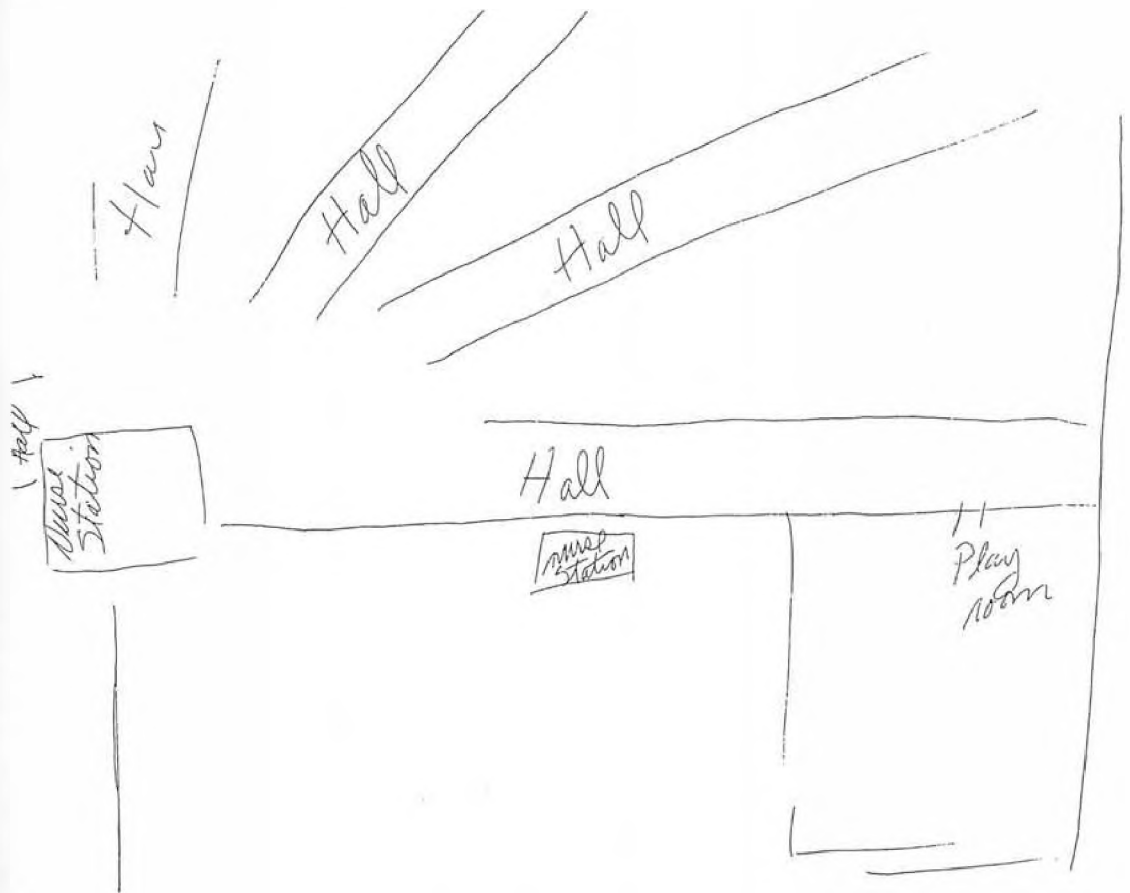
FIGURE 4. Level 3 plan.

By examining the plans for levels 2 and 3, it is apparent that problems discussed above regarding the location of PICU are also present for the toddler and school age units on level 3. For example, Figure 4 shows six different hallways converging at the nurses' stations on level 3, north end.

Because the nursing stations are landmarks for patients and families, adopt a color scheme that helps with way-finding. Scattered stations had the same color scheme, making it difficult to distinguish them. Other stations, though with different colors, had such a mixture of colors it was difficult to use them as wayfinding aids.

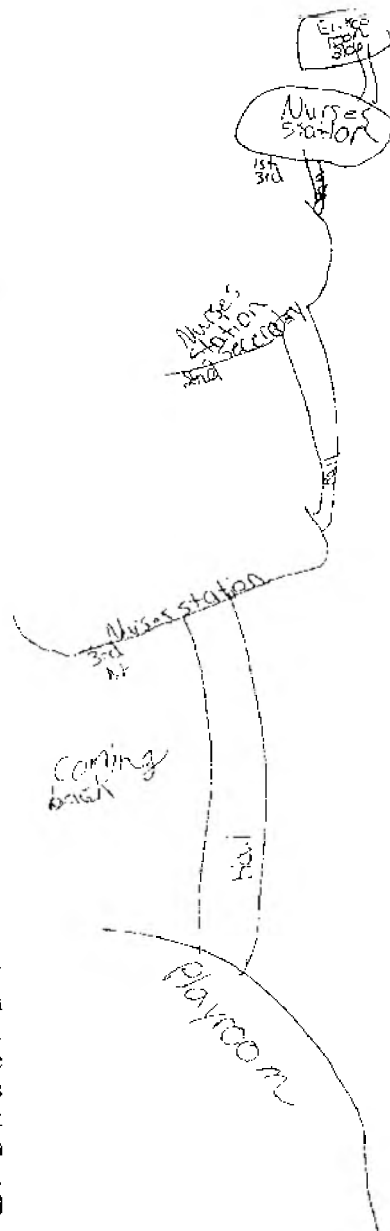
FIGURE 6. Cognitive map showing confusion and inaccuracy in pathways.

hallways, the halls are not connected to each other and the area is not related coherently to the rest of the hospital. Figures 6 and 7 are maps drawn by 12- and 10-year-old patients, respectively, who frequently used the Child Life room. The 12-year-old concentrated on the details of the accurate pathway, but drew confused and inaccurate pathways converging to the nurses' station. The 10-year-old patient also chose to emphasize the correct pathway and linked the nurses' stations as nodes or landmarks, simply ignoring all the other hallways. Although the mapping strategies work for these users, it is clear that the spatial plan of the floor does not facilitate wayfinding. It also reveals how important the nurses' stations are to the landmark-oriented wayfinder.
