Preliminary Report on the 22 December 2003, M 6.5 San Simeon, California Earthquake

Jeanne L. Hardebeck[1], John Boatwright[1], Douglas Dreger[2], Rakesh Goel[3], Vladimir Graizer[4], Kenneth Hudnut[5], Chen Ji[6], Lucile Jones[5], John Langbein[1], Jian Lin[7], Evelyn Roeloffs[8], Robert Simpson[1], Keith Stark[5], Ross Stein[1], and John C. Tinsley[1]

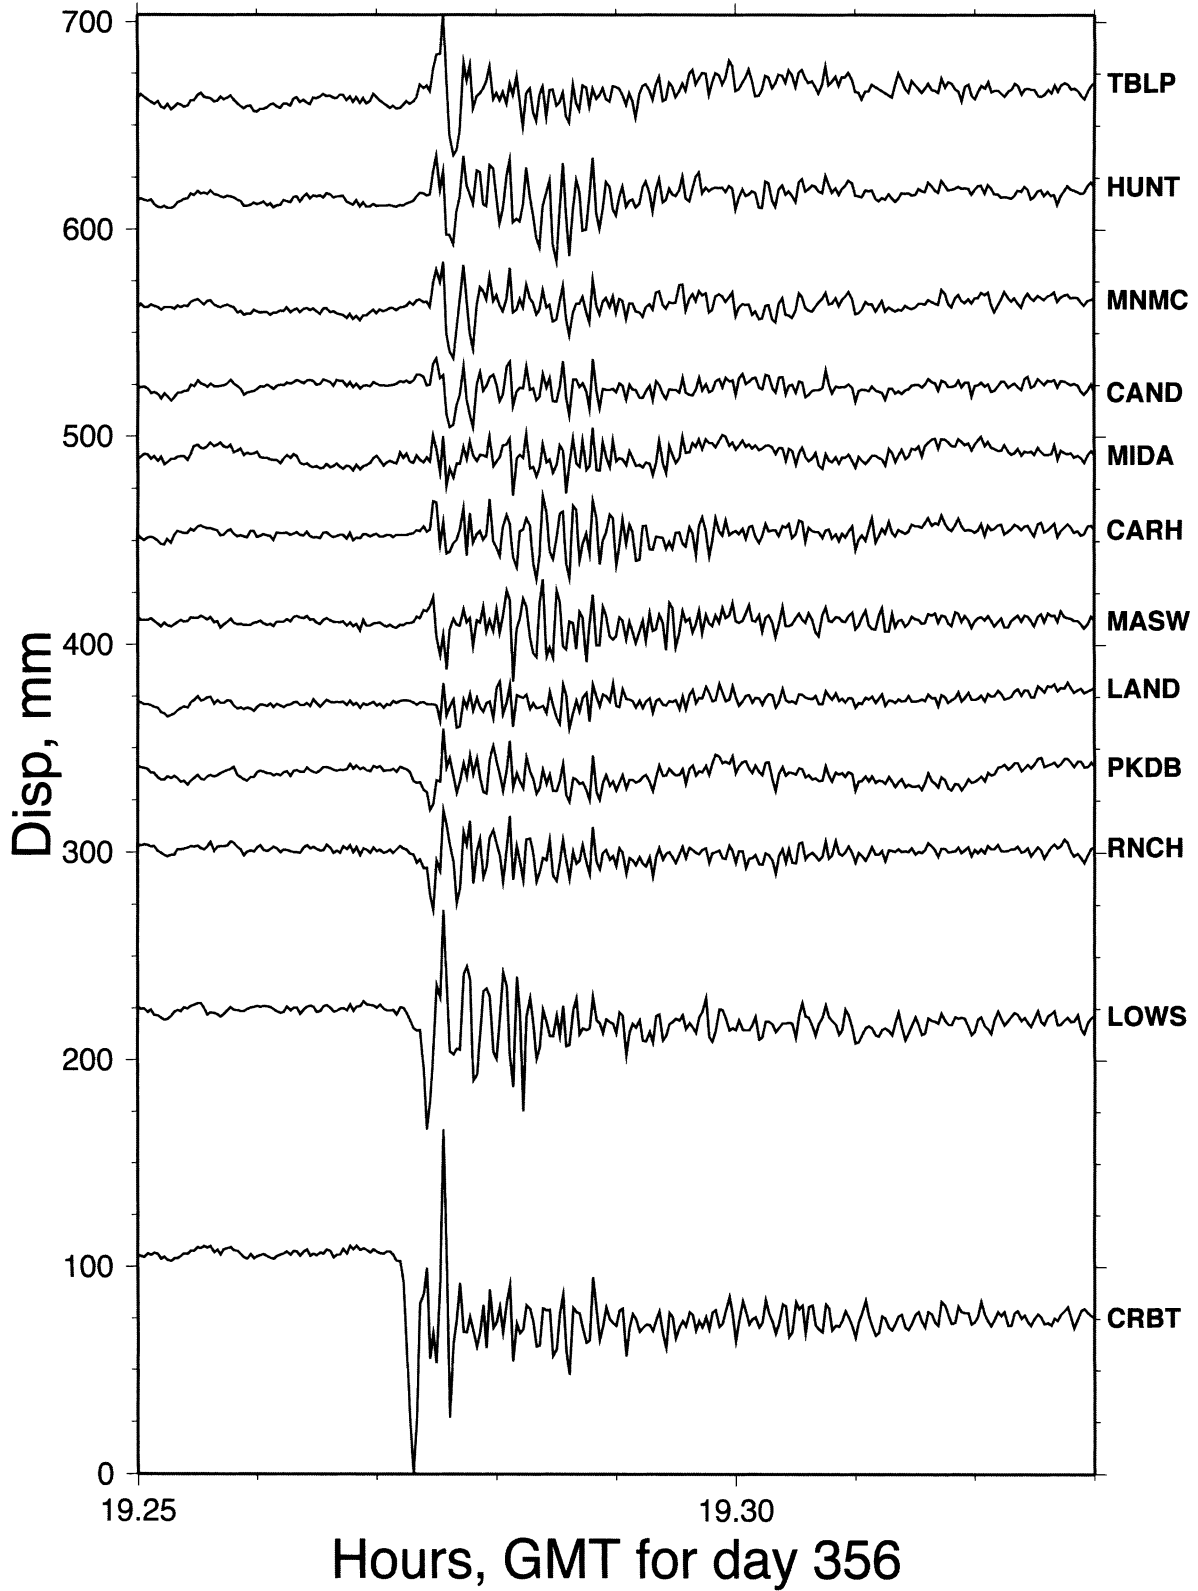
▲ **Figure 8.** The San Simeon mainshock recorded at the GPS network at Parkfield, recording at 1 Hz.

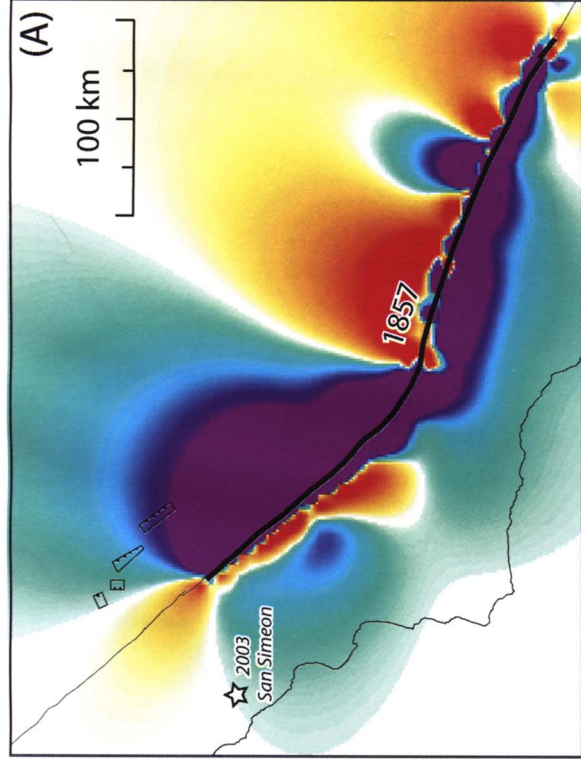
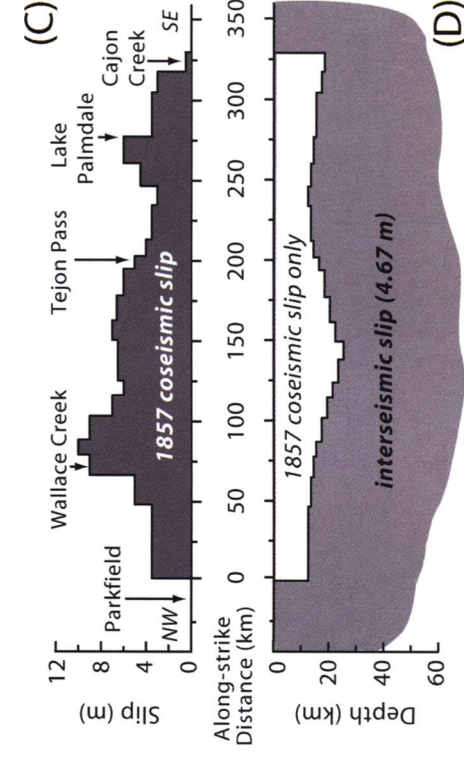
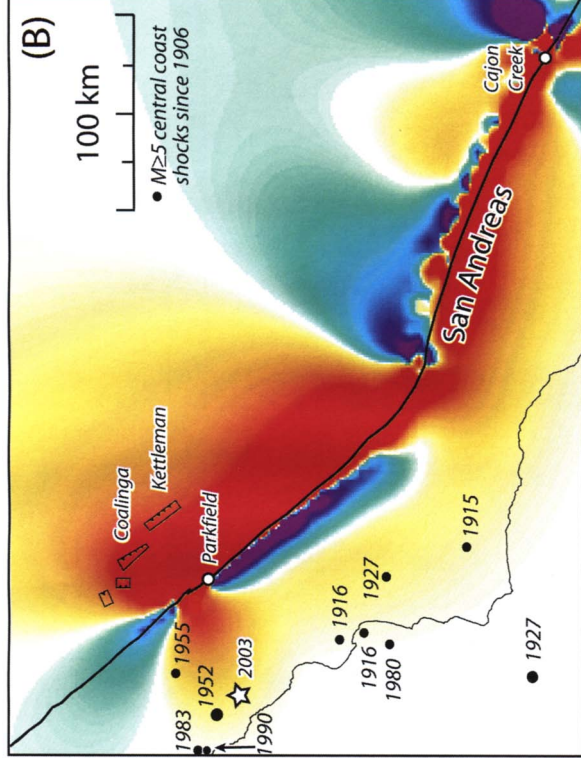
▲ Figure 11. Coulomb stress imparted to the likely San Simeon earthquake rupture surface by San Andreas Fault slip, modified from Lin and Stein (2004). (A) Coseismic stress transferred by the 1857 M_w 7.9 Fort Tejon earthquake, resolved onto the 22 December 2003 M_W 6.5 San Simeon rupture plane (NEIC solution; strike 297°, dip 56°, rake 97°). The 1857 coseismic slip model is shown in (C). (B) Interseismic stress accumulation during 1857–2003 using the elastic-half-space model shown in (D). Black dots show M ≥ 5 earthquakes that have occurred in the central coast area since 1906, from McLaren and Savage (2001), many with focal mechanisms similar to the 2003 quake. (C) Slip model for the 1857 earthquake from Sieh (1978), as modified by subsequent work (Weldon and Sieh, 1985; Salyards *et al.*, 1992; Grant and Sieh, 1993; Grant and Donnellan, 1994). The assumed depth of 1857 faulting is shown in (D), based on the lower depth of current seismicity from Hill (1990). The San Andreas is assumed to be vertical and right-lateral. (D) Interseismic stressing model for the 146-year period between the 1857 Fort Tejon and the 2003 San Simeon events, in which the San Andreas slips at the long-term rate of 3.2 mm/yr everywhere except in the 1857 rupture zone.

▲ **Figure 12.** Static stress changes due to the San Simeon earthquake. The rupture model is 20 km long, 15 km wide, and dipping 56°E, with rake 97°. The northern edge of the plane is aligned with the hypocenter. *Top:* Coulomb stress change ΔCFF on planes striking N40W, dipping 90°, approximately parallel to the SAF in the Parkfield region. Red: Right-lateral strike-slip is encouraged; blue, right-lateral strike-slip is discouraged. *Bottom:* Dilatational component of strain. Red: expansion; blue, contraction.

▲ Figure 13. USGS Parkfield 10-minute dilatometer data. Each record contains one or two points that were sampled during the passage of seismic waves with large dynamic strains; these points are left in. Raw data are shown as a light line, and data with atmospheric pressure and tides removed are shown as a heavier line. Contraction is positive. Times are UT. Station locations shown in Figure 12.

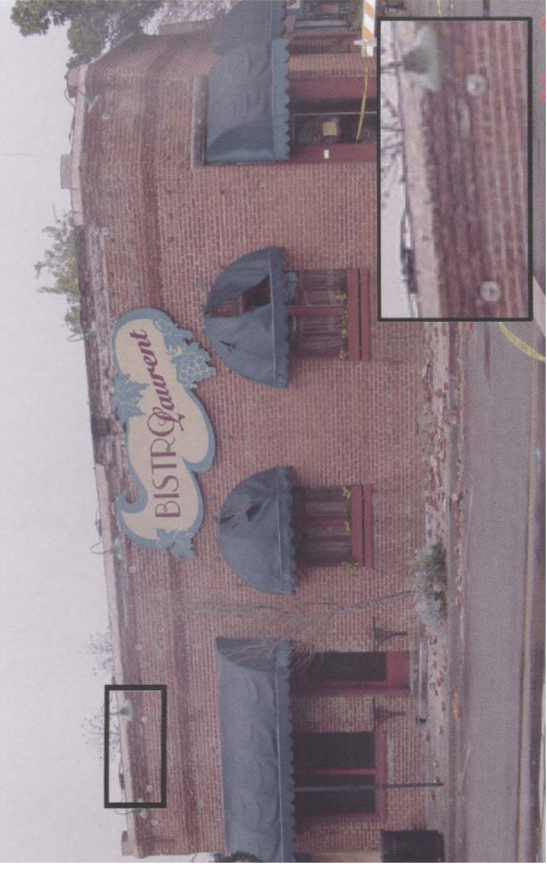
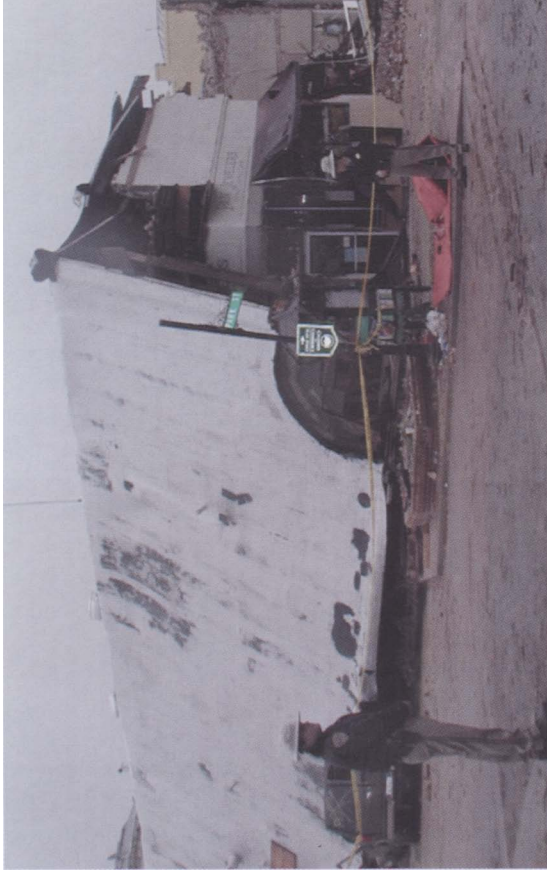
Most buildings in the downtown Paso Robles business district area are very old, some built more than a century ago, constructed of unreinforced masonry (URM). This type of construction is known to be especially vulnerable to earthquakes, and it is not surprising that such buildings suffered extensive damage during the San Simeon earthquake. Most of these buildings were not designed for seismic loads and lacked proper seismic load transfer path. One such building (Acorn building, Figure 14) collapsed, killing two people.

URM buildings that had been seismically retrofitted (Bistro Laurent Building, Figure 14) in general performed much better compared to those that had not been retrofitted; none of the retrofitted buildings collapsed. The basic seismic retrofit scheme included tying the floor diaphragm to the walls (see the bolts in the insert in Figure 14).

URM buildings (even without seismic retrofit) located midblock did not suffer catastrophic failure such as that of the Acorn building, which was located at the end of a block. Most buildings in the affected area are constructed without any gaps between them. It seems that adjacent buildings provided confinement to each other and prevented collapse, except to those buildings sited on the corners. In general, URM parapets and facades were damaged due to out-of-plane motion of both midblock buildings and corner buildings (Ali's Persian Rug building, Figure 14), imposing hazard to adjacent buildings and pedestrians.

▲ **Figure 14.** *Upper left:* Collapsed Acorn building on the corner of 12th and Park Streets in downtown Paso Robles (photo by Rakesh Goel). *Upper right:* Bistro Laurent building with seismic retrofit survived the earthquake; inset shows bolts from retrofit (photo by Rakesh Goel and Khalid M. Mosalam). *Lower left:* Facade damage of Ali's Persian Rug building at the corner of Park and 13th Streets (photo by Khalid M. Mosalam). *Lower right:* Collapsed wine barrel stacks at Turley Wine Cellars, Highway 46 West, Paso Robles (photo by Josh Marrow).

The most significant implication of this event is societal: the importance of retrofitting buildings in earthquake-prone areas. The relatively few lives lost in the San Simeon earthquake can be compared to the more than 30,000 casualties just four days later in the 26 December 2003 M 6.6 Bam earthquake in Iran, mostly due to the collapse of unreinforced masonry buildings. Part of the difference is that the strongest shaking from the San Simeon earthquake probably occurred in the sparsely populated epicentral region, while the fault in the Bam earthquake ran directly through a sizable city. California was also more prepared: Some potentially hazardous buildings in Paso Robles had been retrofitted and performed well in the earthquake. However, there are still many unreinforced masonry buildings in California cities. The tragedies in Paso Robles and in Bam emphasize the importance of retrofitting unreinforced masonry buildings before another earthquake strikes. ▨
