Localization of Off-Stress-Induced Damage in AlGaN/GaN High Electron Mobility Transistors by Means of Low Frequency 1/f Noise measurements

Marco Silvestri[1,a], Michael J. Uren[1], Nicole Killat[1], Denis Marcon[2], and Martin Kuball[1]

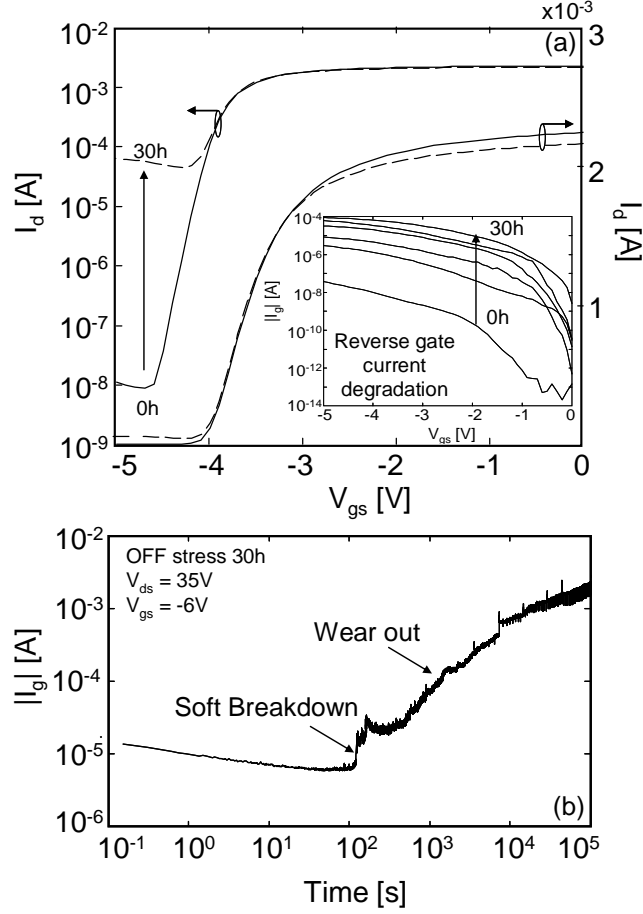
Figure 1(a) shows the I_d-V_{gs} characteristic before and after 30 hours of OFF stress in the linear regime V_{ds}= 50 mV, with the inset illustrating the degradation of the reverse gate current and figure 1(b) the evolution of the gate leakage at fixed stress bias. Initial degradation (soft-breakdown - SBD) is apparent as a first jump in the leakage current (figure 1(b)) followed by a wear-out phase that correlates with the increase, up to three orders of magnitude, of the reverse gate current as shown in the inset of figure 1(a). In agreement with other authors[5,7,14], the degradation is apparent in the emergence of a large gate leakage current while other device parameters, such as threshold voltage V_T, drain current I_d, and on-resistance R_{on}, were affected by OFF stress by less than 10%.

FIG. 1. (a) DC drain current (V_{ds}= 50 mV) in linear and logarithmic scale and reverse gate current degradation (inset) as function of the gate voltage before and after OFF-state stress; (b) gate leakage current as function of the stress time.

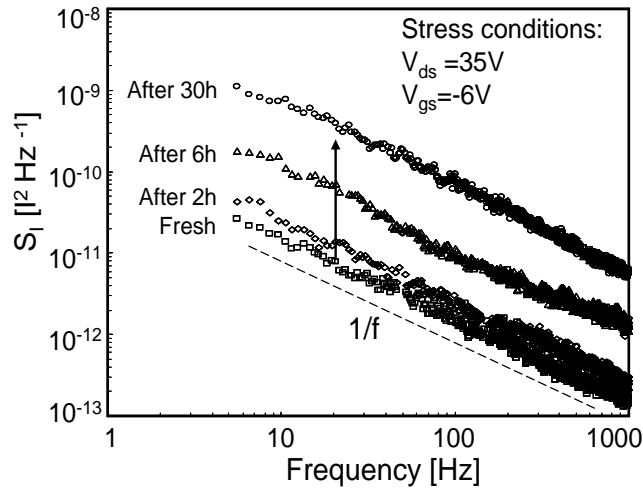
The low frequency spectral noise current density S_I is shown in figure 2 for V_G=V_{gs}-V_T = 0.1V, indicating a progressive increase by up to two orders of magnitude with stress time.

FIG. 2. Low frequency 1/f channel noise current spectral density in OFF stressed AlGaN/GaN HEMT for V_{gs}-V_T ~ 0.1V.

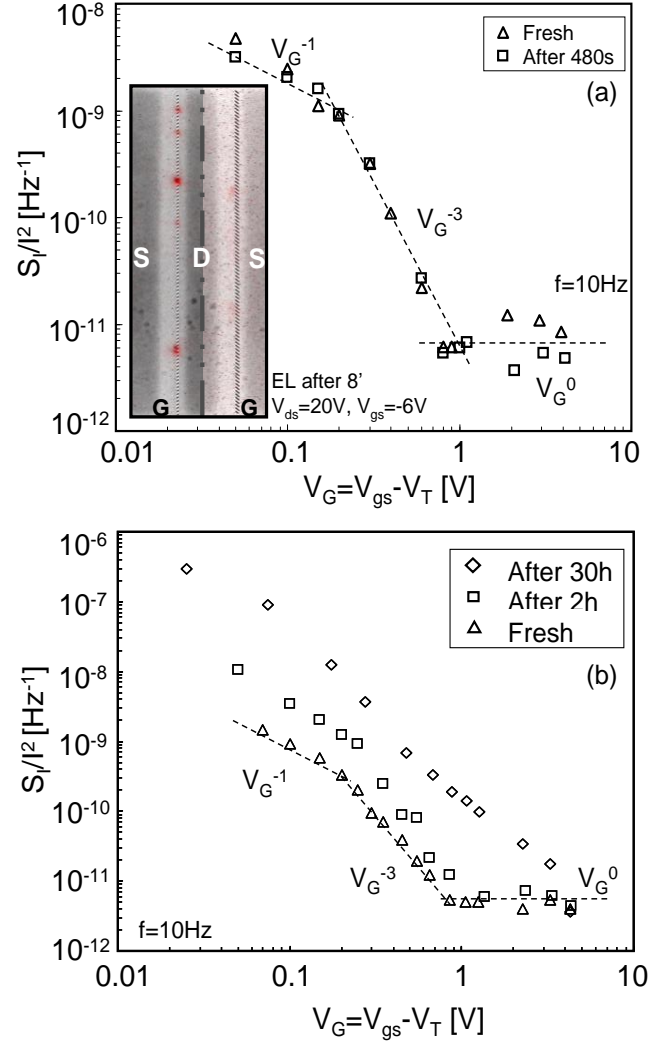
Figure 3 depicts the change of the normalized current spectral density noise S_I/I^2 versus the effective gate voltage V_G before and during OFF-state stress. Immediately after the onset of the SBD, no increase in channel noise, neither in the gated nor ungated part, was apparent, even after several EL spots emerged, as demonstrated in figure 3(a) and its inset, respectively. It is worth noting that EL spots were recorded neither in fresh devices nor in the gate-drain access regions. SBD-related hot spots located at the gate edge and the relative gate leakage current increase (figure 1) therefore appears to be independent of the channel noise. At longer times after the SBD event, i.e., during the subsequent device stress in the wear-out phase, S_I/I^2 increased only in the V_G^{-1} and V_G^{-3} regions as shown in figure 3(b) after 2 hours of stress. Hence, the increase of the stress-related defect density underneath the metal gate, possibly where the electric field peaks, led to the noise increase only in the $S_{I,G}$ region. However, subsequently, after 30 hours, S_I/I^2 increased also in the V_G^{0} part of the characteristic reported in figure 3(b), i.e., the ungated portions of the channel. Not only was there an associated increased number of EL spots at the gate edge, but the changes in noise spectrum were characterized by defects possibly generated over an extended portion of the channel, in the gate-drain access region, perhaps associated with the additional electric field peaks at the T-gate corner field-plate edge.[17]

FIG. 3. Gate voltage dependence of the normalized current spectral noise density S_I/I^2 at 10 Hz: (a) Before stress and immediately after the SBD with the corresponding EL image in the inset; no hot-spots were recorded in fresh devices. (b) Before stress and after 2h and 30h of OFF-state stress.

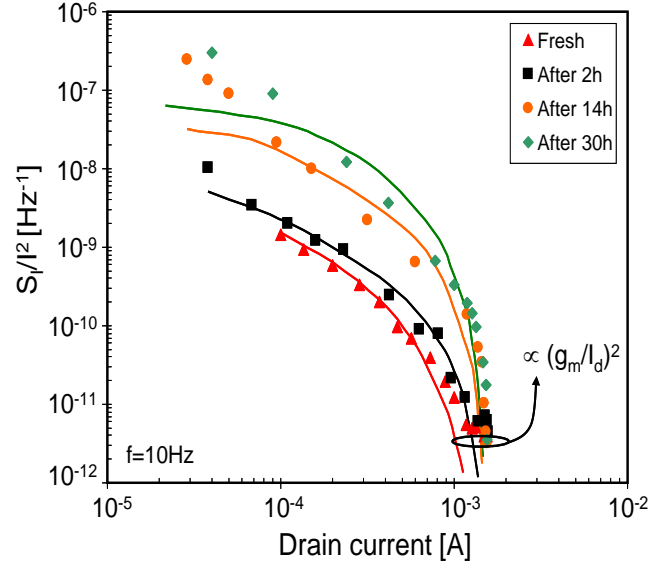
In order to model the measured channel noise, the normalized current spectral density S_I/I^2 taken at 10 Hz was plotted in figure 4 versus the drain current as a function of the stress. Good correlation with the $S_{VFB}(g_m/I_d)^2$ characteristics was found, where S_{VFB} as input-referred spectral noise density was adjusted here to achieve a good fit to the data, and g_m/I_d extracted from the measured characteristics during stress. This indicates that the channel noise can be modeled by the carrier number fluctuation model based on trapping and de-trapping of charge in defects close to the channel interface.[18] Assuming the defects were located in the AlGaN

where $\lambda = 0.5$ nm is a tunneling parameter, here corrected for the AlGaN/GaN conduction band alignment, W and L are the gate width and length, respectively, and C_b is the AlGaN barrier capacitance. From equation (1), N_{ot} resulted, before stress, after 2 hours, and after 30 hours of OFF stress about 2×10^{16} eV^{-1}cm^{-3}, 1×10^{18} eV^{-1}cm^{-3}, and 2×10^{19} eV^{-1}cm^{-3}, respectively. This model assumes a uniform generation of defects in area, depth, and energy in the AlGaN barrier underneath the gate and must be considered as an upper bound value. In fact, it is likely that defects were mostly generated in a narrower barrier region close to the gate edge where the electric field peaks. This assumption can work for short channel transistors, where the ratio between the damaged area at the edge and the rest of gate area is close to 1, but definitely breaks down in long channel devices, where the ratio is $\ll 1$. It is possible that these stress-induced traps are linked to the gate SBD, with gate leakage occurring by percolative transport through defects. This is in reasonable agreement with Ref. 20, where the gate leakage current random telegraph signal fluctuations through the AlGaN barrier were explained in terms of modulation of leakage paths in the AlGaN barrier by the generation of other percolative paths and single active traps[20] during OFF stress.

FIG. 4. Normalized current spectral noise density S_I/I^2 at 10Hz as function of the drain current during OFF-state stress. Data follow the $S_{VFB}(g_m/I_d)^2$ characteristic (solid lines).
