Case Study

Analysis of Structural Health Monitoring Data from Hammersmith Flyover

G. T. Webb[1]; P. J. Vardanega, Ph.D., M.ASCE[2]; P. R. A. Fidler[3]; and C. R. Middleton, Ph.D., C.Eng.[4]

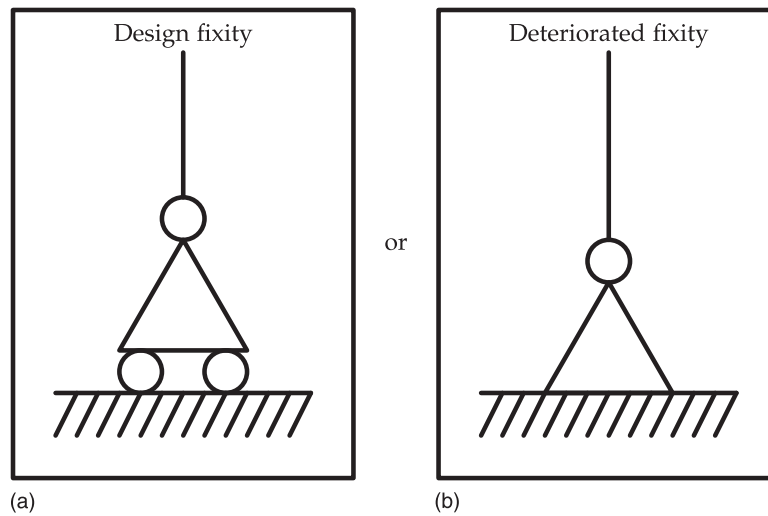
whether deterioration was resulting in a restraint against expansion as symbolized in the schematic in Fig. 4. Thermal movement is accommodated by roller bearings at the base of each pier. Restraint in the bearings due to corrosion would induce additional bending moments in the piers and deck, potentially causing an opening of the joints between segments and exacerbating the stress levels in the corroded prestressing tendons.

Fig. 4. (a) Symbolic representation of fixity of bridge roller bearing as designed and (b) possible actual operational fixity in the deteriorated state

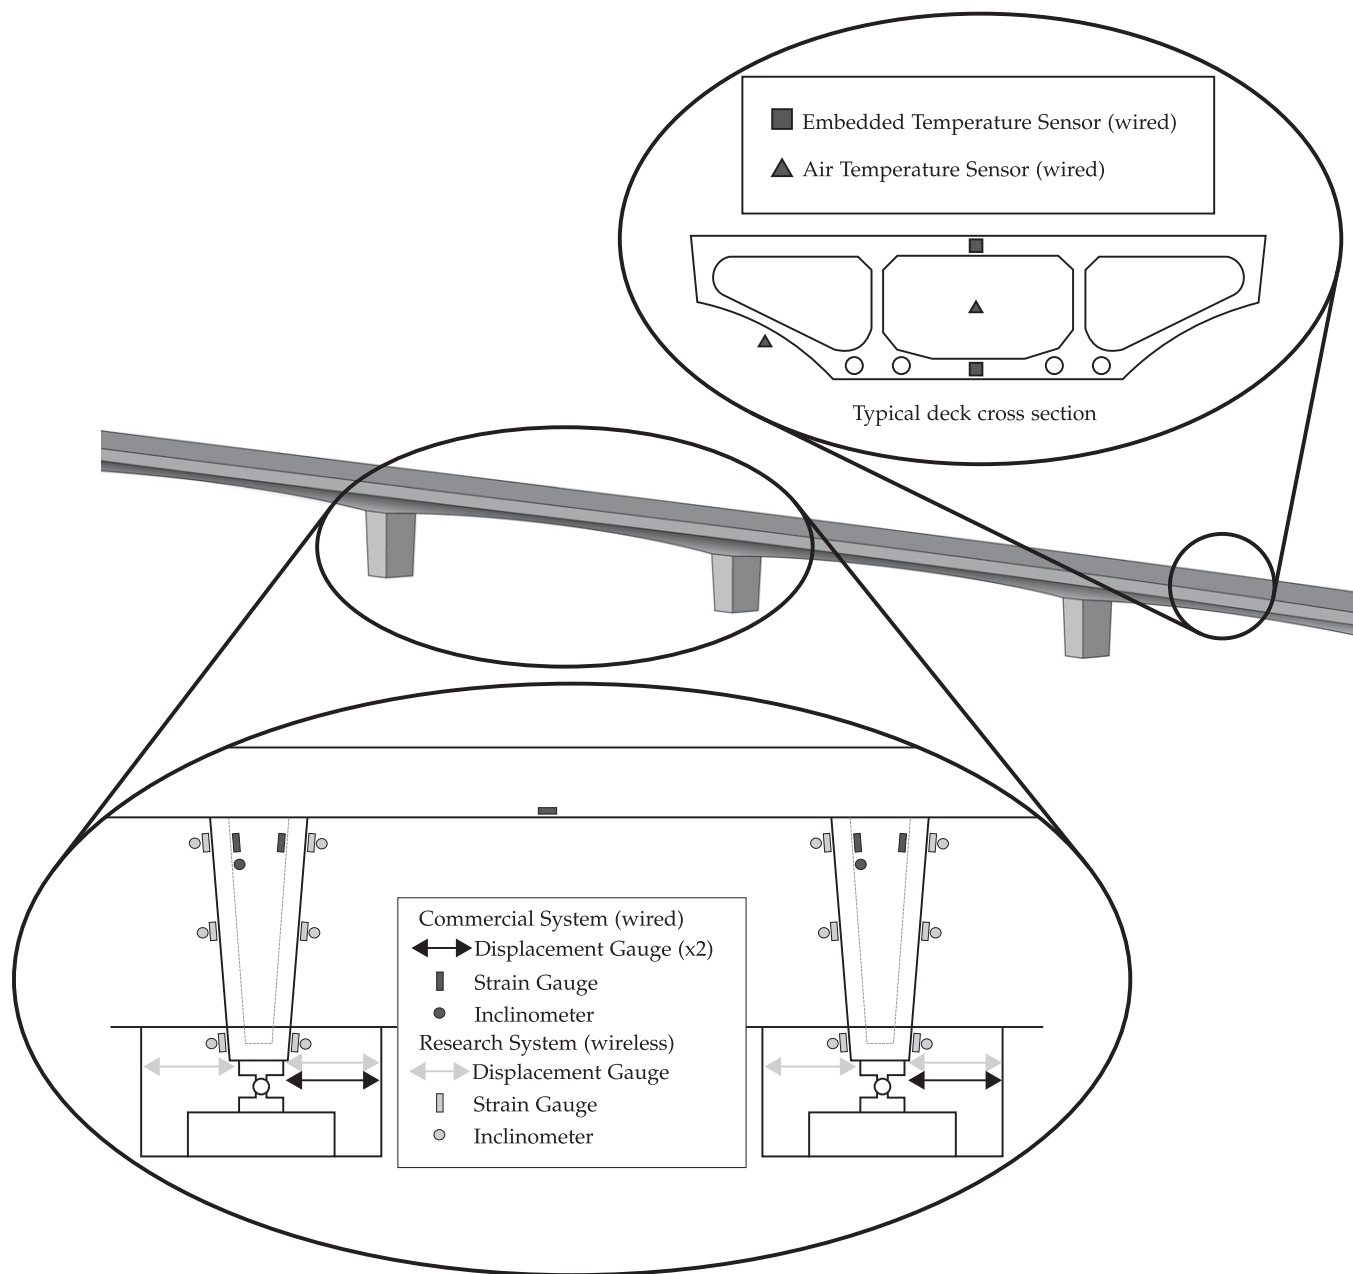
Fig. 5. Representative locations of metrology devices on Hammersmith Flyover

Each pier has gauges measuring vertical strain on the concrete surfaces of both the eastern and western pier walls (Fig. 5). These should allow the combined effect of both axial and bending strains to be observed. If the roller bearings function correctly and allow unrestrained longitudinal movement of the pier bases, the piers should rotate rather than bend. Consequently, there should only be variations in axial strains caused by temperature and traffic live loading. Therefore, the strain gauges on the eastern and western sides of each pier should give similar readings. The monitoring system records temperatures in a variety of locations, allowing the strains due to temperature to be calculated. Temperature data from the bridge deck show a yearly range of approximately 25°C. In addition, there is a daily variation. In the top surface of the bridge deck, the daily range was found to be 10°C, whereas sensors in other locations gave a smaller daily range of approximately 2°C. The larger range of temperature observed in the top slab will be due in part to insolation and the black surfacing absorbing and radiating heat more rapidly than other surfaces.

Both the Commercial and Research monitoring systems measure longitudinal displacements at the bases of the piers (Fig. 5). The actual overall loading applied to the bridge at any time is not quantifiable because the live load cannot be measured. However, the

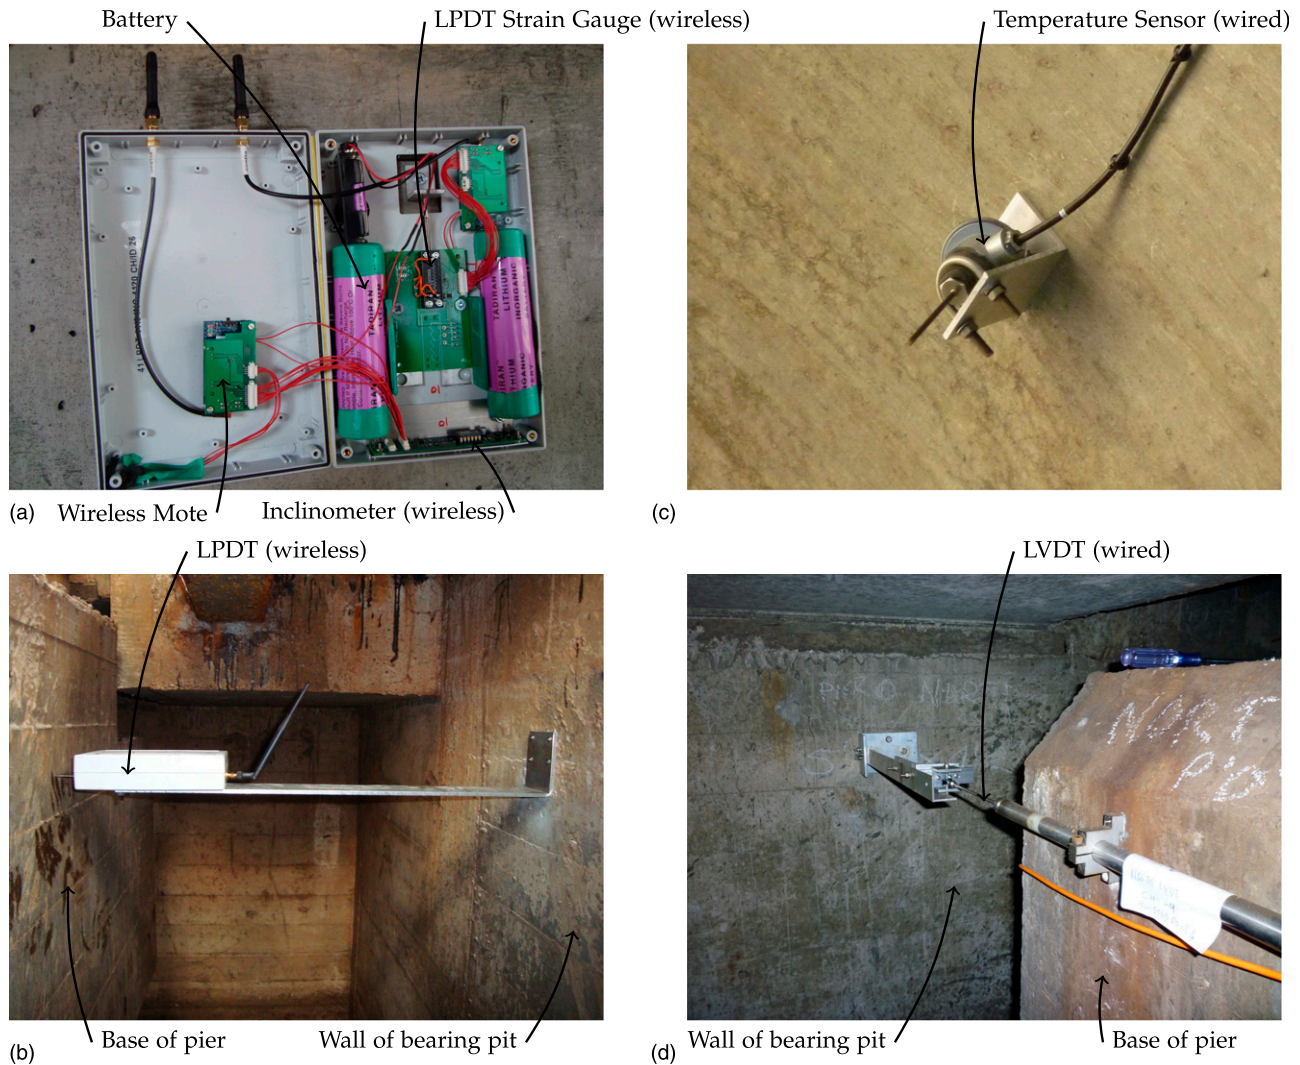
LPDT Displacement Sensors
A hardware circuit fault was identified in the LPDT sensor boards after installation. The actual board layout design used did not match the intended schematic. These boards had been designed very shortly before the field deployment and, as a result of time constraints, were installed without adequate calibration and testing, which would have revealed the fault. Eventually new circuit boards were designed and manufactured by the lead author and were installed in March 2012, replacing the faulty boards.

Fig. 6. Some sensors used in the monitoring study; photos taken on (a) August 26, 2009 (image courtesy of Dr. Peter Bennett); (b) September 22, 2009 (image courtesy of Dr. Peter Bennett); (c) February 8, 2011 (image by authors); (d) February 8, 2011 (LVDT = linear variable differential transformer; image by authors)

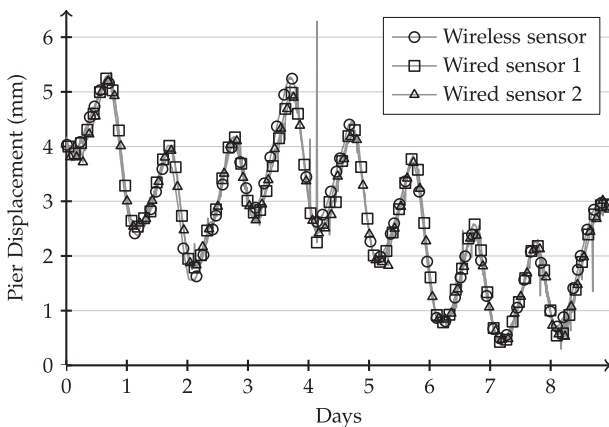
systems both provided very similar readings for displacement at the base of the piers.

Fig. 7. Comparison of data from commercial wired and research wireless monitoring systems (start date March 22, 2012)

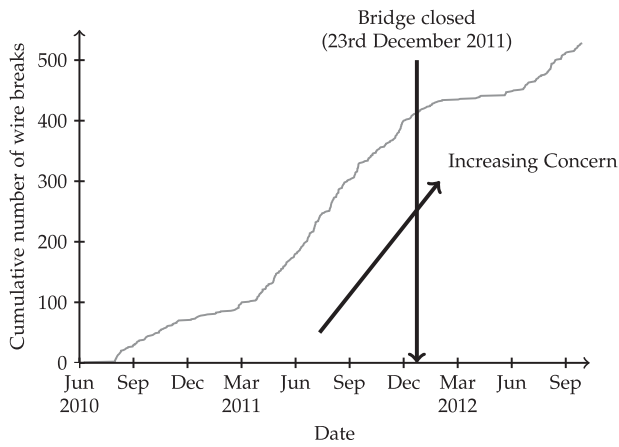
Fig. 8. Cumulative wire breaks in all spans (2010–2012)

The commercial AE system was installed with the aim of detecting wire breaks in the prestressing tendons in the deck box section. Fig. 8 shows a cumulative plot of the number of wire breaks detected throughout the whole bridge by the AE system over approximately 2 years. Investigations following from the results of the AE monitoring led to the closure of the bridge for emergency repairs on December 23, 2011. It might be expected that losses of prestressing force would result in a change in longitudinal strain in the bridge deck. The installed monitoring systems included a limited number of gauges at critical sections measuring longitudinal strain in the deck, and a study was undertaken by the University of Cambridge research team to determine what magnitude of strain is caused by different levels of prestress loss, although it was anticipated that these strains would be very small.

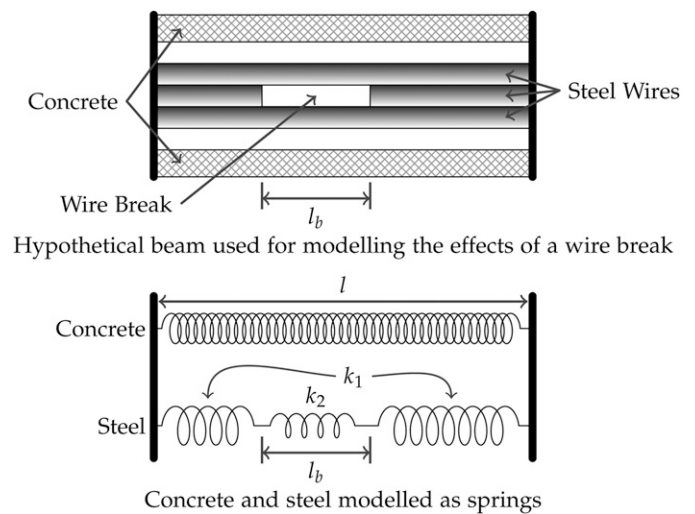
When a single prestressing wire ruptures, the structural effect is complex because it is assumed that some of the force will be transferred into neighboring wires because of friction. This effect can be explored by considering a simple hypothetical case of a single prestressed concrete beam of length l, with gross concrete cross-sectional area A_c, and prestressing steel wires of total cross-sectional area A_s (Fig. 9). In the analysis that follows, compression will be taken as positive. Bending moments will be neglected initially, with only the axial forces being considered. It will also be assumed that the prestressing tendons are unbonded and that there is therefore no friction force between the wires and the concrete. The tendons in the

Hypothetical beam used for modelling the effects of a wire break

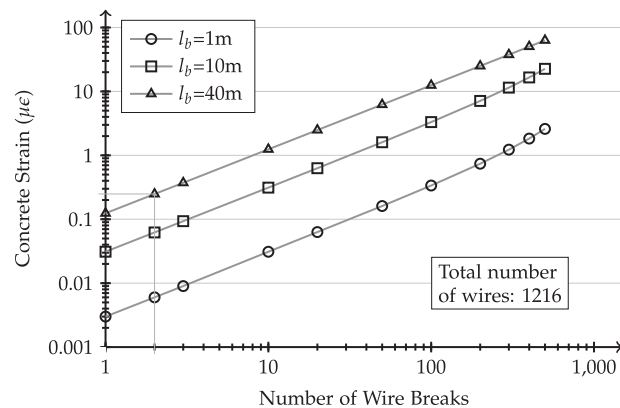
Fig. 10. Calculation of concrete strain variation versus number of wire breaks (assuming unbonded tendons)

The plot in Fig. 10 assumes that all wire breaks occur in different wires and at the same location along the beam; however, this is unlikely to be manifested in practice in the field. It is thus necessary to consider how subsequent breaks affect a tendon that already contains wire breaks at other locations. When a wire break occurs, the tension in that individual wire is assumed to reduce to zero over the effective break length, meaning it cannot break again within that region. If another wire break is detected in the same area of the tendon, it must therefore be a different wire. If, instead, the next wire break occurs farther away, it could be in any wire, including the already broken wire, because a wire break is assumed to not affect the wire outside the effective break length. In this case, the effect on the whole tendon will be the same as a single wire break with an increased effective break length.

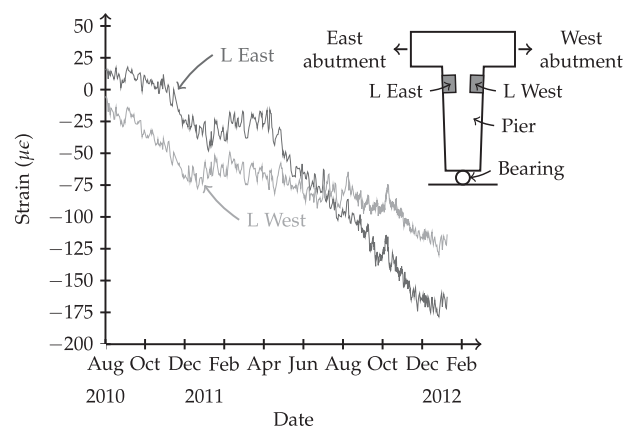
The Commercial System includes a single longitudinal strain gauge at the midspan of three of the deck spans of the flyover. Fig. 11 shows a plot of longitudinal strain of a typical span measured at midspan. The recorded number of wire breaks of 1% of the tendon cross section over a 2-year period would result in a predicted strain change of $0.2\,\mu\varepsilon$, which cannot be detected with any confidence

given that there is a general background variation of approximately $40\,\mu\varepsilon$ in the readings, almost four times the predicted strain change expected for a loss of 20% of the prestressing wires. A large, unexplained shift in strain of approximately $100\,\mu\varepsilon$ in the concrete deck was detected during April and May 2011 (Fig. 11). A number of the other strain gauges, displacement transducers, and inclinometers also displayed a significant change at the same time, for which there does not appear to be an obvious physical explanation. This suggests that it is probably not a problem with any individual sensors; however, without further data from an independent monitoring system there is no way of verifying the cause. Unfortunately, the Research System was not functioning during this time and therefore no alternative data are available. However, even if this unexplained jump was not present, it would still not be possible to distinguish any small strain changes caused by prestress loss from the noise present in the data.

Fig. 11. Measured longitudinal strain at midspan of a typical span (2010–2012)

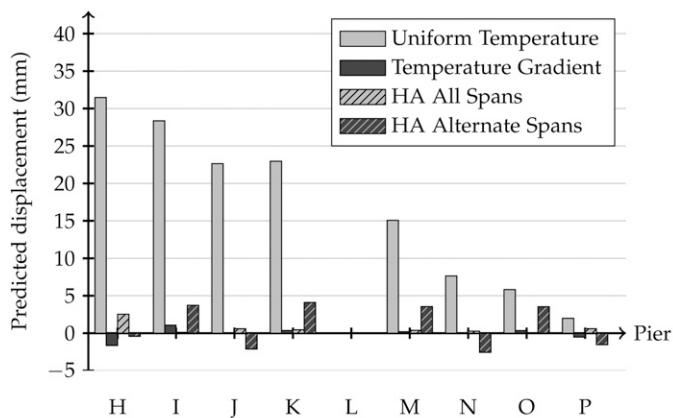
Fig. 13(a) shows the predicted displacements for each pier for each of these load cases when all bearings are functioning correctly

Fig. 13. Predicted displacements for various load cases: (a) all bearings free; (b) one bearing pinned (at pier L), others free (HA loading is defined in Table 1)

Subsequently, the analyses were repeated with the support at one pier (pier L) assumed fixed to prevent any longitudinal displacement, simulating a corroded and jammed bearing. In Fig. 13(b), it can be seen that, with the exception of pier L, the predicted displacements of the piers are very similar to those shown in Fig. 13(a) (the undamaged scenario). Repeating the aforementioned analysis with any other pier assumed fixed results in a similar outcome. This means that deterioration of one of the bridge's bearings is not expected to significantly alter the displacements measured at the other piers. This should make it possible to determine the state of any bearing if the correlation between temperature and movement is no longer present.

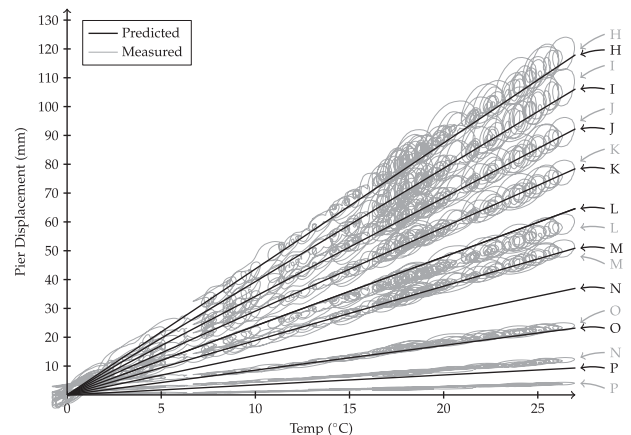
For each pier, there appears to be a good linear relationship, suggesting that pier displacements are caused predominantly by temperature changes, as expected. A hysteresis effect can be seen, caused by the thermal mass of the bridge taking time to react to temperature changes. The actual measured displacements of seven of the piers (H, I, J, K, L, M and O) compare very well with the predictions, whereas piers N and P do not. Although these two piers move with temperature variations, they do not move to the same extent as would be expected from the modeling predictions. This implies that the bearings for these piers behave as if partially restrained and do not allow completely free longitudinal movement. No access to pier P was available to the authors; however, inspection of the bearings at pier N revealed the cause at that location. In each bearing pit, in addition to the bearings supporting the pier, there are also four steel plinths designed to prevent catastrophic damage occurring if any of the bearings were to fail by only allowing the pier to drop by a few millimeters. During construction, metal shim plates were inserted between the top of the plinths and the base of each pier to maintain a gap of approximately 13 mm (Rawlinson and Stott

Fig. 14. Predicted and measured longitudinal displacement versus temperature plots for piers H to P

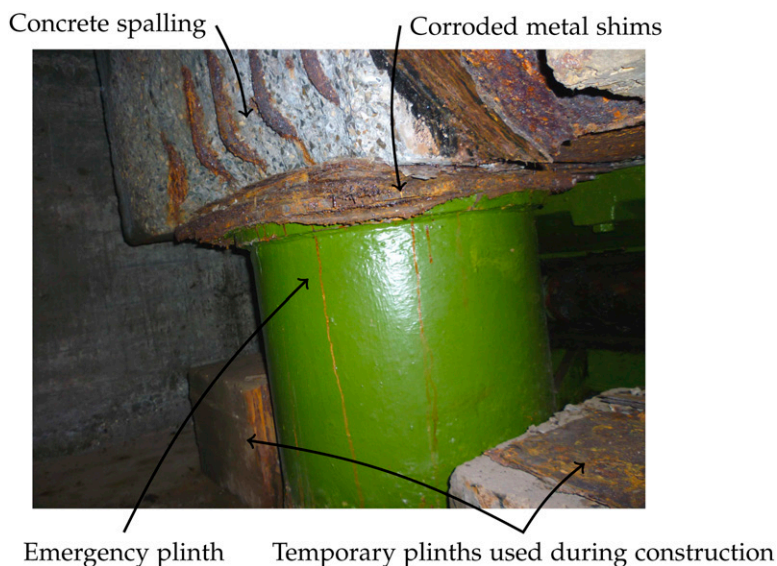
Concrete spalling   Corroded metal shims

Fig. 15. Base of pier N showing metal shims (image by authors, taken February 8, 2011)

1962). Fig. 15 shows pier N in 2012 with the shims in place but they have corroded over the last 50 years and become wedged between the pier and the plinth, restricting horizontal movement of the pier.

4. Measurements from both the Commercial and Research Systems have indicated that two of the flyover's pier bearings are partially restrained, rather than freely allowing longitudinal movement as had been intended by the designers; this was verified in the case of one pier (pier N) by visual inspection.
