# Mo 21 B06

# Photogrammetry and 3-D Ultrasonic Tomography to Estimate the Integrity of Two Sculptures of the Egyptian Museum of Turin

L. Sambuelli* (Politecnico di Torino), G. Böhm (OGS), C. Colombero (Università di Torino) & A. Filipello (Università di Torino)

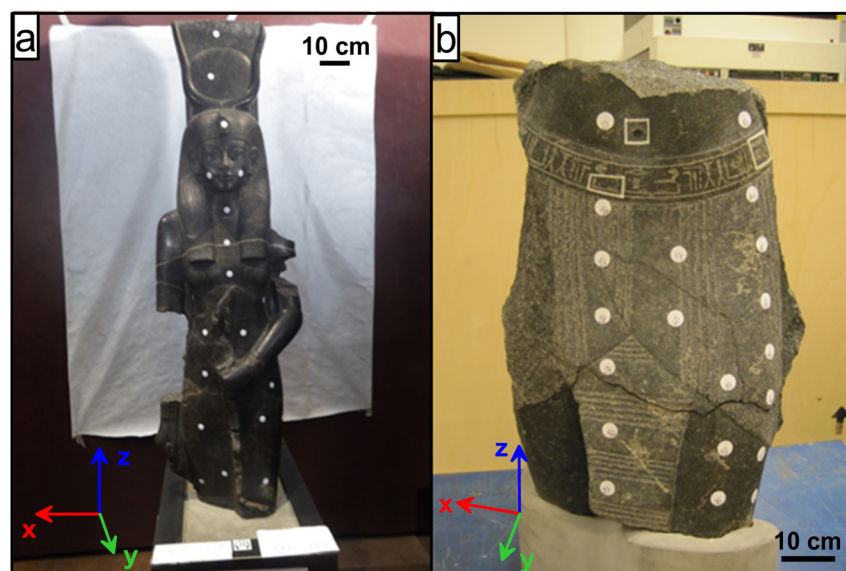
*Figure 1 The statue of Hator (a) and the remaining part of the sculpture of Uahka II (b). White round stickers correspond to the position of sources and receivers of the ultrasonic survey.*

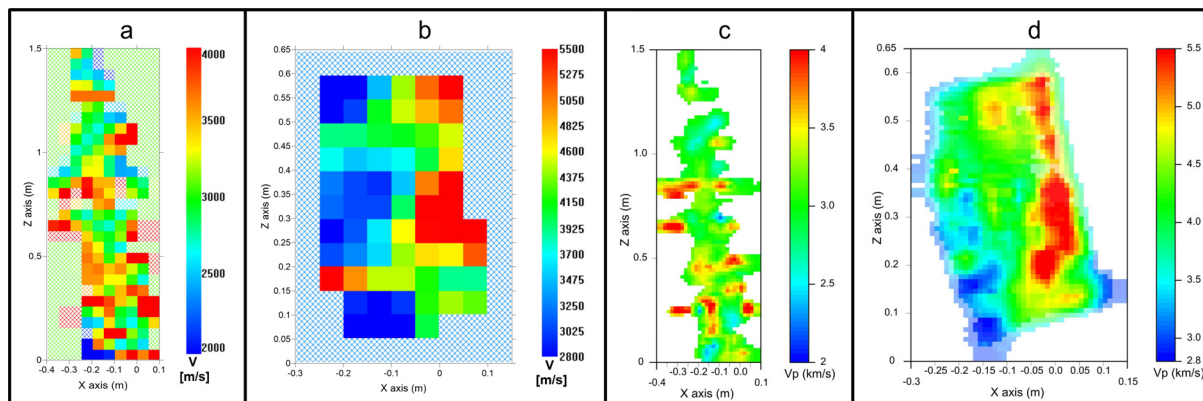
*Figure 2 Comparison of the tomographic inversion using classical (a, b) and staggered grids (c, d), starting from a model with cubic cells (dx=dy=dz=5 cm). All the results refer to vertical sections (XZ plane) at the middle of Y dimension of the 3D models obtained from the tomographic inversion (Hator: a and c; Uahka II: b and d).*

The results of classical and staggered tomography showed a good agreement in locating the low velocity zones, even if, starting from the same initial model, staggered grids circumscribed them with a finer resolution, as it is clear from Figure 2.

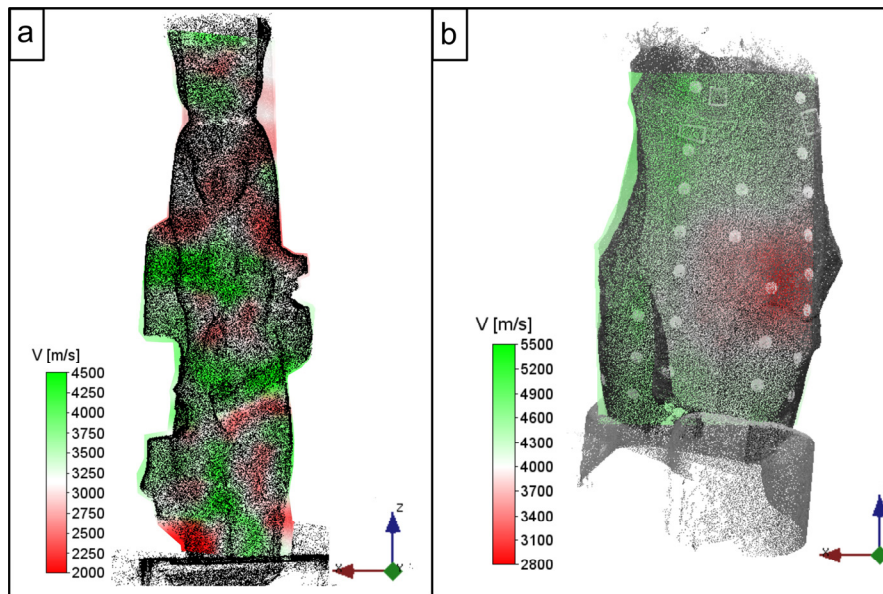
For the statue of Uahka II, all the results showed that the surface fracture do not affect in depth the volume of the statue, except for a relevant open fracture on the back left side (Fig. 3b), highlighted from both volumetric analysis of the mean velocities and classical and staggered tomographies.

While Uahka II can be considered as an intact volume with circumscribed and shallow criticalities, the results on Hator showed widespread problems, with no high-velocity rays crossing the whole statue. The tomographic results emphasized the main weaknesses in the neck, head and back base of the statue (Fig. 3a).

Compared with the simple analysis of the mean ray velocities, the processing of data with tomographic inversion allowed to better circumscribe the low velocity zones (Fig. 3). The use of staggered grids led to a more detailed final resolution of the investigated volumes.

***Figure 3*** *Tomographic results superimposed to the simplified photogrammetric point clouds of the statue of Hator (a) and Uahka II (b).*
