Tribological Aspects of Rolling Bearing Failures

Jürgen Gegner
SKF GmbH, Department of Material Physics
Institute of Material Science, University of Siegen
Germany

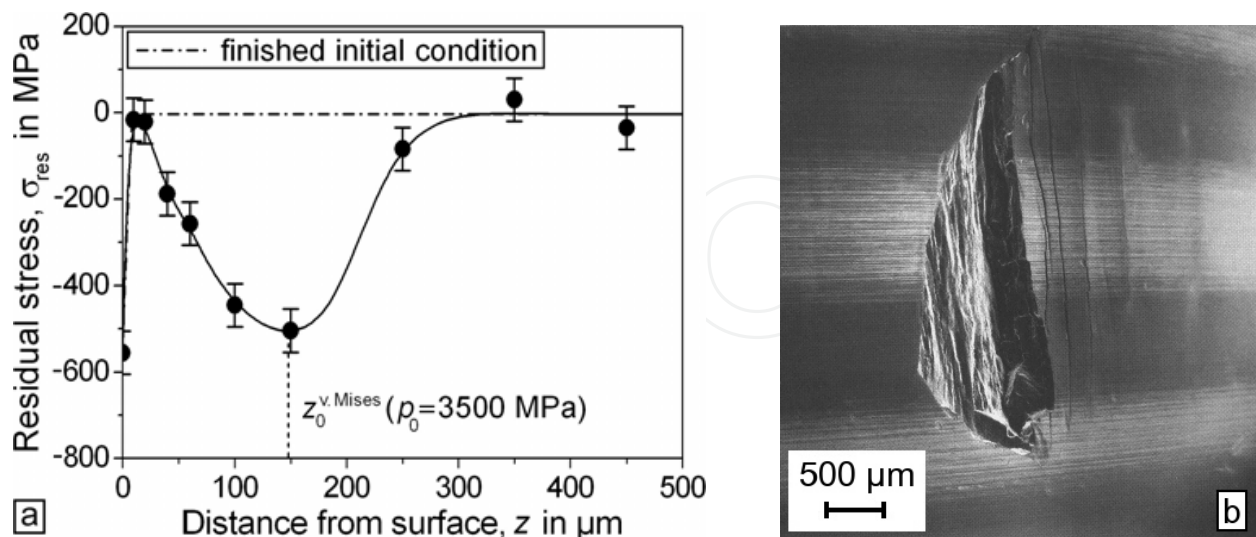
Fig. 2. Subsurface material loading and damage characterized, respectively, by (a) the residual stress distribution below the inner ring (IR) raceway of a deep groove ball bearing (DGBB) tested in an automobile gearbox rig, where the part is made of martensitically through hardened bearing steel and (b) a SEM image (secondary electron mode, SE) of fatigue spalling on the IR raceway of a rig tested DGBB with overrolling direction from left to right

Fatigue spalling is eventually caused by subsurface crack initiation and growth to the surface in overrolling direction (OD), as evident from Figure 2b (Voskamp, 1996). In the scanning electron microscope (SEM) image, the still intact honing structure of the raceway confirms the adjusted ideal EHL conditions.

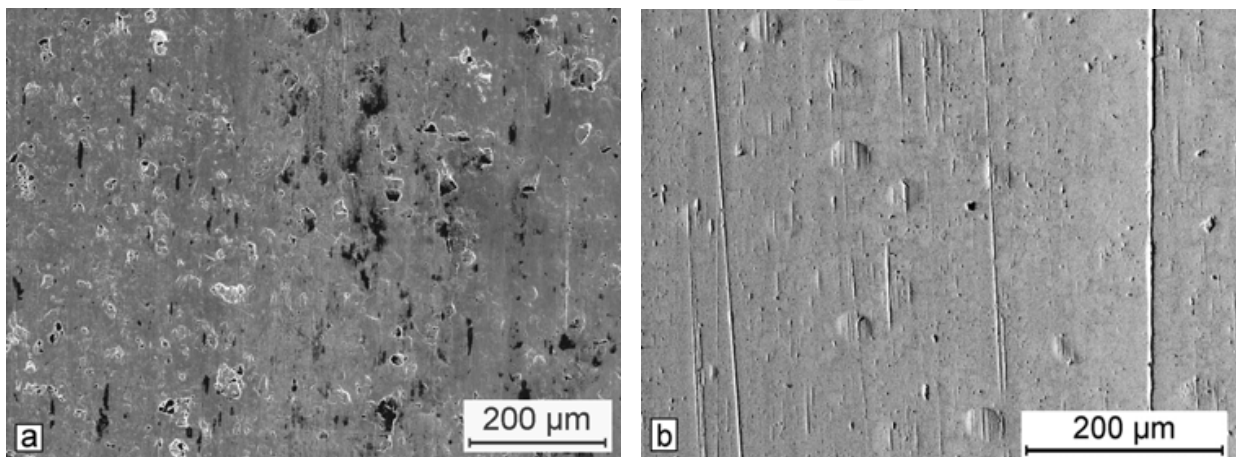
Fig. 3. SEM images (SE mode) of (a) randomly distributed dense hard particle raceway indentations (also track-like indentation patterns can occur, e.g. so-called frosty bands) from contaminated lubricant and (b) indentations of metallic particles on the smoothed IR raceway of a cylindrical roller bearing (CRB) that clearly reveal earlier surface conditions of better preserved honing structure

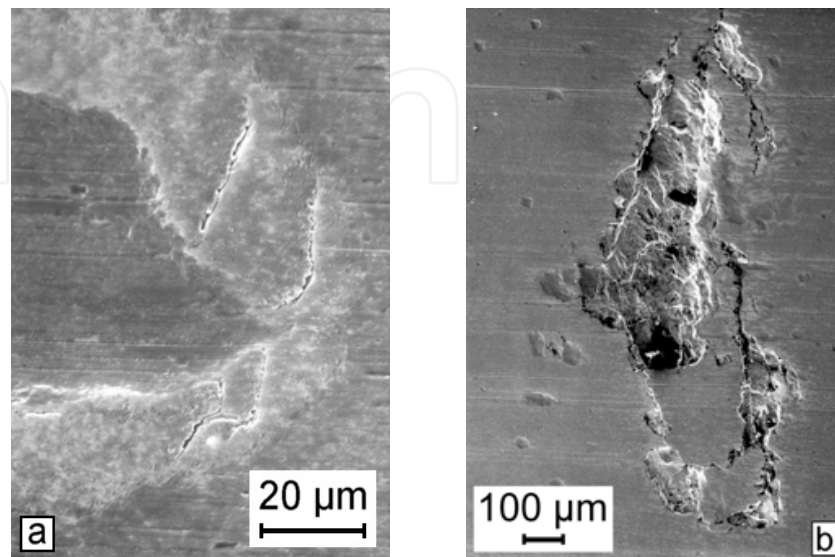
embrittlement and subsequent crack initiation on the surface. Further failure development produces a so-called V pit of originally only several μm depth behind the indentation, as documented in Figure 6b. It is instructive to compare this shallow pit and the clearly smoothed raceway with the subsurface fatigue spall of Figure 2b that evolves from a depth of about 100 μm below an intact honing structure.

Fig. 6. SEM image (SE mode) of (a) incipient cracking and (b) beginning V pitting behind an indentation on the IR raceway of a TRB. Note the overrolling direction from left to right

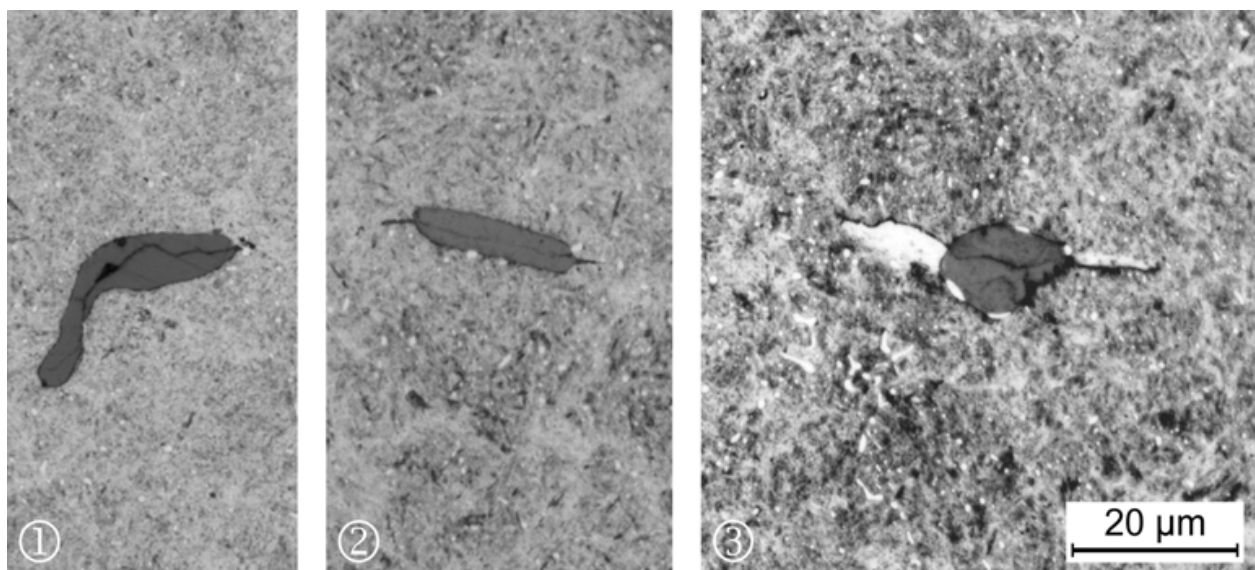
Fig. 13. Butterfly formation on sulfide inclusions observed in etched axial microsections of the outer ring of a CRB of an industrial gearbox after a passed rig test at p_0=1450 MPa

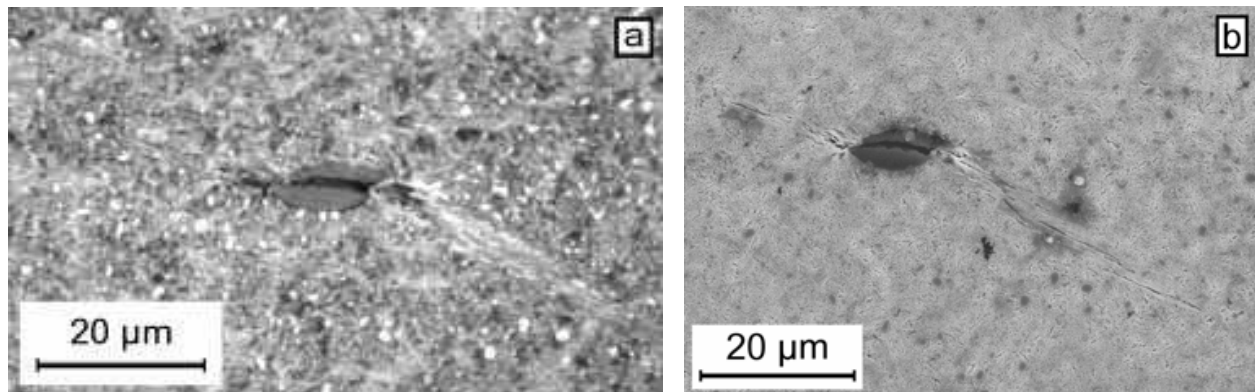
Fig. 14. LOM micrograph (a) and corresponding SEM-SE image (b) of butterfly development on a cracked MnS inclusion in the etched radial microsection of the stationary outer ring of a spherical roller bearing (SRB) after a passed rig test at a Hertzian pressure p_0 of 2400 MPa

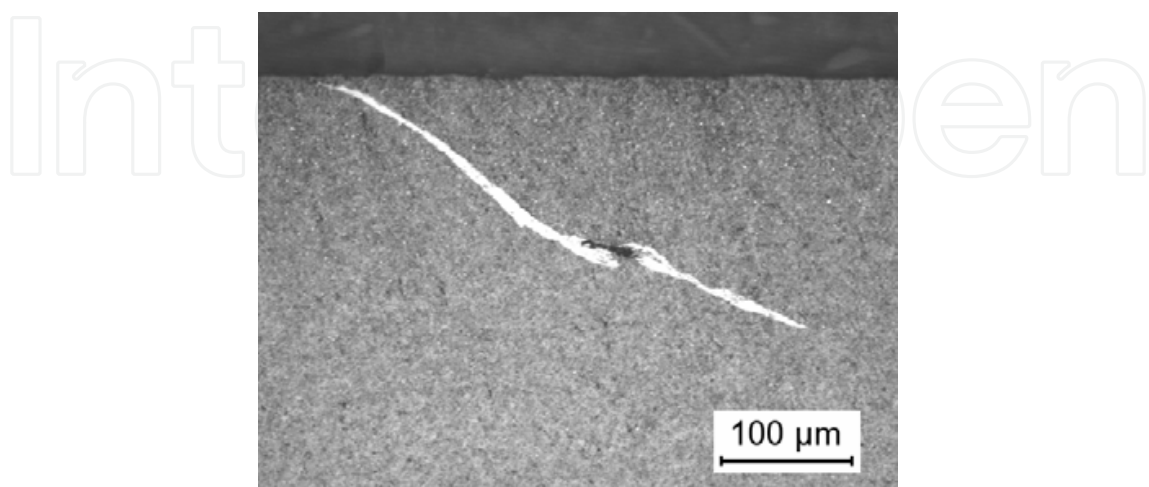
Fig. 15. Butterfly wing growth from the depth to the raceway surface in overrolling direction (right-to-left) in the etched radial microsection of the IR of a CRB loaded at p_0=1800 MPa

Critical butterfly wing growth up to the surface (see Figure 15), which leads to bearing failure by raceway spalling eventually, occurs very rarely (Schreiber, 1992). The metallurgically unweakened steel matrix in some distance to the inclusion can cause crack arrest. Multiple damage initiation, however, is found in the final stage of rolling contact fatigue. Subsurface cracks may then reach the raceway (Voskamp, 1996). Butterfly RCF damage develops by the microstructural transformation of low-temperature dynamic recrystallization of the highly strained regions along cracks rapidly initiated on stress raising nonmetallic inclusions in the steel (Böhm et al., 1975; Brückner et al., 2011; Furumura et al., 1993; Österlund et al., 1982; Schlicht et al., 1987; Voskamp, 1996), If this localized fatigue process occurs at Hertzian pressures below 2500 MPa (Brückner et al., 2011; Vincent et al., 1998), it is not recognizable alone by an XRD analysis that is sensitive to integral material loading (see section 3.2).

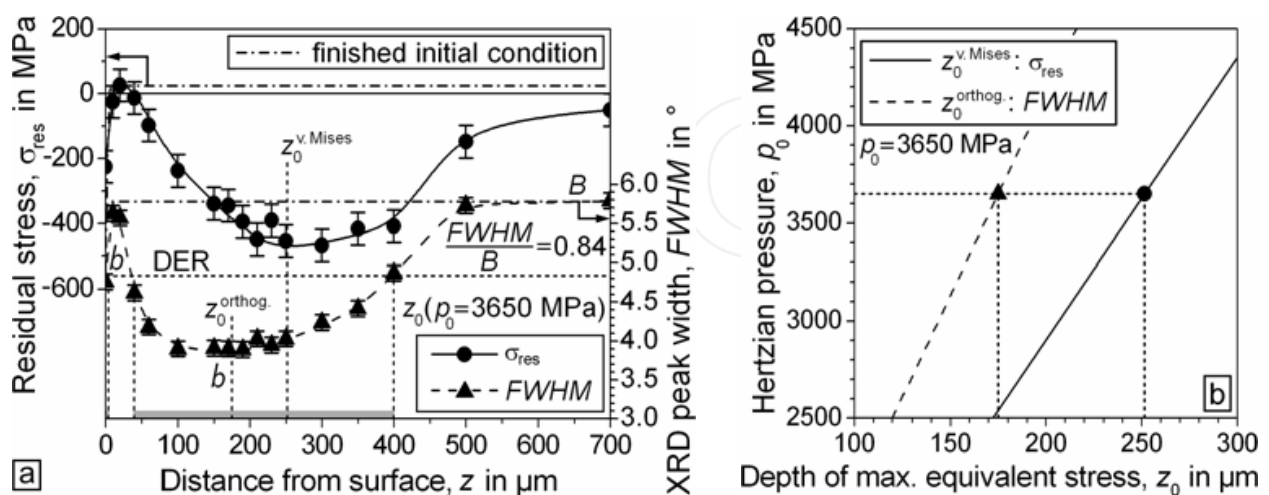
Fig. 16. Graphical representation of (a) the residual stress and XRD peak width depth distribution measured below the IR raceway of a DGBB tested in an automobile gearbox rig with indication of the initial as-delivered condition and (b) the joint subsurface profile evaluation

The predicted dark etching regions at the surface and in a depth between 40 and 400 µm are well confirmed by failure metallography, as evident from a comparison of Figure 16a with Figures 17a and 17b. The DER-free intermediate layer is clearly visible in the overview micrograph. The dark etching region near the surface ranges to about 10 to 12 µm depth.

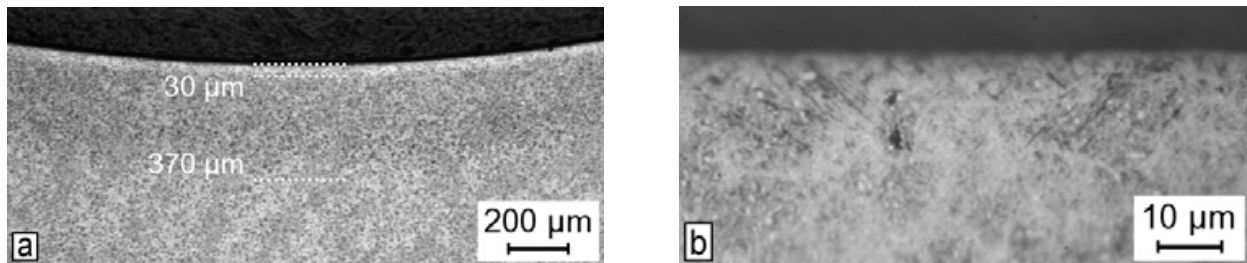
Fig. 17. LOM images of (a) the etched axial microsection of the inner ring of Figure 16a with evaluation of the extended subsurface DER and (b) a detail revealing the near-surface DER

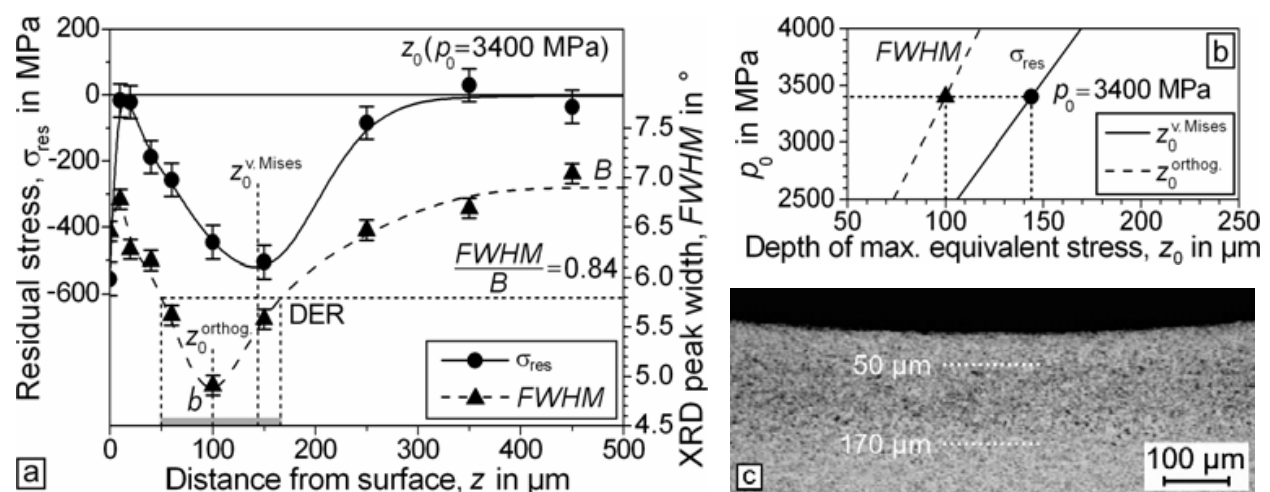
Fig. 18. Subsurface RCF analysis of the IR of a run DGBB including (a) the measured depth distribution of residual stress and XRD peak width ($b/B \approx 0.71$) with DER prediction, (b) the joint XRD profile evaluation and (c) an etched axial microsection with actual DER extension

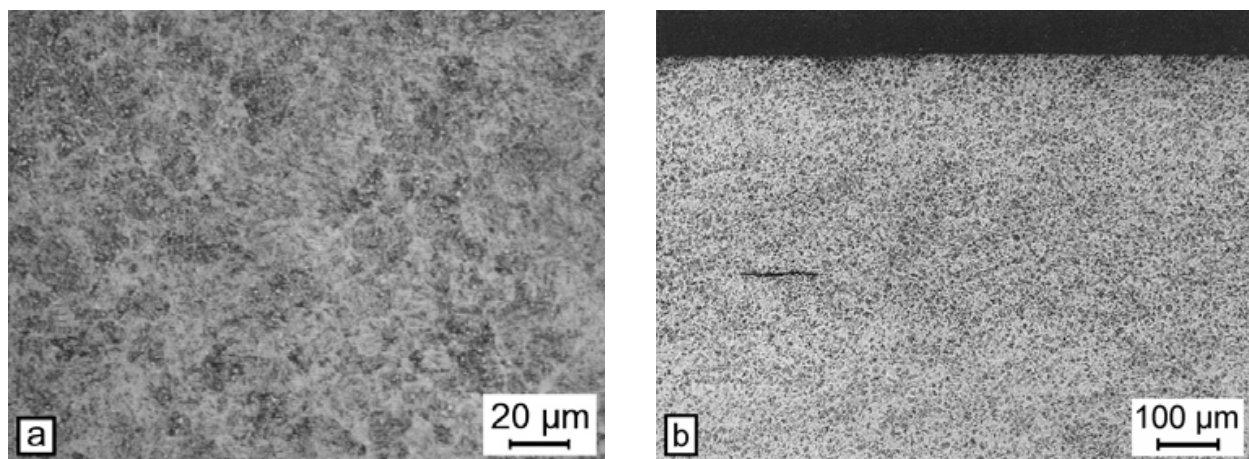
Fig. 19. LOM micrographs of (a) a detail of the DER of Figure 17a and (b) typical subsurface fatigue crack propagation parallel to the raceway around the depth of maximum orthogonal shear stress in the etched radial microsection of the inner ring of a deep groove ball bearing

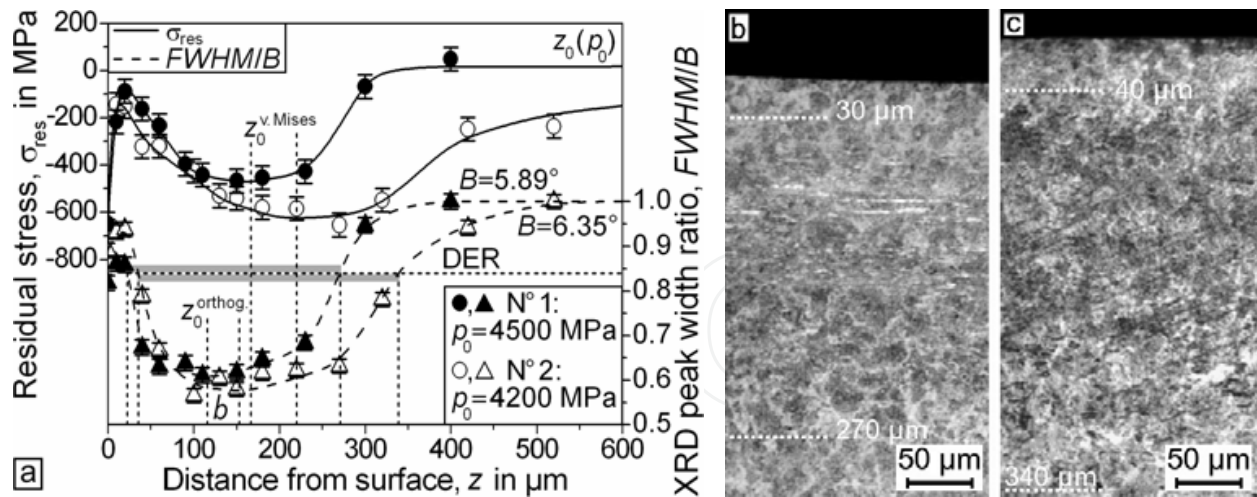
Fig. 20. Subsurface RCF analysis of the IR of two run DGBB (N° 1, N° 2) including (a) the evaluated depth distribution of residual stress and XRD peak width (N° 1: $b/B \approx 0.61$, N° 2: $b/B \approx 0.57$, the given B values reflect different tempering temperature of martensite hardening of bearing steel) with DER prediction, (b) an etched axial microsection of IR-N° 1 and (c) an etched radial microsection of IR-N° 2, respectively with DER indication and visible FWB

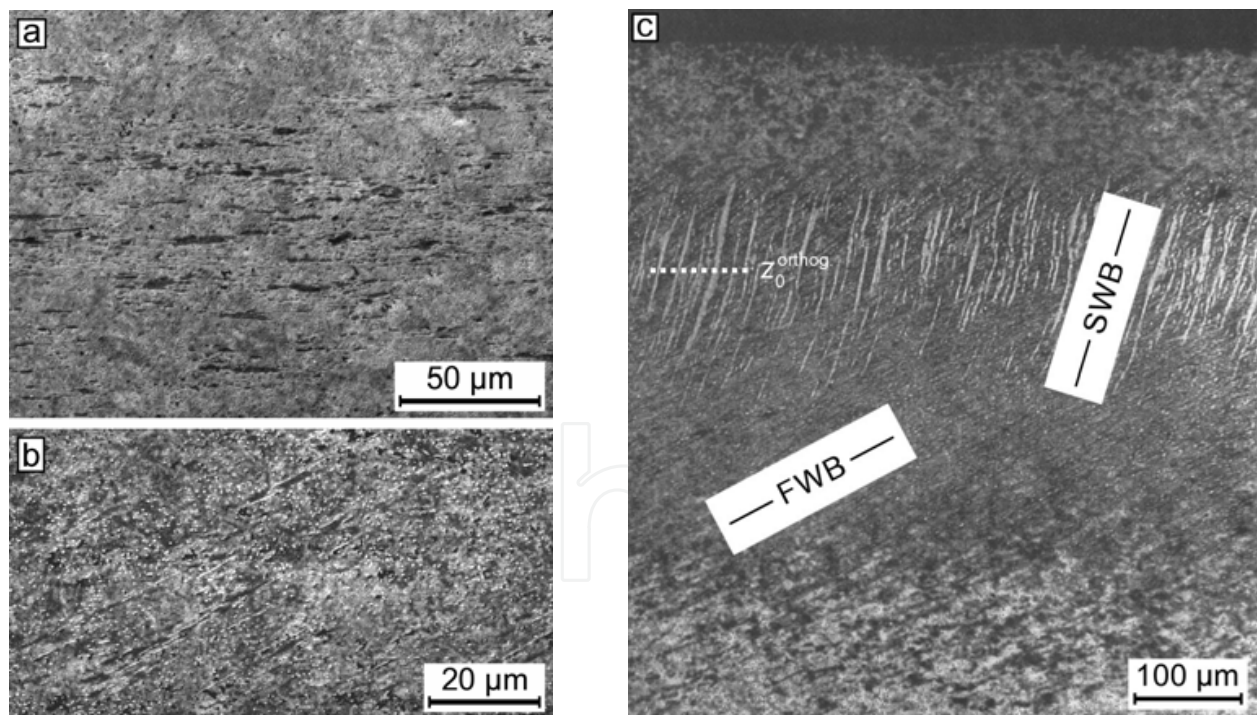
Fig. 21. SEM-SE detail of (a) Figure 20b (preparatively initiated cracks expose the DER) and (b) Figure 20c ($\beta_f = 22°$) and (c) an etched radial microsection of the IR of a DGBB rig tested at a Hertzian pressure of 3700 MPa with indicated depth of maximum orthogonal shear stress

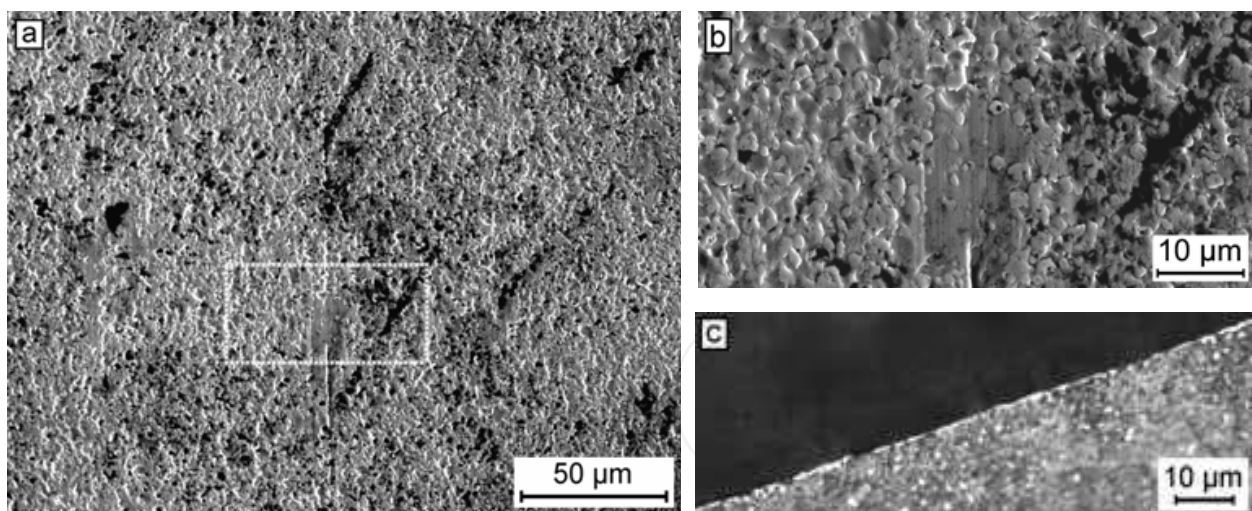
Fig. 25. Characterization of severe high-frequency electric current passage through a DGBB by (a) a SEM-SE overview and (b) the indicated SEM-SE detail of the remelted OR raceway track and (c) a near-surface LOM micrograph of an etched axial microsection

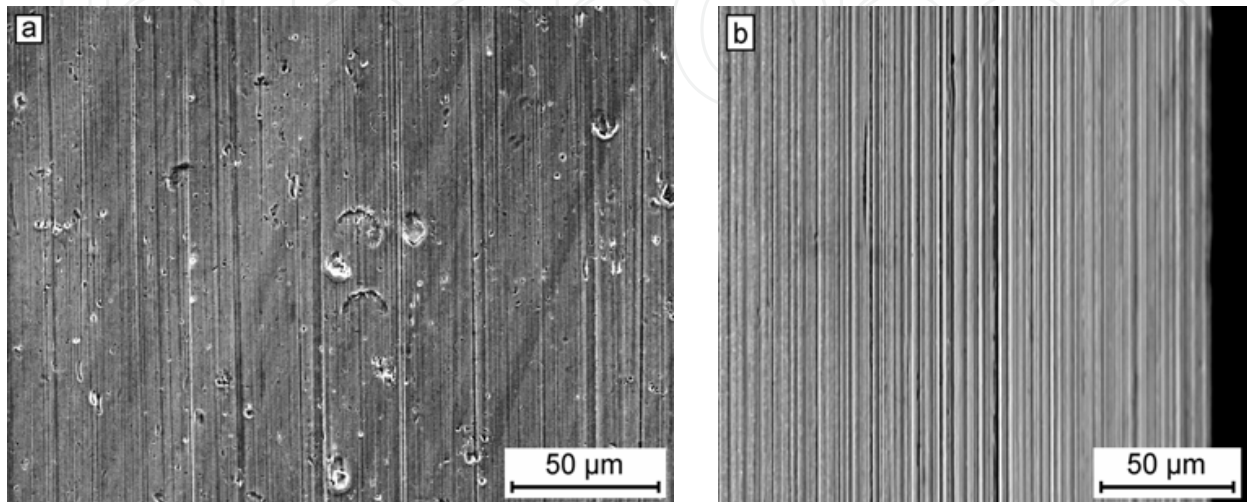
Fig. 26. SEM-SE image of the raceway (a) of the OR of an identical DGBB tested in the same alternator rig as the bearing of Figure 25 after moderate high-frequency electric current passage and (b) in as-delivered (non-overrolled) surface condition with original honing marks

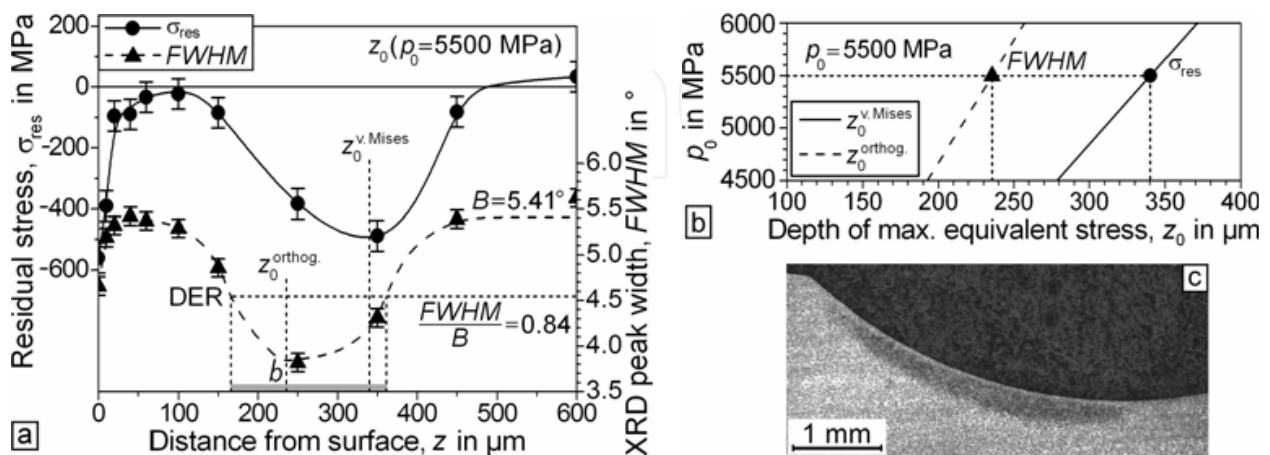
Fig. 27. Material response analysis of the OR of the tested DGBB of Figure 25 including (a) the residual stress and XRD peak width distribution ($b/B \approx 0.71$, B measured below the shoulder), (b) the joint profile evaluation and (c) an axial microsection with pronounced DER

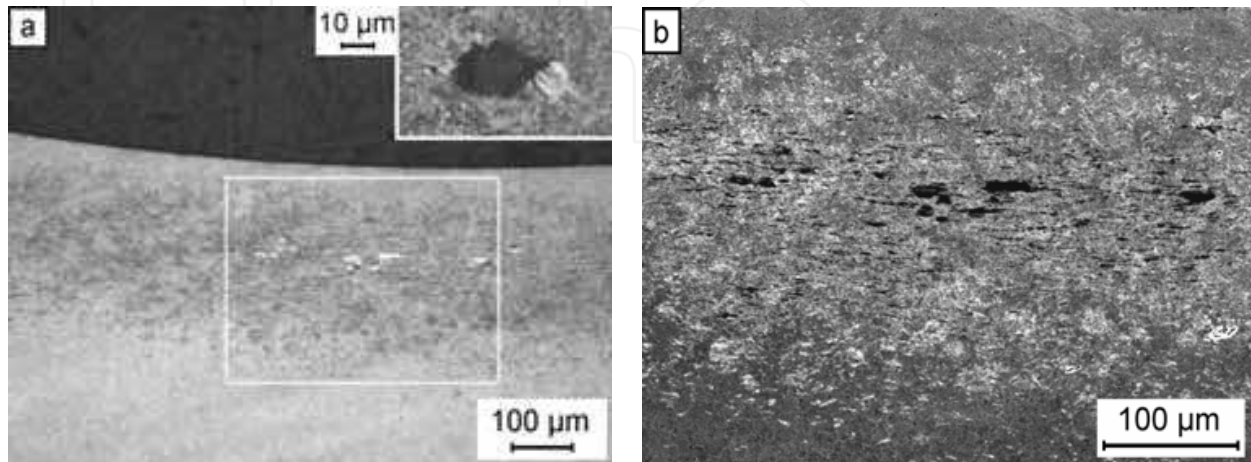
Fig. 28. Etched axial microsection of the DGBB outer ring of Figure 27c revealing (a) a LOM overview (the inset shows an embryo butterfly) and (b) the indicated SEM-SE detail

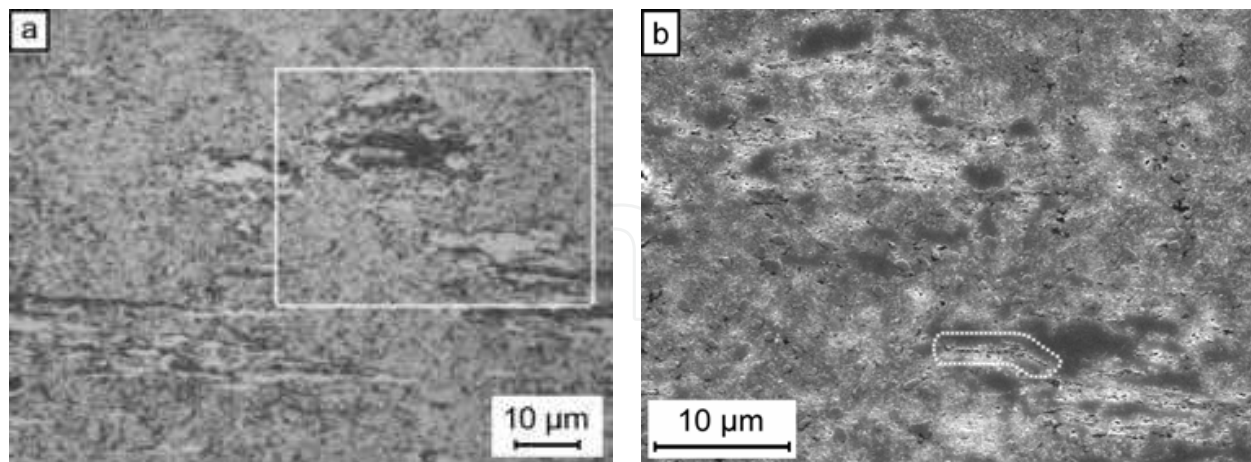
Fig. 29. Etched axial microsection of the DGBB outer ring of Figure 27c revealing (a) a LOM image and (b) the indicated SEM-SE detail

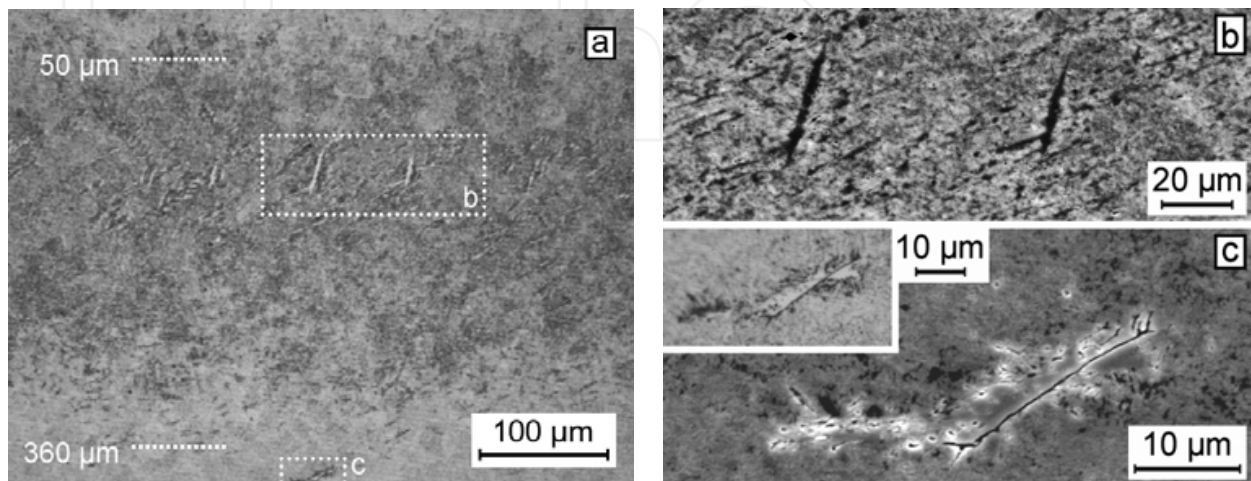
Fig. 30. Etched radial microsection of the OR of Figure 27c revealing (a) a LOM overview with indicated DER, (b) the SEM-SE detail b and (c) the SEM-SE detail c, where the corresponding LOM inset highlights the WEA precursor effect of the surrounding DER

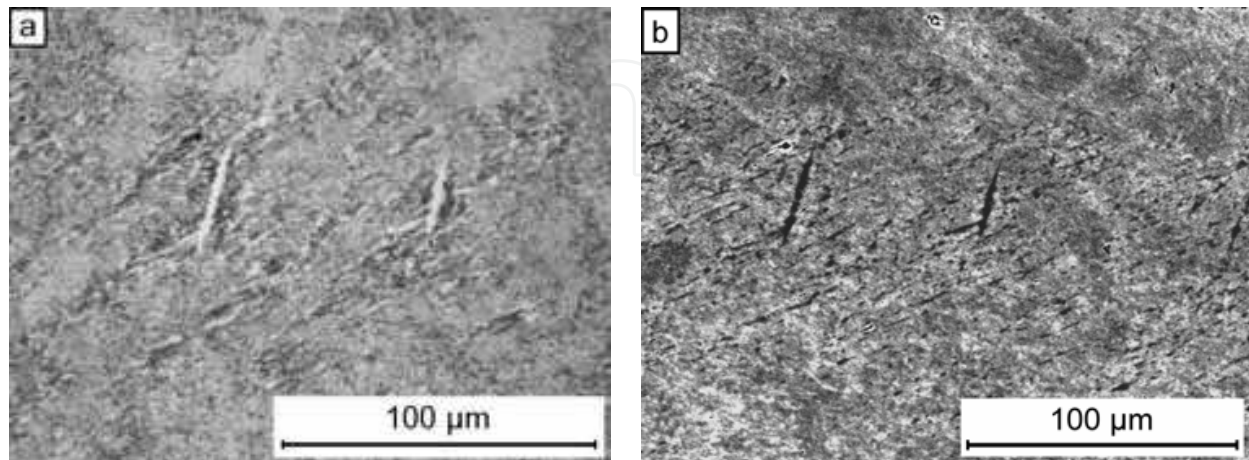
Fig. 31. Detail (approx. b) of Figure 30 comparing (a) a LOM and (b) a SEM-SE micrograph

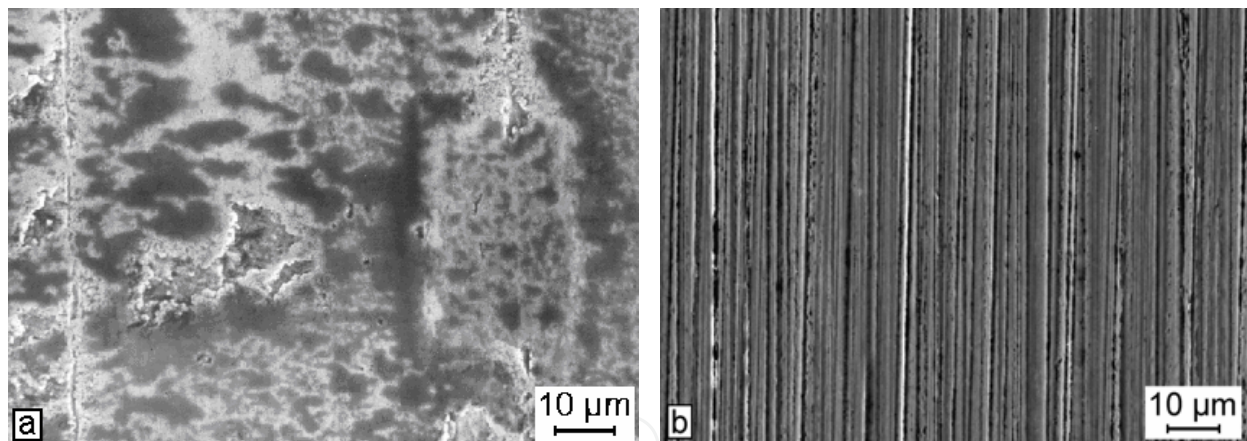
Fig. 32. SEM-SE image of (a) the damaged raceway of the inner ring of a CRB after rig testing under engine vibrations and (b) an original honing structure at the same magnification

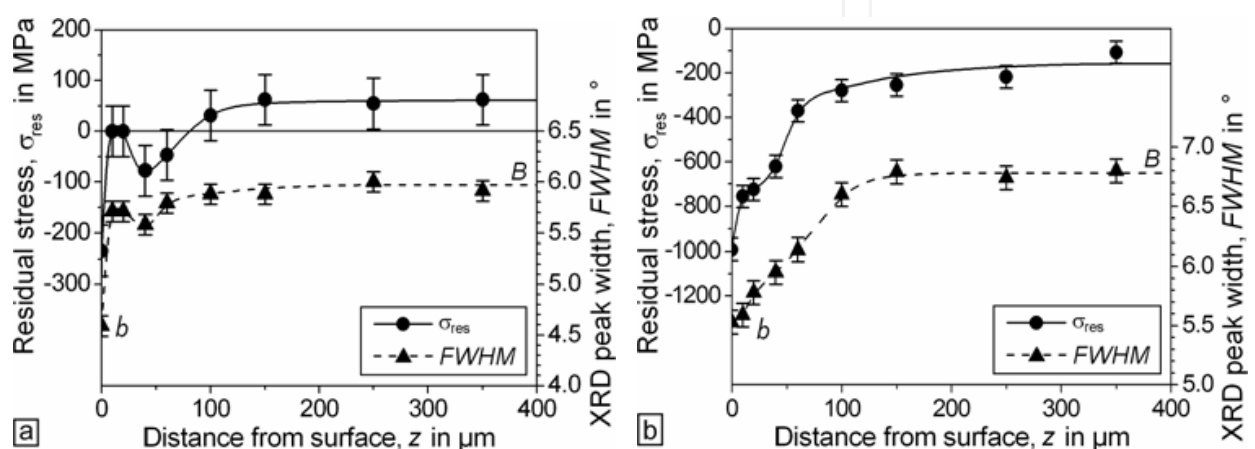
Fig. 33. The two types of vibration residual stress-XRD line width profiles, i.e. (a) type B with near-surface side peaks measured on the IR raceway of a CRB from a motorcycle gearbox test rig and (b) type A with monotonically increasing curves from a field application

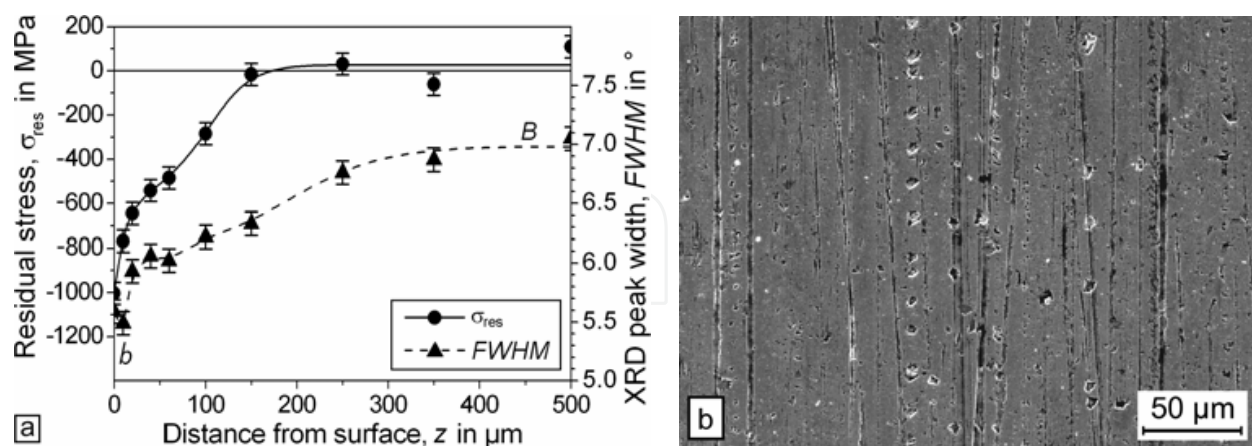
Fig. 34. Investigation of the IR of a vibration-loaded harvester TRB revealing (a) the obtained type A residual stress pattern and (b) a SEM-SE image of the raceway with indentations

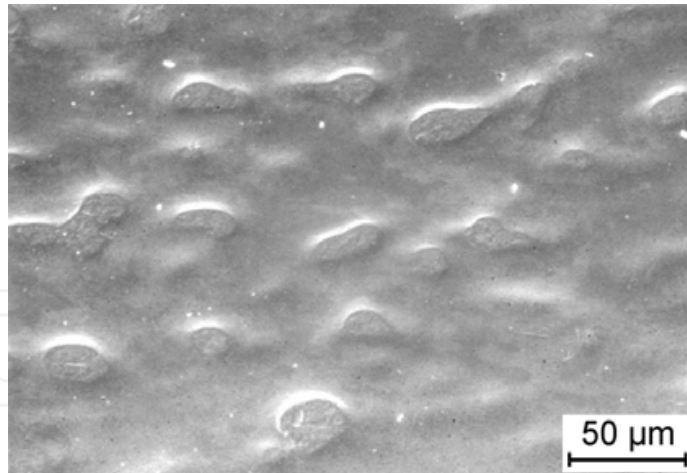
First, Figure 37 gives a demonstrative example of a corrosive attack by a decomposed lubricant. The etching pattern on the raceway reveals chemical smoothing of the surface.

Fig. 37. SEM-SE image of a chemical surface attack on the outer ring raceway of a CRB

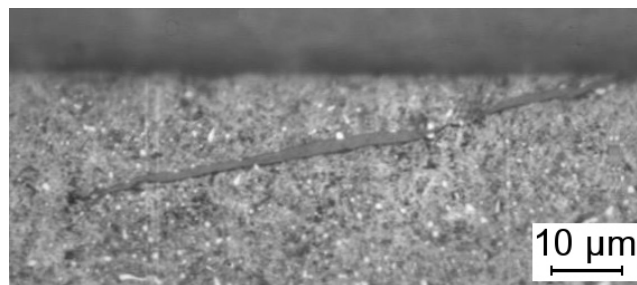
Fig. 38. LOM micrograph of the etched metallographic section of a sulfide inclusion line intersecting the surface of the inner ring raceway of a cylindrical roller bearing

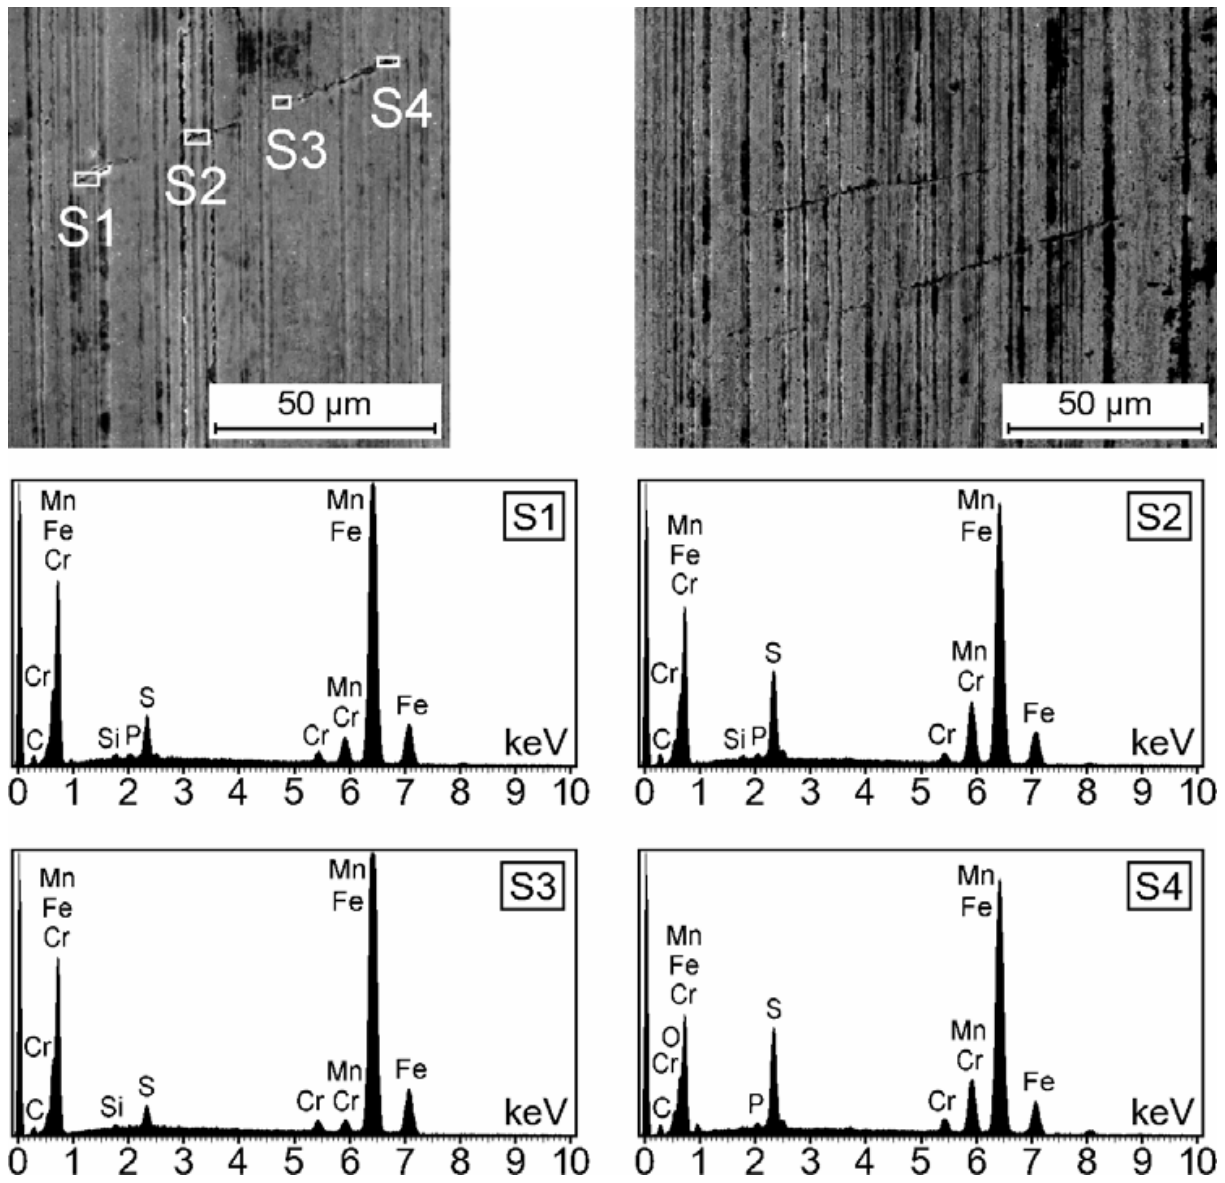
Fig. 39. SEM-SE images of cracks on the IR raceway of a CRB from the gearbox of a weaving machine and EDX spectra S1 to S4 taken at the indicated analysis positions

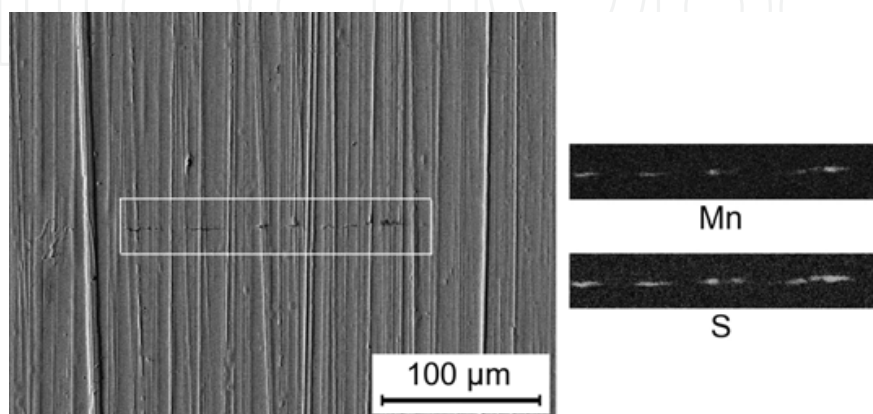
Fig. 40. SEM-SE image of a crack on a CRB roller and elemental mapping (area as indicated)

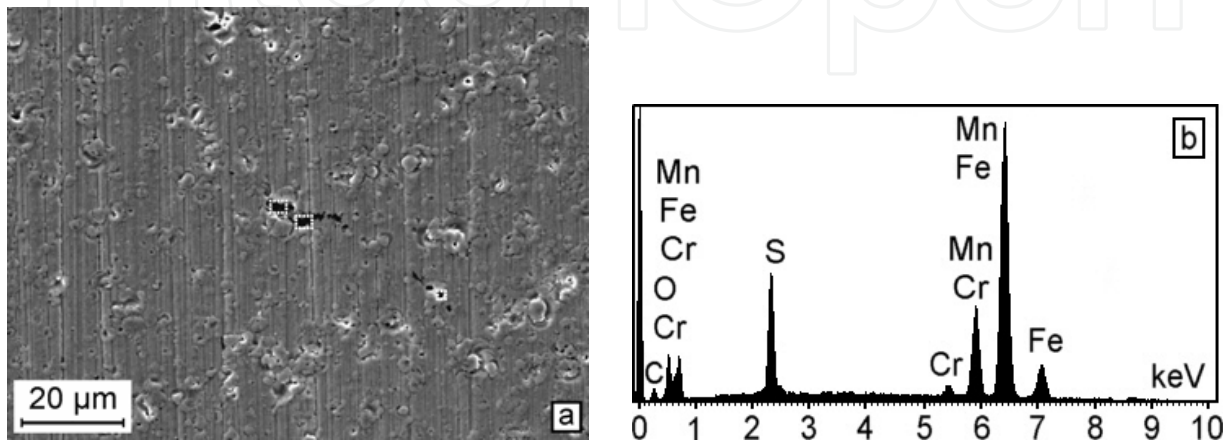
Fig. 41. Tribochemically induced crack evolution on the IR raceway of a DGBB revealing (a) a SEM-SE image with indicated sites where EDX analysis proves the presence of residues of MnS dissolution and (b) a recorded EDX spectrum exemplarily of the analysis results

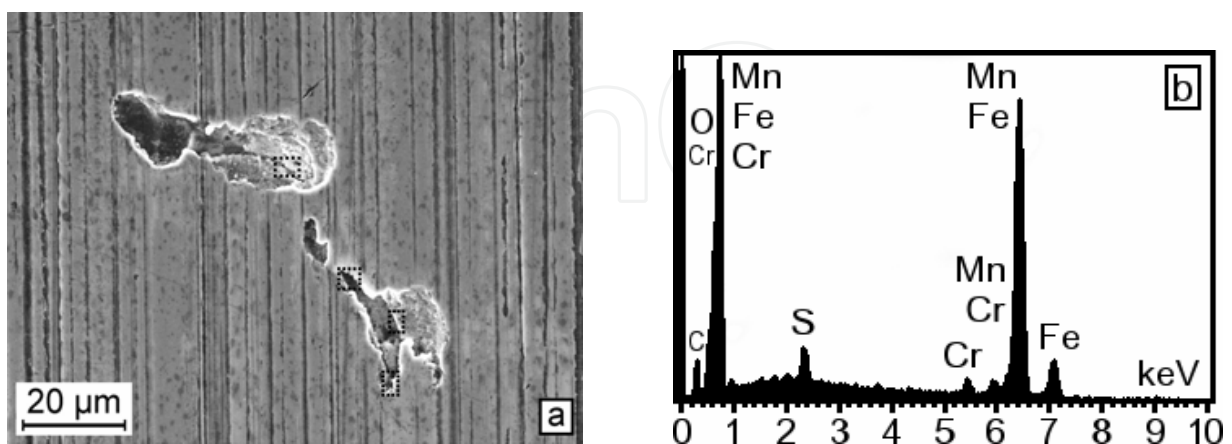
Fig. 42. Documentation of damage evolution by (a) a SEM-SE image of shallow material removals along dissolved MnS inclusions on the IR raceway of a TRB from an industrial gearbox with indication of four positions where EDX analysis reveals MnS residues and (b) EDX spectrum exemplarily of the analysis results recorded at the sites given in Figure 42a

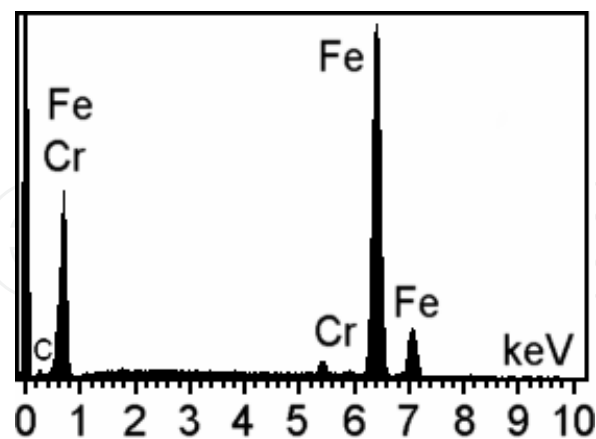
The EDX reference analysis of bearing steel is provided in Figure 43. It allows comparisons with the spectra of Figures 39, 41b and 42b.

Fig. 43. EDX reference spectrum of bearing steel for comparison of the signals

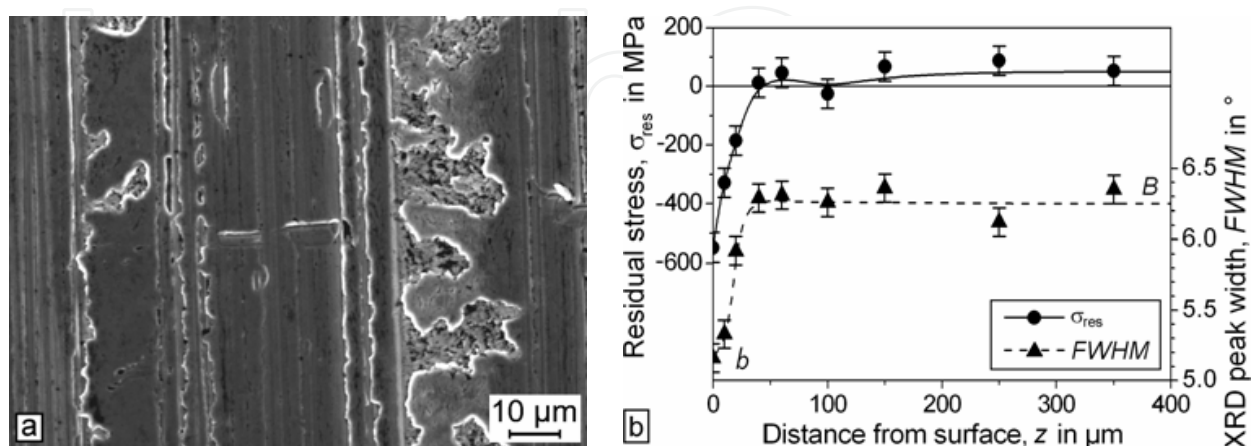
Fig. 44. Investigation of gray staining on the IR raceway of a CRB revealing (a) a SEM-SE image and (b) the measured type A vibration residual stress and XRD peak width distribution

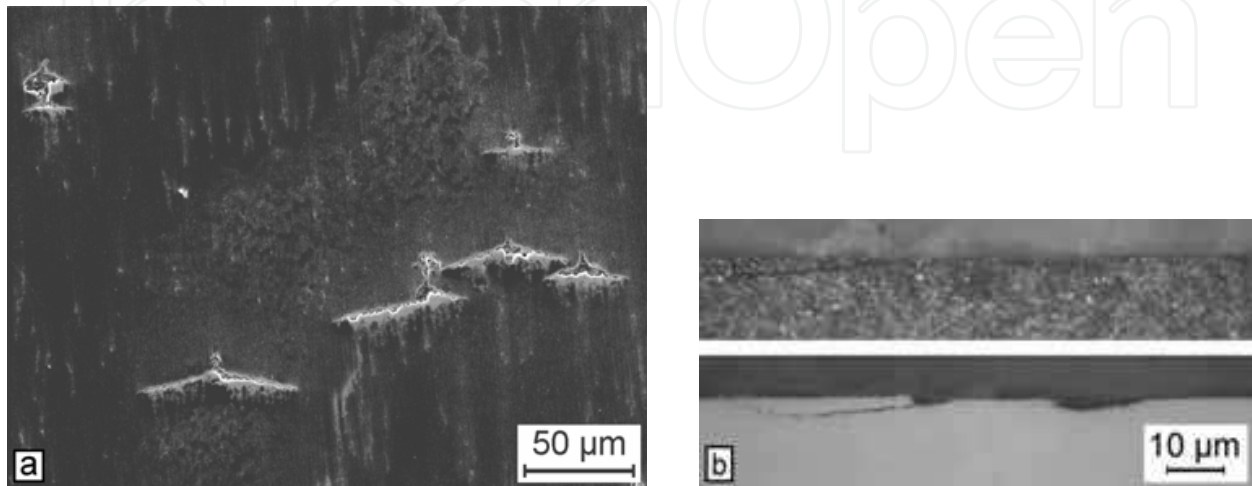
Fig. 45. Investigation of gray staining on the IR raceway of a rig tested automobile gearbox DGBB revealing (a) a SEM-SE image and (b) LOM micrographs of the etched (top) and unetched section of a developing micropit

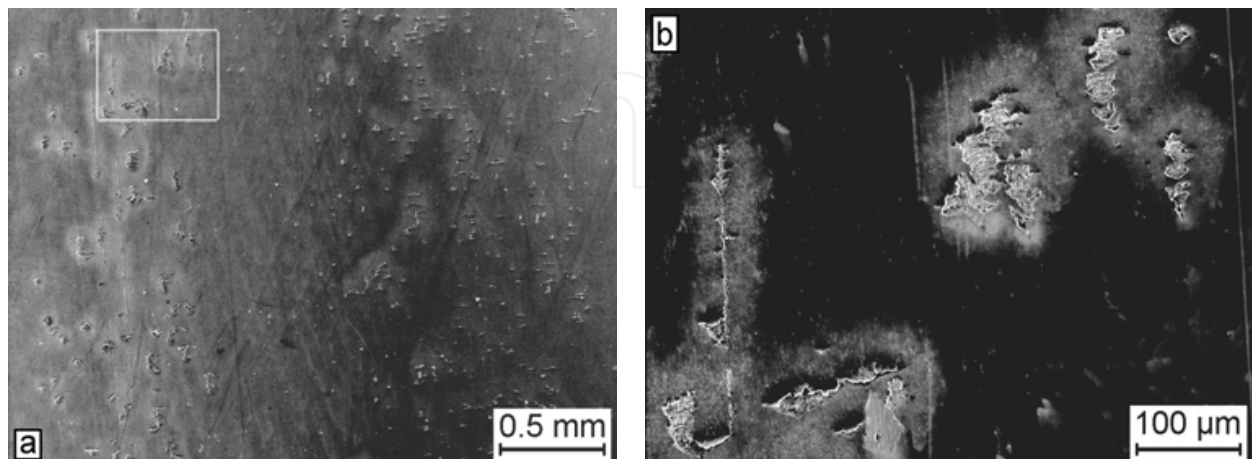
Fig. 46. Investigation of the smoothed damaged inner ring raceway of the deep groove ball bearing of Figure 45a presenting (a) a SEM-SE overview and (b) the indicated detail that reveals near-surface crack propagation in overrolling direction from the bottom to the top

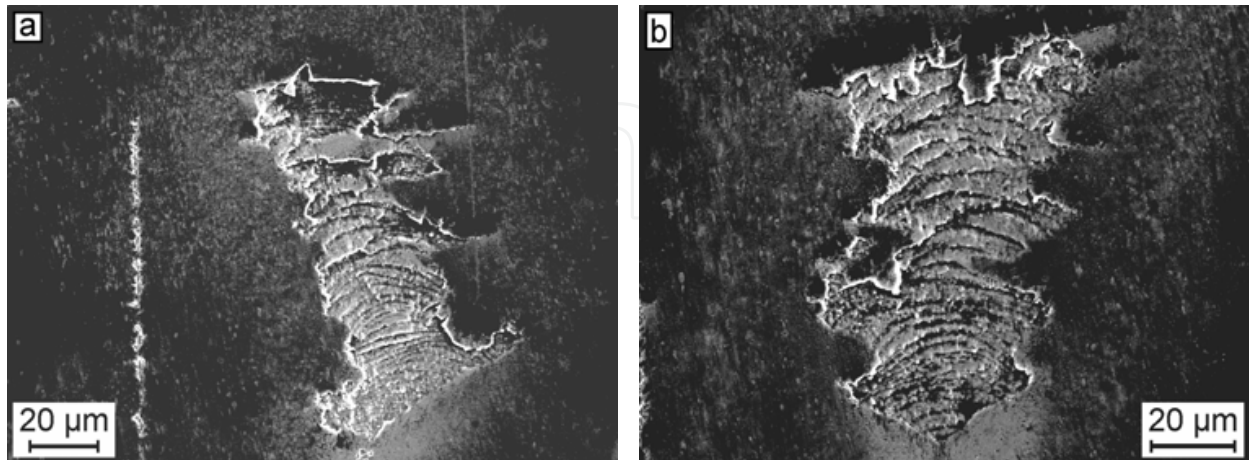
Fig. 47. SEM-SE details of the inner ring raceway of the deep groove ball bearing of Figure 46a revealing (a) distinct striations on a micropit fracture surface and (b) the same microfractographic feature on the open fracture face of another micropit

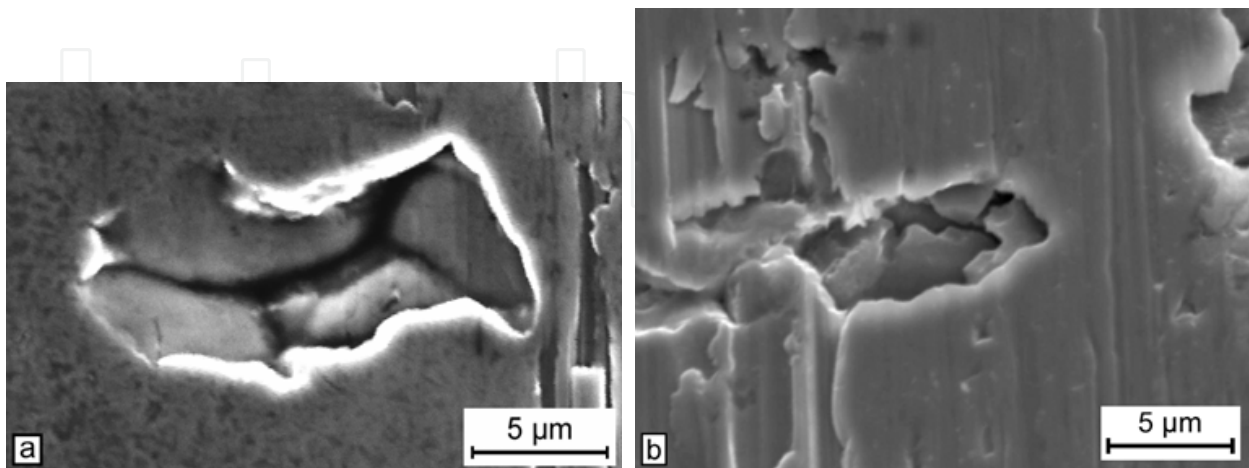
Fig. 48. SEM-SE images of the rolling contact surfaces of (a) a TRB roller and (b) a cam

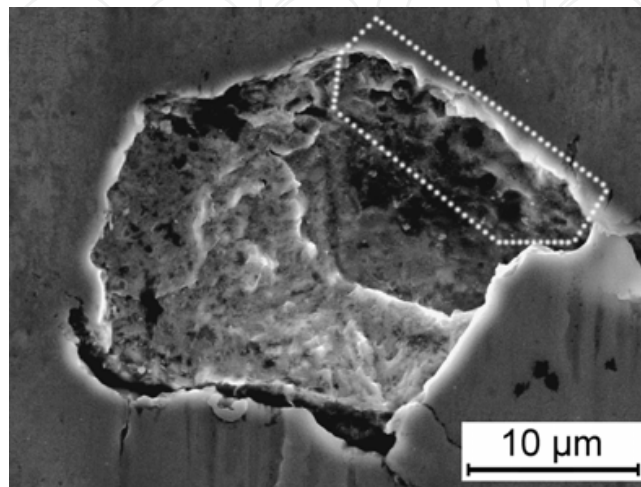
Fig. 49. SEM-SE image of a micropit on the IR raceway of a CRB from a field application
