Tribological Aspects of Rolling Bearing Failures

Jürgen Gegner
SKF GmbH, Department of Material Physics
Institute of Material Science, University of Siegen
Germany

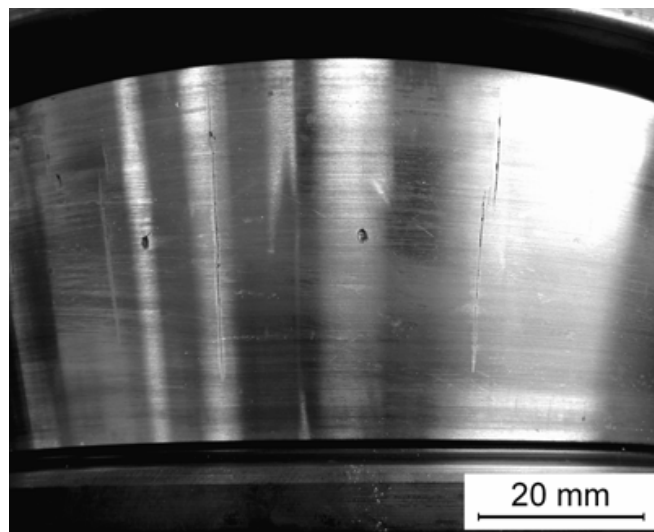
Fig. 50. Macro image of the raceway of a martensitically hardened inner ring out of bearing steel of a taper roller bearing from an industrial gearbox

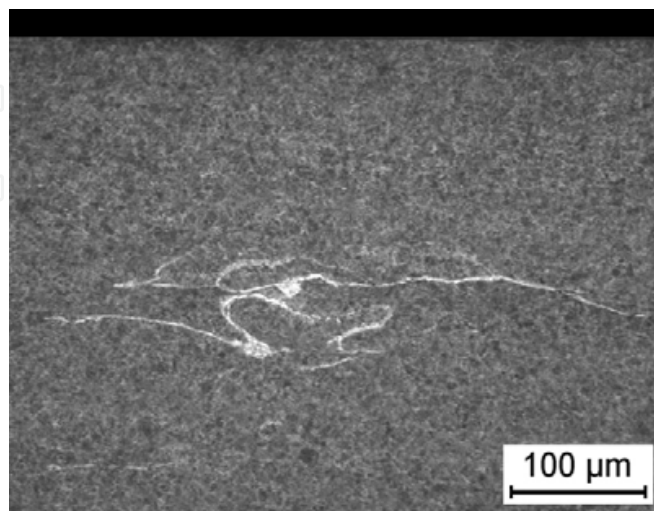
Fig. 51. LOM micrograph of the etched axial microsection of the bainitically hardened inner ring of a spherical roller bearing from a crane lifting unit

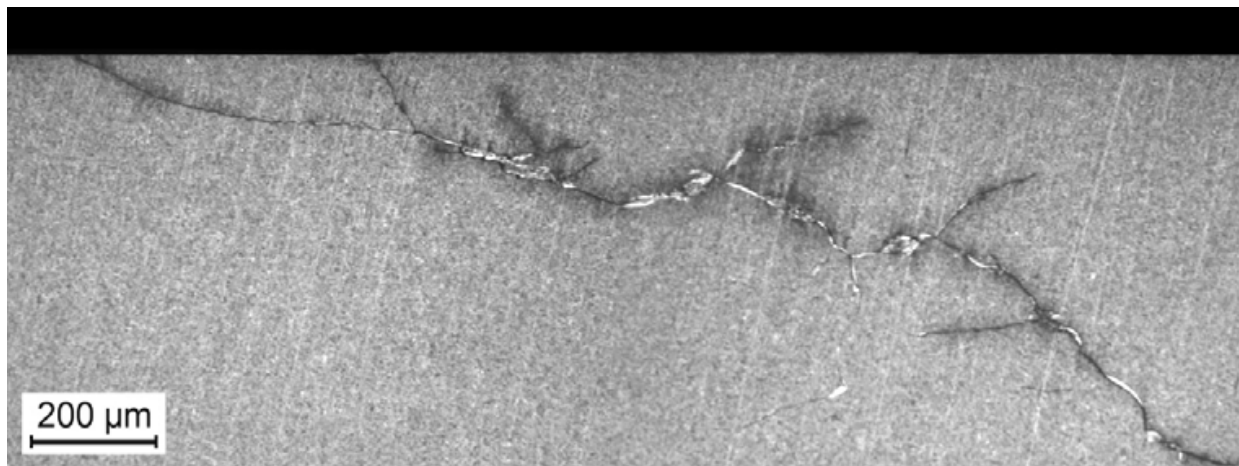
Fig. 52. LOM micrograph of the etched radial microsection of the case hardened inner ring of a CARB bearing from a paper making machine. The overrolling direction is left-to-right

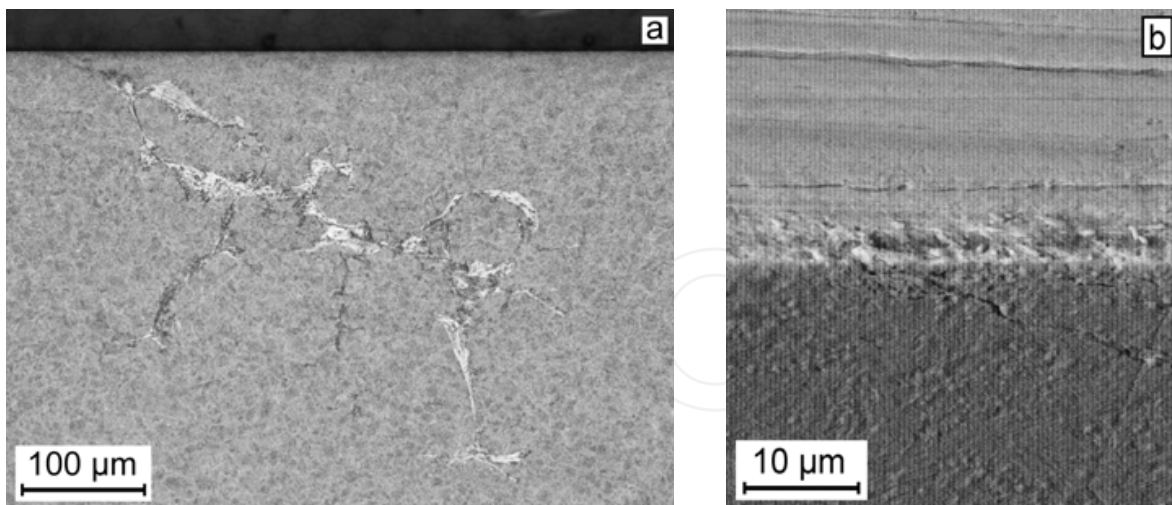
Fig. 53. Investigation of a white etching crack system in the martensitically hardened inner ring of a taper roller bearing from a coal pulverizer revealing (a) a LOM micrograph of the etched radial microsection (overrolling direction from left to right) and (b) a near-surface SEM detail (backscattered electron mode) of the view of the edge of the same microsection

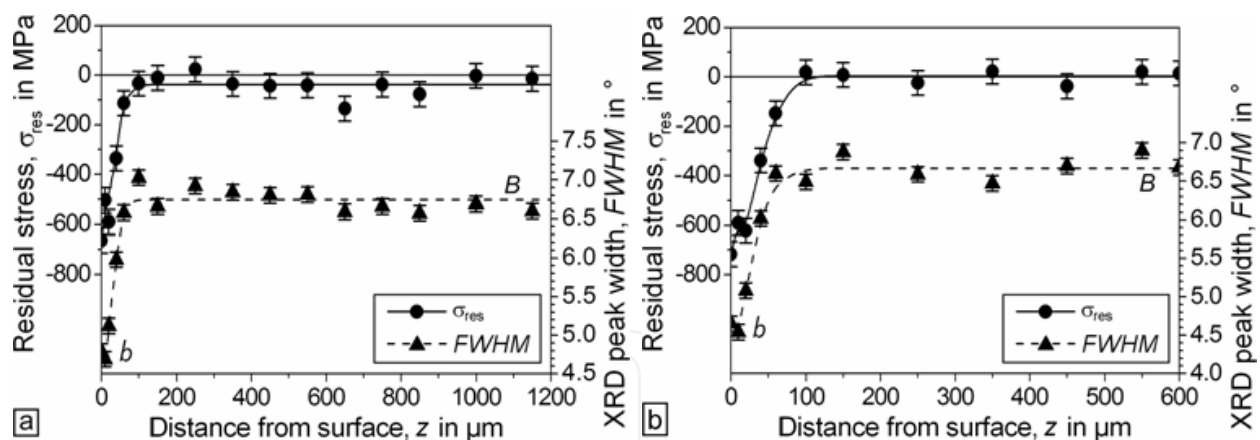
Fig. 54. Material response analysis showing a type A vibration residual stress and XRD peak width distribution below (a) the first and (b) the second raceway surface of the inner ring of a prematurely failed double row spherical roller bearing from a paper making machine

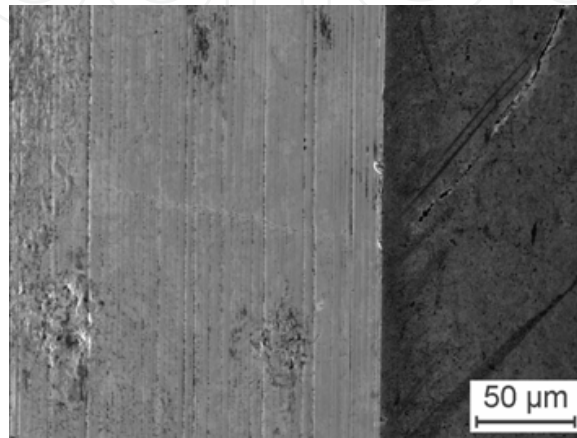
Fig. 55. SEM-SE image of a hairline crack initiation site on the smoothed raceway surface and incipient fatigue crack growth into the material in overrolling direction from bottom to top visible in the cut microsection on the right. The SRB failure of Figure 54 is investigated

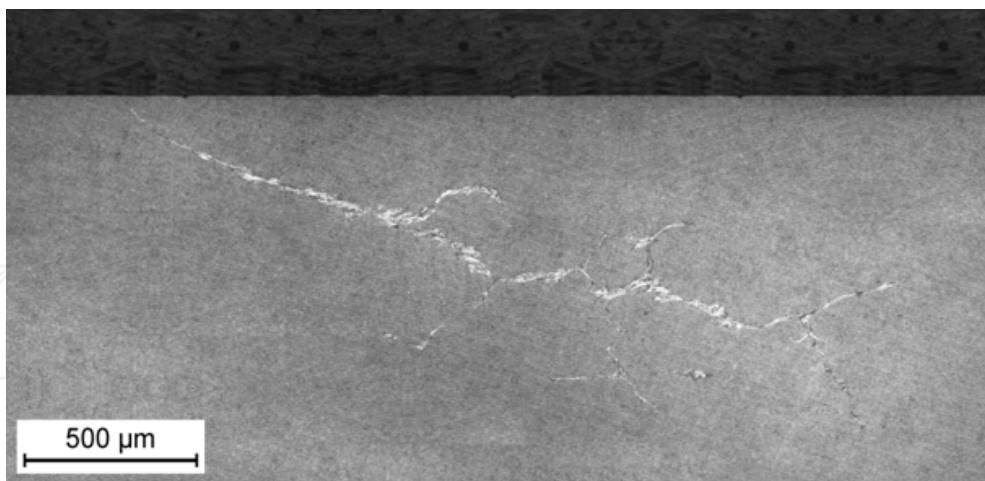
Fig. 56. LOM micrograph of the etched metallographic section on the right of Figure 55. The raceway surface is at the top of the image. The overrolling direction is from left to right

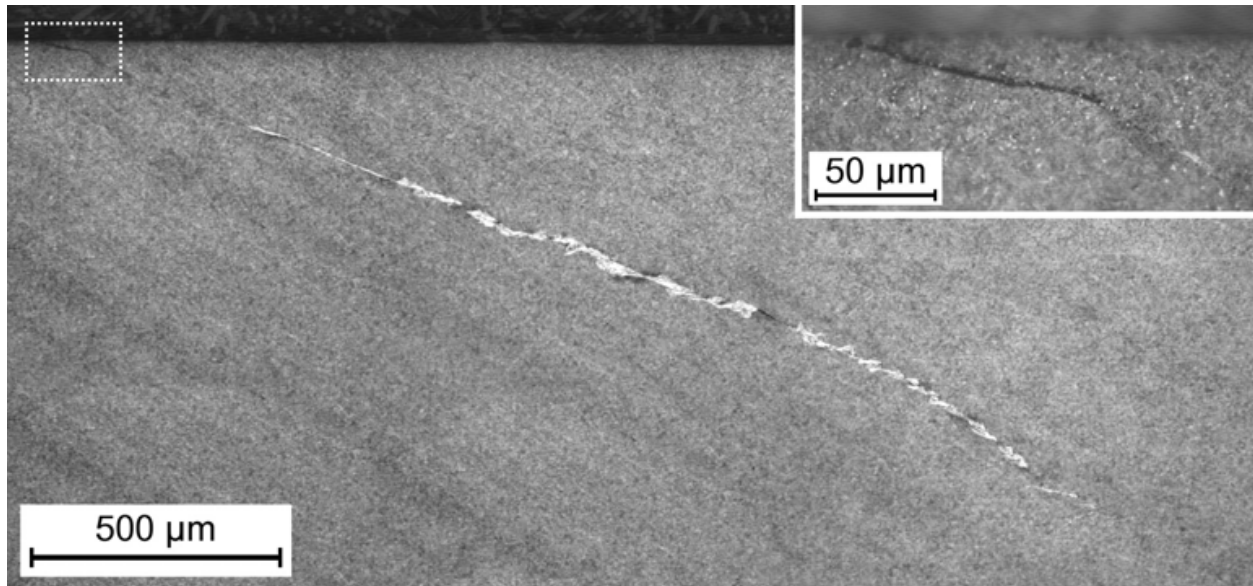
Incipient hairline cracks on the raceway are almost undetectable even in the SEM. The virtually perspective view of the edge of a microsection in Figure 55 provides an example (cf. Figure 53b). A corresponding micrograph of the etched microsection is shown in Figure 56.

Shear stress control of surface fatigue crack initiation, under varying load and friction-defining slip in the contact area, and subsequent propagation is apparent from crack advance in overrolling direction in a small angle to the raceway tangent. The mechanism is particularly evident from the unbranched crack in Figure 57. The inset zooms in on the edge zone. Compressive residual stresses near the surface (cf. Figure 54) demonstrate the effect of

shear stresses required for crack development. According to Figure 58, extended white etching crack systems up to a depth of more than 1 mm are formed, where crack returns to the raceway result in pitting by break-out of the surface eventually. Note that in Figures 56 to 58, the overrolling direction from left to right strikingly indicates top-down WEC propagation.

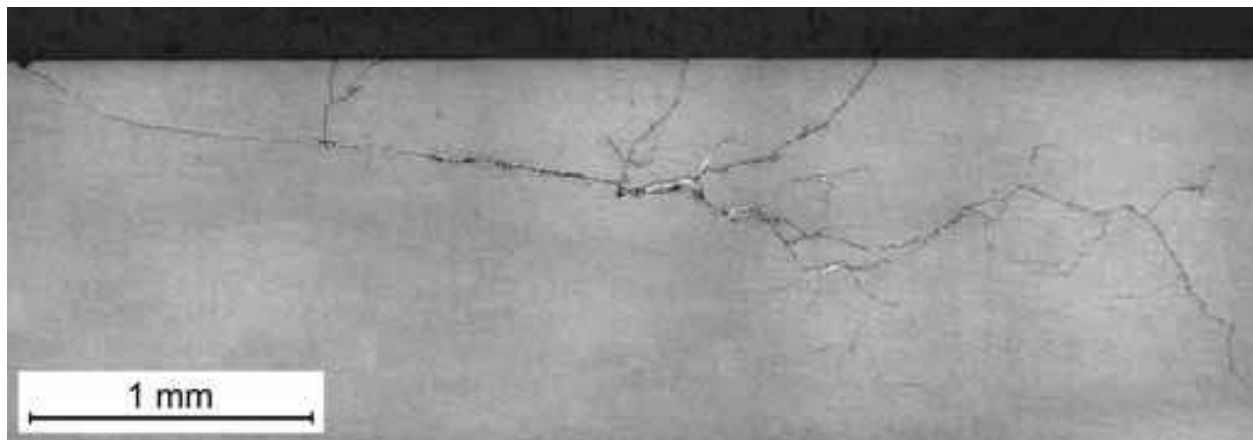
Fig. 57. Same as Figure 56, another crack. The overrolling direction is from left to right

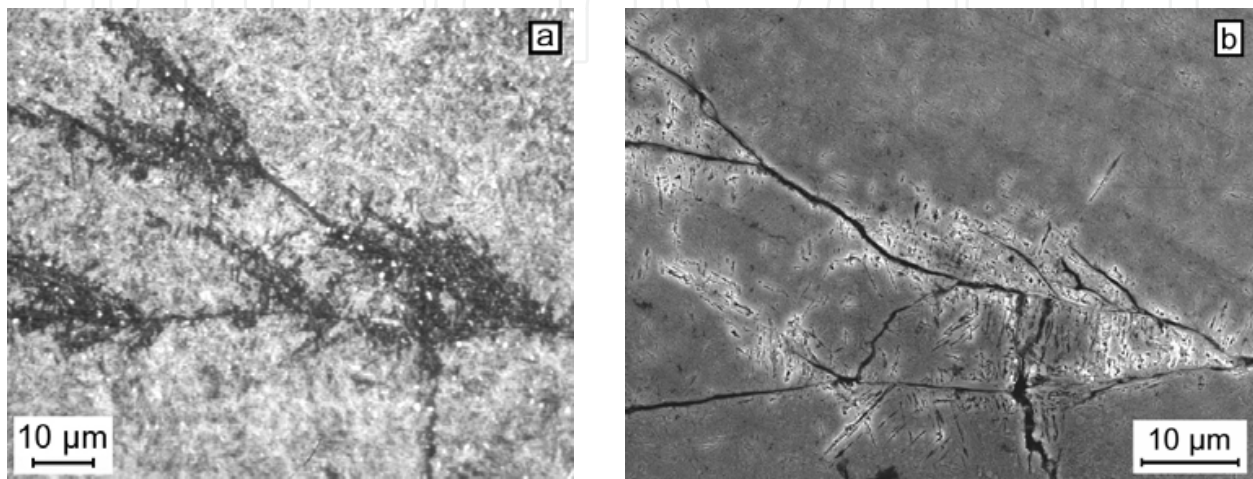
Fig. 59. DER around CFC crack paths indicate localized material aging in (a) a LOM and (b) a SEM micrograph of an etched microsection of the IR of a TRB from an industrial gearbox

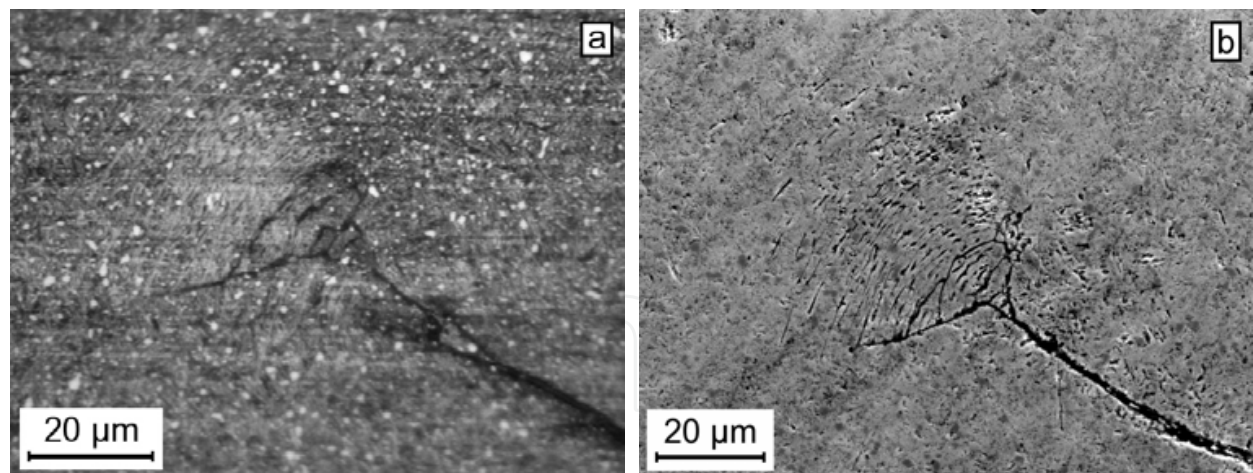
Fig. 60. Carbide dissolution and distinct localized plastification at the multi-branching tip of a CFC crack visible in (a) a LOM and (b) a corresponding SEM micrograph of an etched radial microsection of the inner ring of a cylindrical roller bearing from a weaving machine

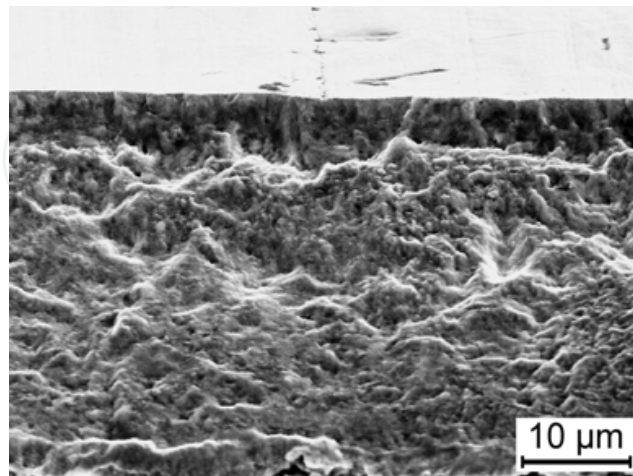
Figure 62 completes the investigation of the SRB failure of Figures 54 to 58. The fracture face of a preparatively opened crack at the initiation site on the surface is shown. The inner ring raceway is visible at the top. Following the brittle incipient crack of about 5 µm depth, dense striations indicate the fatigue nature of crack propagation almost from the surface.

Fig. 62. SEM-SE fractograph of the original fracture surface of a subsequently opened raceway crack on the inner ring of the spherical roller bearing of Figures 54 to 58

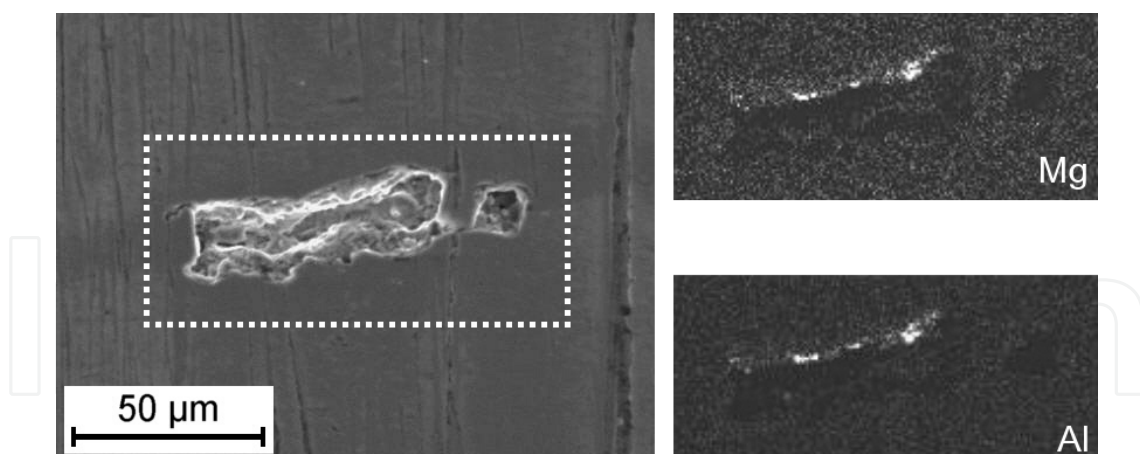
Figure 63 reveals a micropit on the smoothed inner ring raceway of a CARB bearing from a paper making machine. Material removal is caused by a brittle Mg-Al-O spinel inclusion that breaks off from the surface under tribomechanical loading of the rolling-sliding contact.

Fig. 63. SEM-SE image of the IR raceway of a CARB bearing and indicated elemental mapping (on the right) revealing an oxide inclusion (Al and Mg detected) that breaks off from the surface under frictional rolling contact loading to cause a micropit eventually

In Figure 63, the demonstrative elemental distribution images of magnesium and aluminum are mapped over the damaged region. Sharp-edged axial surface cracks on tribochemically dissolved MnS inclusions (see section 5.2, e.g. Figure 42a), which advance vertically downwards into the material (Nierlich & Gegner, 2006), as well as grain boundary cleavage (cf. Figure 48) further indicate the action of frictional tensile stresses. Another type of failure

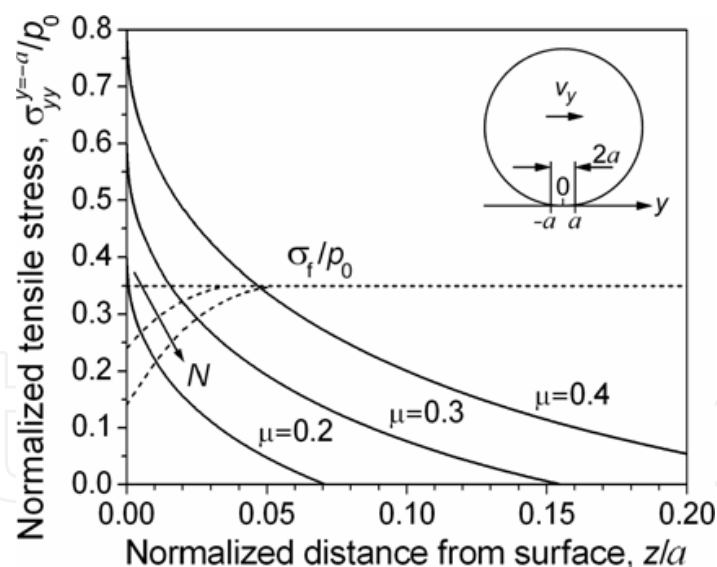
The relationships of Eqs. (9) and (10) hold for the elliptic coordinates. Figure 64 shows a graphical representation of calculated depth distributions for increased friction coefficients μ of 0.2, 0.3 and 0.4. On the raceway surface at $z=0$, maximum tension of $2\mu p_0$ is reached.

Fig. 64. Normalized distribution of the equivalent normal stress below a rolling-sliding contact (rolling occurs in y direction at velocity v_y, see inset) and indication of the level of the critical fracture strength $\sigma_f \approx R_e$ for typical peak loading with illustration of the expanding failure range by gradual in-service surface embrittlement (cf. section 5.4) with running time

As spontaneous incipient crack formation is considered, the illustration of Figure 64 realistically refers to short-term loading of high Hertzian pressure $p_0 \geq 2000$ MPa and friction coefficient $\mu \geq 0.2$. Rough indication of the relative σ_f/p_0 level occurs accordingly. Note that the exact magnitude of the fracture strength $\sigma_f \leq R_{p0.2}$ does not make an essential difference to the validity of the introduced normal stress failure hypothesis but only influences the frequency of the rare events of raceway cracking as critical peak load operating conditions can cause tensile stresses $2\mu p_0 \approx 2000$ MPa on the surface. The length of the brittle mode I propagation of a frictionally initiated cleavage-like raceway crack depends on the stress intensity factor K_I and the fracture toughness K_{Ic} according to $K_I > K_{Ic}$. The depth effect of operational material embrittlement (see section 5.4) on the critical fracture strength σ_f (also valid for K_{Ic}), which increases with the number N of ring revolutions, is schematically included in Figure 64, where larger size bearings with a in the range of 0.5 mm are considered. A concrete calculation example is given in the literature (Nierlich & Gegner, 2011). The semiminor axis a of the contact ellipse influences the extension of the failure range according to Eq. (12) and Figure 64. The micro friction model of Figure 36 is regarded. As deduced in section 5.1 from the effect of the induced equivalent shear stresses on plastification and the resulting type A or B residual stress patterns, vibrational loading can intermittently cause locally increased mixed friction. Under peak load operating conditions, such short-term states generally coincide with the impact of high Hertzian pressures. As the detection of type A residual stress distributions (see Figure 54) indicates, friction coefficients

Further fractographic verification of normal stress failures is provided in the following. The steep gradient of the causative frictional tensile stress in Figure 64 indicates limited advance and rapid stop of an initiated brittle spontaneous mode I surface crack. The fracture faces of two preparatively opened vertical axial raceway cracks in the SEM images of Figures 66 and 67 confirm this prediction. The development of the (semi-) circular shape of the spontaneous cracks may be described by the depth dependence of the stress intensity factor and an energy balance criterion to minimize the interface energy.

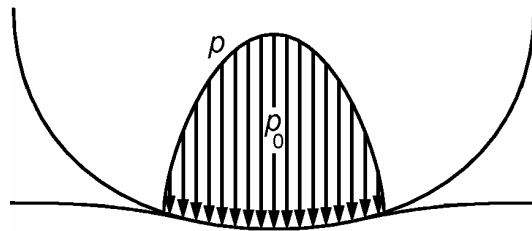
Note that Figure 1 represents the stress field in the center of the Hertzian contact area. At the runout ($y=-a$, see inset of Figure 64), where the maximum sliding friction induced circumferential tensile stresses of Eq. (7) occur in the surface zone of the material, the hydrostatic pressure reduces to zero. A graphical illustration is provided in Figure 65.

Fig. 65. Schematic representation of the macro contact area with elliptical Hertzian distribution of the pressure p (maximum p_0 in the center is indicated)

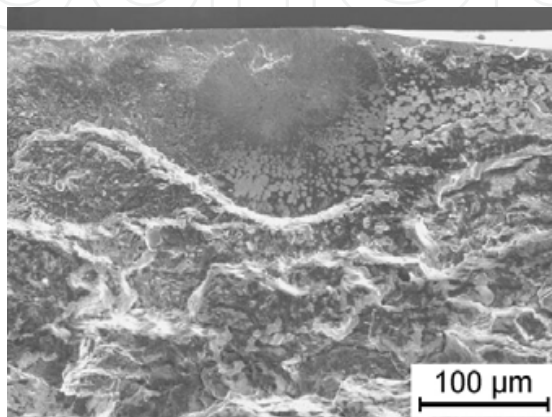
Fig. 66. SEM-SE fractograph of the original fracture surface of a preparatively opened axial crack on the inner ring raceway of a failed taper roller bearing from an industrial gearbox

The low-deformation transcrystalline lenticular cracks of about 150 μm depth act as incipient cracks of subsequent corrosion fatigue cracking into the depth, to the sides and on the surface. The distinct change of the fracture pattern in Figures 66 and 67, respectively with a demarcating bulge or crack network, on the latter of which Figures 68a and 68b zoom in, is evident. The crack arrest indicating numerous side cracks in Figure 68 reflect local material embrittlement as observed in the affected DER microstructure around CFC cracks in the SEM micrographs of etched microsections in Figures 59b and 60b.

In the area of the spontaneous crack of Figure 66, a mixed TiCN-MnS nonmetallic inclusion near the raceway surface in a depth of about 25 μm acts as stress ra

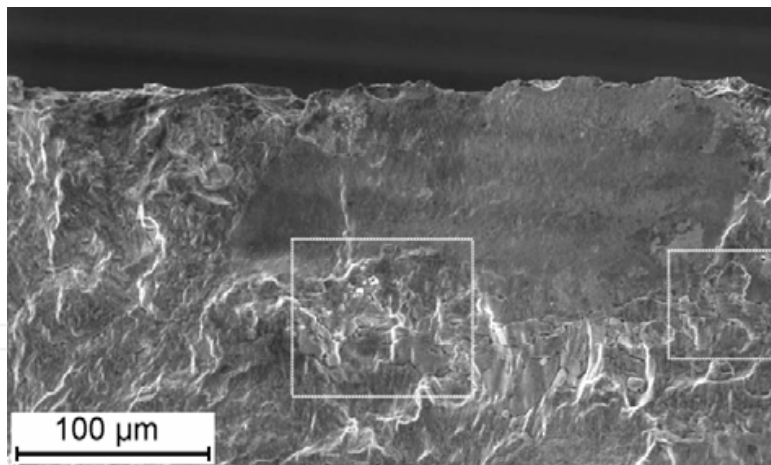
Fig. 67. SEM-SE fractograph of the original fracture surface of a preparatively opened axial crack on the inner ring raceway of a failed taper roller bearing from an industrial gearbox

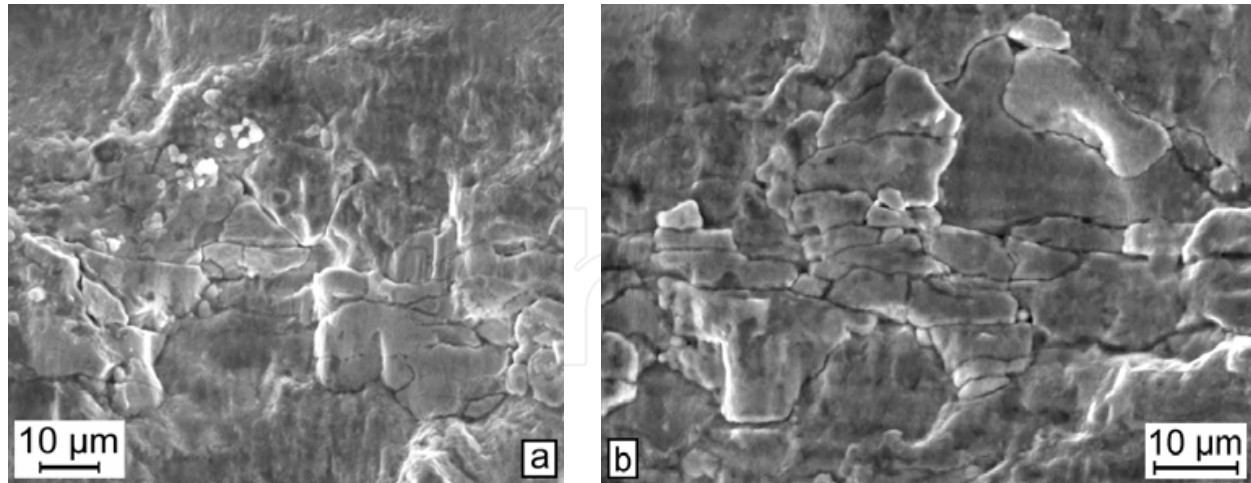
Fig. 68. SEM-SE details of Figure 67 as indicated (a) in the lower middle and (b) on the right

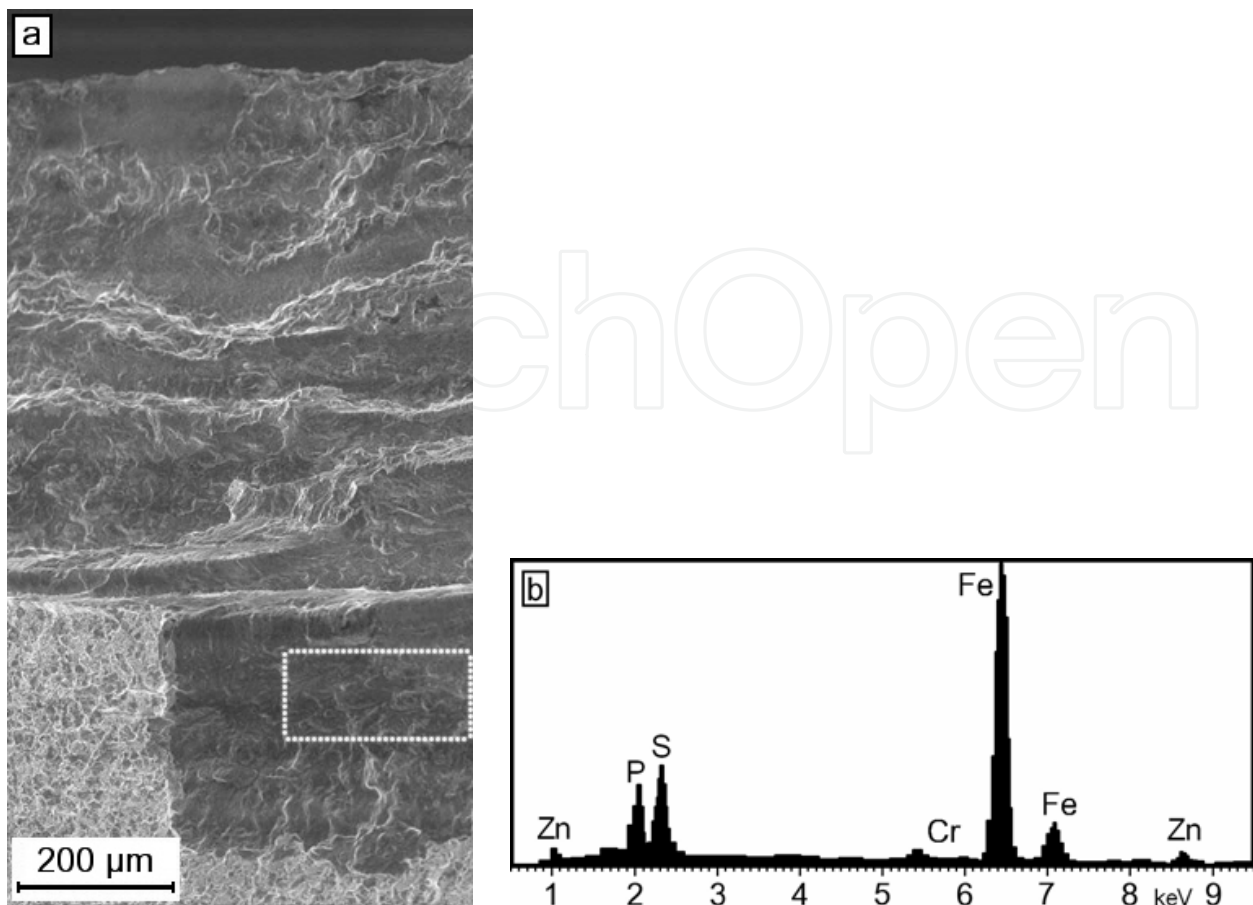
Hydrogen releasing aging reactions of the lubricant during corrosion fatigue crack growth are proven by EDX microanalysis on preparatively opened fracture surfaces. As an example, Figure 69a shows an overview of the deep CFC region below the brittle lenticular crack of Figure 67. The area of the performed EDX analysis is marked in the SEM fractograph. Sulfur, phosphorus and zinc in the recorded spectrum of Figure 69b indicate reacted residues of oil additives near the crack tip in a depth of about 1 mm in higher concentration than on the low-deformation spontaneous incipient crack visible at top left of Figure 69a, where chemical attack is restricted to subsequent surface corrosion. Furthermore, numerous side cracks characterize corrosion fatigue fracture faces (see also, for instance, the microsections of Figures 56, 58 and 59). The forced rupture from preparative crack opening stands out clearly at the bottom and bottom left of Figure 69a against the dark original CFC fracture structure.

Fig. 69. Investigation of the fracture surface of Figure 67 in the deep corrosion fatigue crack region revealing (a) a SEM-SE fractograph and (b) the EDX spectrum taken at the indicated position where the presence of the tracer elements S, P and Zn of the oil additives proves the assistance of fatigue crack growth by chemical reactions, i.e. CFC, in a depth of 1 mm

It is worth noting that post-machining thermal treatment (PMTT) of ground and honed rings and rollers, previously proposed in the literature for material reinforcement in the mechanically influenced edge zone (Gegner, 2006b; Gegner et al., 2009), is recently reported to be an effective countermeasure against premature bearing failures by white etching crack formation (Luyckx, 2011). The short reheating process of, e.g., 0.5 to 1 h after the finishing operation occurs below the tempering or transformation temperature to avoid undesired hardness loss (cf. section 4.2, Figure 23). As only the plastically deformed material in the outermost layer up to a depth of about 10 μm is microstructurally stabilized, a success of this simple treatment would provide further indication of surface WEC failure initiation.
