Seismic Performance of Masonry Building

Xiaosong Ren, Pang Li, Chuang Liu and Bin Zhou
Institute of Structural Engineer and Disaster Reduction, Tongji University,
China

2. Seismic damage caused by 5.12 Wenchuan earthquake

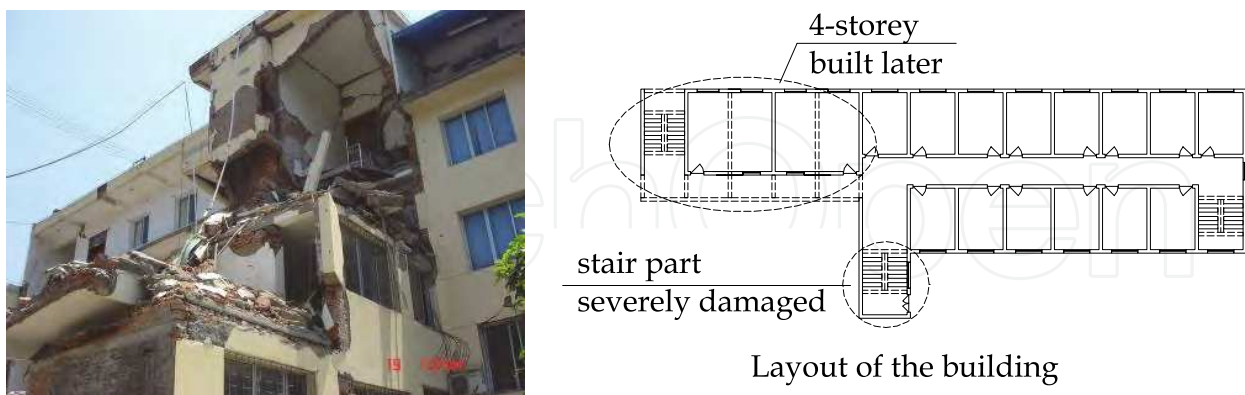
Comparing with the other parts, the damage of stair part is relative severe because of the relative large stiffness of the slope structural members. Fig. 3 shows the severe damage of the stair part in the building with irregular plan. From the layout of this building, it is seen that the stair part is the convex part of the T-shaped plan.

Fig. 3. Partial collapse of stair part

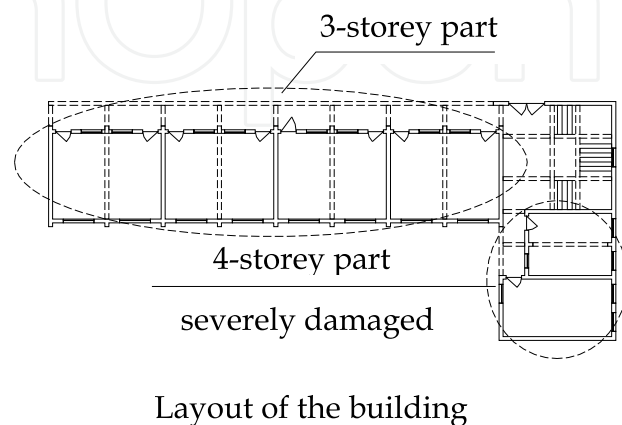
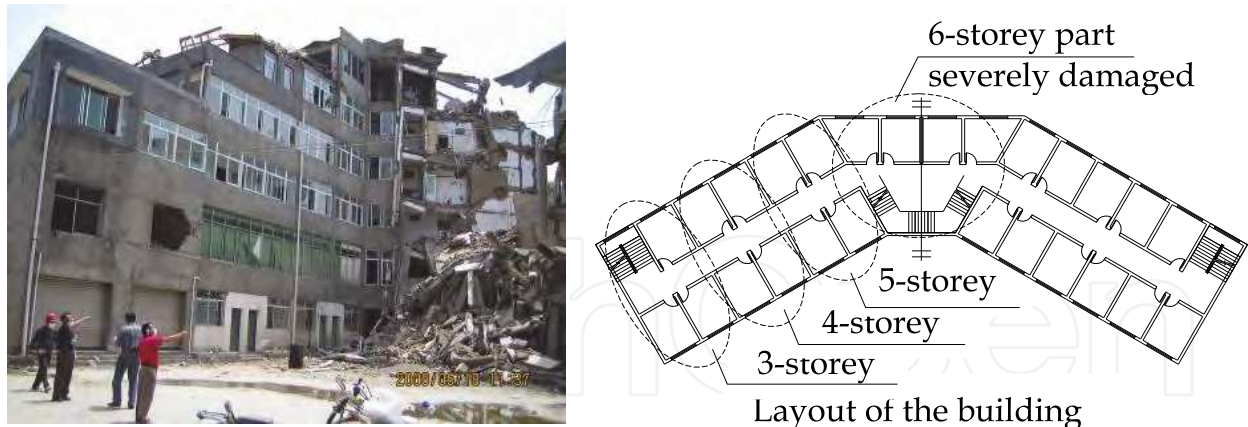
Two examples are given here to show the harmful influence of structural irregularity on the building damage. Fig. 6 shows the severe damage of the L-shaped building with unequal height. Fig.7 shows the severe damage in the part of staggered elevation.

severely damaged

Fig. 6. Severe damage of masonry buildings with plan irregularity

Fig. 7. Severe damage of masonry buildings with elevation irregularity

More attention to enhance the structural ductility should be paid to the irregular structures if the seismic joint is not feasible to set, although separating the irregular structure into regular parts by seismic joint is a simple and good way in usual condition. Try to avoid the structural system of one bay transverse bearing wall with outside corridor supported by the cantilever beam.

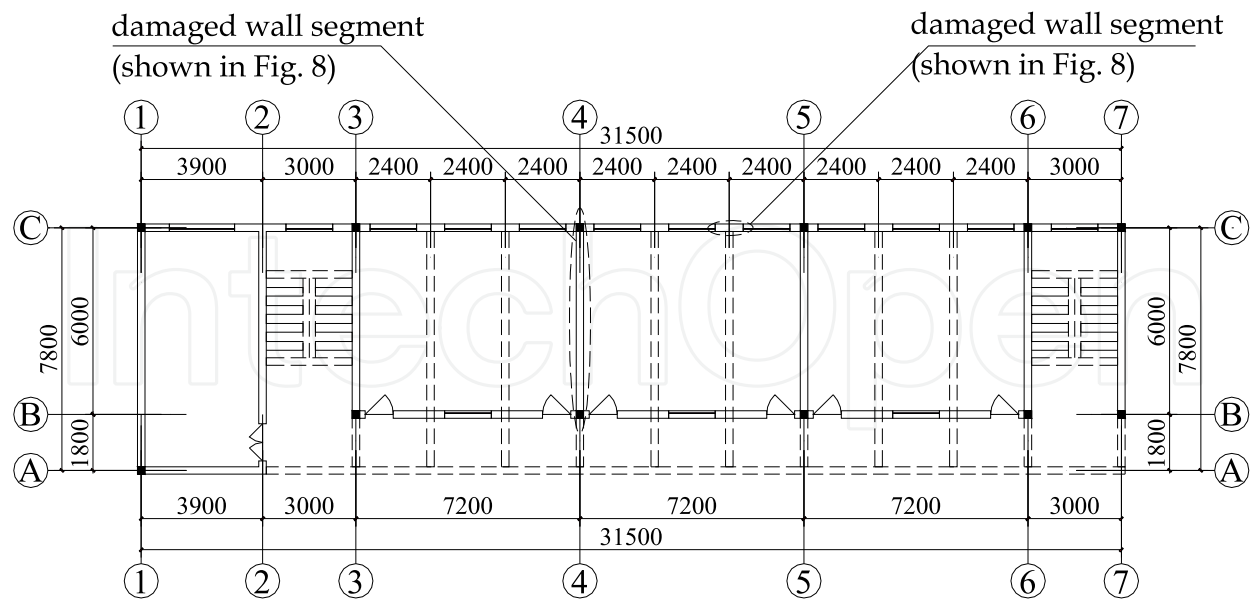
Fig. 9. Structural layout and the position of the severely damaged wall segments

Qualified result under minor earthquake is shown in Fig.10, as the strength check parameter is larger than 1. The damaged wall segments as shown in Fig. 9 are verified to be the most dangerous segment in transverse and longitudinal direction because of the smallest value of shear strength check parameter, which are 1.26 and 2.19 respectively.

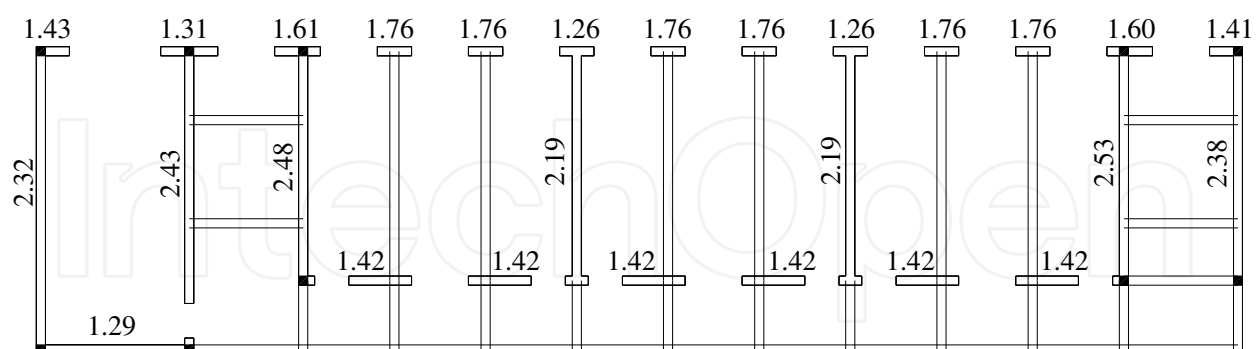
Fig. 10. Shear strength check parameter of the bottom storey

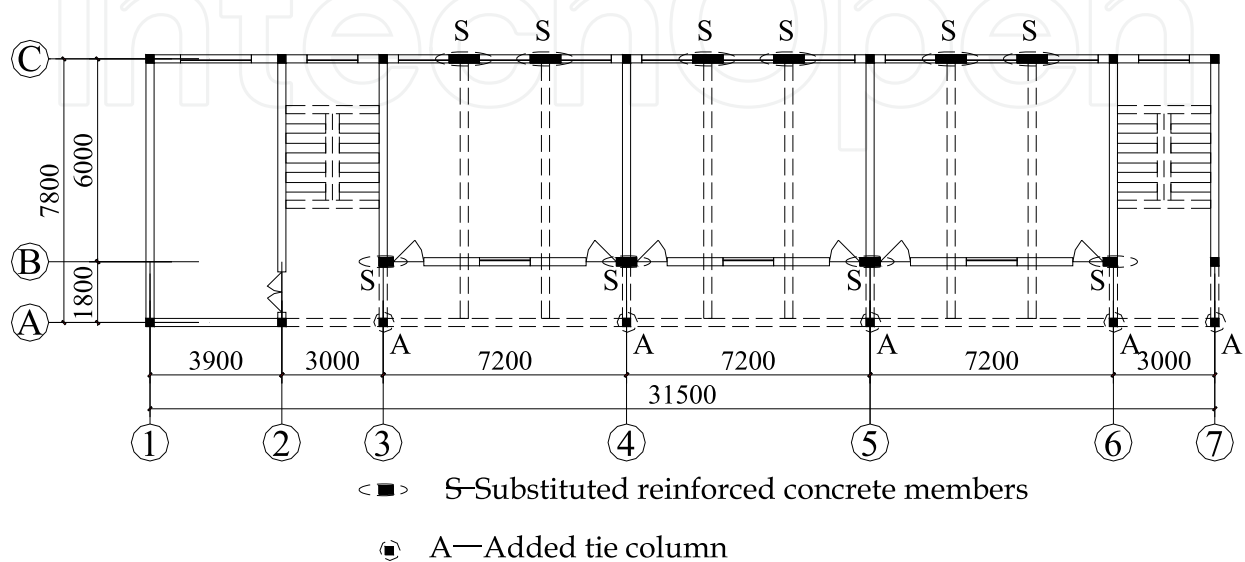
Fig. 13. Strengthened structural layout

The damaged school building is illustrated here as an example here to demonstrate the authors' suggestion. As less tie columns are set, it is suggested to strengthen the structure in the longitudinal direction. As shown in Fig. 13, the small wall segments in axis B and C

should be substituted by reinforced concrete member with section 900mmX240mm, while the reinforced concrete tie-columns should be set in axis A at the outside corridor part.

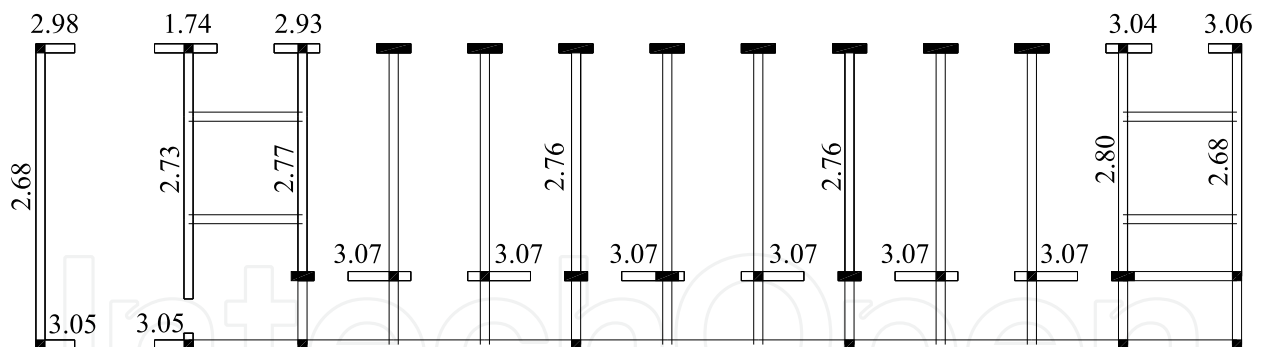
Similar structural analysis by PKPM software is done for strength check under minor earthquake. The main results are shown in Fig, 14 and Table 3. By comparison with Fig.10, it can be seen that the shear strength check ratio along transverse direction is raised from 2.19-2.53 to 2.68-2.80 and the parameter along longitudinal direction is raised from 1.26-1.76 to 1.74-3.07. The strengthened scheme can greatly enhance the seismic capacity.

Fig. 14. The shear strength check parameter of the bottom storey of strengthened scheme

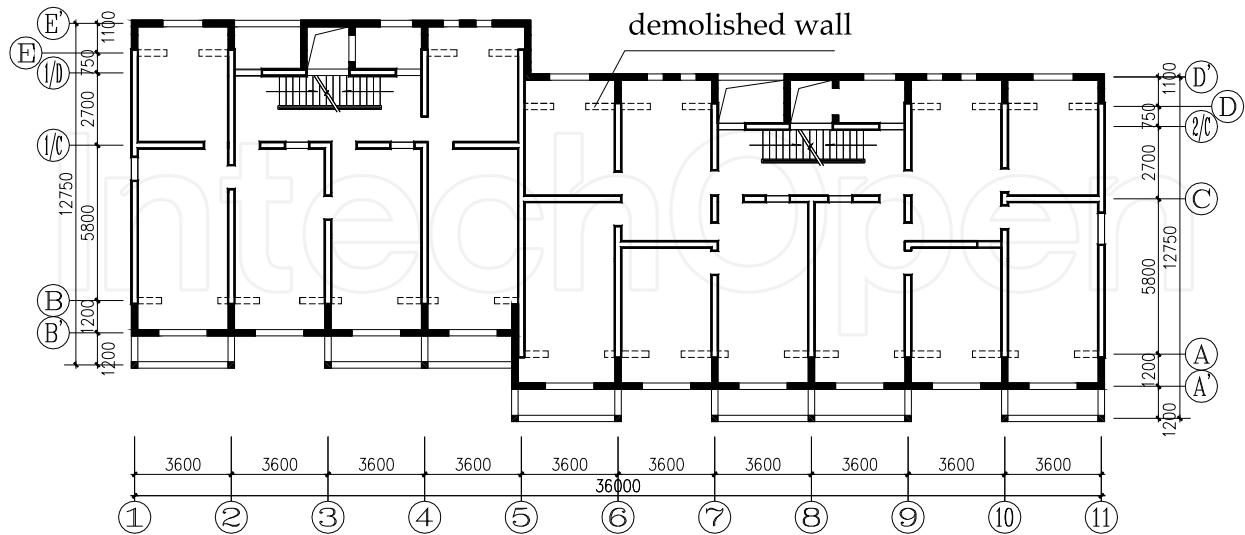
The structure is a supported-on-transverse-wall system while the stair part is a supported-on-longitudinal-wall subsystem. Reinforced concrete ring beams are set in every floor, but no tie column is set. And prefabricated slab is used for floor. It is found that the potential capacity in vertical direction is exerted for the static strength demand of adding storey while the capacity of seismic resistance is insufficient, especially in longitudinal direction. For the difficulty to retrofit the structure by direct method, the strengthening strategy of load transferring is applied here for the improvement of poor seismic capacity. In Fig.18, the dashed lines represent the demolished walls while the black lines represent the parcelled reinforced concrete members.

Fig. 18. Structural layout after comprehensive transformation

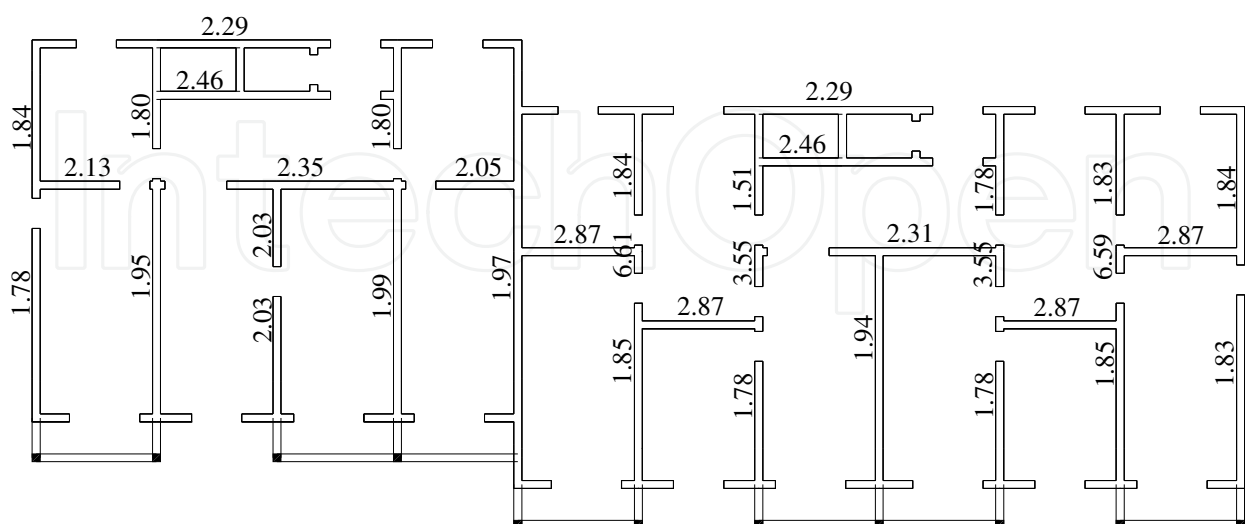
An eight storey model is established by PKPM software. The overhead floor is treated as the first storey in the model, and the added floor including the duplex part is treated as the eighth storey in the model with the load of one and half storey on it. Detailed results of shear strength check are got. The weakest structural member is located in the 2nd floor, which is shown in Fig. 19. The seismic performance is effectively enhanced.

Fig. 19. The shear strength check parameter of the second storey
