Compressive Creep Behavior of NEXTEL™ 720/Alumina Ceramic Matrix Composite at 1200°C in Air and in Steam Environment

THESIS

Neil R. Szymczak, Ensign, USN

AFIT/GAE/ENY/07-J20

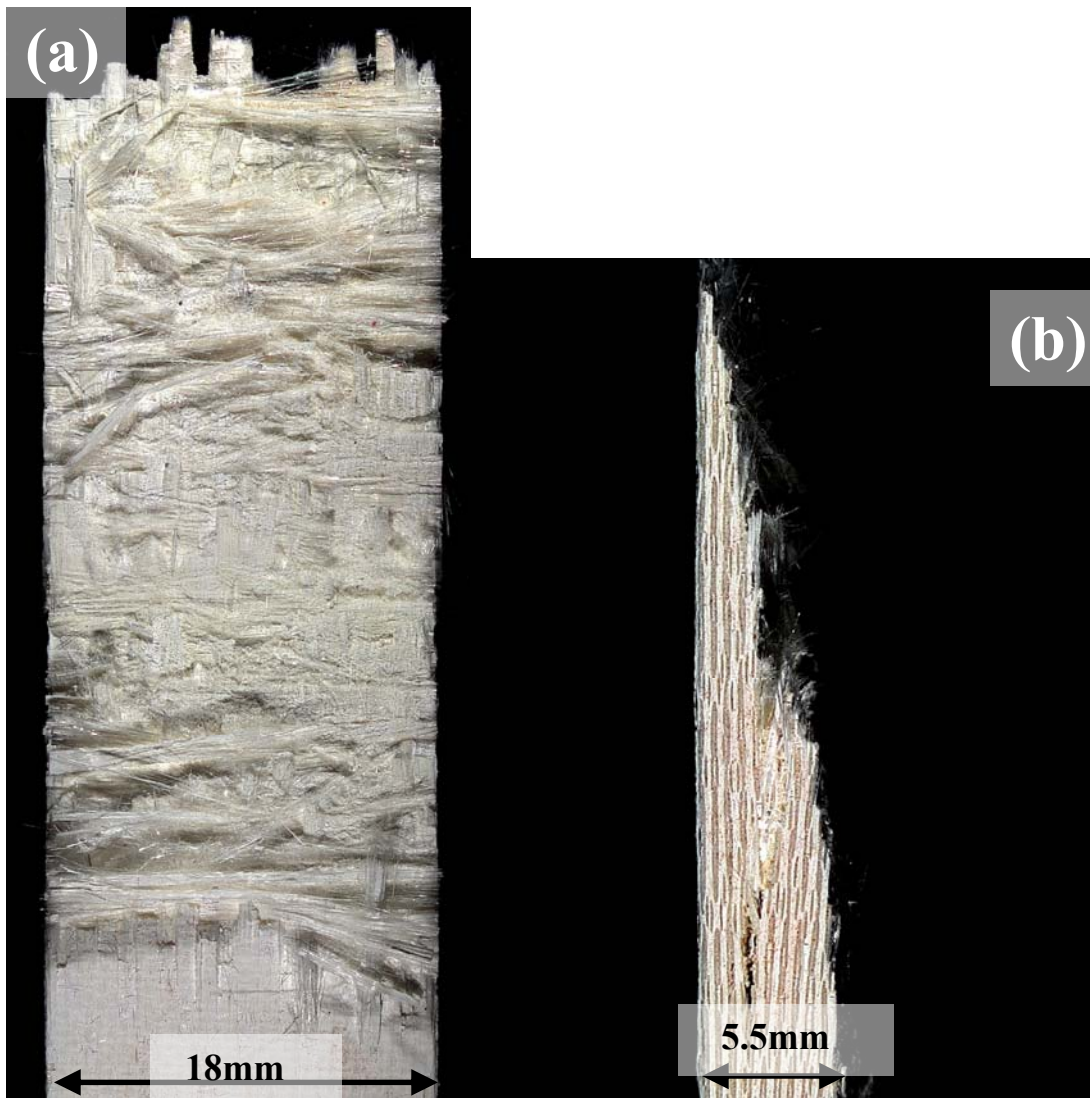
mechanism observed in this compression to failure specimen is shearing of the fibers and matrix. The fracture is not extremely clean; however, there is a distinct stair-step pattern which is easily seen in Figure 33b. The side view also reveals that some delamination occurred during failure. This failure mode is common among dense matrix CMCs with a fiber coating (weak interface). It is important to note that only 9.0 seconds elapsed before the specimen in Figure 33 failed at a compressive stress of 122 MPa.

Figure 33. Fracture surfaces of N720/A specimen tested in compression to failure at 1200°C in laboratory air: (a) top view, (b) side view.

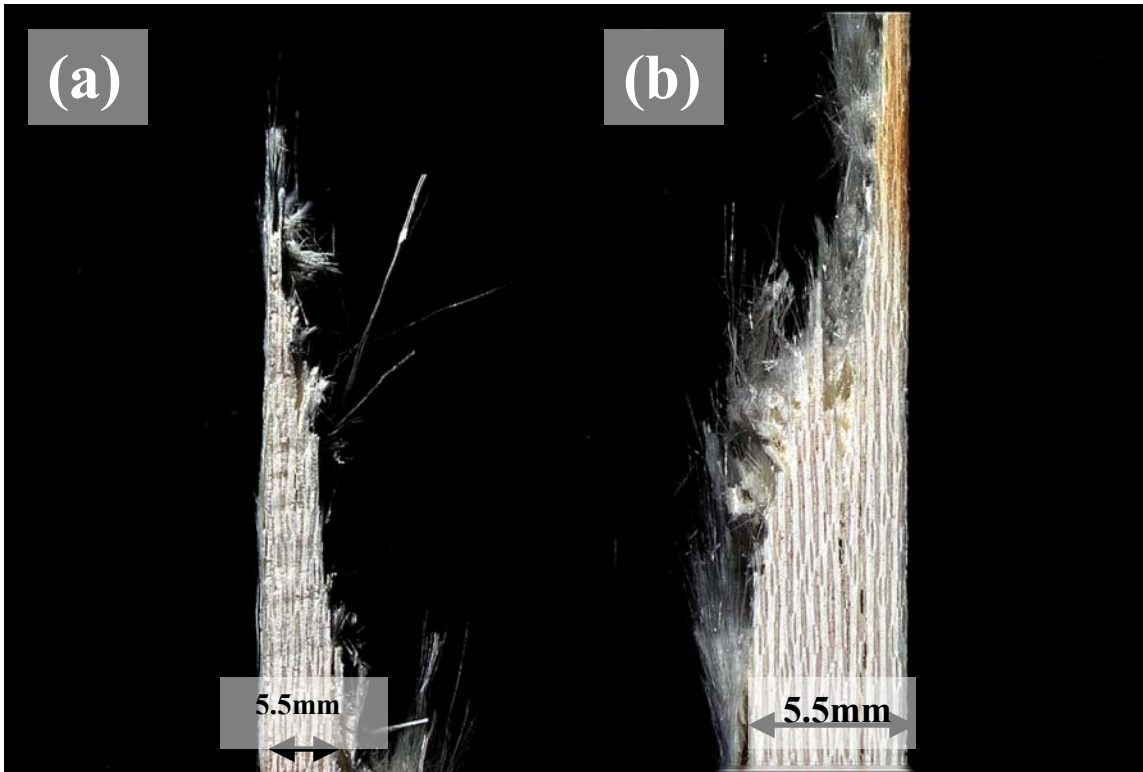
Figure 35. Fracture surfaces of N720/A specimens subjected to compressive creep tests at 1200°C in air: (a) -60 MPa side view and (b) -100 MPa side view.

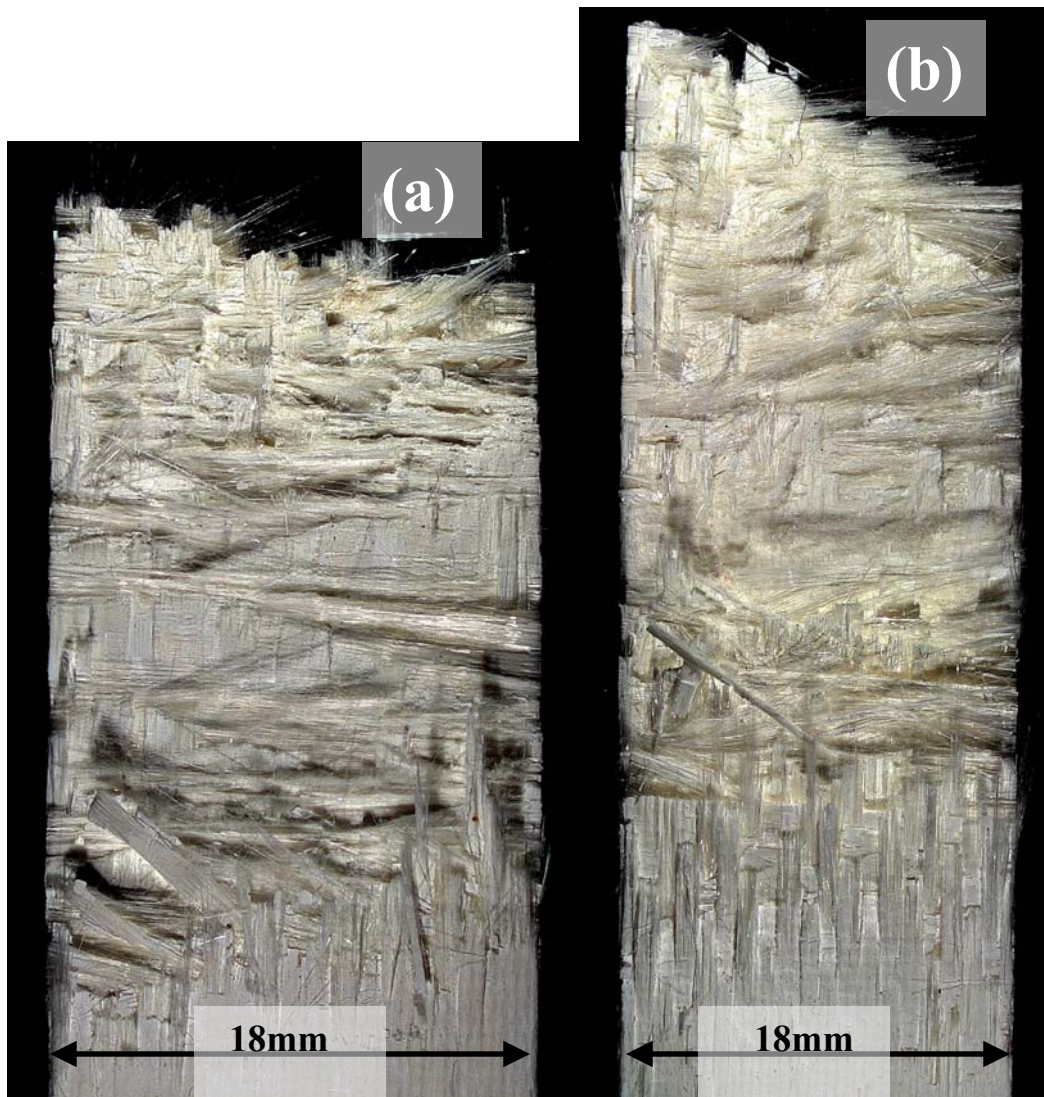
steam at 1200°C. All three fracture surfaces show a significantly denser matrix, however data obtained during this investigation suggests that in steam this matrix coarsening/densification does not translate into matrix strengthening. In this case the dense matrix appearance is an indication of both grain growth and hydrothermal softening of α-alumina yielding a decreased compressive performance. It is important to note that none of these specimens achieved creep run-out of 100 h and consequently failed in creep loading.

Figure 36. Fracture surfaces of N720/A specimens subjected to compressive creep tests at 1200°C in steam: (a) -100 MPa, (b) -60 MPa, (c) -40 MPa.

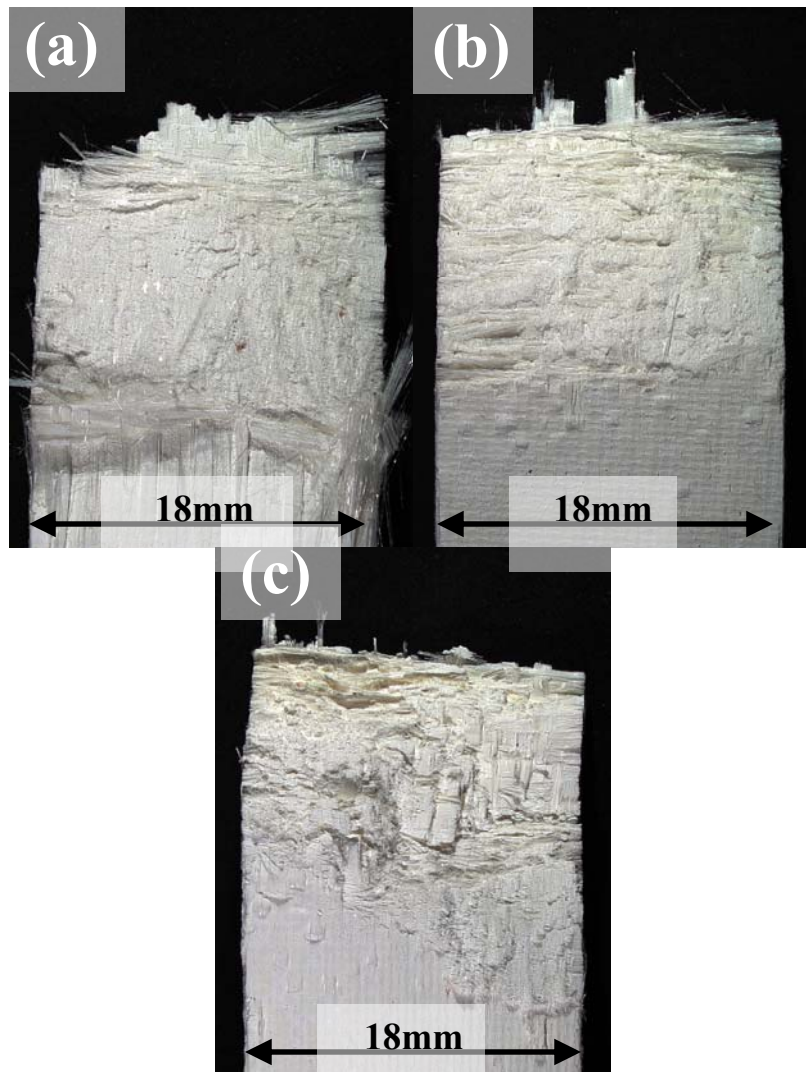
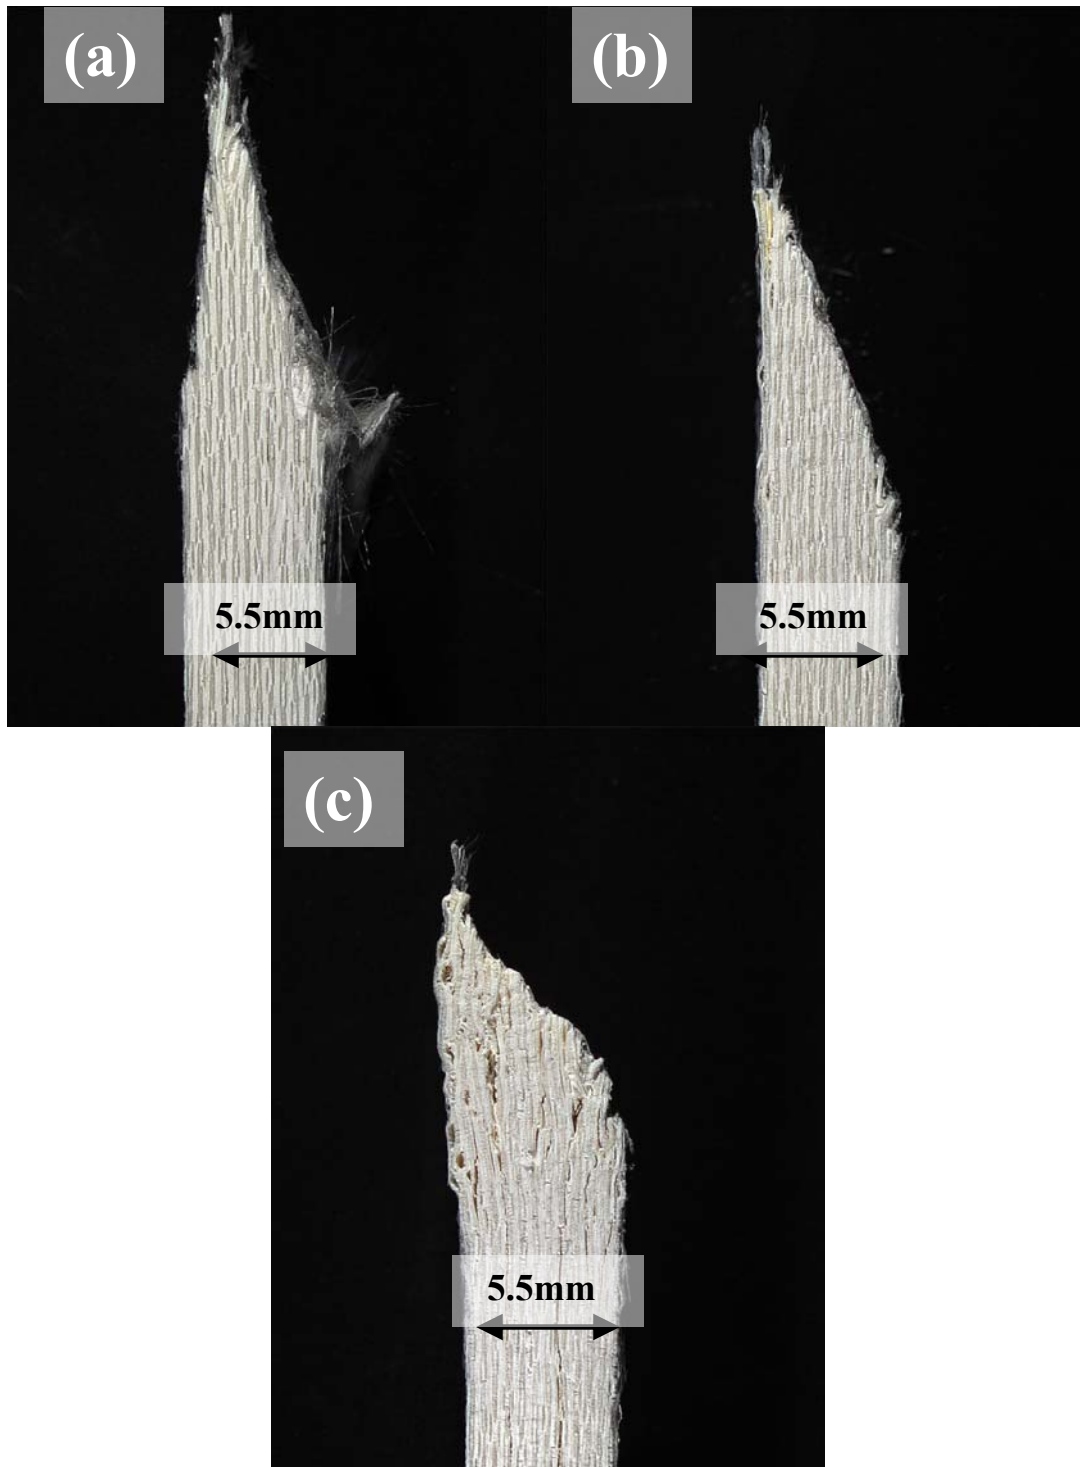
The most noticeable difference between the fracture surfaces produced in creep tests conducted in steam and those produced in air is the length of the damage zone. Specimens tested in creep in steam produced much shorter damage zones. Accompanying this shorter fracture zone is a denser appearance indicated by a coalescence of failure for both fibers and matrix. The stair-step topography of the fracture surface seen in creep tests performed in air is not present in the fracture surfaces obtained in steam due to the fact that steam "softens" the matrix, making it adhere more readily to the fibers. As a result of matrix coarsening and densification coordinated fiber fracture is observed. The side views in Figure 37 show the "smooth" nature of the fracture surfaces obtained in steam. Brushiness that characterizes failure surfaces obtained in compression of N720/A in laboratory air is not present in the fracture surfaces produced in steam. Although minor cracking is present in the 40 MPa specimen, only very little delamination is observed in the fracture surface of N720/A specimen tested in creep at -40 MPa in steam. This is due to the fact that the matrix is weakened and fails at a lower load.

Figure 37. Damage Zones: compression to failure of N720/A specimens failed in creep in steam at 1200°C: (a) -100 MPa side view, (b) -60 MPa side view, (c) -40 MPa side view.

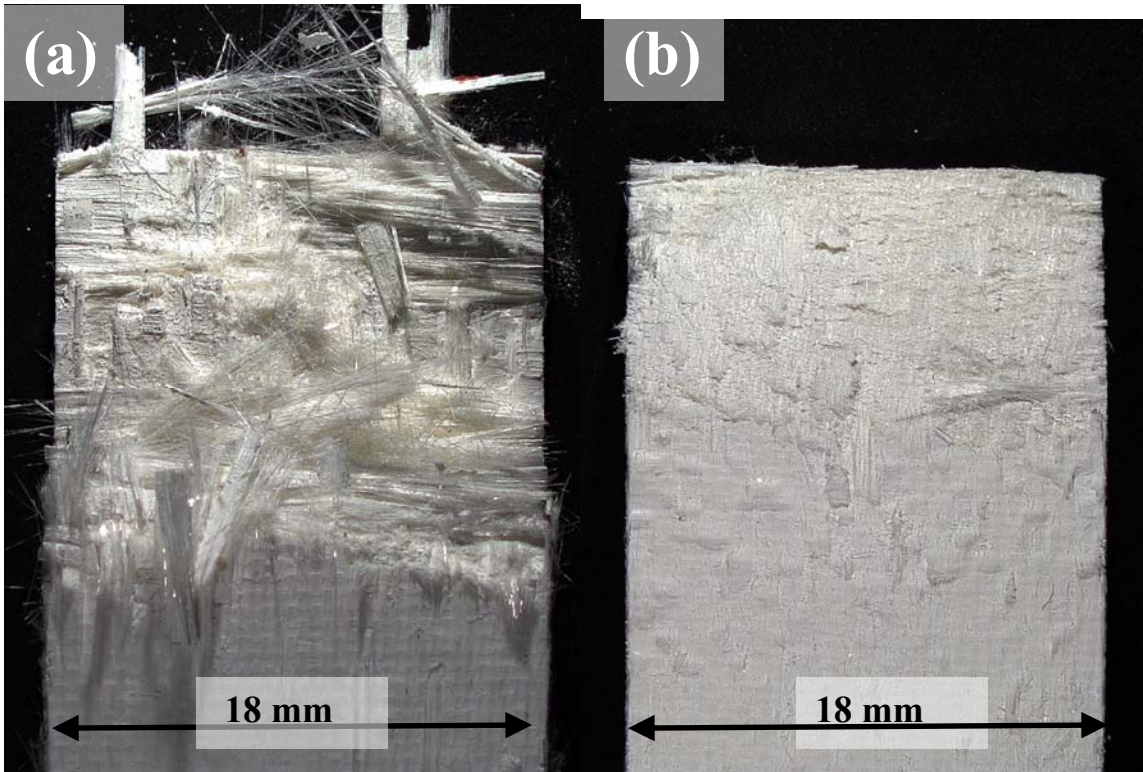
The specimen tested in a laboratory air environment at a load rate of -0.0025 MPa/s exhibits similar characteristics to the as-processed sample tested in air at -0.05 mm/s. The damage zone of the specimen tested at -0.0025 MPa/s is only slightly shorter. The surface is very brushy with fibers separating from bundles. A clear stair-step appearance is observed indicating shearing was the failure mechanism as opposed to buckling or kinking of the fibers. On the other hand, the fracture surface of the specimen tested in steam looks much like those obtained for specimens subjected to creep loading in steam. The "smooth" appearance of the damage zone and the short length of the break all indicated that matrix densification paired with hydrothermal weakening were contributing factors to the failure mechanism. It is also interesting to note that mechanical loading in the presence of steam causes more degradation to the N720/A CMC material system than either loading or environment acting individually. The specimen failed in steam produced a compressive strength of only 54 MPa, a mere 44.3% of the compressive strength produced by the as-processed composite.

Figure 38. Fracture surfaces of N720/A specimens tested in monotonic compression at the rate of -0.0025 MPa/s at 1200°C: (a) air and (b) steam.

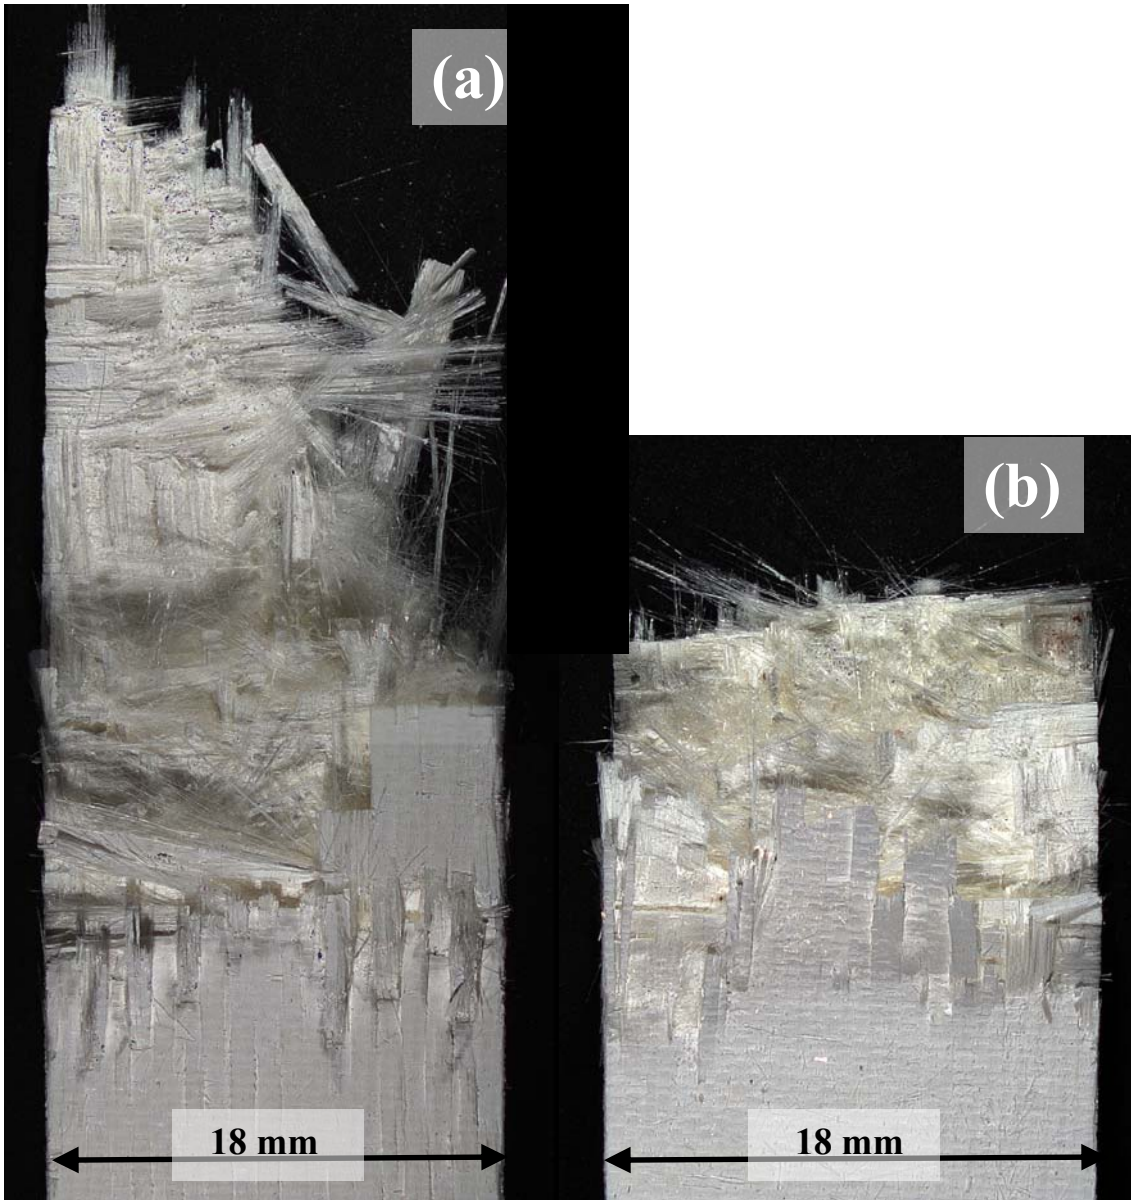
Figure 39. Fracture Surfaces: compression to failure of N720/A specimens failed at a displacement rate of -.05 mm/s at 1200°C: (a) steam and (b) aged for 25 hours in steam.

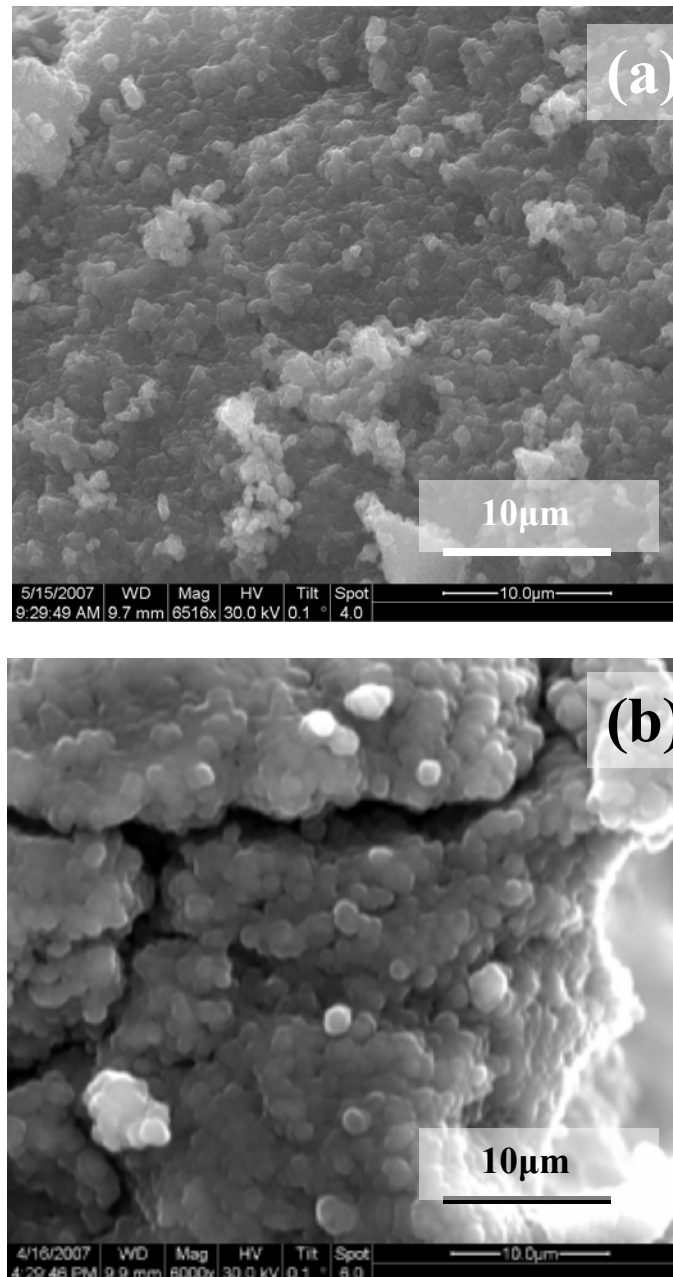
Figure 41. Fracture surfaces that exhibit grain growth in the α-alumina matrix of N720/A specimens at 1200°C (a) subjected to prior creep in air at 60 MPa, (b) subjected to prior creep in steam at 60 MPa.

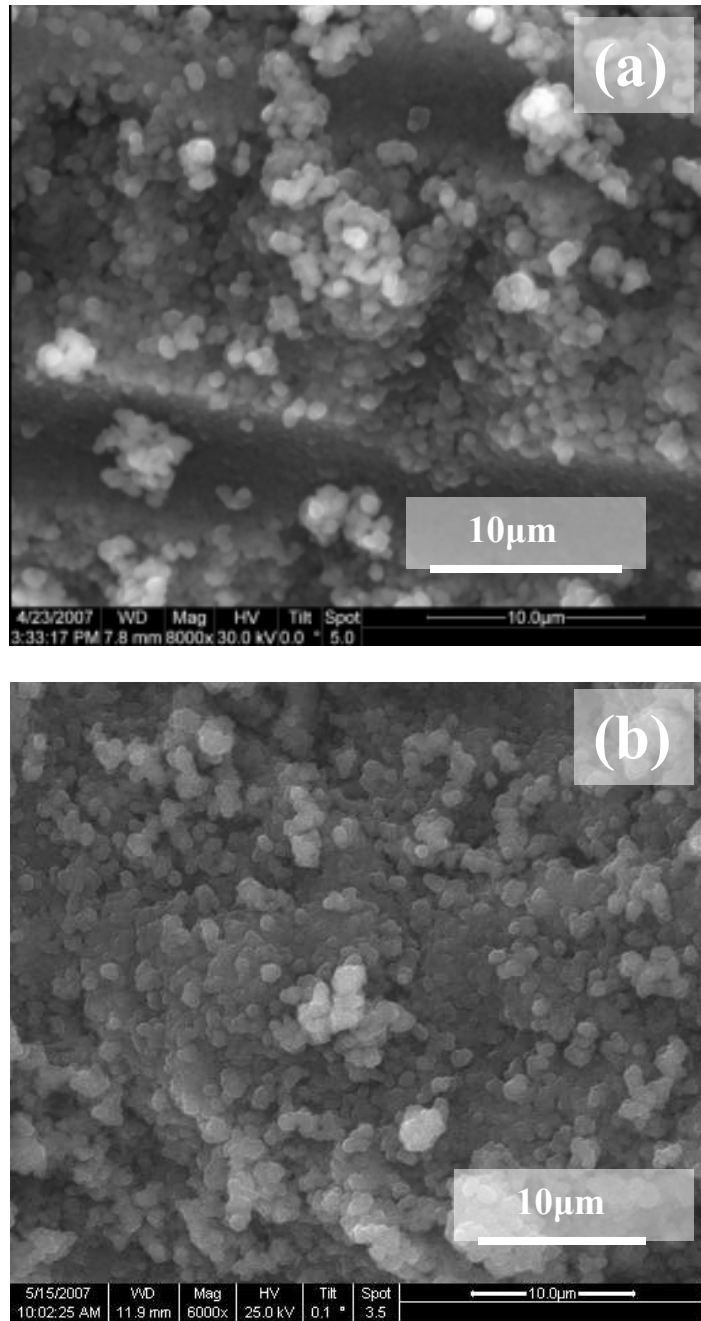
Figure 42. Fracture surfaces that exhibit grain growth in the α-alumina matrix of N720/A specimens at 1200°C (a) compression to failure at -.0025 MPa/s in steam, (b) subjected to 25 hours aging in steam and then failed in compression.

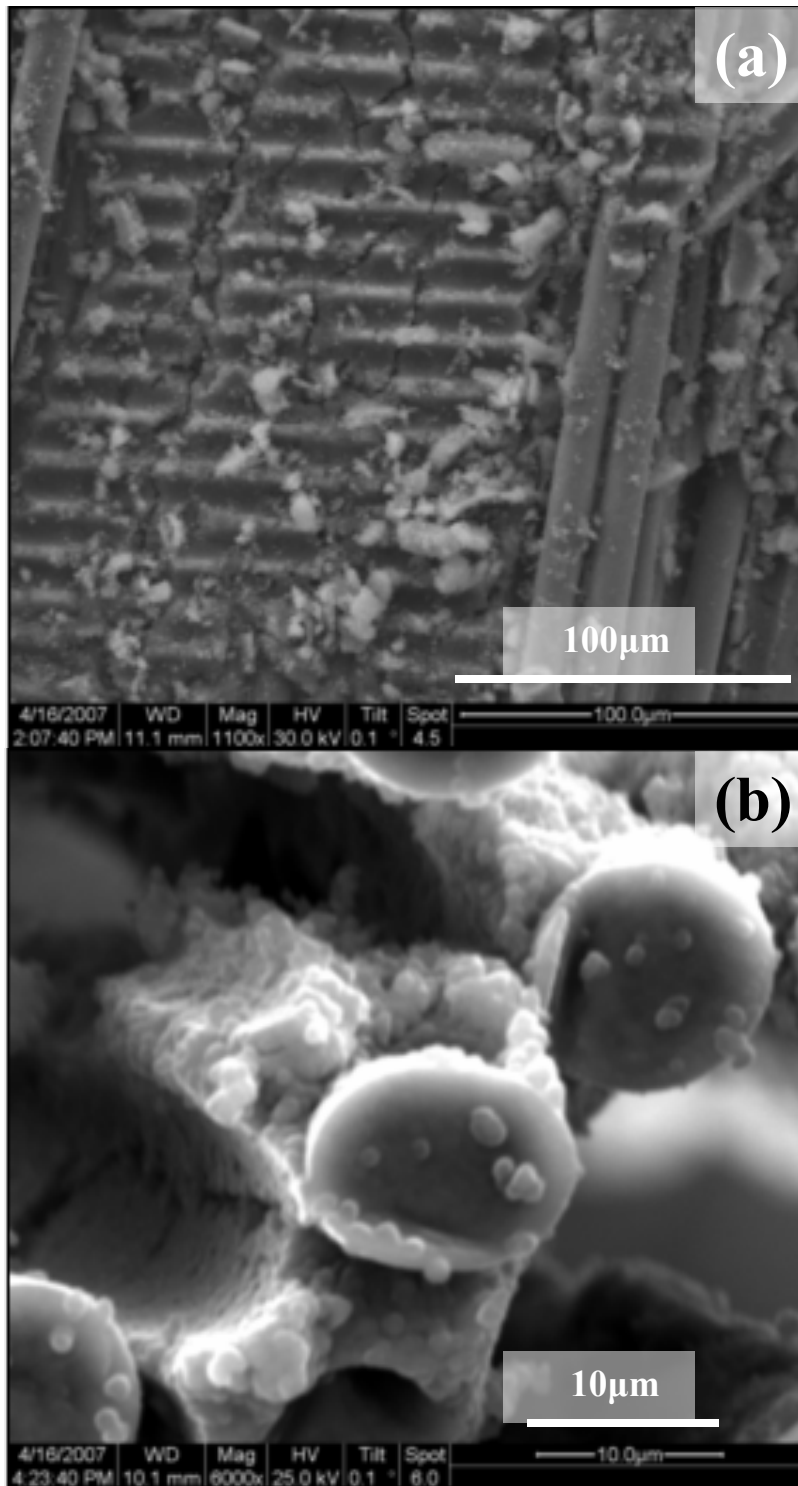
Figure 43. Fracture surfaces of N720/A specimens tested at 1200°C in: (a) compression to failure in air, (b) creep in steam at 60 MPa. Matrix troughs are apparent.

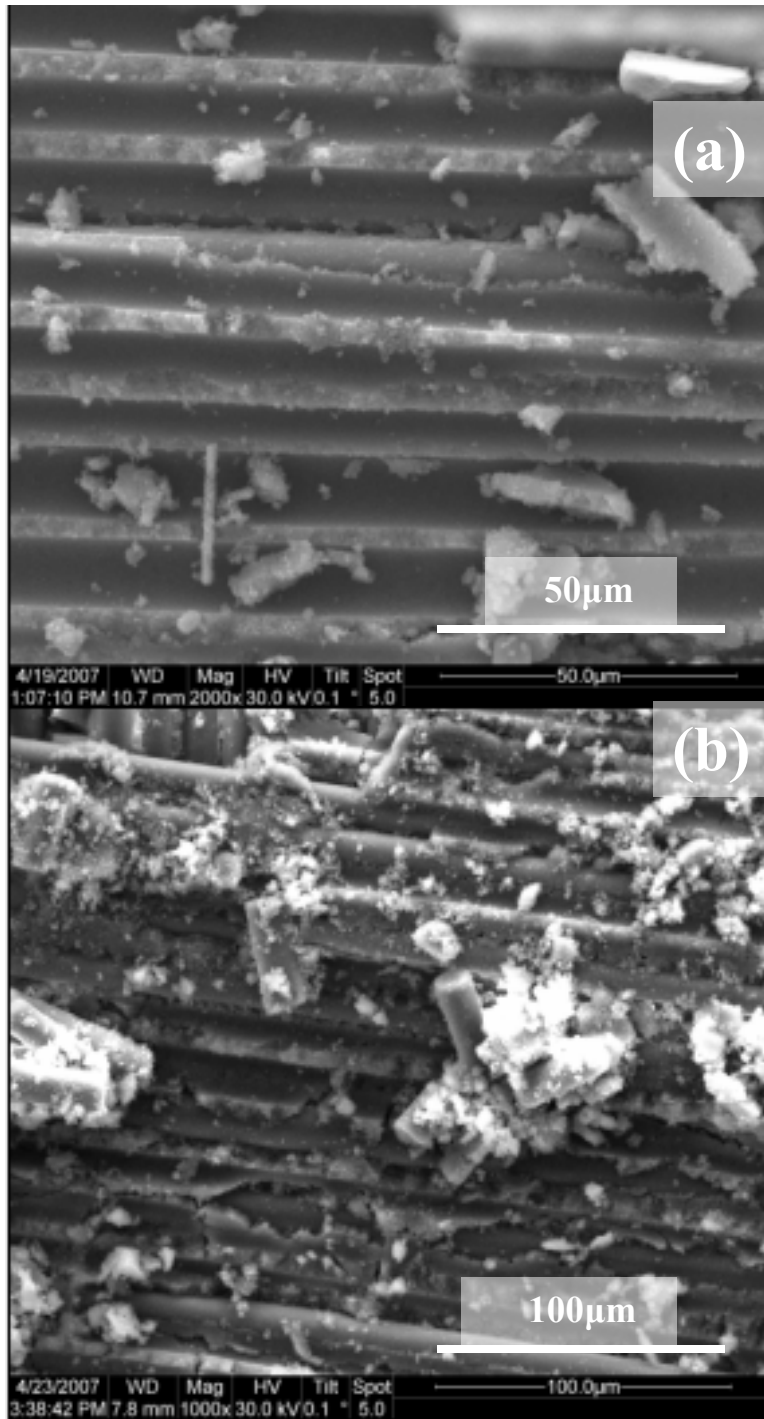
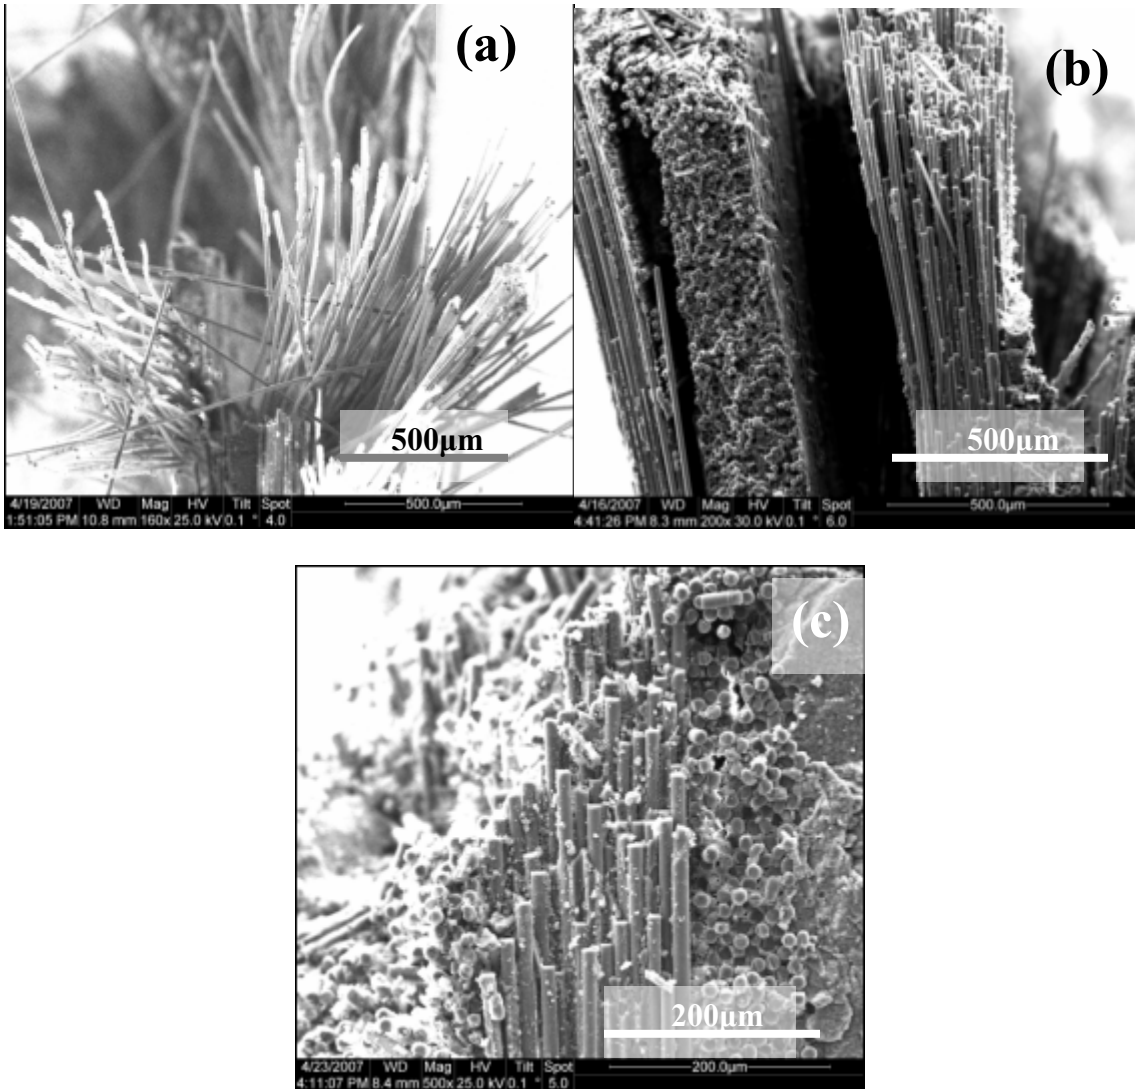
Figure 44. Fracture surfaces of N720/A specimens tested at 1200°C in: (a) creep in air at 60 MPa, (b) compression to failure at -0.0025 MPa/s in steam.

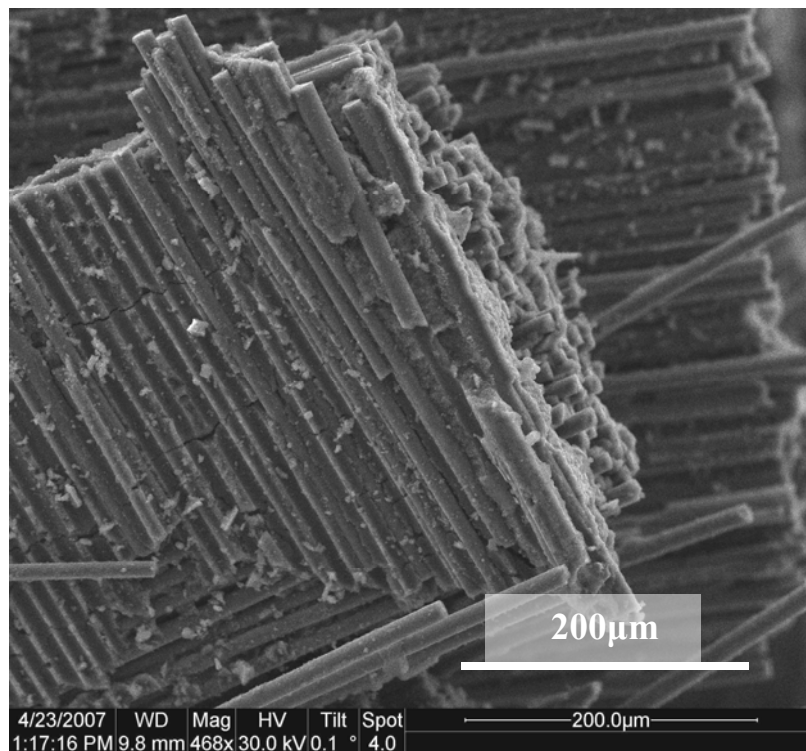
Figure 45. Fracture surface of an N720/A specimen subjected to 25 hours aging at 1200°C in steam, then tested in compression to failure at 1200°C in steam.

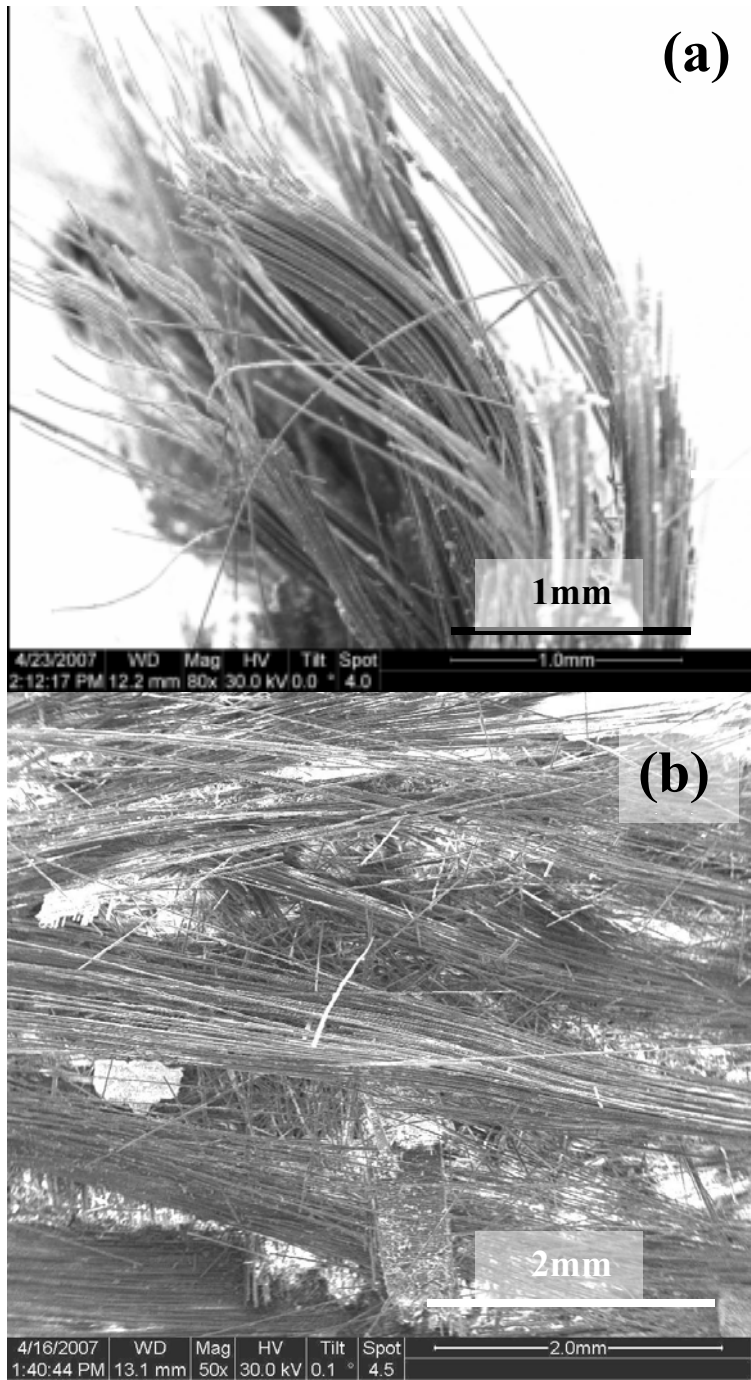
Figure 46. Fracture surfaces of N720/A specimens (a) subjected to 25 h aging at 1200°C in steam and then failed in compression, (b) compression to failure in air.

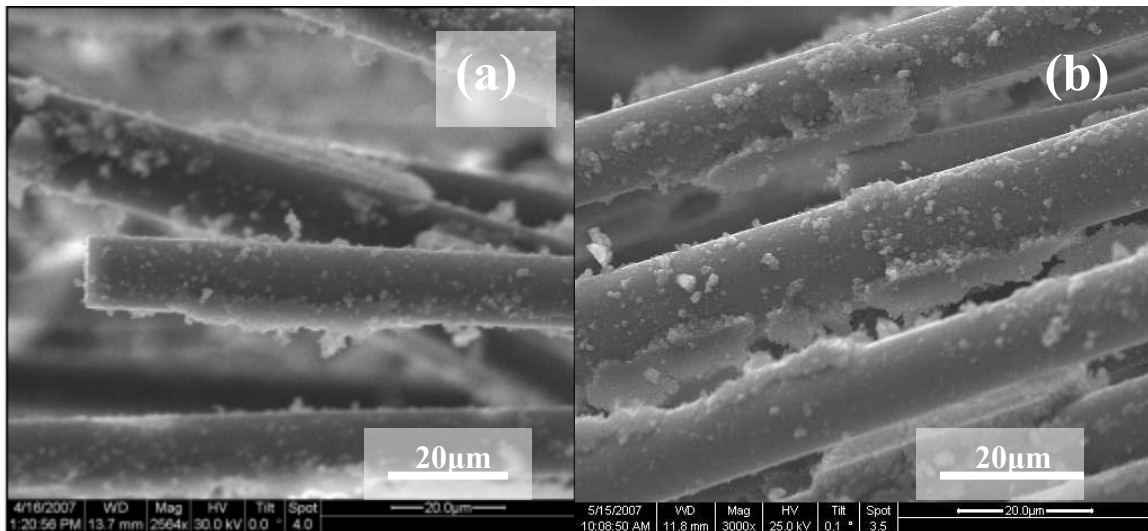
Figure 48. Fracture of N720/A specimens tested at 1200°C in: (a) compression to failure in air, (b) compression to failure in steam following 25 h of aging at 1200°C in steam.

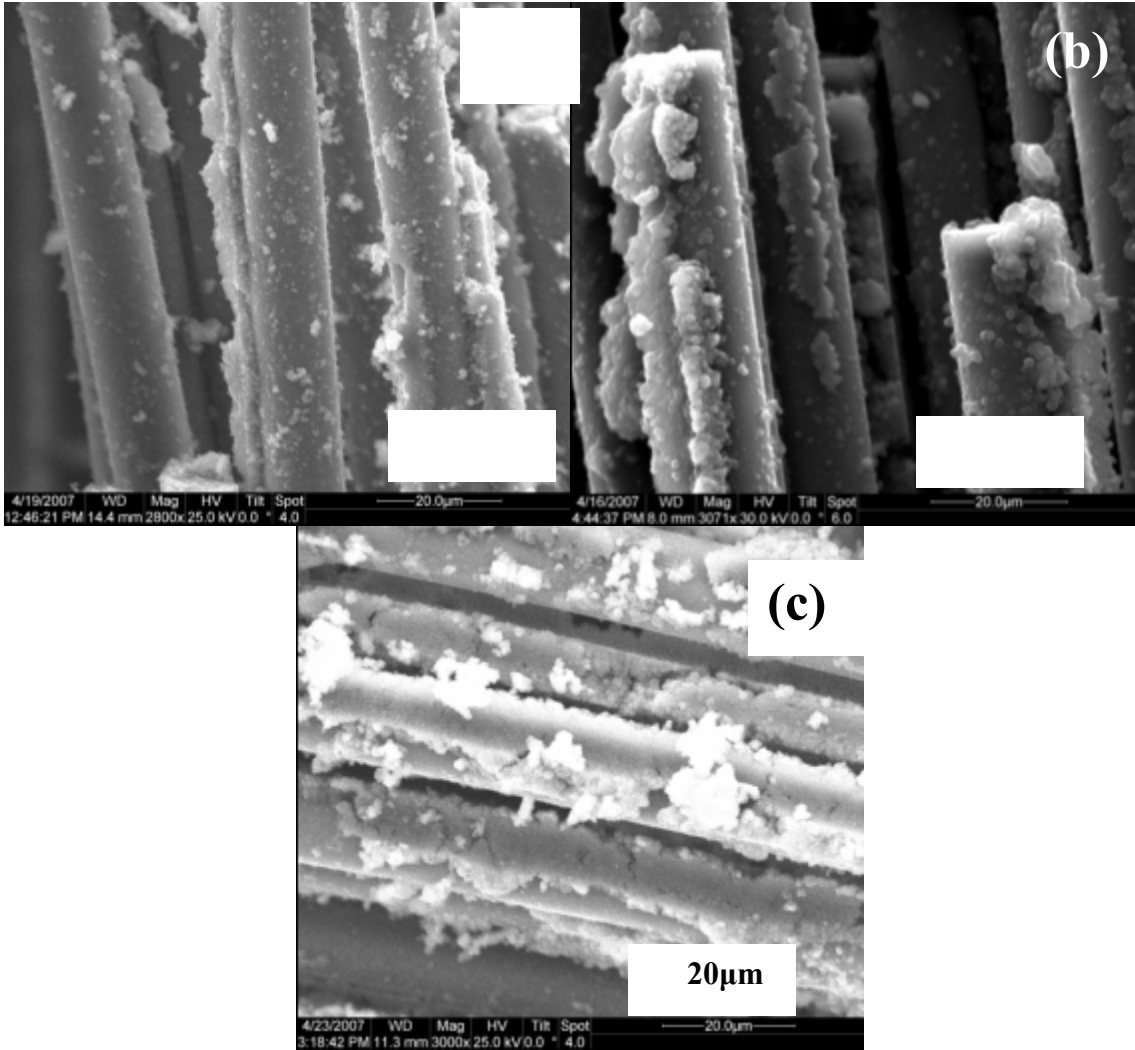
Figure 49. Fracture of N720/A specimens tested at 1200°C in: (a) creep in air at 60 MPa, (b) creep in steam at 60 MPa, (c) compression to failure at -0.0025 MPa/s in steam.
.
