PHENOMENA IN PENETRATING PIERCING BULLETS IN ARMORED STEEL PLATE

The presented work studied the response of new generation armored steel plates PROTAC 500 to the ballistic testing with armored piercing bullets with a core of tungsten carbide, charge 7,62 mm, and interactions between the piercing bullets and the armored steel plate were also investigated. The most obvious and significant phenomena in penetrating of the piercing bullets Nammo AP8 in steel target PROTAC 500 are strain hardening of steels, the appearance of cracks and local failure, adiabatic shear bands (ASB) with related phase transformations, and melting as well as alloying at the border of the bullet / the steel plate.

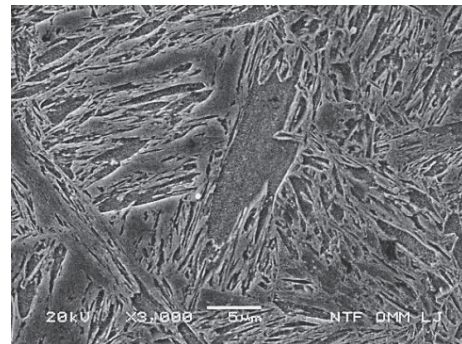
In Figure 1 there is the microstructure of the steel PROTAC 500 before the ballistic test. The microstructure consists of tempered martensite, and the hardness of such steel is 540 HV.

**Figure 1** The microstructure of steel PROTAC 500 (SEM)

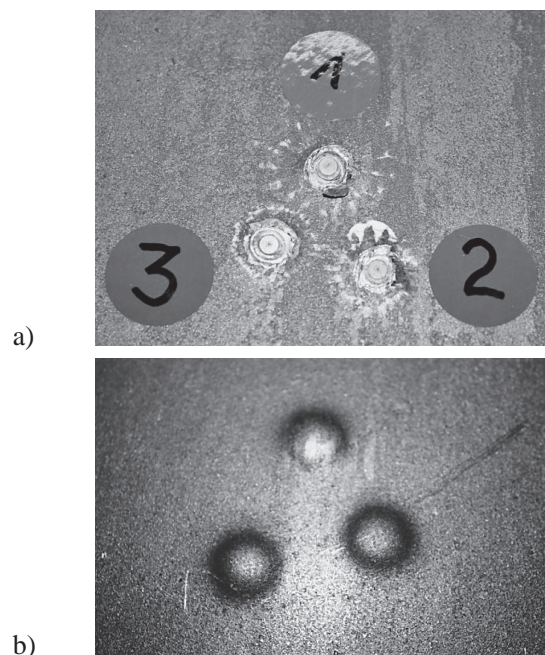
Figure 2 Front (a) and back (b) side of the steel plate PROTAC 500 after ballistic testing – details of three shots

In Figure 2 (a) there is a front side of the panels PROTAC 500 after ballistics testing with the markings of three samples were have cut and prepared for further analysis. All armored piercing bullets are stopped in the plate. In interpreting the results of ballistic tests is the most important imformation if a bullet penetrates the target [15]. In Figure 2 (below) there is the back side of the panel after ballistic test. In none of the shots no perforation of the panel occurred. The testing results and descriptions of the standard VPAM are in Table 3.

By the shot to the sample 1 the bulge with a crack was formed, that does not transmit light by other shots, but it was smaller bulge without cracks. For a more detailed picture of the interactions between bullets and plate the samples for metallographic analysis were prepared.

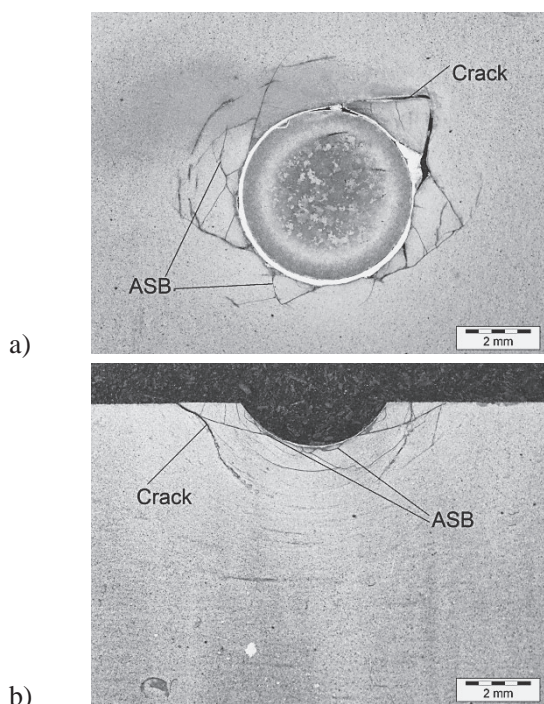
Figure 3 Macroscopic cross-sectional images of the sample 1 (a - upper level, b - lower level)

Figure 3 consists of a macro-picture of two analytical levels of sample 1 cross-sections. In Figure 3a there is a cross-sectional view of the upper level of the sample, where there are a significant number of cracks, and branched adiabatic shear bands which extend from the border between the envelope bullets (bright narrow band around the circumference of the core) and the base material towards the interior of the target. In Figure 3b is a half cross-sectional view of the lower level of the sample. At this level it is less ASB and cracks and at the same time do not go so far into the interior of the target. Most of the kinetic energy of the projectile to the lower level is already spent.

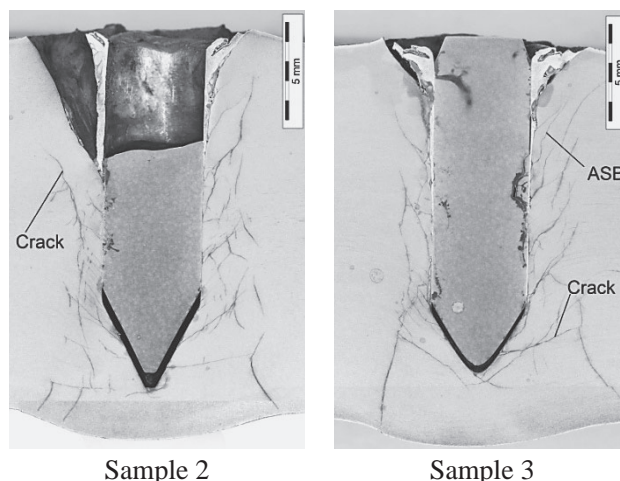
Figure 4 shows the macro-picture breakthroughs balls on the analysis of samples 2 and 3, giving examples of cracks and ASB. In the area between the ball and the lower edge of the steel plate they have cracks in the form of a pin. Breakthrough with pin is a common

Figure 4 Macroscopic picture of breakthroughs bullets trough the samples 2 and 3, marked as cracks and ASB

mechanism of penetration through the high strength steels in which the phenomenon of ASB has an important role. The formation of the plug occurs when the thickness of the target is approaching to the diameter of the bullet. Notice also that the bullet after a stoppage due to elastic deformation and the target are slightly separated. For the sample 3 we have also measured the length of the cracks and ASB. The average length of the cracks on the sample 3 is 3,9 mm, the average length of the ASB was 4,3 mm, which indicates a very high-speed deformation. In figure 5 is transformed ASB, which extends from the edge of penetration (primary ASB) inside the plate (secondary ASB), the medium level of sample 1 ASB in the investigated steel vary in length, width and branching. Mechanism for the growth and spread of ASB is not a generally accepted criteria, in the literature is generally assumed that the spread and growth of ASB are related dictated to the dynamic recrystallization inside the ASB [12].

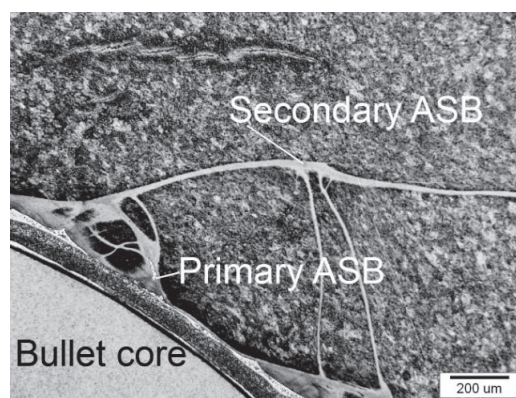
Figure 5 The microstructure of the cross-section of the target at the centre of the bullet. Course of ASB and cracks (sample 1)

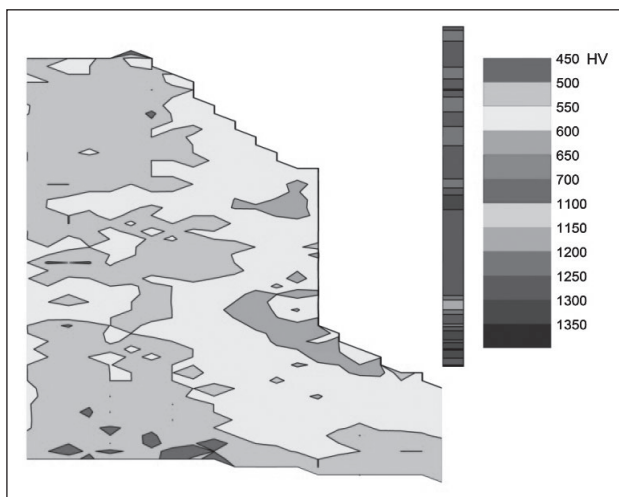
In Figure 6 the distribution of hardness of the steel in the vicinity of the bullet's penetration and bullet cores (gray scale) to the sample 3 is the result of 855 measurements in a mutual distance of 400 mm. Hardness distribution map shows the progress and scope of consolida-

tion deformation of the steel in the vicinity of the projectile penetration. The maximum difference between the average hardness of the undeformed and deformed steel hardness is 95 HV on a sample 3. For the samples 3 and 2 we performed the measurements of the hardness of ASB. On the sample 3 was performed 32 and on a sample of 2 13 hardness measurements of ASB. Hardness of the steel in the ASB was significantly higher than the initial hardness of steel. Maximum hardness of 775 HV was measured in the ASB on the sample 3. The hardness of the steel in the ASB is about 170 HV is higher than the initial hardness of the steel (sample 3), on the sample 2 is higher for about 160 HV.

Figure 6 Distribution of hardness of the steel in the vicinity of the bullet penetration through sample 3
