To cite this article: MAZZANTI Paola *et al* 2020 *IOP Conf. Ser.: Mater. Sci. Eng.* **949** 012062

In-situ checking various mechanical parameters of original nail connections between crossbeams and wooden support, in the framework of an innovative method for rationally dimensioning the crossbeams of panel paintings, applied on an original artwork

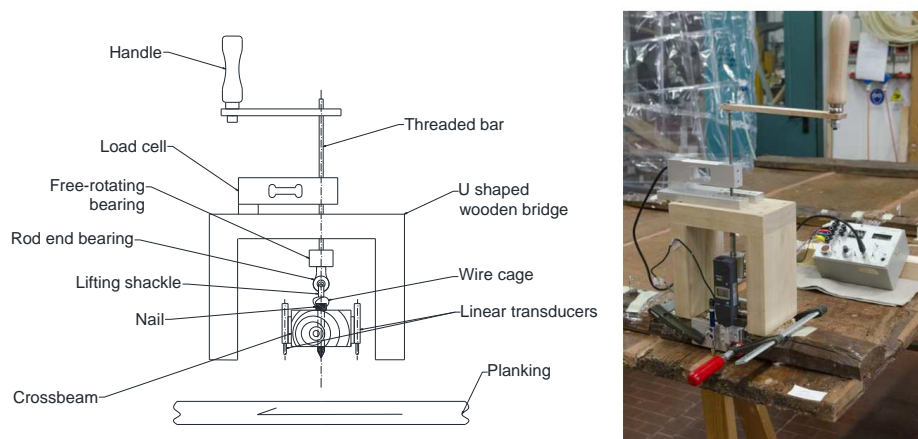
Figure 2 The drawing of the measurement apparatus, applied on nail A2 (see Figure 3). From top to bottom, the components are visible: handle, threaded bar, load cell, wooden bridge-support, free-rotating bearing, rod end bearing, lifting shackle, wire cage built on the nail's head, potentiometric displacement transducers mounted on metal plates fixed on the crossbeam's sides. The drawing is a schematic image of the test method showing all the components, dimensions are not realistic; when the handle is rotated, the nail is pulled or released. The photo shows the measurement apparatus mounted on the original artwork in the restoration laboratory; also two digital centesimal comparators were added in parallel to the transducers in order to have comparison measurements.

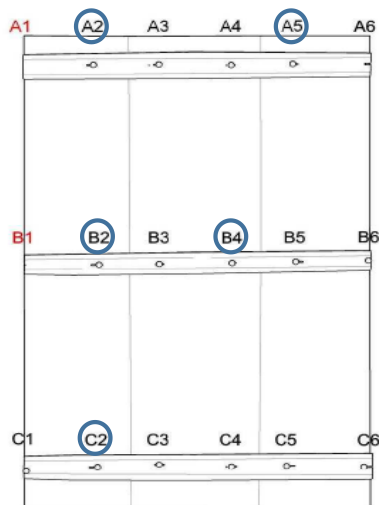
Five original nails were then non-destructively tested in-situ (see Figure 3): two on the upper crossbeam (A2 and A5), two on the central crossbeam (B2 and B4), one on the lower crossbeam (C2).

Figure 3 Schematic drawing of the back of the panel painting, showing the locations of all the nails. Nails A1 and B1 are no longer present, their existence was only hypothesised. The tested nails are circled.

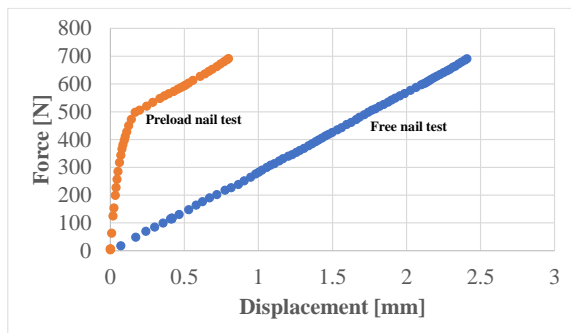
The tests on the mock up provided clear and useful data as shown in Figure 4. When the not preloaded nail was tested, the graph shows a linear correlation between the displacement and the force, produced by the transverse flexural deformation of the wooden support; on the other hand, when the preloaded nail was pulled out, an initial phase of quickly increasing force with almost no displacement occurred, followed by a linear less steep phase, after the preload was exceeded.

Figure 4 The graphs show the tests performed on the mock-up panel. The blue curve was observed when a not preloaded nail ("free nail") was pulled out; the orange curve resulted from a preloaded nail.

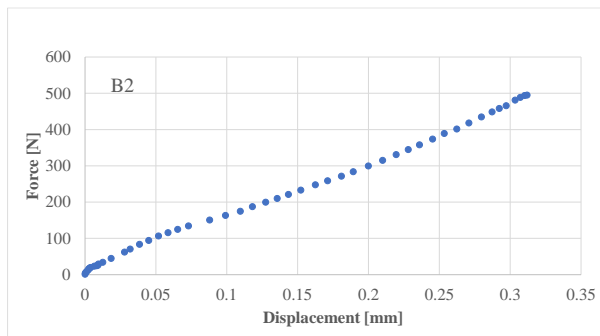
Comparable results were observed on the original artwork as in Figure 5, which shows the test on nail B2. The graph shows a linear correlation between the force and the displacement, which highlights a not preloaded nail, free to move through the crossbeam; again, the displacement is produced by the transverse flexural deformation of the cupped wooden support, pulled by the nail against the crossbeam.

Figure 5 The graph shows the pull-out test on nail B2. In this case the nail was free to move through the crossbeam (the graph shows no initial steep increase of the force, which would be caused by friction or adhesion between nail shank and crossbeam), and a linear correlation is observed between the force and the displacement.

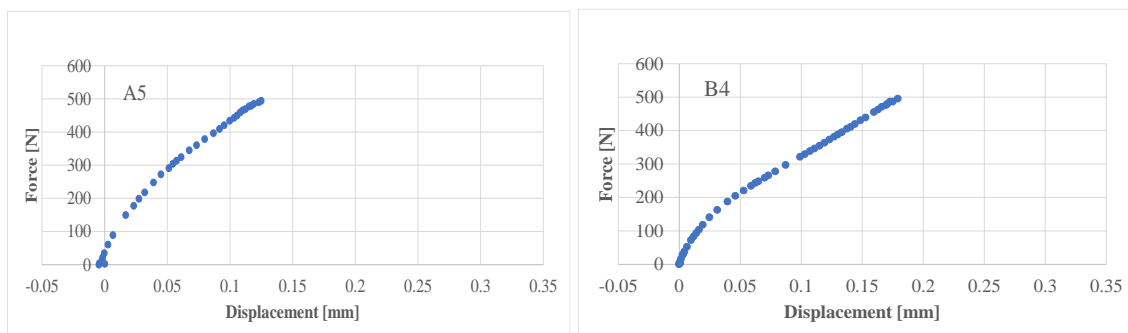
In Figure 6 two situations similar to each other (nails A5 and B4) are presented, recalling the mock-up tests with preloaded nails. In this case, the nails showed a preload of about 200 N. However, here the transition between the two phases (initial part: overcoming the preload – final part: bending of the wooden support) is not clearly defined. The straight segments in Figure 7 represent the ideal trend assumed for the graphs, in the absence of adhesions or frictions.

Figure 6 The graph shows the pull-out test of nails A5 and B4. Both the tests show a steep initial phase (up to around 200 N) at the end of which the preload was reached; presumably the curved trend of that part of the graphs indicates the presence of friction and / or deformation of the nail shanks. After the preload limit is exceeded, the smaller slope indicates the nails were freely slipping through the crossbeams, and the wooden support was deforming in transversal bending.

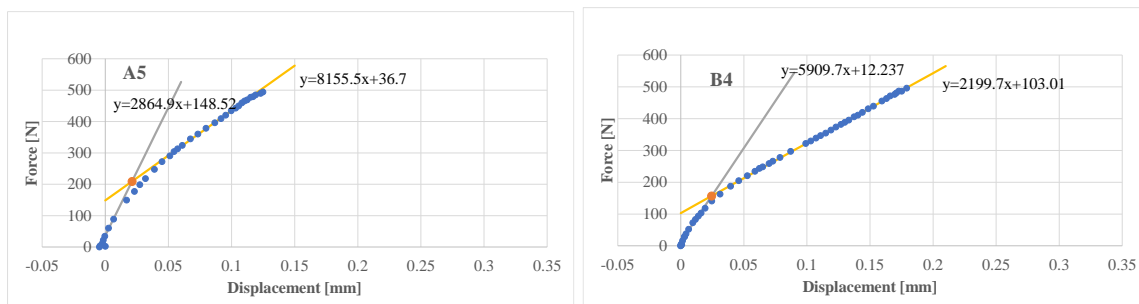
In order to determine a specific preload value for each nail, the following method is chosen .The curve was ideally divided in two parts according to the changing slope observed during the test: a first part made of 7-9 data representing the preload reaching phase and a second part made of 11-15 data, extrapolated from the central part of the transversal bending phase. For each of these two parts, a trend line was calculated by means of Excel and the equations are reported in Figure 7. Therefore, a system of two equations in two unknown variables is obtained and its solution gives the computed preload value (see the orange circles in Figure 7). For nail A5, the solution gives a preload value of 209 N; probably the main reasons for the divergence between the experimental curve and its schematization with two segments consists in some friction and/or shank deformation and/or lateral yielding of the crossbeam's wood. Such phenomena are more evident than for nail B4 and, as a consequence, the computed value for the displacement (0.02 mm) does not approximate the experimental one (0.03 mm). However, it is possible to identify a preload value that belongs to the curve and best approximates this experimental test, which probably is 177 N. The same method applied to nail B4 gives a solution of 157 N, which once again does not belong to the curve, but lays close to it both for displacement (same value) and force (the difference is 15 N, probably due to the friction).

Figure 7 The graphs show a method to determine the possible preload value. Two different trend lines are calculated for each curve, one for the "preload phase" and a second one for the "transversal bending" part; the solution of the system of equations gives the preload value, in the graphs, the computed preload value is represented by an orange circle. The values are 209 N for A5 (which shows a divergence from the experimental data probably because it is influenced by friction or deformation of the nail shank) and 157 N for B4.

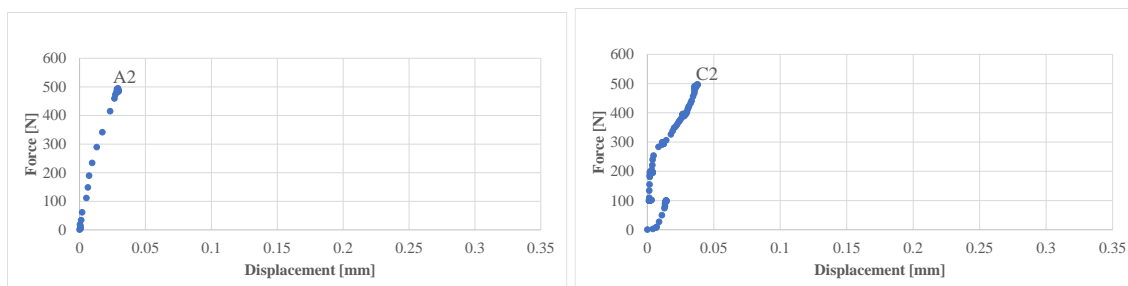
Lastly, the nails A2 and C2 (Figure 8) show a completely different behaviour, indeed the force-displacement curves are characterised by one only very steep phase, that is, a rapid growth of force, in correspondence with very limited displacements. This behaviour is interpreted as a consequence of completely blocked nail shanks into the crossbeams.

Figure 8 The graphs show the pull-out test of nails A2 and C2. Both the tests showed very steep curves, possibly due to the nail shanks completely blocked into the wooden crossbeams.
