Identification of a putative man-made object from an underwater crash site using CAD model superimposition

Keywords: Vehicle accident; video analysis; Amelia Earhart; aircraft

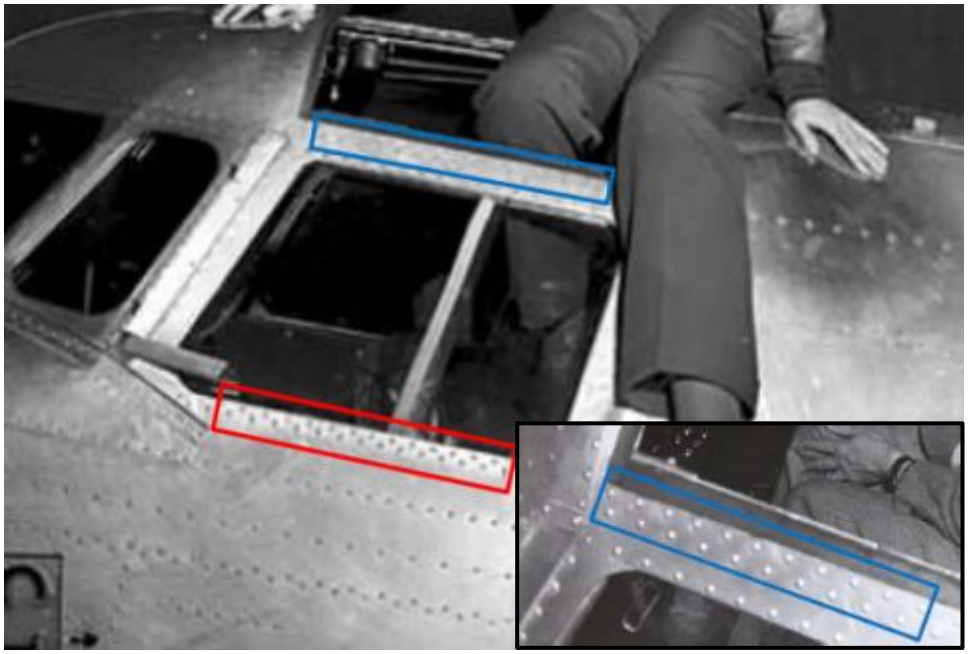
Using the provided video, we identified two potentially man-made objects, shown in Figure 2. The top object contains a series of repeating, staggered features on a rectangular or cylindrical base. A second object, perpendicular to the first, contains two long, parallel edges. The left side of the second object contains a series of repeating, staggered features, similar to those on the first object. These objects were investigated further because they presented features that bore a resemblance to a rivet pattern seen on the aircraft in Figure 3, and they were located in the suspected crash site.

Figure 2: An object was identified in the suspected underwater crash site.

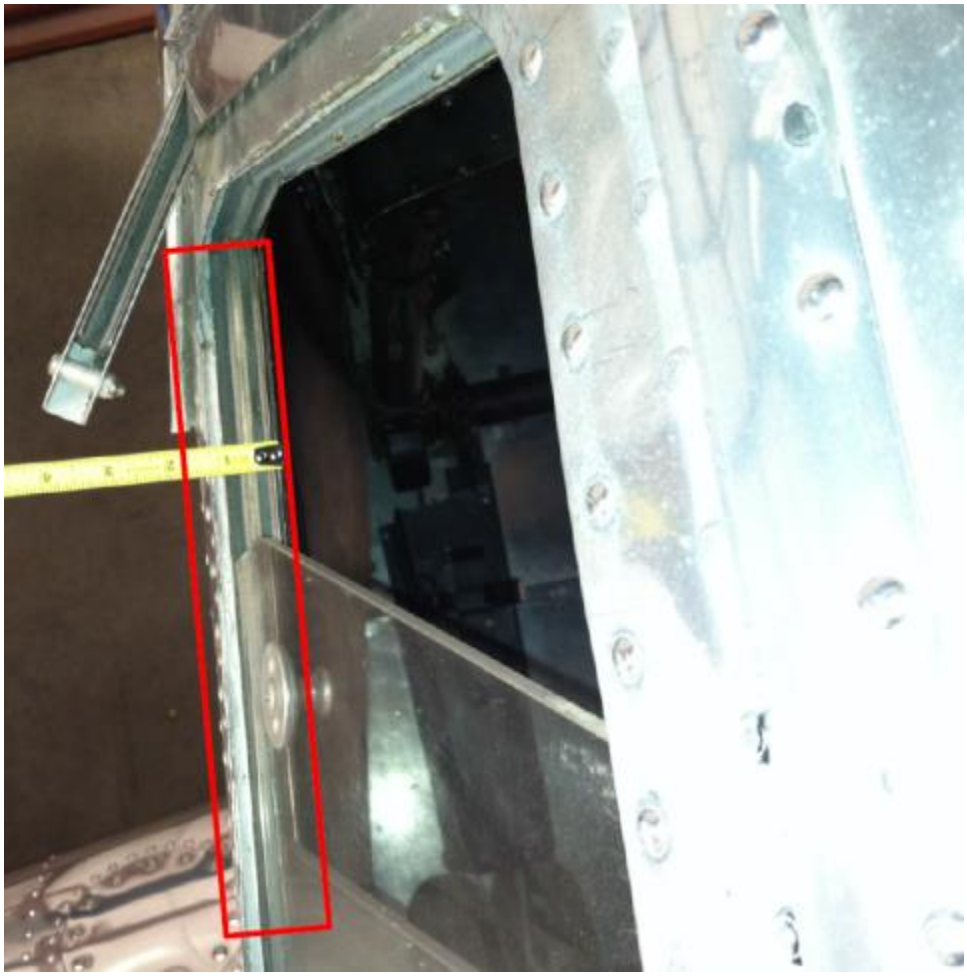
An aircraft of the same make and model as the one at the potential crash site was used for measurement of the identified rivet pattern, using photographs supplied by the owner of the aircraft. The window slide rail of the intact aircraft contained parallel features, and rivets (Figure 4) that were similar to those seen in the wreckage image (Figure 2) and the historical aircraft (Figure 2).

Figure 4: Parallel rails constrain the side window and allow it to slide.

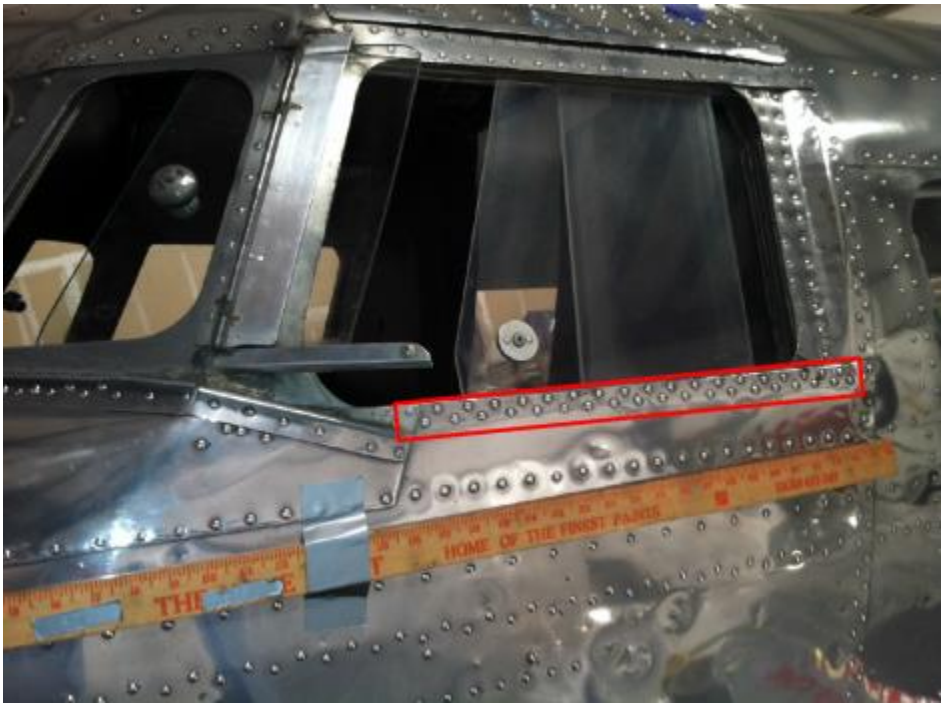
Figure 5: The reference aircraft photograph was not taken perpendicular to the yard stick or rivets.

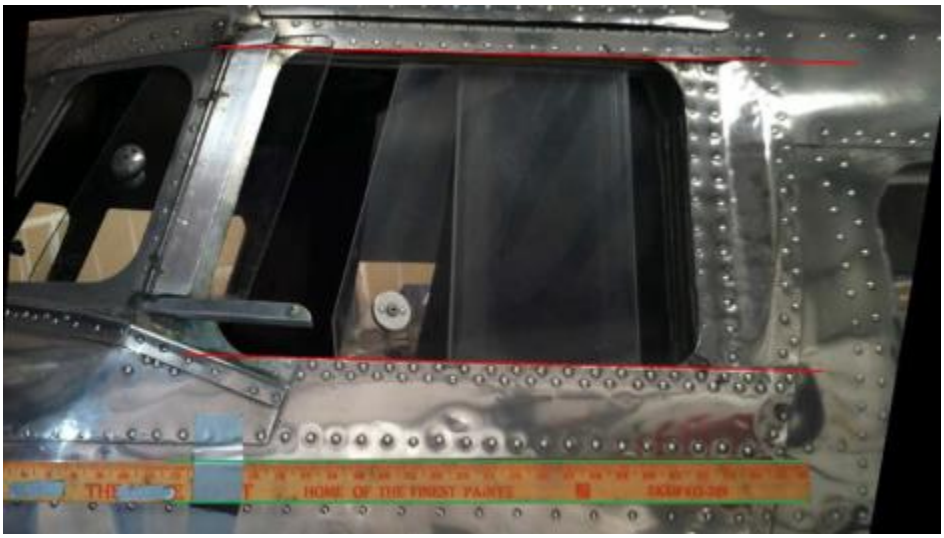
transformation of the angled photograph was performed using MATLAB in order to view the window from a perpendicular view (Figure 6). Orthographic projections preserve both distances and angles, and there is no distortion of shape for two-dimensional transformations [11]. The yard stick, having a known length, width, and shape was used as a reference to perform the transformation, with the assumption that the outer face of the window slide rail and yard stick was parallel. The transformed view is orthographic for all features contained in the same plane as the yard stick. The transformed image can be used to measure objects contained in the same geometric plane, such as the rivets on the outside of the slide rail. After the transformation, it is seen that the rectangular geometry and uniform spacing of the yardstick is preserved (Figure 6).

Figure 6: The photograph of the reference aircraft was transformed to a perpendicular, orthogonal view.

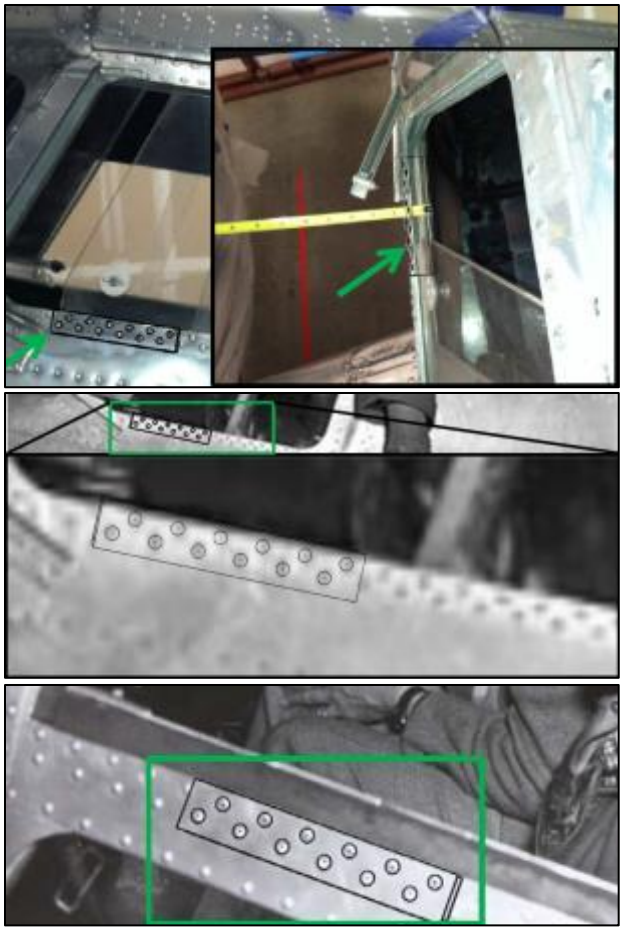
Figure 7: The CAD model was overlaid on the reference aircraft (top) and on historical photos of the crashed aircraft (middle and bottom).

Other sections of rivets seen in the historical photographs the plane, such as those seen in front of the roof hatch and behind the side window, were not good fits for the CAD model. However, another section of rivets, located below the roof hatch in the aircraft (bottom, Figure 7), shared the same size and spacing as the series of rivets below the side window.

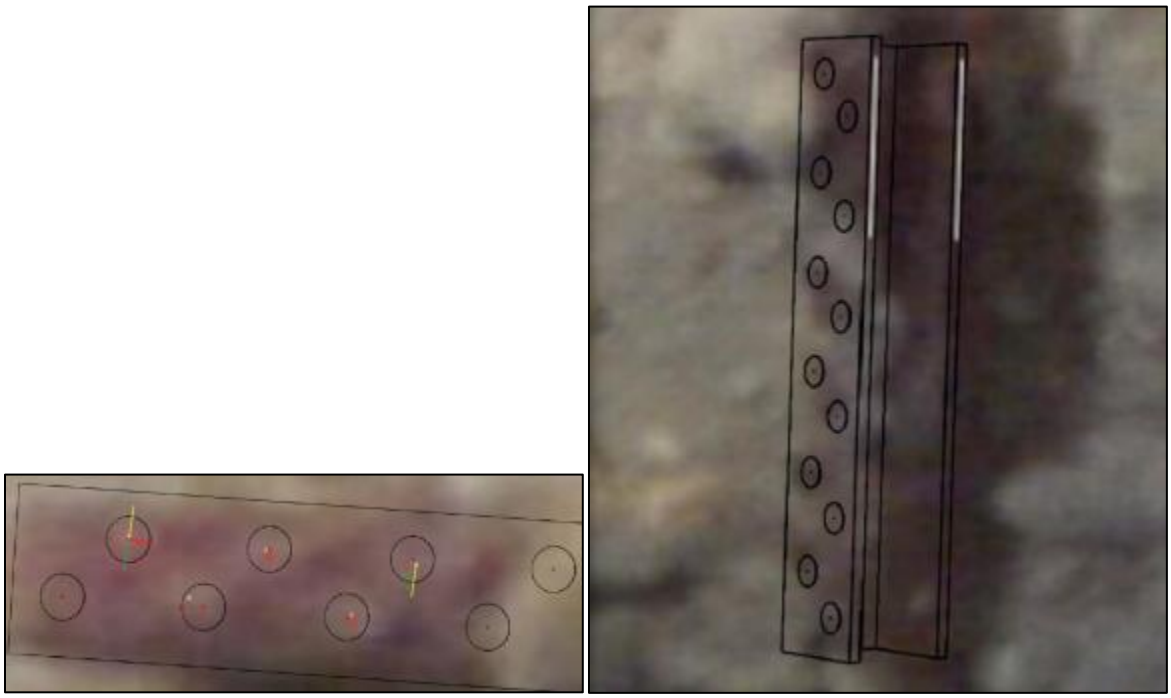
Figure 8: The CAD model of the window slide rail was overlaid onto marked-up images from the wreckage video.

When the CAD model is overlaid on the image of the wreckage, the centers of the rivets do not perfectly align. The distance between these centers was measured. The average error, or mean of these distances, was 1.3 mm with an arithmetic standard deviation of 1.1 mm (N=8). The distance between the centers of the corresponding, farthest-spaced CAD model rivets measured 52.6 mm. The distance between the centers of the farthest-spaced purported rivets in the wreckage image measured 53.3 mm. The difference between these measurements gives an overall scaling error of 0.7 mm.

Every measured point on the image from the ROV video is located within the radius of the rivets, and using the collected data, there is an 84% fit between the rivets and the centers of the staggered objects seen in the video.

Furthermore, using the equation for percentage error, and applied to the worst-case scenario of using the farthest-spaced rivets to measure the error between the image from the ROV video and the CAD model, the error is 1.3%, or conversely, has a fit of 98.7% using this metric:

In addition, for the vertically-oriented object, the long edges of the rail aligned with the edges of the vertical object in the rover image to within 3.18 mm, the approximate thickness of the sheet metal, establishing a second correspondence between the CAD model and the objects on the sea floor. Furthermore, there are additional repeating, staggered features toward the bottom of this vertical object, but the vertical object appears nonuniformly bent. Therefore, it was not useful to perform a numerical analysis of this section of the object.

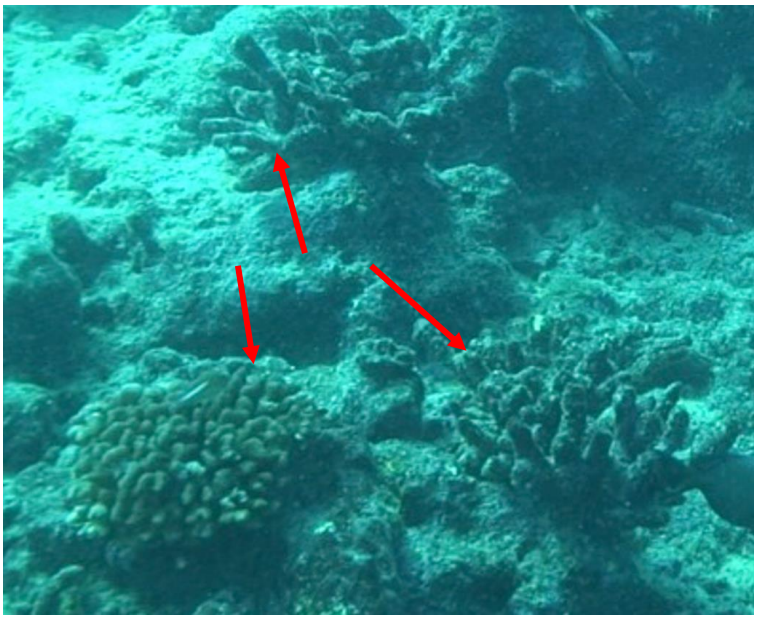
Figure 9: Still image from video recorded in shallow waters near the purported wreckage site illustrating hard coral, order Scleractinia.

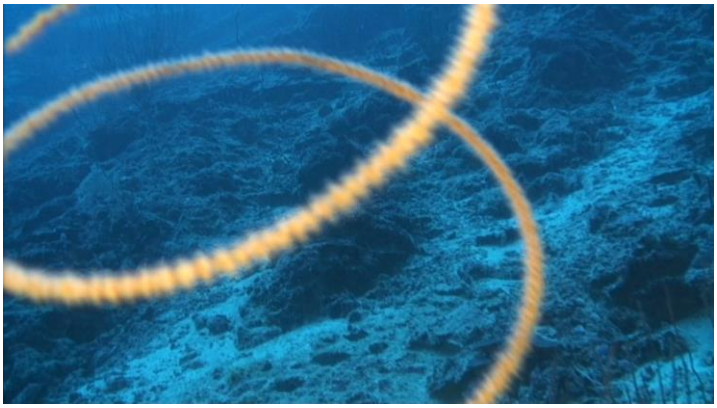
Figure 10: Still image from video recorded in shallow waters near the purported wreckage site illustrating soft coral, subclass Octocorallia.
