Optimizing Pavement Base, Subbase, and Subgrade Layers for Cost and Performance of Local Roads

AUGUST 2014

Final Field Data Report

Sponsored by
Iowa Highway Research Board
(IHRB Project TR-640)
Iowa Department of Transportation
(InTrans Project 11-422)

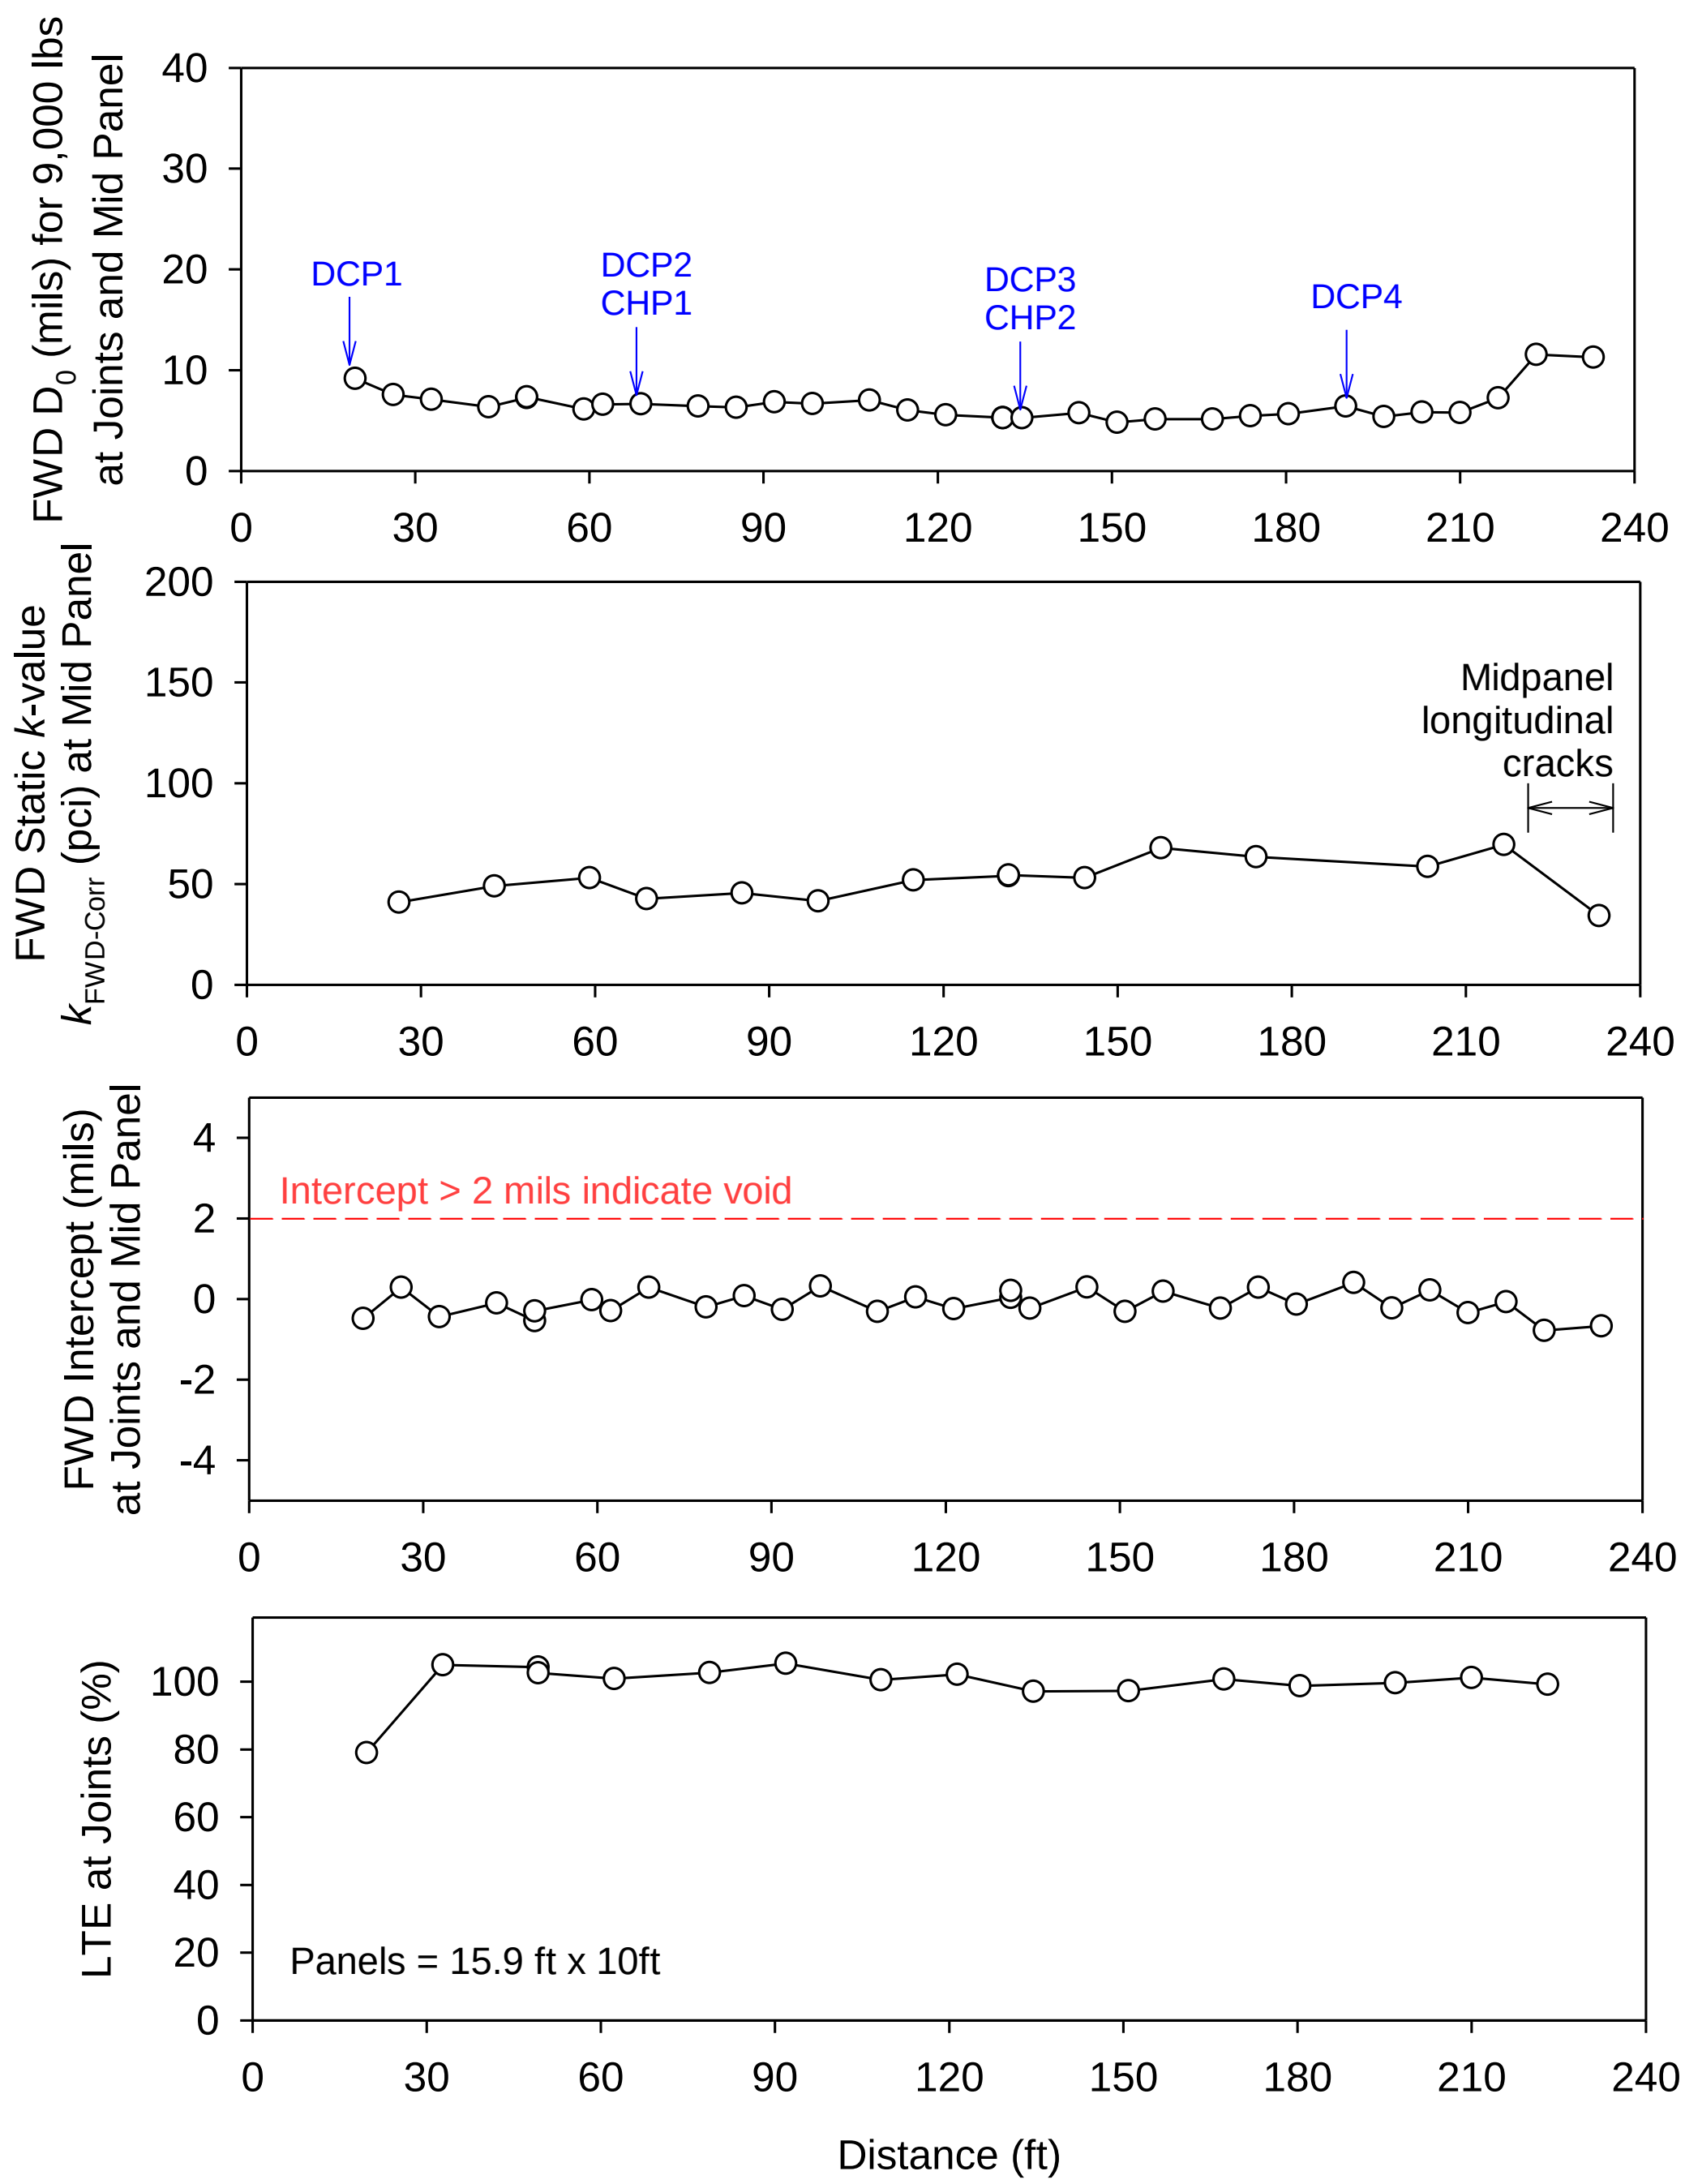
Figure 37. FWD test results — NW3rd Street and Greenwood Drive, Ankeny

The measured core thickness at this site was 8.25 in. FWD test results with deflection under the loading plate (D_0), Static $k_{FWD\text{-}Corr}$, intercept, and LTE at joints are shown in Figure 37. DCP-CBR profiles and cumulative blows with depth are shown in Figure 38. Average and coefficient of variation (COV) of CBR_{SG} is noted on Figure 38. Figure 39 compares CBR_{SG} and Static $k_{FWD\text{-}Corr}$. CHP test results showing K_{CHP} with time are shown in Figure 40.

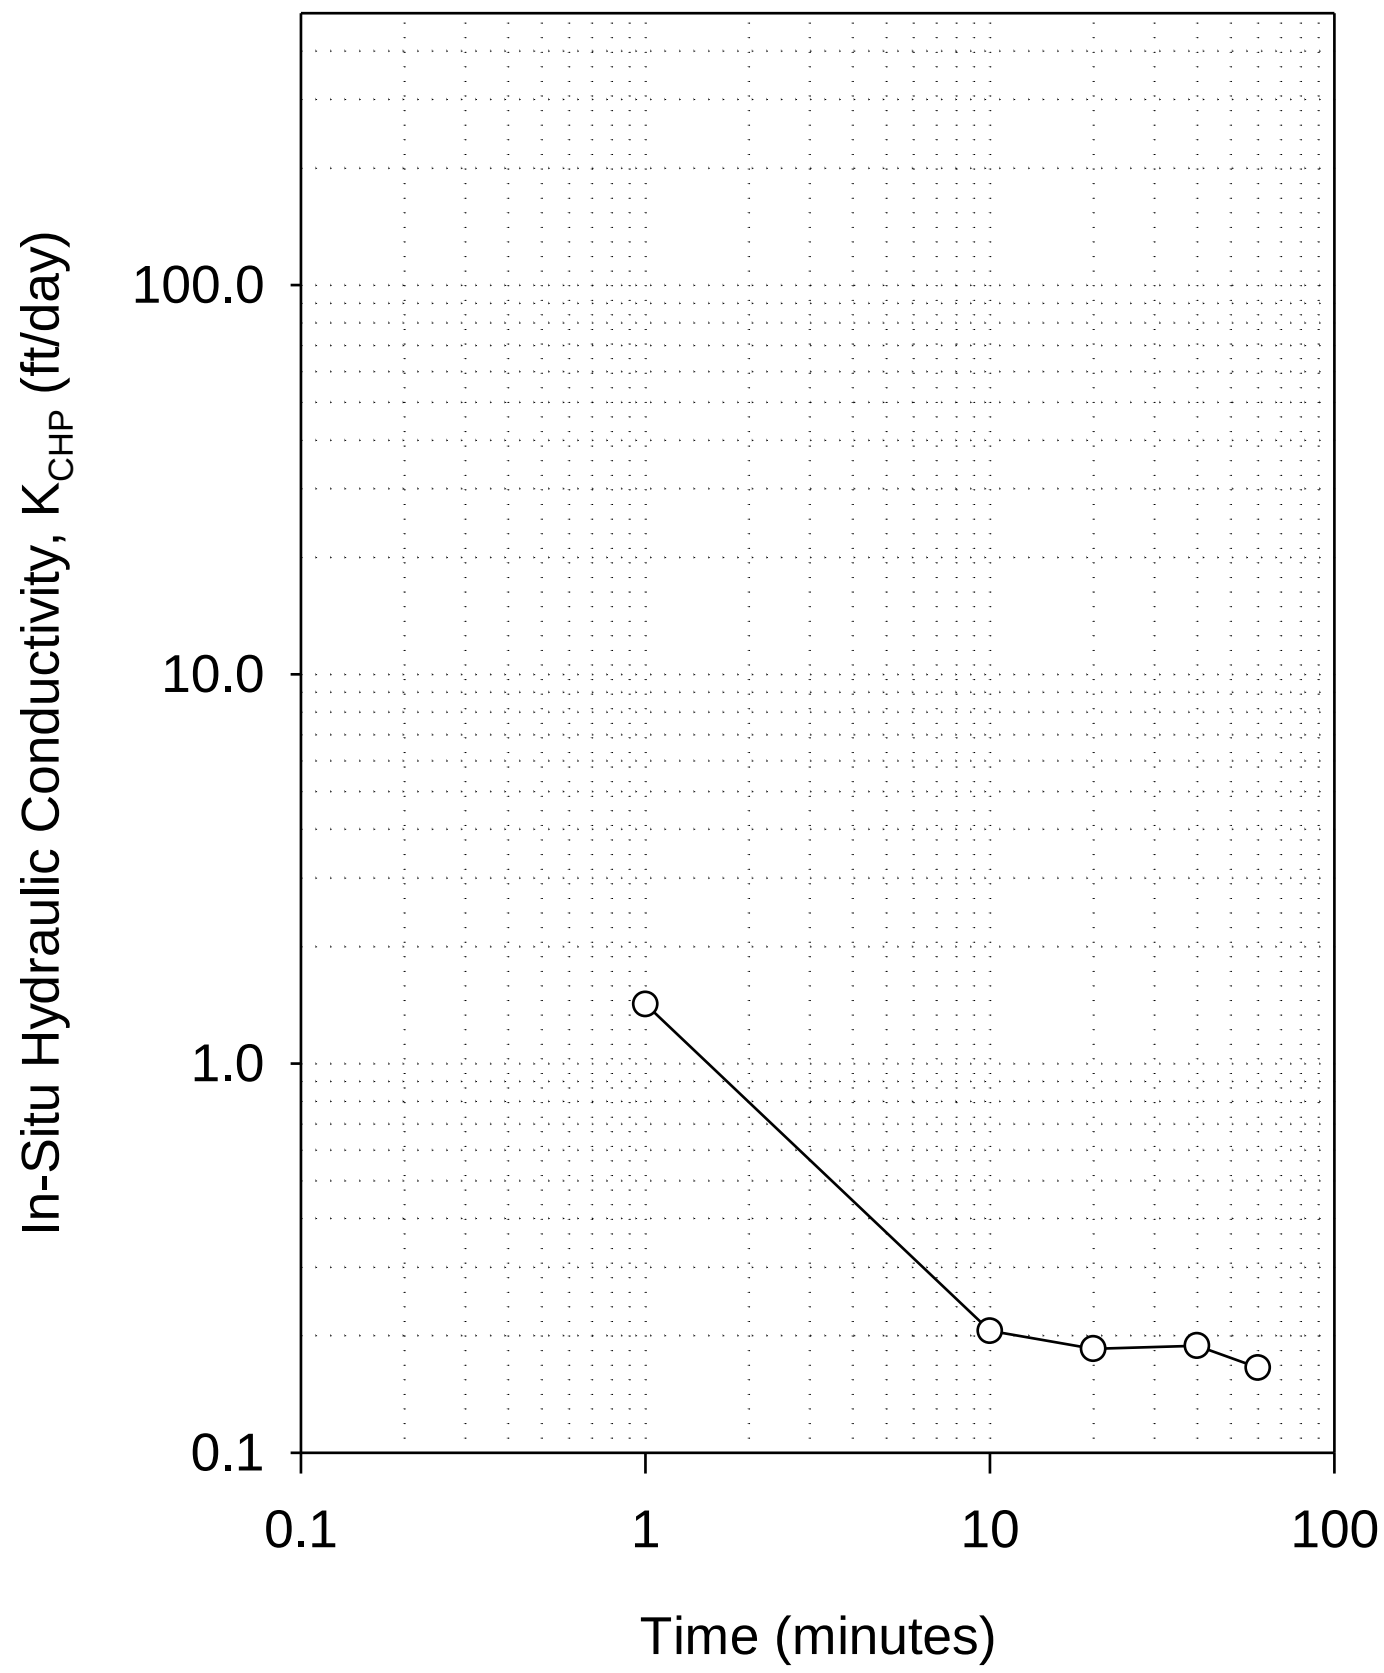
Figure 40. CHP test results — NW3rd Street and Greenwood Drive, Ankeny

CHP tests showed an in situ K_{CHP} = 0.2 ft/day. Based on the K_{CHP} value, pavement geometry, and an assumed effective porosity of 0.04 (see Table 7), the time to 50% drainage at this site is estimated as > 1 month (84 days). This time of drainage corresponds to "very poor" drainage quality per SUDAS (2013b) and AASHTO (1993) and C_d = 0.71.

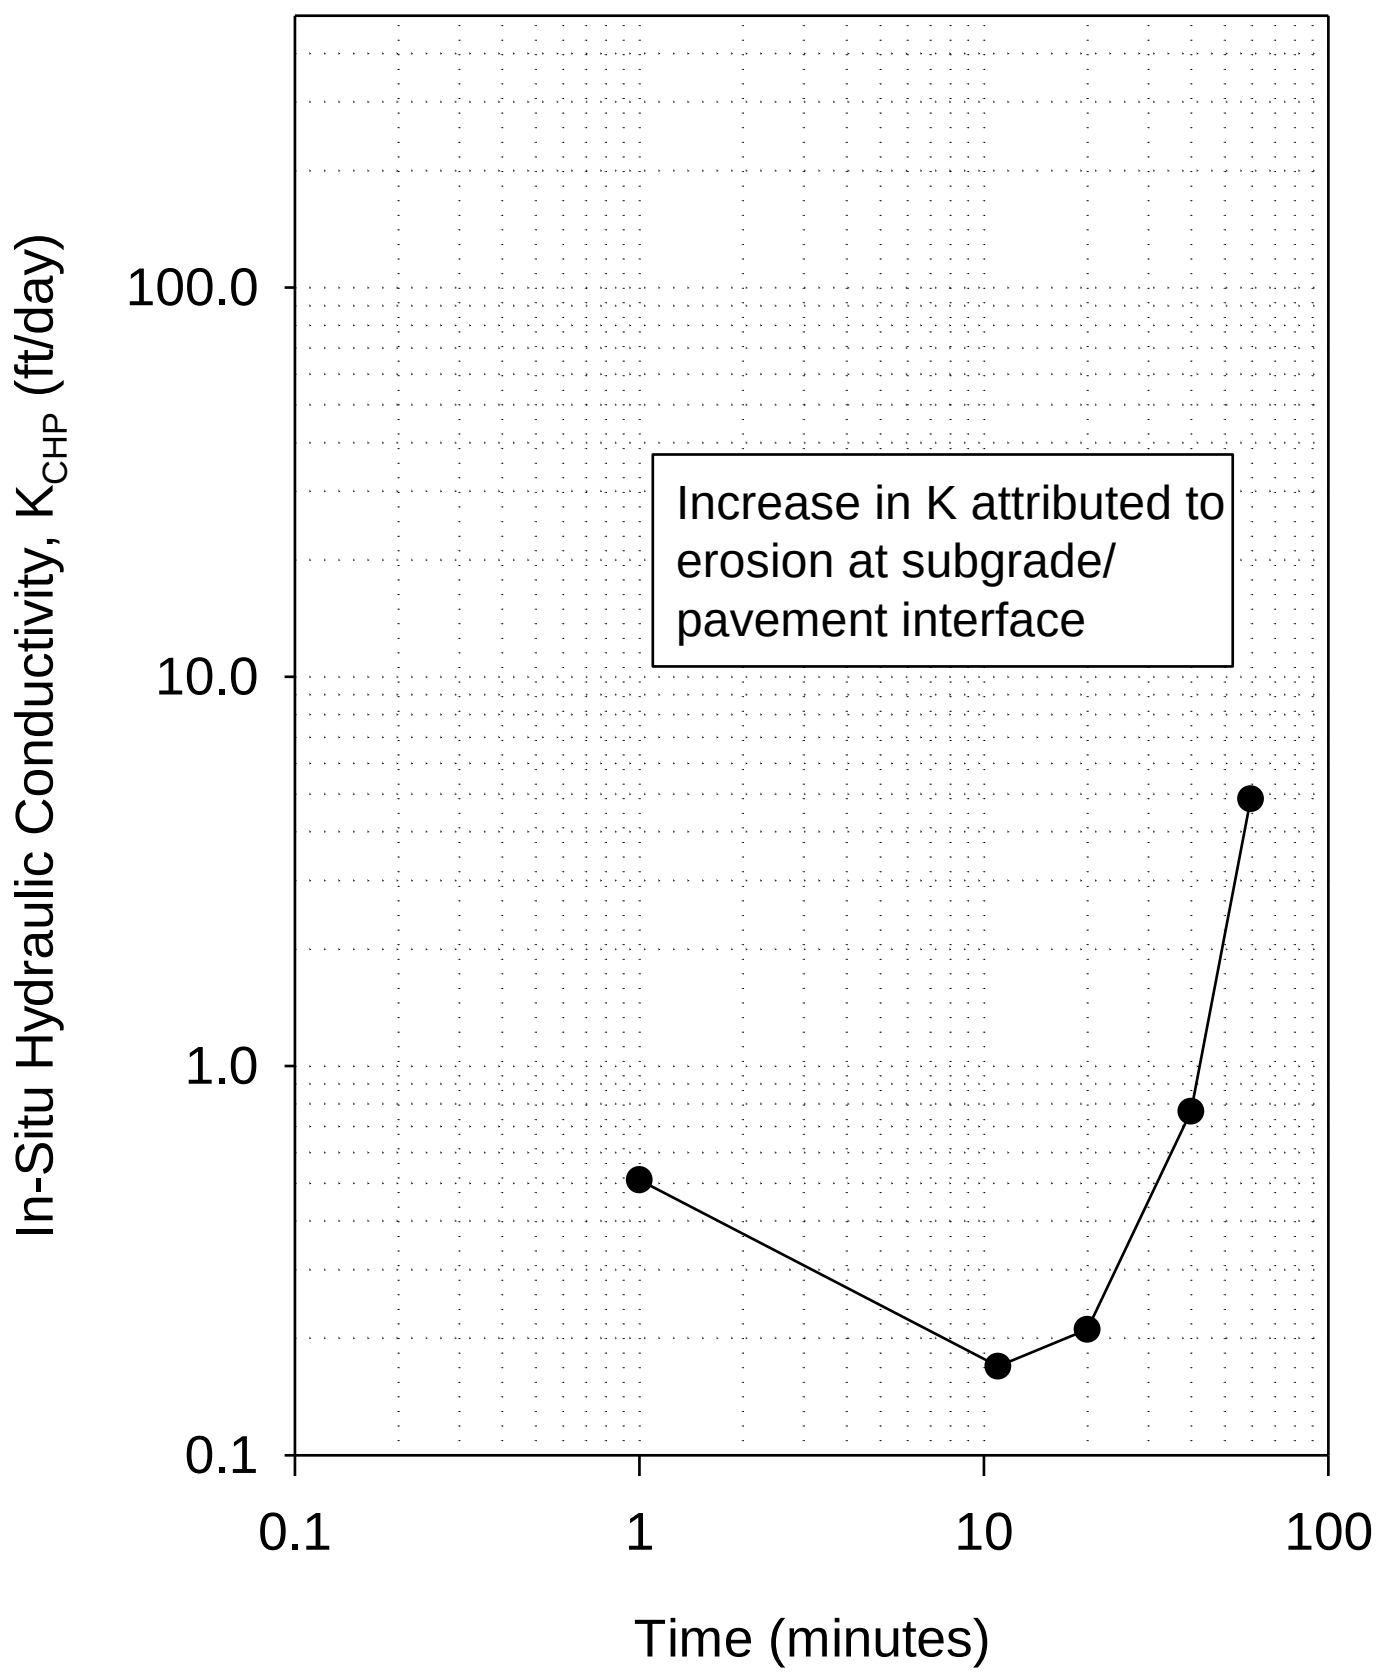
Figure 45. CHP test results — NW5th Street and Greenwood Drive, Ankeny

CHP tests showed an in situ K_{CHP} = 0.2 ft/day. Permeability values increased for readings taken after 10 min and this increase is attributed to erosion of material at the pavement/subgrade interface and potential void underneath the pavement. Based on the K_{CHP} value, pavement geometry, and an assumed effective porosity of 0.04 (see Table 7), the time to 50% drainage at this site is estimated as > 1 month (84 days). This time of drainage corresponds to "very poor" drainage quality per SUDAS (2013b) and AASHTO (1993) and C_d = 0.71.

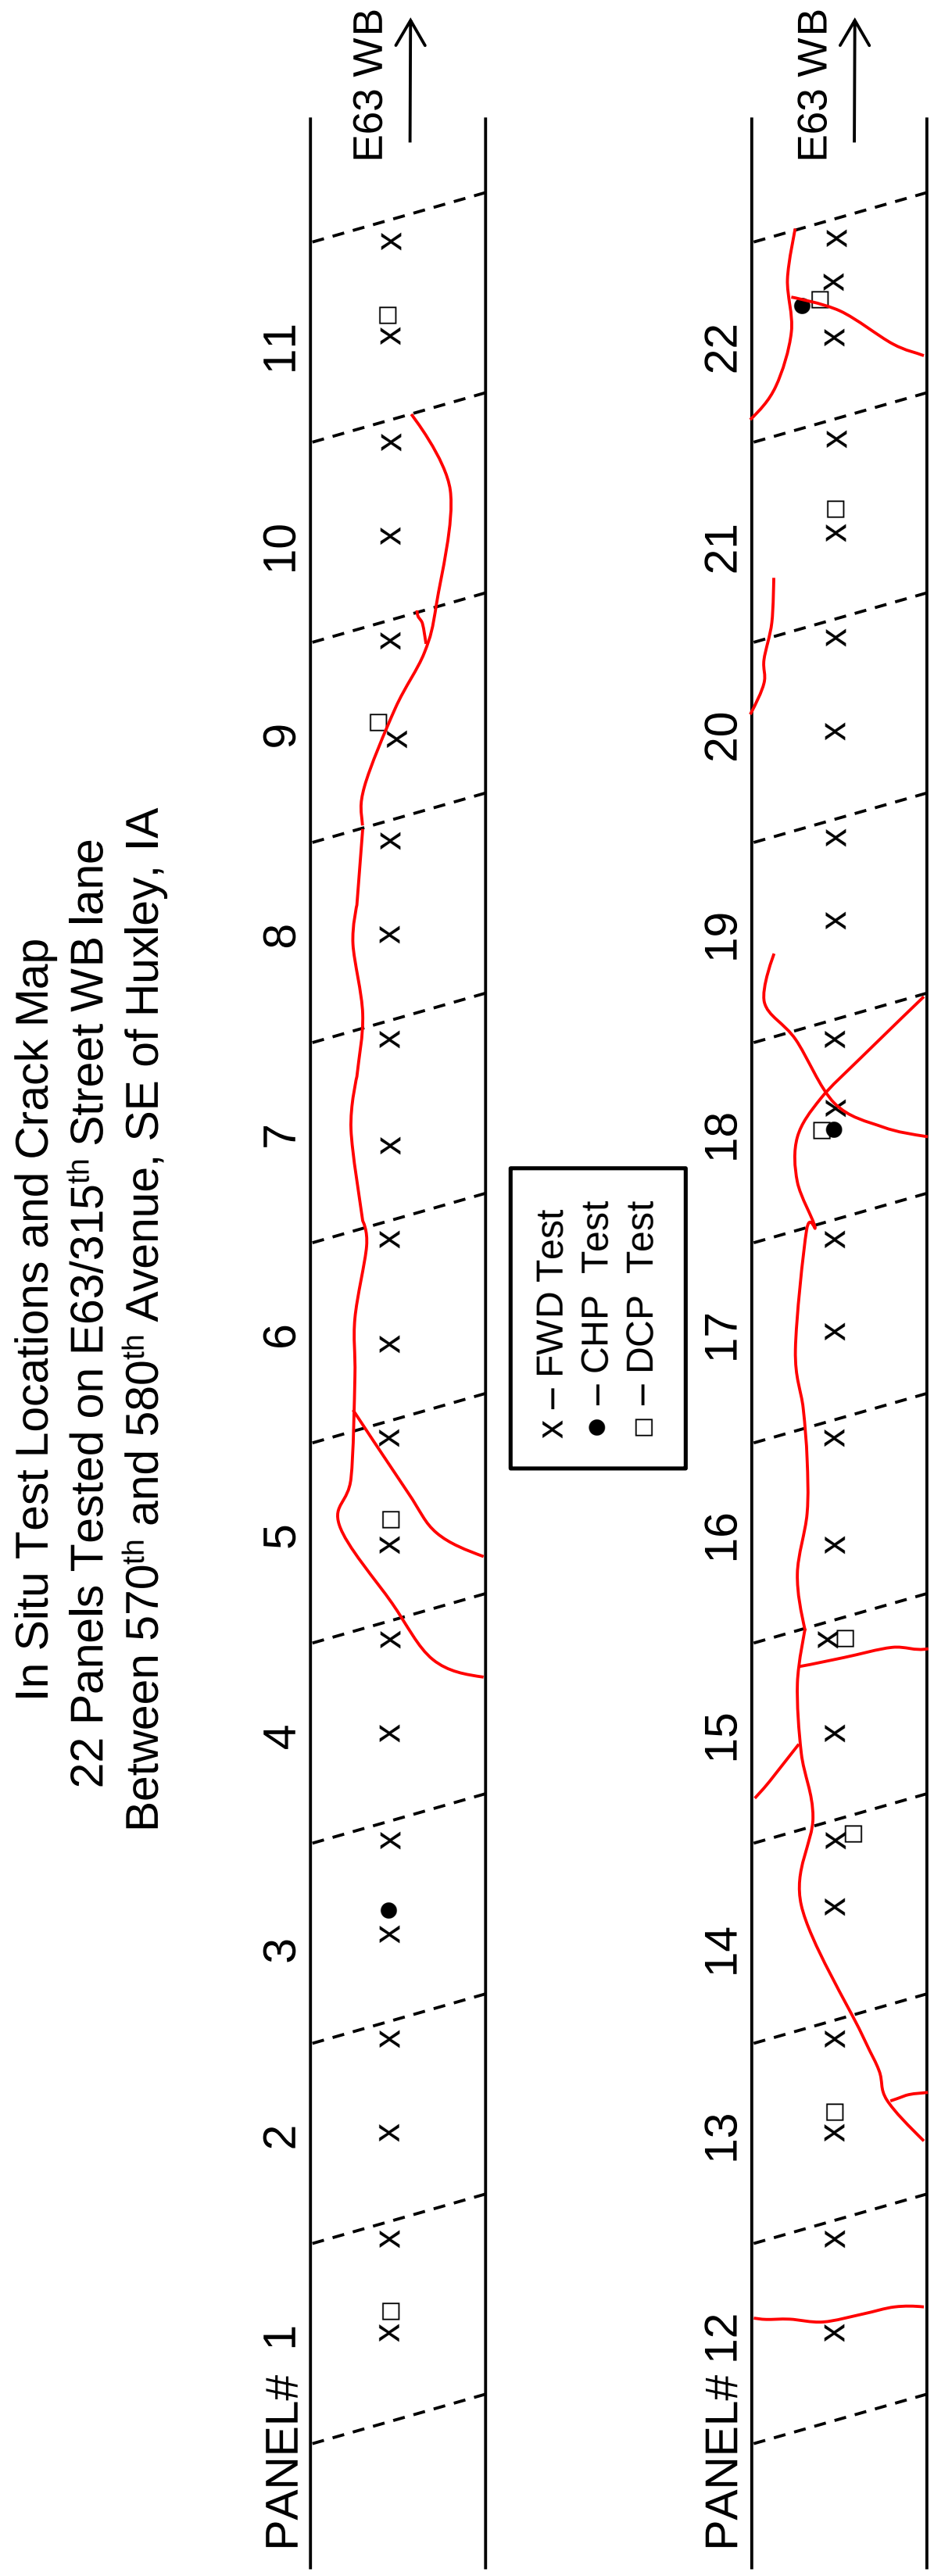
Figure 47. Crack Survey Map — E63, Story County

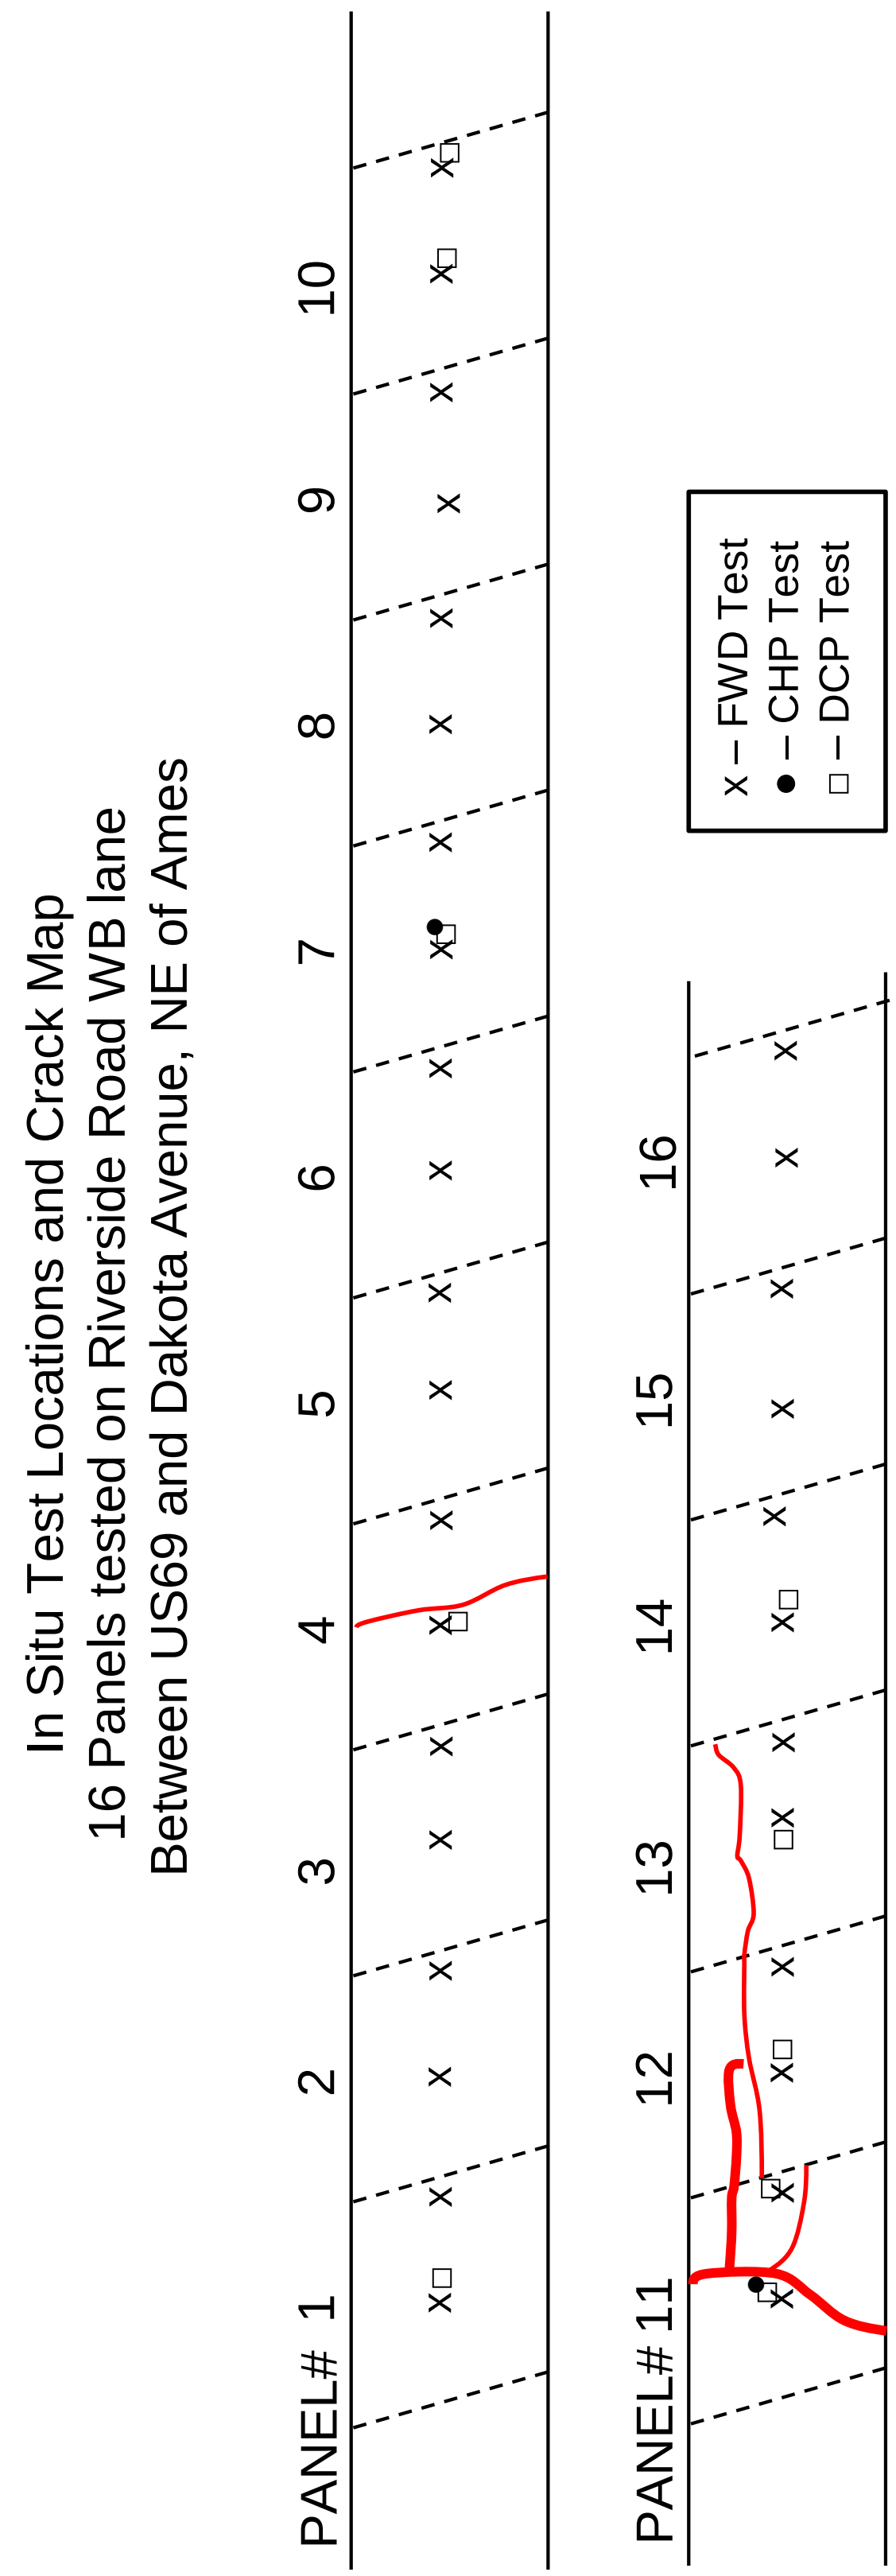
Figure 54. Crack Survey Map — Riverside Road, Ames

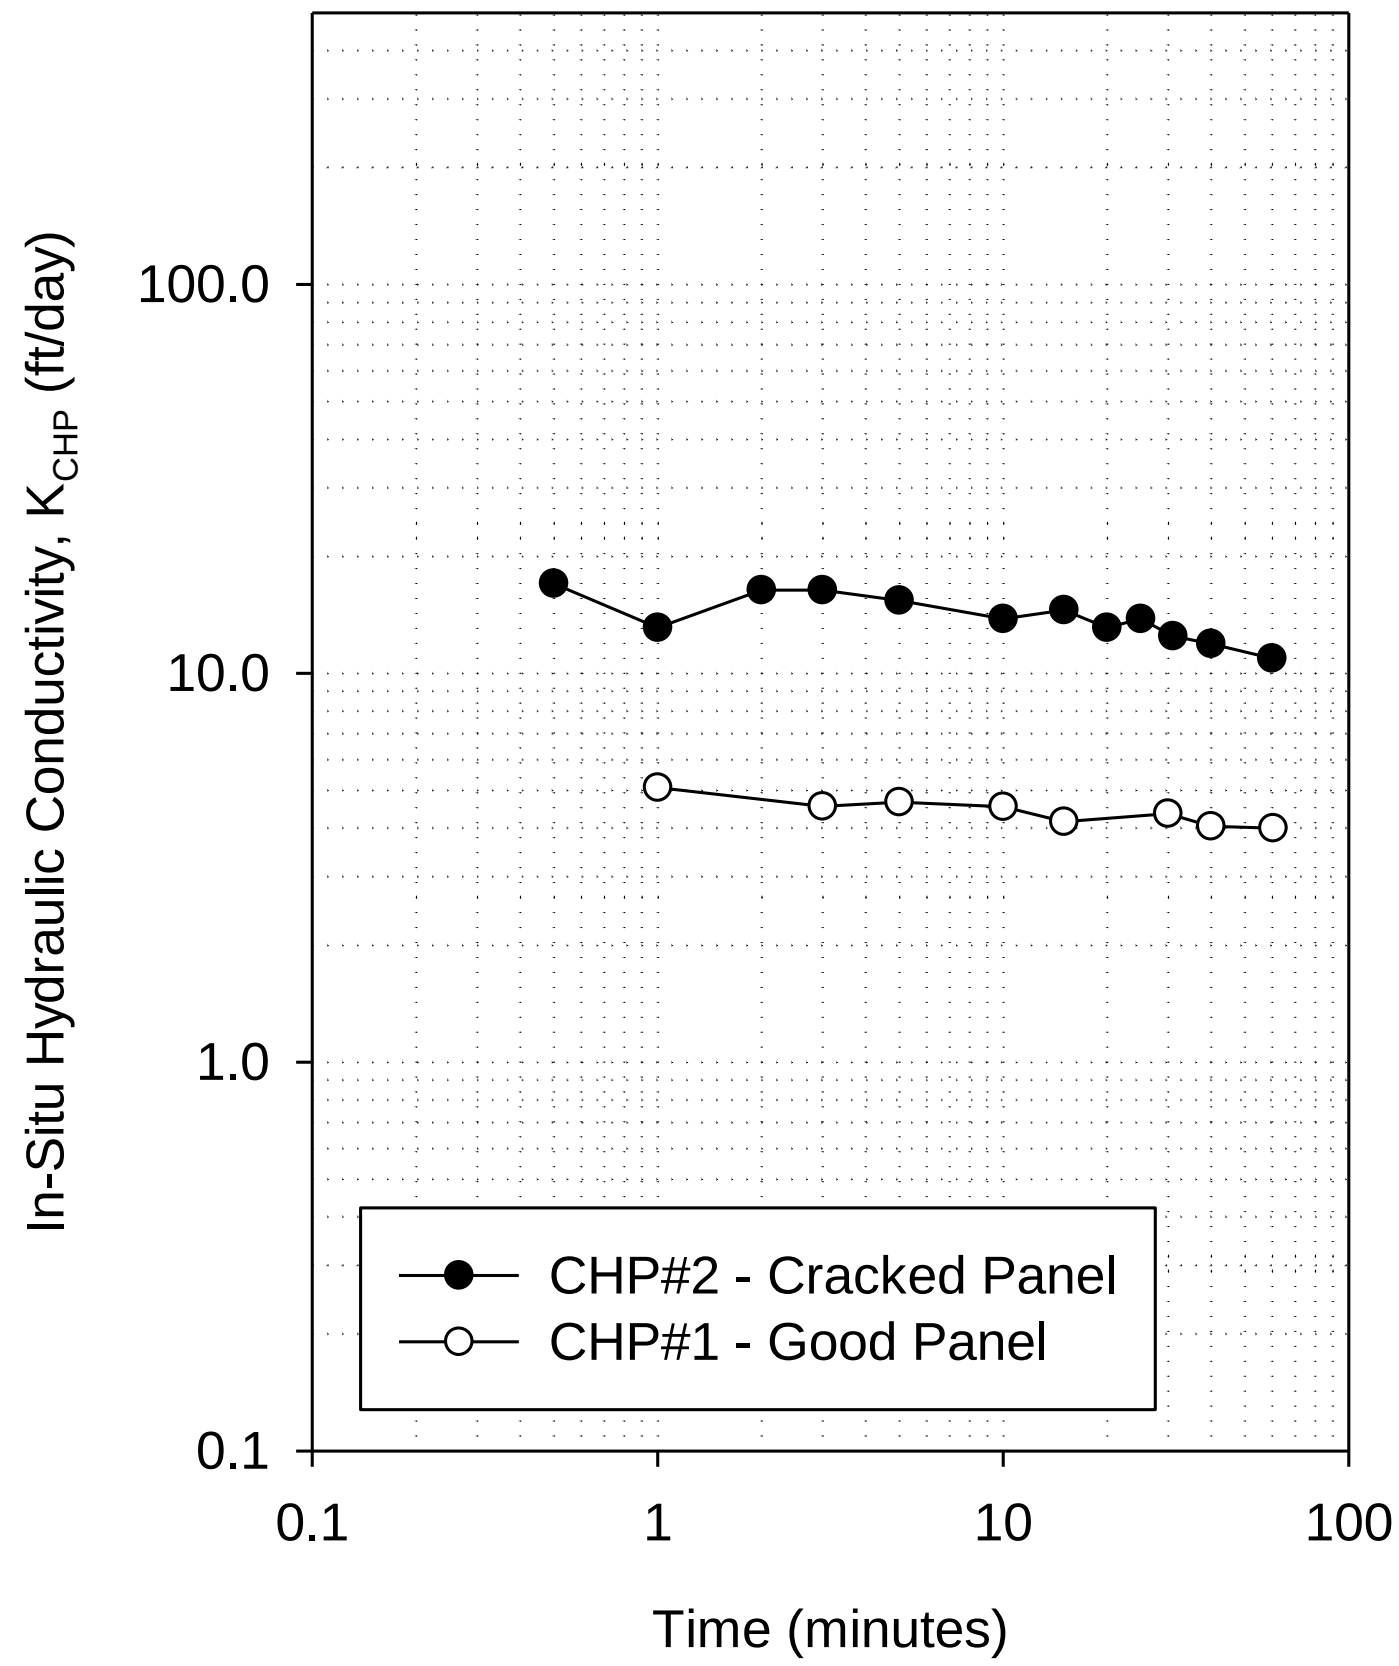
Figure 58. CHP test results — Riverside Road, Ames

CHP tests showed an in situ K_{CHP} = 4.0 ft/day under a panel with no cracks and K_{CHP} = 10.9 ft/day under a panel with cracks. Photographs of the two panels are shown in Figure 59. Based on the K_{CHP} value, pavement geometry, and an assumed effective porosity of 0.30 (see Table 7), the time to 50% drainage at this site is estimated as 7 days and 3 days under the panel with no cracks and the panel with cracks, respectively. The times of drainage correspond to "fair" quality per SUDAS (2013b) and AASHTO (1993) and C_d = 0.88 and 0.95.

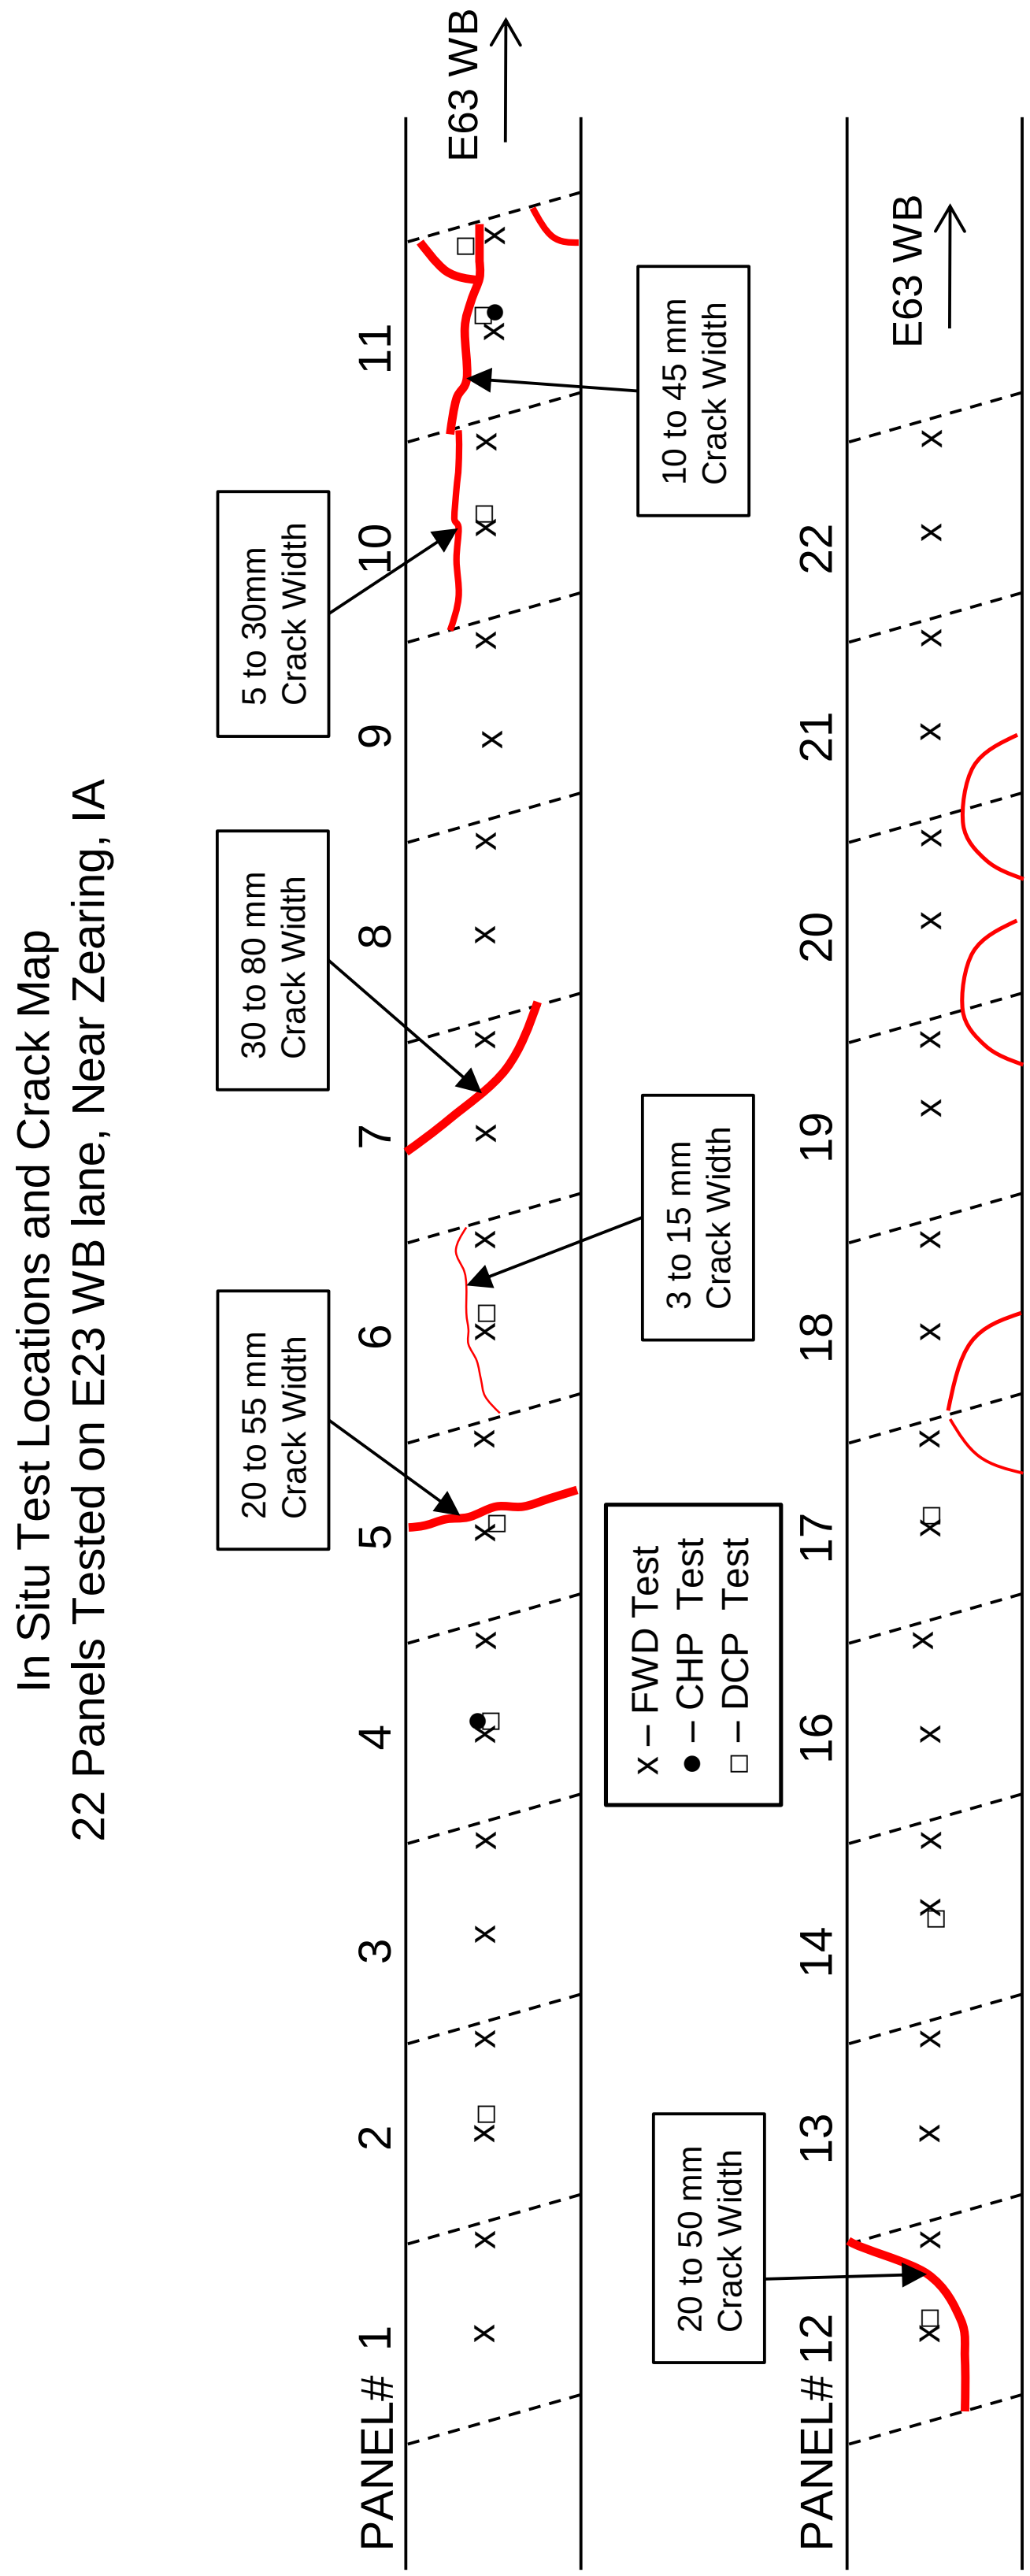
Figure 62. Crack Survey Map — E23, Story County

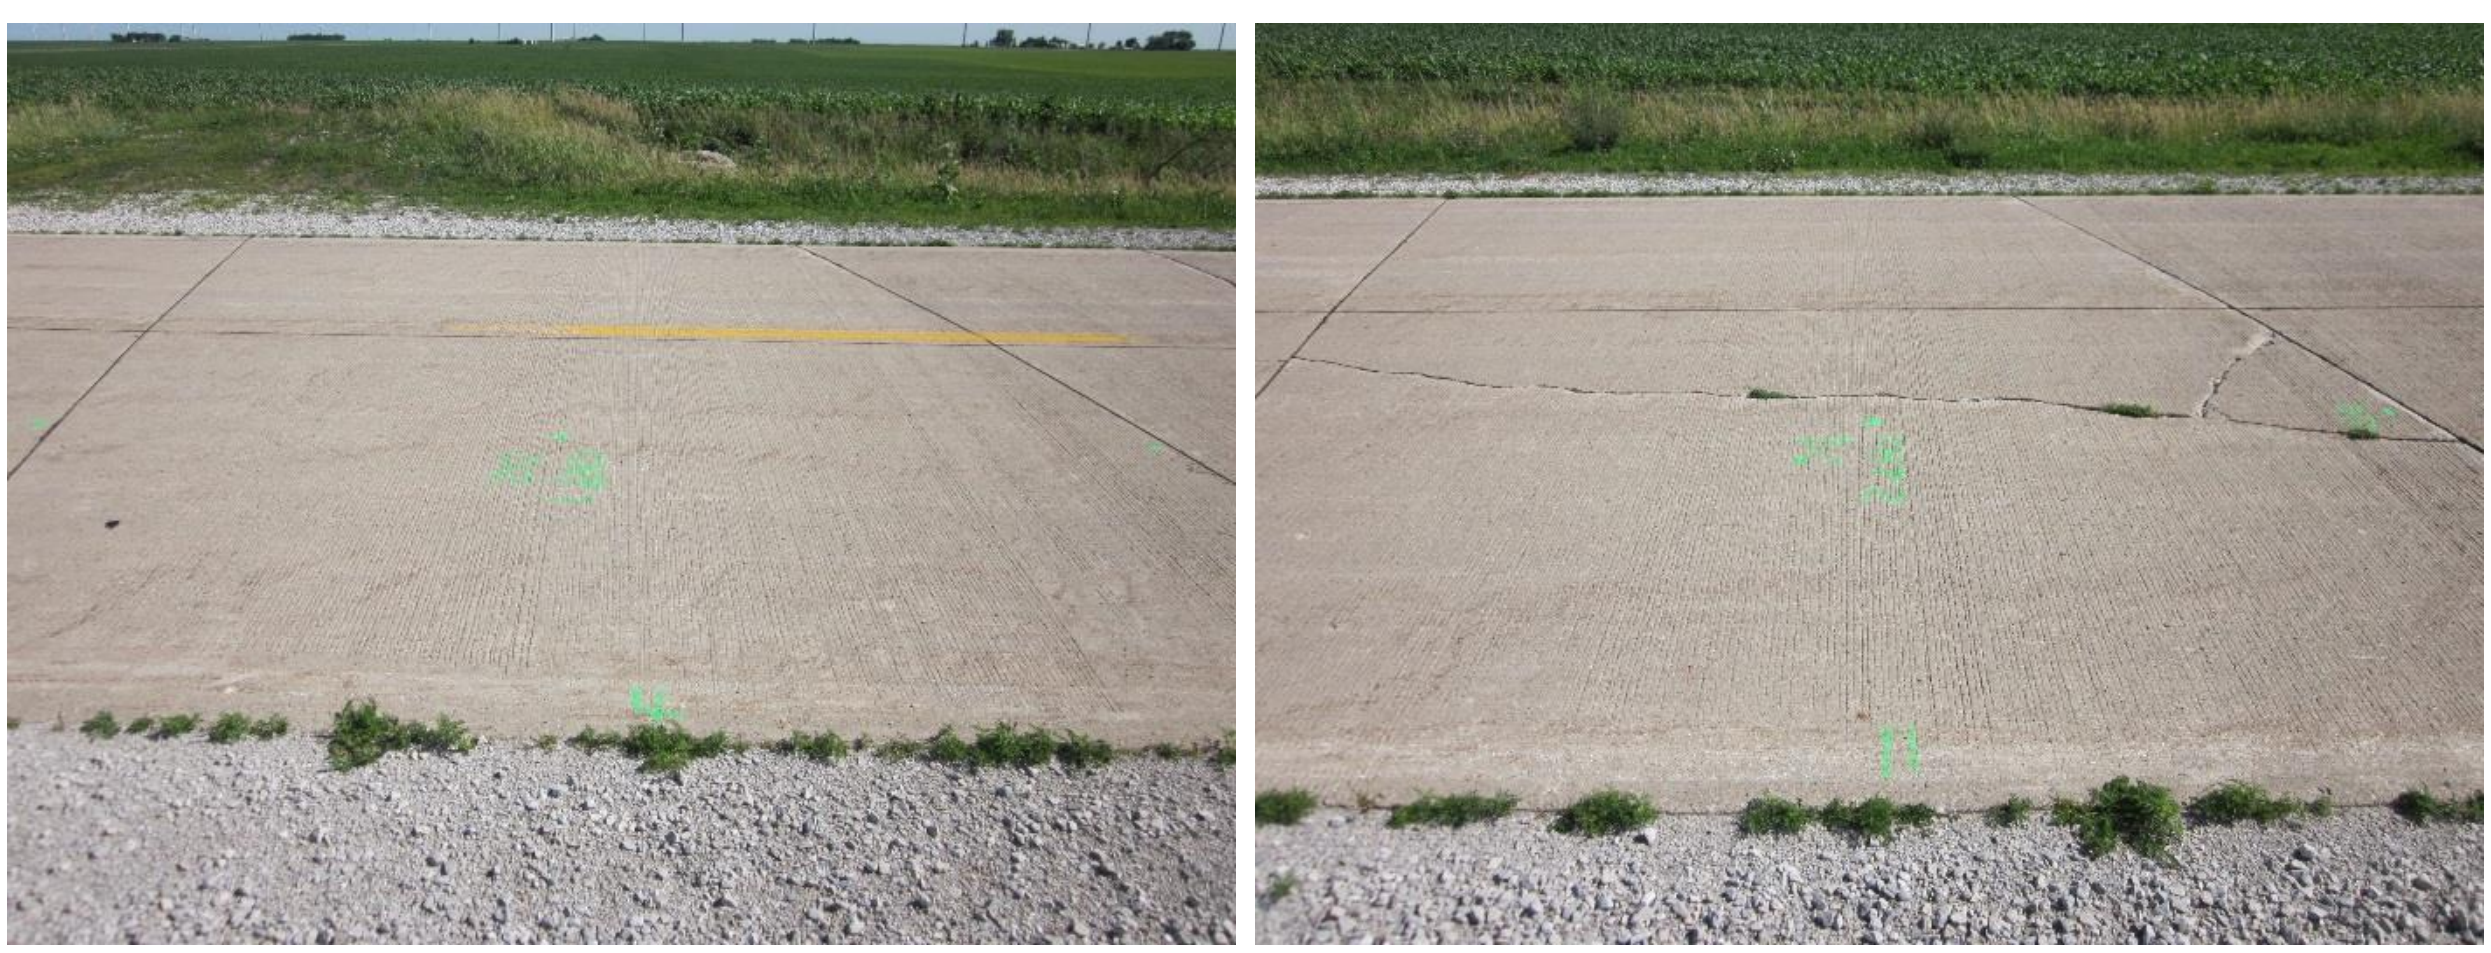
Figure 67. Photographs of good panel with CHP#1 test (left) and cracked panel with CHP#2 test (right) — E23, Story County
