Optimizing Pavement Base, Subbase, and Subgrade Layers for Cost and Performance of Local Roads

AUGUST 2014

Final Field Data Report

Sponsored by
Iowa Highway Research Board
(IHRB Project TR-640)
Iowa Department of Transportation
(InTrans Project 11-422)

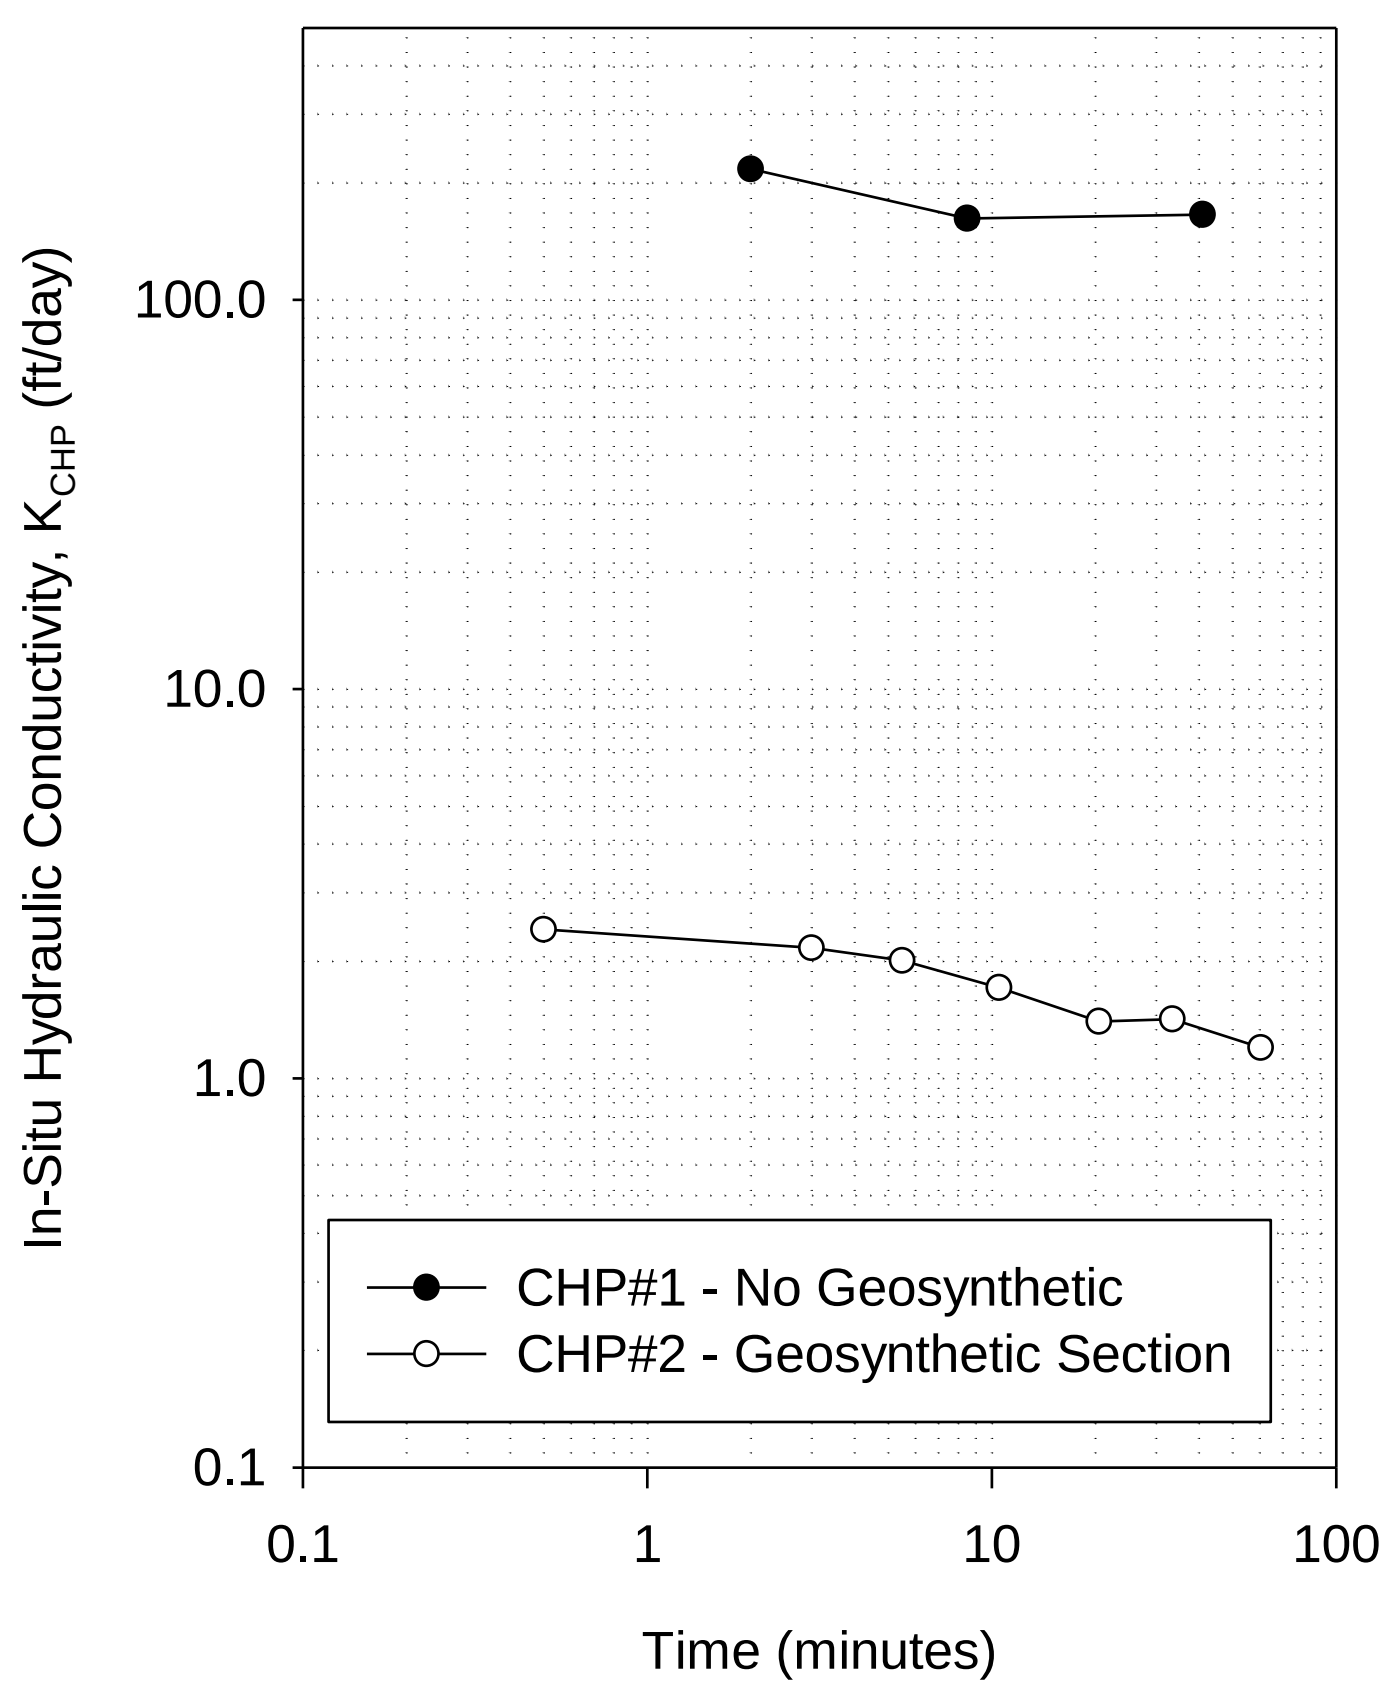
Figure 73. CHP test results — SW Westlawn Drive, Ankeny

CHP tests showed in situ K_{CHP} = 1.2 ft/day (CHP#1) in the section without geosynthetic and K_{CHP} = 160 ft/day (CHP#2) in the section with geosynthetic. Although not noticed in the FWD intercept values, voids were noticed in the CHP#2 core hole at the pavement/subbase interface, which contributed to the higher K_{CHP} in CHP#2. Based on the K_{CHP} values, pavement geometry, and an assumed effective porosity of 0.30 (see Table 7), the time to 50% drainage at this site is estimated as about 14 days at CHP#1 and about 2.4 hours at CHP#2. The times of drainage correspond to “poor” to “fair” drainage quality at CHP# 1 with C_d = 0.84 and “excellent” drainage quality at CHP#2 with C_d = 1.09, per SUDAS (2013b) and AASHTO (1993).

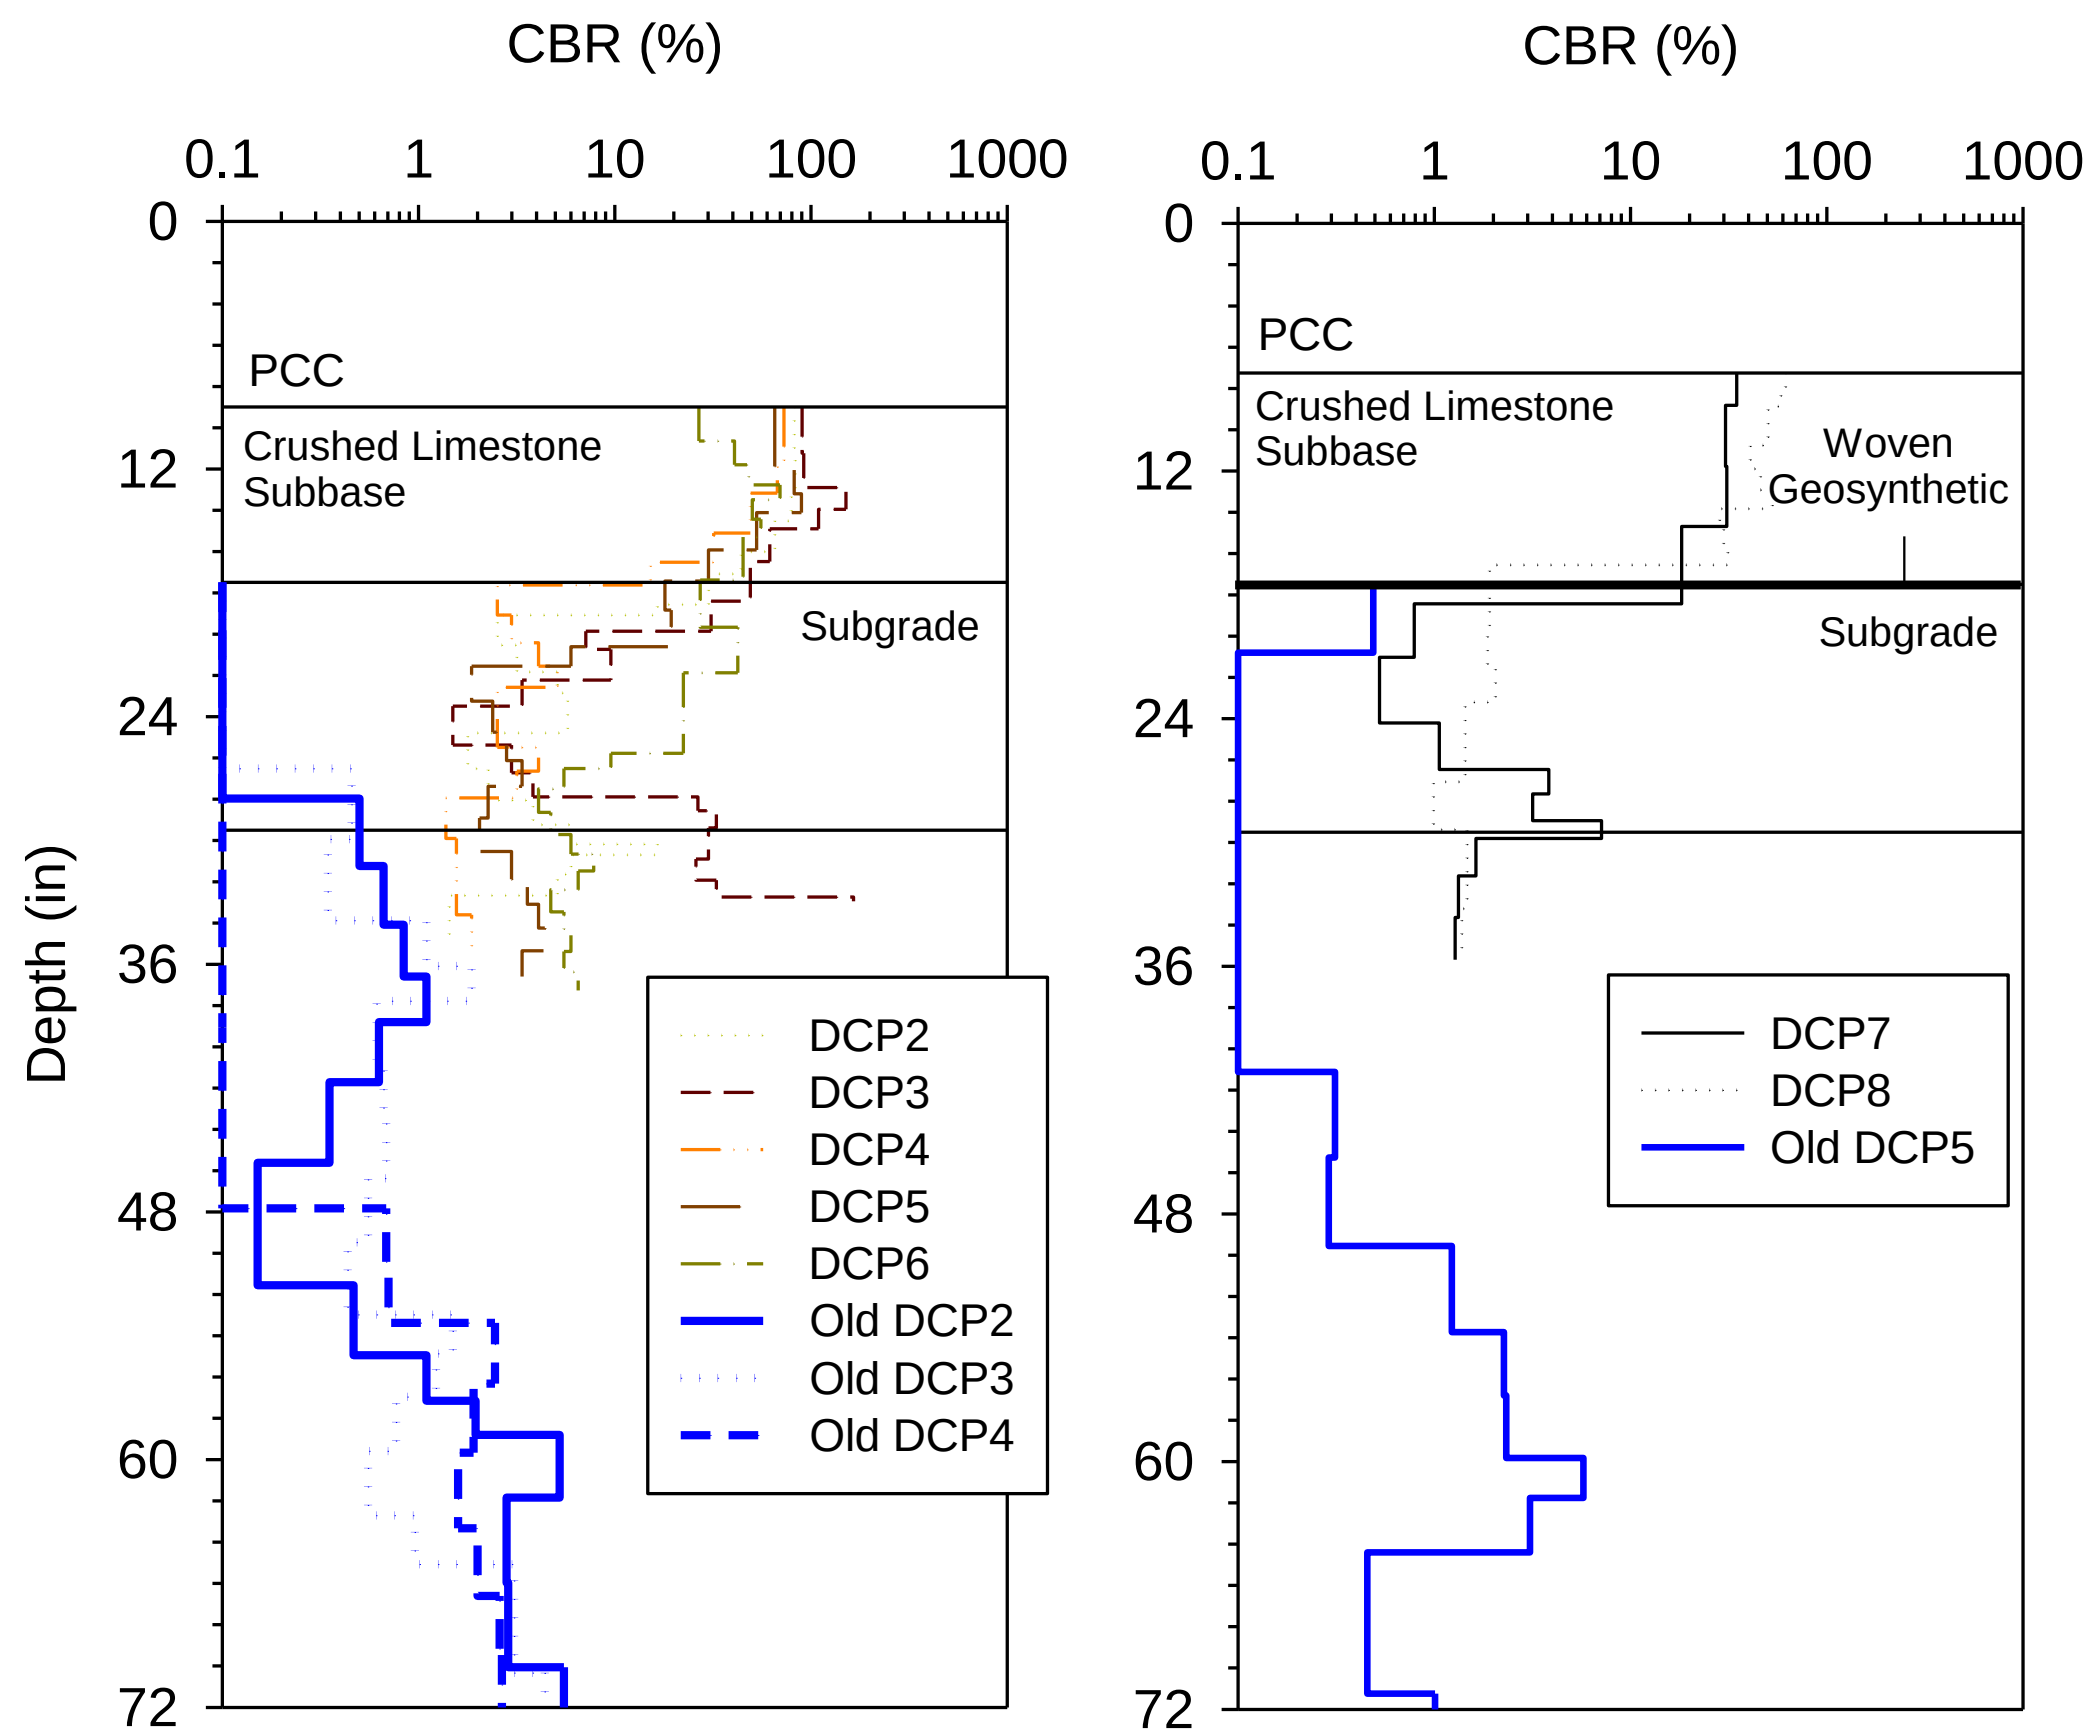
Figure 75. Comparison between 2008 DCP-CBR profiles and 2012 DCP-CBR profiles — SW Westlawn Drive, Ankeny

The research team was present at this site in 2008 during construction of the subgrade and conducted 6 ft deep DCPs in the subgrade (Figure 74). The locations of these DCPs are shown in Figure 70 in reference to the new test locations (labelled as old DCPs). The 2008 tests were conducted in trench backfill material placed along this road that was compacted using a vibratory plate compactor (Figure 74). DCP-CBR profiles from 2008 testing are shown along with the 2012 testing results in Figure 75. Results showed poor subgrade compaction with CBR < 3 in the top 3 ft of the subgrade during construction. The high intercept values on this site (Figure 70), premature cracks on the surface and voids beneath pavement can likely be related to non-uniform vertical deformations of this poorly compacted backfill material and potential loss of support beneath the pavement.

Results in Figure 75 shows that CBR values obtained in 2012 were comparatively higher than CBR obtained in 2008 during construction. This increase in CBR can be attributed to changes in moisture content, densification of the material due to settlement of backfill, and trafficking during placement of subbase material over the subgrade. Moisture contents of the subgrade material during 2008 testing varied from about 15% to 16%, while the material was at about 12% during 2012 testing (materials' standard Proctor optimum moisture content was about 12%).

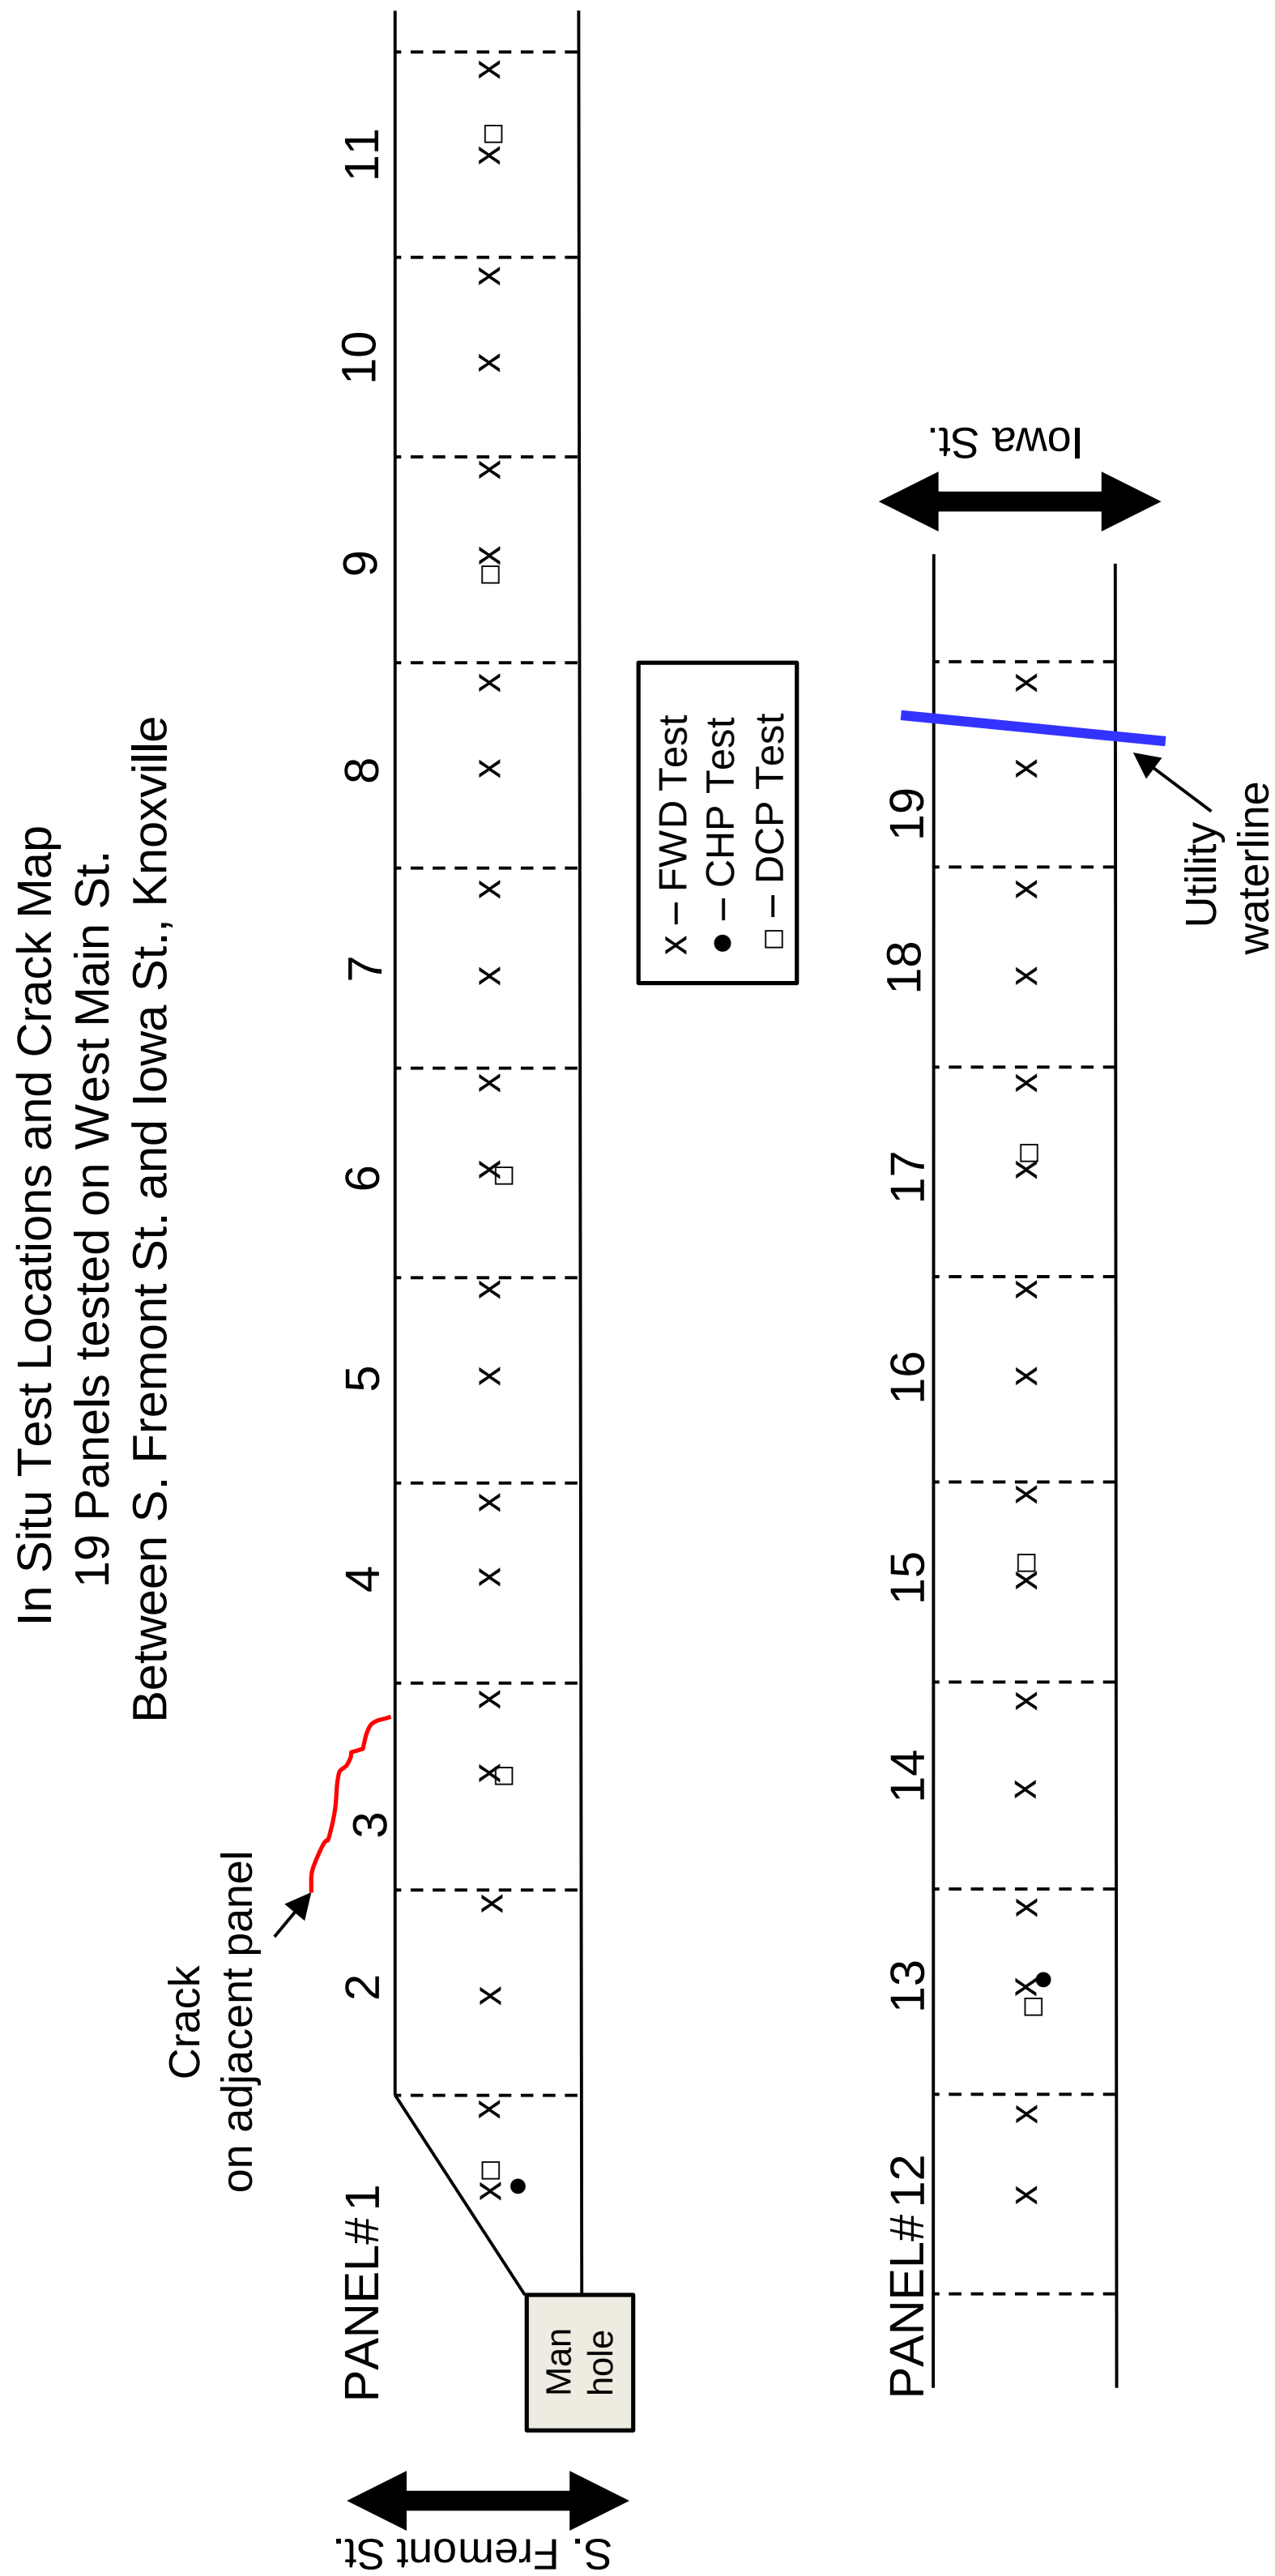
Figure 82. Crack Survey Map — West Main Street, Knoxville

Field testing at this site was conducted on July 12, 2012. A crack survey map of the test site along with in situ test locations is shown in Figure 82. FWD testing was conducted on 19 panels at mid panel and at joint. DCP tests were conducted at eight locations and CHP tests were conducted at two locations. There were three panels across the pavement width, and tests were conducted along the middle panel. All tests were conducted along the center line of each panel. One of the panels tested (on the west end of the test section and close to Iowa St.) was located directly over a utility line.

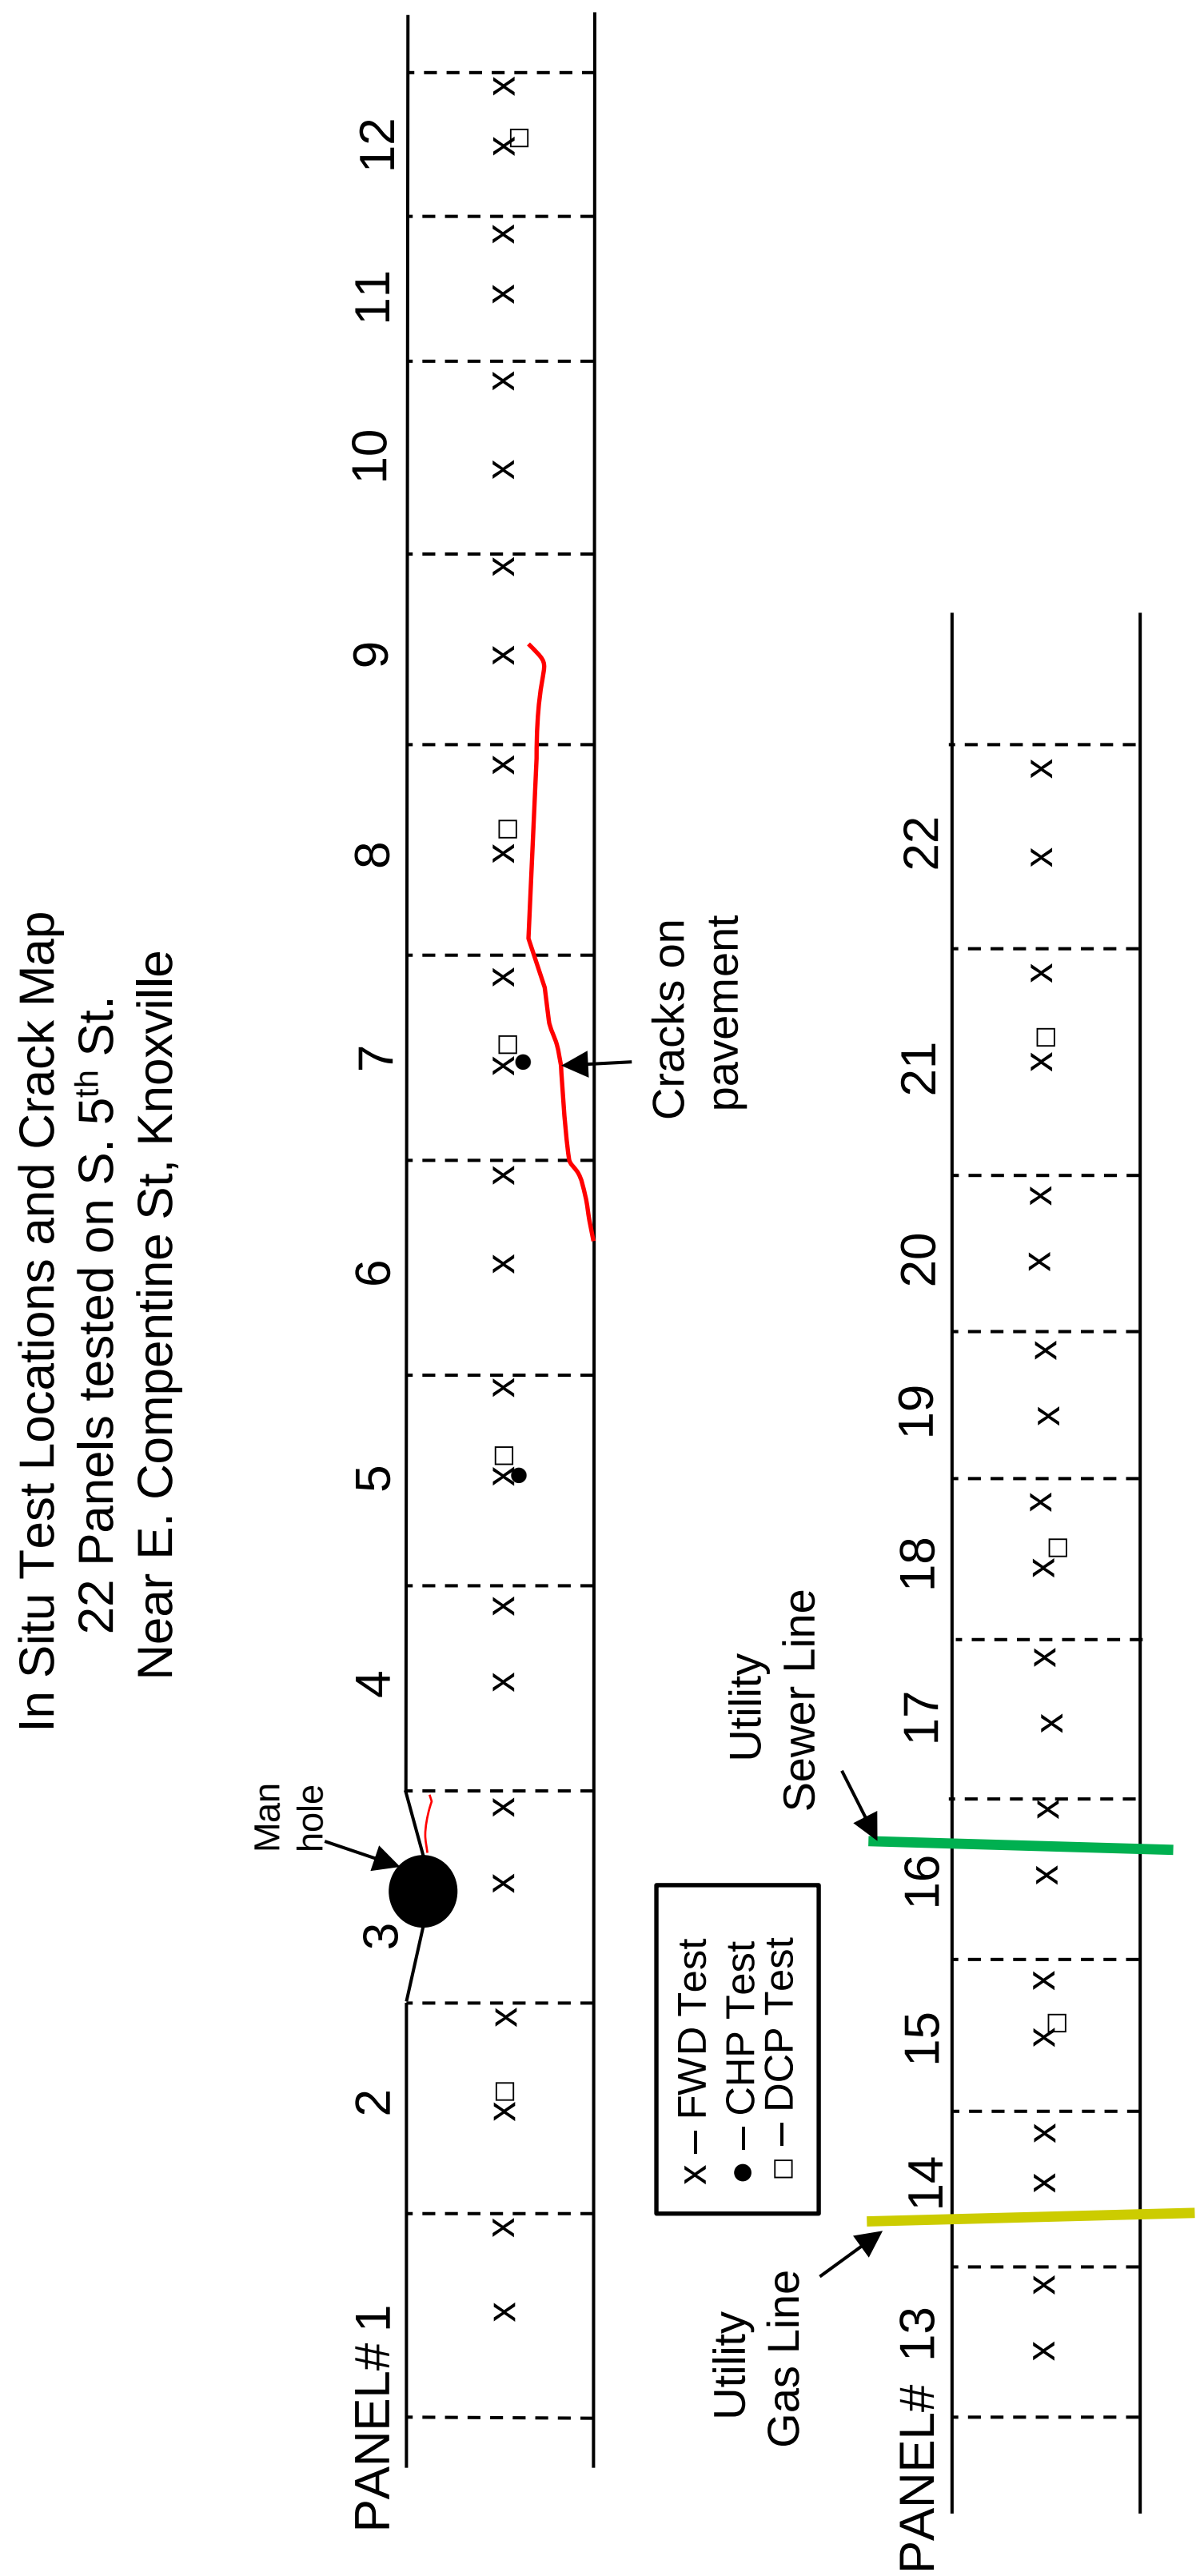
Figure 88. Crack Survey Map — South 5th Street, Knoxville

In situ testing at this site was conducted on July 12, 2012. A crack survey map of the test site along with in situ test locations is shown in Figure 88. FWD testing was conducted on 22 panels at mid panel and at joint. DCP tests were conducted at eight locations and CHP tests were conducted at two locations (one each in panels with and without cracks). All tests were conducted along the center line of each panel. There were utility lines across the pavement at two locations and along the pavement alignment as shown in Figure 88.

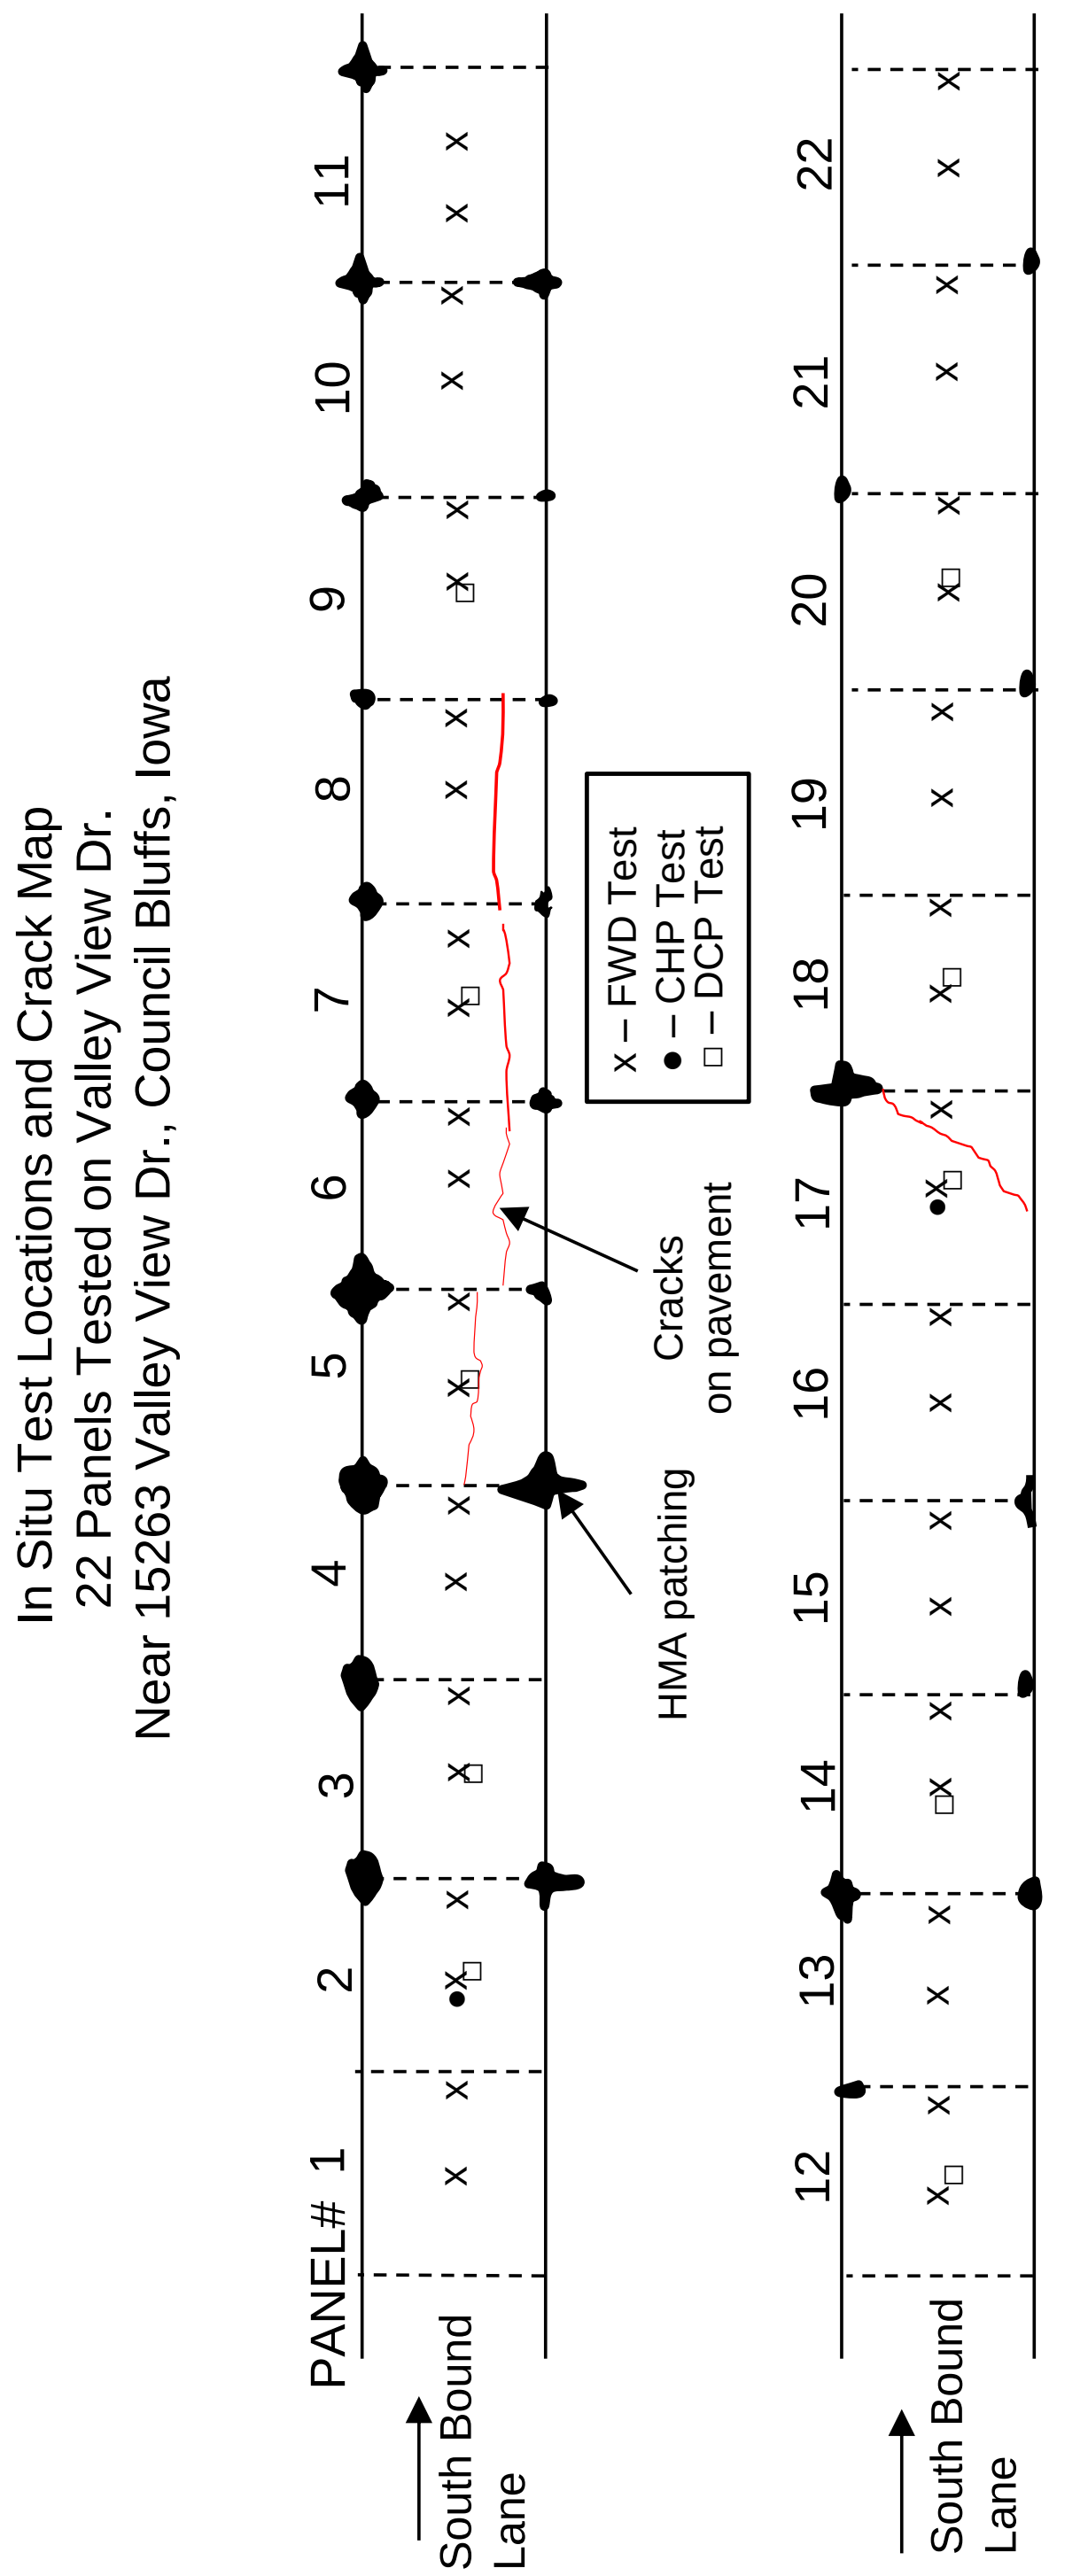
Figure 94. Crack Survey Map — Valley View Drive, Council Bluffs

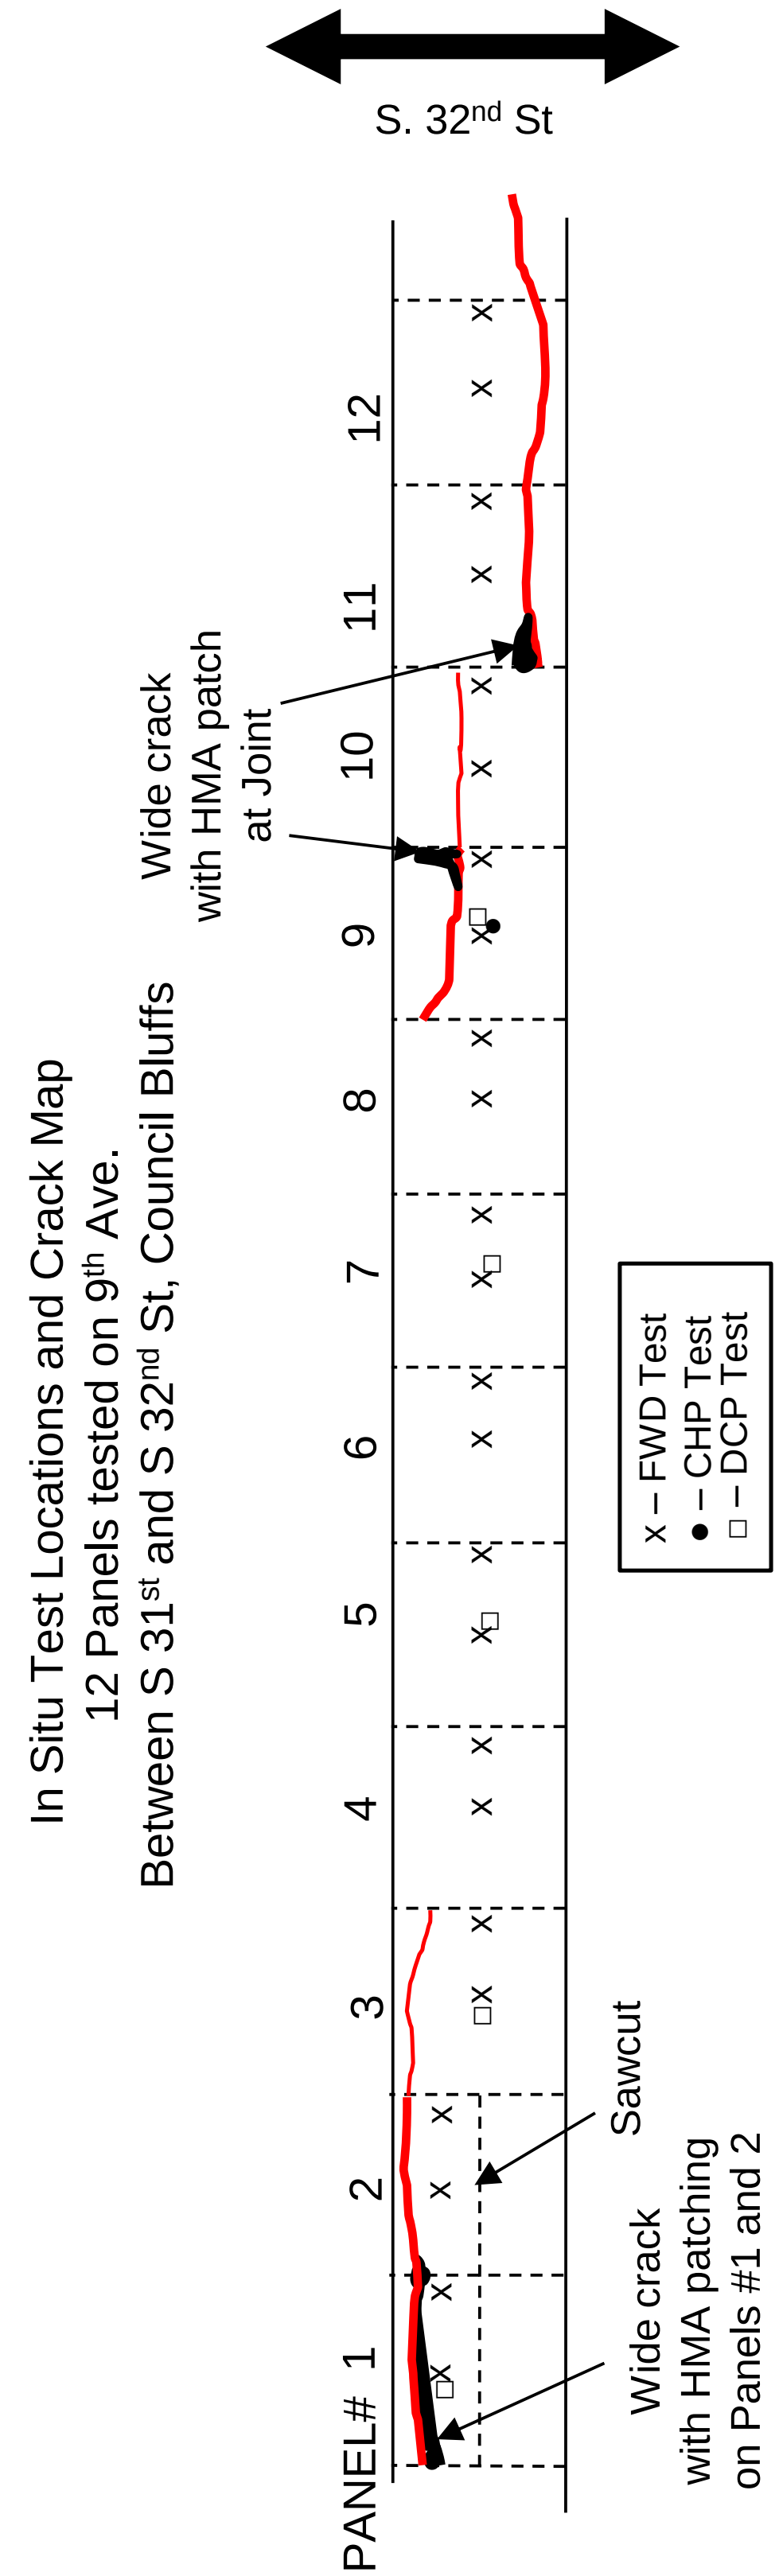
Figure 100. Crack Survey Map — 9th Avenue, Council Bluffs

Field testing at this site was conducted on July 26, 2012. A crack survey map of the test site along with in situ test locations is shown in Figure 100. FWD testing was conducted on 12 panels at mid panel and at joint. DCP tests were conducted at five locations and CHP test was conducted at one location (on a panel with wide longitudinal crack). All tests were conducted on east bound lane along the center line of each panel.

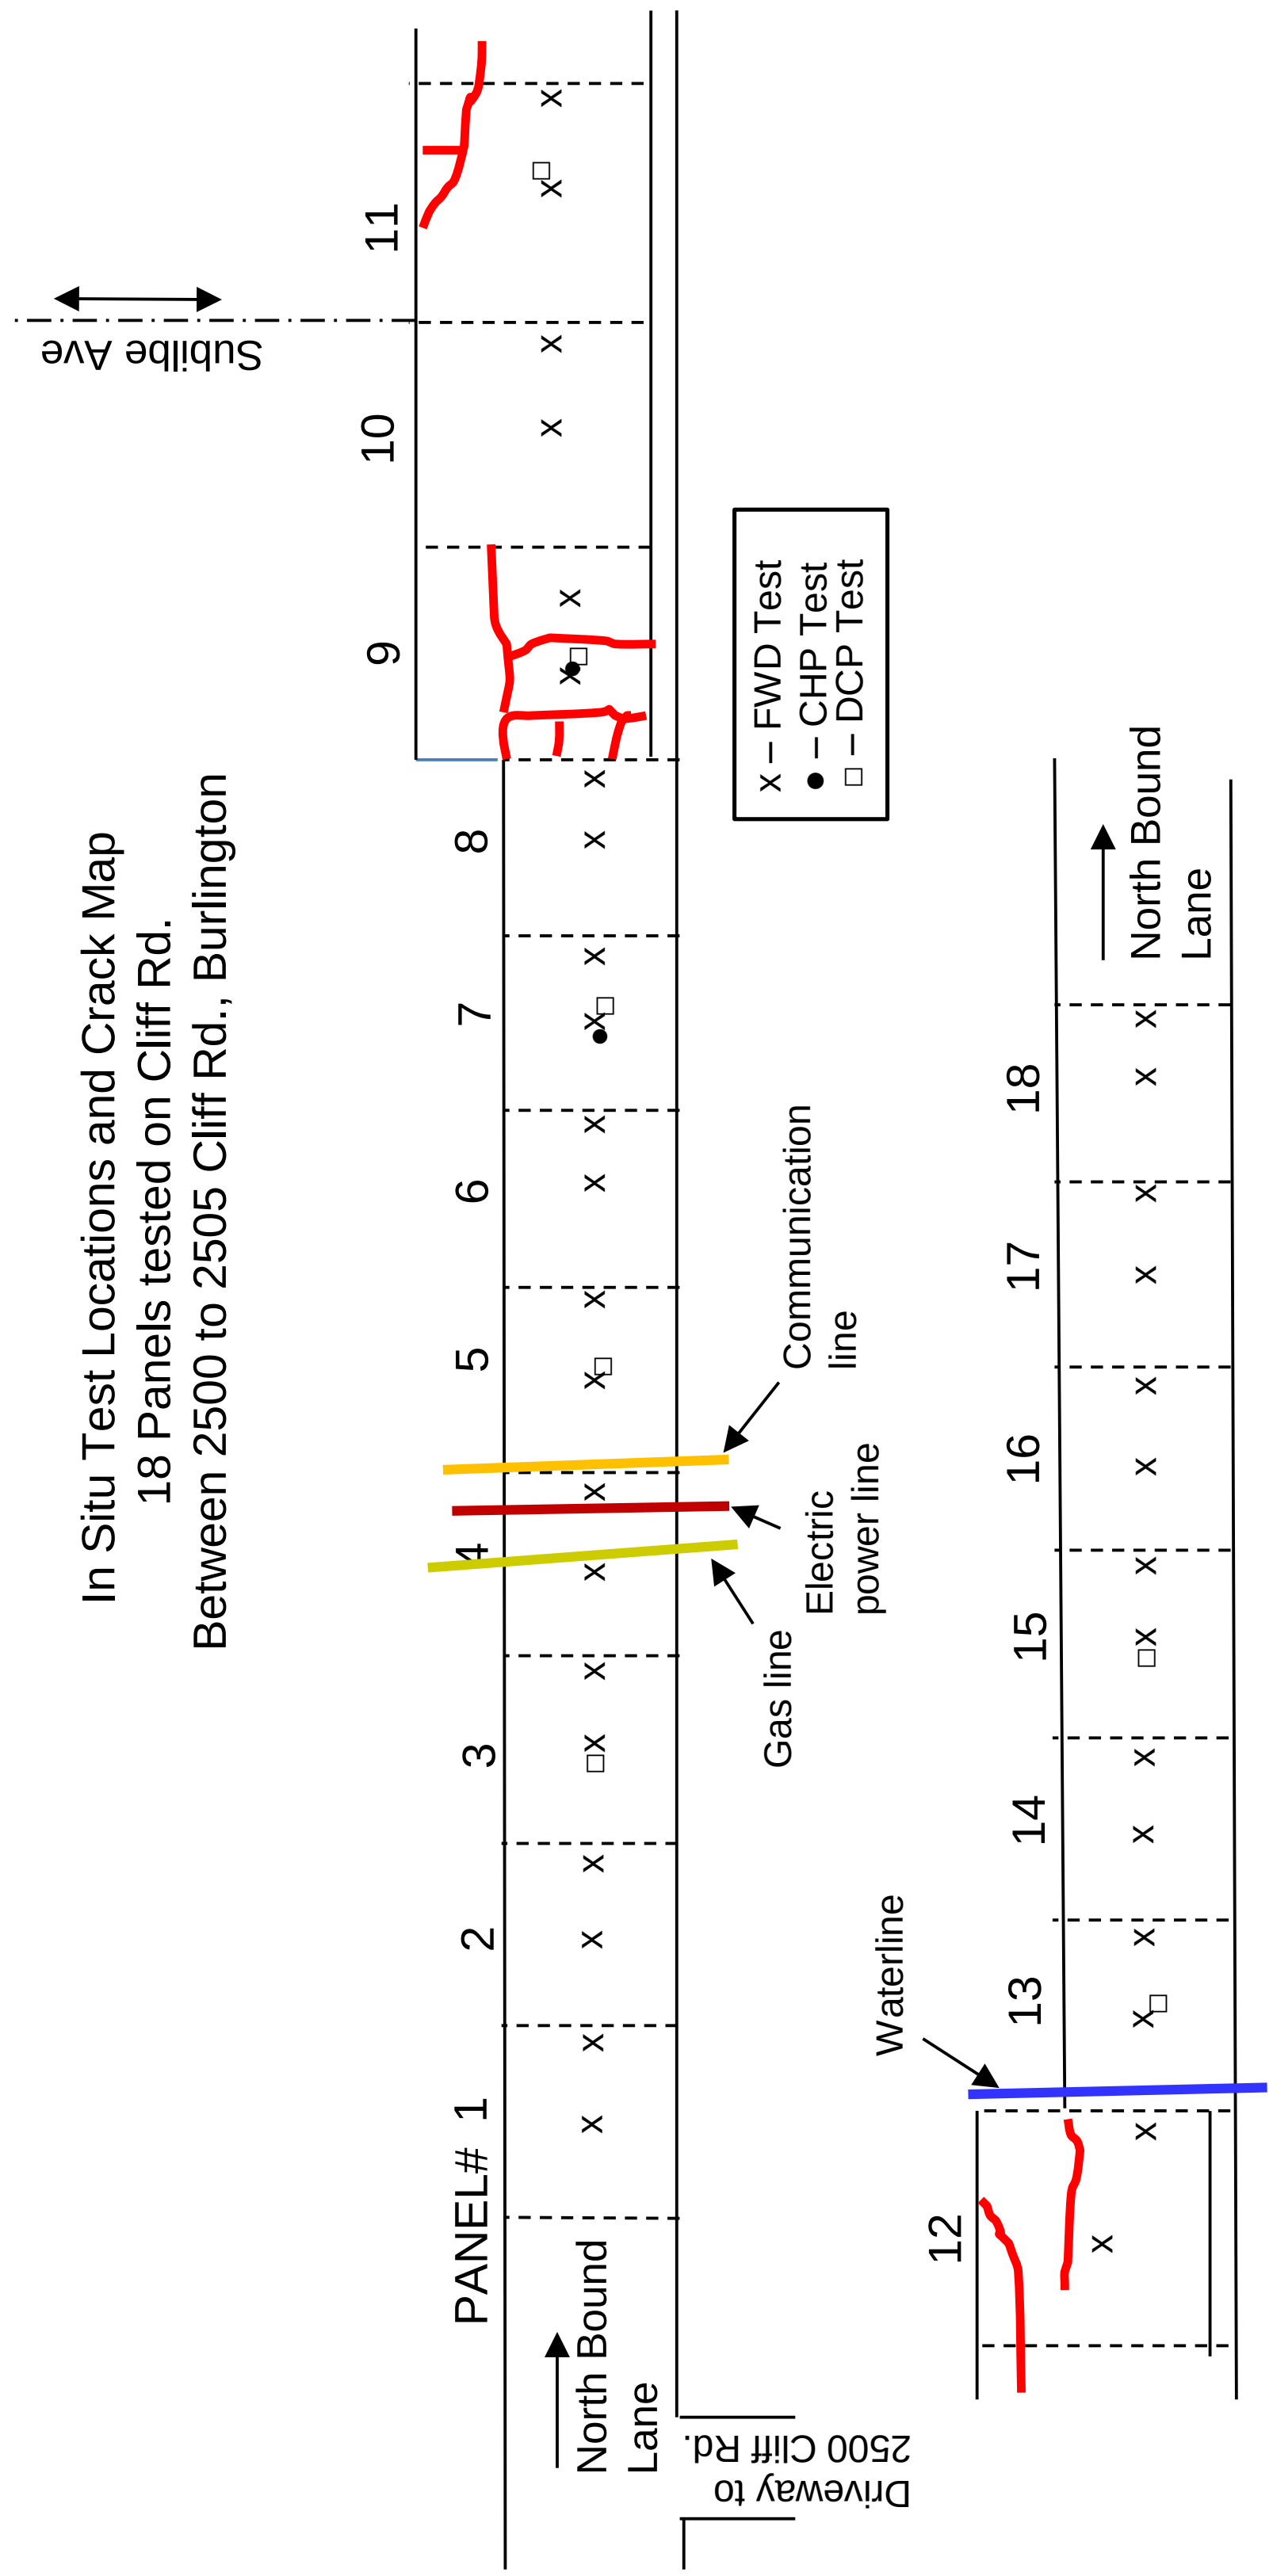
Figure 106. Crack Survey Map — Cliff Road (Site A), Burlington

Field testing at this site was conducted on August 2, 2012. A crack survey map of the test site along with in situ test locations is shown in Figure 106. FWD testing was conducted on 18 panels at mid panel and at joint. DCP tests were conducted at eight locations and CHP tests were conducted at two locations (one under a panel with no cracks and one under a panel with cracks). All tests were conducted along the center line of the north bound lane panels.
