Optimizing Pavement Base, Subbase, and Subgrade Layers for Cost and Performance of Local Roads

AUGUST 2014

Final Field Data Report

Sponsored by
Iowa Highway Research Board
(IHRB Project TR-640)
Iowa Department of Transportation
(InTrans Project 11-422)

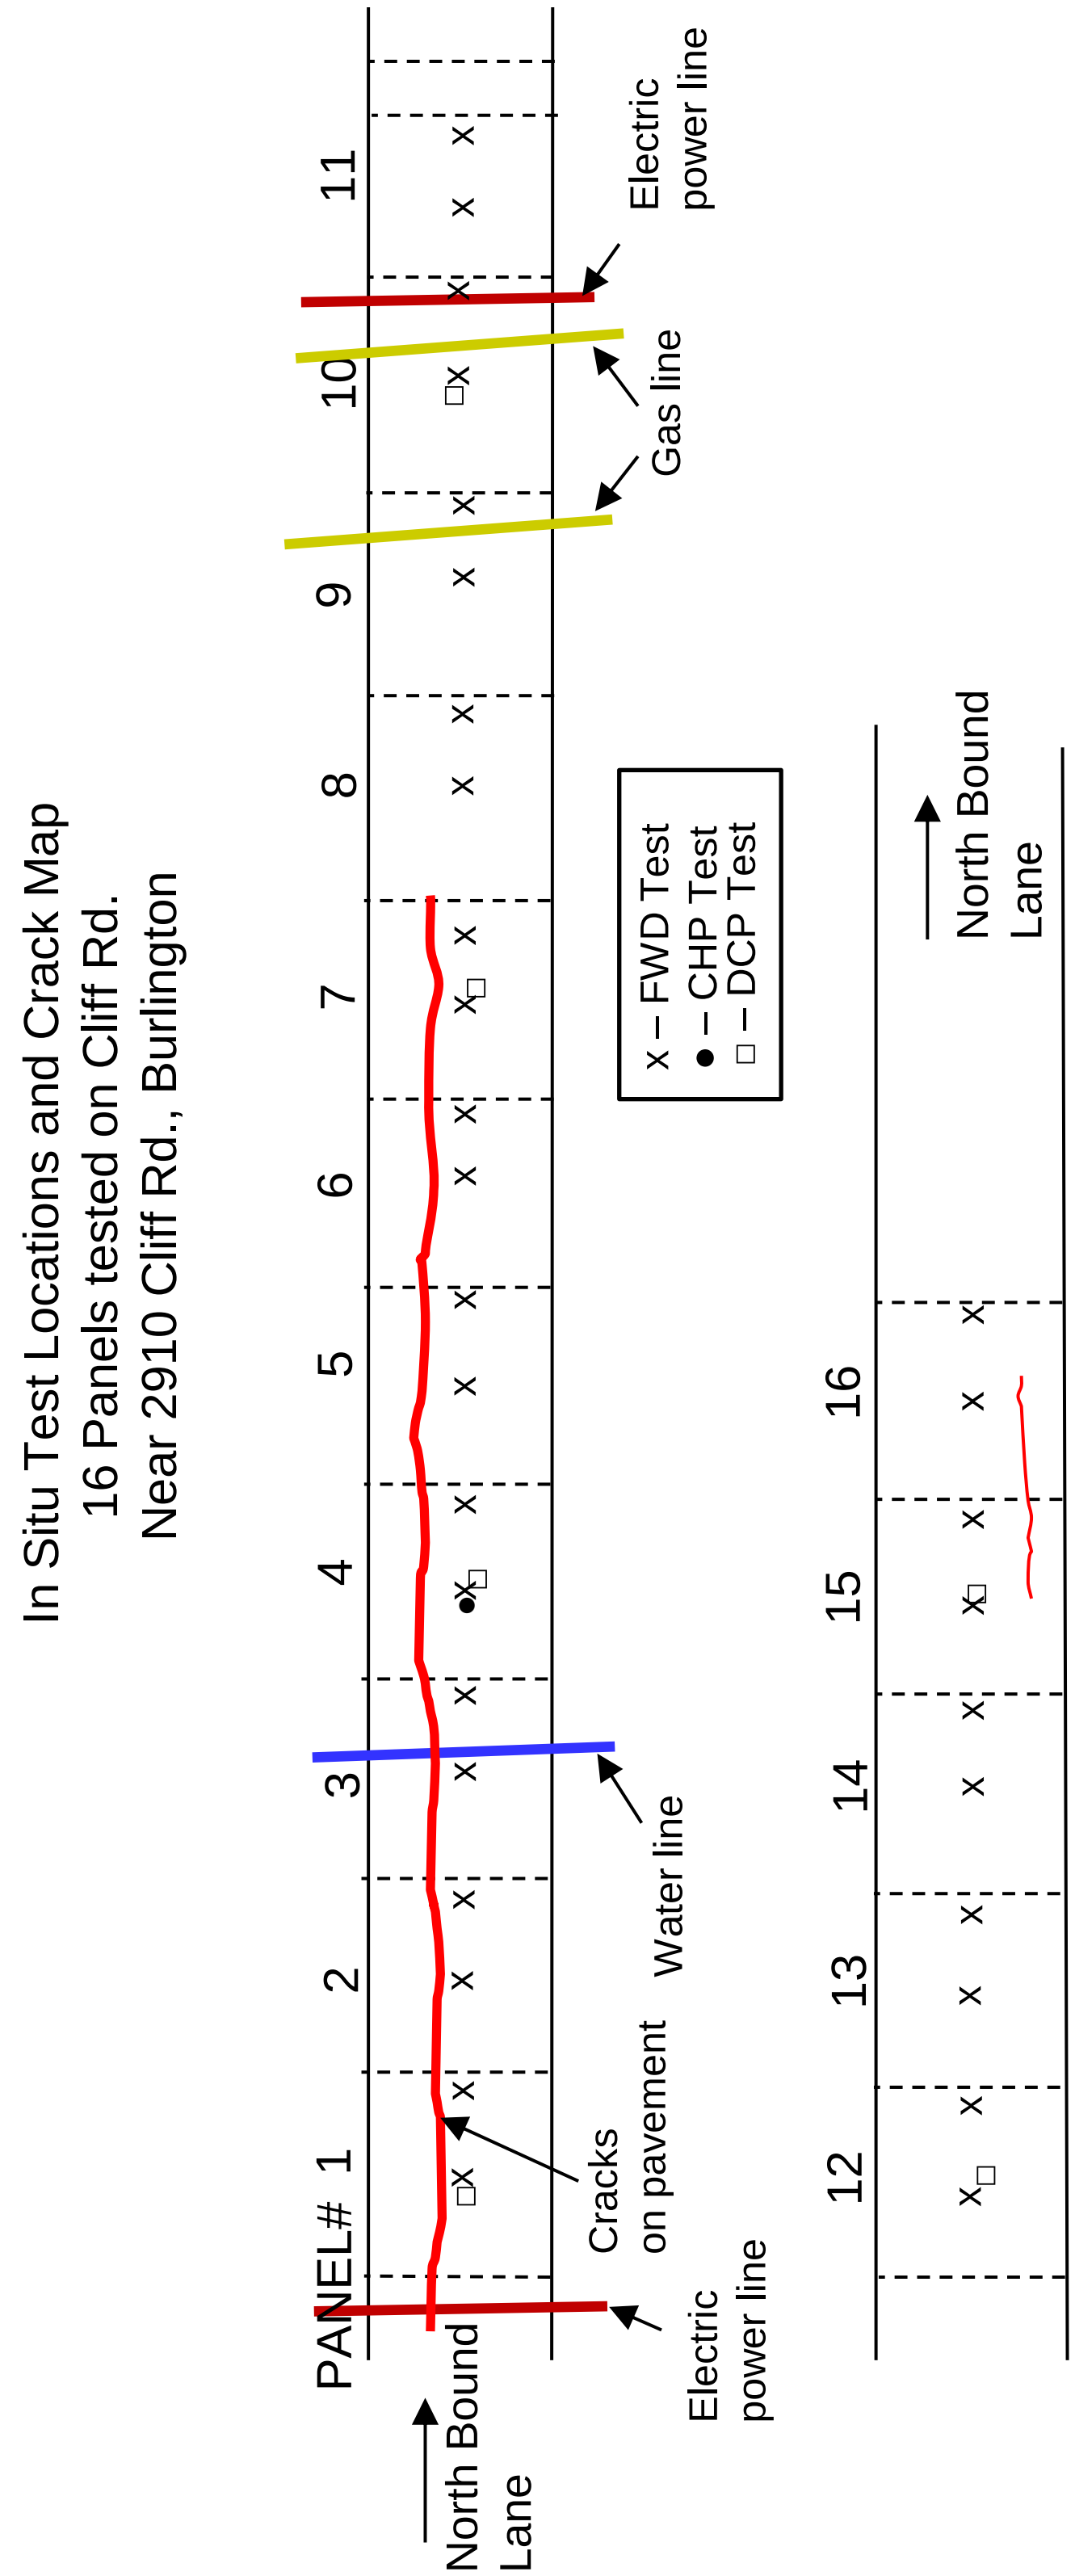
Figure 112. Crack Survey Map — Cliff Road (Site B), Burlington

Field testing at this site was conducted on August 2, 2012. A crack survey map of the test site along with in situ test locations is shown in Figure 112. FWD testing was conducted on 16 panels at mid panel and at joint. DCP tests were conducted at six locations and CHP test was conducted at one locations (under a panel with longitudinal crack). All tests were conducted along the center line of the north bound lane panels.

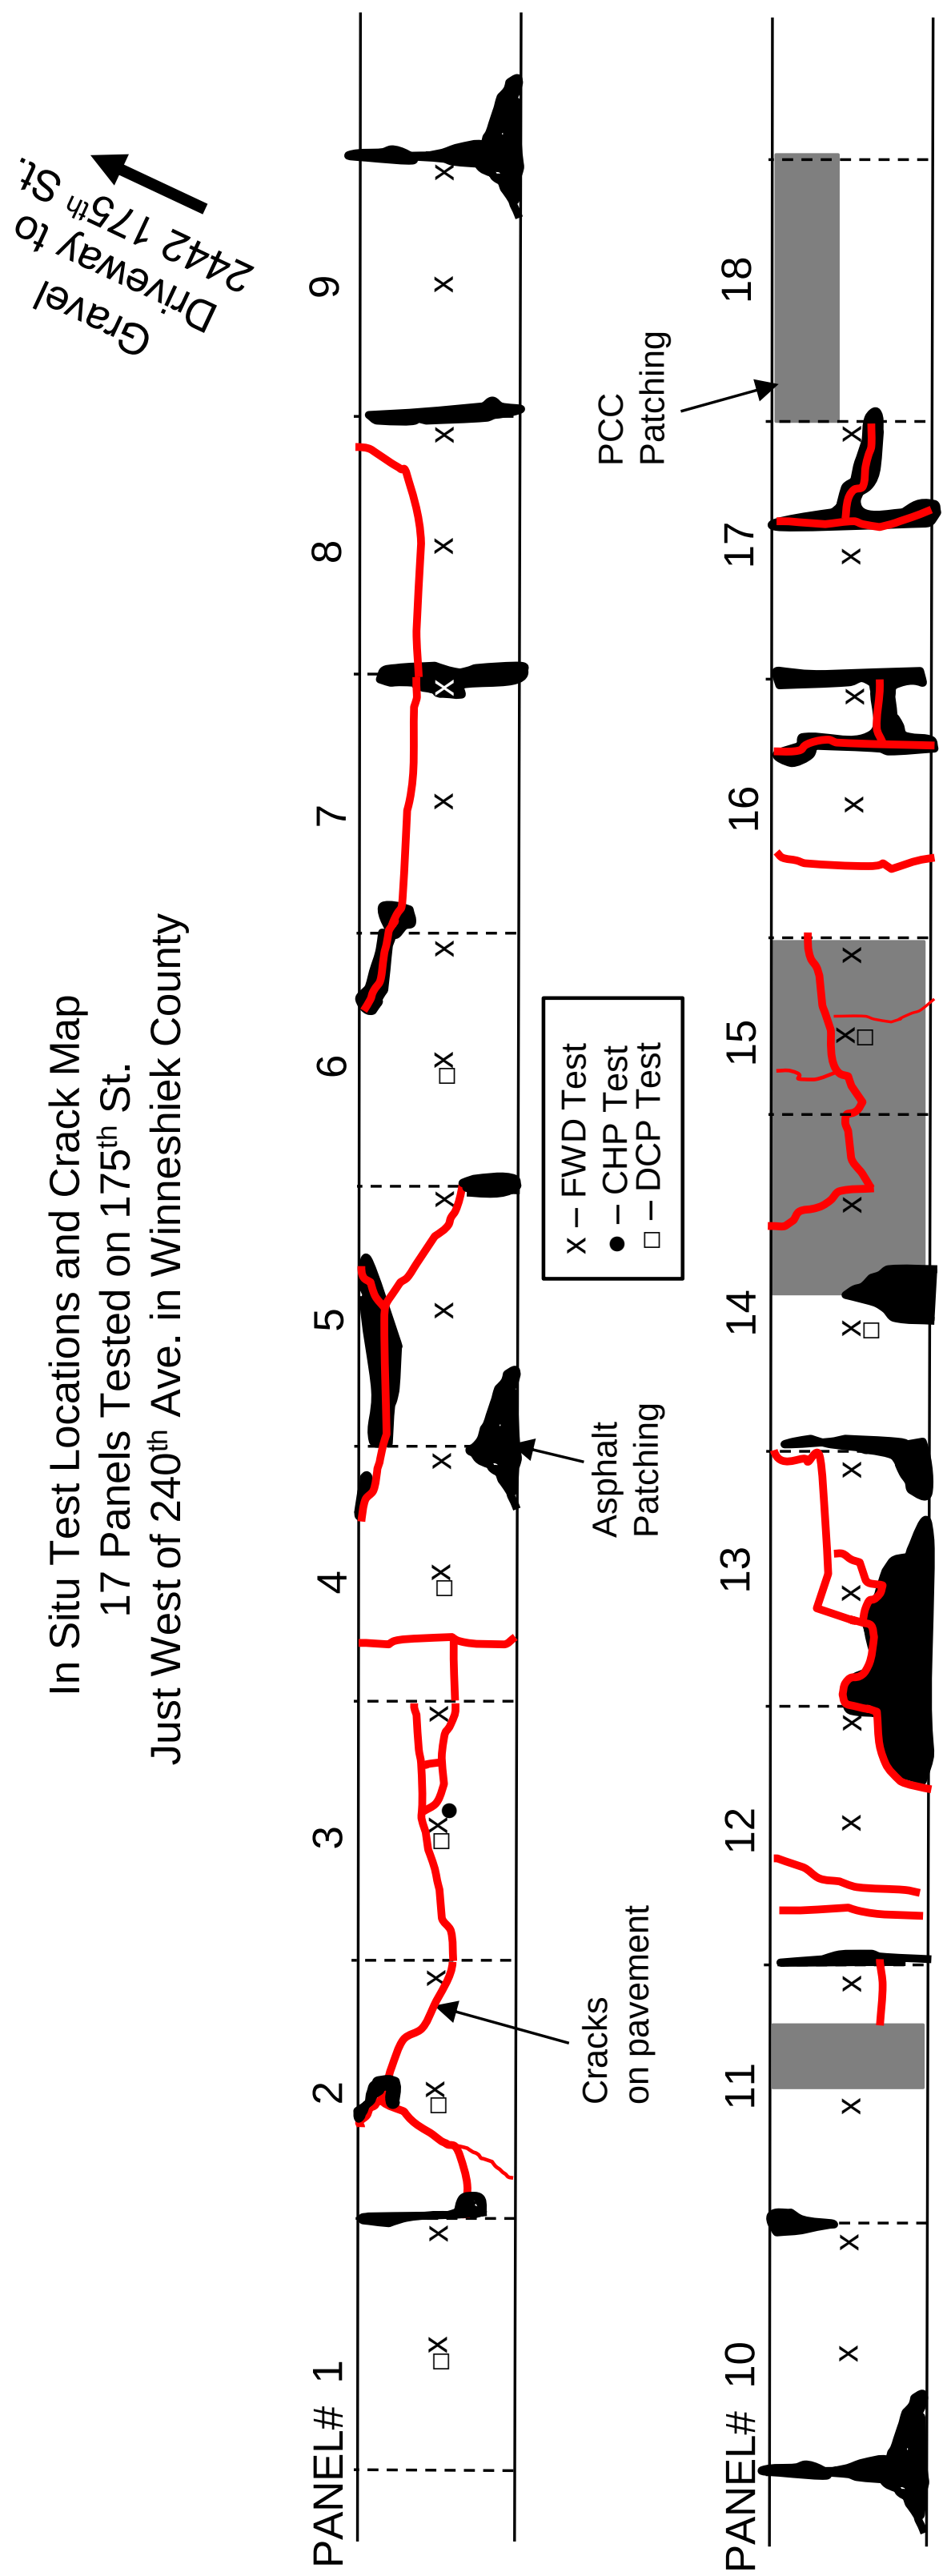
Figure 130. Crack Survey Map — 175th Street, Winneshiek County

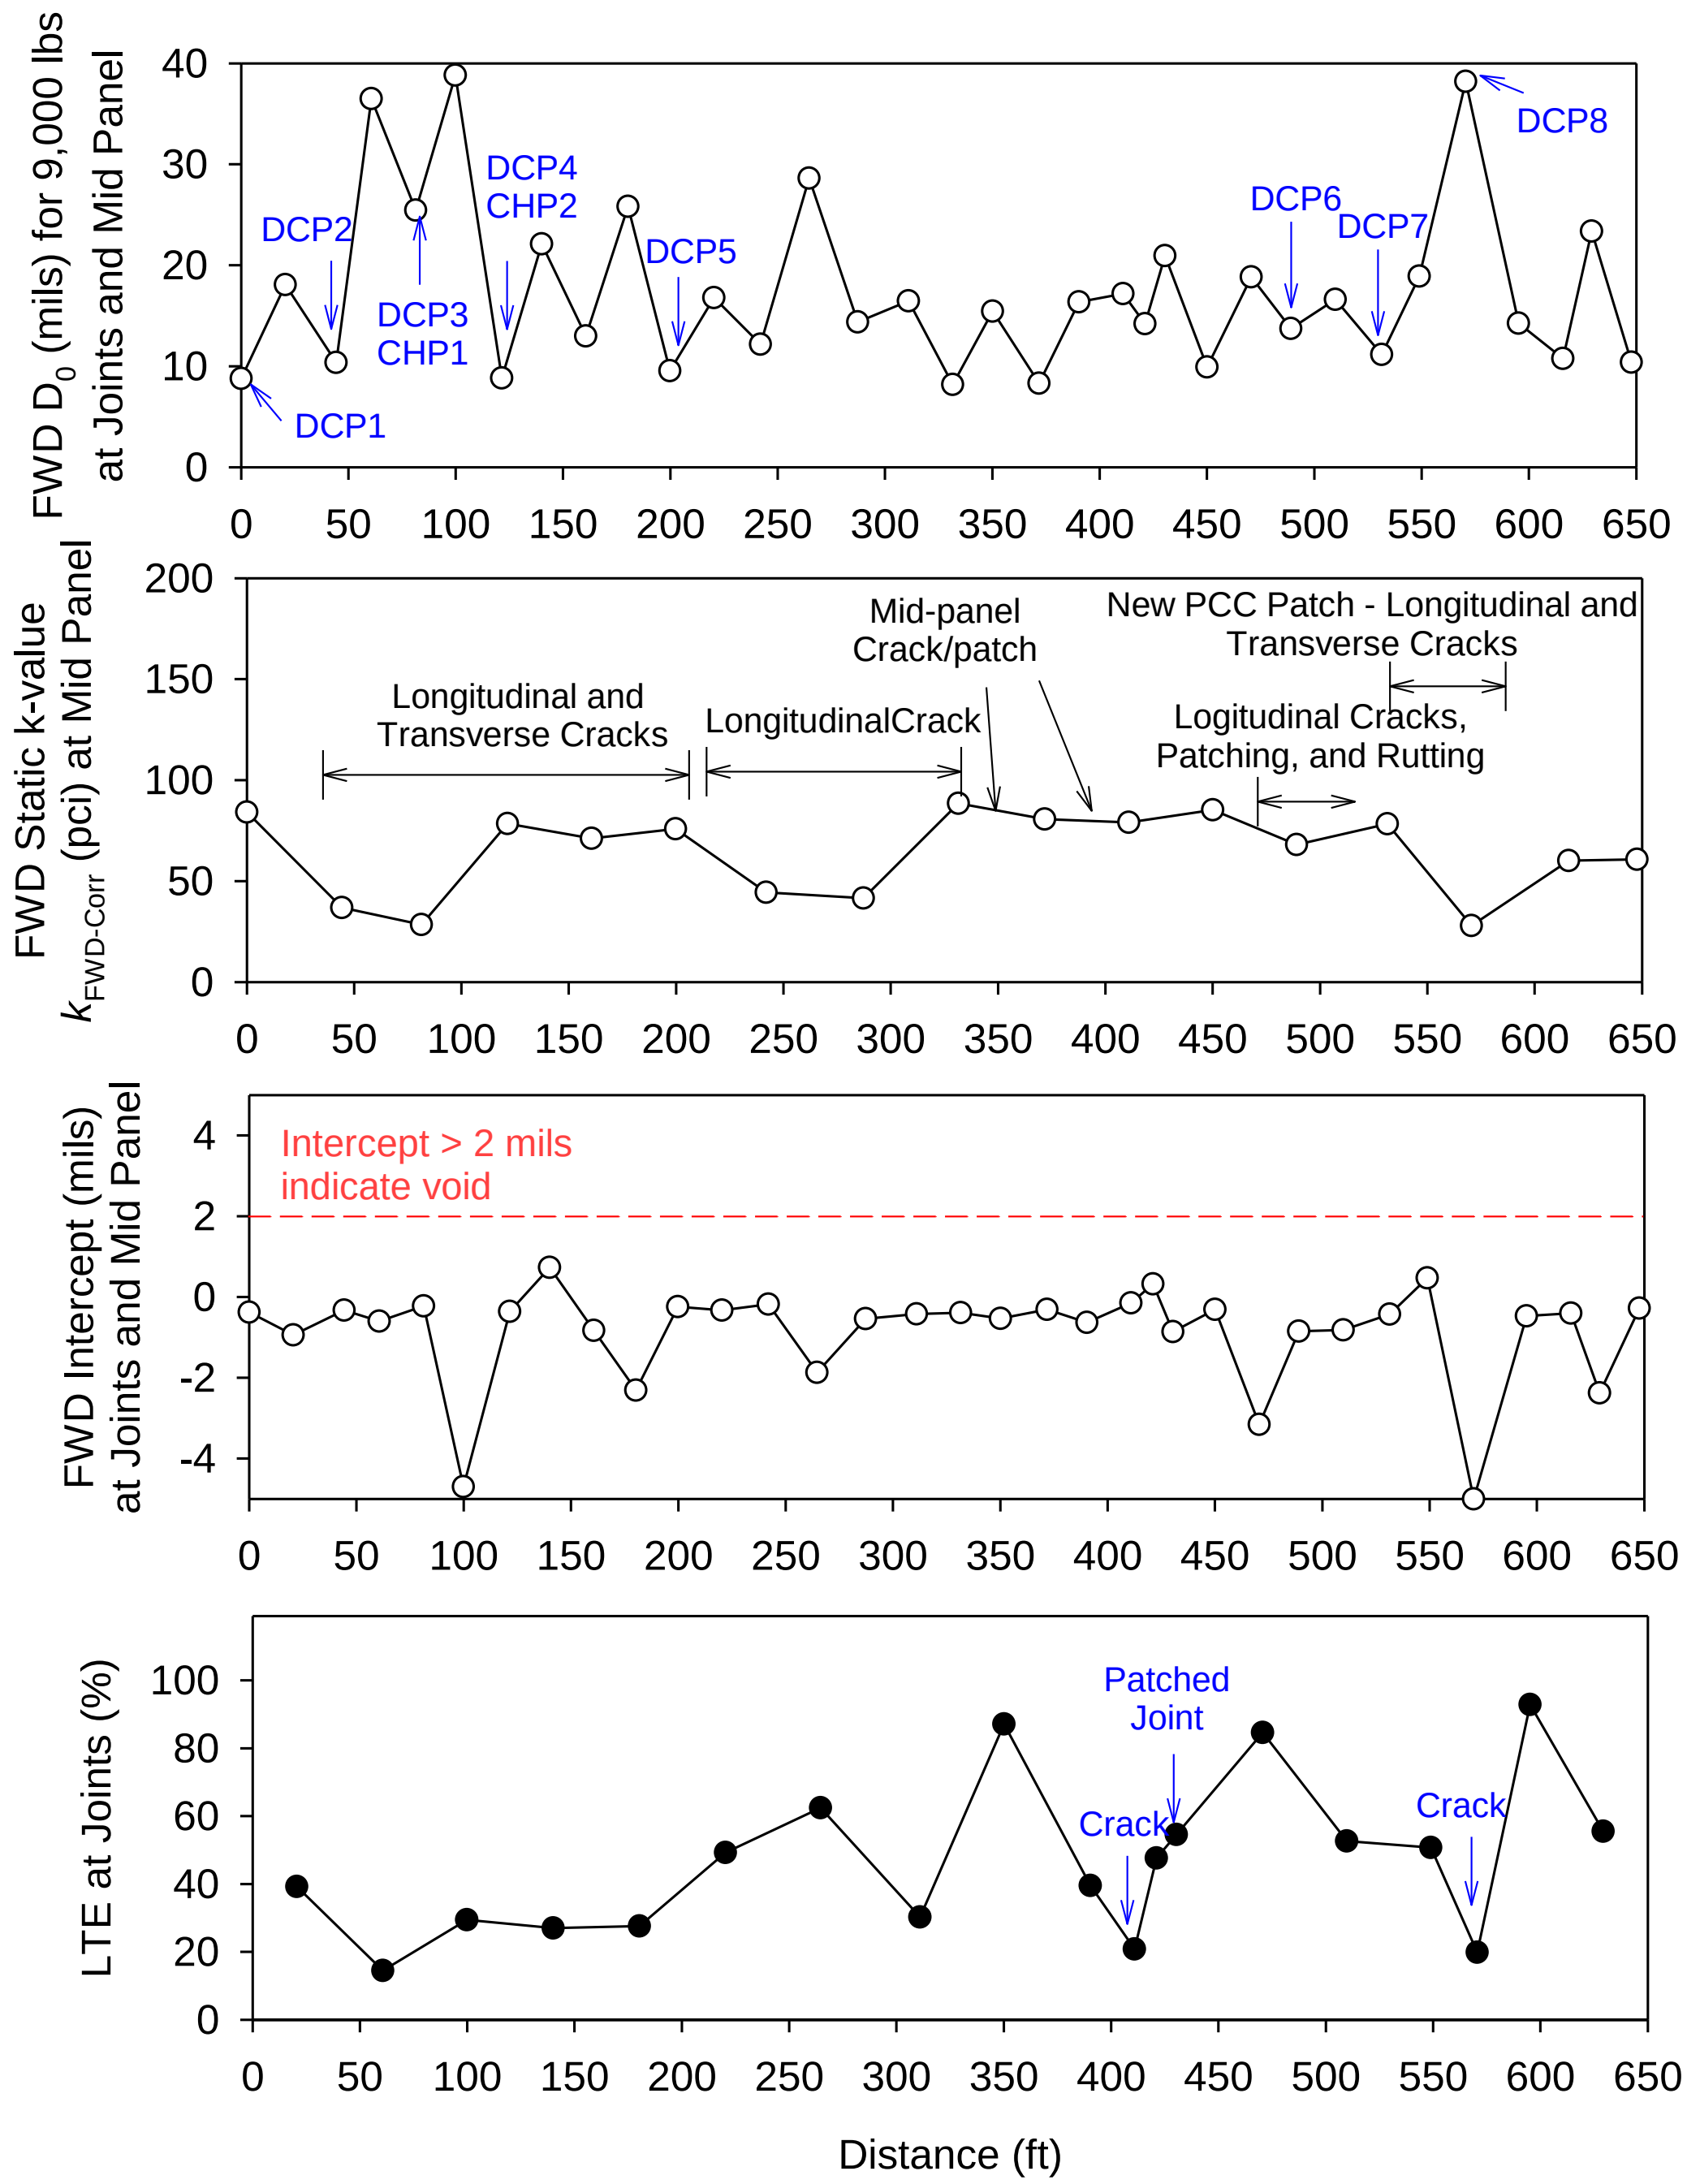
Field testing at this site was conducted on August 9, 2012. FWD testing was conducted on 17 panels at mid panel and at joint. Load transfer efficiency was evaluated at joints as well as at mid panel with transverse cracks. DCP tests were conducted at eight locations and CHP tests were conducted at two locations. All tests were conducted along the center line of the east bound lane panels. A crack map with in situ test locations are shown in Figure 130.

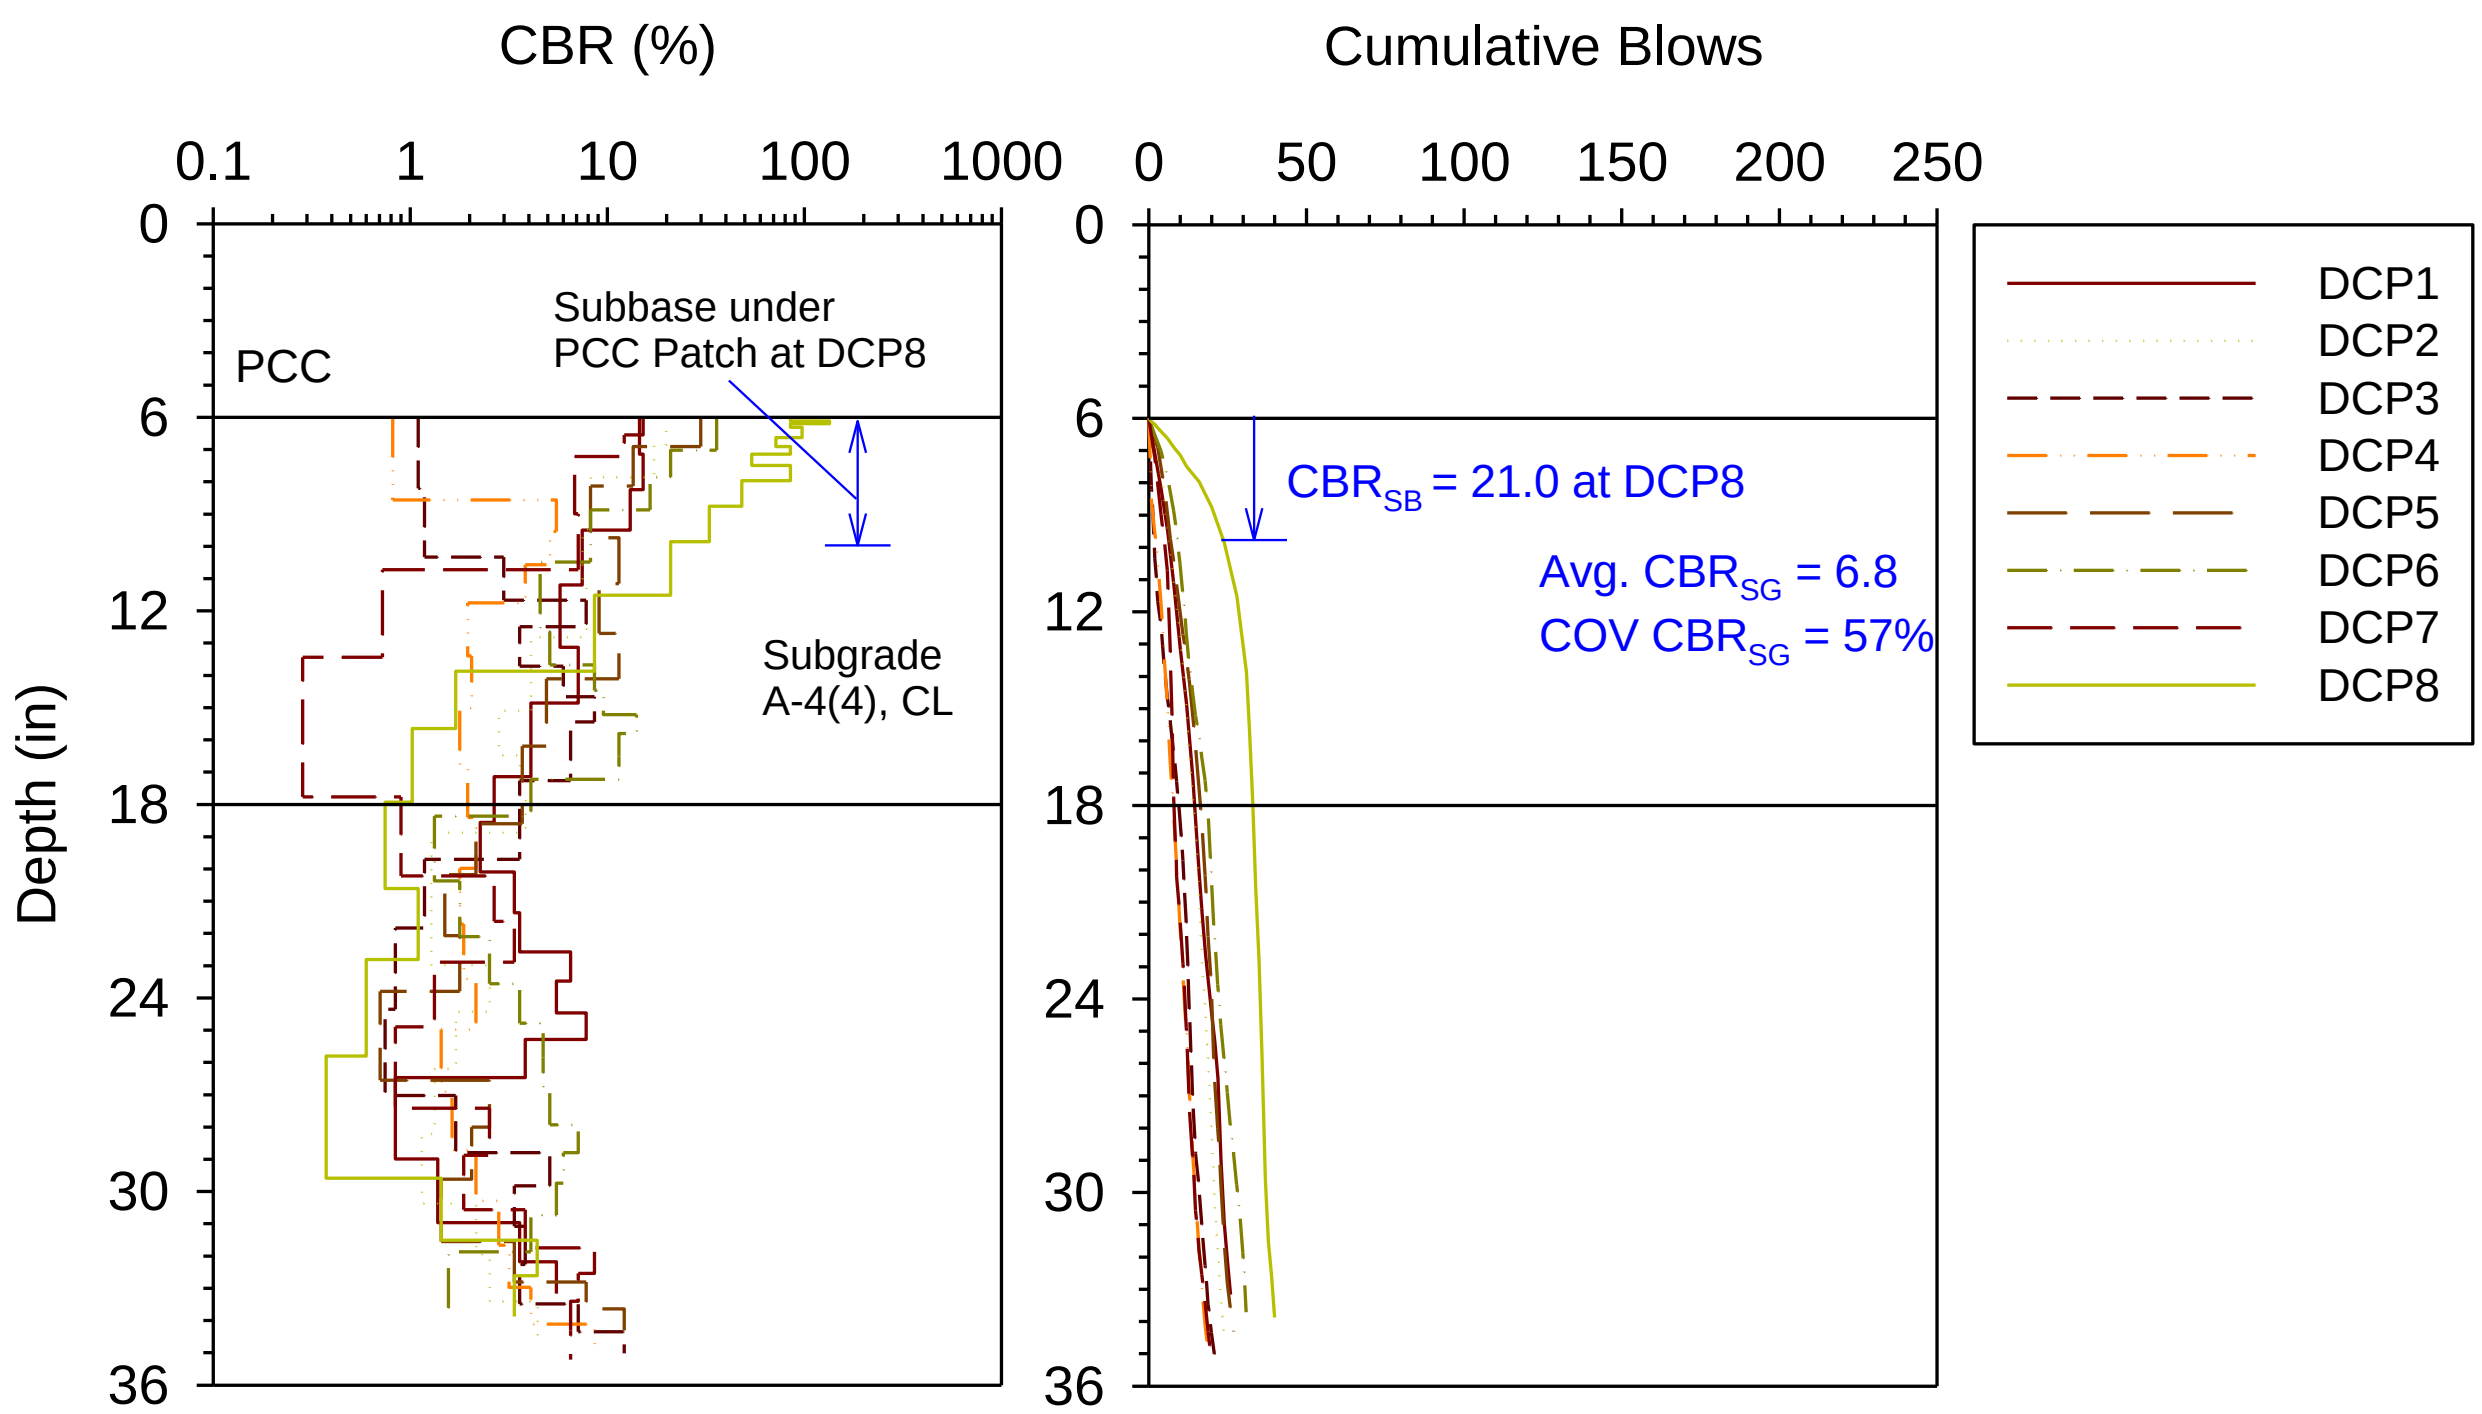
Figure 131. FWD test results — 175th Street, Winneshiek County

The average LTE at joints was about 47%, which indicates poor joint efficiency. The average Static $k_{FWD\text{-}Corr}$ was 64 pci, while the average $k_{comp\text{-}DCP}$ values were higher with 358 pci. The average CBR_{SG} was 6.8, which indicate "poor" subgrade conditions per SUDAS (2013a). One of the DCP-CBR profiles (DCP8) located in a patching area indicated high CBR values (~ 60 to 100) in the top 6 in., which is likely due to subbase layer installed under the patch. The uniformity of support conditions is rated as "good" based on COV = 32% of $k_{FWD\text{-}Corr}$ measurements.

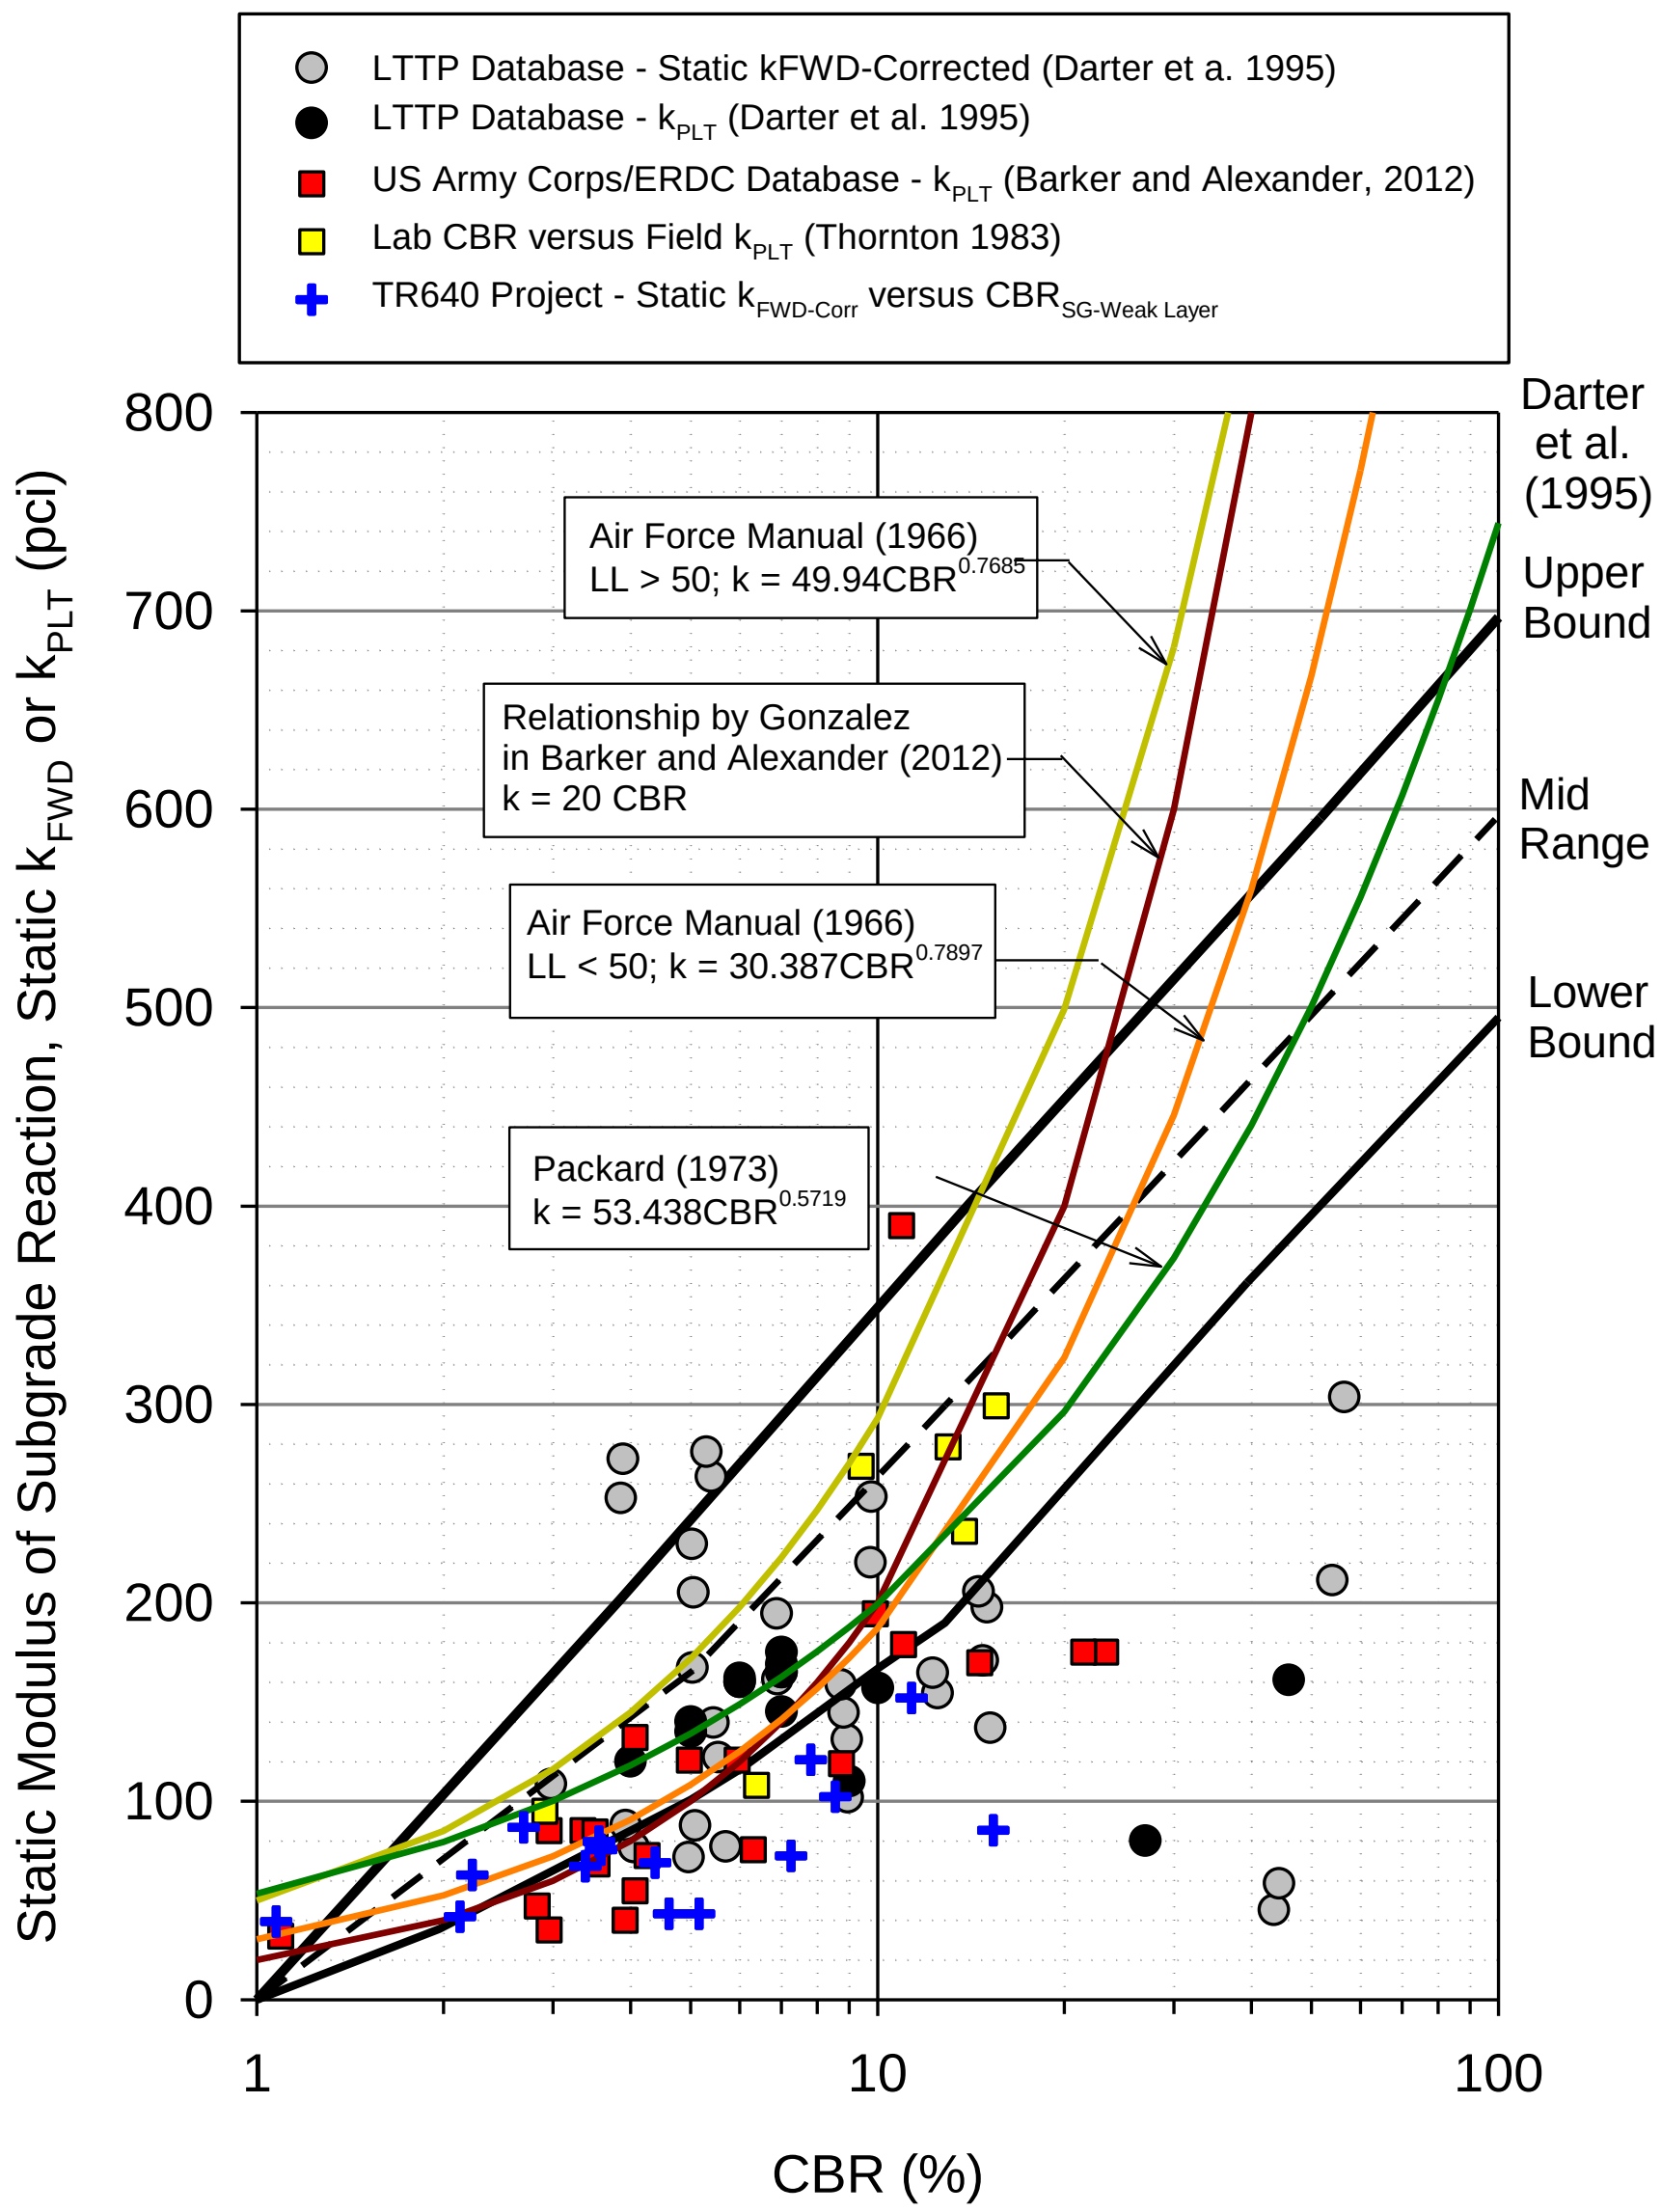
Figure 137. Average Static $k_{FWD\text{-}Corr}$ versus average $CBR_{SG\text{-}Weak\ Layer}$ (average from each site) in comparison with relationships published in the literature

Comparison between the average (based on 3 to 10 measurements per site) $k_{\text{FWD-Corr}}$ and CBR_{SG} (which represents the average of the top 12 in. of subgrade) indicated that the $k_{\text{FWD-Corr}}$ values were generally lower than results published in the literature. All DCP-CBR profiles were reviewed closely to assess if "weak" layers within the subgrade could be contributing to the low *k* values. An average CBR of a minimum 3 in. thick layer within the top 16 in. of subgrade (represented as $\text{CBR}_{\text{SG-Weak Layer}}$) was calculated as illustrated in Figure 136. Comparison between the average $k_{\text{FWD-Corr}}$ and $\text{CBR}_{\text{SG-Weak Layer}}$ is shown in Figure 137, which shows that the data collected from this project is generally in line with the data published in the literature.

- It is found that modulus of subgrade reaction values determined from FWD test (Static $k_{\text{FWD-Corr}}$) correlate well with subgrade layer CBR, when the weakest layer CBR within the top 16 in. of subgrade ($\text{CBR}_{\text{SG-Weak}}$) is used. These correlations are also in line with the data published previously by the U.S. Army Corps of Engineers (Barker and Alexander 2012), Thornton (1983), and Darter et al. (1995). There is significant variability in the *k* versus CBR relationships, however.

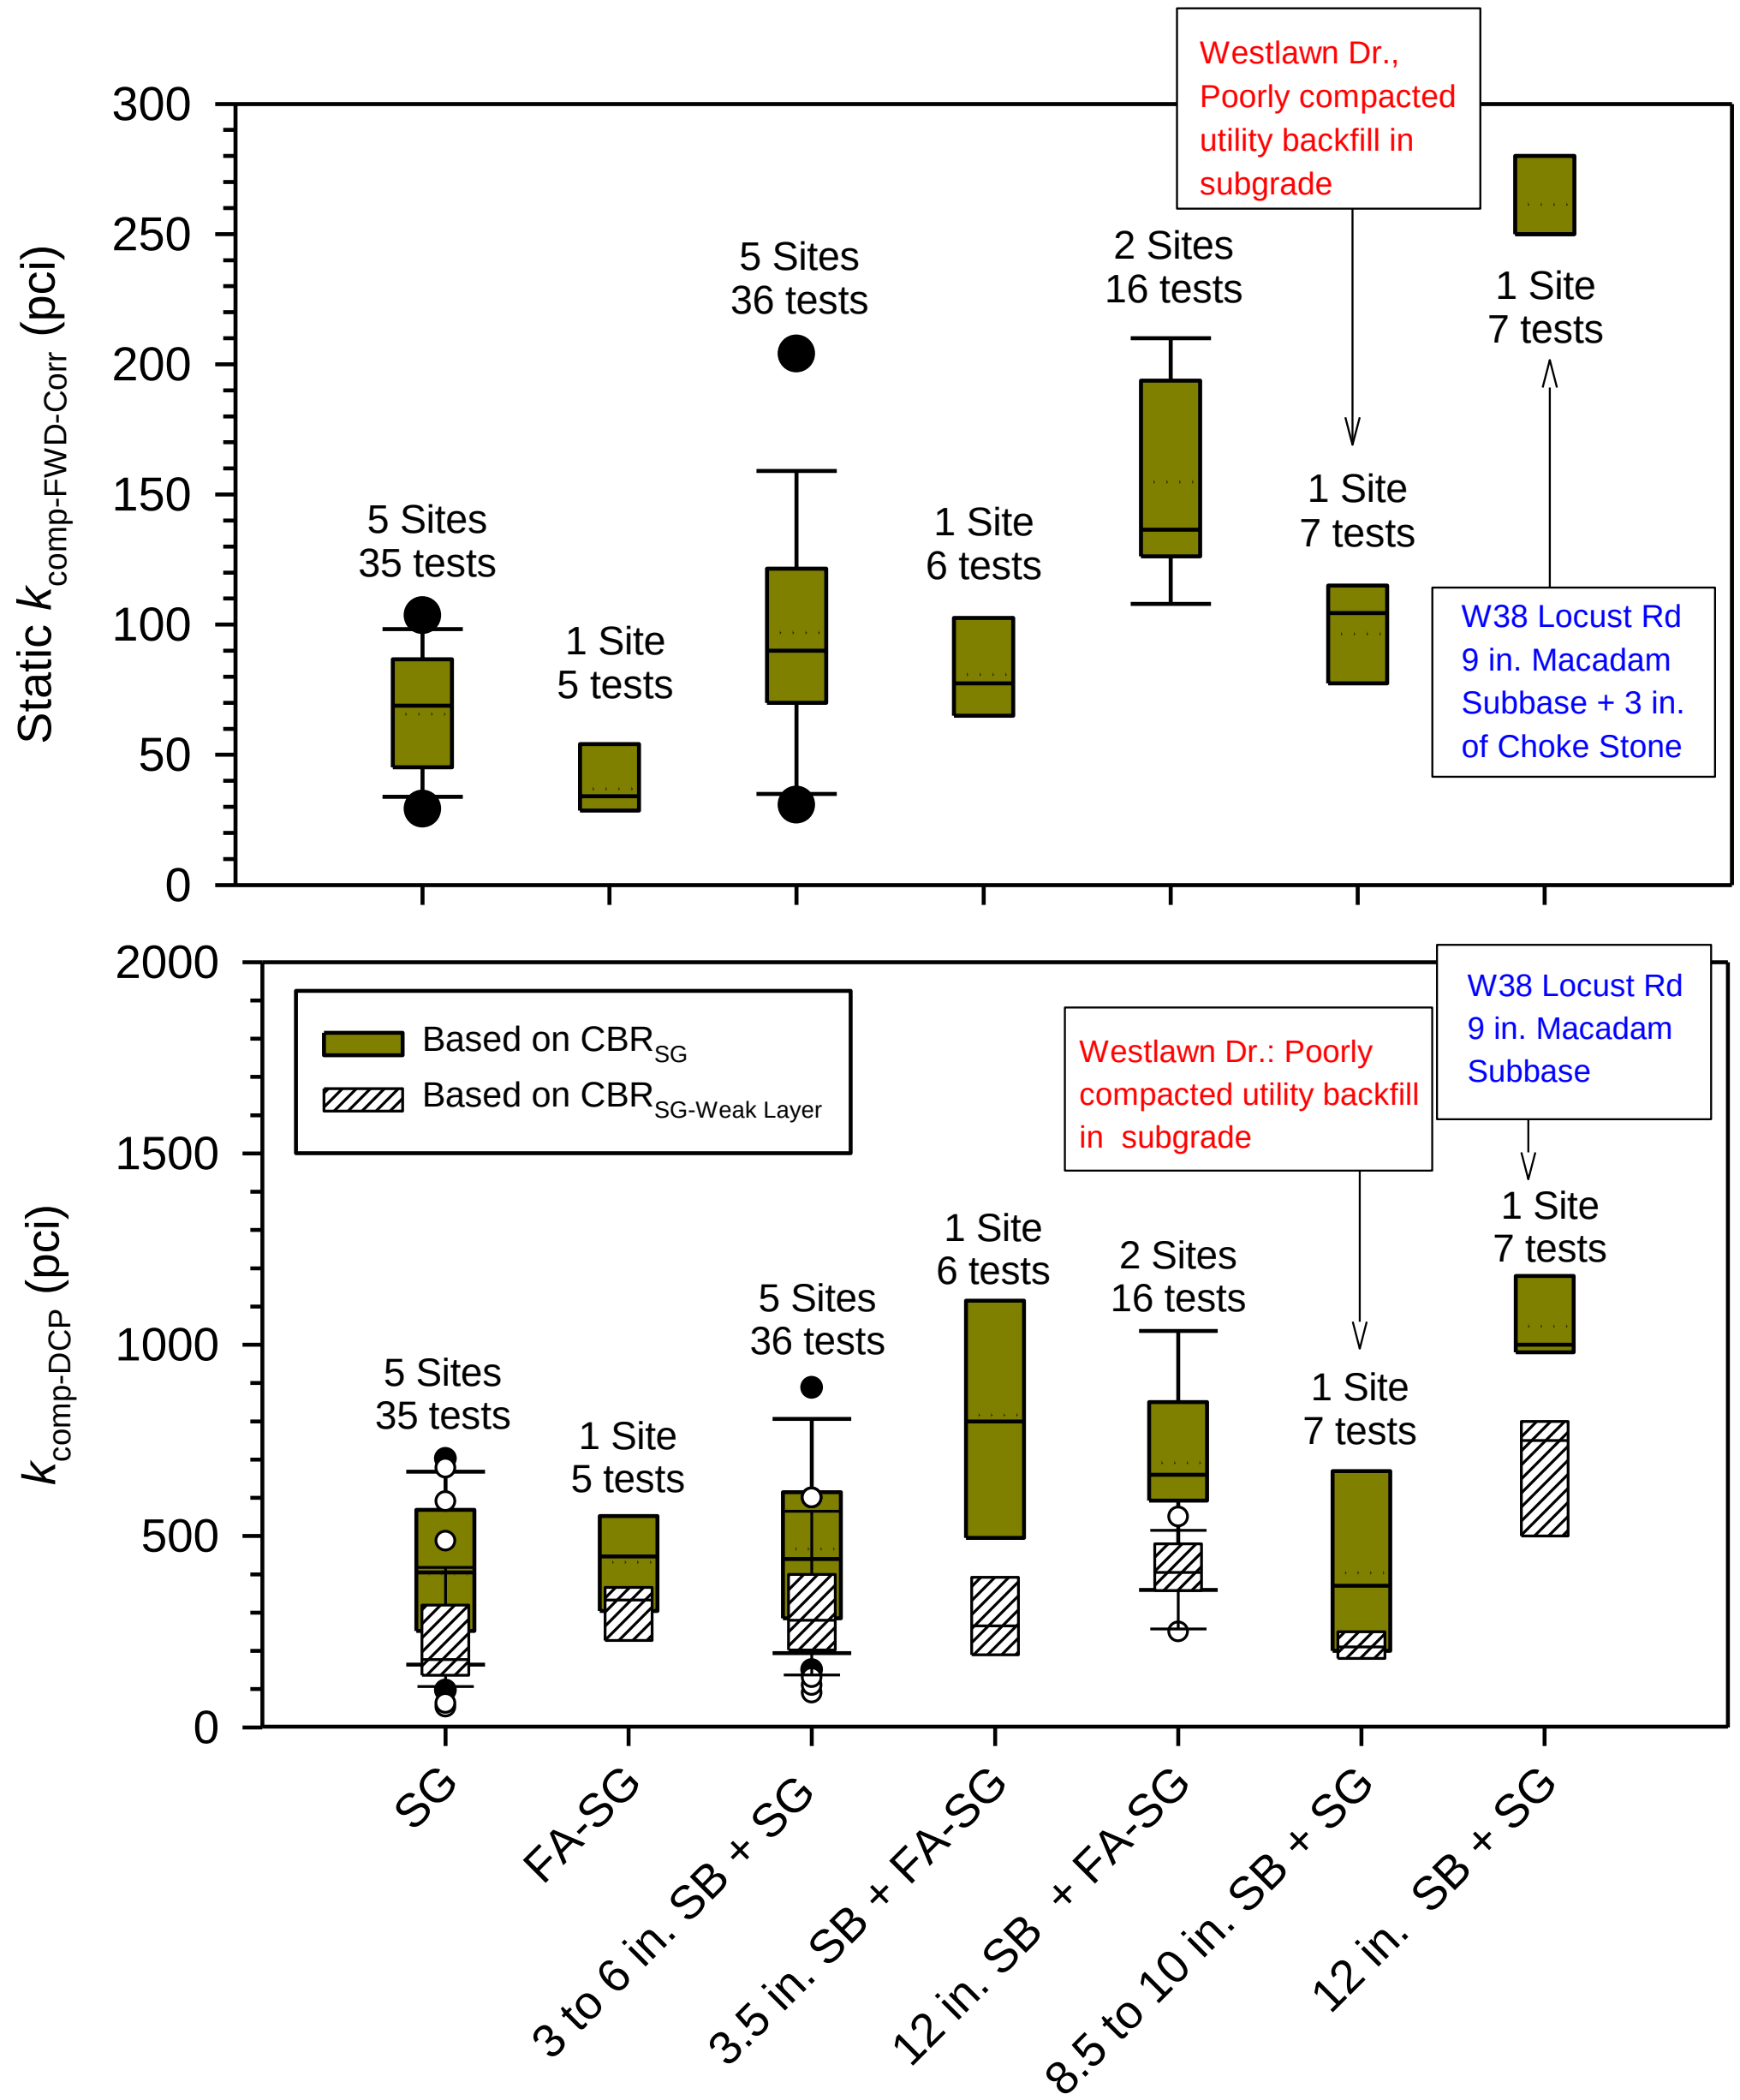
Figure 138. Boxplots of Static $k_{comp\text{-}FWD\text{-}Corr}$ and $k_{comp\text{-}DCP}$ values for different foundation layer support conditions

The Static $k_{comp\text{-}FWD\text{-}Corr}$ values were on average about 3.2 to 12.2 times lower than the $k_{comp\text{-}DCP}$, while they were on average about 0.9 to 6.2 times lower than the $k_{comp\text{-}DCP\text{-}Weak}$. It must be noted that the $k_{comp\text{-}DCP}$ or the $k_{comp\text{-}DCP\text{-}Weak}$ values do not account for LOS under the pavement in situ, while the $k_{comp\text{-}FWD\text{-}Corr}$ values do. The k_{comp} values calculated from FWD and DCP tests are compared in Figure 140, by overlaying the LOS factors from AASHTO (1993), as a way to interpret the LOS at each test location. Average values from each site are shown in Figure 141. The LOS factors are back-calculated for each test location and the average values per site using these charts. The range of back-calculated LOS and the average LOS value for each site is summarized in Table 23. These LOS values are compared with the recommended LOS values in AASHTO (1993) based on the material type in Table 23 as well as with values currently being used in the SUDAS design procedure.

Results presented in Figure 138 indicate that on average, the $k_{comp\text{-}FWD\text{-}Corr}$ values generally increased with increasing subbase layer thickness. The Westlawn Dr. site (with 8.5 to 10 in. of subbase) was an exception because of poorly compacted backfill material in the subgrade at that site, which likely contributed to loss of support and lower $k_{comp\text{-}FWD\text{-}Corr}$ values. The W38/Locust Rd. section with 12 in. of granular subbase (3 in. subbase and 9 in. of macadam subbase) showed the highest k_{comp} values.
