Optimizing Pavement Base, Subbase, and Subgrade Layers for Cost and Performance of Local Roads

AUGUST 2014

Final Field Data Report

Sponsored by
Iowa Highway Research Board
(IHRB Project TR-640)
Iowa Department of Transportation
(InTrans Project 11-422)

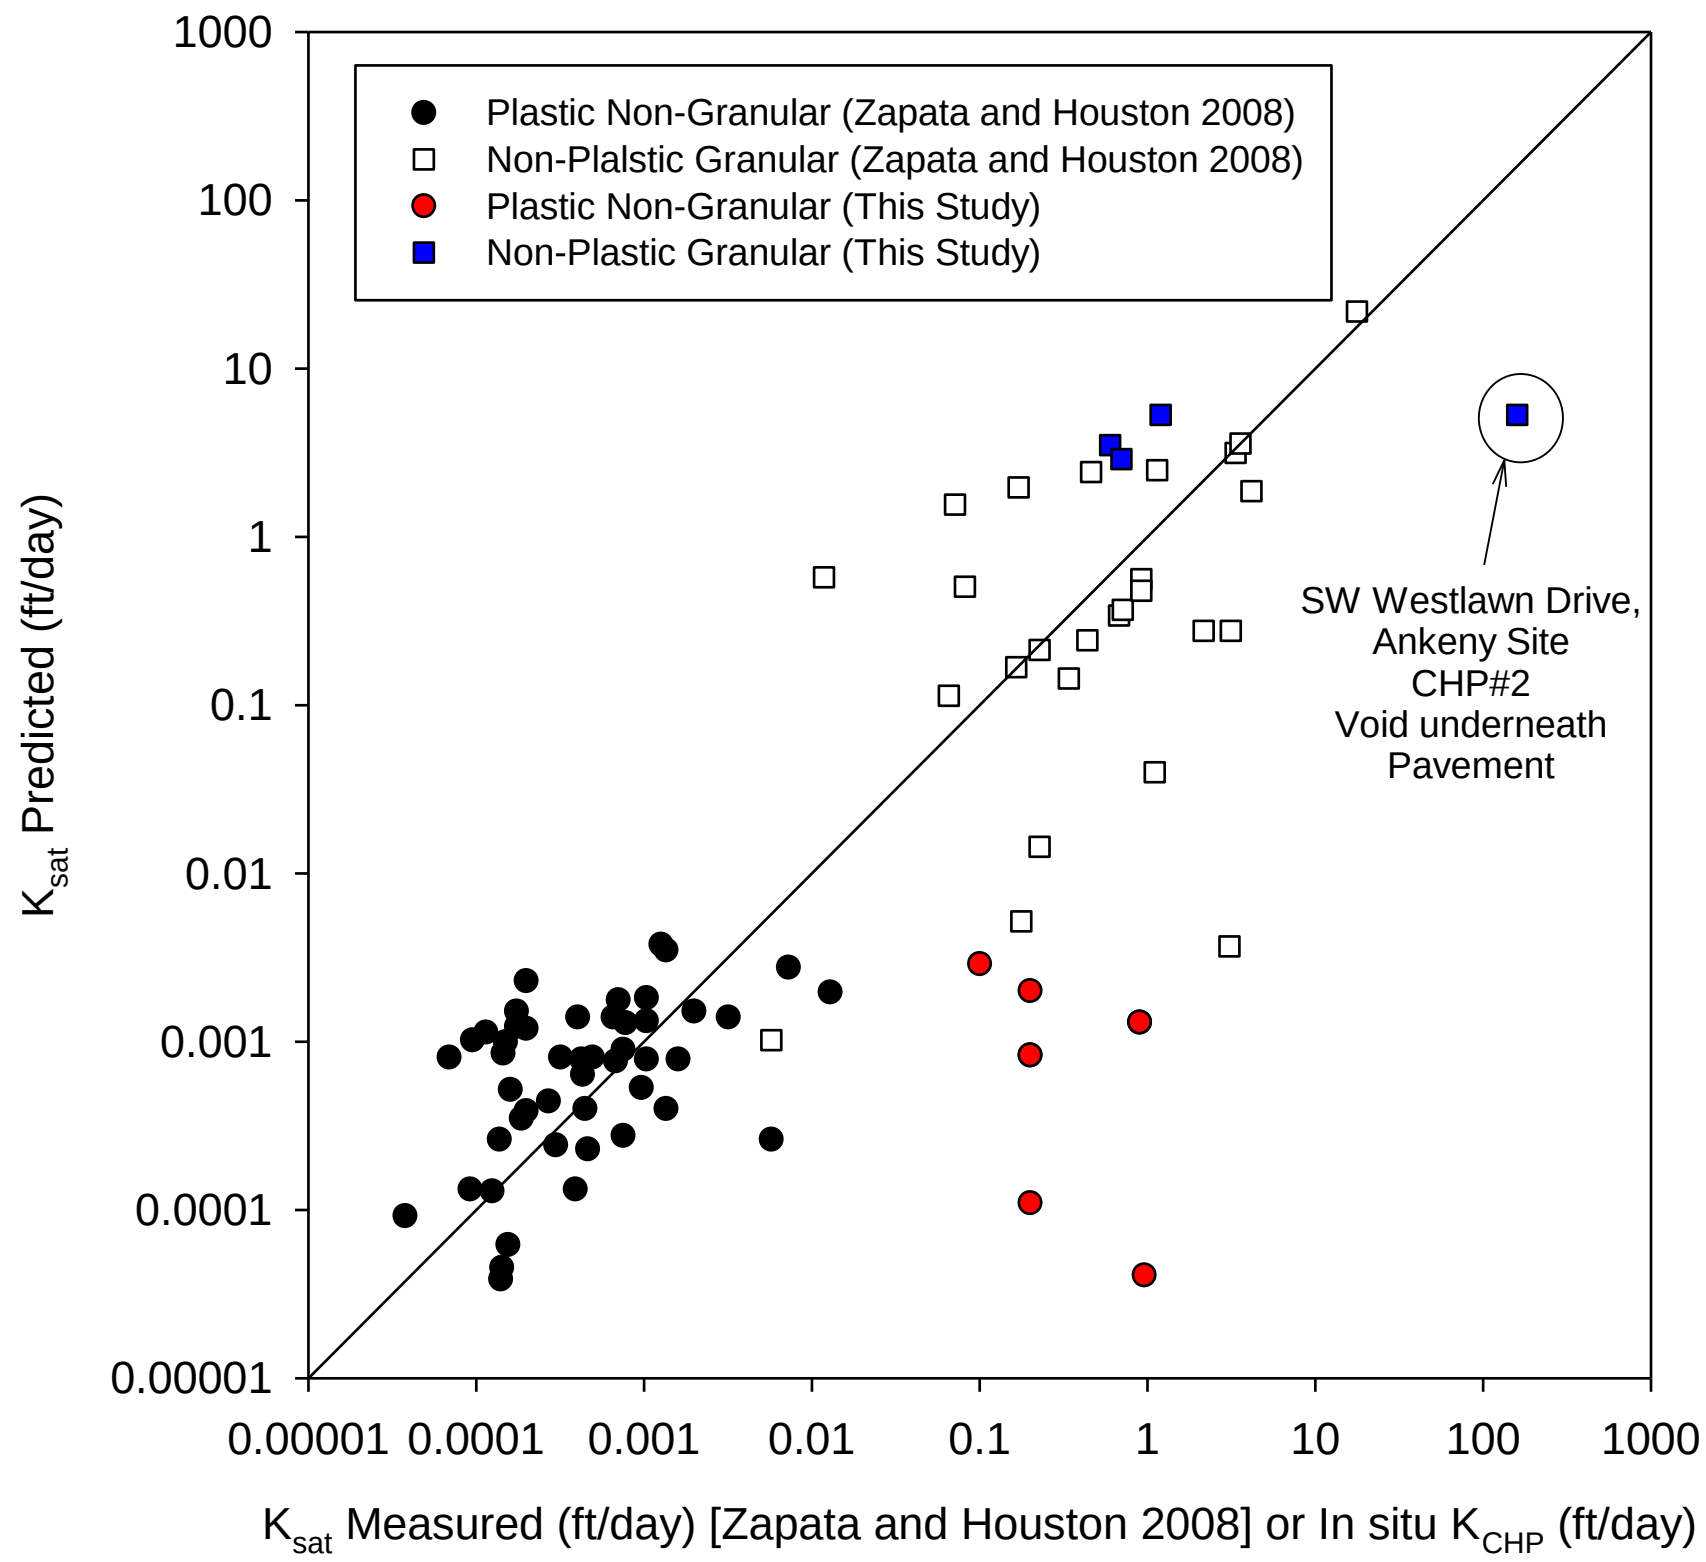
Figure 142. Measured K_{CHP} versus predicted K_{sat} in comparison with data used in empirical models from Zapata and Houston (2008)

The K_{CHP} values measured in situ are compared with empirically estimated K_{sat} values in Figure 142. Results indicate that the measurement K_{CHP} values on granular non-plastic (subbase) materials compare well with the empirical data. However, the K_{CHP} values on the fine-grained (subgrade) materials were higher than the estimated K_{sat} values. This should be expected because water seepage is likely to occur at the pavement/ subgrade interface during CHP tests and not all water is expected to infiltrate through the low permeability subgrade.

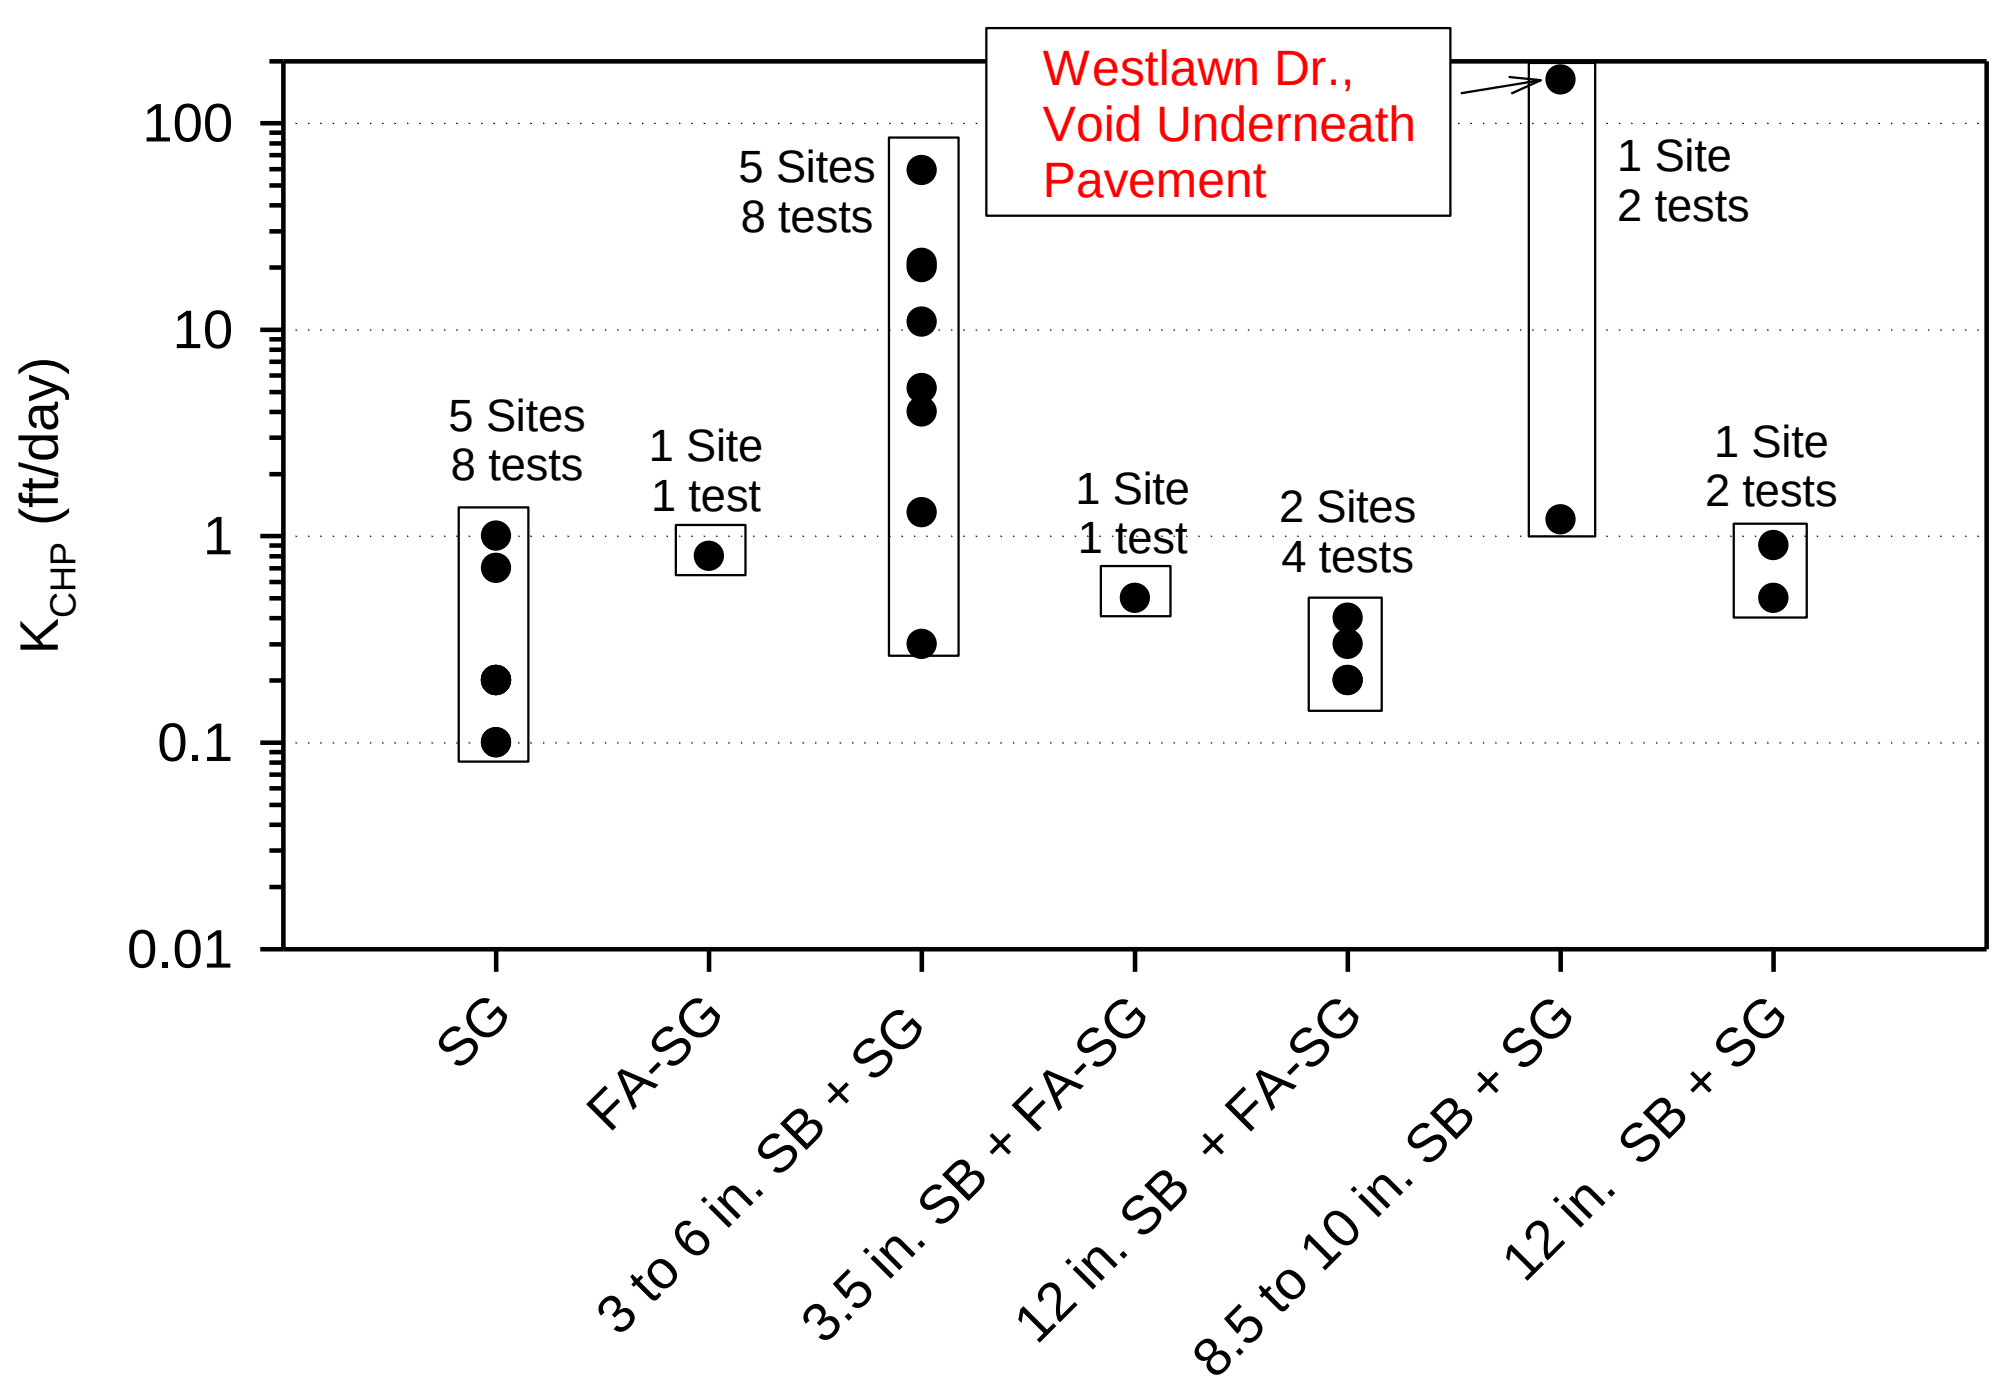
Figure 143. K_{CHP} values measured for different foundation layer support materials

K_{CHP} values measured for the seven different foundation layer support categories and the corresponding C_d values are presented in Figure 144 and Figure 144, respectively. The results did not show improvement in C_d values with increasing subbase layer thickness.

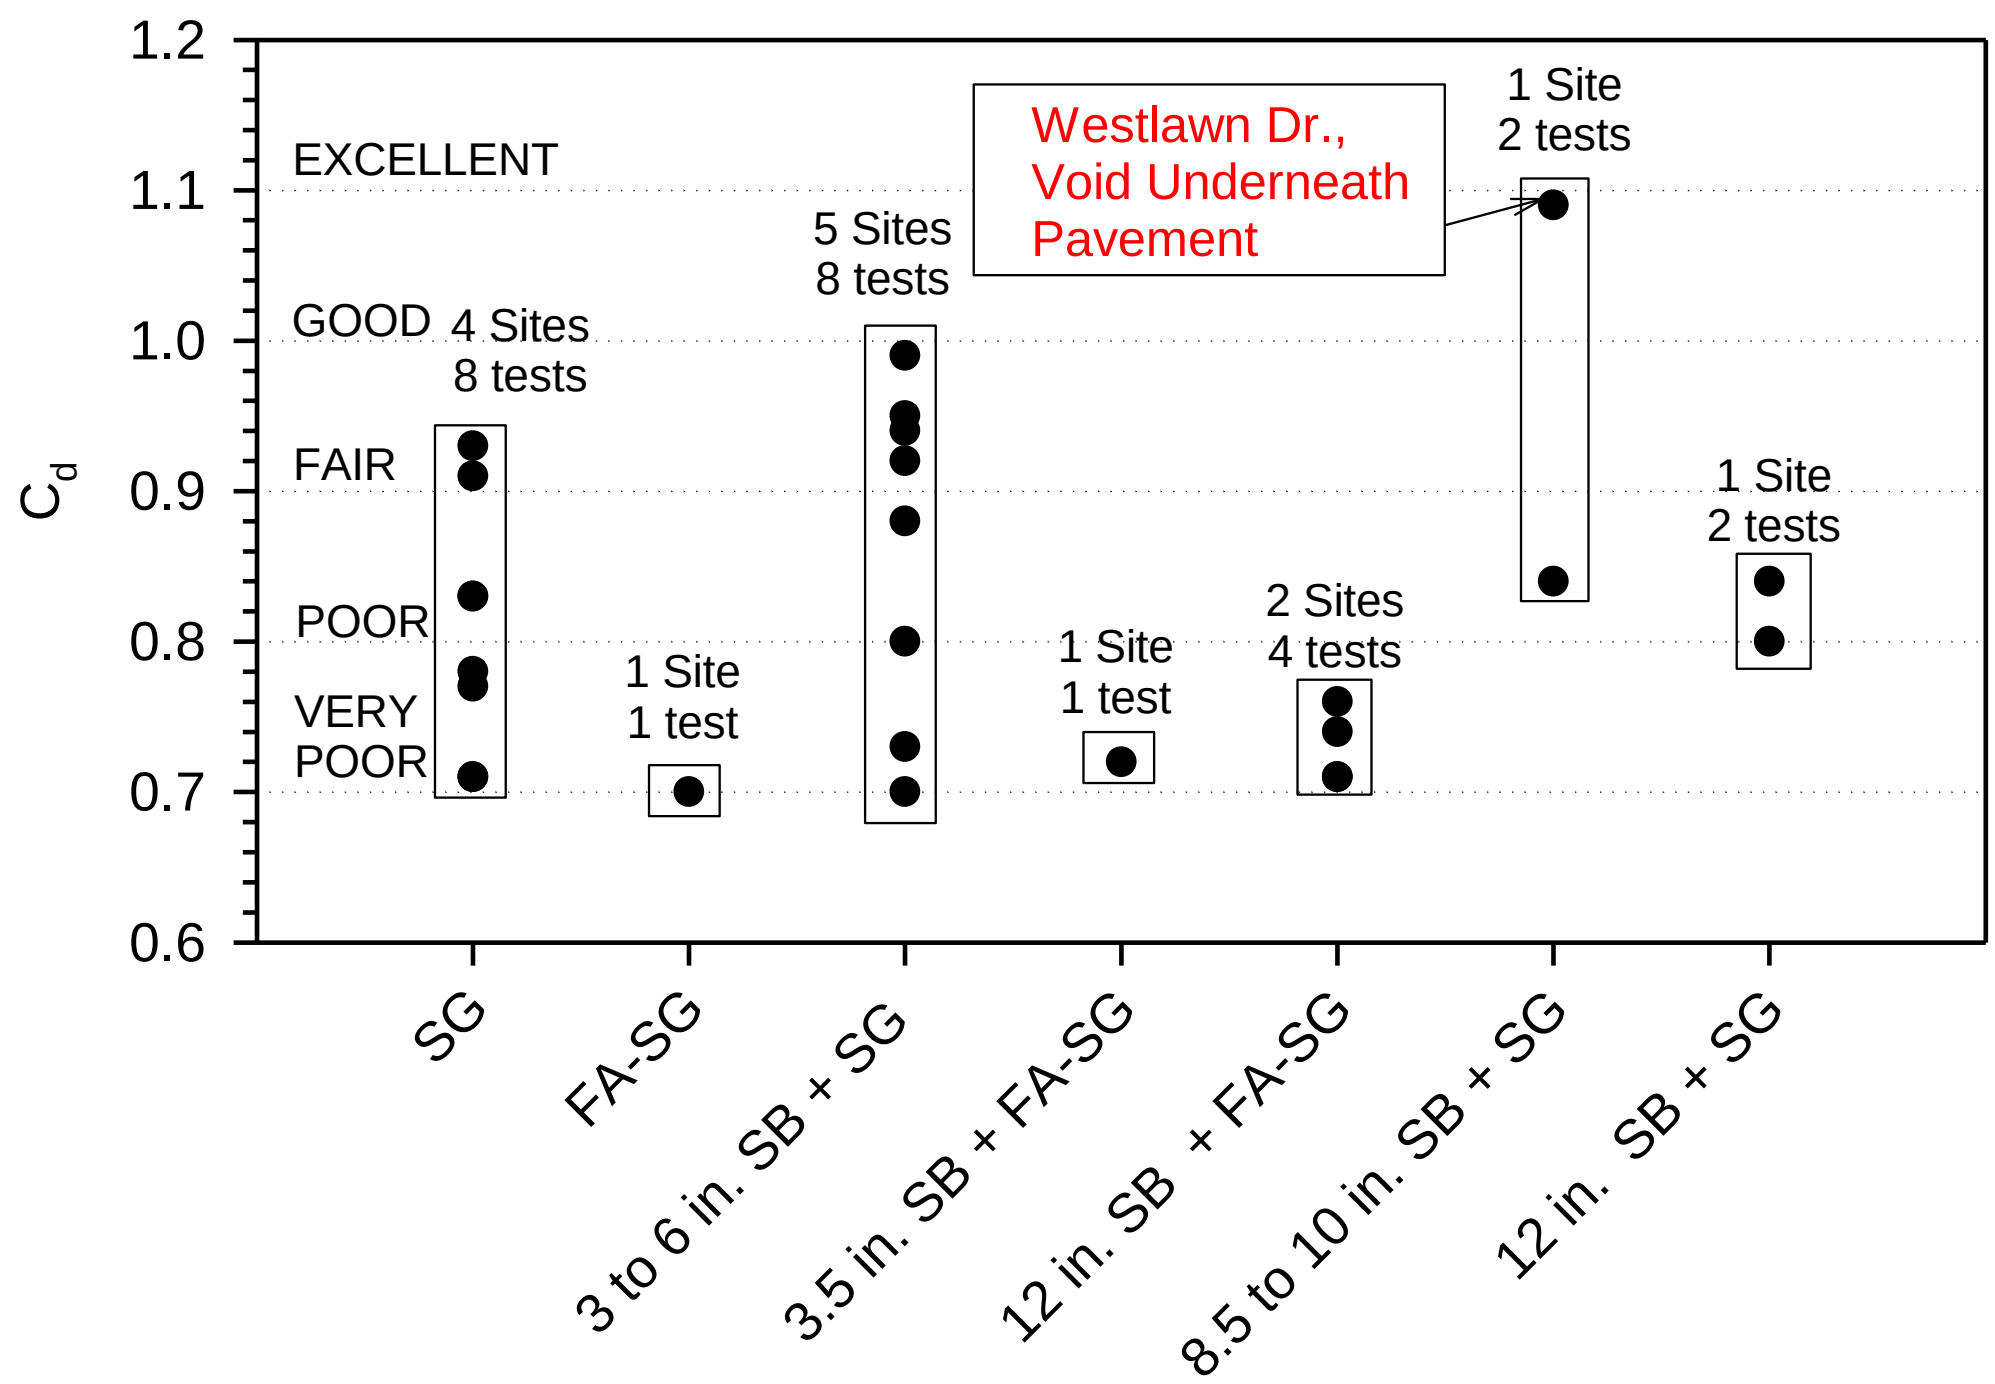
Figure 144. C_d values observed for different foundation layer support materials

- In situ hydraulic conductivity measurements (K_{CHP}) values measured for the seven different foundation layer support categories did not show improvement in C_d values with increasing subbase layer thickness and were generally lower than suggested for design in SUDAS (C_d = 1.0).

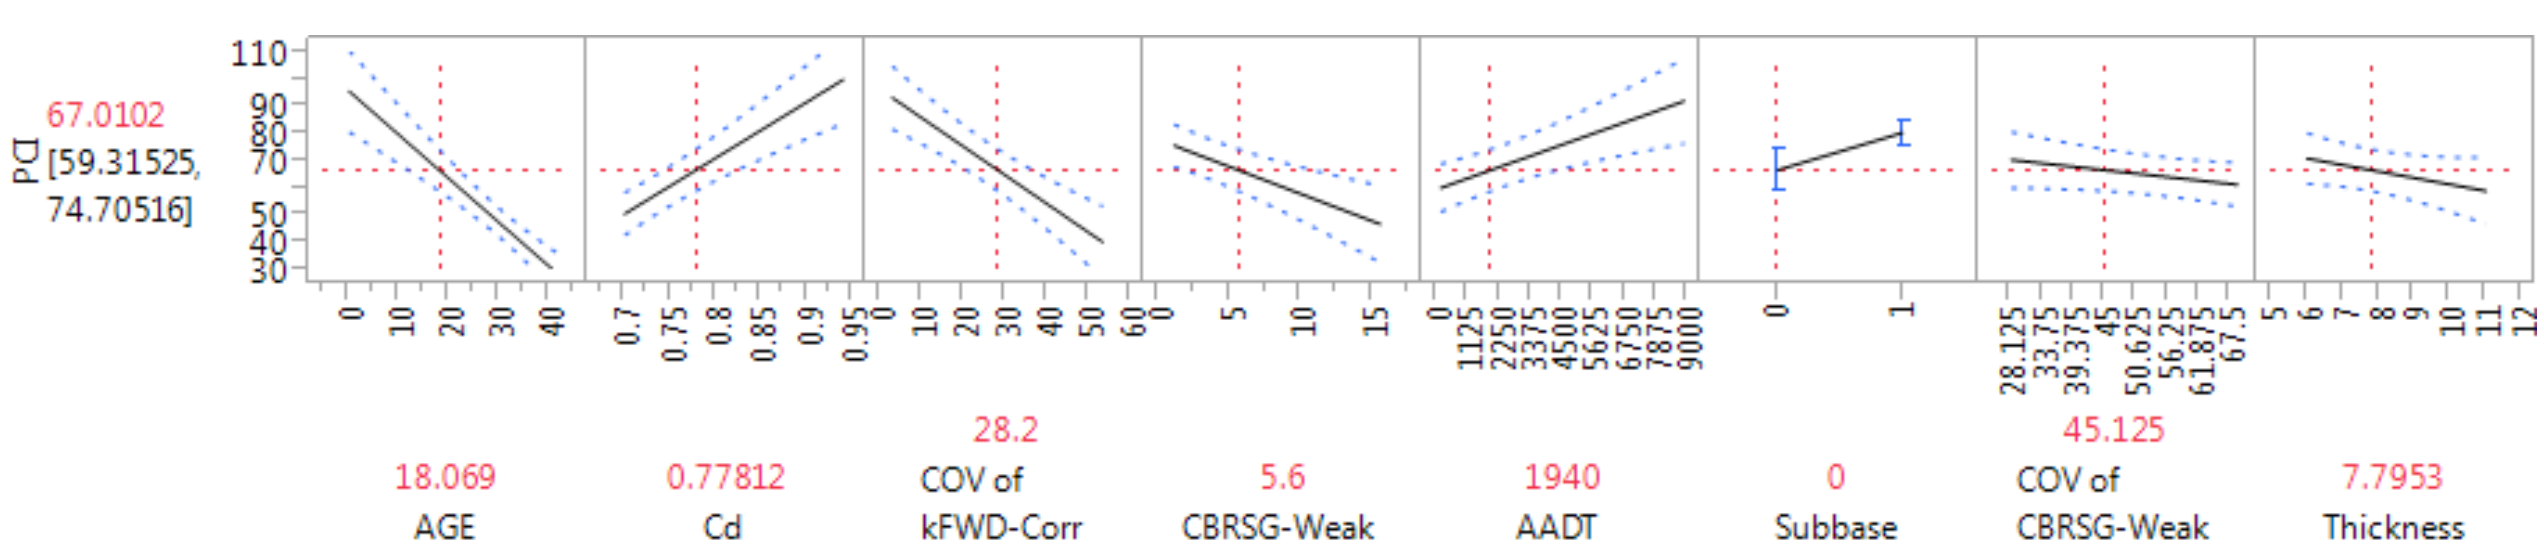
Figure 145. Summary of multi-variate analysis results

The results of multi-variate analysis are summarized in Figure 145. Of all the parameters assessed, the following parameters were found to be statistically significant in the decreasing order of significance (based on t- and p- values): (1) pavement age; (2) C_d; (3) COV of $k_{FWD\text{-}Corr}$; (4) $CBR_{SG\text{-}Weak}$; (5) AADT; (6) presence of subbase; (7) COV of $CBR_{SG\text{-}Weak}$; and (8) PCC thickness. The coefficient estimate values summarized under parameter estimates in Figure 145 indicate whether the parameter has a positive or a negative influence on the PCI value. For e.g., the negative coefficient values for pavement age, COV of $k_{FWD\text{-}Corr}$, $CBR_{SG\text{-}Weak}$, COV of $CBR_{SG\text{-}Weak}$, and PCC thickness indicate that as these parameters increase, the PCI value decreases. On the other hand, the positive coefficient value for C_d indicates that PCI increases with increasing C_d. In case of the subbase layer parameter, which was modeled as a nominal parameter, the intercept value shown must be subtracted if subbase layer is not present and must be added if subbase layer is present. This indicates that the presence of subbase layer increases the PCI value (see prediction profiler in Figure 145).

The multi-variate analysis revealed that improving subgrade strength/stiffness (within the top 16 in. of the subgrade layer), improving drainage, providing a subbase layer, and reducing variability, can contribute to increasing the PCI value. Subgrade layer properties can be improved by stabilization, drainage can be improved by the presence of a relatively thin drainable subbase layer (note that subbase layer thickness was not statistically significant), and variability can be reduced by adequate in situ testing. Some recommendations regarding these aspects are provided in Chapter 8. The PCI prediction model developed from this analysis is based on limited data (16 points), and should be updated and validated with a larger pool of data.
