METHODS TO DETECT FAULTY SPLICES IN THE SUPERCONDUCTING MAGNET SYSTEM OF THE LHC

Abstract

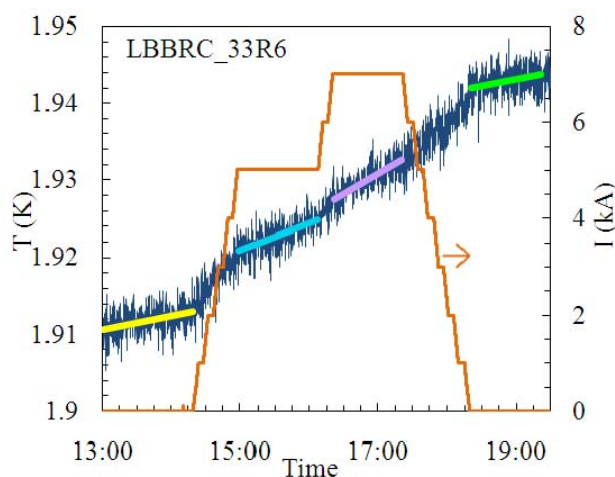
This technique is illustrated in Fig. 1, which shows the temperature in one dipole in sector 6-7 over a 4.5 hour period. The current was ramped to 5 kA and then 7 kA, and held at each current for 1 hour. A linear fit is made to T = f(t) during initial and final zero current periods, and during each of the high-current plateaus. Since superfluid helium effectively conducts heat throughout the common liquid volume, the measured dT/dt of all thermometers in a subsector are averaged, and the slope with zero current

Figure 1: Measured T = f(t) for one thermometer during a power run of the main dipole circuit. Linear fits during periods of constant magnet current are shown.

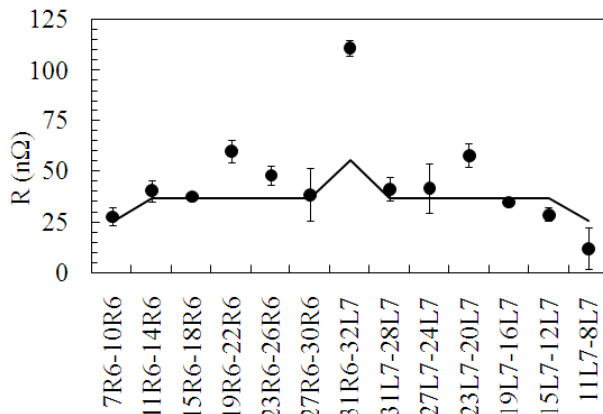
Fig. 2 shows the measured resistance per subsector for sector 6-7. The error bars returned by the least-squares fit are a measure of the scatter of individual measurements about the best fit for each subsector. The solid line represents the expected resistance per subsector. Ten of the 13 subsectors are of a standard length as described above. The central sub-sector is 1.5 times as long, and the end (dispersion suppressor) subsectors have 2/3 the number of dipoles.

The resistance in the central subsector (31R6-32L7) is 111±4 nΩ, compared with an expected 55 nΩ. The net excess resistance is 56±4 nΩ. Independent electrical measurements (see next section) found a resistance of 49 ± 3 nΩ in one of the dipoles in this subsector. This method also identified one subsector in sector 1-2 with an excess resistance of 108±5 nΩ, which was also confirmed electrically to be a high-resistance splice inside a dipole.

Figure 2: Total resistance in the dipole circuit in each sub-sector in sector 67, measured by the calorimetric method.

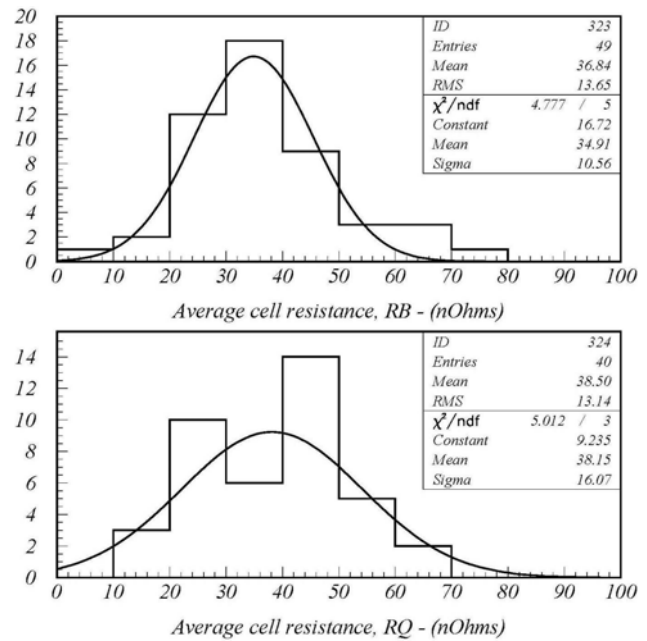
This method has been applied to the dipole (quadrupole) circuits in five (four) of the LHC sectors. Histograms of the calorimetrically measured total resistance per standard-length subsector are shown in Fig. 3. The two subsectors with confirmed resistive splices are not included in these plots, nor are the longer central and shorter end subsectors. The data are consistent with Gaussian distributions with means of ~35 nΩ and sigma of ~15 nΩ. This width is somewhat larger than the typical error bar from the individual fits to subsector data. This suggests additional systematic errors coming from small uncertainties in the cryogenic system settings. Since15 nΩ deposits only 0.7 W at 7 kA, detected in a helium bath>200 m long, this represents remarkable sensitivity.

Figure 3: Histograms of main dipole and quadrupole circuit resistances in standard-length sub-sectors, measured by the calorimetric method.

including the non-standard-length subsectors but excluding those with known high-resistance splices, the mean resistance per splice is measured to be 271±9 pΩ (354±23 pΩ), consistent with the expected values.

Not all splices covered by the calorimetric measurements were electrically measured to confirm or deny the presence of excess resistance. The dipole distribution shows a slightly asymmetric tail on the high side, which may indicate the presence of one or more faulty splices with resistances of a few 10's of nΩ. Table 1 shows, for each LHC sector, the 90% confidence upper bound on the maximum excess resistance, relative to the mean values shown in Fig. 3, that could exist in any subsector, based on calorimetry.

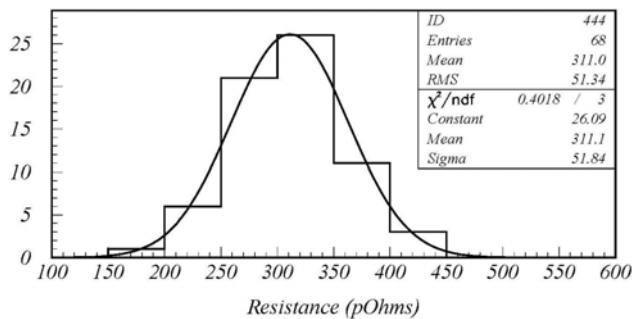
same pairs of voltage taps indicates an rms reproducibility error of 45 pΩ. The technique is labour and time intensive; therefore it was used only in subsectors deemed suspicious by the cryogenic analysis. In total 68 measurements were performed in five cryogenic subsectors, all on the dipole bus. No abnormal splice resistance was seen. The mean splice resistance is 311 pΩ, with an rms spread of 52 pΩ. (See Fig. 4.)

Figure 4: Histogram of electrical measurements of bus splice resistances.

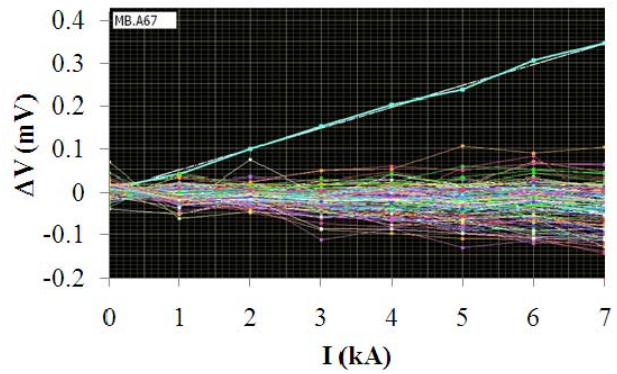
An electrical technique to identify faulty splices inside magnets was also developed. The "QPS snapshot" method uses the post-mortem system (2450 voltage measurements over 13 s with typical peak-to-peak noise of 4 mV), semi-automatically triggered at different current plateaus. The QPS measures voltage differences between two apertures of a dipole or two half-coils of a quadrupole, and there-fore *differences* in splice resistances. QPS snapshot meas-urements were performed on five (four) sectors for the dipoles (quadrupoles). An example of the data for the 154 dipoles in sector 6-7 is shown in Fig. 5. A magnet (B32R6) with large resistance is clearly visible, which is in the cryogenic subsector identified as having excess resistance. Its resistance is measured to be 49±3 nΩ, consistent with the calorimetric measurements. Another magnet in sector 1-2 (B16R1) was identified by this technique with R = 100±3 nΩ, also consistent with the calorimetric measurements.

Figure 5: Voltage differences between two halves of all dipoles in sector 67.

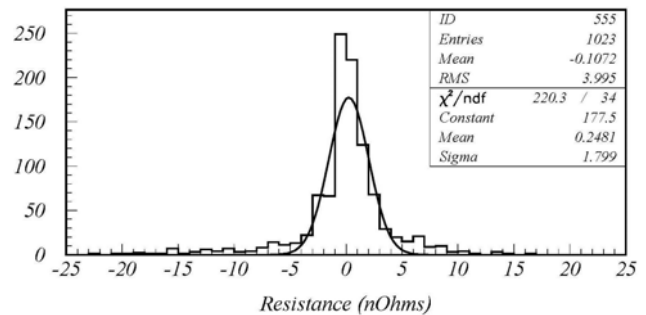
Fig.6 is a histogram of all of the snapshot measurements. The central peak has a width of about 2 nΩ. However there are long tails, which come from channels with extra electrical noise, and which may also include magnets with internal splices with R ~10 nΩ.

Figure 6: Histogram of electrical measurements of internal magnet splice resistance differences.
