Dhimish, Mahmoud (2020) Performance Ratio and Degradation Rate Analysis of 10-Year Field Exposed Residential Photovoltaic Installations in the UK and Ireland. Clean Technologies. pp. 170-183. ISSN 2571-8797

Performance ratio and degradation rate analysis of 10-year field exposed residential photovoltaic installations in the UK and Ireland

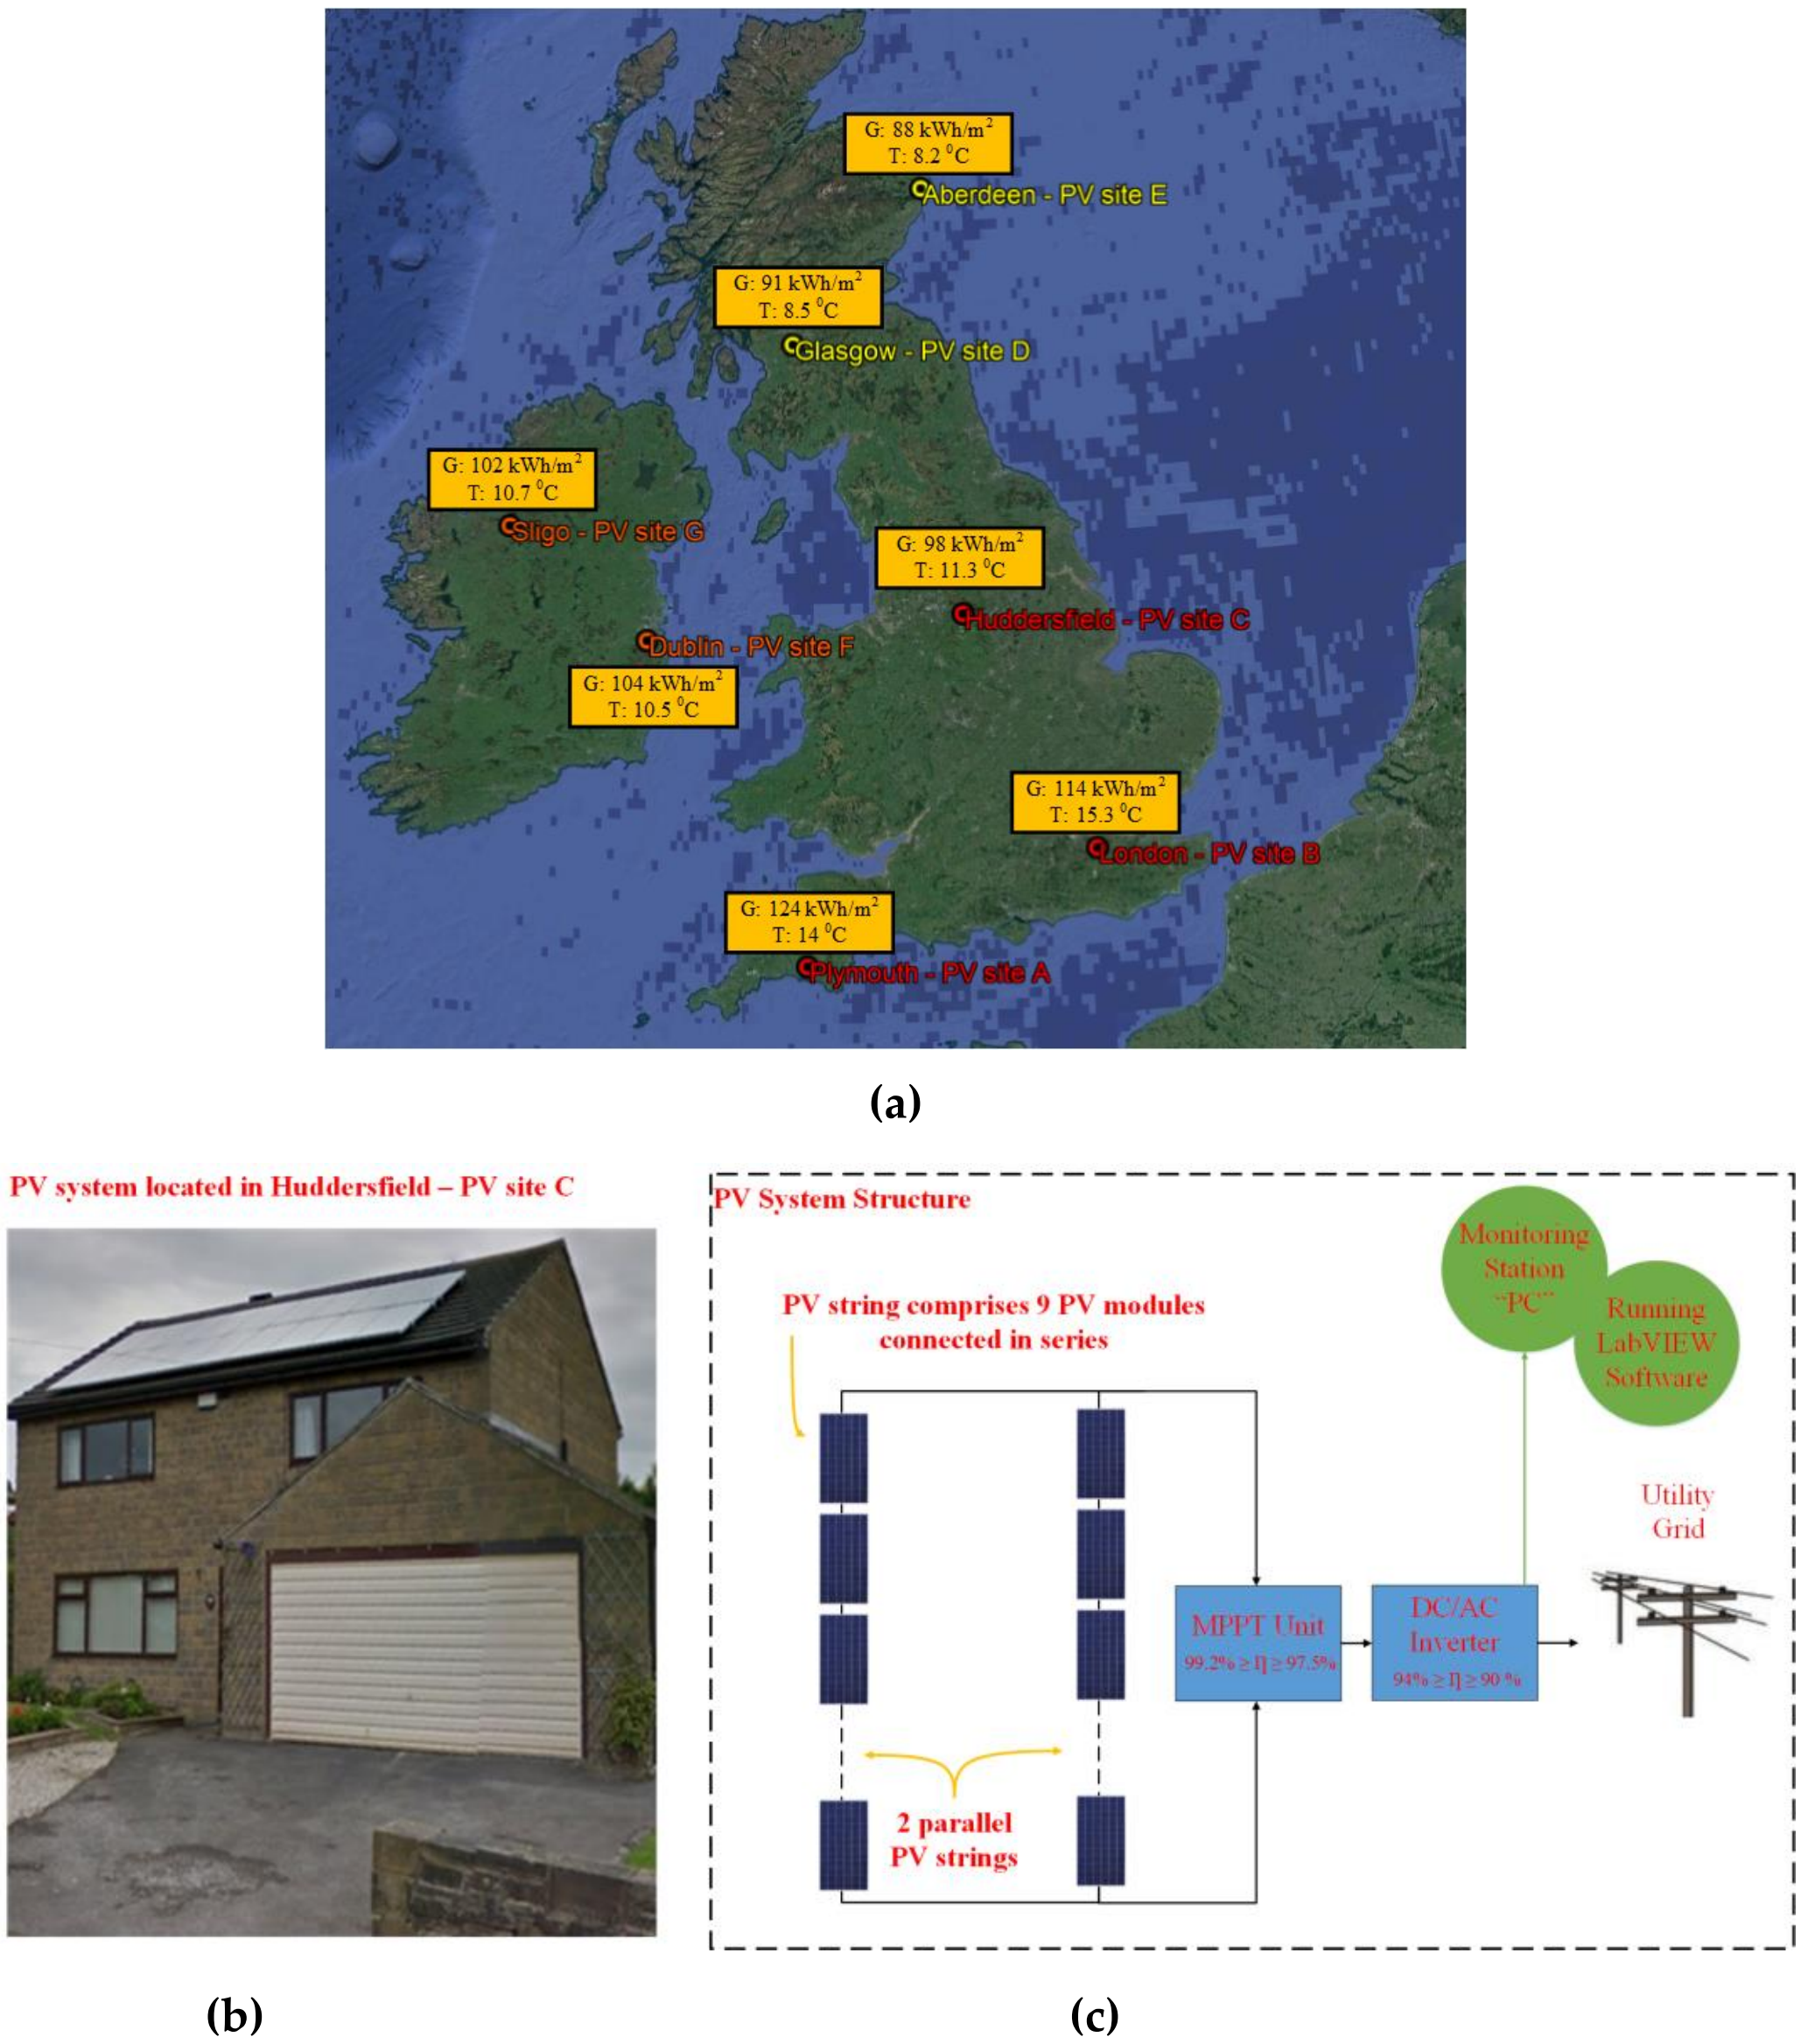
Figure 1. Examined PV systems configuration and its geographical representation: (**a**) Geographical distribution of the examined PV installations in the United Kingdom including the average irradiance (G) and temperature (T) over the last 30 years; (**b**) Real picture of the examined PV system installed at Huddersfield site – PV site C; (**c**) PV sites configuration that comprises two parallel PV string each consists of nine series connected PV modules.

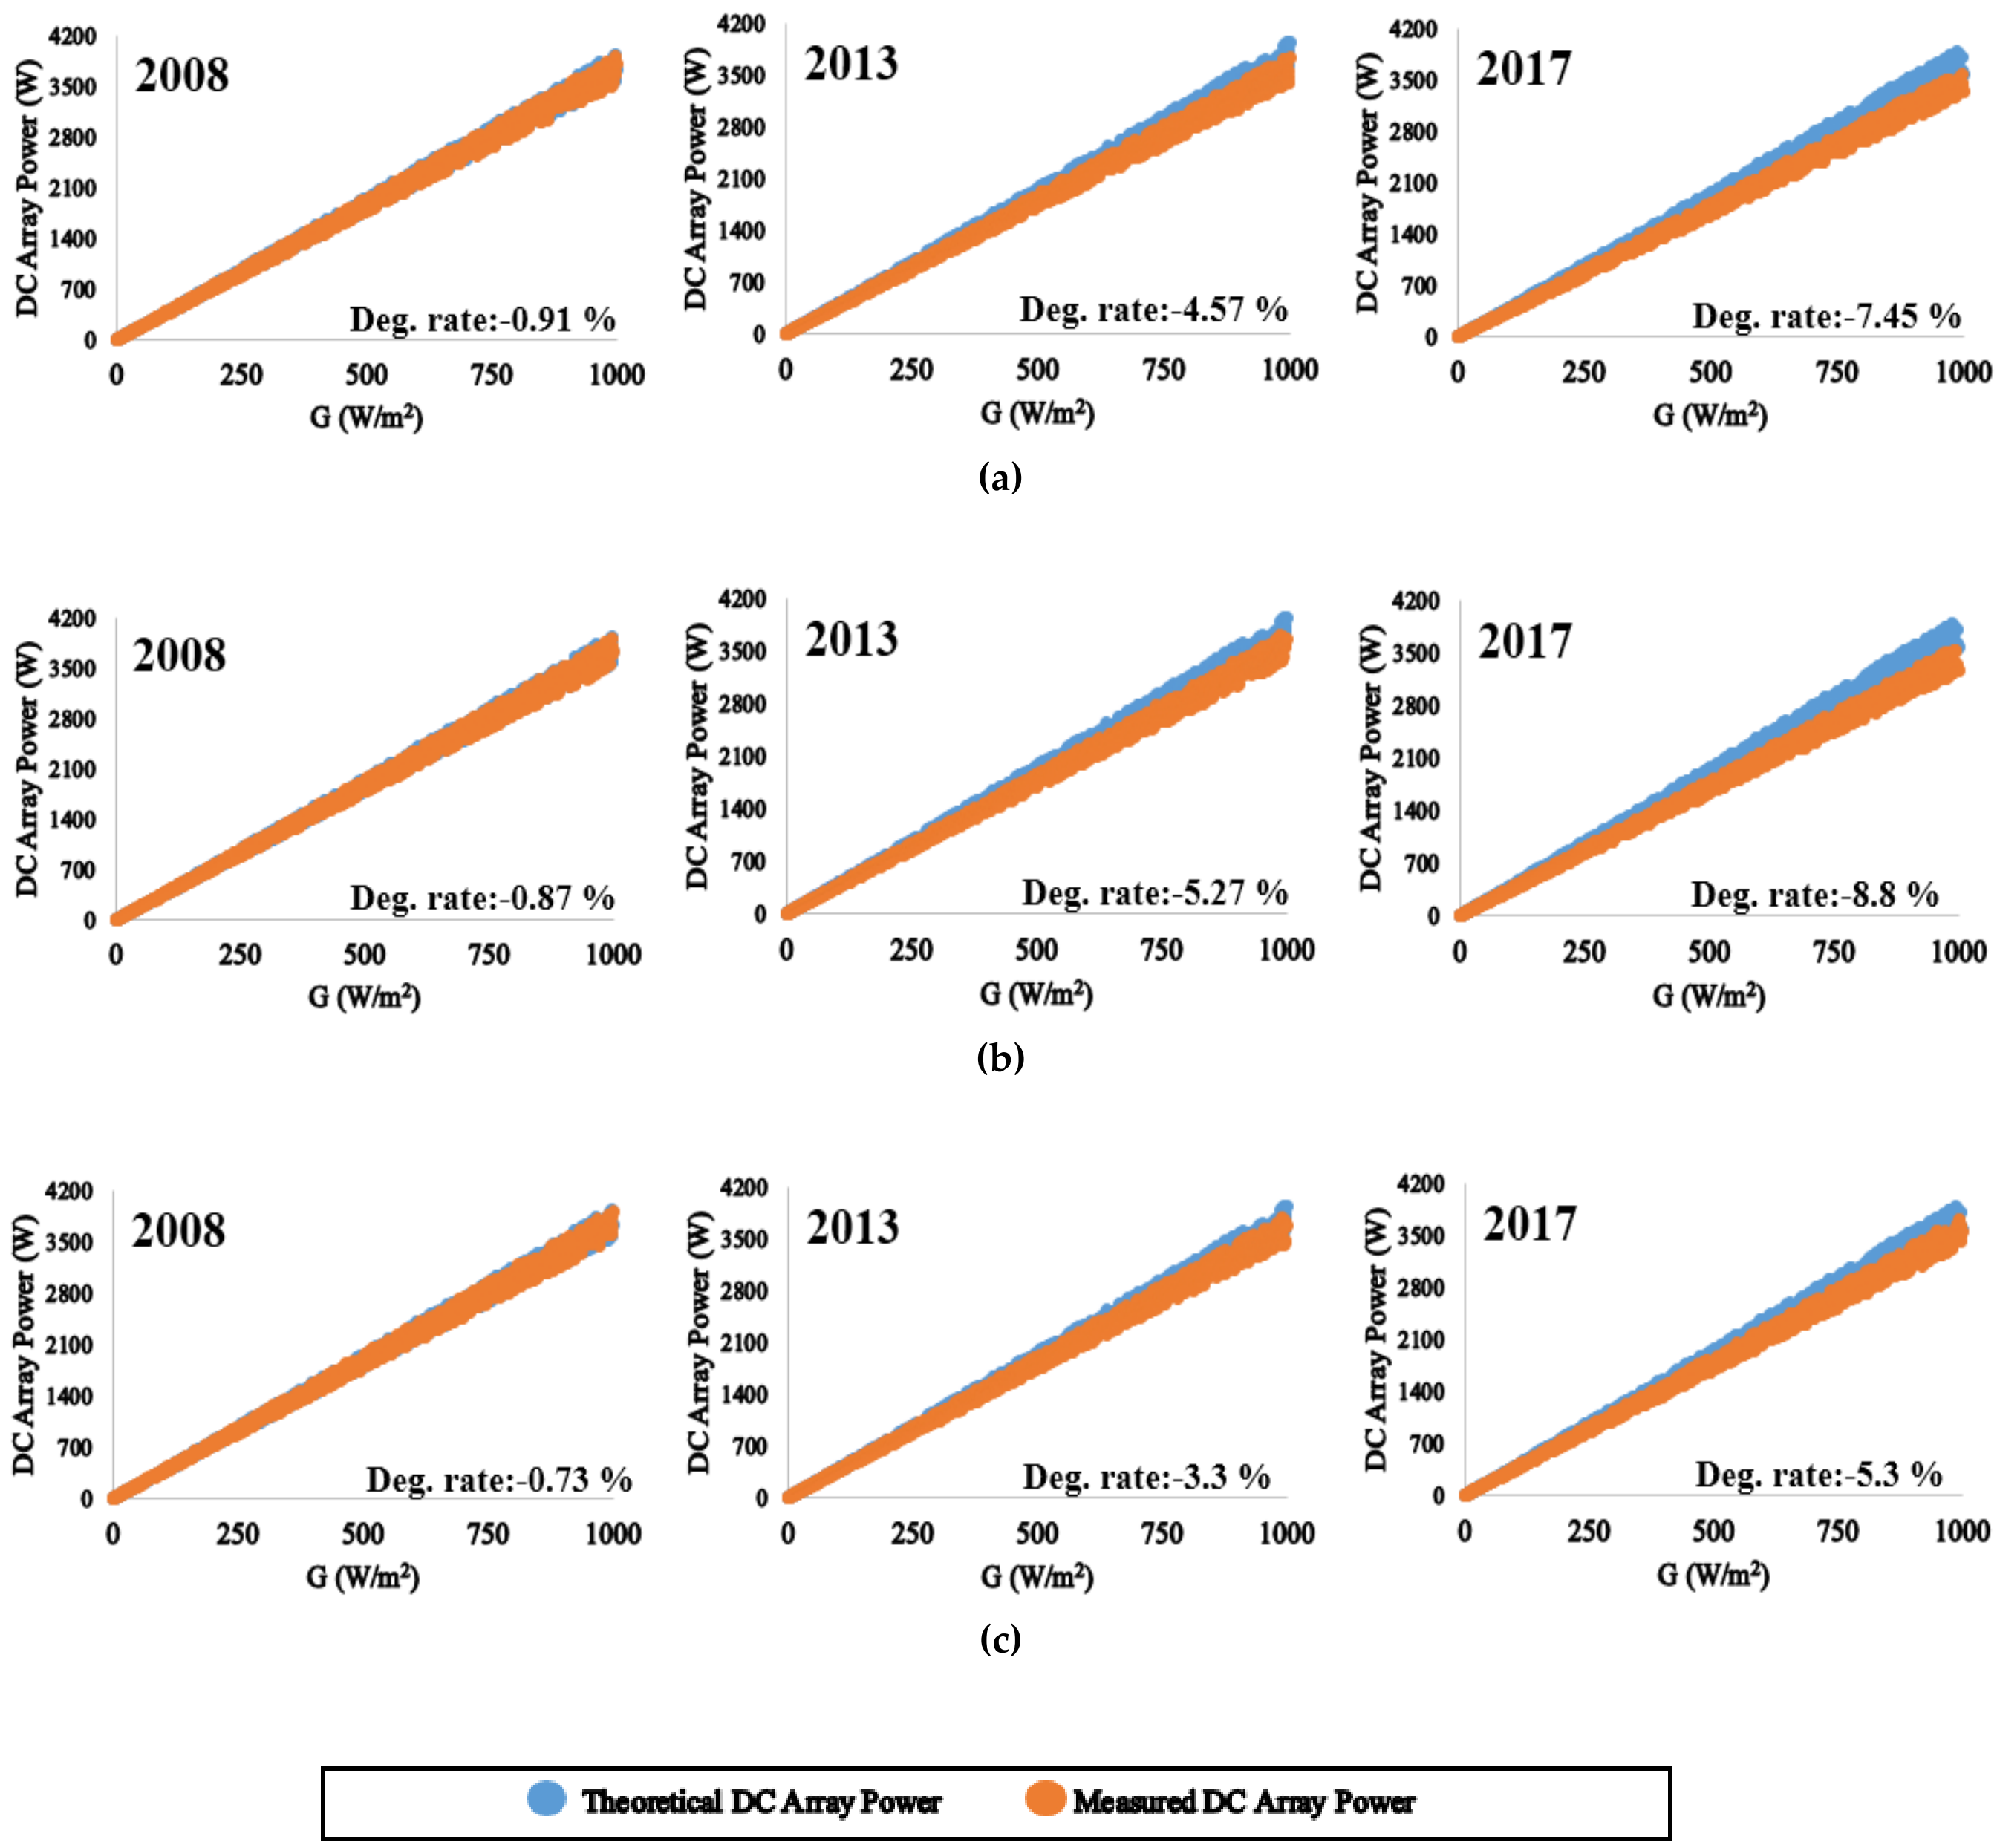
As can be noticed in Figure 2 and Table 3, there is almost a linear degradation rate for PV site A. The average degradation rate over the last ten years is equal to -0.74%/year. The highest average degradation rate is observed in site B at -0.88%/year. The PV system installed in Huddersfield (PV site C) has the minimum degradation rate compared to PV sites A and B; its annual degradation rate is equal to -0.53%/year.

Figure 2. Cumulative degradation rate for PV systems A, B, and C in 2008, 2013, and 2017: (**a**) PV site A – Plymouth; (**b**) PV site B – London; (**c**) PV site C – Huddersfield.

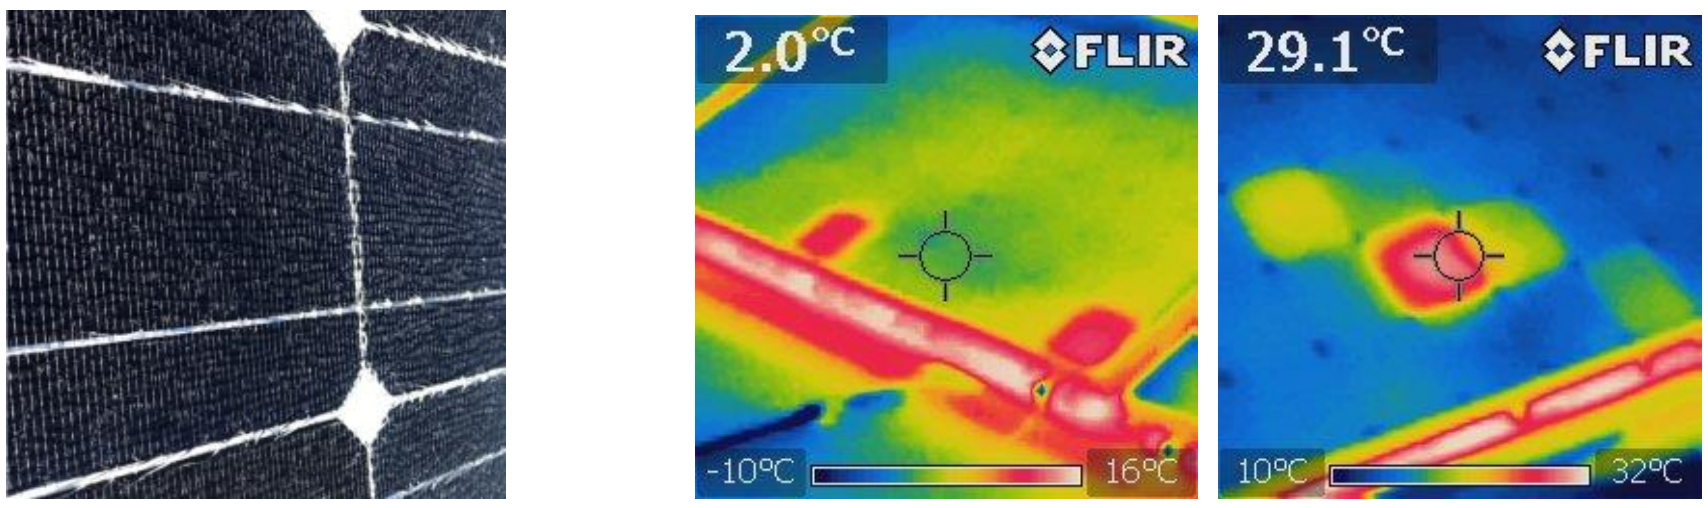
Remarkably, it was found that the yearly average degradation rate for Glasgow and Aberdeen PV installations are equal to -1.05% and -1.16%/year, respectively. This high degradation rate is related to the fact that both PV sites are in cold areas. The increase in the degradation rate is due to the effect of the heavy snow, rain, and high wind speed on the surface of the PV modules, thus there is a higher risk for PV hot spots [25], micro cracks [26] and [27], and damage in the surface of the PV modules. Figure 3a shows an actual image of broken glass for a PV module located in Aberdeen site due to hoarfrost (this image was captured in February 2018), whereas in Figure 3b two hot spots were observed in Glasgow PV system (these images were captured in June 2018). Therefore, in comparison to the degradation rates observed in the PV systems located in England, the PV systems located in Scotland had a higher degradation rate over the studied period.

Figure 3. Example for the Impact of hoarfrost and heavy snow on PV modules: (**a**) PV module glass damage observed in Aberdeen site (PV site E) due to a hoarfrost weather condition; (**b**) Hot spots captured in two different PV modules in Glasgow site (PV site D) after a heavy snow weather condition.

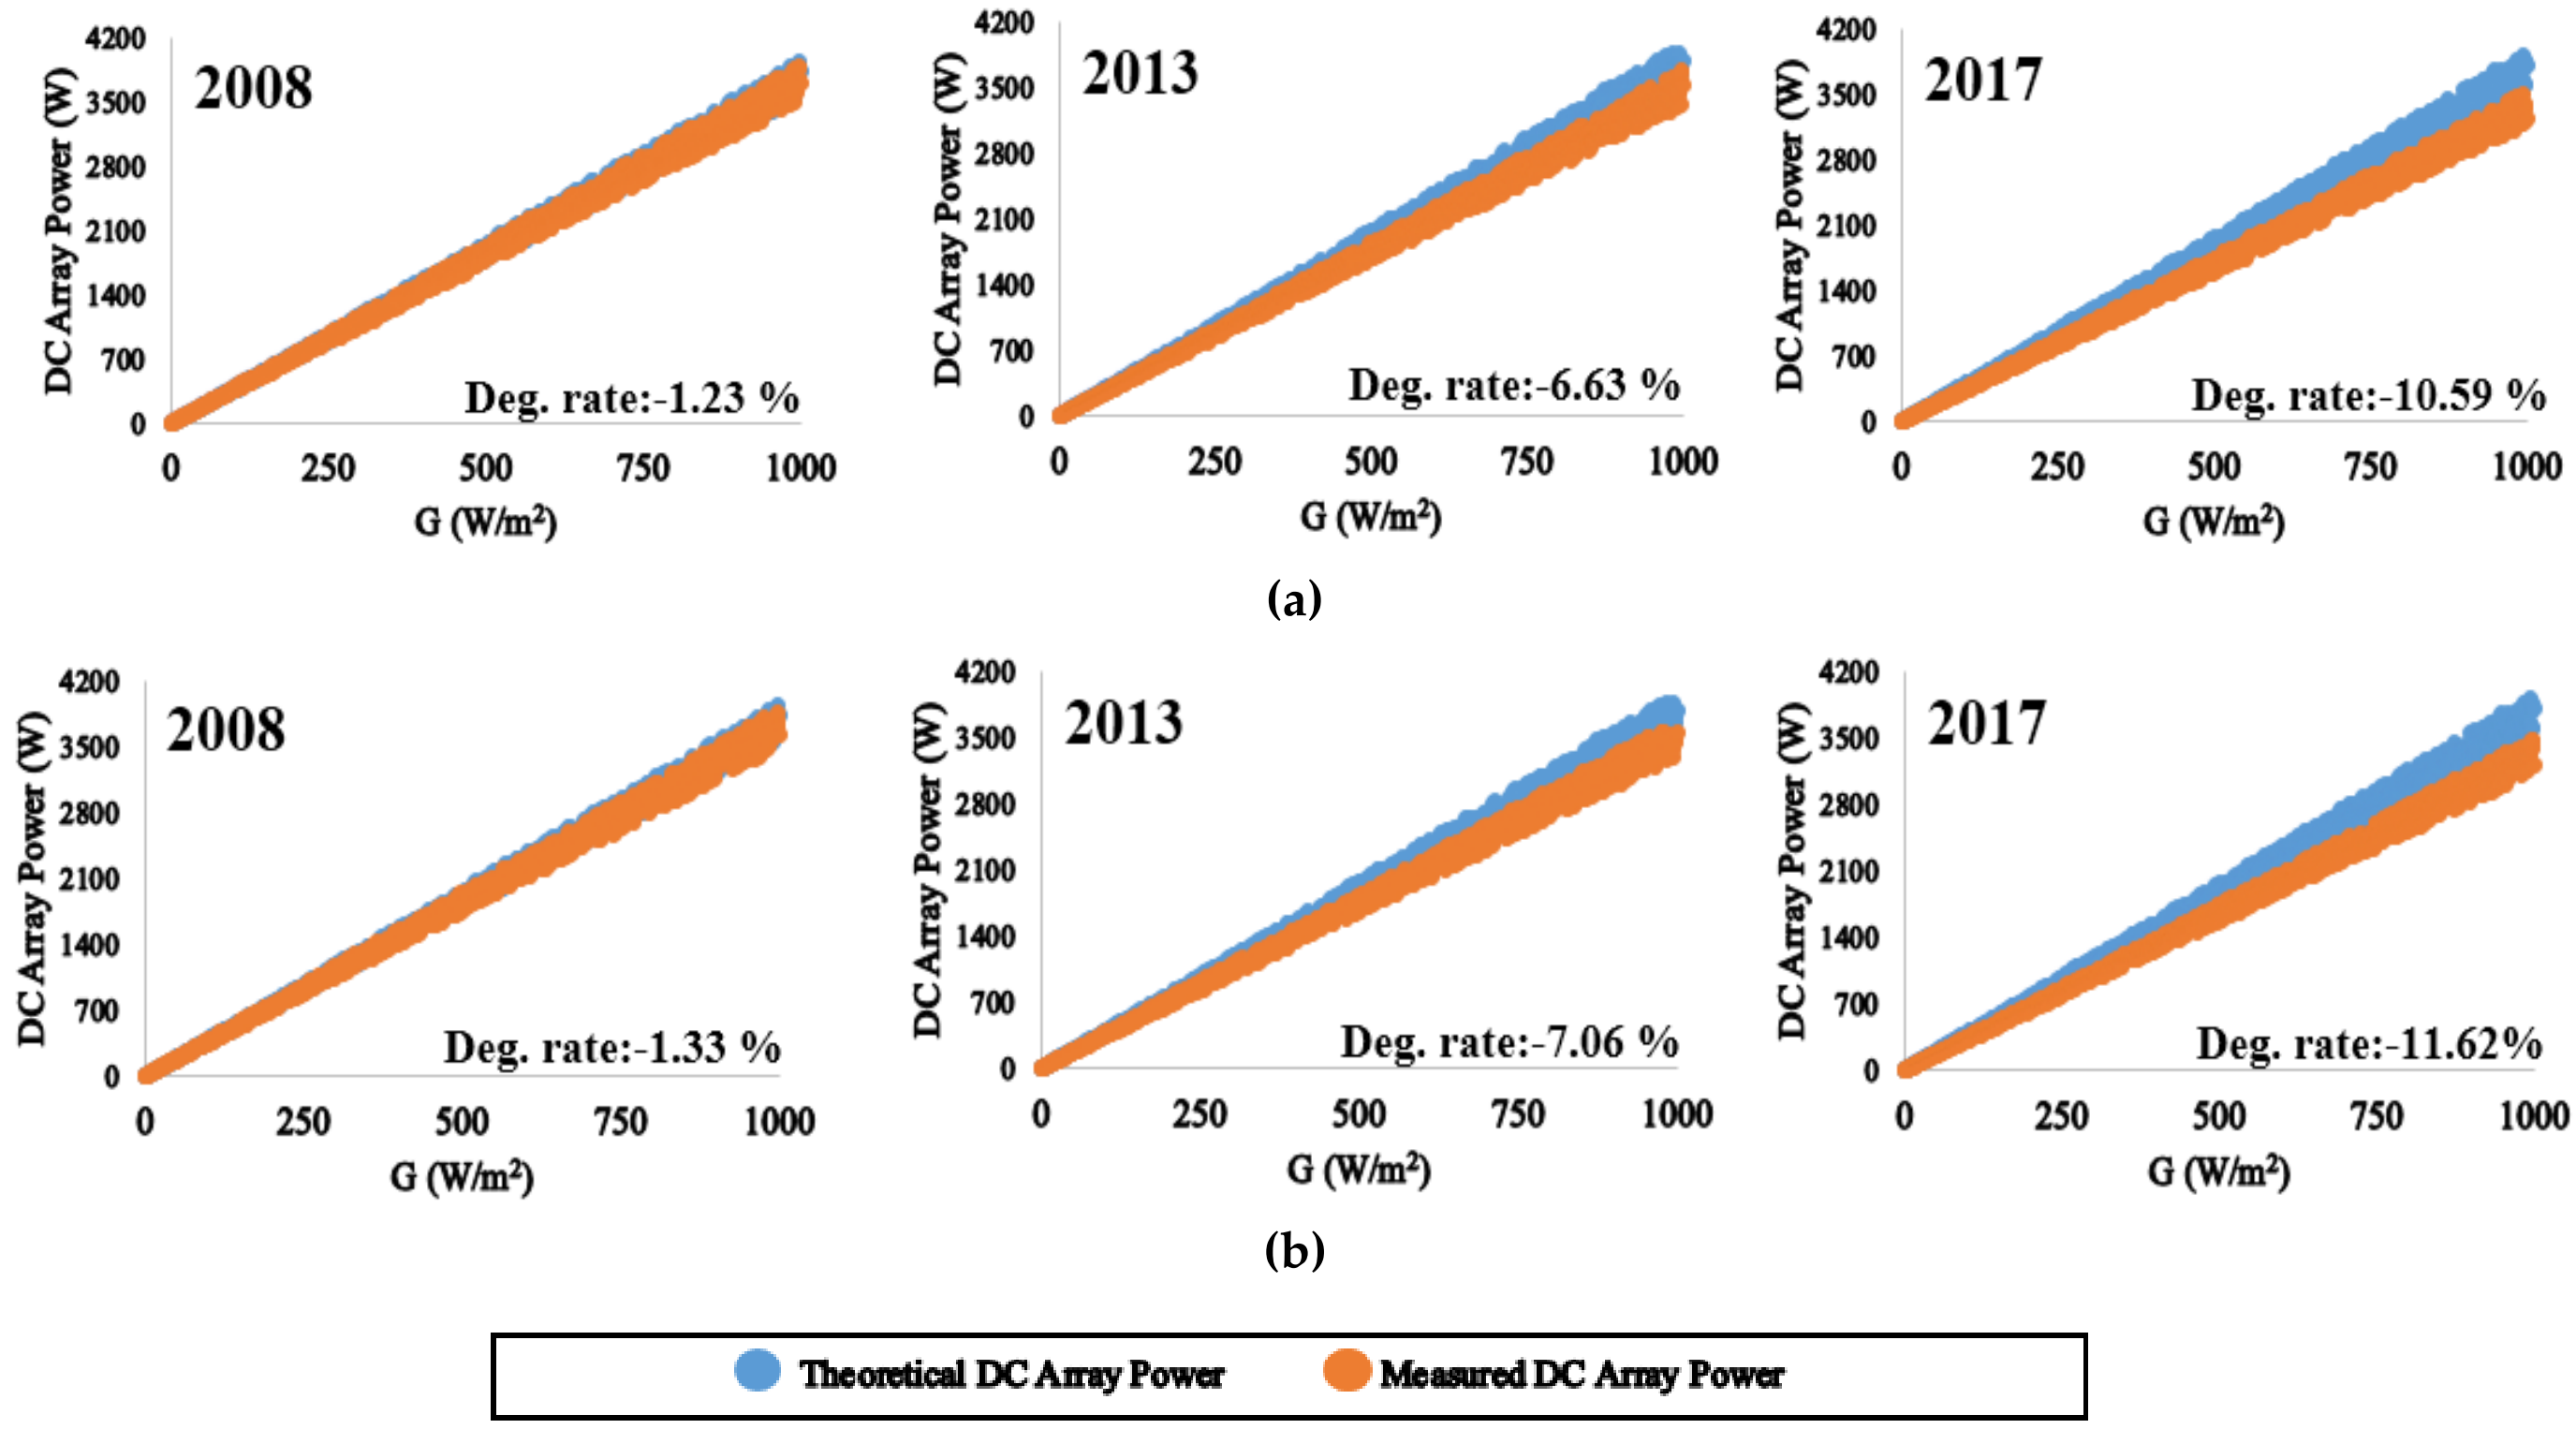
The annual and cumulative degradation rate from 2008 to 2017 for both sites D and E are presented in Table 4. It is evident that both PV sites had a maximum degradation rate in their first year of operation "2008", the degradation rate is equal to -1.23% and -1.33% for site D, and E, respectively. The power-irradiance profile in 2008, 2013, and 2017 for both PV systems are shown in Figure 4. The degradation rate for the PV modules increases over the years. For example, in site D, the accumulative degradation rate increased from -1.23% to -10.59% from 2008 to 2017. However, there is a further reduction in the annual output power in Aberdeen compared to Glasgow. The degradation rate for Aberdeen PV system in 2008 is equal to -1.33%, and it increased to an accumulative of -11.62% in 2017.

Figure 4. Cumulative degradation rate for PV systems D and E in 2008, 2013, and 2017: (**a**) PV site D – Glasgow; (**b**) PV site E – Aberdeen.

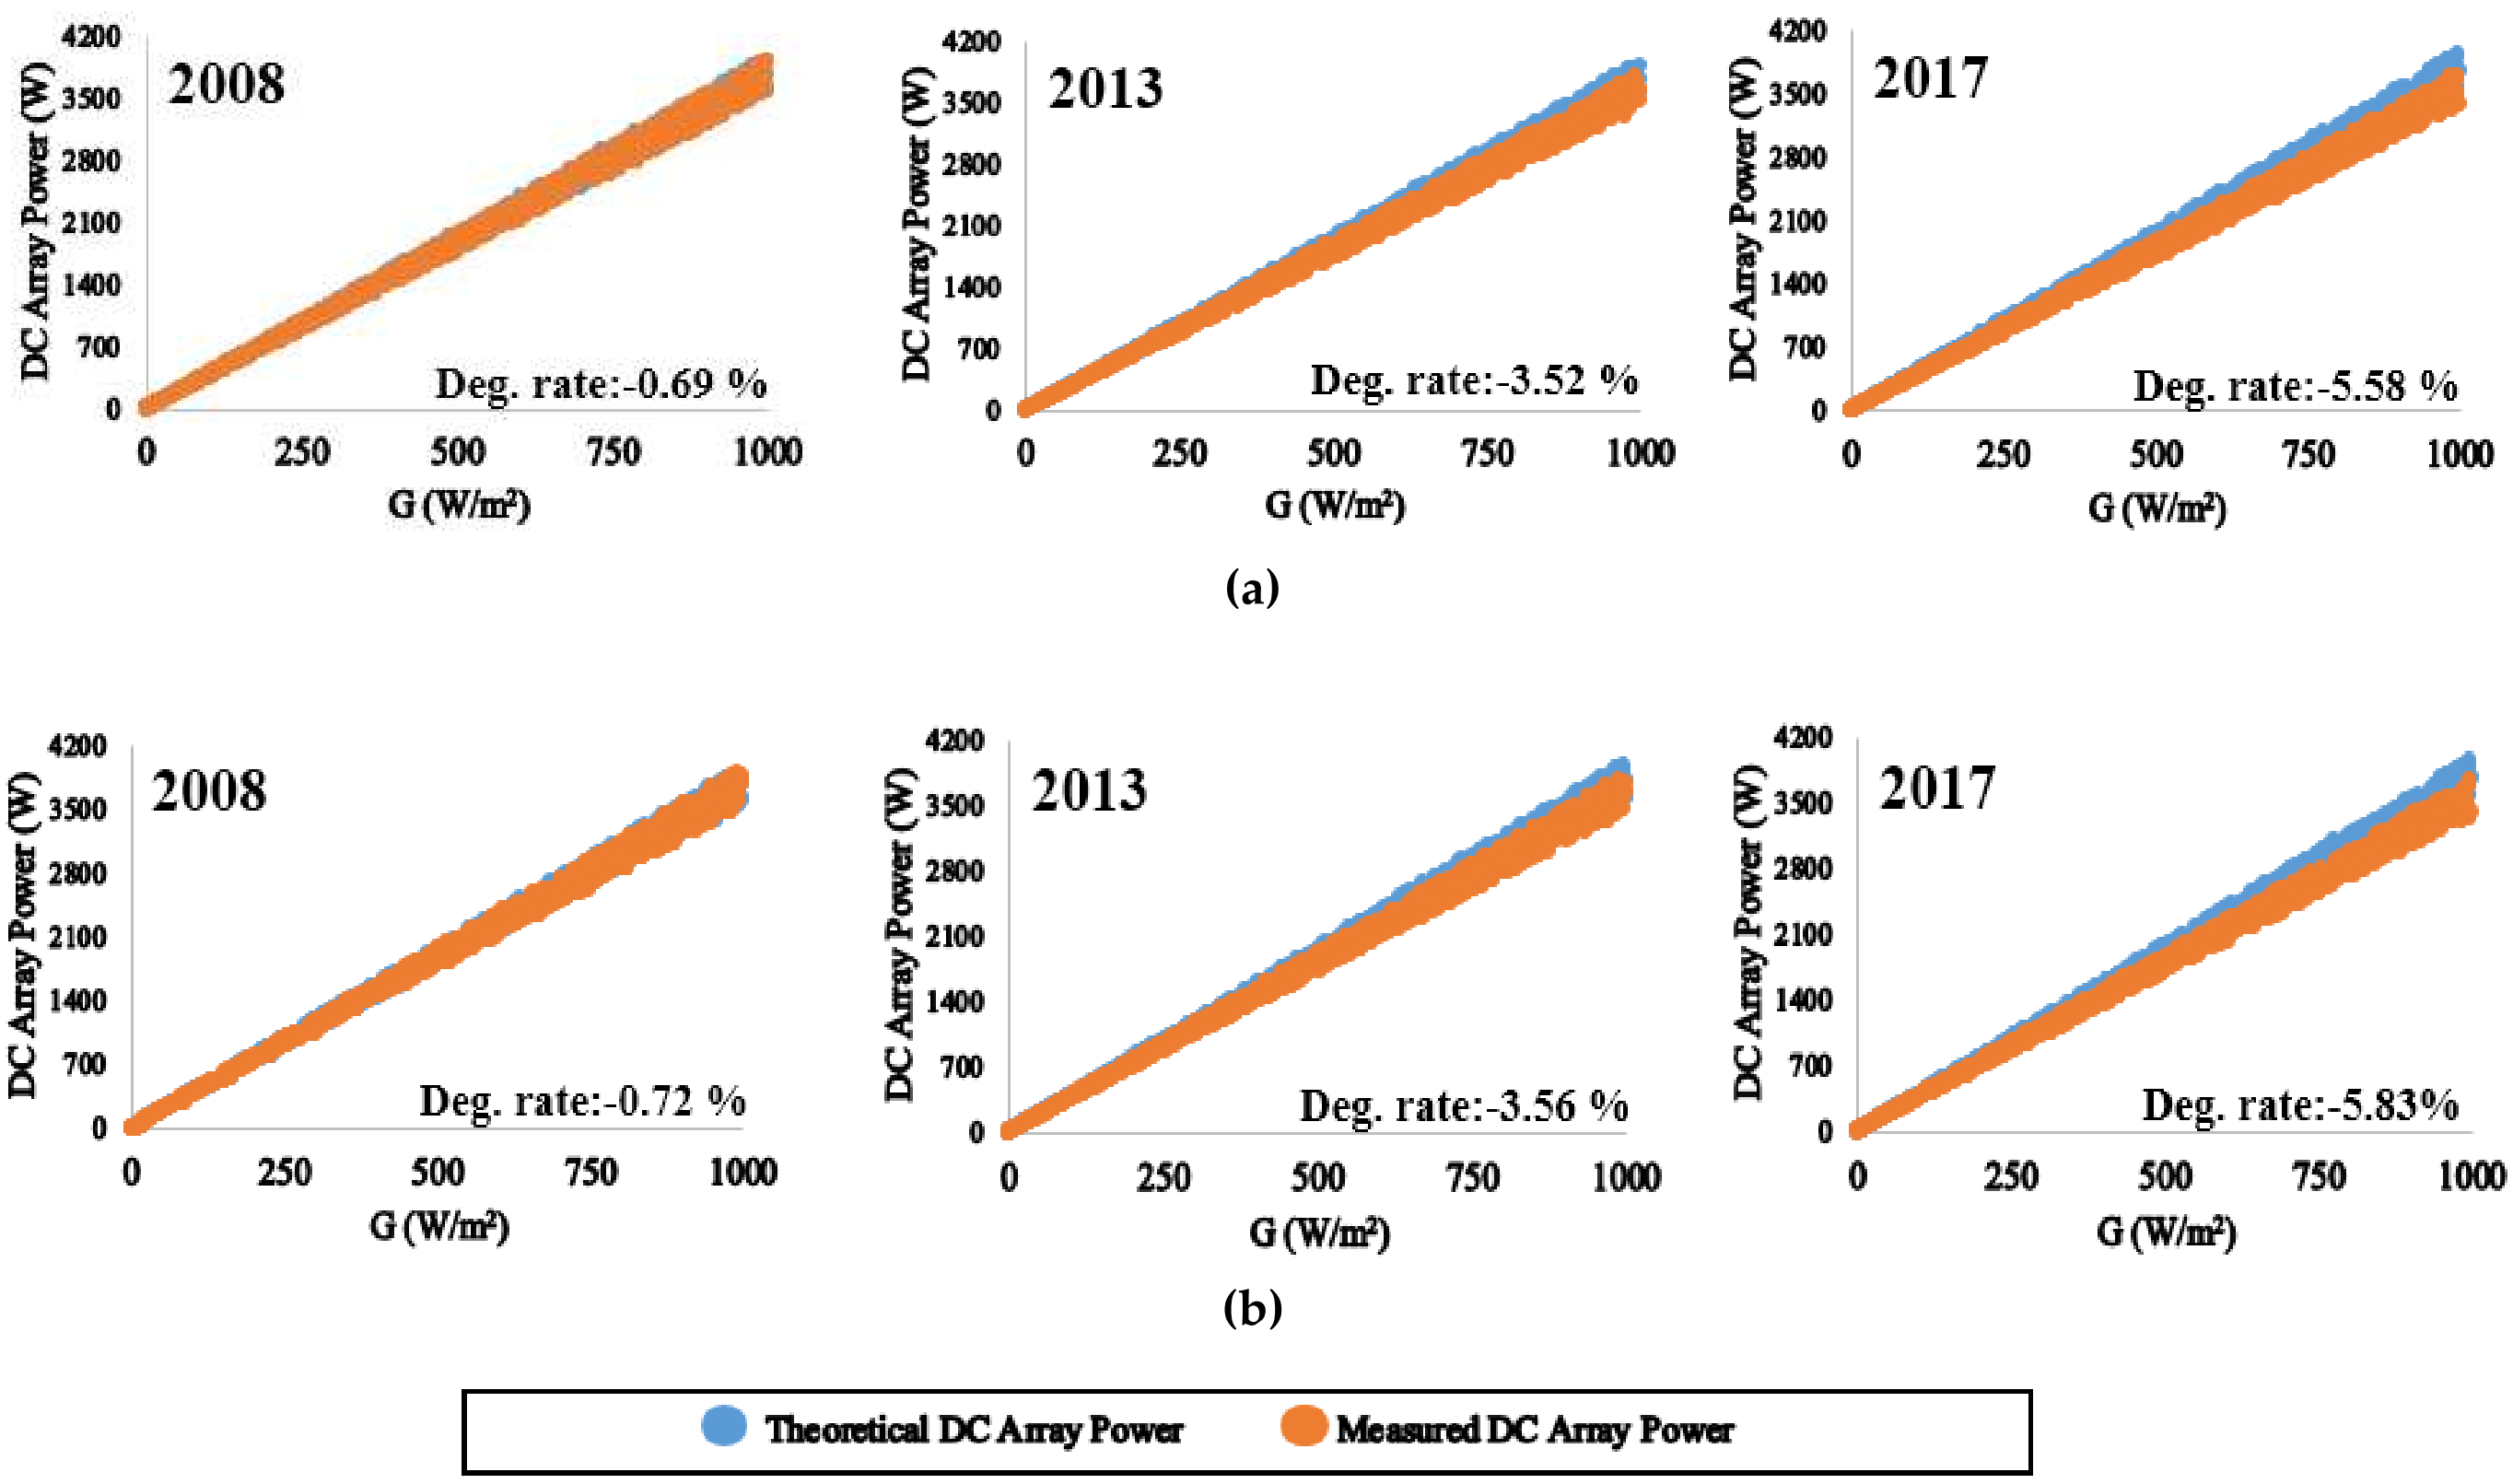
The annual and cumulative degradation rate for site F and G are presented in Table 5. It is evident for both PV sites have a maximum degradation rate in their first year of operation "2008" which is equal to -0.69% and -0.72%, respectively. The power-irradiance profile in 2008, 2013, and 2017 for both PV sites are shown in Figure 5. The degradation rate for the PV modules increases over the years. For example, in site F, the accumulative degradation rate increased from -0.69% to -5.58% from 2008 to 2017. However, there is more loss in the annual output power in the PV systems located in Sligo, where the degradation rate for this site in 2008 is equal to -0.72%, and it increased to an accumulative of -5.8% in 2017.

Figure 5. Cumulative degradation rate for PV systems F and G in 2008, 2013, and 2017: (**a**) PV site F – Dublin; (**b**) PV site G – Sligo.

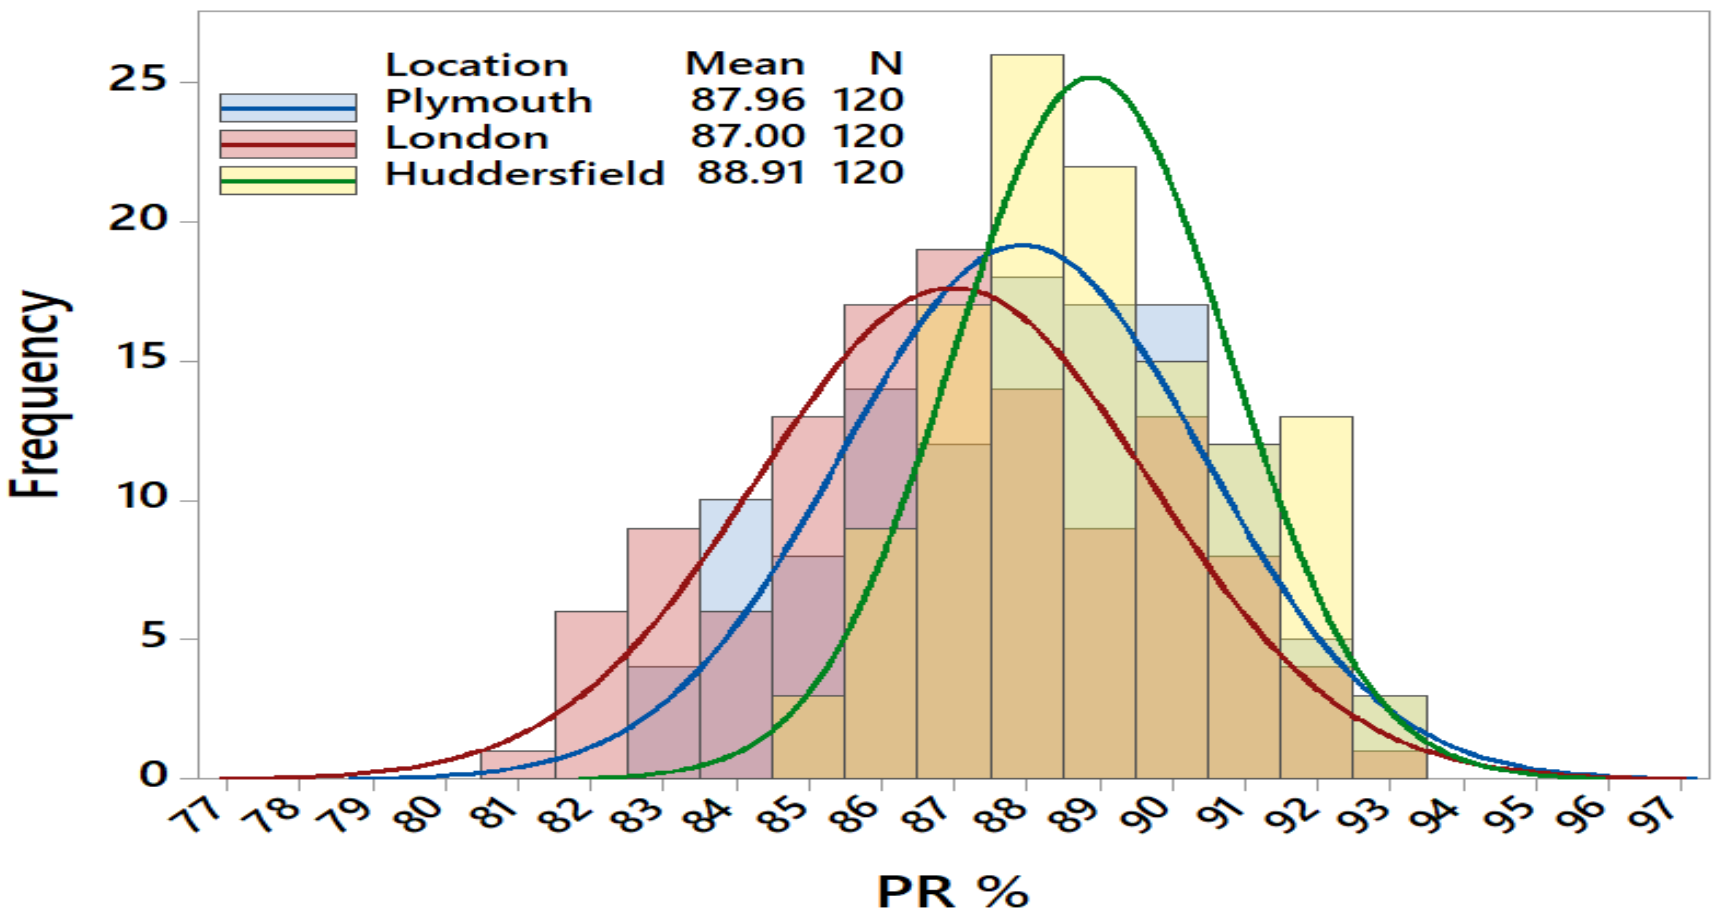
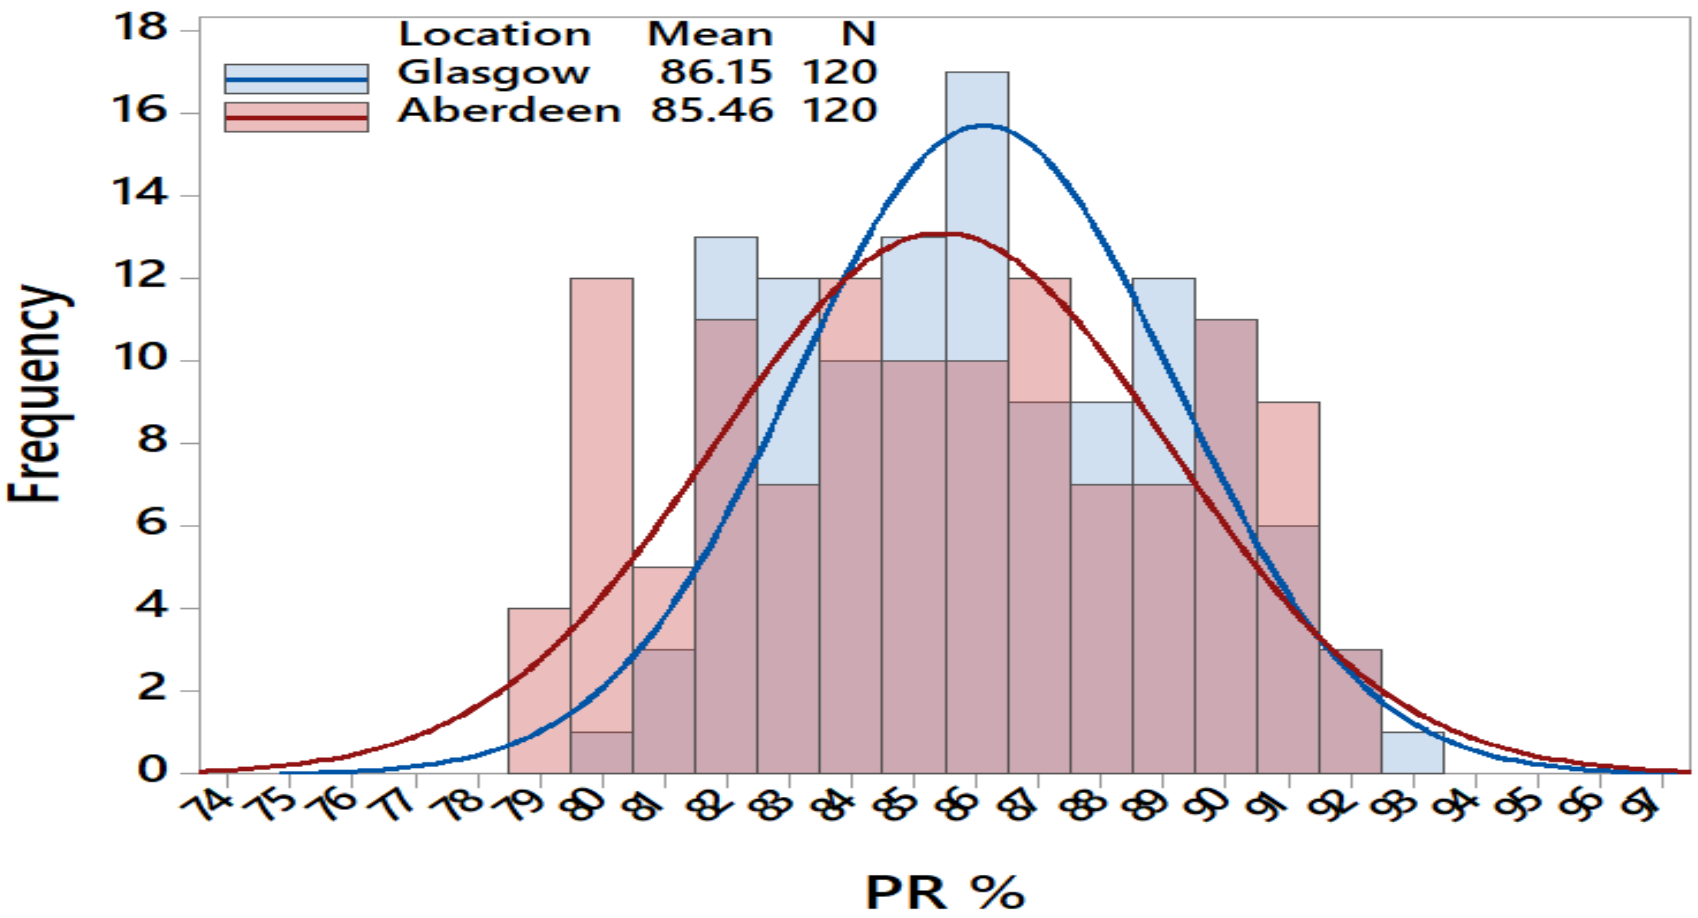
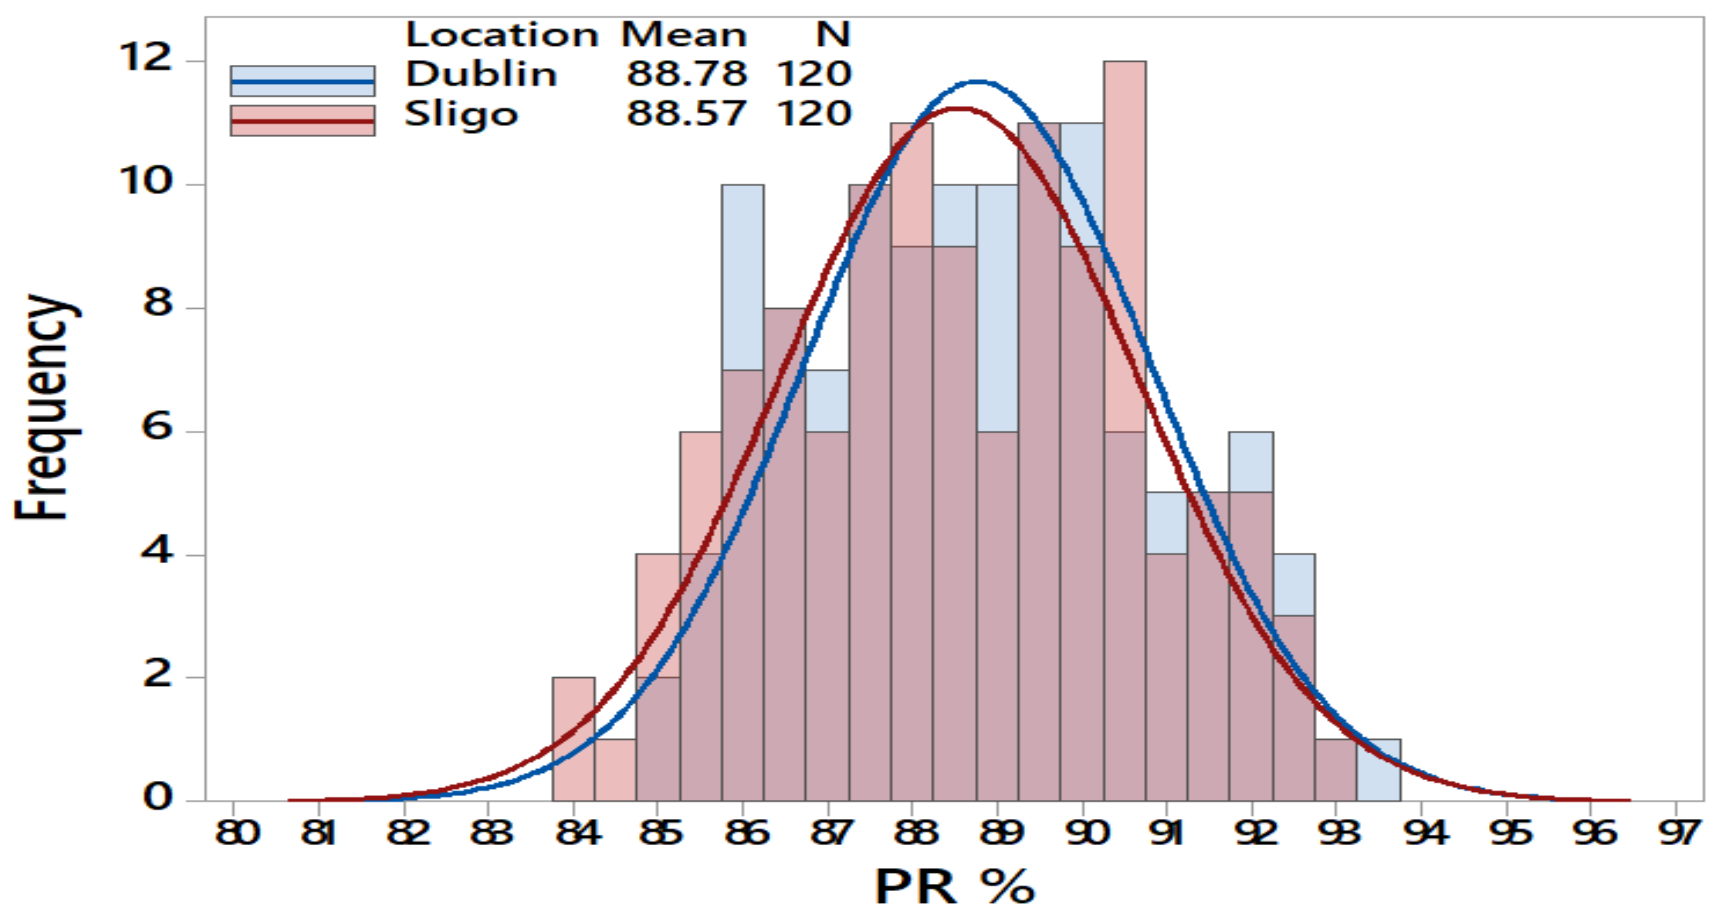
Figure 6a presents the PR of the PV systems installed in England. The mean PR value is equal to 88.91%, 87.96%, and 87% for PV systems installed in Huddersfield, Plymouth, and London, respectively. This result is consistent with the results obtained by the Power-Irradiance technique described earlier in section 3.1. Huddersfield PV system has the lowest annual degradation rate of -5.03%/year, while the highest PV degradation rate of -0.88%/year is observed for the PV system located in London.

According to Figure 6b, PV systems in Scotland had the lowest PR ratio compared to all other examined PV systems, the monthly mean PR are equal to 86.15% and 85.46% for Glasgow and Aberdeen, respectively. This result is due to the high degradation rate of these PV systems; their annual degradation rate was always higher than -1.0%/year. This result also confirms that PV hot-spotting, heavy snow, and the hoarfrost affects the PR ratio of the entire PV systems installed in cold areas [32].

In the previous sections, we have demonstrated that the PV systems installed in Huddersfield, Dublin, and Sligo had almost identical annual degradation rates, varying from -0.53%/year in Huddersfield, -0.56%/year in Dublin, and -0.58%/year in Sligo. Consequently, according to results shown in Figure 6 a,c, the PV systems have nearly identical monthly mean PR ratios. In Huddersfield, it is equal to 88.91%, while in Dublin and Sligo, the monthly mean PR is equal to 88.78% and 88.57%, respectively.

Figure 6. Performance Ratio (PR) analysis for all examined PV systems: (**a**) PV Systems installed in England; (**b**) PV systems installed in Scotland; **(c)** PV Systems installed in Ireland.
