Dhimish, Mahmoud (2020) Performance Ratio and Degradation Rate Analysis of 10-Year Field Exposed Residential Photovoltaic Installations in the UK and Ireland. Clean Technologies. pp. 170-183. ISSN 2571-8797

Performance ratio and degradation rate analysis of 10-year field exposed residential photovoltaic installations in the UK and Ireland

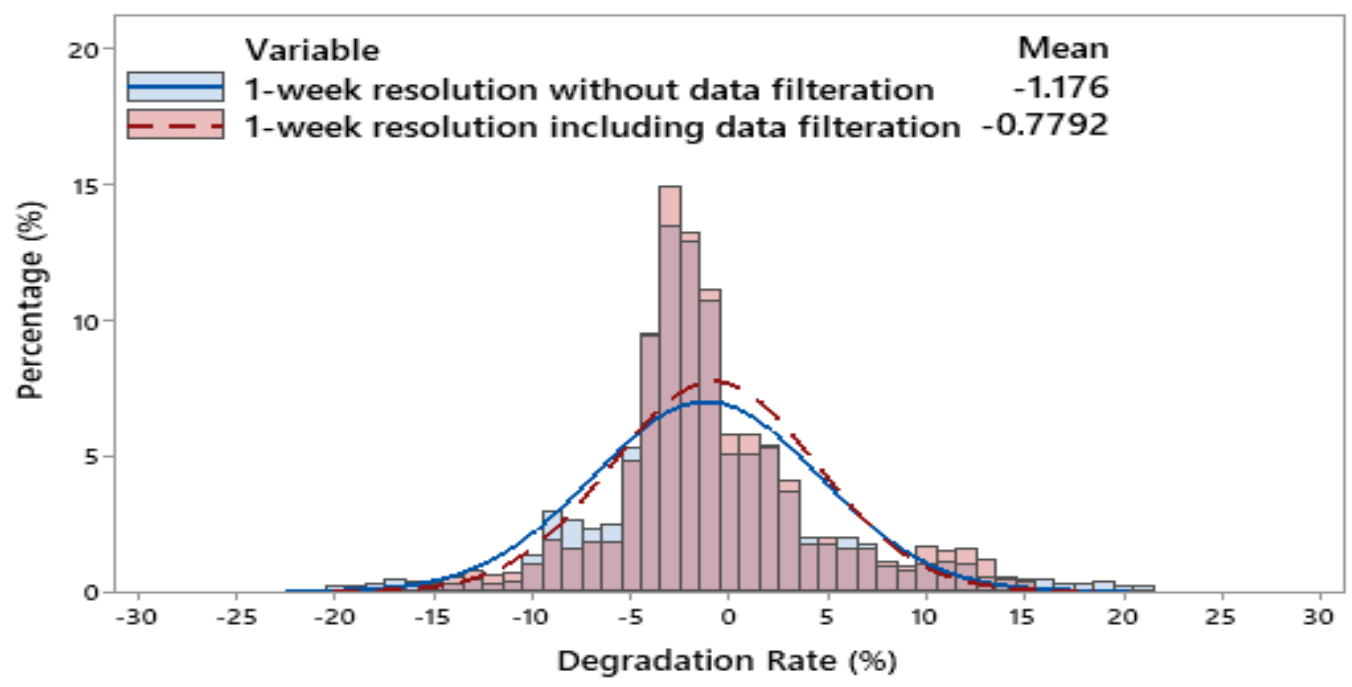
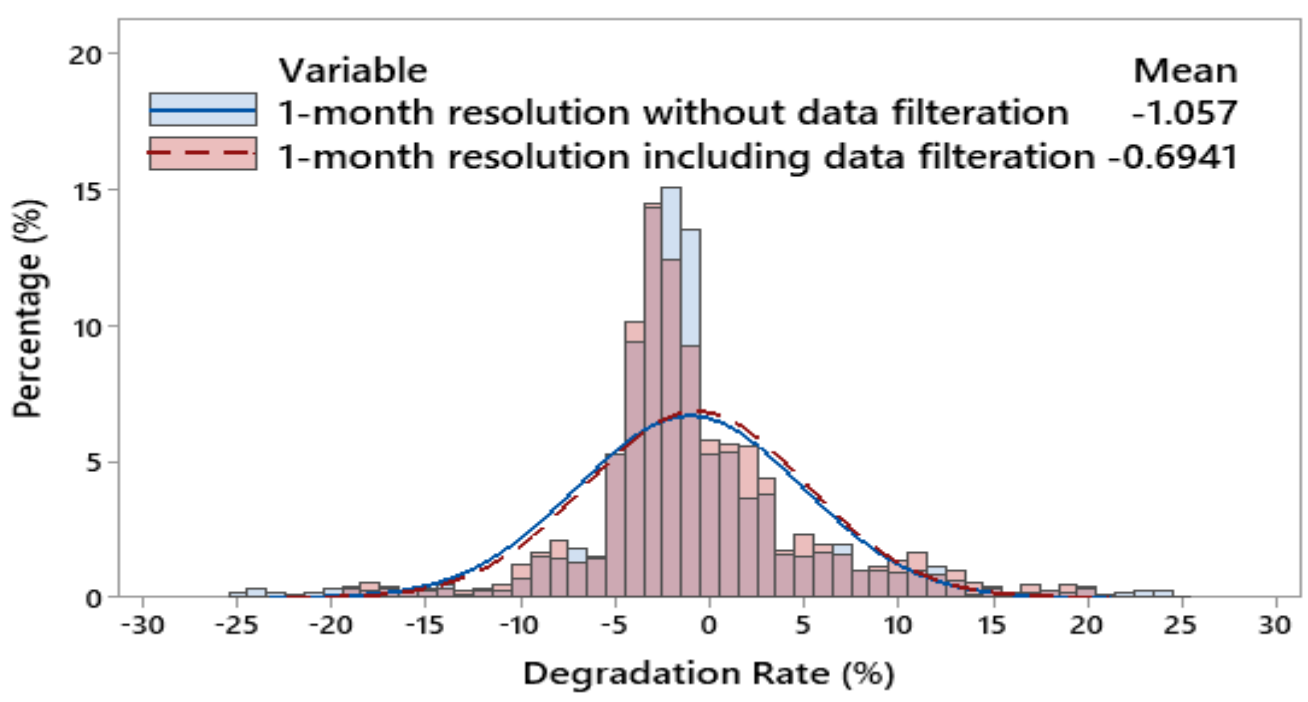
The results of the degradation using the RdTool is shown in Figure 7. As can be seen in Figure 7(a), the degradation rate of the PV site is equal to -1.176%/year without any data filtration; means that all aggregated data of the PV site is used for this analysis, while any missing data or inaccurate data has been considered. After the filtration process, which typically takes considerable time to do so, the degradation was as accurate as -7.77%/year, close to our previous findings of -0.74%/year as shown in Figure 2a. The results of 1-month resolution without any data filtration is shown in Figure 7(b), the estimated degradation is -1.057%/year, while the degradation is estimated at -0.69%/year after filtering the data samples.

Figure 7. Degradation rate analysis for Plymouth city using RdTool [34]: (**a**) 1-week data resolution; (**b**) 1-month data resolution.
