Micro Cracks Distribution and Power Degradation of Polycrystalline Solar Cells Wafer: Observations Constructed from the Analysis of 4000 Samples

Mahmoud Dhimish

University of Huddersfield, Co-Director of Photovoltaics Laboratory, Huddersfield HD1 3DH, United Kingdom

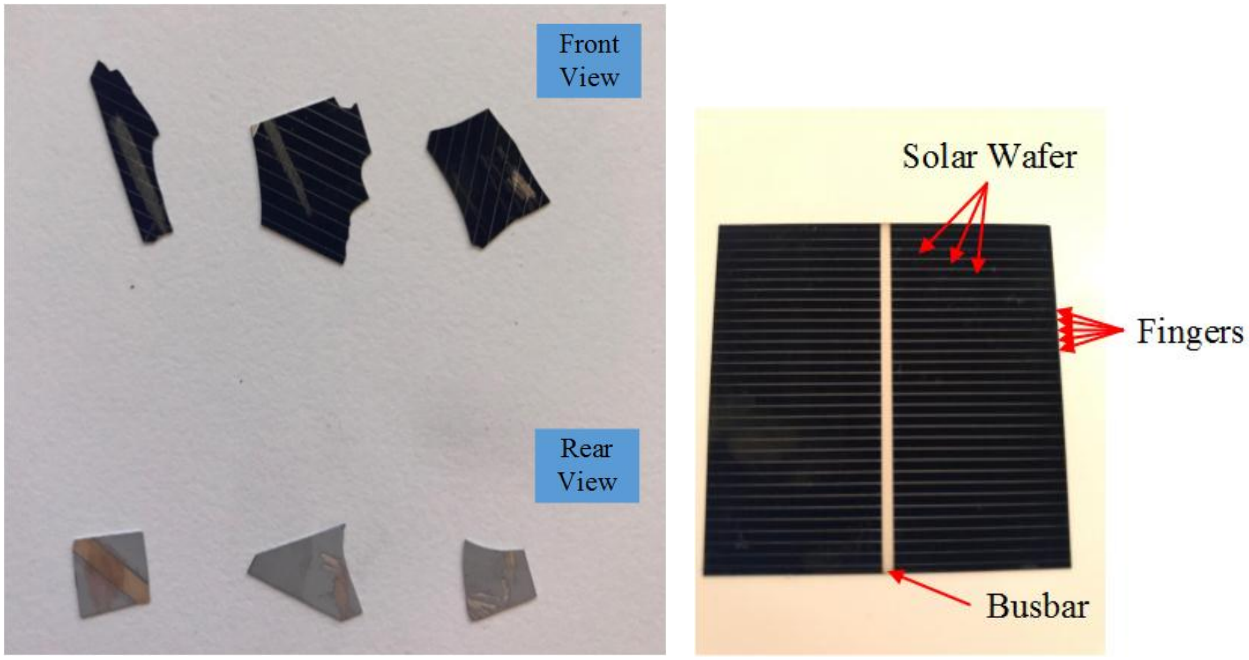
In this article, the examination of 4000 cracked solar cell have been examined; example of multiple samples are shown in Fig. 2(a); showing both front and rear view for diffident types of cracks. All tested samples are dismounted from actual PV modules operated in a field across the UK. The solar cells have been on actual operation for 5 to 13 years.

Fig. 2. (a) Example of the front and rear view for multiple examined solar cell wafers, (b) Solar cell wafer, fingers and busbar

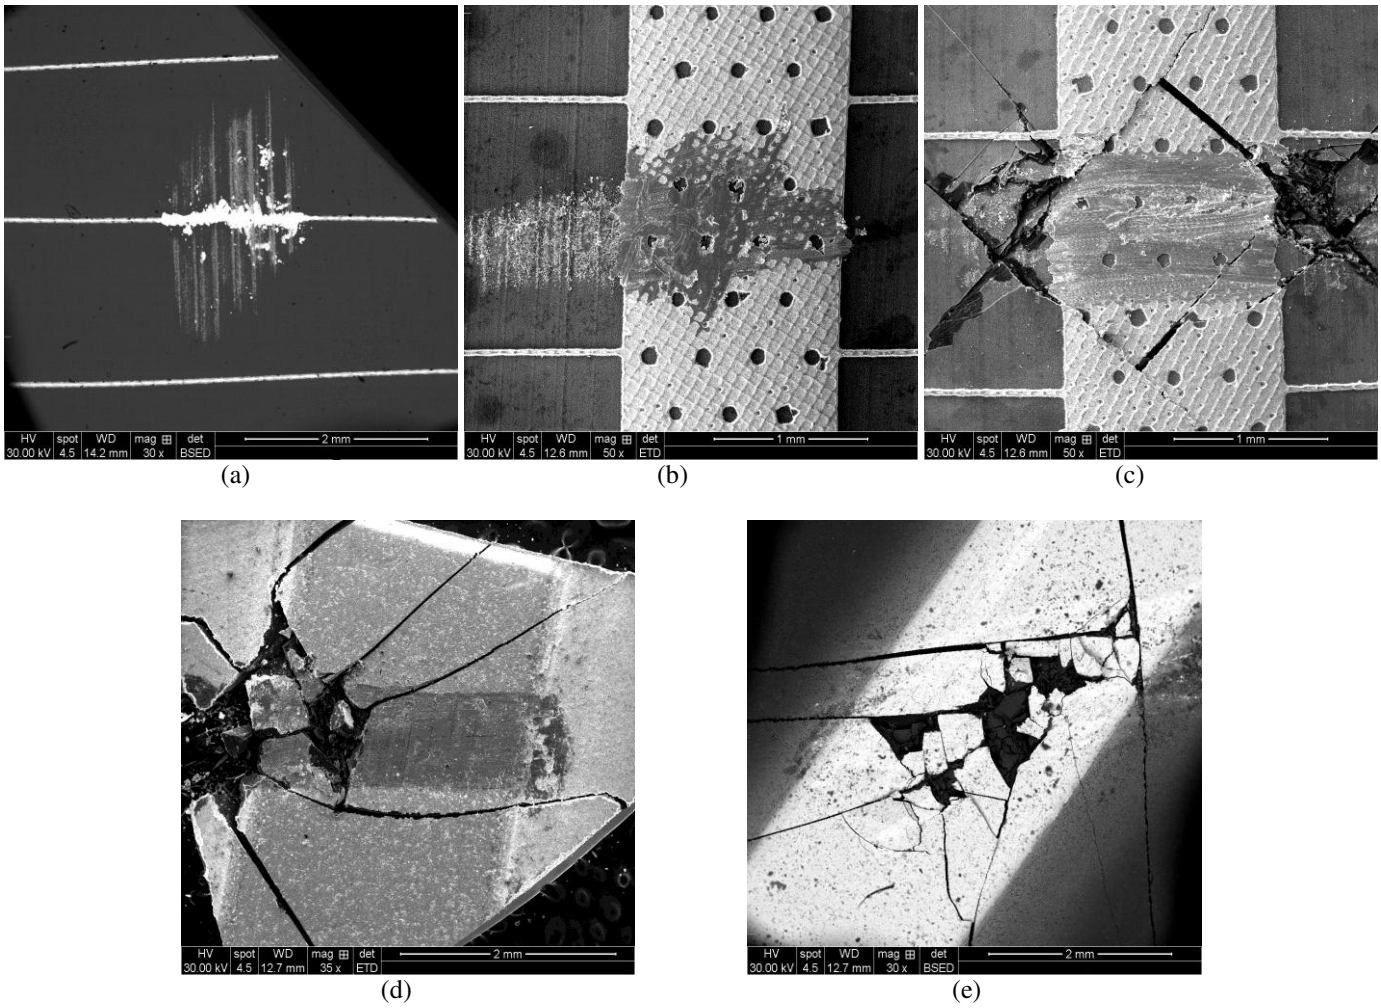
1) Wafer + Fingers (Fig. 3(a)): micro cracks affecting both wafer and the fingers of the solar cell.
2) Wafer + Busbar (Fig. 3(b)): existence of micro cracks on solar cell wafer and busbar, but not fingers.
3) Wafer + Fingers + Busbar (Fig. 3(c)): micro cracks affecting the wafer, fingers, and the busbars.

1) Micro cracks affecting rear surface of the solar cell, example shown in Fig. 3(d).
2) Micro cracks affecting both rear surface of the solar cell and the rear busbar, example shown in Fig. 3(e).

Fig. 3. Examples of the distribution for the micro cracks in different solar cell samples. (a) Micro cracks affecting solar cell wafer and fingers, (b) Micro cracks affecting solar cell wafer and busbars, (c) Micro cracks affecting solar cell wafer, fingers and busbar, (d) Micro cracks in the rear surface of the solar cell, (e) Micro cracks affecting rear surface of the solar cell as well as the rear busbar

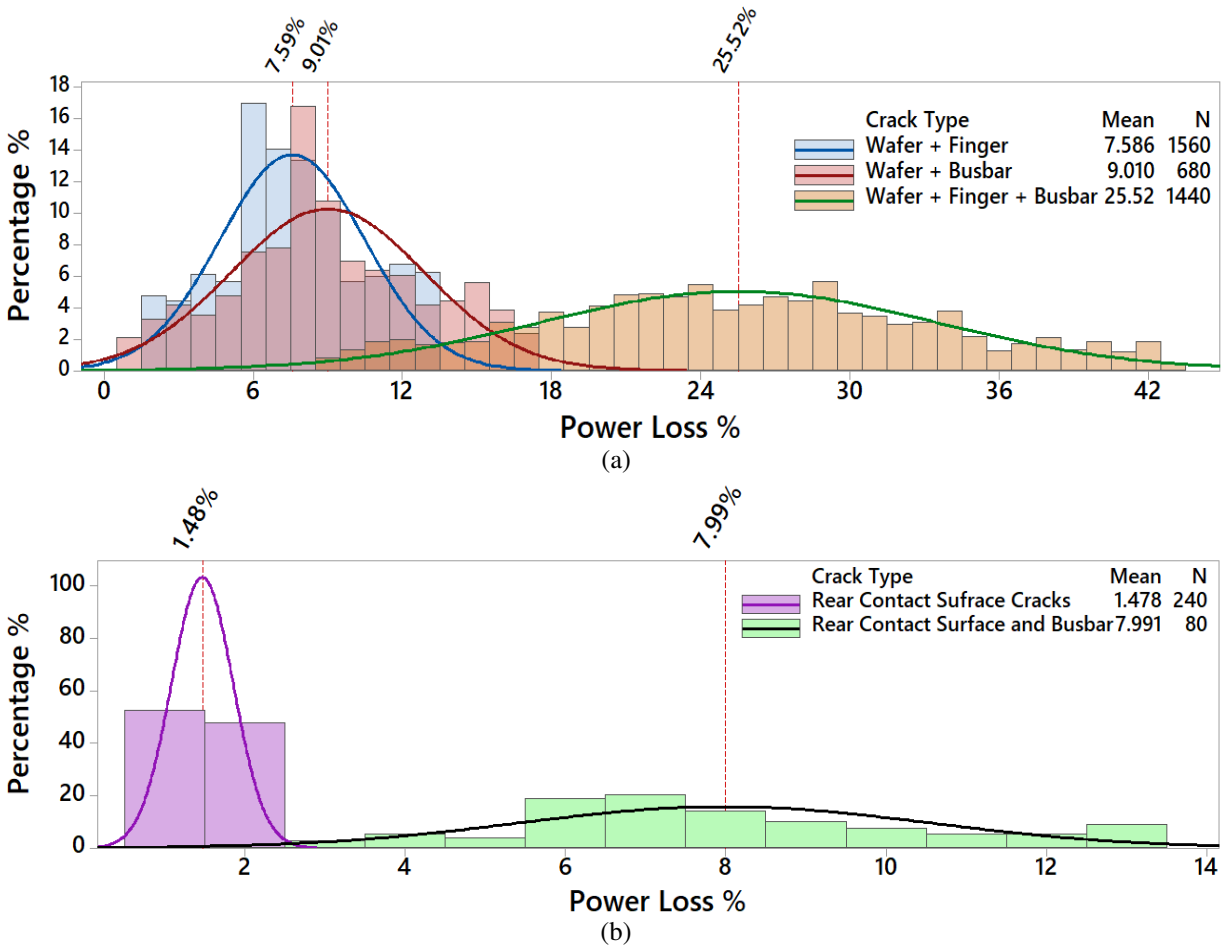
According to Fig. 4(a), the solar cell samples affected by cracks in the front contact have a power loss ranging from:

It is noticeable that front contact micro cracks have the most significant impact on the overall performance of the solar cells because these cracks affects the surface of the junction, ultimately limiting the amount of solar energy to be extracted by the cell. On the other hand, the output power loss for micro cracked rear surface is far less than the front contact, since it is much further away from the junction, whereas the rear busbar plays significant role in driving the solar cell current, therefore, cracks in rear and front busbar have a much higher output power loss.

Fig. 4. Power loss analysis of the cracked solar cell samples. (a) Front contact crack-types, (b) Rear contact crack-types

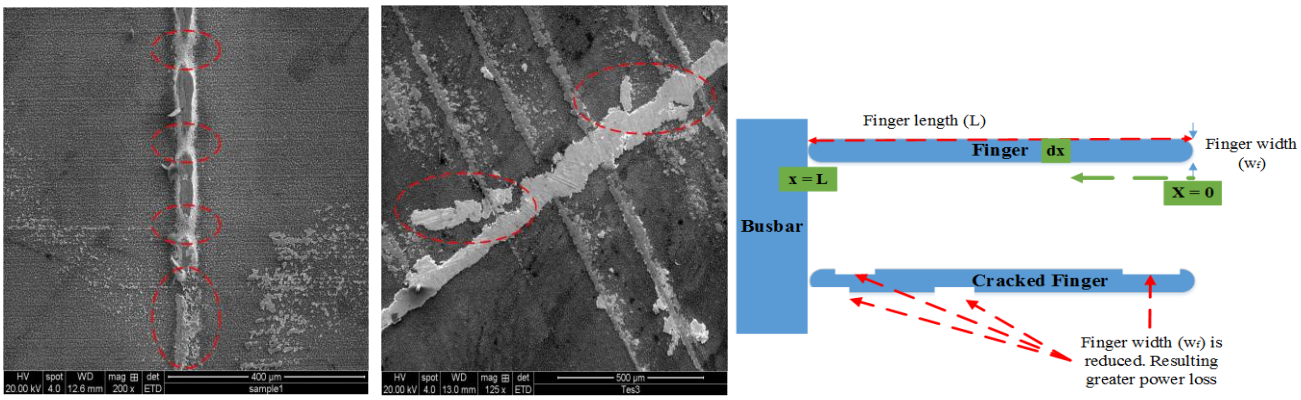
Due to the existence of micro cracks, it was observed that out of all examined samples, almost there are 1500 samples that has a breakdown/cracks in the solar cell fingers, resulting a less forward current generation of the solar cell. Two examples of the micro crack, damage and discontinuity in the solar cell fingers are shown in Figs. 5(a) and 5(b).

There is an increase in the output power loss due to the cracked/damaged fingers. In order to calculate the power loss in a single finger, the integration of the length for the finger starting from 0 to L (shown in Fig. 5(c)) gives the power loss as calculated by (2).

Fig. 5. (a) Cracked – non discontinuity in solar cell finger, sample 1, (b) Cracked – non discontinuity in solar cell finger, sample 2, (c) Illustration on the fingers main parameters, where the width of the cracked finger is reduced resulting a greater power loss

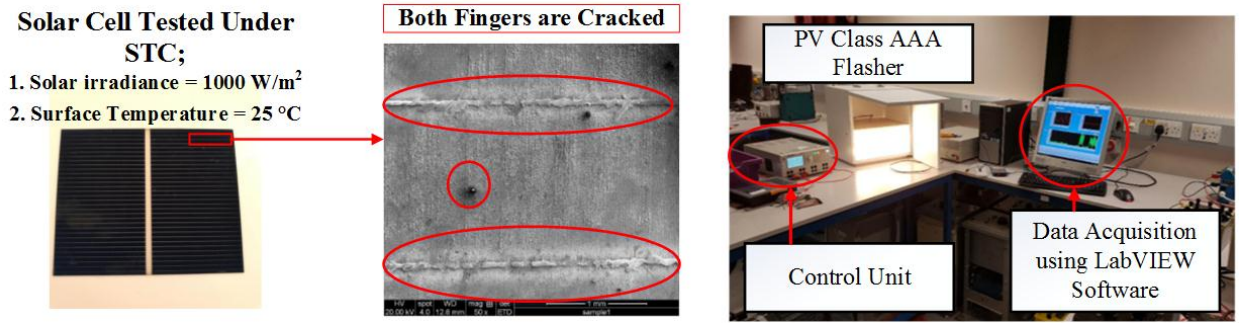
Fig. 6. (a) Cracked solar cell tested under STC, (b) PV Class AAA Flasher setup

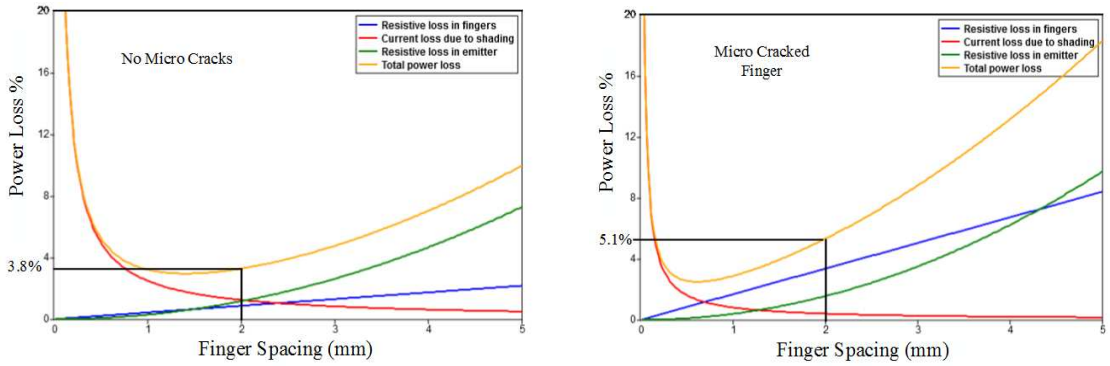
As shown in Figs. 7(a) and 7(b), the measured total power loss for the solar cell finger without the existence of micro cracks is equal to 3.8%, while it is increased to 5.0% for the cracked finger sample. The main reason in the increase of the power loss is due to the decrease in the finger width. Therefore, According to (2), if the width of the finger w_f decrease, the finger power loss will increase. Furthermore, the cracks in the solar cell fingers increase the heat-level of the affected solar cell, because the forward current will be delivered though marginal size of metal (due to the reduction of the finger width size). Consequently, this will create a hot-spot in the finger and will reduce the forward current delivered by the cracked cell. Fig. 6(a) shows a cracked solar cell sample tested under STC conditions, where two fingers are cracked.

Fig. 7. (a) Power loss estimation (~3.8%) for finger without existence of micro cracks, (b) Power loss estimation (~ 42%) for finger including micro cracks

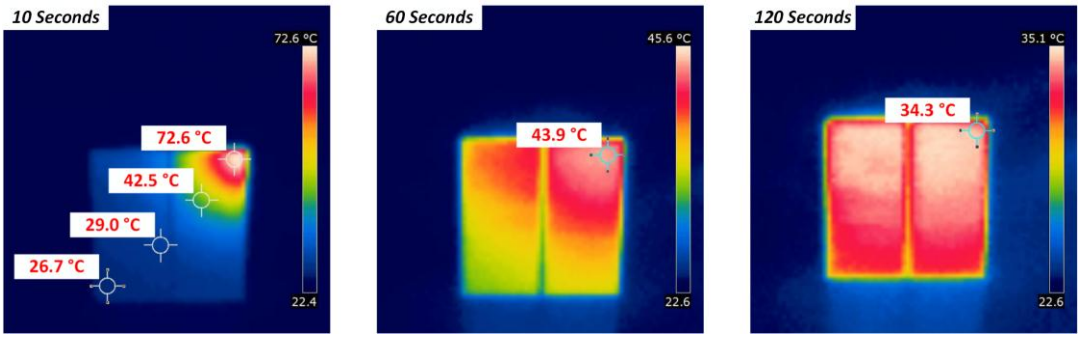
The output heat-map/thermal-image of the solar cell is shown in Fig. 8. By contrast with the results shown in Fig. 8(a), after ten seconds of evaluating the solar cell sample under STC, the temperature of the cracked area raised to 72.6 °C, whereas adjacent regions started to heat-up to a limit of 42.5 °C. Interestingly, due to the expansion of the heat over the whole solar cell, the heat of the cracked area started to decrease due to the flow of the heat over the full cell sample. In Fig. 8(b), thermal image of the solar cell sample is captured after 60 seconds, it is evident that the cracked area has a lower temperature of 43.9 °C, but more area of the solar cell is affected by a rise in the temperature. In addition, according to Fig. 8(c), after 120 seconds (the test sample was still under STC), the solar cell sample almost have an identical temperature level of 34.3 °C, compared to original temperature of 26.7 °C, therefore, the increase of the solar cell temperature due to the existence of the micro cracks is raised by 7.6 °C. It is worth noting that this temperature level remains same after 120 seconds. This result confirms that micro cracks in solar cells cause hot-spots, where the main heat source of the cell is spread from the original cracked area, and it heats up significantly due to the excitation of the electrons through a thinner width of the metal carrying the current either in the fingers or busbars, subsequently an increase in the solar cell temperature will be garneted, as well as an increase in the output power loss would highly be expected.

Fig. 8. Heat-Map distribution of the cracked solar cell shown in Fig. 6, operating under STC, images are captured using FLIR thermal camera. (a) After 10 seconds, (b) After 60 seconds, (c) After 120 seconds – this level of temperature remains steady

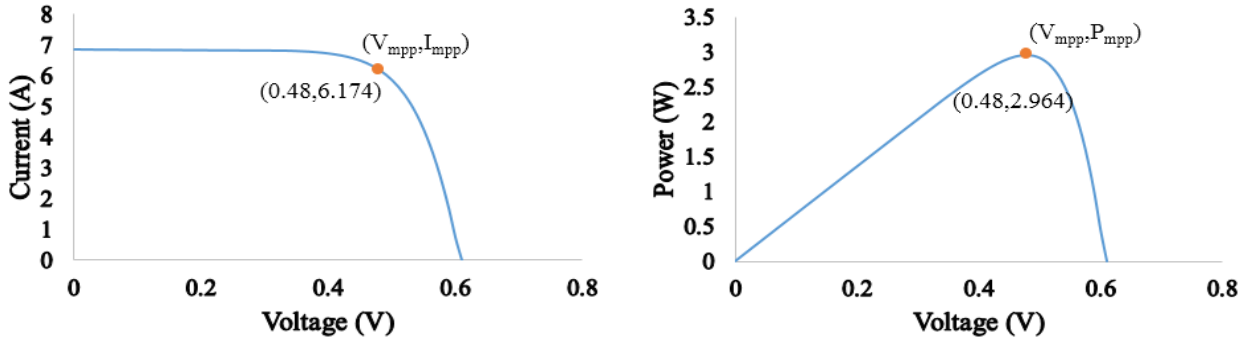
In order to determine the I-V and P-V curves of the solar cell sample under STC, an experiment has been carried out using the class AAA LED flasher shown in Fig. 6(b). The obtained I-V and P-V curves are presented in Fig. 9. Compared to the theoretical predictions (discussed earlier in Table 1), the solar cell sample has almost equal V_{mpp} of 0.48V. However, there is drop in the I_{mpp} by 0.286A; I_{mpp} (theoretical: 6.46A) – I_{mpp} (cracked solar cell: 6.174A). Resulting an output power loss of 4.39%; calculated as follows:

Fig. 9 Obtained I-V & P-V curves of the cracked solar cell sample shown in Fig. 6(a) under STC

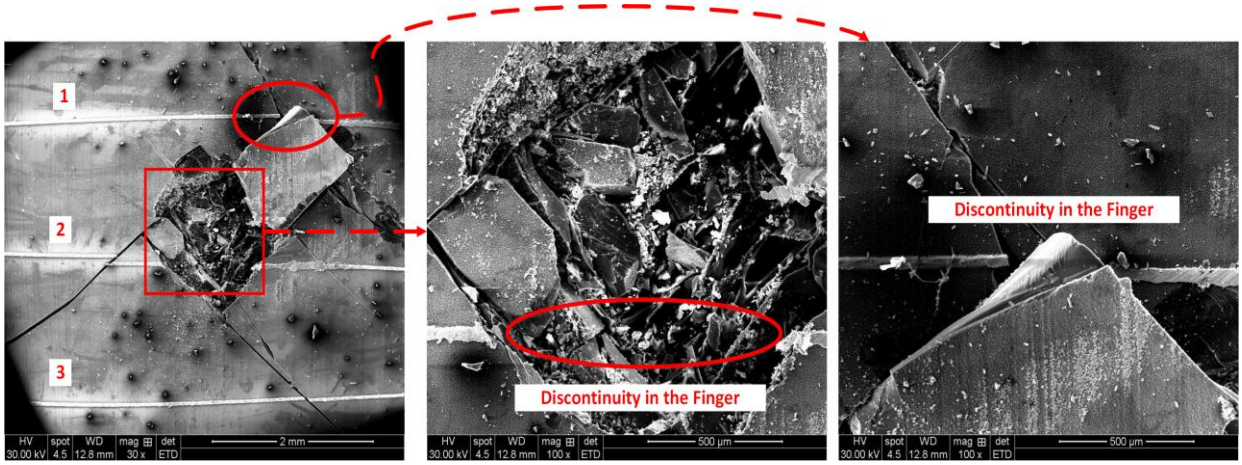
Another example of cracked fingers has been examined, the cracked cell is shown in Fig. 10. The cell is affected by three cracked fingers, where it is evident that there is a discontinuity in the finger connections, this would result an increase in the amount of heat generated by this particular case.

Fig. 10. Micro crack affecting three fingers – there is a discontinuity in the finger connection to the main busbar

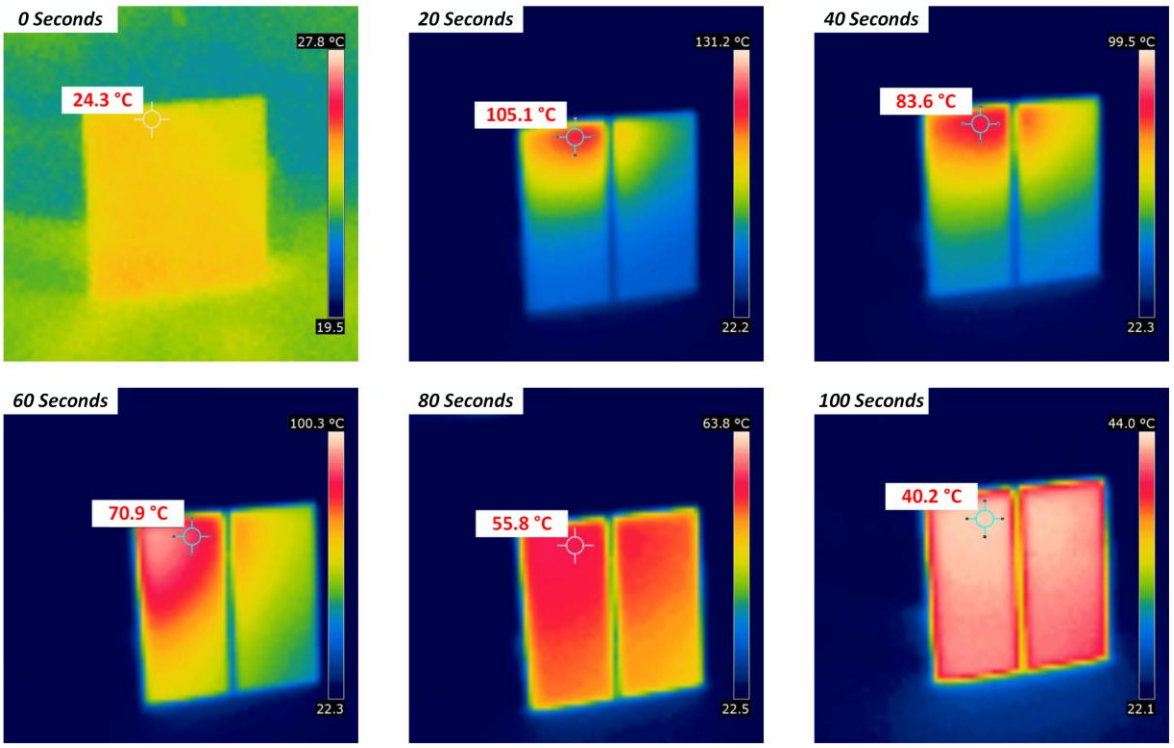
At zero seconds, the temperature of the cell is equal to 24.3 °C. The temperature of the cracked area raised to 105.1 °C after 20 seconds of testing the cell under STC. Ultimately, the heat-level of the cracked would decrease, due to the expansion of the heat over the cell, resulting a temperature levels of:

1) 83.6 °C (40 seconds)
2) 70.9 °C (60 seconds)
3) 55.8 °C (80 seconds)
4) 40.2 °C (100 seconds) - this level of temperature remains consistent

In contrast with the results of the heat-distribution, the solar cell had an increase in the temperature of about 15.9 °C; final temperature level 40.2 °C – original temperature level 24.3 °C. Therefore, this results confirms that micro cracks in solar cells are one of the main cause of PV hot-spotting, as well as, the increase in the size of cracked area, ultimately will increase the heat-level of the hot-spot in the affected solar cell.

Fig. 11. Heat-Map distribution from 0 to 100 seconds of the cracked solar cell shown in Fig. 9; the solar cell is operated under STC

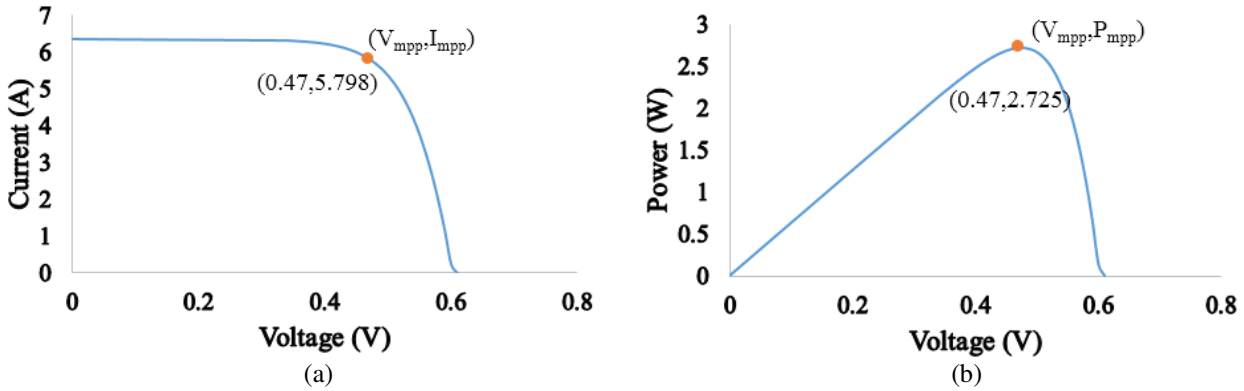
The solar cell sample has been tested under STC. The obtained I-V and P-V curves are presented in Fig. 12. Compared to the theoretical predictions (discussed earlier in Table 1), the sample has almost equal V_{mpp} of 0.47V. However, there is drop in the I_{mpp} by 0.662A. Hence, the output power loss is equal to 12.09%; calculated as follows:

Fig. 12 Obtained I-V & P-V curves of the cracked solar cell sample shown in Fig. 10 under STC

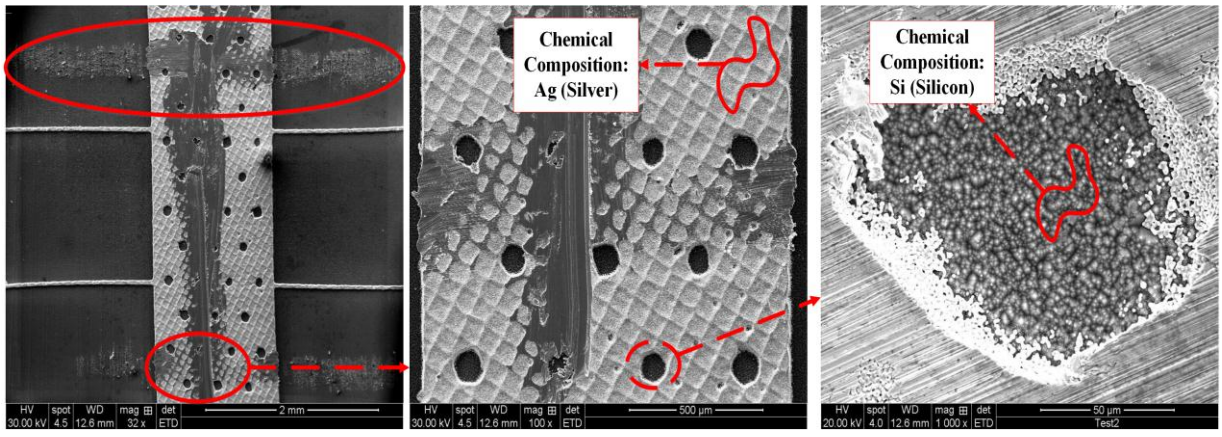
A sample showing a poor adjustment of the busbar metal is shown in Fig. 13. As noticed, there are a number of cracks in the solar wafer, while the busbar contains multiple cracks. The silicon (Si) chemical composition is present instead of original chemical composition of the silver (Ag). This poor busbar structure leads to a second breakdown in the solar cell sample, ultimately causing hot-spot.

The solar cell shown in Fig. 13 has been examined under STC (experimental setup similar to Fig 6). The solar cell has a micro crack as well as poor soldiering in the busbar. It is expected after 10 seconds the heat would increase significantly in the cracked area, and as shown in Fig. 14(a), the temperature of the cracked area increased to abnormal level of 91.4 °C. After 60 seconds, the heat started to expand over the entire solar cell, where the busbar and the cracked area has a temperature of 77.3 °C, as presented in Fig. 14 (b).

Fig. 13. Micro cracks and soldering mismatch in a solar cell busbar

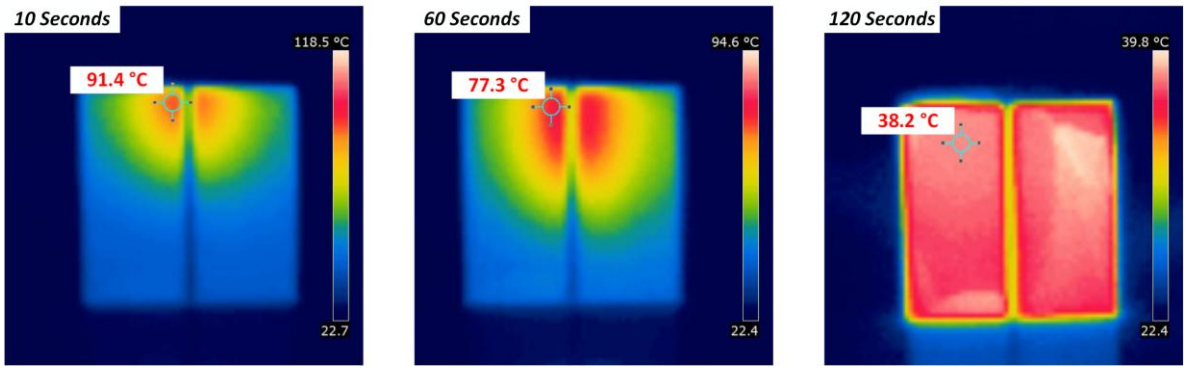
Fig. 14. Heat-Map distribution of the cracked solar cell shown in Fig. 8. (a) After 10 seconds of operating the solar cell under STC, (b) After 60 seconds, (c) After 120 seconds – this level of temperature remains consistent

According to Fig. 14(c), the heat is spread all over the solar cell sample, the temperature is equal to 38.2 °C; this temperature level stays consistent after 120 seconds. Therefore, this experiment proves that cracks in solar cell busbars have a significant impact on the solar cell heat level, ultimately initiating hot-spots.

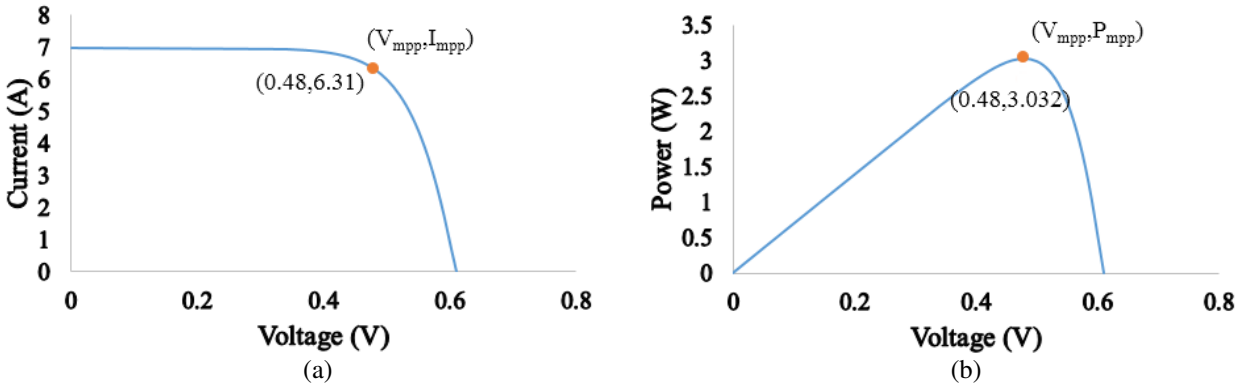
I-V and P-V curves for the solar cell sample have been measured under STC, results are presented in Fig. 15. The measured V_{mpp} of 0.48V is identical with the theoretical predictions (presented earlier in Table 1). However, there is a drop in the maximum output current of 0.15A; I_{mpp} (theoretical: 6.46A) – I_{mpp} (cracked solar cell: 6.31A). Resulting a loss in the output power equals to 2.19%; calculated as follows:

Fig. 15 Obtained I-V & P-V curves of the cracked solar cell sample shown in Fig. 13 under STC

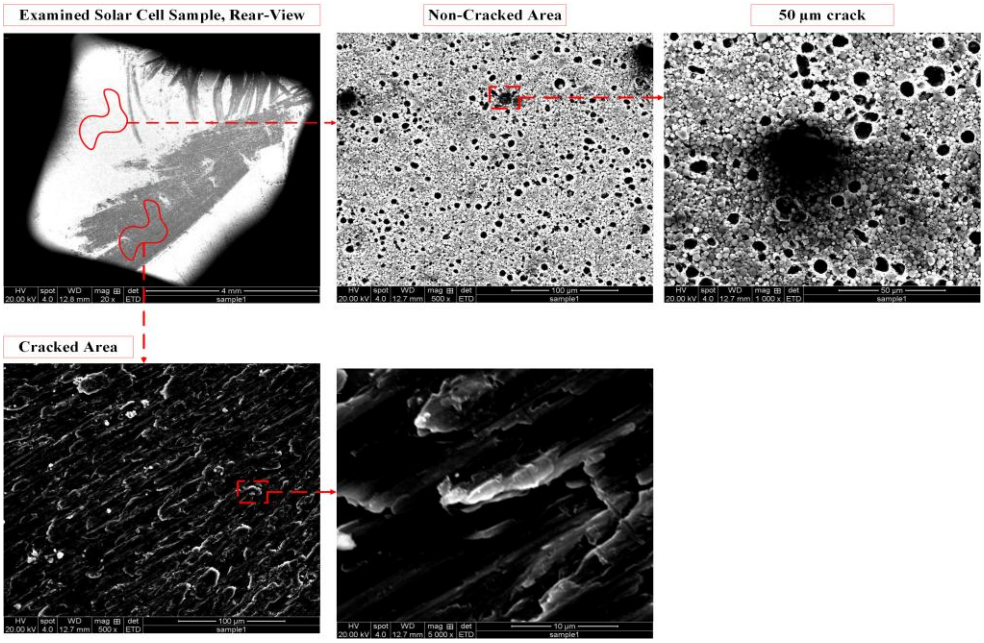
As shown in Fig. 16, the non-cracked area has multiple micro cracks of 50 µm width; nevertheless, it does not have a noteworthy loss to the solar cell rear contact. However, the actual size of cracked rear area varies from 4mm to 300 µm. This damage in the rear contact of solar cell resulting a limited open circuit voltage (V_{oc}), subsequently will reduce the efficiency of the cell. In light of what was observed during the experiments, hot-spotting phenomena has no correlation with the presence of micro cracks in solar cells rear contact surface.

Fig. 16. Micro cracks affecting rear contact of a solar cell

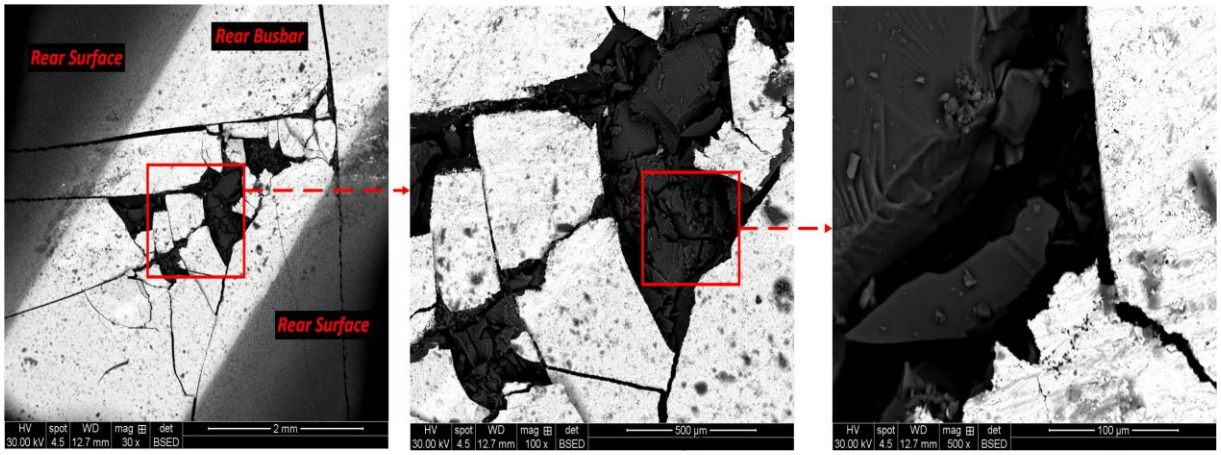
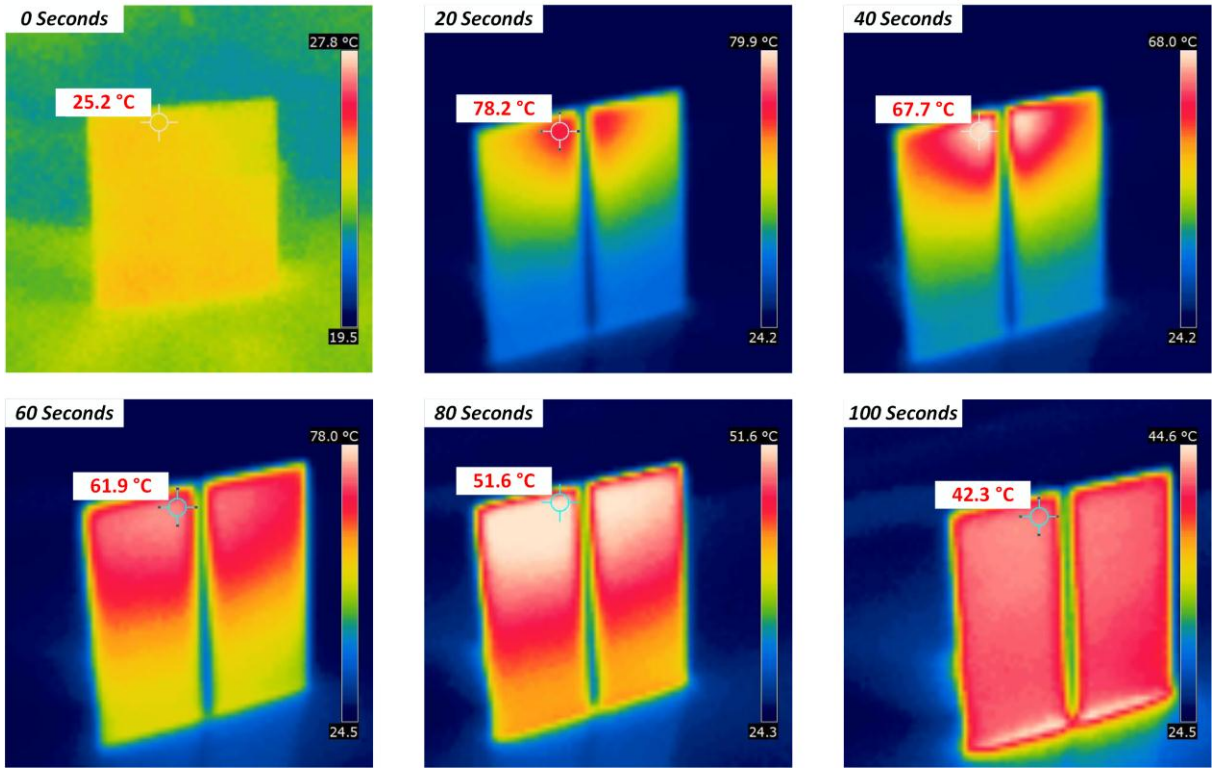
Likewise, Fig. 17(a) shows a rear contact image for a solar cell samples affected by micro cracks in the surface and busbar. The solar cell was tested under STC, while the temperature of the cell has been captured and reported in Fig. 17(b); image is taken from 0 seconds to 100 seconds.

At zero seconds, the temperature of the cell is equal to 25.2 °C. The temperature of the cracked area raised to 78.2 °C after 20 seconds. Eventually, the heat-level of the cracked area will decrease, due to the expansion of the heat over the cell and would result a temperature levels of 67.7 °C (40 seconds); 61.9 °C (60 seconds); 51.6 °C (80 seconds); and 42.3 °C (100 seconds), this level of temperature remains consistent. In light with the results of the heat-distribution, the solar cell had an increase in its temperature of 17.1 °C; final temperature level 42.3 °C – original temperature level 25.2 °C. Therefore, this result shows the impact of micro cracks on the rear contract temperature, while it was evident that there is an abnormal increase in the cell temperature while performing at STC.

Fig. 17. Micro cracks affecting rear contact surface and busbar of a solar cell. (a) Crack affected rear surface and busbar; images magnification of 2mm, 500µm and 100µm, (b) Heat-Map distribution from 0 to 100 while the solar cell is illuminated under STC

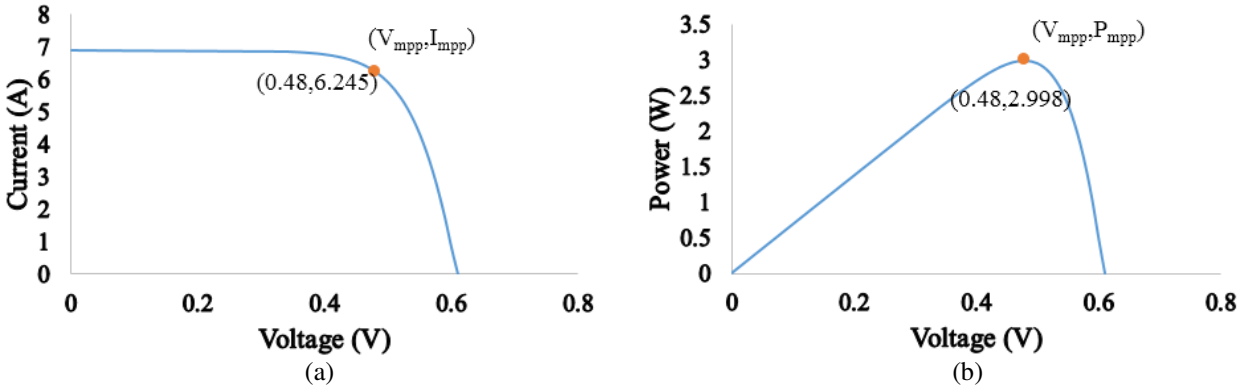
I-V and P-V curves for the solar cell sample have been measured under STC, results are presented in Fig. 18. The measured V_{mpp} of 0.48V is identical with the theoretical predictions (presented earlier in Table 1). However, there is a drop in the maximum output current of 0.215A; I_{mpp} (theoretical: 6.46A) – I_{mpp} (cracked solar cell: 6.245A). Resulting a loss in the output power equals to 3.29%; calculated as follows:

Fig. 18 Obtained I-V & P-V curves of the cracked solar cell sample shown in Fig. 17(a) under STC
