SIMPLIFIED METHODOLOGY FOR TESTING COMMON RAIL PIEZOELECTRIC INJECTORS TAKING INTO ACCOUNT REFERENCE CHARACTERISTICS

Tomasz Stoeck[1*] – Karol Franciszek Abramek[1] – Tomasz Osipowicz[1]

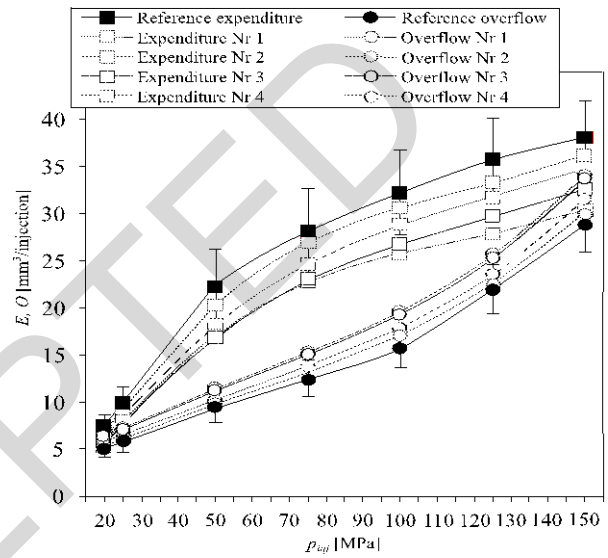
Figure 3. Preliminary characteristics: $E=f(p_{inj})$, $O=f(p_{inj})$

Analyzing the individual curves it can be seen that the admissible ranges were exceeded for injectors No. 1 and No. 3. However, their course, despite the observed deviations, remains close to the reference characteristics. This does not indicate the occurrence of more serious defects in the control and executive units, although at this stage of research it cannot be ruled out that the cooperation of precision pairs will worsen. It is also worth emphasizing that the reduction of expenditures and the simultaneous increase in the intensity of overflows were observed in the entire examined area, and their intensification became particularly noticeable at injection pressures of p_{wtr}=100÷150MPa. This may indicate a reduced dynamic of the work of individual actuators, which transfers to a change in the dosage method and excess flow [17]. The most likely cause of such a phenomenon is the presence of internal IDID deposits (*Internal Diesel Injector Deposit*) [18]. This has an adverse effect on the slowdown of the clipping time, mainly due to the delayed reaction of the needle to the electric impulse [19]. In addition, during the operation,

the process of gradual coking of the nozzle tip [20] takes place, which additionally changes the geometry of the outlet holes (nozzles) [21]. As a result, there is a diversification of the amount of fuel injected into the engine cylinders [22].

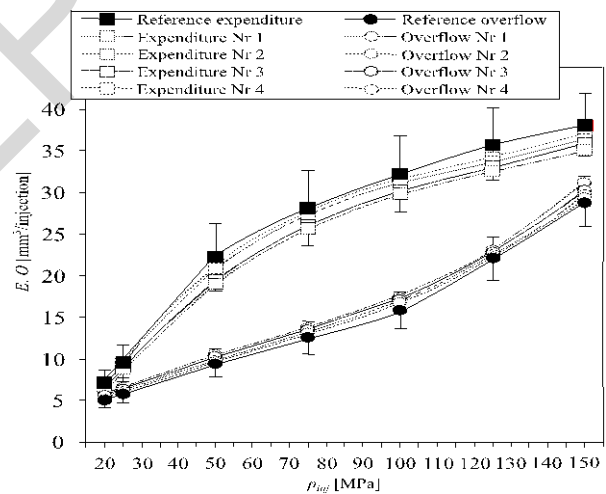
Figure 4. Basic characteristics: $E=f(p_{inj})$, $O=f(p_{inj})$

In none of the considered measurement and calculation points, exceeded limit values were found. In addition, the course and shape of the plotted characteristics is very comparable. It should be concluded, therefore, that the malfunction was due only to the presence of impurities and persistent deposits that were removed during the thermo-chemical washing on the test bench. In such cases, it is suggested to replace the fuel filter, as well as rinsing the tank and the entire supply system in the vehicle [23]. In extreme cases, primarily related to the presence of metal filings, it may be necessary to replace all fuel distribution elements [24].This guarantees the correct operation of the injectors during further operation on the engine, provided that the dates of periodic servicing and the use of high quality diesel oils are met.

After cleaning the injectors, baseline tests were performed. The results obtained are summarized in Tables 4 and 5 and their graphical representation in Figure 4.
