Design of load-to-failure tests of high-voltage insulation breaks for ITER's cryogenic network

S.A.E.Langeslag[1], **E.Rodriguez Castro**[1,2], **I.Aviles Santillana**[1,3], **S.Sgobba**[1], **A.Foussat**[4]

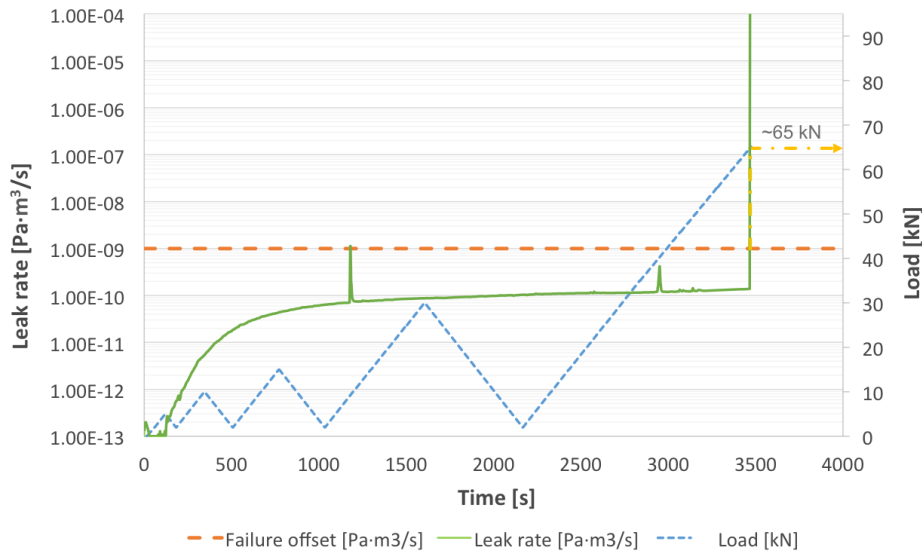
In both cases, during the fifth load cycle, up to 85 kN, a very sudden rise in leak rate is observed, passing rapidly beyond the imposed failure level. The cycle was immediately interrupted at the recorded sample breakdown to avoid any damage to the mass spectrometer pump. The load at which failure is noted is ∼65 kN and ∼71 kN, for IB30kV1 and IB30kV2, respectively. These values exceed by far the expected performance of such cryogenic insulation breaks, which lies a factor ten below.

Primarily at the onset of the measurement, some noise is observed in the leak rate for both sample IB30kV1 and IB30kV2. An assumption is made that the observed spikes in the leak rate curve appear as a result of internal pollution inside the IB, present prior to testing. Samples have not been specifically prepared for vacuum application, and can therefore contain some particles which can interfere with the leak rate reading of the mass spectrometer pump. For future application of the test procedure a preparation as such may be beneficial.

Figure 6: Diagram showing the leak rate and applied load over time for the primary load-to-failure test of <u>IB30kV1</u> at 77 K, measured following the presented loading procedure. Breakdown was recorded at $\sim$ 65 kN.

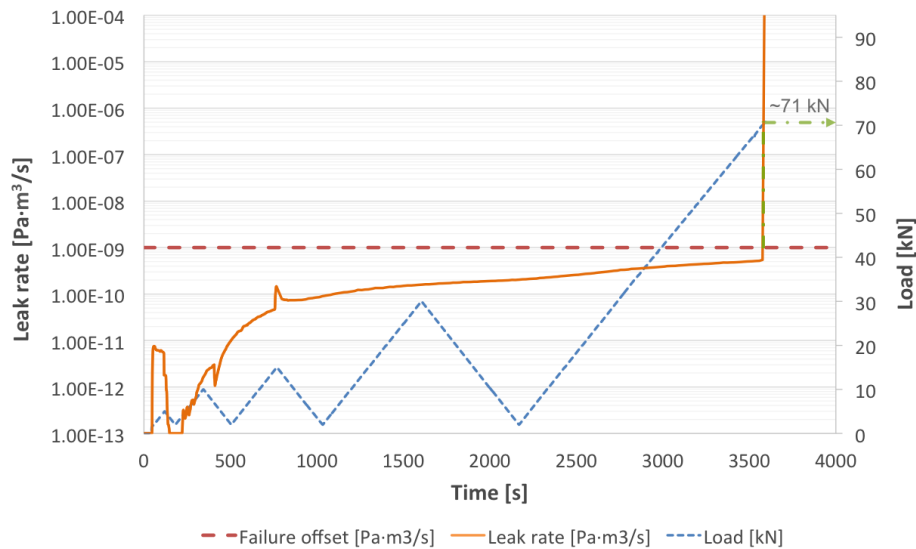
Figure 7: Diagram showing the leak rate and applied load over time for the primary load-to-failure test of <u>IB30kV2</u> at 77 K, measured following the presented loading procedure. Breakdown was recorded at $\sim$ 71 kN.

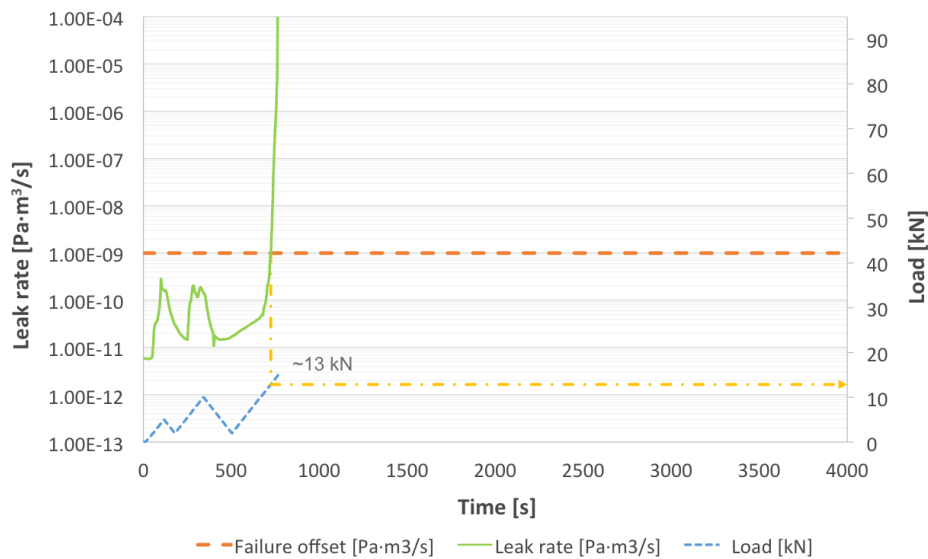
An additional test was performed, following the load-to-failure test, aimed at confirming breakdown and discriminating between reversible and irreversible defects. The leak rate over time, versus the applied load cycles for this secondary test, presented in figure 8 shows a leak rate directly related to the applied load. The leak rate changes abruptly with load, demonstrating a partially reversible feature of the induced defect during the primary test. The imposed failure level is now however exceeded at a significantly lower load, i.e. at $\sim$13 kN, at which the permanent leak becomes apparent.

Figure 8: Diagram demonstrating leak rate and applied load over time for the secondary test of IB30kV1 at 77 K. At low applied loads one can note a reversible feature of the leak introduced during the primary test.
