Top-down cracking in Italian motorway pavements: A case study

Lorenzo Paolo Ingrassia[a,*], Paolo Spinelli[b], Giulio Paoloni[b], Francesco Canestrari[a]

[a] Università Politecnica delle Marche, Via Brecce Bianche, 60131, Ancona, Italy
[b] Autostrade per l'Italia, Via A. Bergamini 50, 00159, Roma, Italy

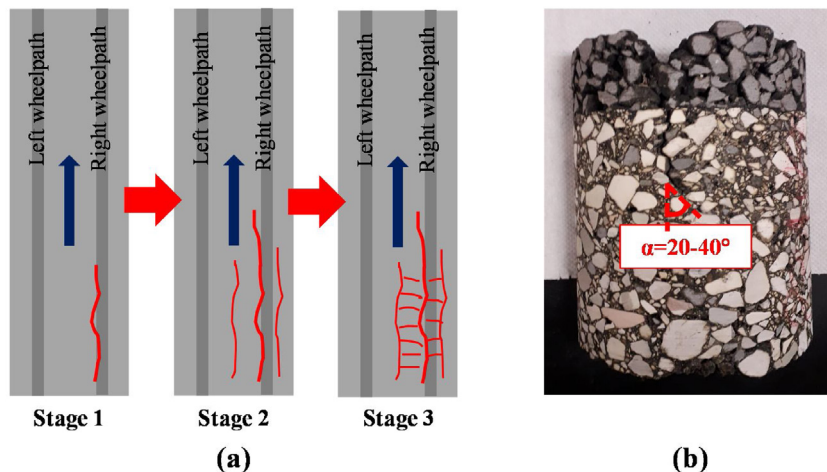
In general, TDC evolves on the pavement surface in three stages [10–13], as schematized in Fig. 1a. Initially, it typically appears on the pavement as a single crack close to the wheelpath. Afterwards, so-called "sister cracks", i.e. new longitudinal cracks parallel to the initial one, appear at a distance of about 0.3–1.0 m. In the third stage, the longitudinal cracks may be connected by short transverse cracks, leading to a cracking pattern that is very similar to that of bottom-up cracking. As for the evolution of TDC along the pavement thickness, the cracks evolve vertically until a certain depth, then they tend to form angles of $20-40°$ with respect to the vertical plane towards the center of the wheelpath, according to the orientation of the principal stress plane [14], as shown in Fig. 1b.

Fig. 1. Evolution of TDC: (a) three-stage evolution on the pavement surface (scheme), (b) evolution with depth (extracted core).

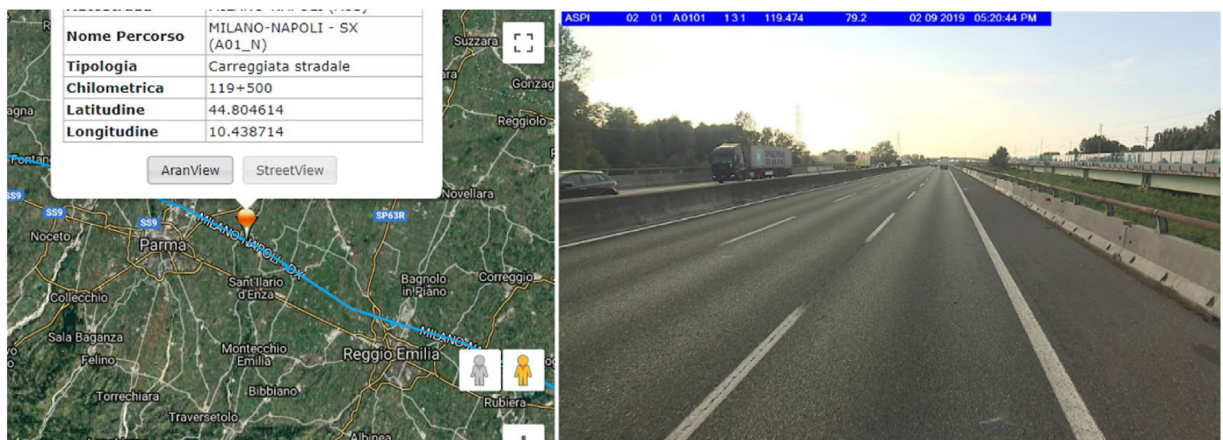
**Fig. 2.** Example of ARAN View output from Autostrade Google Earth software.

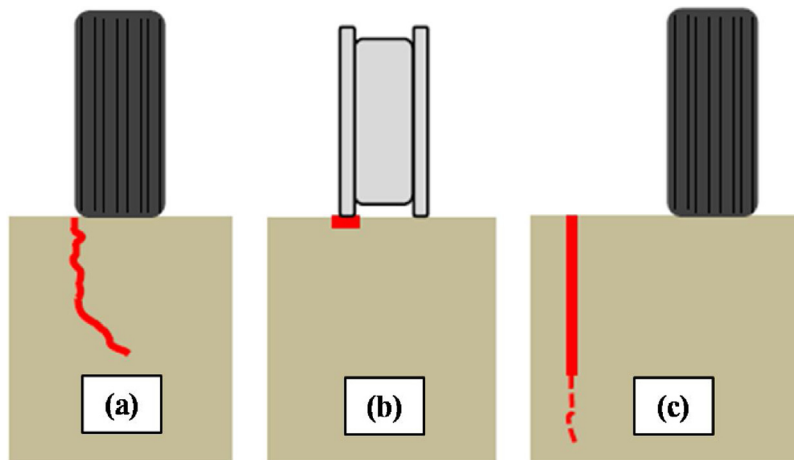
From the visual analysis of the images and the extraction of some control cores from the cracked areas, three types of longitudinal cracks were observed on the trial network, as schematized in Fig. 3: TDC, cracks due to heavy vehicles tire blowout and cracks related to construction joints. It should be noted that in this study (which is part of a larger project focused on TDC) the control cores were just visually examined with the aim of distinguishing the different types of longitudinal cracks. Further cores were taken afterwards to be subjected to an in-depth characterization in a subsequent phase of the project, as better explained in Section 5.

Fig. 3. Types of longitudinal cracks observed on the trial network (scheme): (a) TDC, (b) crack due to tire blowout, (c) construction joint.

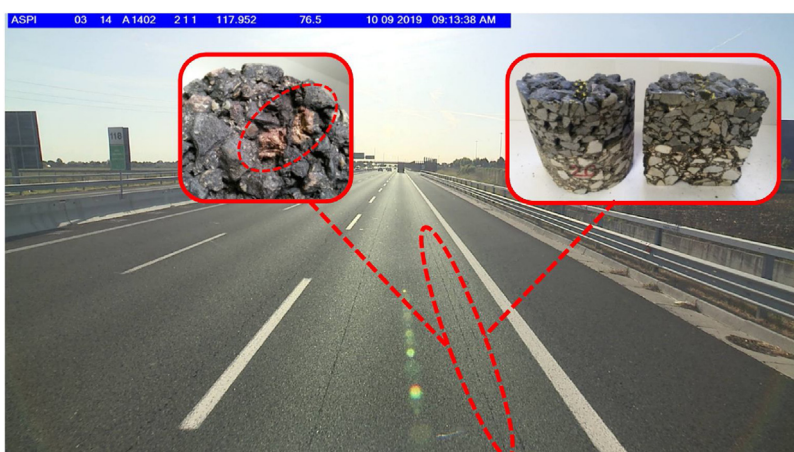
Fig. 4 shows an example of TDC, confirmed by the extraction of a core presenting a crack initiated at the pavement surface and propagated downwards. As can be seen from the figure, in order to better analyse the crack, the core was cut vertically perpendicular to the wheelpath direction.

An example of a crack due to tire blowout is shown in Fig. 5 together with the corresponding cores. It can be observed that the cores do not exhibit any crack along the pavement thickness but only an incision on the surface, accompanied by scratched aggregates.

Fig. 4. Example of TDC.

Fig. 5. Example of crack due to tire blowout.

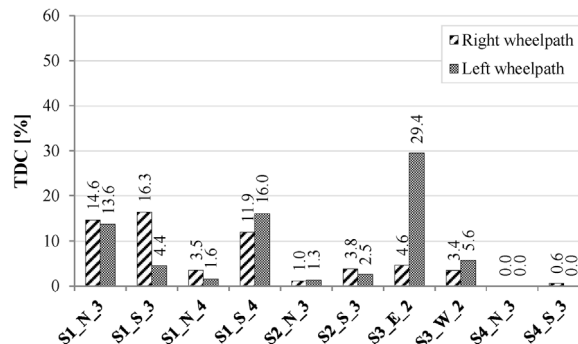
Fig. 8 shows that there is no well-defined trend, as the distress is more concentrated along the right wheelpath in some cases and along the left wheelpath in other cases. Once again, it is worth noting that these results are affected by the numerous recent patches observed on the network (which make the previous TDC position unknown) and it cannot be excluded that a more evident trend existed before patching. However, inertial effects in curve can be considered negligible due to the high minimum planimetric radius for the sections examined (equal to 339 m), which makes a statistical analysis related to the planimetric characteristics pointless. Therefore, it can be reasonably concluded that the distribution of the distress is random, likely determined by the local pavement/mixture characteristics.

**Fig. 8.** TDC amount along the right and left wheelpaths.

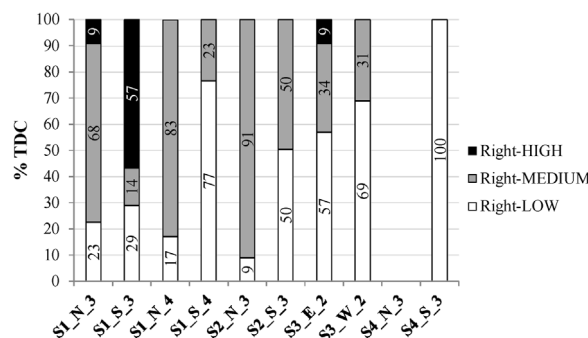
Fig. 9. TDC severity, right wheelpath.

Figs. 9 and 10 show that, in most cases, TDC severity was low (single longitudinal crack with limited width) or medium (single longitudinal crack with considerable width or sister cracks). For instance, as regards the high TDC concentration along the left wheelpath for section S3_E_2 (almost 30 %), 95 % of the distress presented low severity. High severity level (longitudinal cracks connected by transverse cracks) was basically found only on the older pavement portions of section S1 (the one with the most significant heavy traffic level). The prevalence of low severity distress is attributable to the frequent surface maintenance carried out on the motorway network.

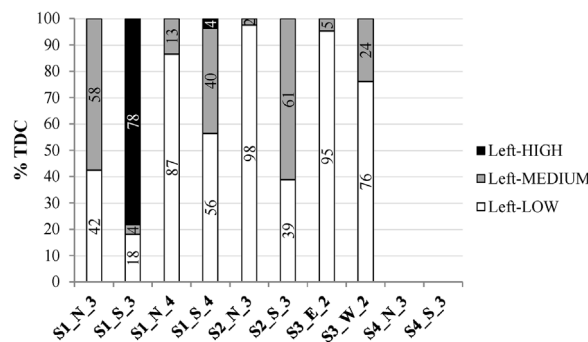
Fig. 10. TDC severity, left wheelpath.

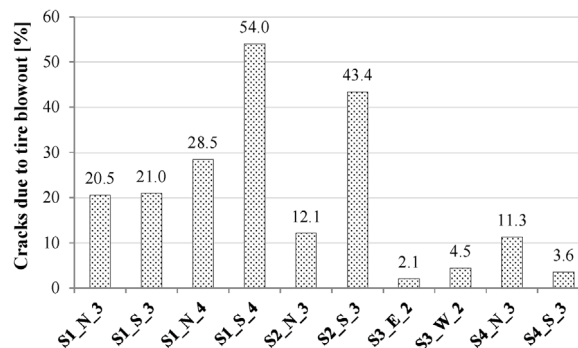
Where l_{TBC} is the cumulated length of cracks due to tire blowout on the slow traffic lane and l_0 is the length of the analysed section. As can be noted from the comparison between Fig. 11 and Fig. 7, surprisingly the concentration of cracks due to heavy vehicles tire blowout was even higher than TDC (in some cases, up to 40–50 %). This finding highlights once again the importance of defining specific identification criteria which allow to distinguish between TDC and other types of longitudinal cracks in the perspective of pavement maintenance/rehabilitation (i.e. in a PMS).

Fig. 11. Amount of cracks due to tire blowout.
