ANALYSIS OF THE DAMAGE STATE OF A MONUMENTAL BUILDING BY CONSIDERING THE VARIATIONS IN SOIL CONDITIONS

ECCOMAS Proceedia

Lenticchia E.[1,2]**, Miraglia G.** [1,2]**, Coccimiglio S.** [1] **and Ceravolo R.** [1,2]

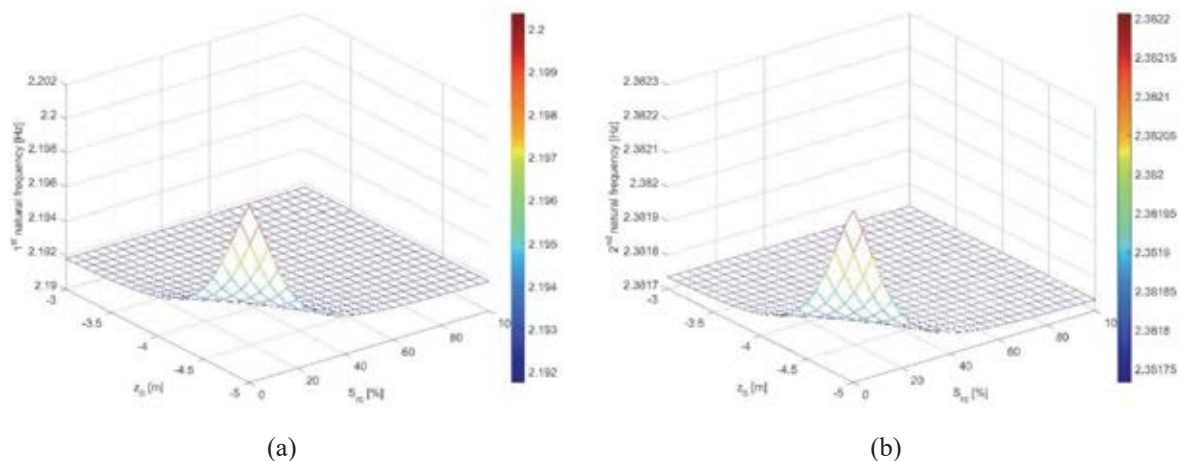
Figure 4 shows the variation of the first two natural frequencies of the model as a function of z_0 and S_{rc}. The figure demonstrates as a sudden decrease in frequency is detected when the soil saturation increases (decrease of water table depth or increase of S_{rc}). Extremely dry condition of the soil, such those one caused by extreme warm seasons, will thus result in an increase of natural frequency. The absolute variations are however very low and without intelligent feature extractions the effect of the alteration of the third soil layer in the "Chiarugi" pavilion could be confused with other Environmental and Operational Variations (EOVs).

Figure 4: (a) First natural frequency of the calibrated FE model as a function of the degree of saturation of superficial layers S_{rc} and the water table depth z_0. (b) second natural frequency of the calibrated FE model.

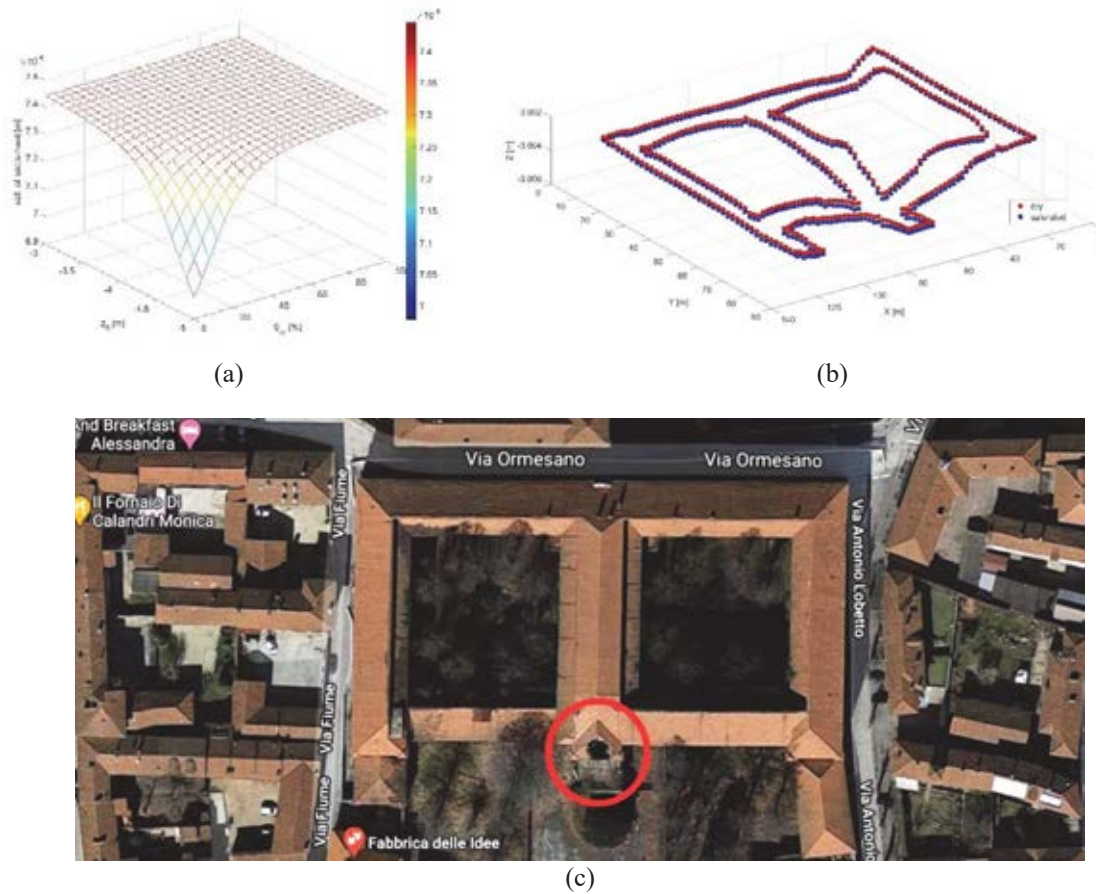
Figure 5 reports the results of the static analysis. In Figure 5a, the standard deviation of the foundation settlements is reported. From the figure, it is also clear that an increase of the saturation in the soil produces an increase of the standard deviation of the settlements. Figure 5b, instead, depicts the settlement profiles at the foundation's depth in case of dry (z_0=5 m and S_{rc}=0) and saturated (z_0=3 m and S_{rc}=1) conditions of the third layer. Comparing Figure 5b with Figure 5c (which depicts the actual condition of the building), it is possible to note how the corroboration of the FE model with the experimental data gathered during the geotechnical campaign can positively produce fitting results since the maximum depression zone foreseen by the model coincides with the area below the collapsed portion of the structure.

Figure 5: (a) Standard deviation of the foundation settlements as a function of the degree of saturation of superficial layers S_{rc} and the water table depth z_0. (b) foundation settlements for the dry (red) and saturated (blue) condition of the 3rd soil layer. (c) Google Maps picture of the structure (lat. 44.765470, long. 7.678842) on March 3rd, 2021 with highlighted (see the red circle) the collapsed portion of the building https://www.google.it/maps.

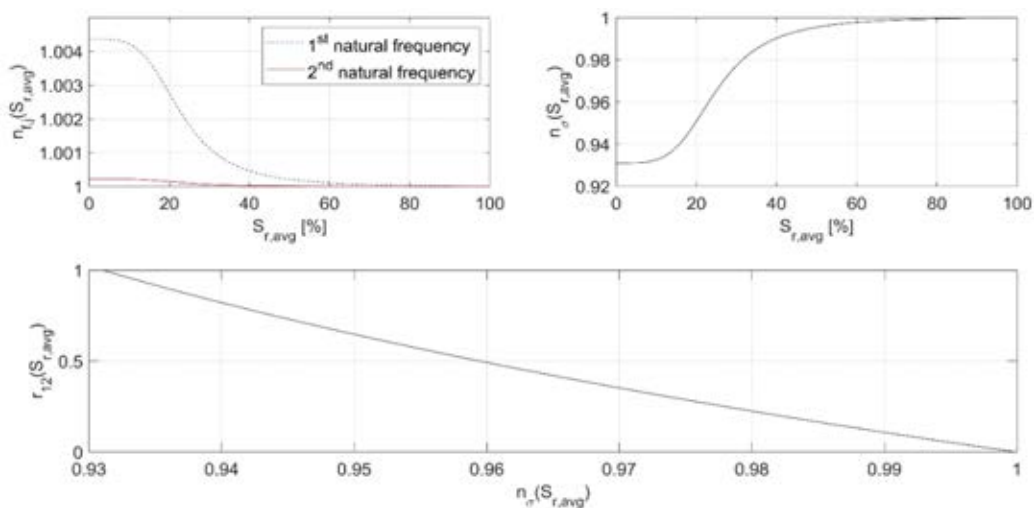
Figure 6: Results in terms of normalized values.

The results of the study are presented in Figure 6 in a normalized scale. In Figure 6, the following quantities are depicted:

with j=1,2; f_j j-th natural frequency; $f_{j,s}$ j-th natural frequency at saturation; $f_{1,d}$ and $f_{2,d}$ 1[st] and 2[nd] natural frequency in dry conditions; σ_c, standard deviation of the foundation settlements; $\sigma_{c,s}$, standard deviation of the foundation settlements at saturation, while $n_{f,j}$, n_σ, and r_{12} are the j-th natural frequency normalized to the saturated value, the standard deviation of the foundation settlements normalized to the saturated values, and the difference between $n_{f,1}$ and $n_{f,2}$ normalized to the difference between the values taken in $S_{r,avg} = 0$. From Figure 6a, the relative variation of the first two natural frequencies demonstrates as the main variations are detected for the first mode and are in the order of 0.4%. On the other hand, Figure 6b depicts a relative variation of the standard deviation of the settlements of about 6%. Despite the fact that these variations are not worrying for the immediate stability of the building, their cyclic nature can determine damage accumulation in the superimposed structure, bringing in time to brittle collapses such as those occurred in the South façade of the "Chiarugi" pavilion. It is worth stressing that data and parameters extracted from real dynamic monitoring systems would be affected by several EOVs (such as the temperature effect) that could hide variations due to soil conditions. Commonly these EOVs, acting on the whole system, do not affect only the first natural frequency. Thus instead of focusing the attention on the variation of single frequencies, intelligent algorithms could be applied to the relative variations of these parameters (see, for example [18]). In these terms, Figure 6c conceptually shows as the normalized difference of the normalized frequencies can provide a correlation to the static response that is more amplified.
