MINIMIZATION OF DEFECTS IN ALUMINIUM

ALLOY CASTINGS USING SQC

Bachelor of Technology

2013

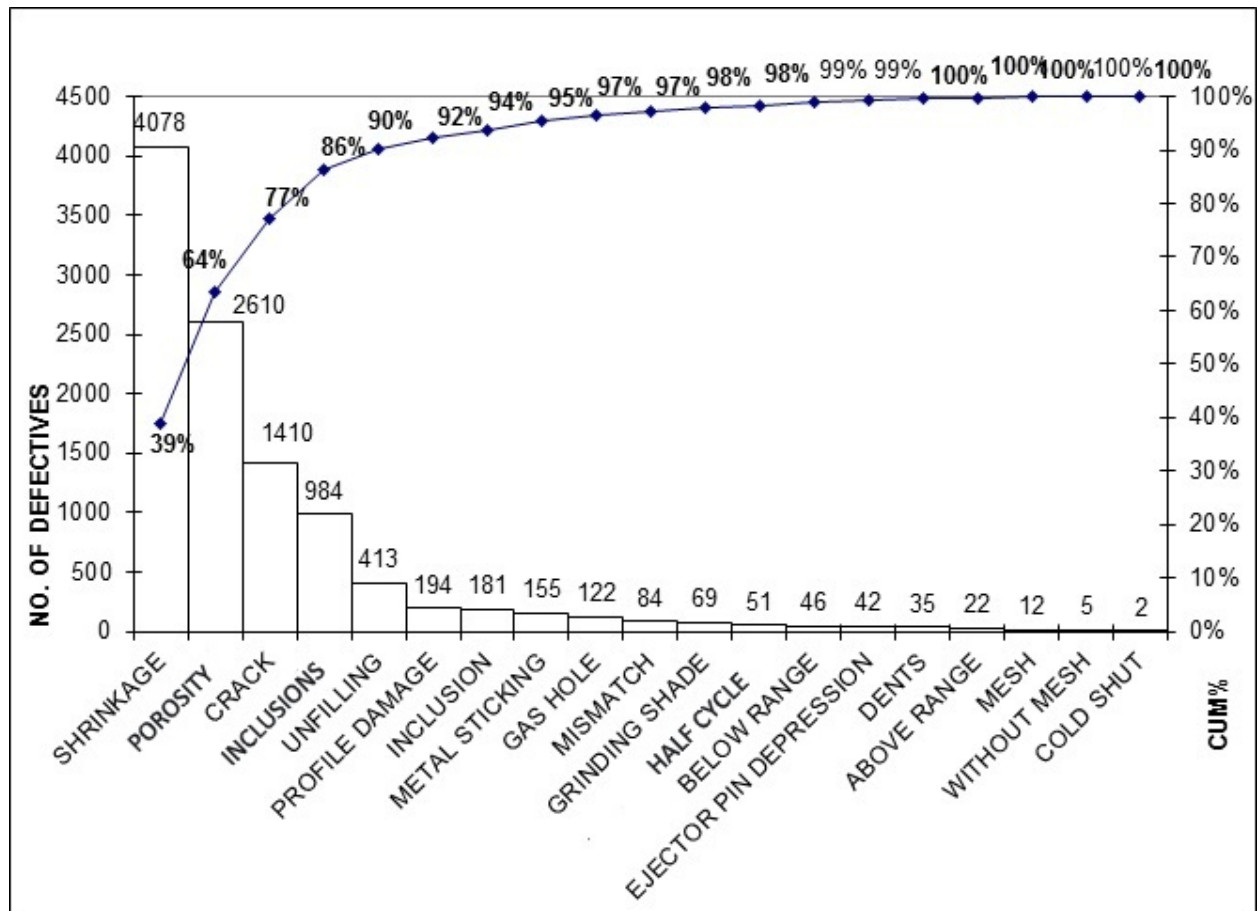
Figure 4.1. Pareto chart of rejections of Al alloy wheels for one year

Using pareto chart shown in Figure 4.1, we can conclude that the major causes for the rejections in Al alloy wheel castings were due to 1) Shrinkages 2) Air leak 3) Crack 4) Inclusions etc. [4].

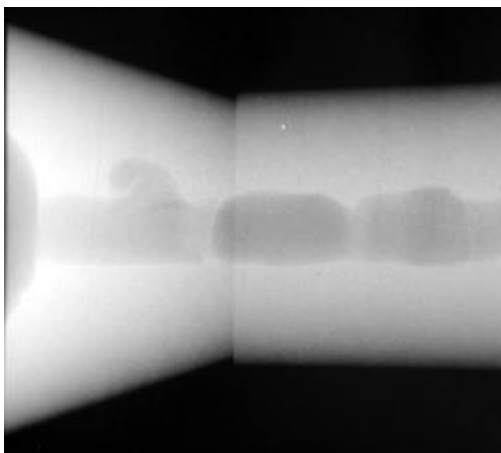
Figure 4.2. Shrinkage cavity [5]

- It appears in areas with distinct jagged boundaries.

- When metal solidifies between two original streams of melt coming from opposite directions to join a common front, cavity shrinkage occurs as shown in Figure 4.2.

- It usually occurs at a time when the melt has almost reached solidification temperature and there is no source of supplementary liquid to feed possible cavities.

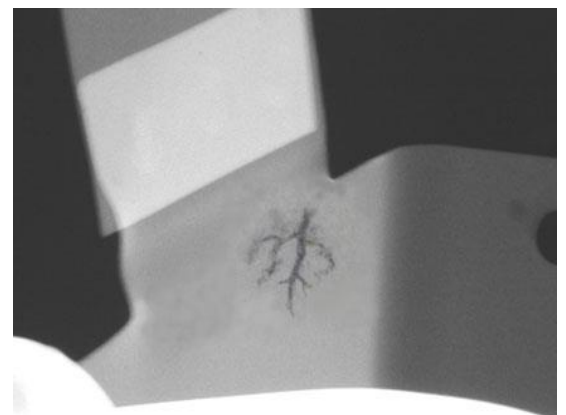
Figure 4.3. Dendritic shrinkage [5]

This type of shrinkage can be identified by seeing distribution of very fine lines or small elongated cavities that may differ in density and are usually unconnected as shown in Figure 4.3.

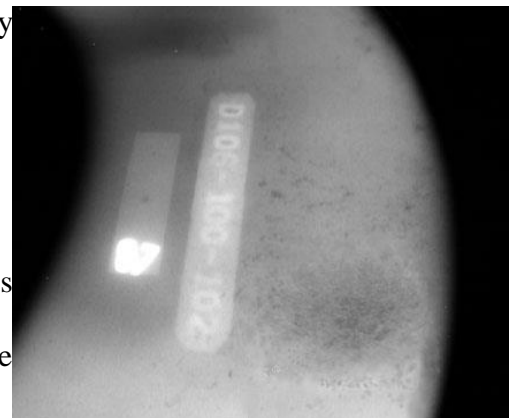
Figure 4.4. Sponge shrinkage [5]

- Sponge shrinkage can be identified from areas of lacy texture with diffuse outlines as shown in Figure 4.4.

- It may be dendritic or filamentary shrinkage.

Filamentary sponge shrinkage appears   more blurred as it is projected through the relatively thick coating between the discontinuities and the film surface.

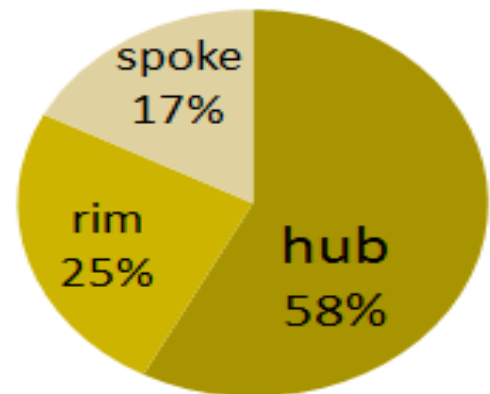
Figure 4.7. Pie chart for shrinkages

Data has been collected using check sheets shown in Table 4.2. The no of rejections due to various shrinkages have been noted and is shown in pie charts shown in Figure 4.7.

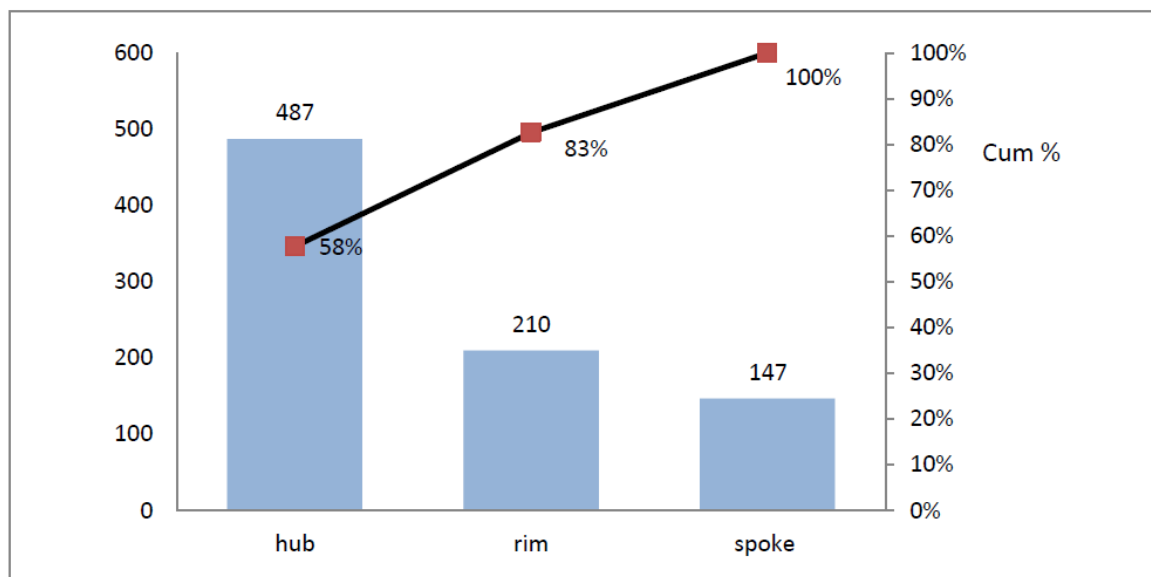
Figure 4.8. Histogram for shrinkage defects

Using histogram as shown in Figure 4.8. It was noted that the hub shrinkages were more compared to rim and spoke shrinkages.

Hub part is the last solidified part of the wheel. Most of the shrinkages occur in the hub region due to the lack of feeding during the solidification.

Hub Shrinkage: It is because of in sufficient feeding of molten metal.

Spoke Shrinkage: It is because of formation of hot spot in the junction, where greater volume of liquid metal will flow. It may be external or internal.

Rim Shrinkage: It happens in rim flange area which is the farthest from the gate. It also occurs when rim thickness is less.

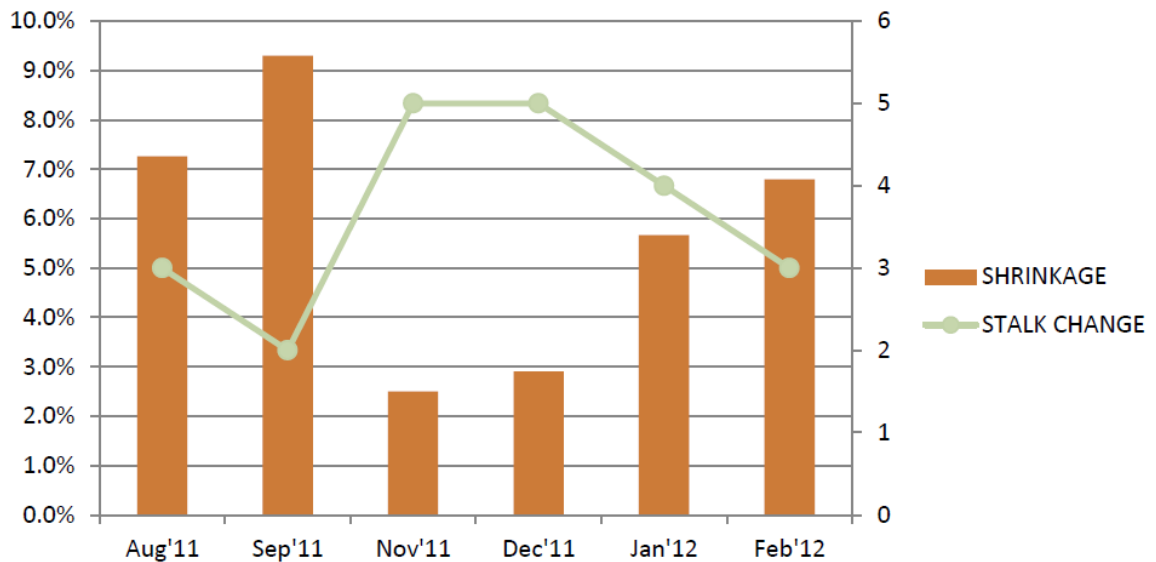
Figure 4.10. Histogram for stalk change & shrinkages

Observation: The shrinkage % and the stalk changing frequency were collected. Both are related using histogram as shown in Figure 4.10.

With the use of histograms as shown in Figure 4.10, it was noted that the shrinkage % decreases with the increase in stalk change frequency.

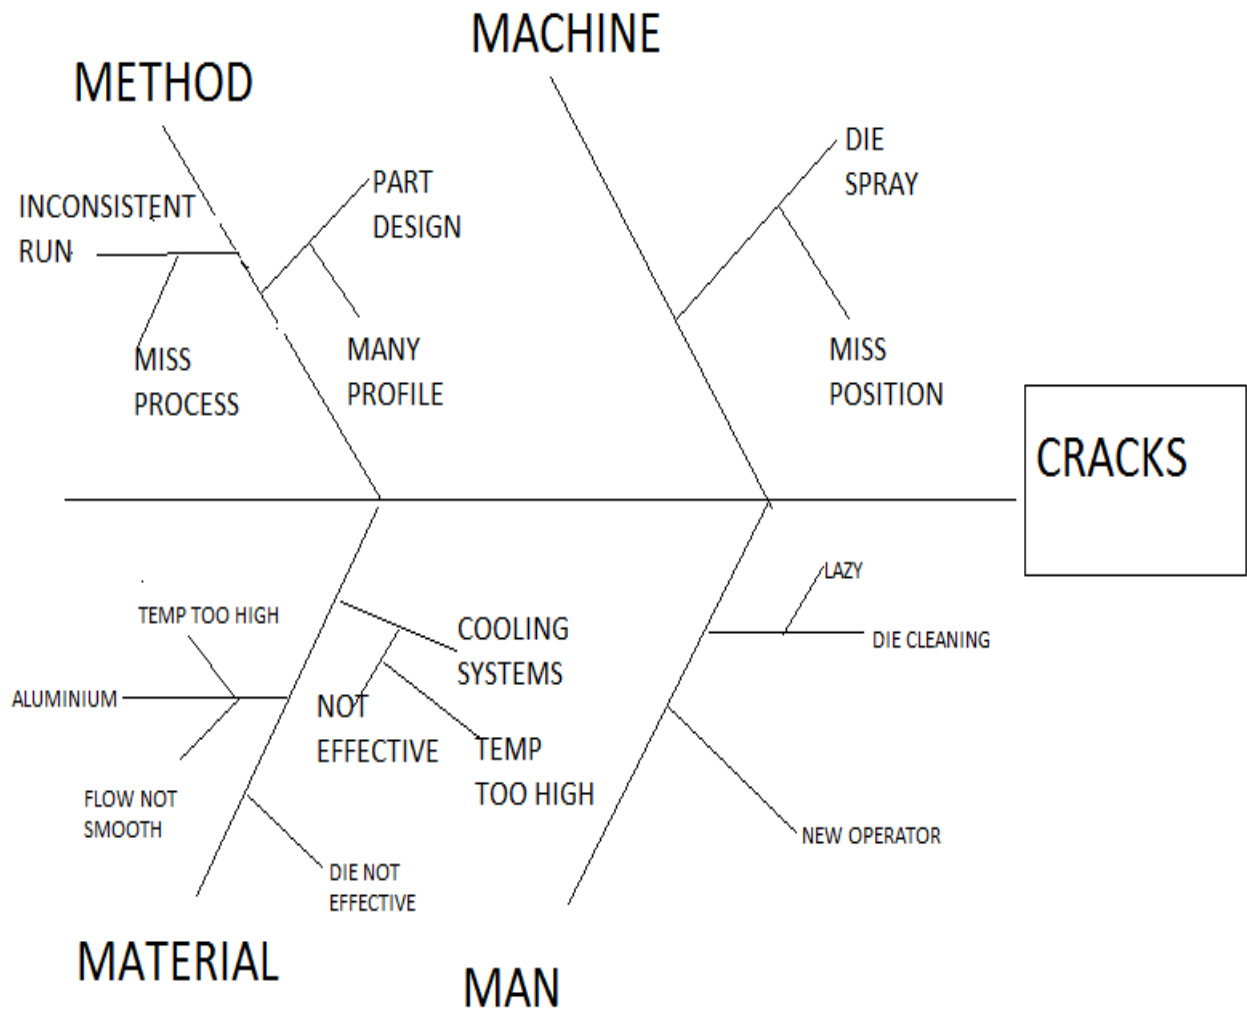
Figure 4.13. Cause effect diagram for cracks

Cracks mostly occur in hub region of the wheel it may internal or external. These are irregular shape cracks formed when the metal pulls itself apart while cooling in the mould or after removal from the mould.

❖ Cause effect diagram for cracks has been drawn and the causes for the cracks have been studied as shown in Figure 4.13.

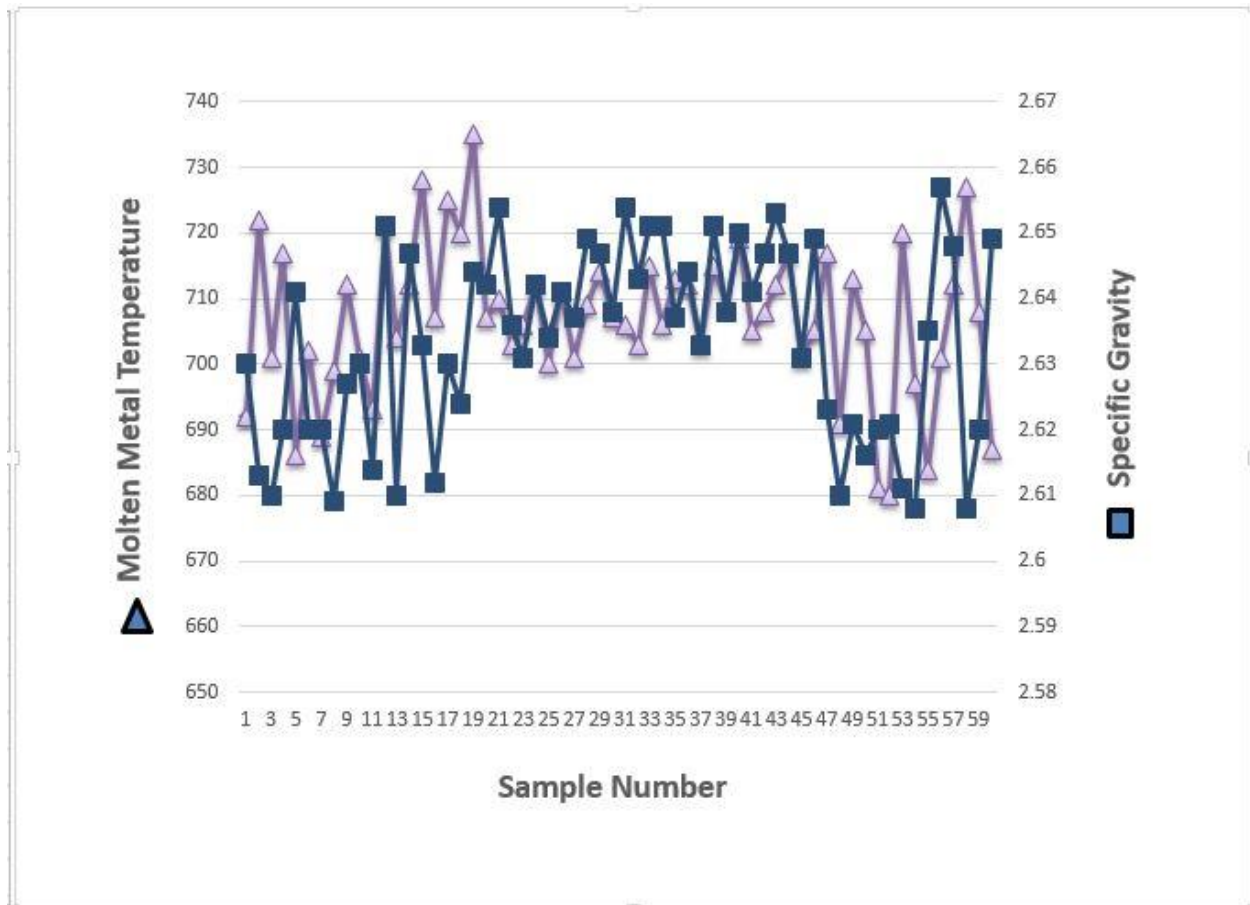
Figure 4.15. Effect of molten metal temperature on specific gravity of sample

> ➢ The effect of molten metal temperature on specific gravity of sample for different number of samples was constructed in a graph as shown in Figure 4.15. The change of hydrogen content in the molten metal, after the application of same degassing time, with the change of metal temperature is shown in Figure 4.15.

➢ From sample number 1 to 20 and 45 to 60 change of the specific gravity is observed as being not in order. In these intervals, there become irregular trends for the specific gravity.

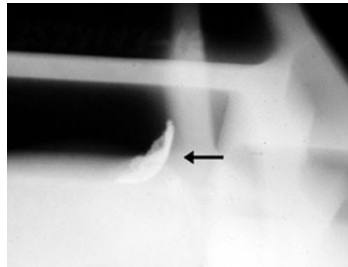
Figure 4.16. Inclusion [5]

Magnesium combines with oxygen present in the atmosphere and forms oxides like MgO. These are micro sized particles which forms inclusions in the molten metal. These inclusions may reduce the ductility and also decrease the fluidity of molten metal which may of Al-Si casting alloys which

may cause shrinkage defects in castings. Inclusions are nonmetallic material in a solid metallic matrix. These inclusions appear as darker or lighter indications on the radiograph as shown in Figure 4.16.
