Failure analysis of wire bonding on strain gauge contact pads using FIB, SEM, and elemental mapping

Failure Analysis of Wire Bonding on Strain Gauge Contact Pads Using FIB, SEM, and Elemental Mapping †

Muhammad Talal Asghar [1,*], Thomas Frank [2] and Frank Schwierz [1]

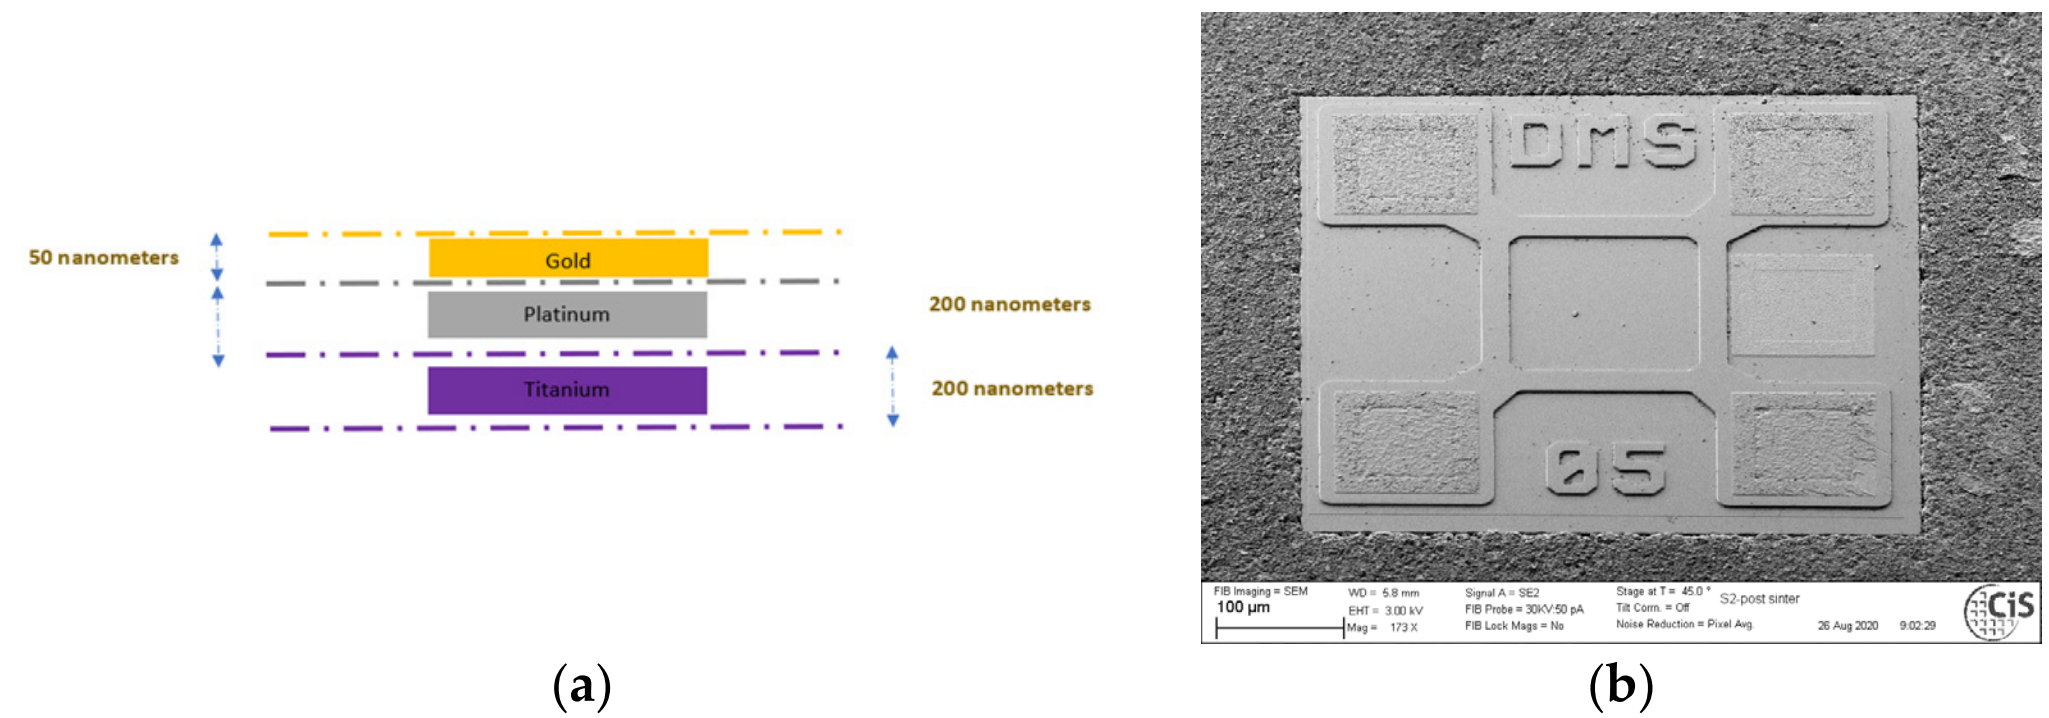
The 500 µm × 500 µm × 15 µm strain gauge with five contact pads is realized on silicon on insulator. Four wire-bondable contact pads are placed at the corner edges while the fifth pad is located on the insulator between two corner edge contact pads. The structure of the wire-bondable pads consisting of Ti/Pt/Au stacks is illustrated in Figure 1a. The strain gauge itself is completely integrated within ceramic by pressure sintering at 875 °C.

Figure 1. (**a**) Metallization stacks of the contact pads at corner edges and (**b**) strain gauge integrated within ceramic.

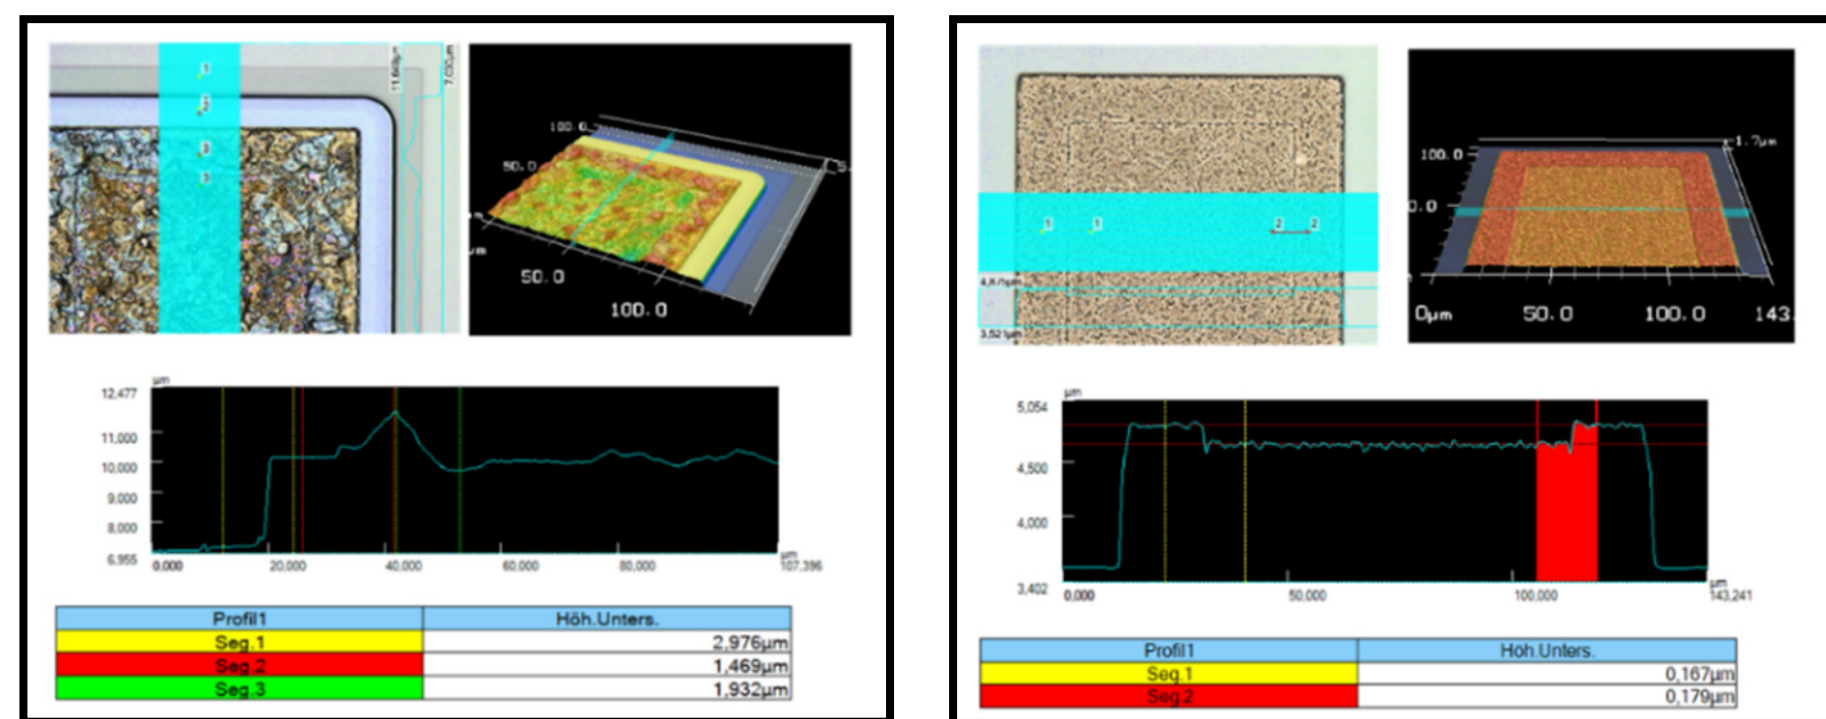
The corner contact pads have been structured in a way that the corner edges have a predefined height difference of 1.932 µm, as illustrated in Figure 2a. This height difference is probably due to the various etching steps for contact pads structuring, which is not straightforward to control.

Figure 2. (**a**) Laser profilometry on corner contact pads and (**b**) laser profilometry on the center contact pad.

Laser profilometry yielded a height difference of 0.179 µm for the center contact pad on insulator. This is insignificant compared to the height difference of the corner contact pads. Therefore, we investigated this corner pad height difference at the interface, considering the earlier mentioned fact that there was no apparent sign of any obvious barrier or oxide formation at the surface of contact pads.

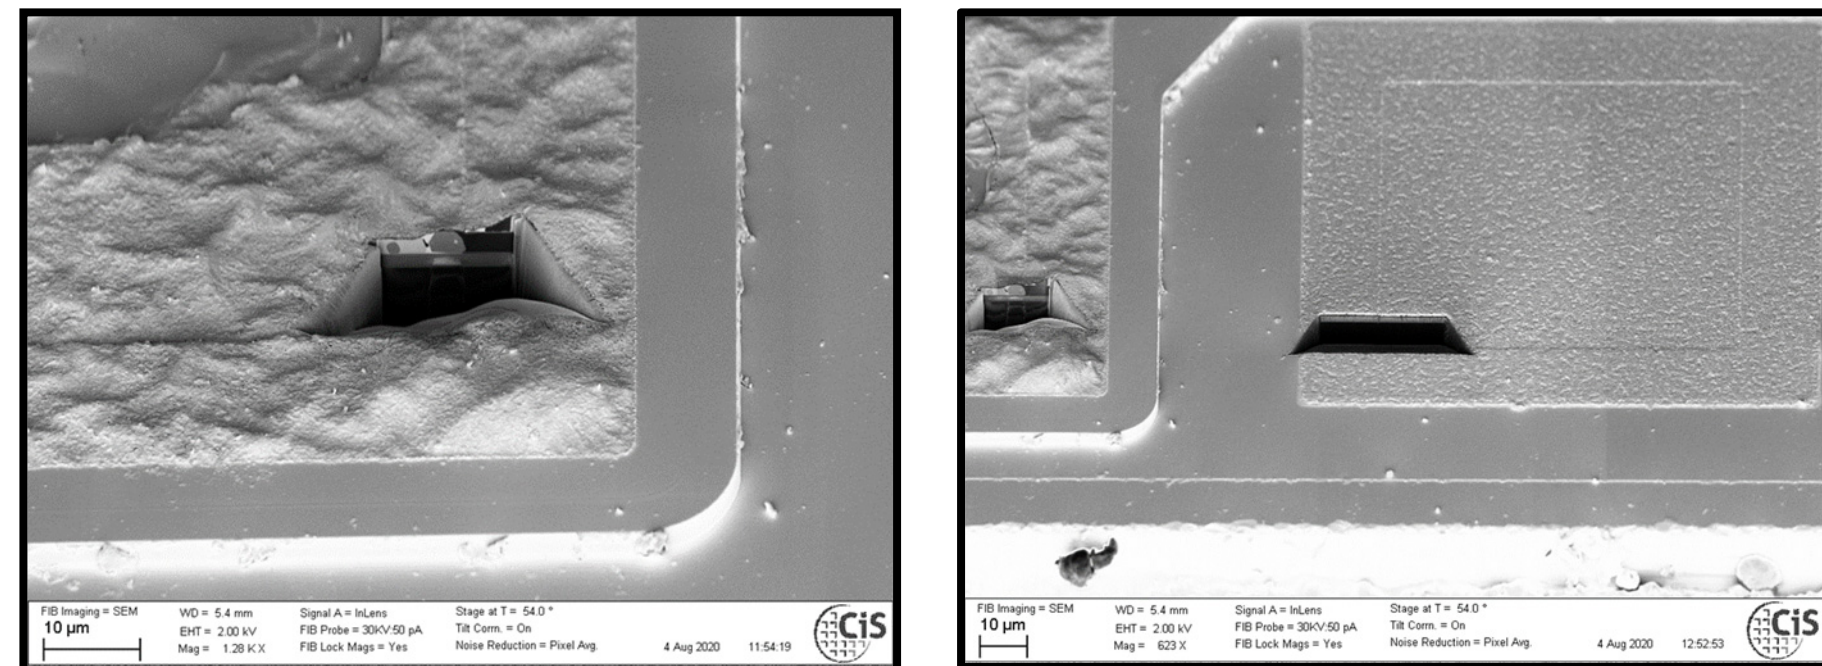
To study the interface height difference, a cross sectioning was performed on a 10 μm^2 area on both contact pads, as illustrated in Figure 3. Since it is critical to perform the cross

Figure 3. (**a**) FIB cross section at corner contact pad and (**b**) FIB cross section at the center contact pad.

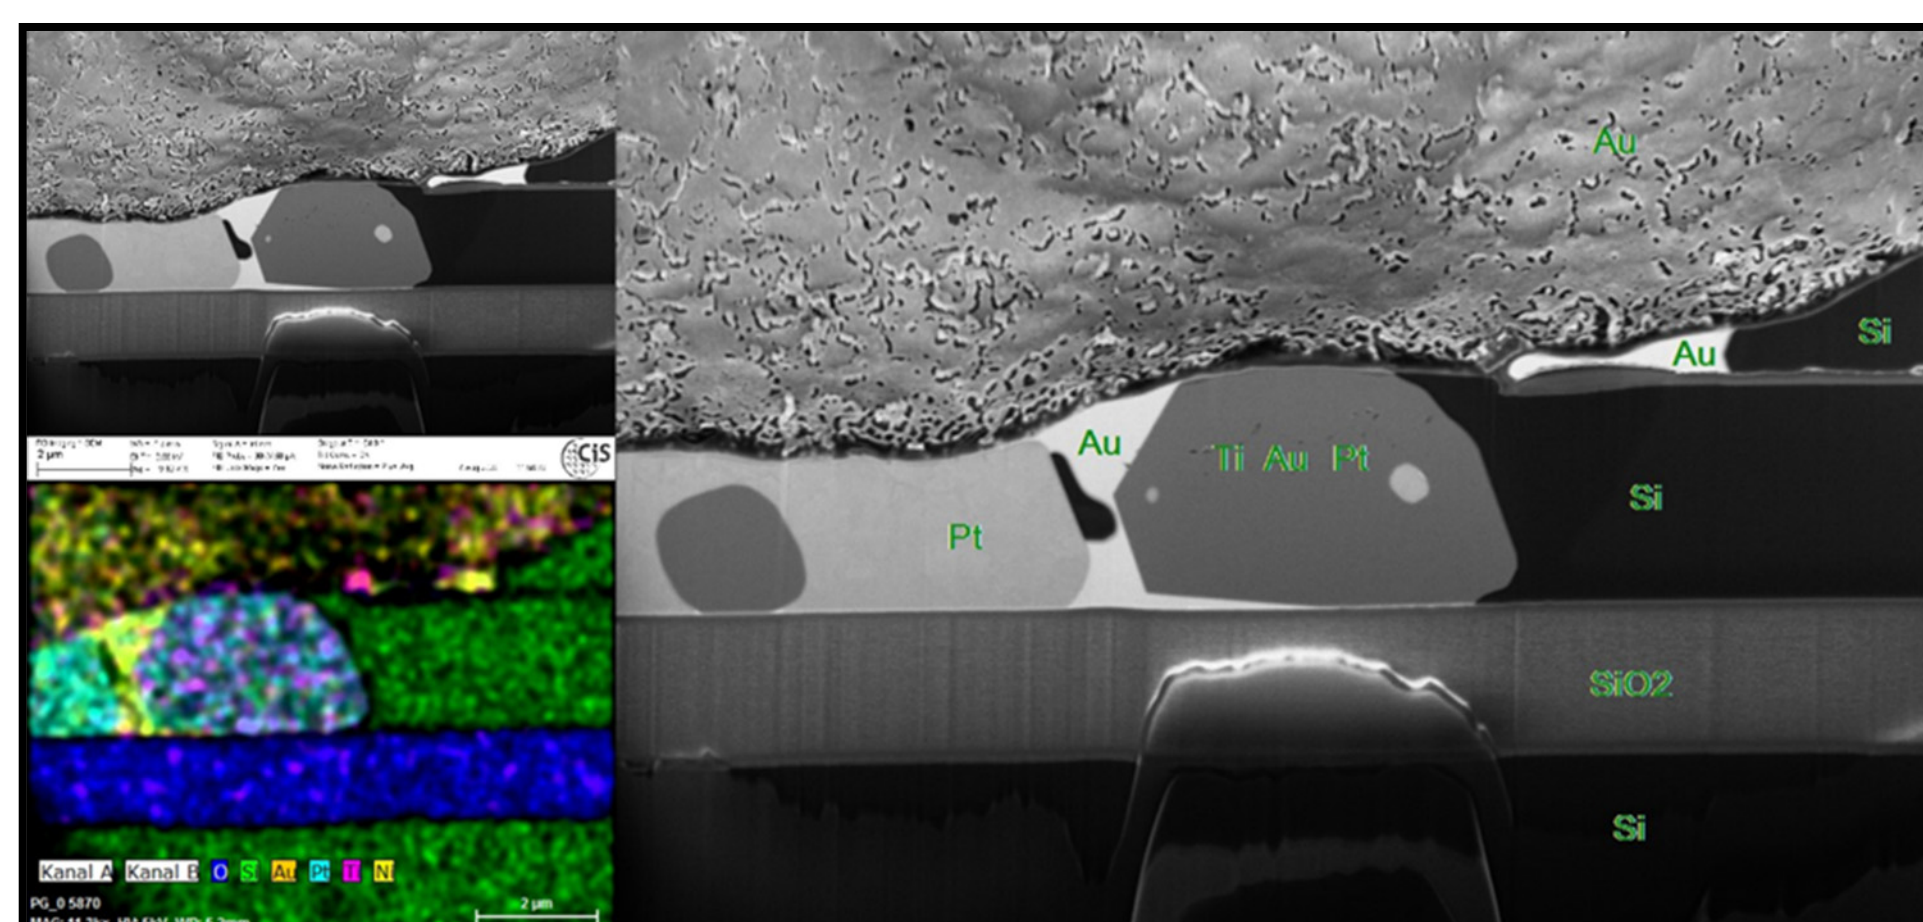
For the corner contact pads, at the intersection of 1.932 µm height difference a metallic alloy agglomerate formation was observed as illustrated in Figure 4. It appears that the high temperature sintering at 875 °C forces Ti, Pt, and Au to move at the interface leading to an agglomerate. This alloy formation leads to an altering pad morphology, which ultimately adds to the surface roughness and may affect the wire bond adhesiveness [7].

Figure 4. Agglomerate formation on edge contact pads at the interface.

FIB, SEM, and EDX analysis showed that the likely mechanism for Au and Al wire bond failure problem could be the metallic alloy agglomerate formation underneath the contact pads due to infusion. To confirm the failure mechanism, further experimentation is deemed necessary. An alternative to overcoming this problem can be to make these metallization layers flatter during structuring or to add an additional Au metal layer at the top in order to suppress the negative impact of agglomerate formation at bottom. Possibly screen printing can be investigated as alternative electrical interconnect methodology.

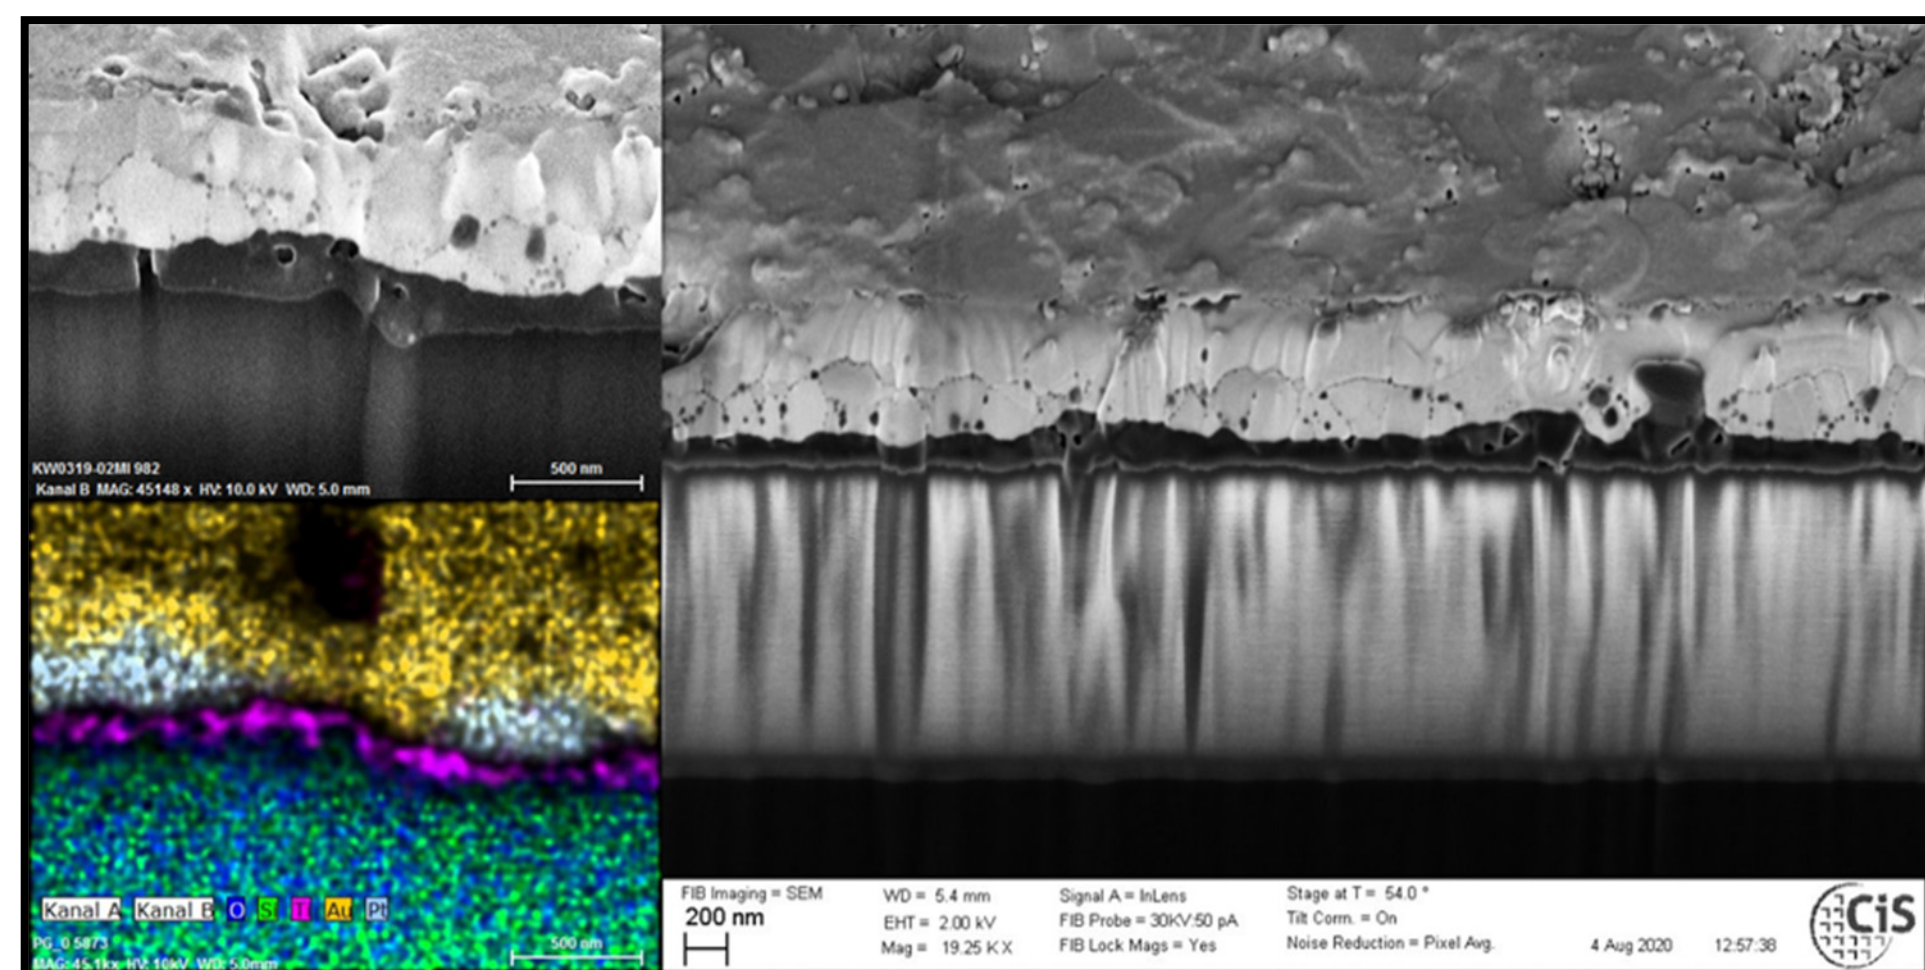
A significantly different situation is observed for the contact pad on insulator. Here, the three metal layers are segregated in between each other, and a more uniform metallization is realized even after firing at high temperature, as illustrated in Figure 5.

Figure 5. Segregated metallization layers on contact pad on insulator.
