SAFETY ASSESSMENT OF THE JERÓNIMOS CHURCH IN LISBON

Paulo B. Lourenço, Konrad J. Krakowiak
University of Minho
Guimarães, Portugal
pbl@civil.uminho.pt
www.civil.uminho.pt/masonry

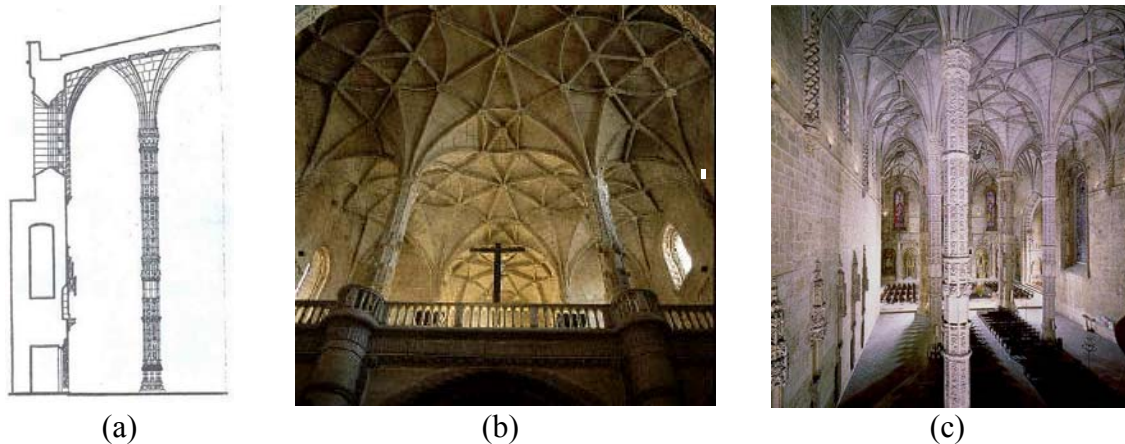
Figure 1. Church of Monastery of Jerónimos: (a) transversal cross-section; (b) vault on top of the choir; (c) aspect of the three naves.

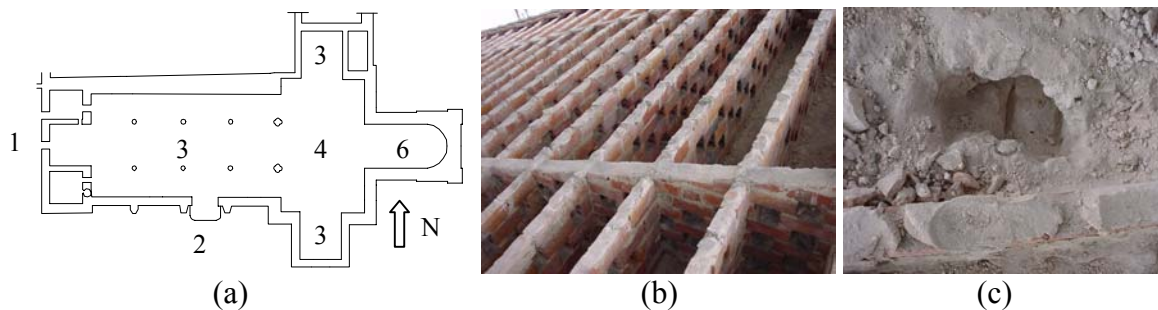
Figure 2. Survey: (a) Plan, with 1 – Axial doorway, 2 – Lateral doorway, 3 – Nave, 4 – Transept, 5 – Side chapels, 6 – Chancel; (b) removal of the roof and existing system to support the roofing tiles; (c) visual inspection of the infill and rib.

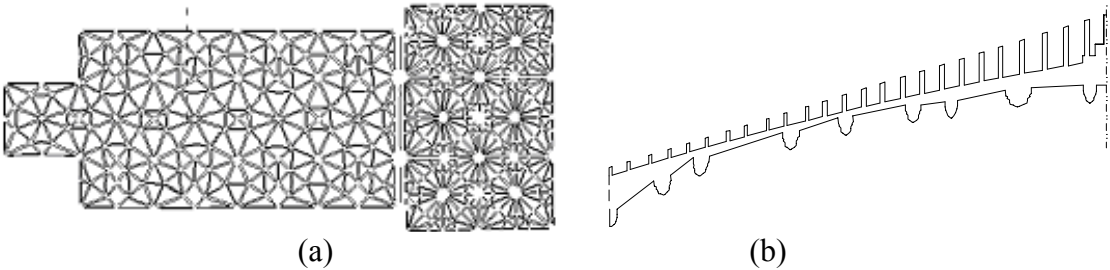
The vaults are ribbed and are connected to the columns by the large fan capitals, see Fig. 3. Cross section of the nave vault is, mostly, a slightly curved barrel vault, even if supported at the columns. Thin stone slabs are placed on top of the stone ribs. On top of the slabs, a variable thickness mortar layer exists. The part of the slab inside the capital is filled with a concrete-like material with stones and clay mortar. On top of the vaults, brick masonry wallets were built during the 30's to provide support for the roofing tiles, see [6] for details.

Figure 3. Aspects of the vaults: (a) plan and (b) transversal cross-section of the nave.

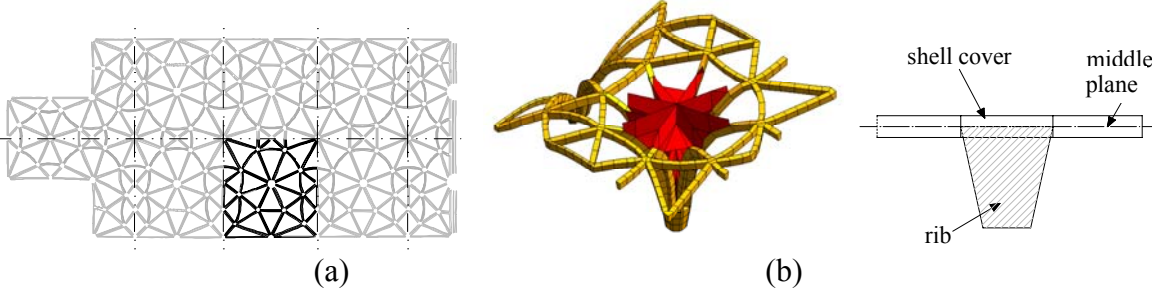
The adopted model for the main nave includes the structural detail representative of the vault and more unfavourable, see Fig. 4a. Appropriate symmetry boundary conditions have been incorporated. Therefore, the model represents adequately the collapse of the central-south part of the nave. The model includes three-dimensional volume elements, for the ribs and columns, and curved shell elements, for the infill and stones slabs, see Fig. 4b,c. The external (south) wall was represented by beam elements, properly tied to the volume elements. The supports are fully restrained, being rotations possible given the non-linear material behaviour assumed. All elements have quadratic interpolation, resulting in a mesh with 33335 degrees of freedom.

Figure 4. Aspects of the model: (a) basic pattern, (b) details around capital and (c) detail of the connection between the rib and infill.

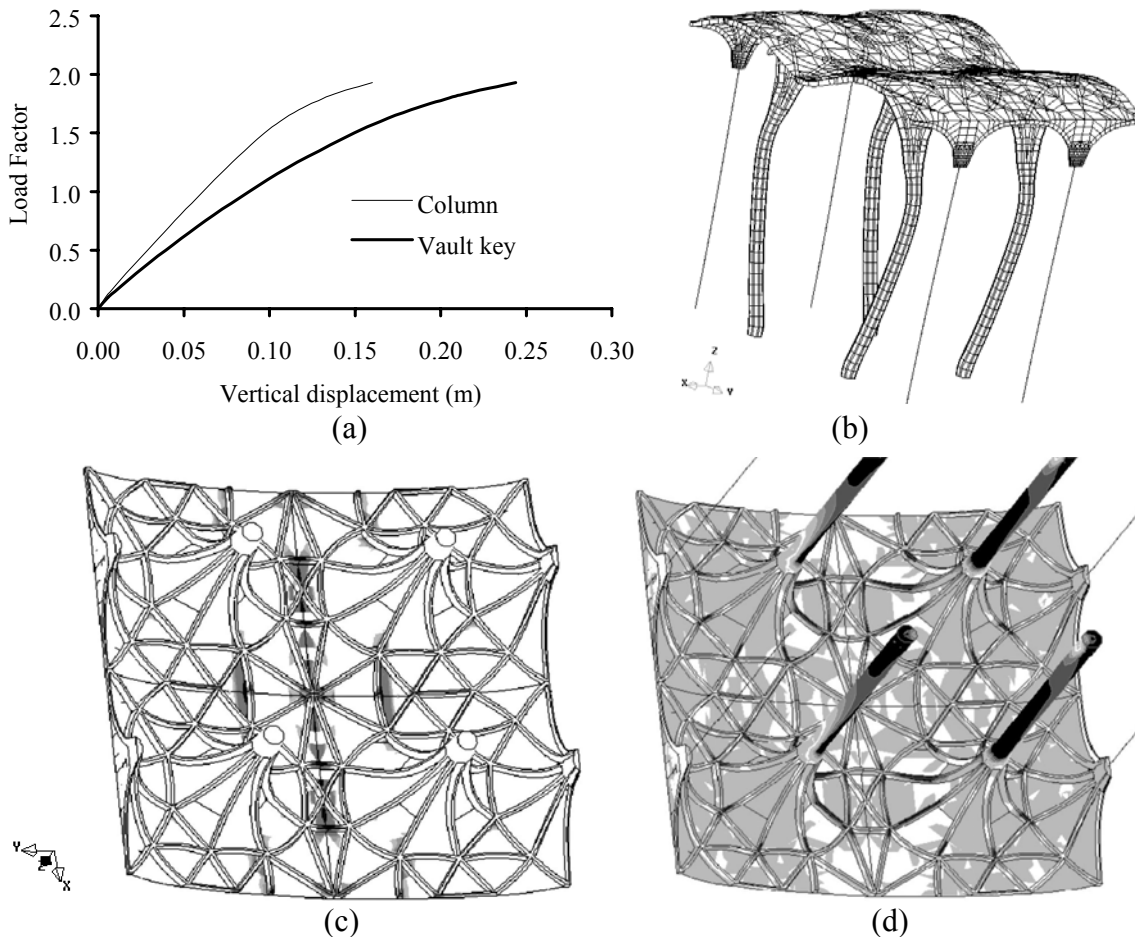
Fig. 5a illustrates the load-displacement diagrams for the vault key and top of the column. Here, the load factor represents the ratio between the self-weight of the structure and the applied load, meaning that the ultimate load factor is equivalent to the safety factor of the structure. It is possible to observe that the response of the structure is severely non-linear from the beginning of loading, for the nave, and from a load factor of 1.5, for the column. The behaviour of the nave is justified by the rather high tensile stresses found in the ribs, using a linear elastic model. The collapse of the columns is due to the normal and flexural action. The safety factor is 2.0, which is rather low for this type of structures.

Figure 5. Results of nave analysis: (a) load-displacement diagram, (b) incremental deformed mesh at failure, (c) maximum principal strains (equivalent to cracks) and (d) minimum principal stress (compression).

The deformed mesh at failure, see Fig. 5b, indicates that the structural behaviour is similar to a two-dimensional frame, with a collapse mechanism of five hinges (four hinges at the top and base of the columns and one at the key of the vault. Nevertheless, there is some vault effect with slightly larger displacements at the central octagon, formed between the four capitals.

The stresses are bounded in tension and compression, meaning that cracking and crushing occurs. Fig. 5c illustrates the maximum principal strains, which are related to cracking of the structure. The pairs of transverse ribs that connect the columns (in the central part of the structure) exhibit significant cracking, as well as the infill in the same area. Additional cracking, less exuberant and more diffused, appears in the central octagon defined by the capitals of the four columns. Such cracking occurs at the key of the octagon and in the longitudinal ribs, which confirms the larger displacements of the vault and the bi-directional behaviour of the vault. Finally, Fig. 5d illustrates the minimum principal stresses at failure. It can be observed that very high compressive stresses are found in the capital ribs, particularly in the transversal area that connects a pair of columns. The columns exhibit also very high compressive stresses, which lead to the collapse mechanism described before.

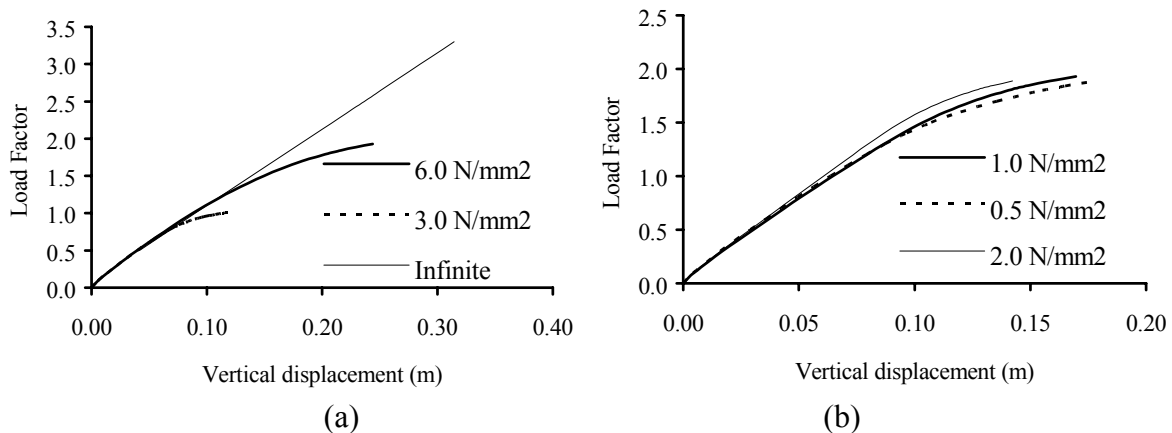
Fig. 6 presents the load-displacement diagrams for different compressive strengths of the stone masonry and infill. The influence of the compressive strength of the stone masonry is very significant, as shown in Fig. 6a. The safety factor of the structure is reduced to 1.0, for a compressive strength of 3.0 N/mm^2, and increased to a value larger than 5.0, for an infinite compressive strength. One the contrary, the influence of the compressive strength of the infill is marginal, as shown in Fig. 6b. The safety factor of the structure is kept constant and only minor changes of stiffness can be observed. The collapse mechanism remains unchanged in all the analysis.

Figure 6. Sensitivity analysis: (a) influence of the compressive strength of stone masonry and (b) influence of the compressive strength of the infill.

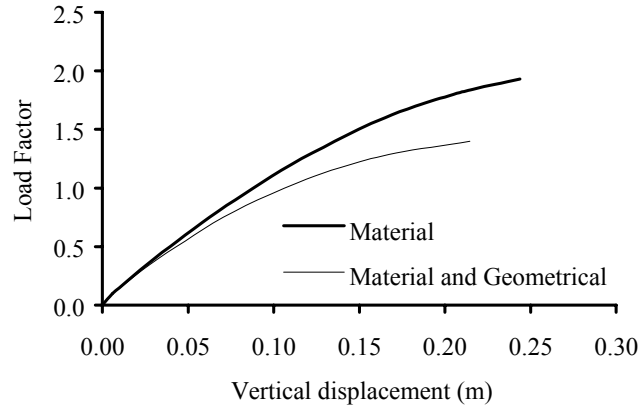
Finally, Fig. 7 illustrates the influence of the geometrical non-linear behaviour in the analysis. It can be observed that this additional non-linear behaviour, in the reference analysis, reduces the safety factor to a value of 1.4, which is rather low. Again, the collapse mechanism remains unchanged.

Figure 7. Influence of geometrical non-linear behaviour.

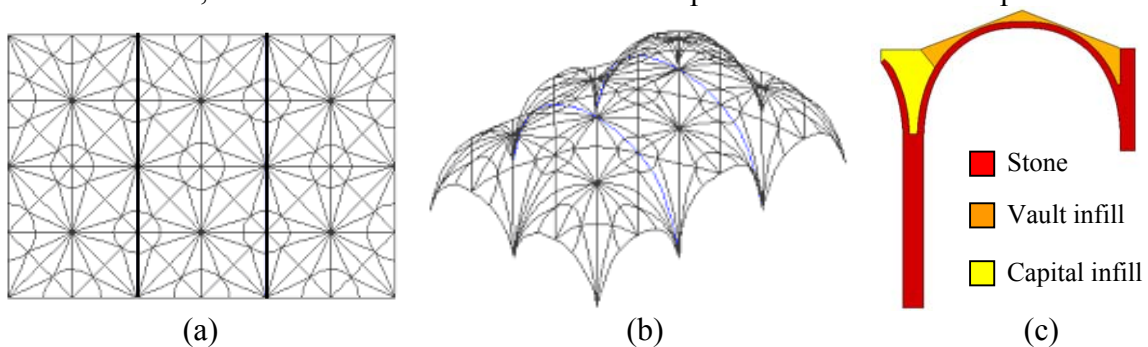
The second part of the structural assessment of the church focus on the transept vault. This vault has a geometry and structural scheme different from the nave. In plan, the vault forms a rectangle with 18.8×28.0 m^2, using a basic square with a side of 4.7 m repeated 24 times. The vault exhibits, in plan, straight and circular ribs, together with keys at the intersection, ser Fig. 8. The transverse section of the ribs is equal to 0.4 m (height) by 0.28 m (width), with the exception of the two central ribs (arches) indicated with a thick line in Fig. 8a, showing a cross section of 0.60×0.40 m^2. Therefore, the two arches are the most significant structural elements of the transept vault. Given the complexity of the vault and the time consumed in the model of the nave, a simplified two-dimensional model of these arches was adopted for the structural analysis. Fig. 8c illustrates the conservative adopted model, which includes the arch, the infill, the nave column and the external wall, with appropriate stiffness values and boundary conditions, see [4] for a complete description. All elements have quadratic interpolation, resulting in a mesh with 3530 degrees of freedom. Again, the actions considered in the analysis include only the self-weight of the structure. For the materials, the reference values described in the previous section are adopted.

Figure 8. Transept vault: (a) plan, (b) perspective and (c) finite element model.

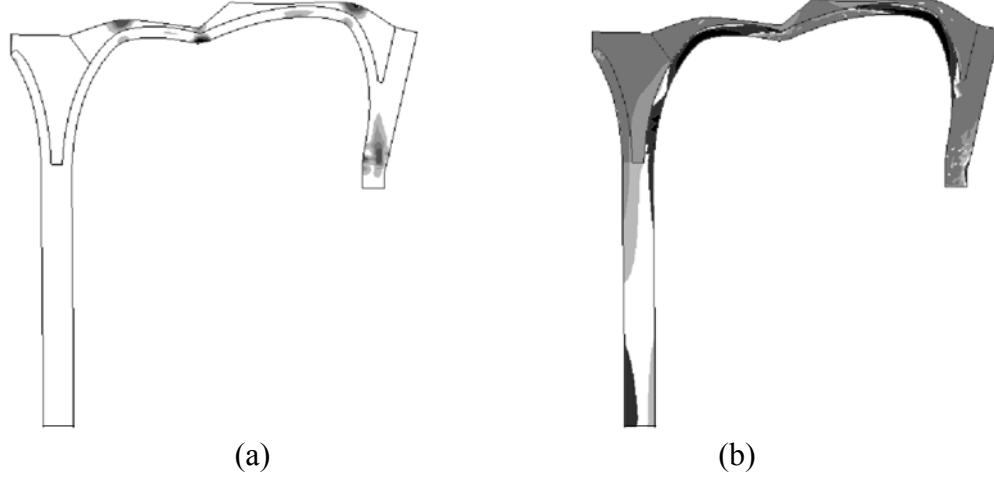
The results for the transept analysis are shown in Fig. 9, in terms of maximum principal strain (equivalent to tensile damage) and minimum principal stresses (compression), depicted on the deformed mesh. The safety factor is 1.7, which is again rather low for this type of structures, even if the model is simplified and conservative. Further discussion on the results can be found in [4].

Figure 9. Results of transept analysis at collapse: (a) maximum principal strains (equivalent to cracks) and (b) minimum principal stress (compression), depicted on deformed meshes.

Collapse occurs with a typical four hinges mechanism, being three hinges located in the vault and one hinge located in the right support, see Fig. 9. The collapse involving the right wall occurs due to the consideration that the nave prevents inwards movement of the (left) column. Fig. 9a indicates that the arch is cracked at the key (intrados) and both quarter spans (extrados). Significant cracking is also present in the right support. Fig. 9b demonstrates that high compressive stresses are found in the arch and in the base of the right wall. The compressive stresses in the left column are moderate and do not govern collapse.
