REDUCED 2ND LEVEL SOLDER JOINT LIFE TIME OF LOW-CTE MOLD COMPOUND PACKAGES

NOORDWIJK, THE NETHERLANDS 20-22 MAY 2014

Bart Vandevelde(1), Riet Labie(1), Lieven Degrendele(2), Maarten Cauwe(2), Johan De Baets(2), Geert Willems (1)

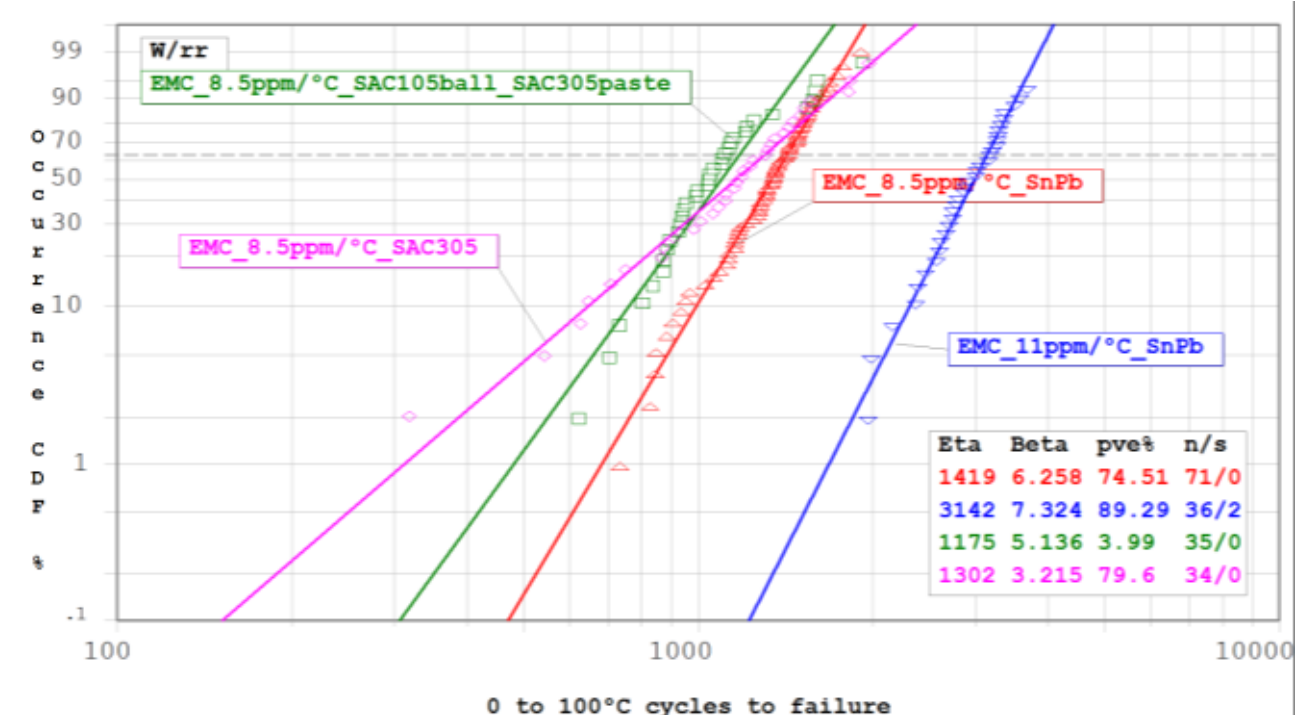
Figure 3: Weibull distribution for four different EMC /solder material combinations for the BGA228 package with 0.5 mm ball pitch.
(cycling test: 0 to 100°C)

- For the SnPb solder versions, the characteristic life time (N63%) decreases from 3142 cycles to 1419 cycles when the CTE of the mould compound is reduced from 11 to 8.5 ppm/°C. This is more than a factor of 2.
- For the three BGA’s with the same low-CTE mould compound but different solder combinations (SnPb, SAC105, SAC305), the characteristic life times are comparable. This supports the statement that the impact of the mould compound material is far greater than the solder material.

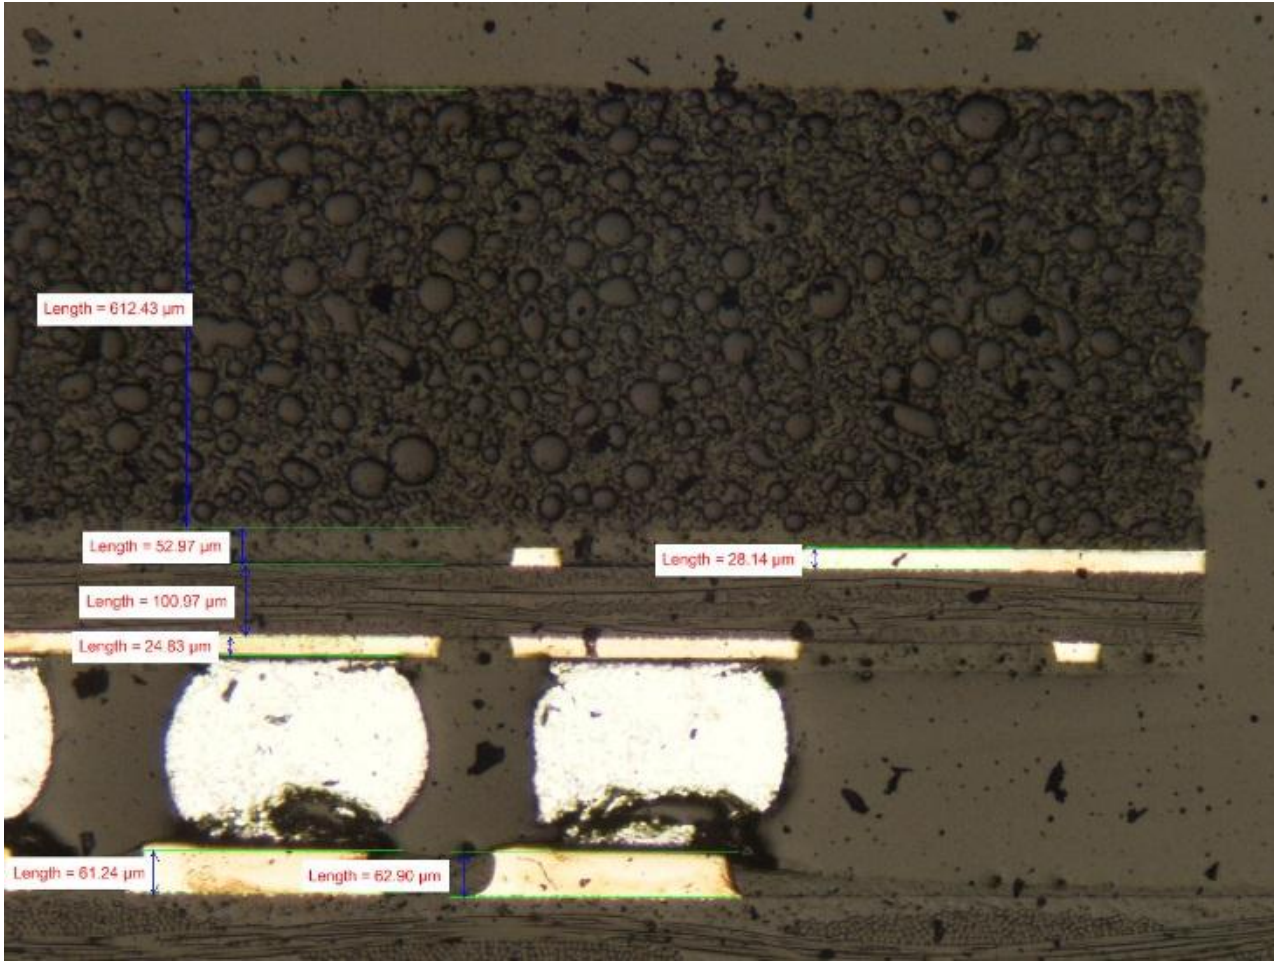
Failure analysis (Figure 4) on a SnPb soldered BGA with 8.5ppm/°C mould compound showed a heavily damaged solder joint especially at the corner/edge area indicative for a large mismatch.

Figure 4: Cross-sections made on a SnPb PBGA with low-CTE mould compound

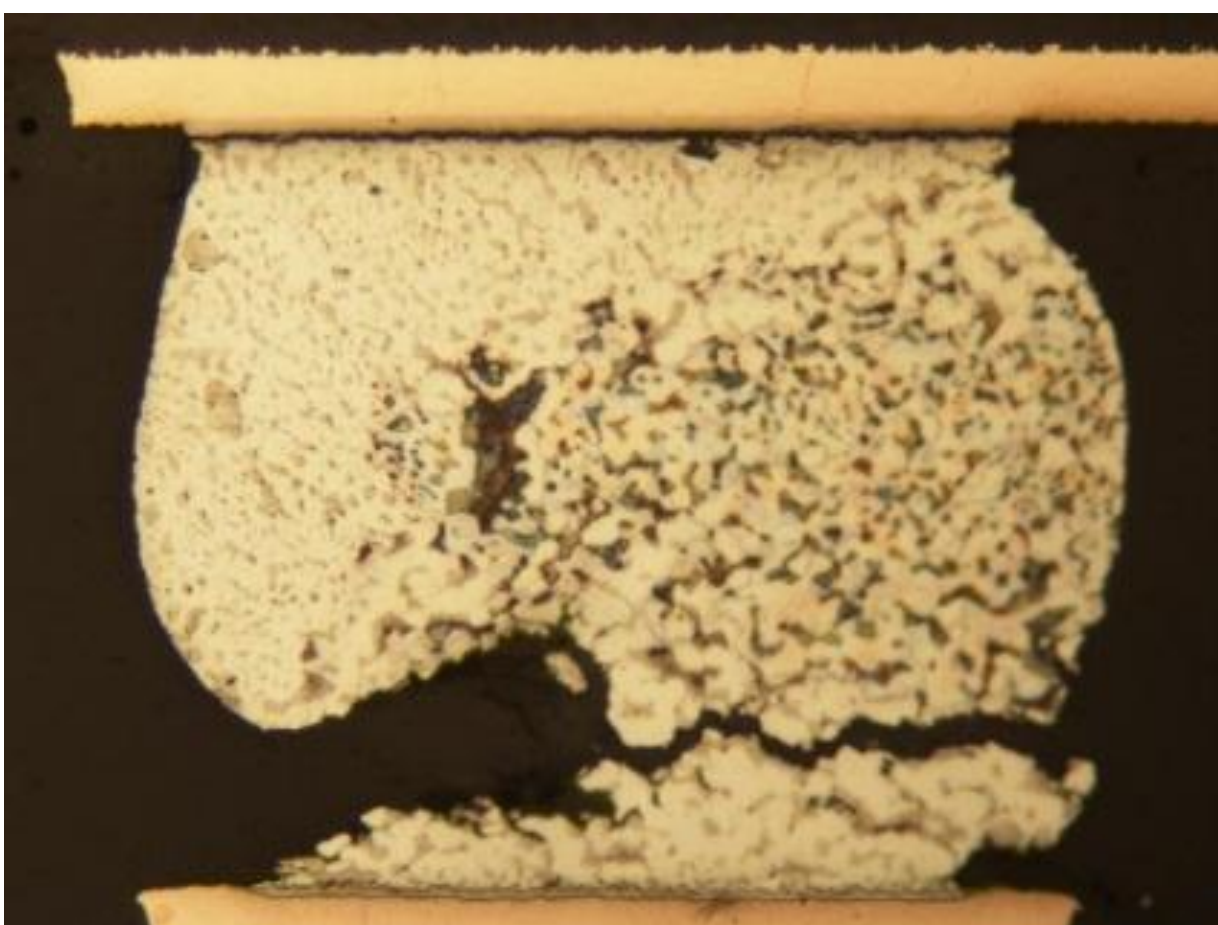
Figure 5: Detailed view of one failing SnPb solder ball joint

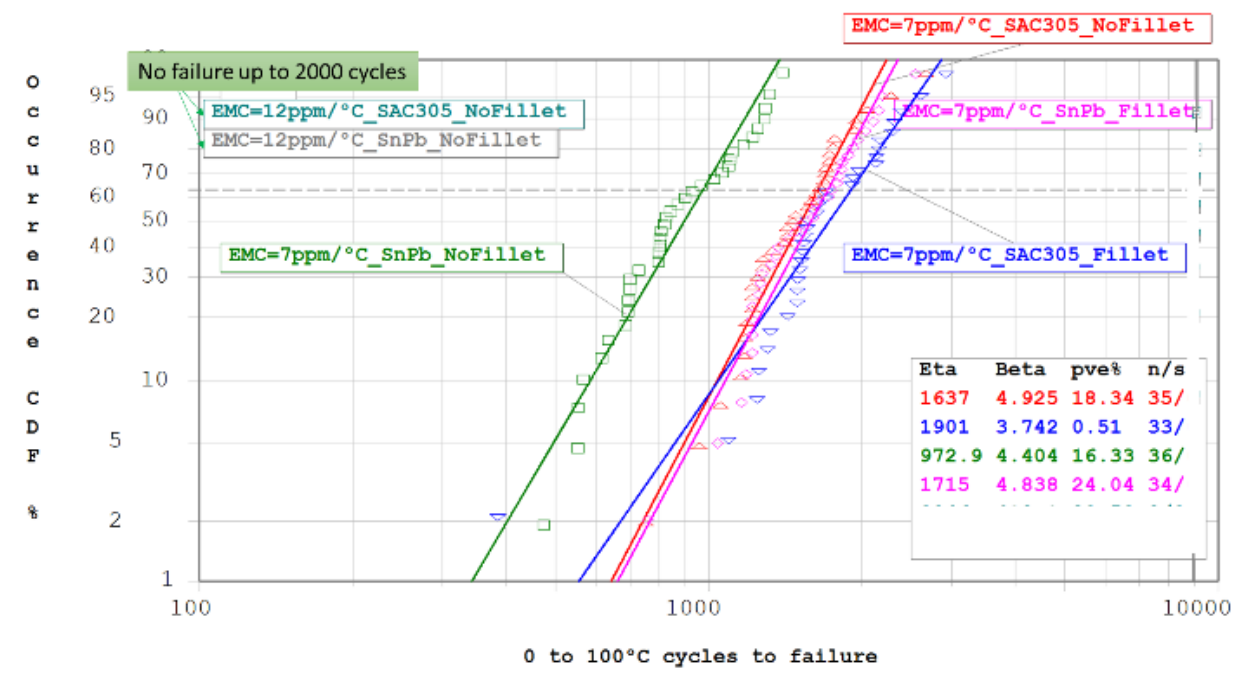
Figure 7: Weibull distribution of 6 tested QFN64 solder assemblies. The two QFN's with high CTE mould compound have not failed yet after 2000 cycles. (cycling test: 0 to 100°C)

- Up to 2000 temperature cycles, none of the QFN with high CTE failed while most of the low-CTE QFN did.
- Flank wetting allowing to have a solder fillet improves the solder joint life time, but the improvement is mainly seen for the SnPb soldered QFN's. At the moment the reason for this is unclear.

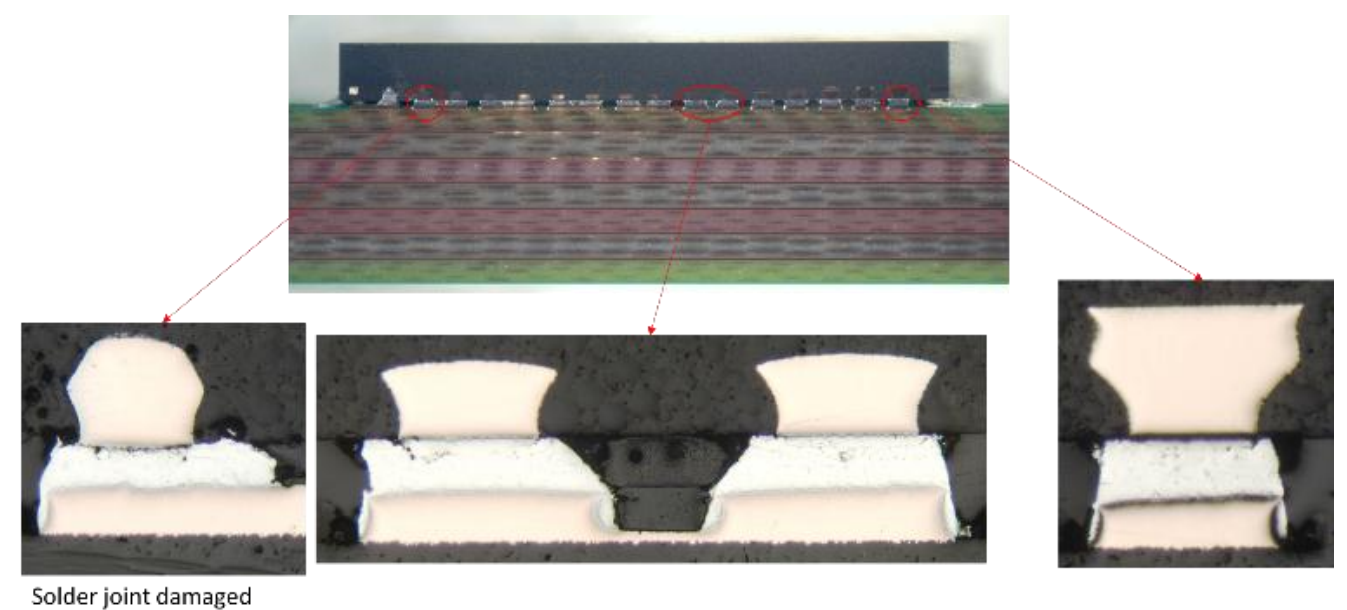
Failure analysis (Figure 8) showed that the corner joints fail first. This is expected as these joints see the highest absolute thermal expansion mismatch between component and board. For the packages soldered with SAC305, failure analysis is shown below.

These QFN's failed in average after 1637 cycles. A fully cracked joint was found in one corner (left side on Figure 8) but also the other corner, damage is found in the solder joint (Figure 14).

Figure 8: Cross-section of SAC305 soldered QFN64 package (9x9 mm) assembled on a 2.4 mm thick PCB after temperature cycling. (EMC = 7 ppm/°C)

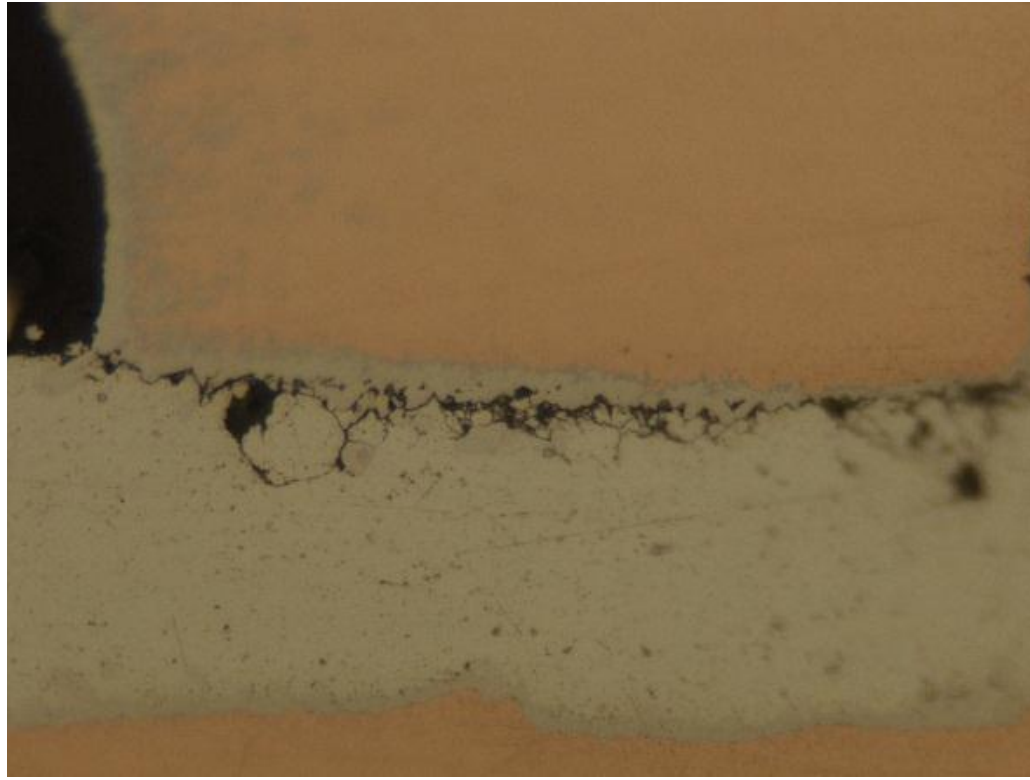
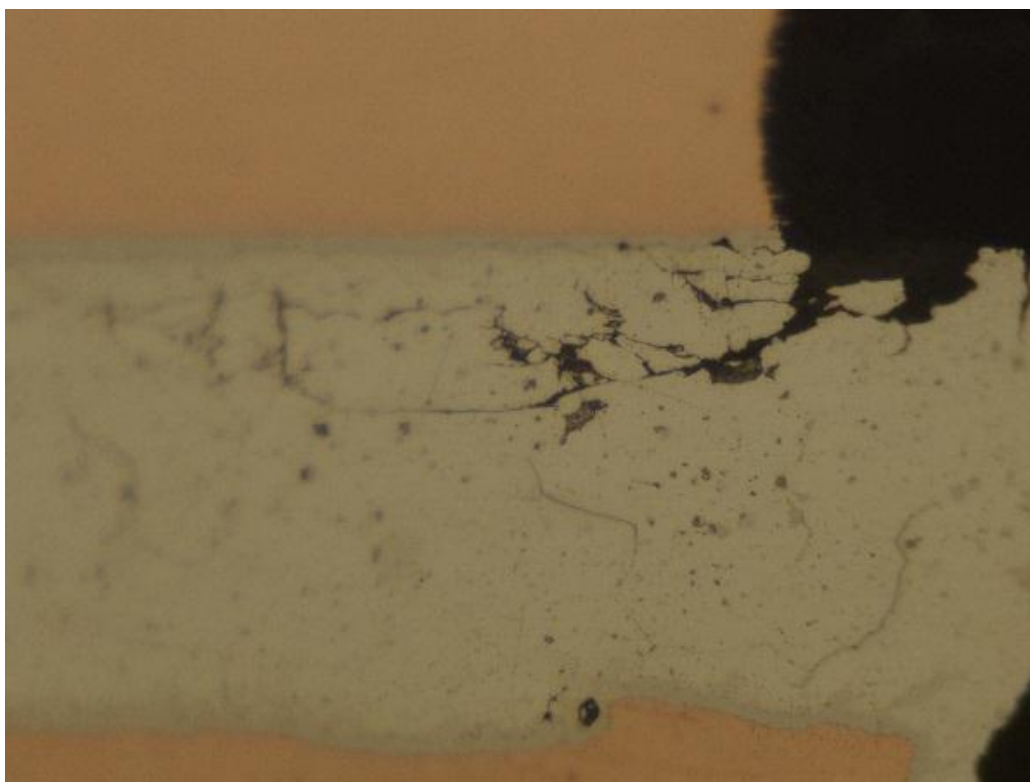
Figure 9: Detailed view of left and right corner joint for QFN's with 7 ppm/°C EMC and SAC305 solder joints without fillet (EMC = 7 ppm/°C)

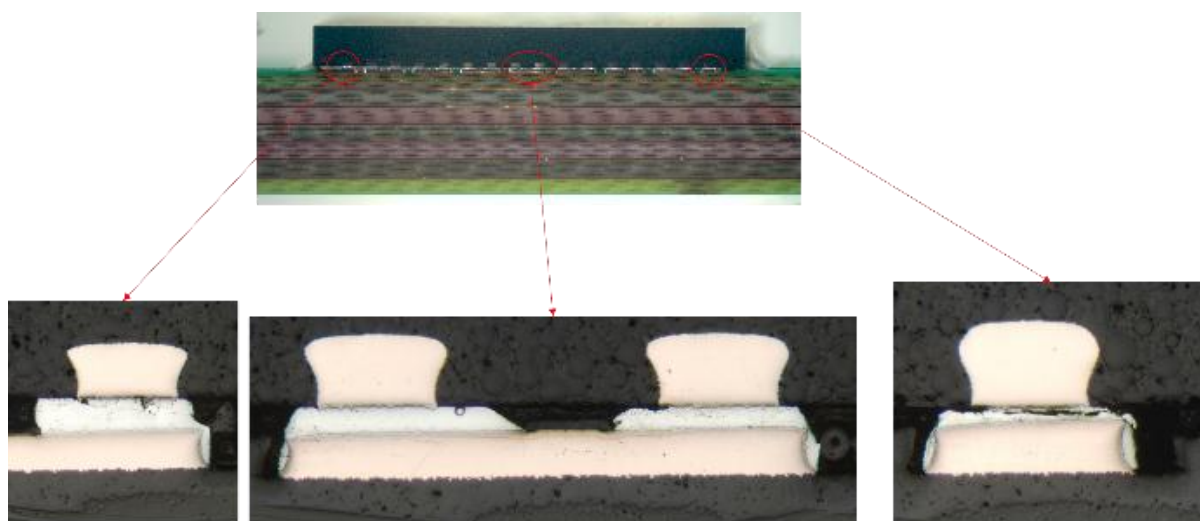
These QFN's failed in average after 1901 cycles which is only 10% higher than without fillet. It is expected that fillet would positively benefit to the life time of the solder joint, but the explanation for the little difference with no fillet is the asymmetric soldering indicated in Figure 10. At the right side, the solder stand-off height is less than 20 µm and it is at this solder joint which fails first.

Figure 10: Cross-section of SAC305 soldered QFN64 package (9x9 mm) with solder fillet (EMC = 7 ppm/°C)

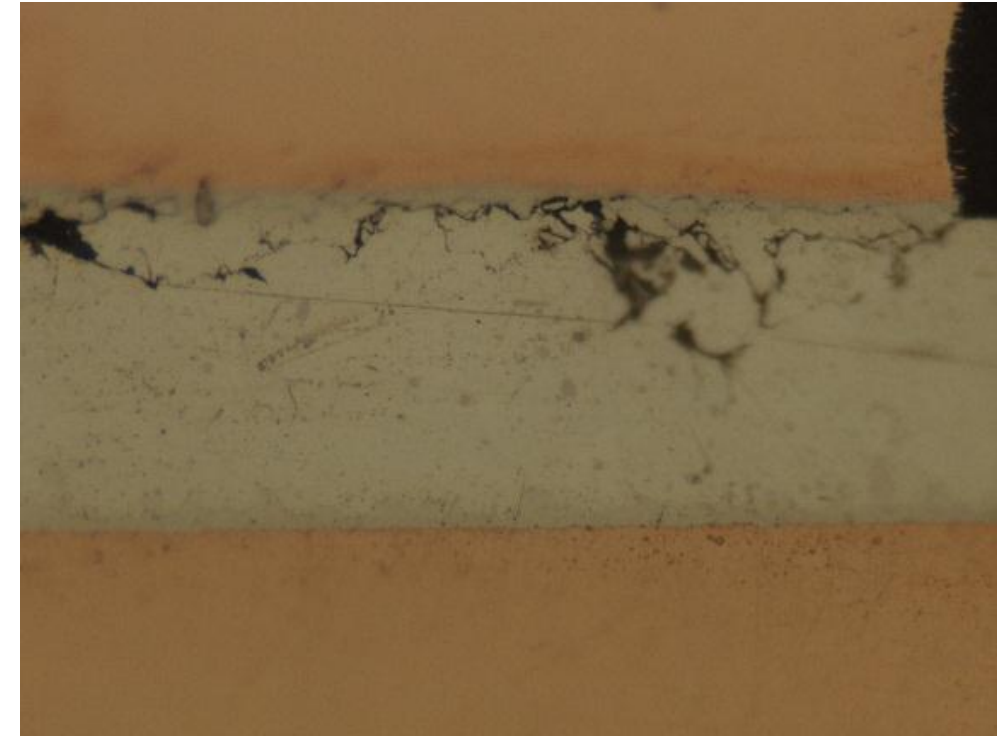
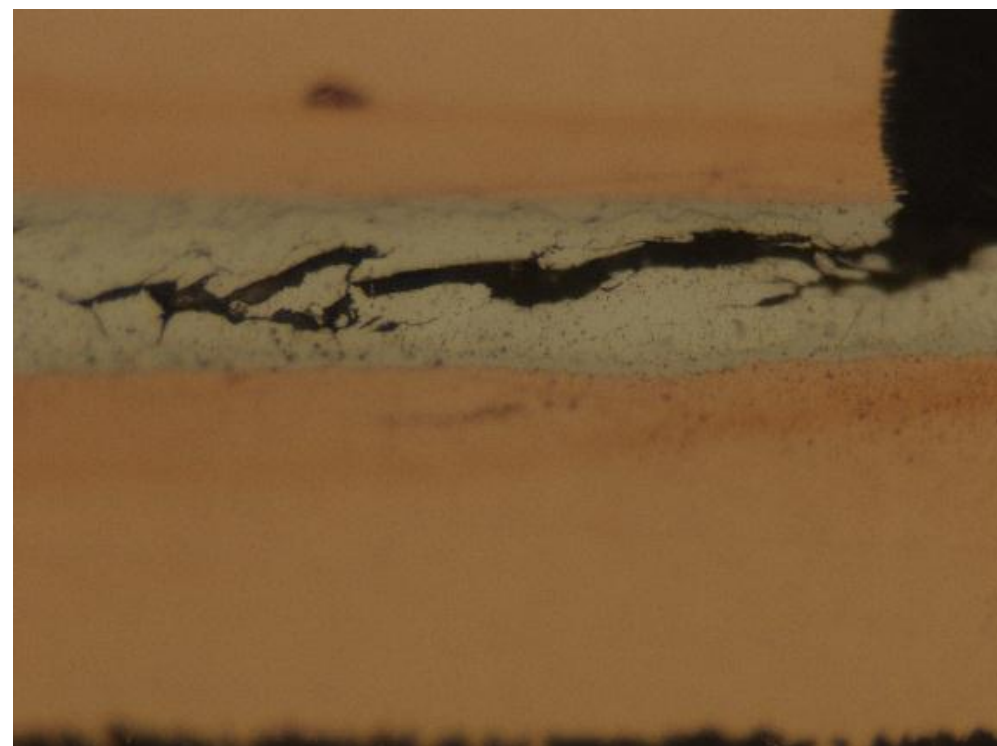
Figure 11: Detailed view on left and right corner joint of SAC305 soldered QFN64 package (9x9 mm) with solder fillet (EMC = 7 ppm/°C)

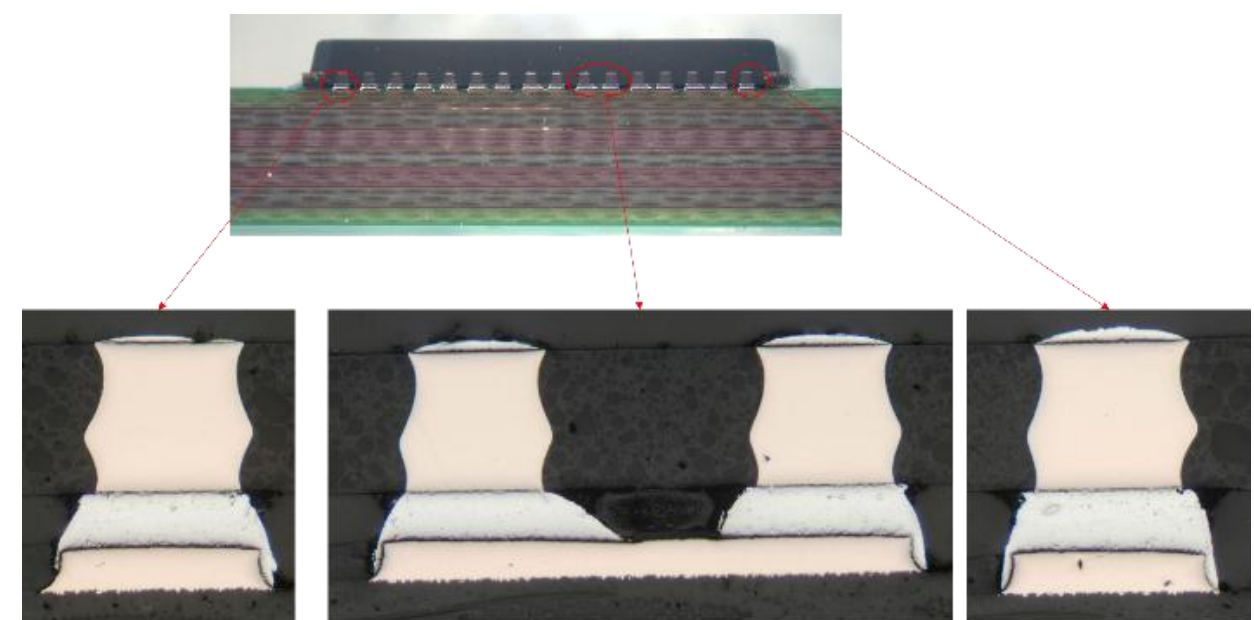
Any of these QFN's with high CTE of the mould compound failed up to 2000 cycles. Cross-sections depict that there is only little damage seen, even in the corner joints.

Figure 12: Cross-section of SAC305 soldered QFN64 package (9x9 mm) without solder fillet (EMC = 12 ppm/°C)

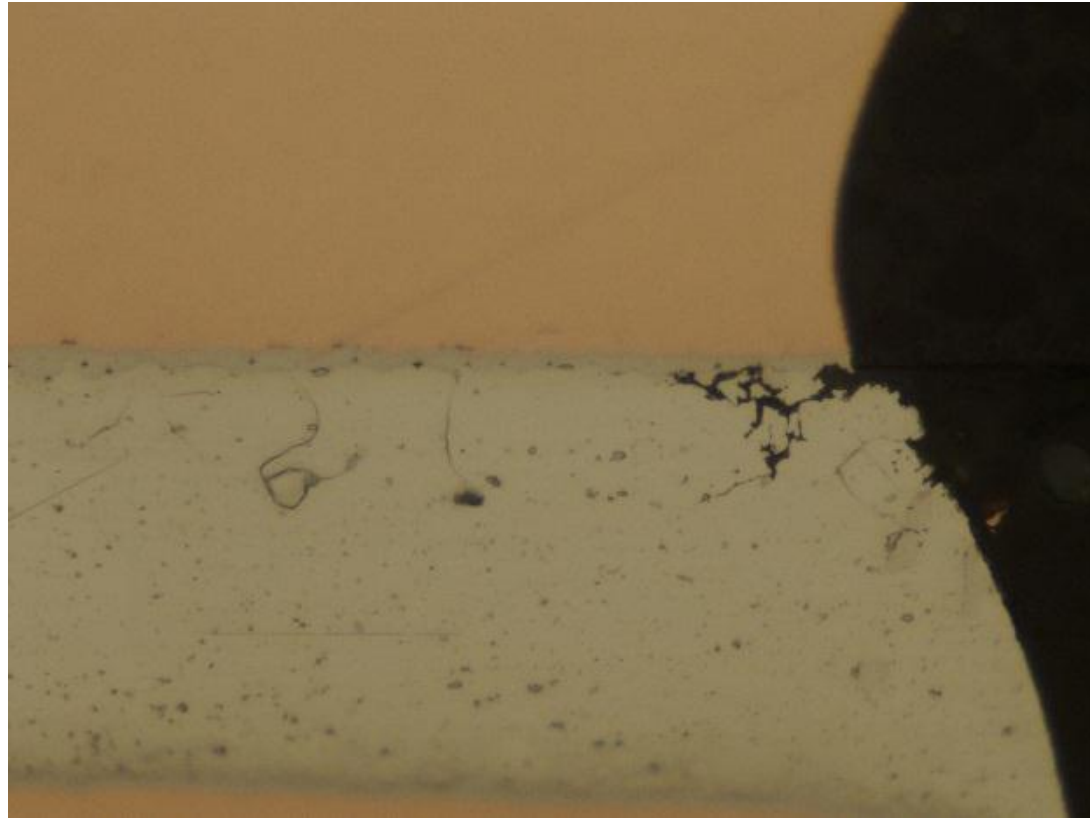
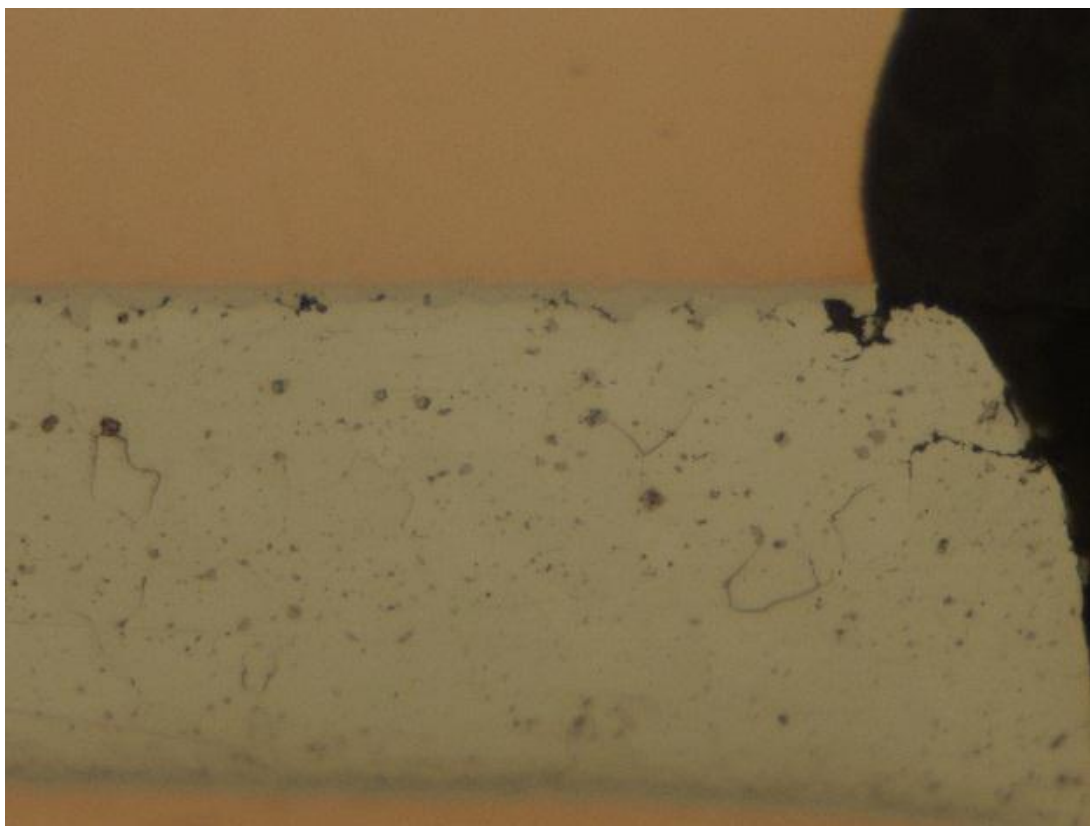
Figure 13: Detailed view on left and right corner joint of SAC305 soldered QFN64 package (9x9 mm) with solder fillet (EMC = 12 ppm/°C)

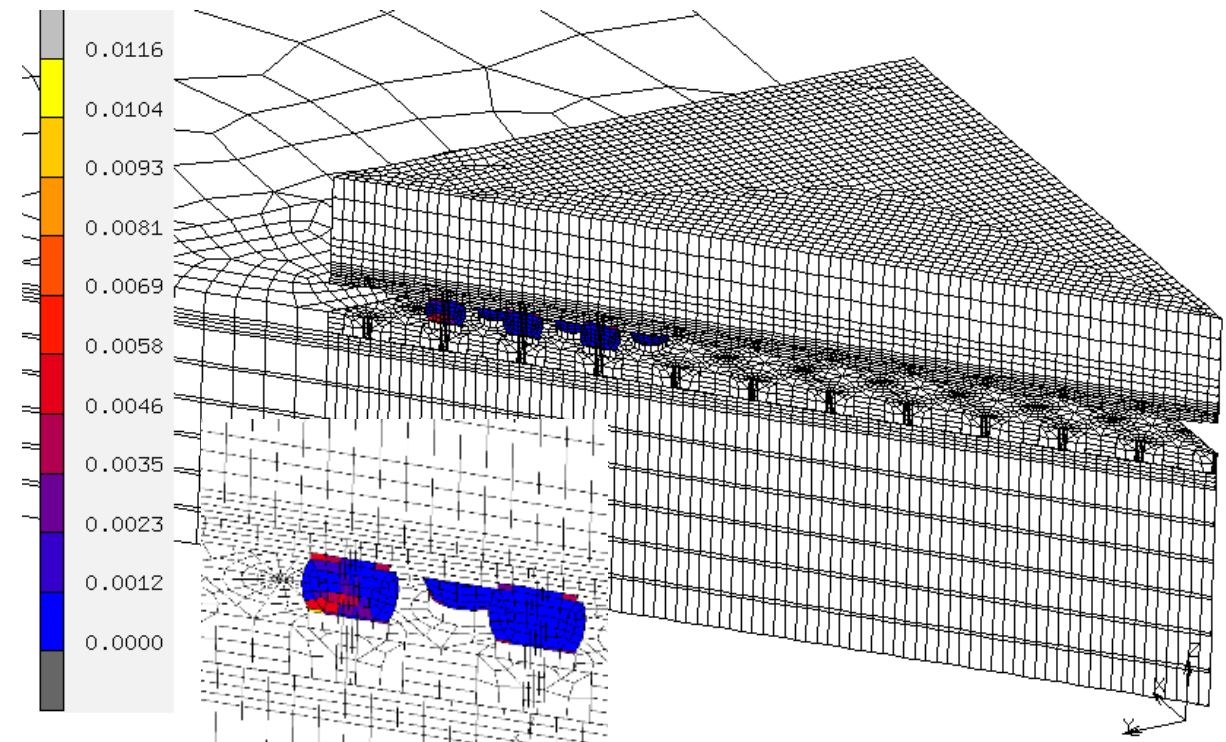
The output relevant for solder joint fatigue are the creep deformation in the solder joint happening during every temperature cycling. The highest creep strains are found in the corner joint at the PCB side Figure 15. This agrees well with the experiments where cracks were found at the corner joint near the PCB side (Figure 4).

Figure 15: Inelastic strain distribution in SAC305 solder balls for BGA228 packages assembled to the 2.4 mm PCB (EMC = 8.5 ppm/°C)

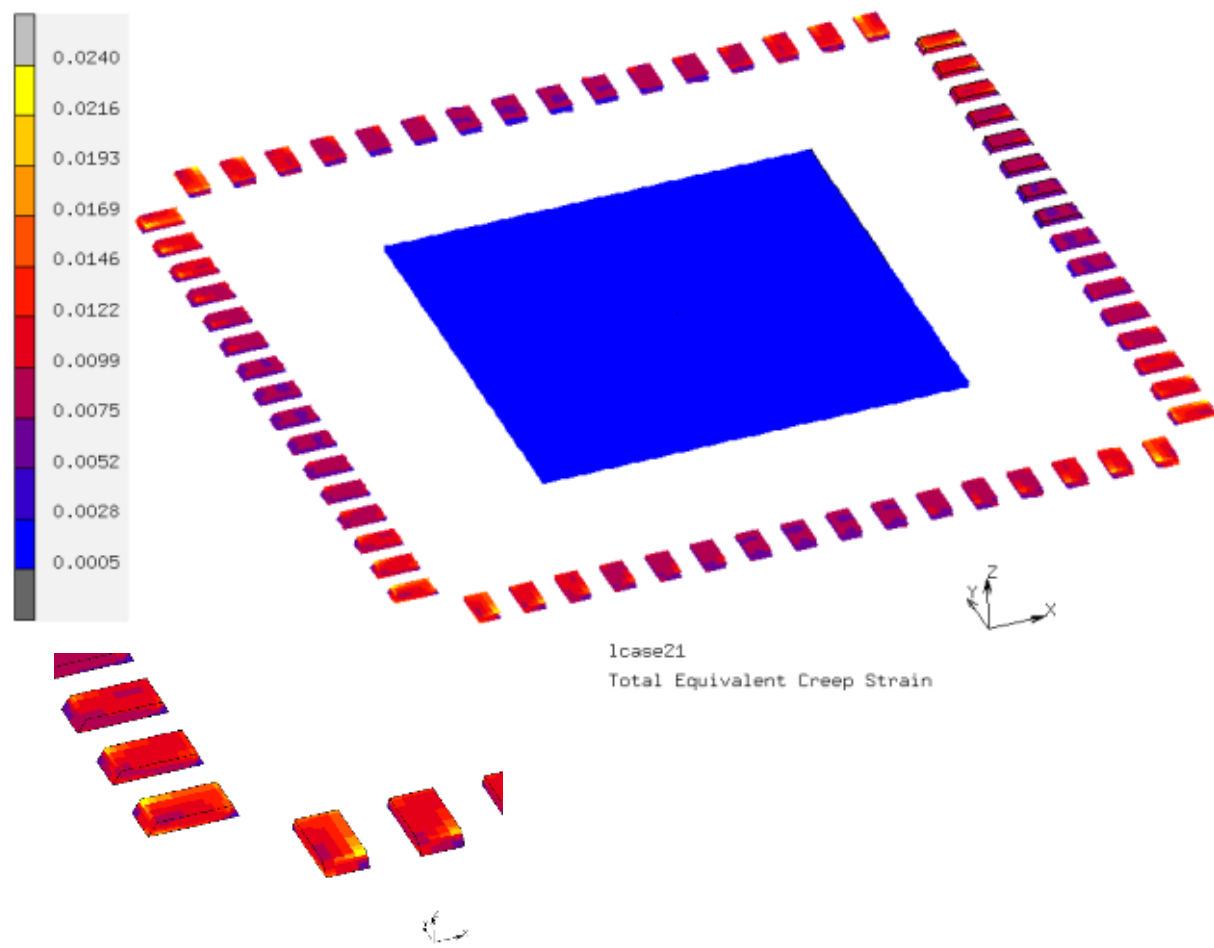
The simulated creep strain is shown in Figure *18*. The maximum is found in the corner and this also agrees with the experiments.

Figure 18: Inelastic strain distribution in SAC305 for QFN228 packages assembled to the 2.4 mm PCB (EMC = 7 ppm/°C)

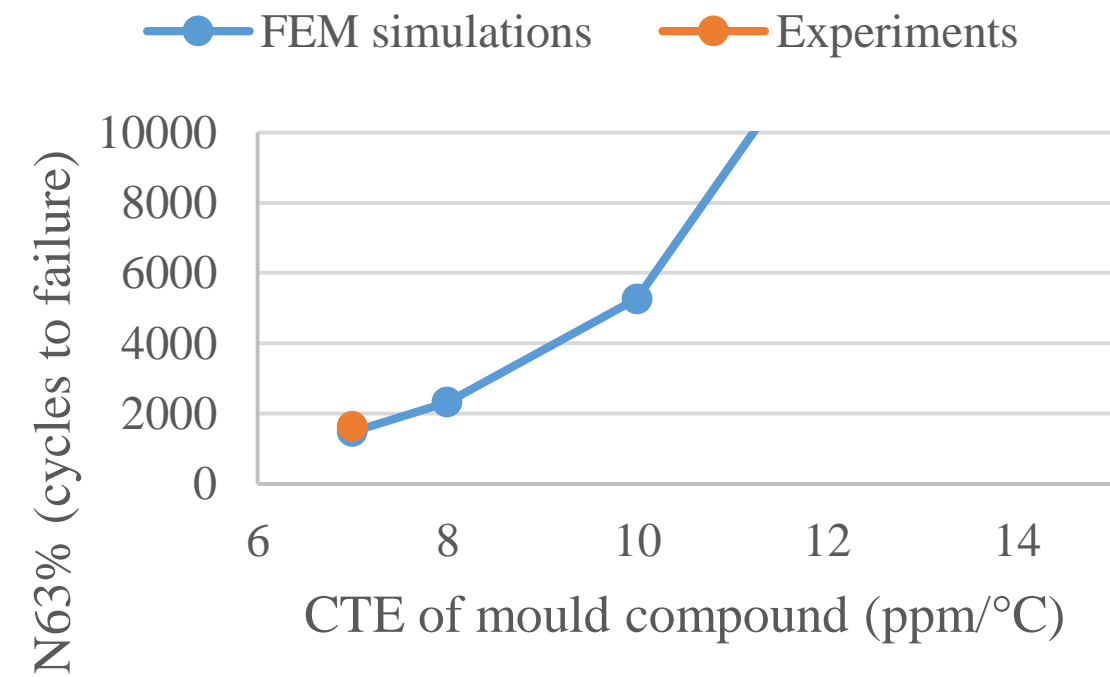
The results are shown Figure 19. The life time exponentially decreases with decreasing CTE of the mould compound. Only one experimental point could be added to the graph. The tests with 12 ppm/°C mould compounds have no failures up to 2000 cycles. A conservative extrapolation gives a characteristic life time of at least two times this number, so at least 4000 cycles. These latter tests will be continued.

Figure 19: Sensitivity of the characteristic life of the QFN64 package as function of the CTE of the mould compound (the E-modulus is linked to the CTE through the table 2).

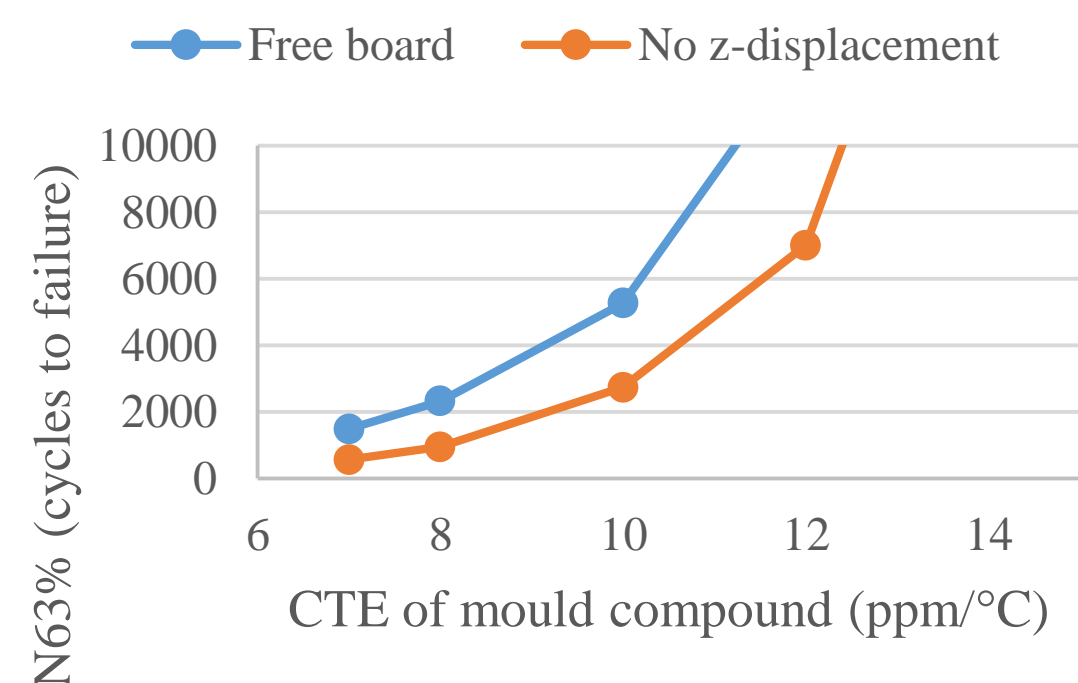
The issues become even worse when the PCB is prohibited to follow the warpage of the component. Figure *20* shows an extreme case (but not unrealistic!) where the board is not allowed to warp (out-of-plane displacement is zero). In that case, the life time really drops to very low numbers (554 cycles characteristic life for 7 ppm/°C).

This study highlights the risk for qualification of QFN's on rather flexible boards (< 1.6 mm) which can be a substantial overestimation for the real application case where the board is either much stiffer (> 1.6 mm; more and thicker copper layers) or even fixed to a frame not allowing any bending anymore.

Figure 20: Impact of board support on life time of QFN assemblies.
