Title of Document: **SURVEILLANCE OF THE PERFORMANCE OF ELASTOMERIC BEARINGS ON MARYLANDS CONCRETE BRIDGES**

Charles J. Angelilli, Masters of Science, Civil Engineering, 2007

Thesis submitted to the Faculty of the Graduate School of the
University of Maryland, College Park, in partial fulfillment
of the requirements for the degree of
Master of Science
2007

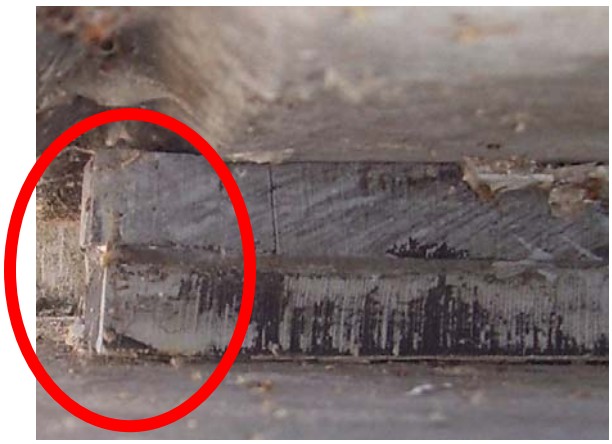
Delamination was not a major symptom found during the field study. This suggests that the bearings were not loaded to the point where the elastomer debonded from the laminate. Cracks that form at areas of concentrated stresses tend to propagate to the bond between the laminate and elastomer. This is a major source of delamination along with poor manufacturing. Figure 3.8 shows the top elastomeric pad moving past the extents of the laminate. This is rarely seen as most laminated bearings are fully encased by the elastomer.

**Figure 3.8 - Delamination of an Elastomeric Pad**

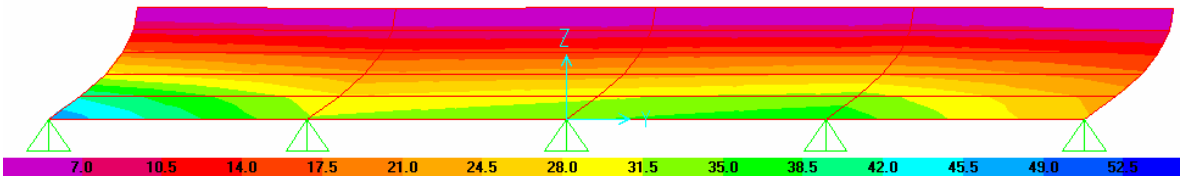
**Figure 6.4 – Stress Contours for Thermal Loading**

Notice the high stress concentration at the corners and along the bottom edge. This may be due to having a low shape factor.

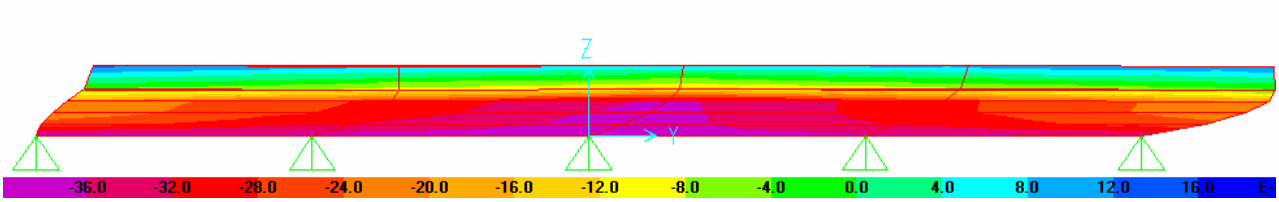
Compressive loading causes bulging as well as stress concentrations at the top corners as well as the bottom edge.

**Figure 6.6 – Stress Contours from Thermal and Compressive Loading**

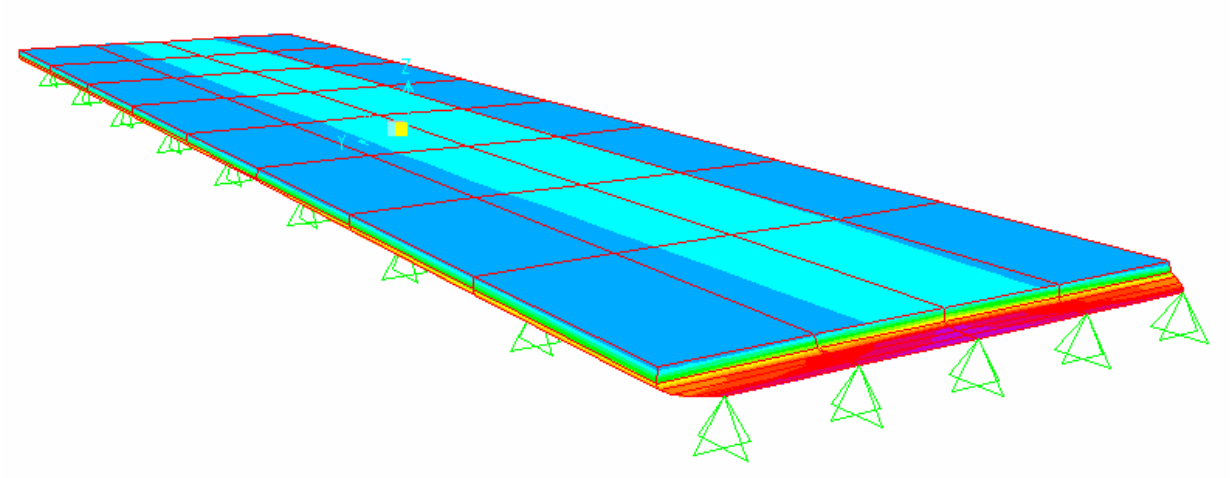
The highest stresses when the bearing is subjected to shear and compression are found along the bottom edge and in the corners of the plain pad.

**Figure 6.7 – Stress Contours from Thermal and Compressive Loading (3D)**

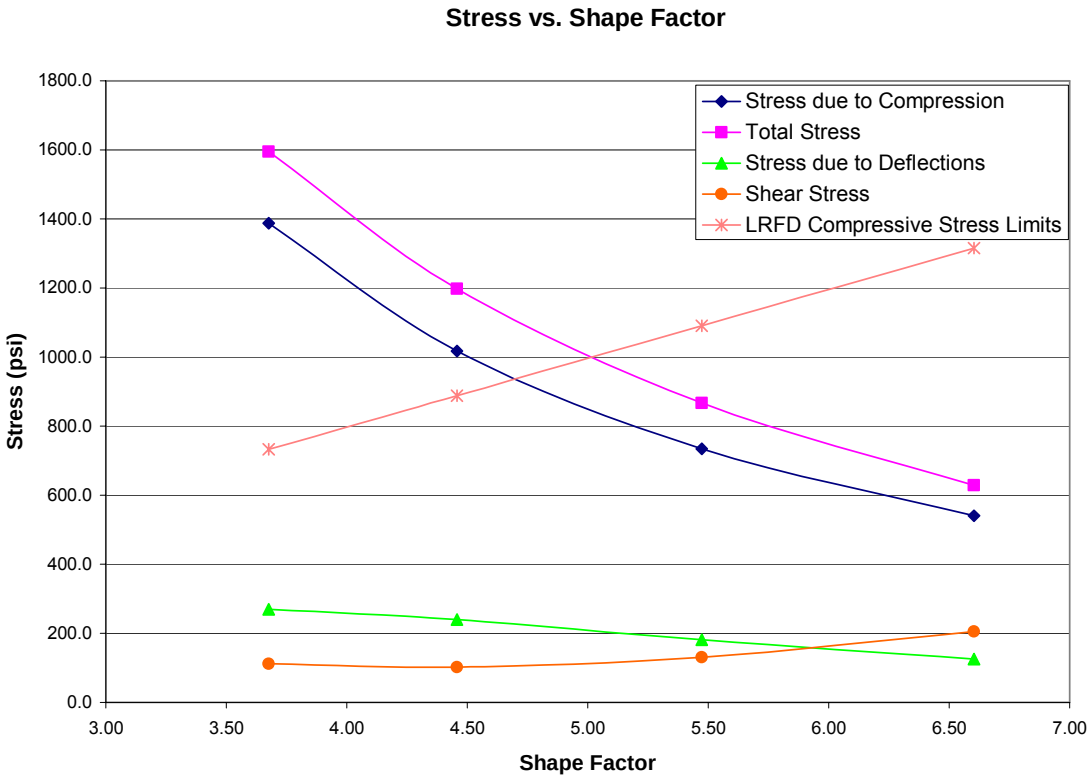
**Figure 6.15 – Stress vs Shape Factor for 16x26x1 5/8" Laminated Bearing**

Figure 6.15 shows the relation of stress and the shape factor for different types of stresses. Stress due to compression and total stress follow a similar pattern of decreasing as the shape factor increases. The difference between the two lines represents the stress due to shear forces and thermal deflections. As the shape factor increases, shear stress increases which is expected as increasing the shape factor is equivalent to reducing the thickness of the pad in terms of shear stress. The stress due to thermal deflections decreases as the shape factor increases. The AASHTO/LRFD limit is also shown on the plot. For this situation, to meet the AASHTO service load stress requirements, the shape factor must be greater then 4.66. Different bearings in different situations will have different allowable shape factors.

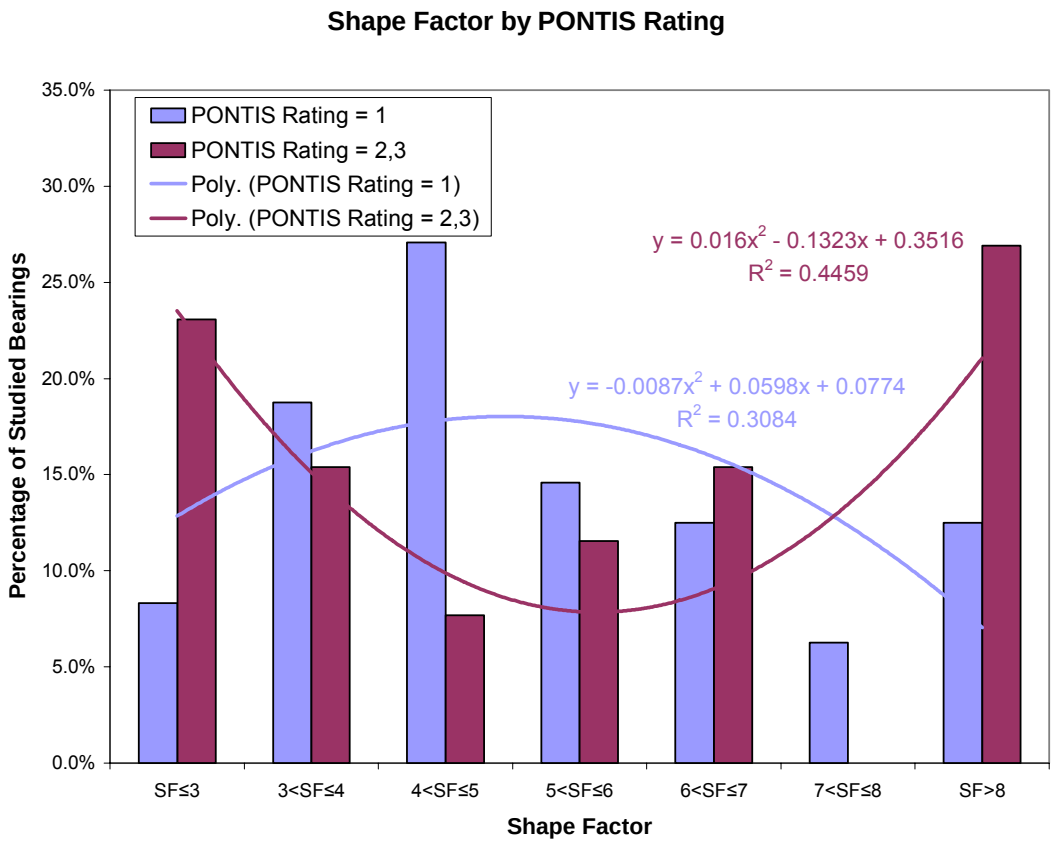
**Figure 7.1 – Bearing Condition by Shape Factor**

Bearings with a PONTIS rating of 2, 3 or 4 tend to be concentrated at the extremes of the graph while bearings with a PONTIS rating of 1 are concentrated in the center of the range. This shows that bearings with shape factor below 3.5 and above 6.5 have a higher probability of being in degraded condition and vice versa for bearing with shape factors

between 3.5 and 7.5. Although previous reports do not give a range of shape factors to design between, they do say that bearings with lower or higher shape factors tend to have problems in the field. Figure7.1 is consistent with these findings.

The shape factor of elastomeric bearings showed the highest correlation and strongest significance of all of the variables which were studied. Based on previous studies as well as this study, higher and lower shape factors seem to have a detrimental effect on the condition of elastomeric bearings. It is recommended that the shape factor of all bearings be kept between 3.5 and 6.5 in accordance to the findings summarized by figure 7.1.

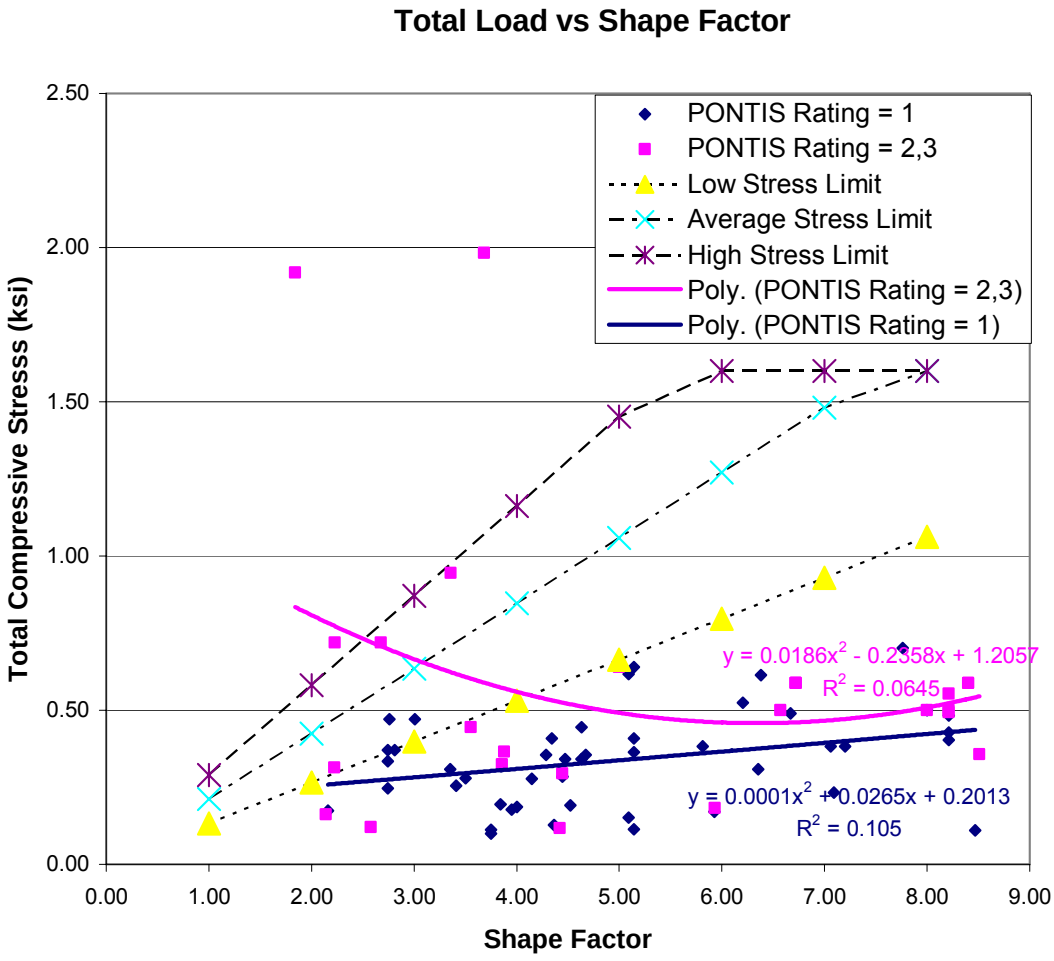
**Figure 7.2 – Total Compressive Stress vs. Shape Factor**

Figure7.2 shows bearings with PONTIS ratings greater than 1 tend to have higher compressive stresses inside the elastomer. This may be expected that bearing in a deteriorating state may be subject to higher compressive stresses, but should not be assumed. From logistic regression this is verified.

The graph in the above figure does not show the relation between the shape factor and elastomer condition but rather the combined effect between compressive stress and shape factor in relation to the condition of the bearing.

Three lines are plotted on the graph in figure7.2, the “Low Stress Limit”, the “Average Stress Limit” and the “High Stress Limit” lines. These lines represent the maximum allowable compressive stress based on the range of shear modules’ allowable for 60 durometer bearings (.8 ksi – 1.75 ksi). Bearings with a PONTIS rating of 1 stay primarily below the lower limit indicating that bearings in good condition do not exceed even the lowest of the allowable compressive stress limits. Bearings rated 2 or 3 can be observed above the average stress limit line and even above the maximum stress limit of elastomeric bearings. This implies that bearings are deteriorating due to excessive compressive stresses. This graph helps to further verify the results from the logistic regression.

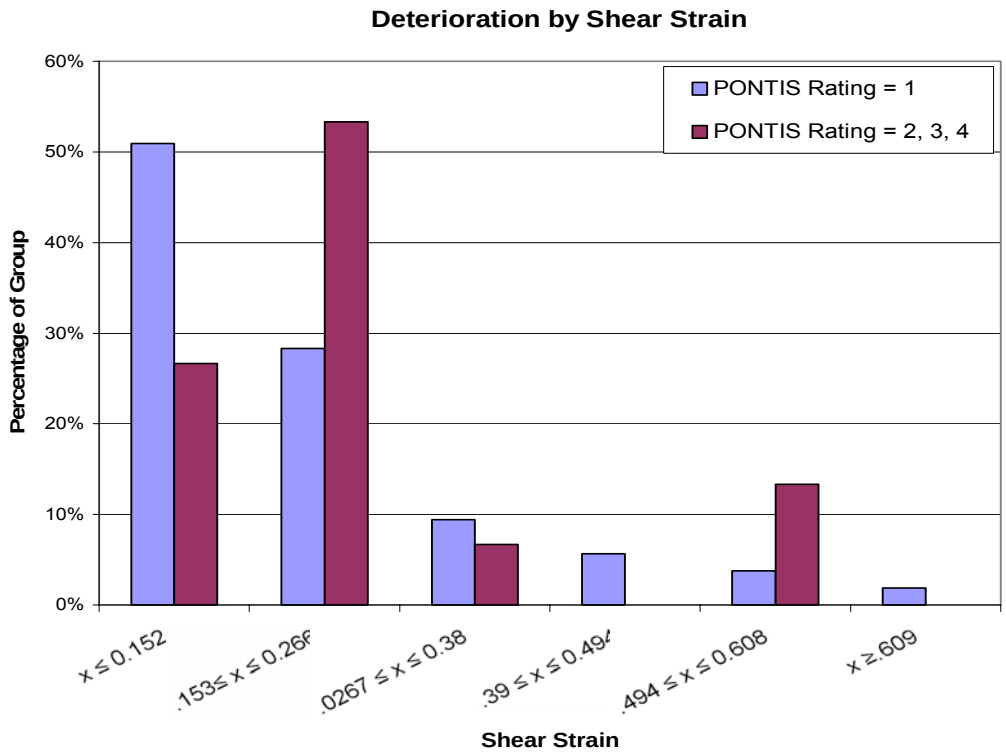
**Figure 7.3 – Bearing Condition by Shear Strains**

The above figure shows that the majority of bearings with a PONTIS rating of 1 have shear strains less than .152 in/in while the majority of bearings with a PONTIS rating of 2, 3 or 4 have shear strains between .153 and .266 in/in. Shear strains alone can cause the deterioration of the bearing but are not usually the sole cause of deterioration. With this stated, shear strains seem to be a heavy contributor to the overall condition of the bearing. The combination of shear strains, compressive stresses and rotation on the bearing can lead to the failure of the bearing.

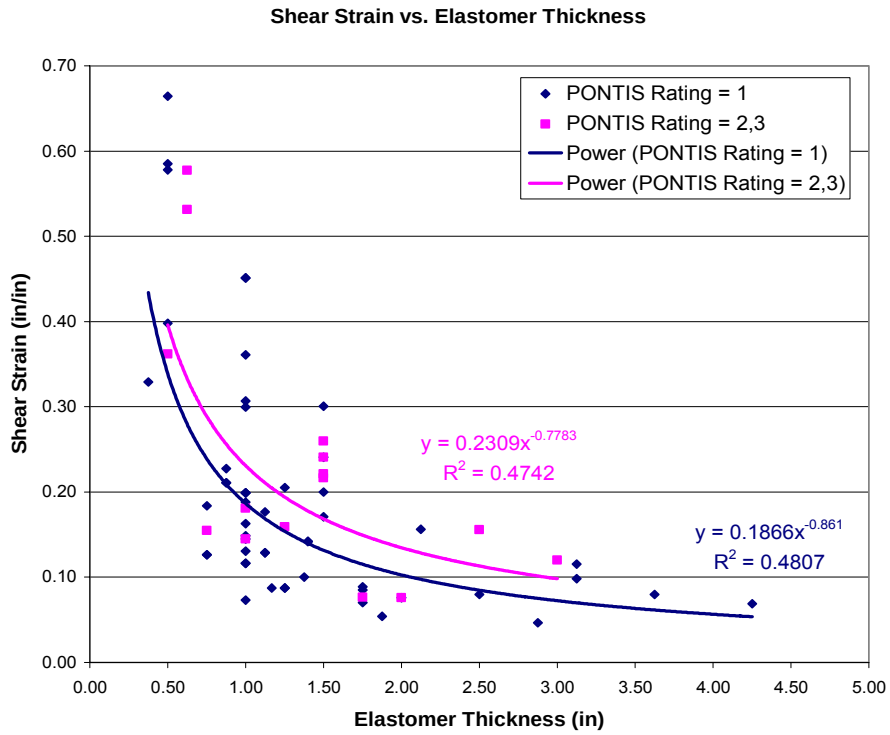
**Figure 7.4 – Shear Strain vs. Elastomer Thickness for All Sample Bridges**

Figure7.4 for all sample bridges, including slab and girder bridges, shows that higher shear strains are associated with bearing that have begun or are beginning to deteriorate. According to the regression lines in figure7.4, bearings with a higher PONTIS rating show 28.4% higher shear strains on average.

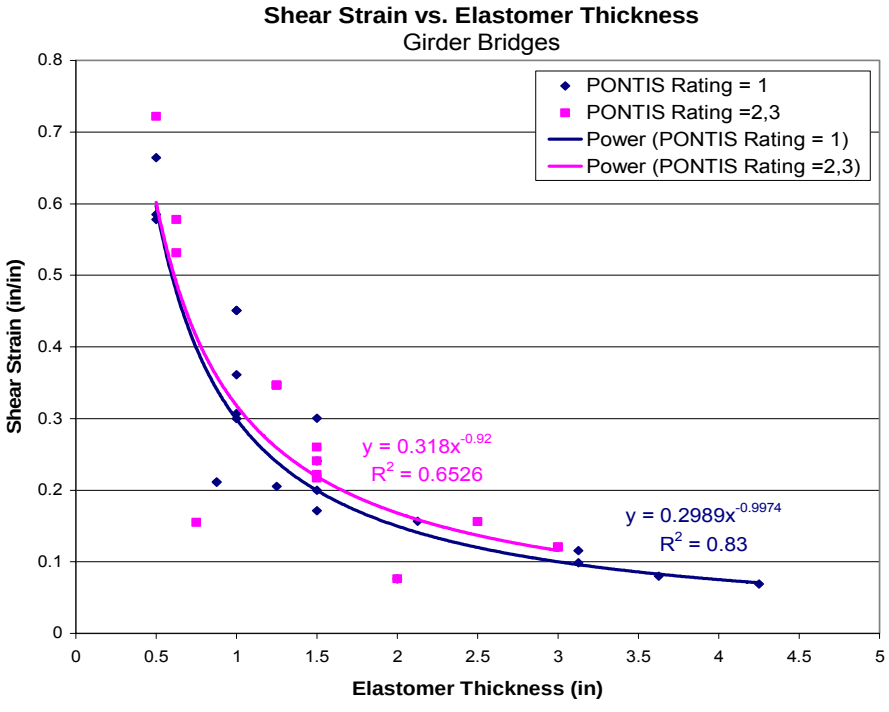
**Figure 7.5 – Shear Strain vs. Elastomer Thickness for Girder Bridges**

Figure7.5 shows the relationship between shear strains and the elastomer thickness for girder bridges. For the studied girder bridges bearings with higher PONTIS ratings had slightly higher shear strains by 11.6%. The trend of this graph follows closely with that of the graph for all sample bridges implying the there is a consistent tendency for bearings that are beginning to deteriorate or have already to have higher strains due to thermal deflection.

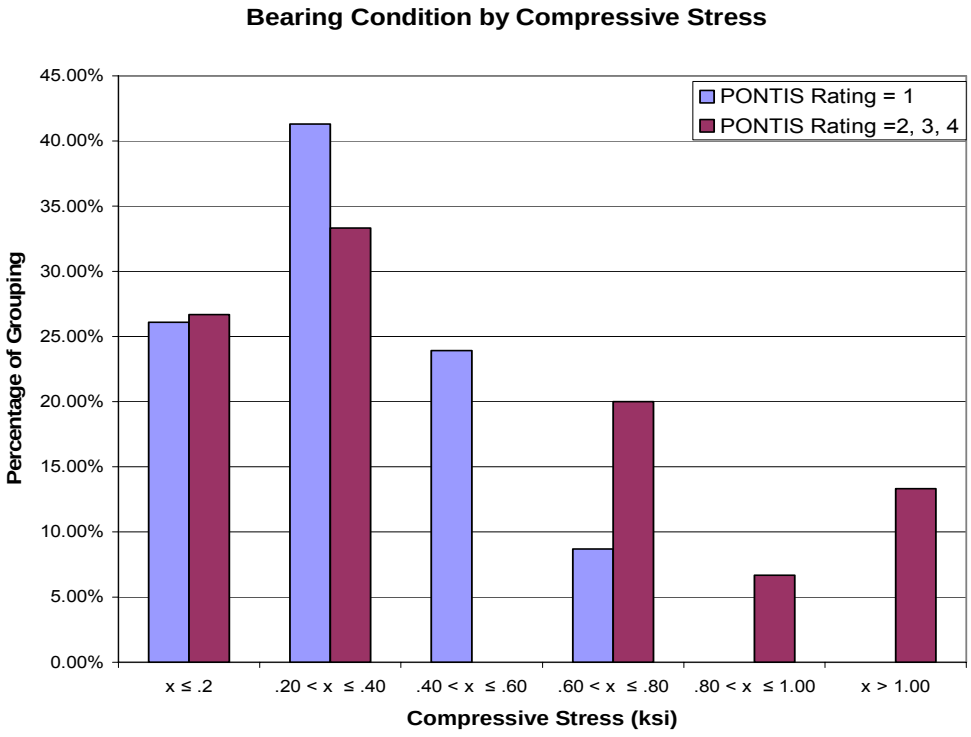
**Figure 7.6 – Bearing Condition by Compressive Stress**

Bearings in either PONTIS group seem to have a similar rate of occurrence when compressive stresses are below .4 ksi. Of the bearings studied, ones with a PONTIS rating of 1 had compressive stresses concentrated below .6 ksi with a maximum of .7 ksi. Conversely, bearings with a PONTIS rating of 2, 3 or 4 do have instances of compressive stresses above .8 ksi. In the editions of the AASHTO "Standard Specifications" prior to the 14$^{th}$ edition, .8 ksi was the upper limit for allowable compressive stress for elastomeric bearings. Approximately 40% of bearings with a rating of 2, 3 or 4 have compressive stresses approaching or exceeding this criterion. Later editions of the "Standard Specifications" give higher allowable stresses in "design method B". As can be seen in figure 7.4, the majority of bearings have compressive stresses below.6 ksi. It seems that if possible, the designer should decrease the compressive stress of the bearing as much as possible. High compressive stresses coupled with thermal strains and rotations may be critical in the overall condition of the bearing.

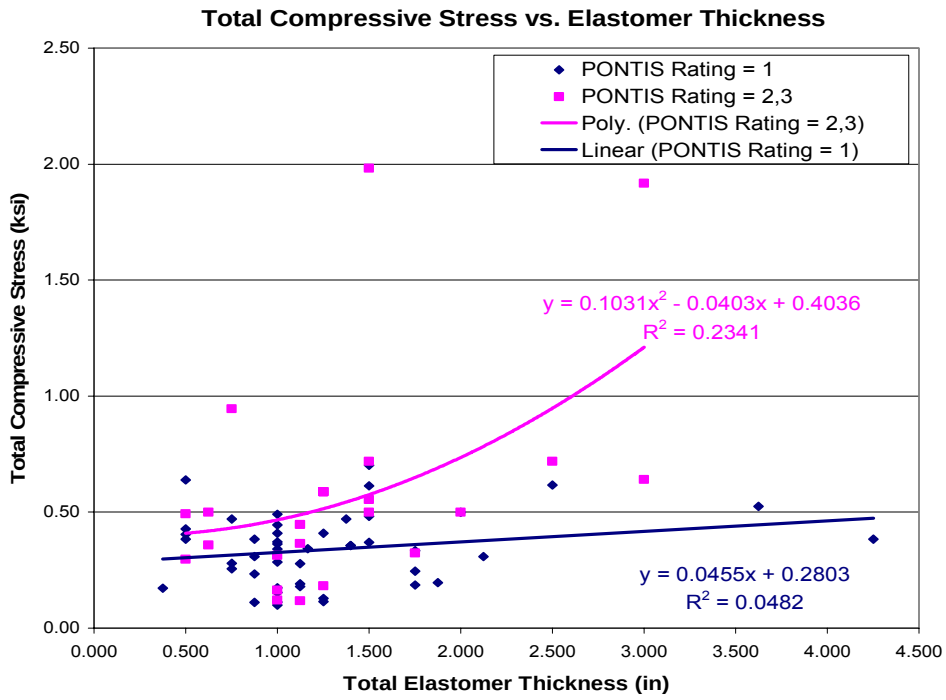
**Figure 7.7 – Compressive Stress vs. Elastomer Thickness for All Sample Bridges**

Figure7.7 for all sample bridges shows the relation between compressive stress and elastomer thickness. Bearings with PONTIS ratings of 2, 3 or 4 show higher compressive stresses than bearings with a rating of 1. Based on the regression lines in figure 7.7, bearings with a PONTIS rating of 2, 3 and 4 have an average of 93% higher compressive stress than bearings with a rating of 1. The same trend is found in the study for girder bridges. Figure7.8 for girder bridges shows a similar result. Consistent results between the two graphs imply that the deteriorated condition of elastomeric bearings may be correlated to the compressive stresses.

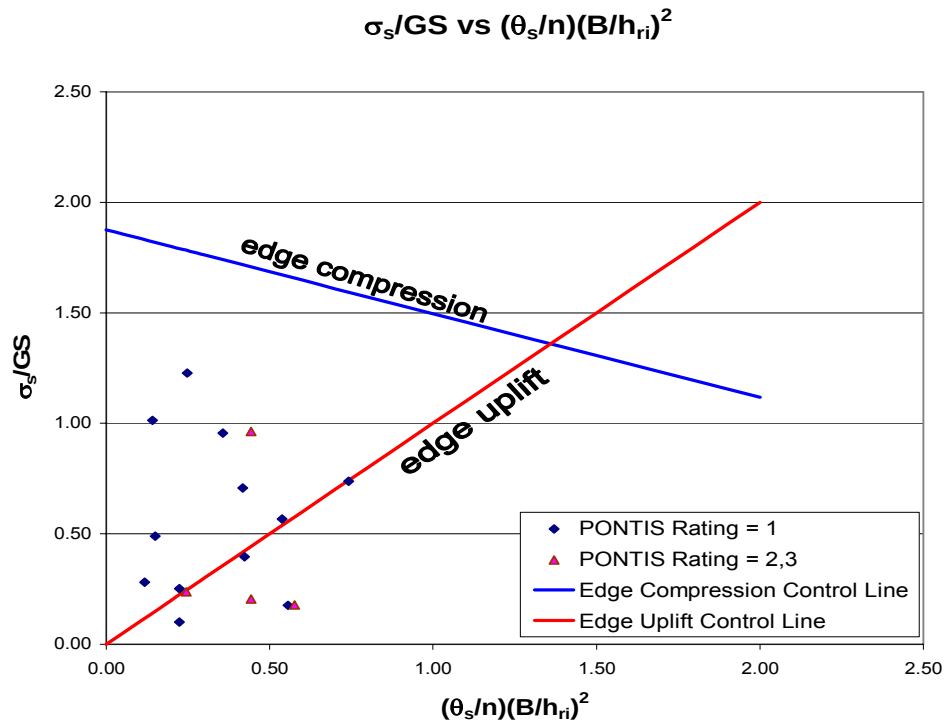
**Figure 7.9 – Combined Compression and Rotation Limits of Elastomeric Bearings**

The two lines in the above figure represent the edge compression limit and the edge uplift limit for elastomeric bearings. Bearings should be above the edge uplift line to prevent tearing or delamination of the elastomer and below the edge compression line to prevent crushing at the edges. The data from the field study with known compressive stresses and rotations follow this requirement for the most part and are shown in the same figure. The bearings with ratings of 2, 3 or 4 are lower than the edge uplift line for the most part and bearings with a rating of 1 are above it. The strong significance from the logistic regression implies that the graph is a good measure of the condition of the bearing.

Based on the findings of this study and the current AASHTO design standards, combined compression and rotation were found to have strong correlation to the condition of elastomeric bearings. Figure7.9 is based on the AASHTO requirements for edge uplift and edge compression. The results of the field study fit well with the AASHTO requirements. It is recommended that the current AASHTO requirements be followed in this regard.

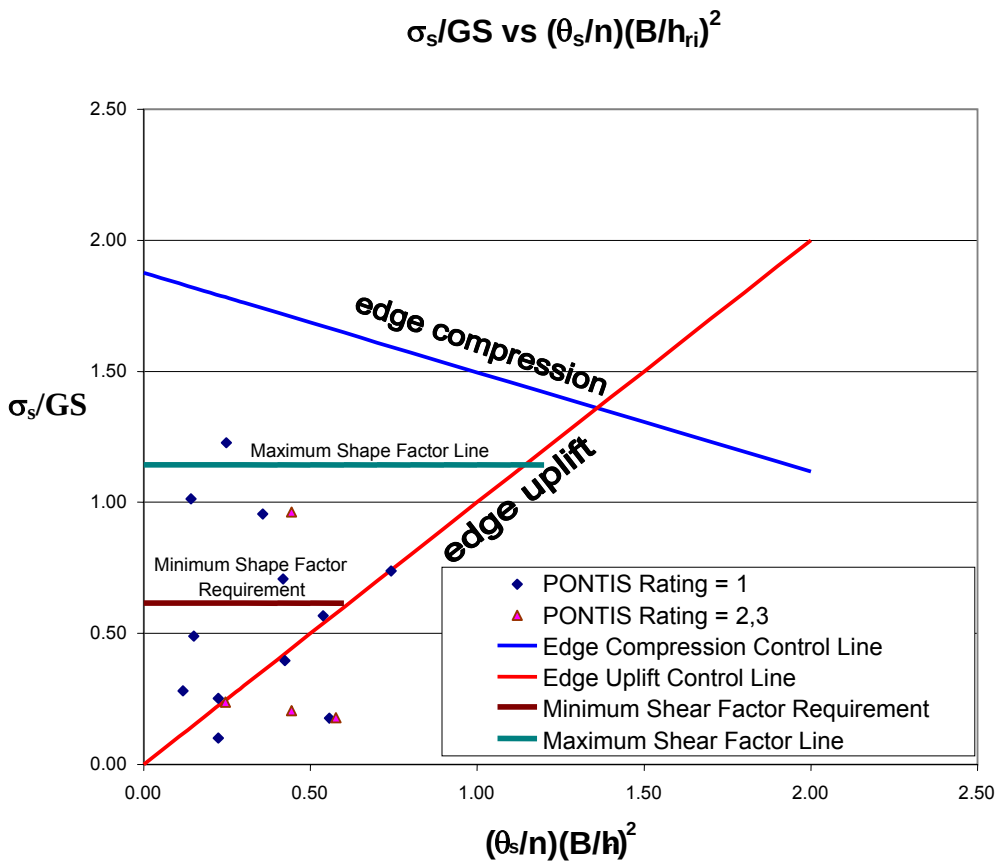
**Figure 7.10 – Combined Compression and Rotation Limits of Elastomeric Bearings**

This being the case, considering the above recommendation for the shape factor of a bearing is combined with the edge requirement graph of AASHTO and is based on the range of shear modulus for 60 durometer bearings and an .8 ksi compressive stress limit, a stricter recommendation can be asserted. Figure7.10 combines the recommendation for shape factors and edge uplift/edge compression.

To satisfy both recommendations for the shape factor and the combined compression and rotation it is recommended that all designs of 60 durometer elastomeric bearings coincide with figure 7.10. The limiting design criteria shall be the "maximum shear factor line", the "minimum shear factor line" and the "edge uplift line as described by AASHTO.
