PERFORMANCE VERIFICATION STATEMENT

for the YSI Inc. Rapid Pulse Dissolved Oxygen Sensor

UMCES Technical Report Series: TS-457-04-CBL / Ref. No. [UMCES]CBL 04-120

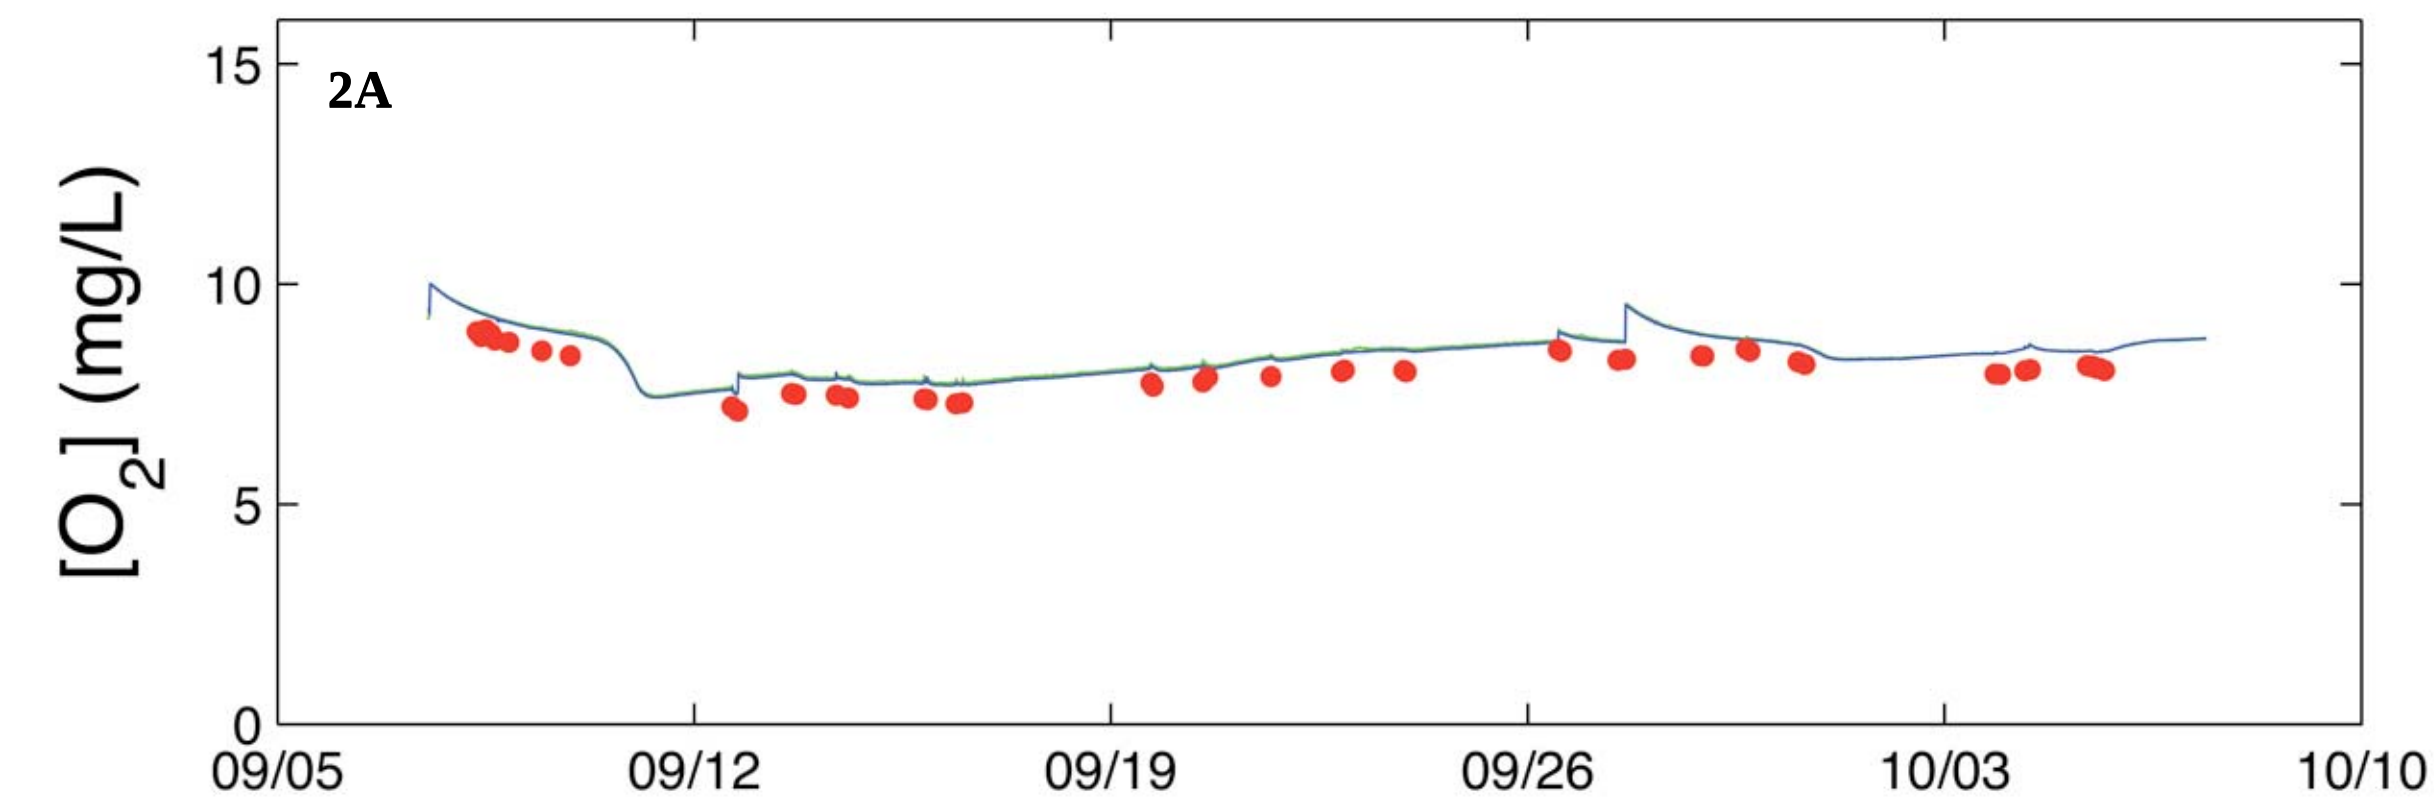
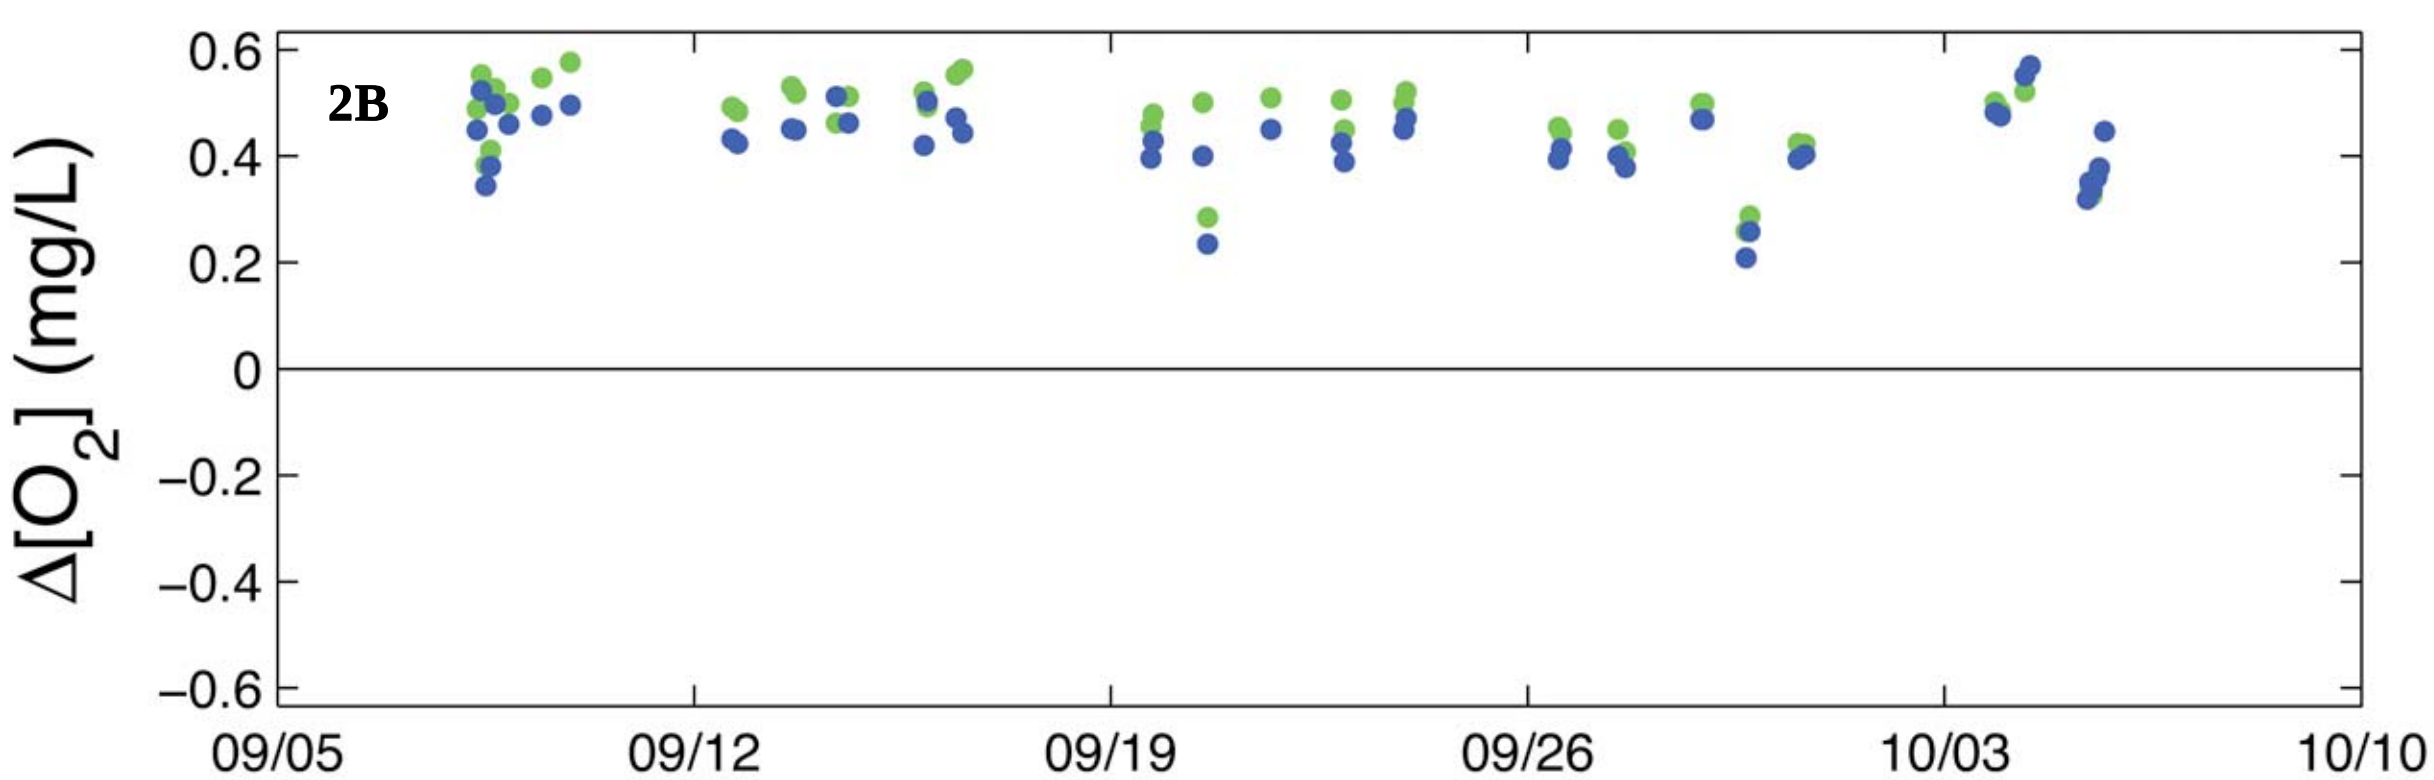
Sensor without the biofouling prevention system after four-week laboratory deployment.

Sensor with the biofouling prevention system after four-week laboratory deployment.

Laboratory Reliability – The YSI Rapid Pulse sensors were programmed to collect and record DO values every 15 minutes during the four-week laboratory, freshwater bath deployment. All expected data points were successfully downloaded from both instruments and are plotted above. There were no obvious instrument malfunctions.

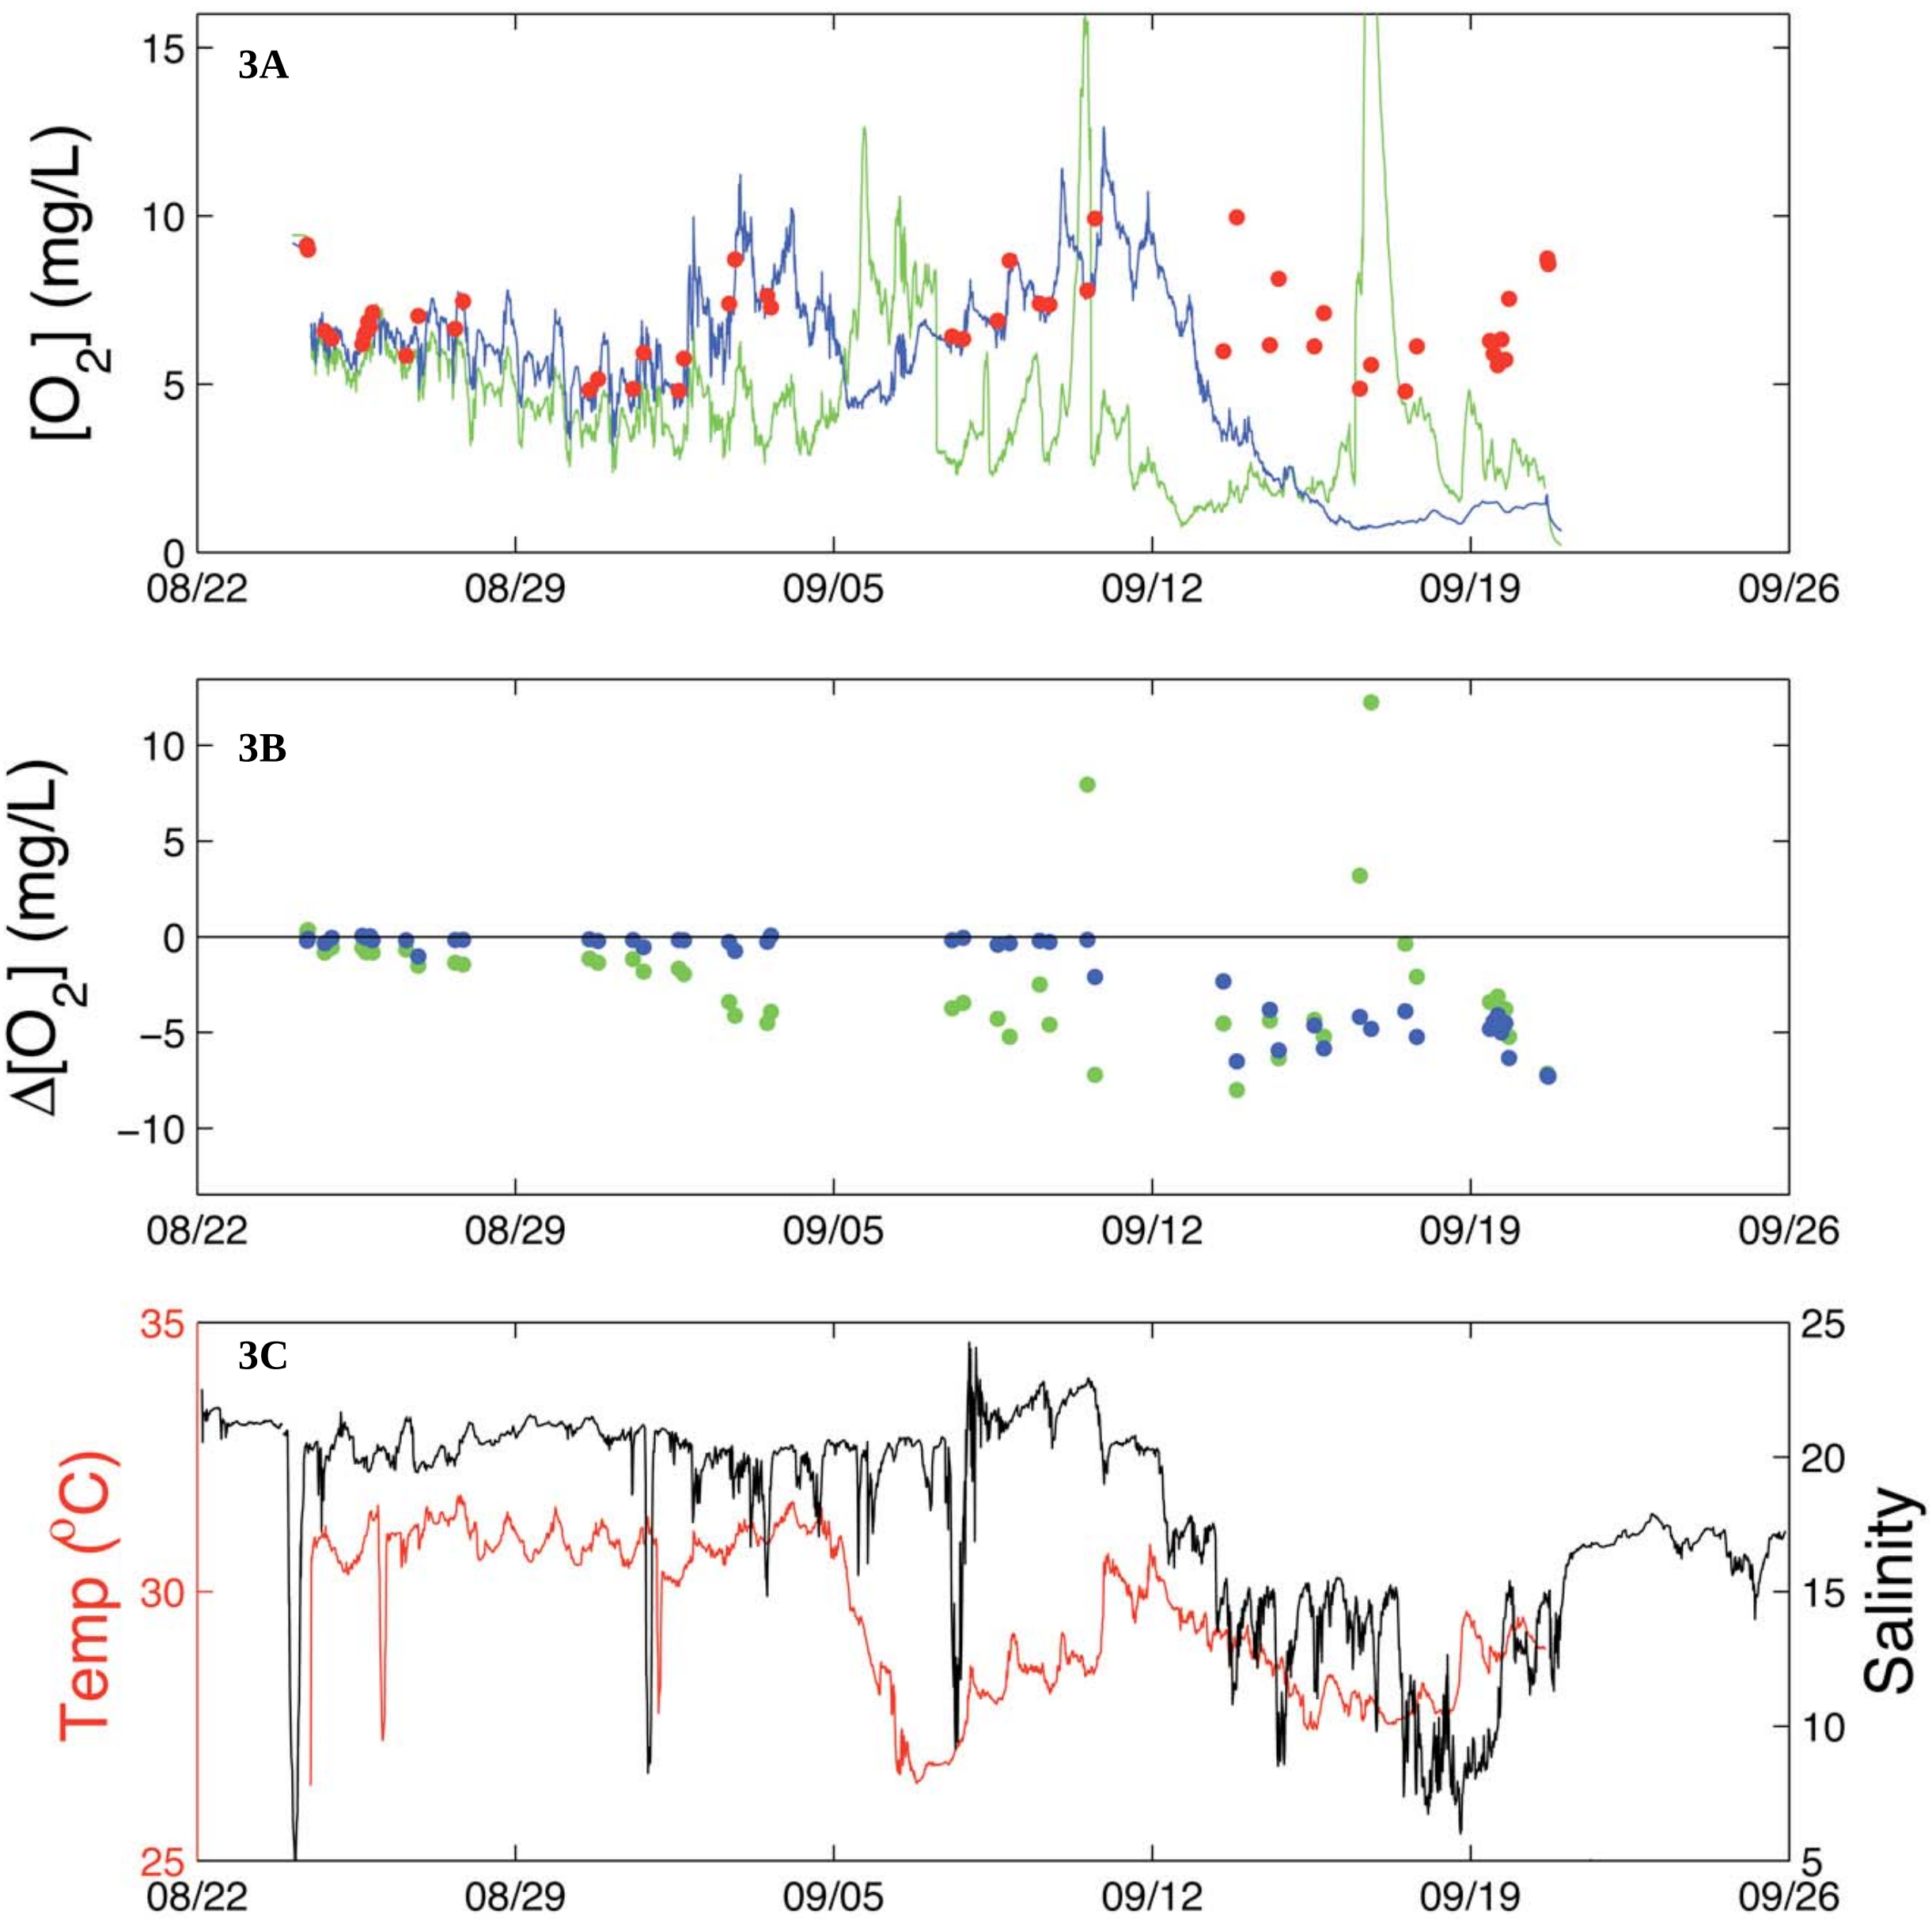
Figures 3A and 3B. Instrument drift at Bayboro Harbor, FL, 3C (USF).

Sensor <u>without</u> the biofouling prevention system after four-week field deployment.

Sensor <u>with</u> the biofouling prevention system after four-week field deployment.

Bayboro Harbor FL - The EDS sonde resisted fouling for a period of 2.5 weeks in this heavy fouling environment. The standard sonde showed the effects of fouling in 2 days!

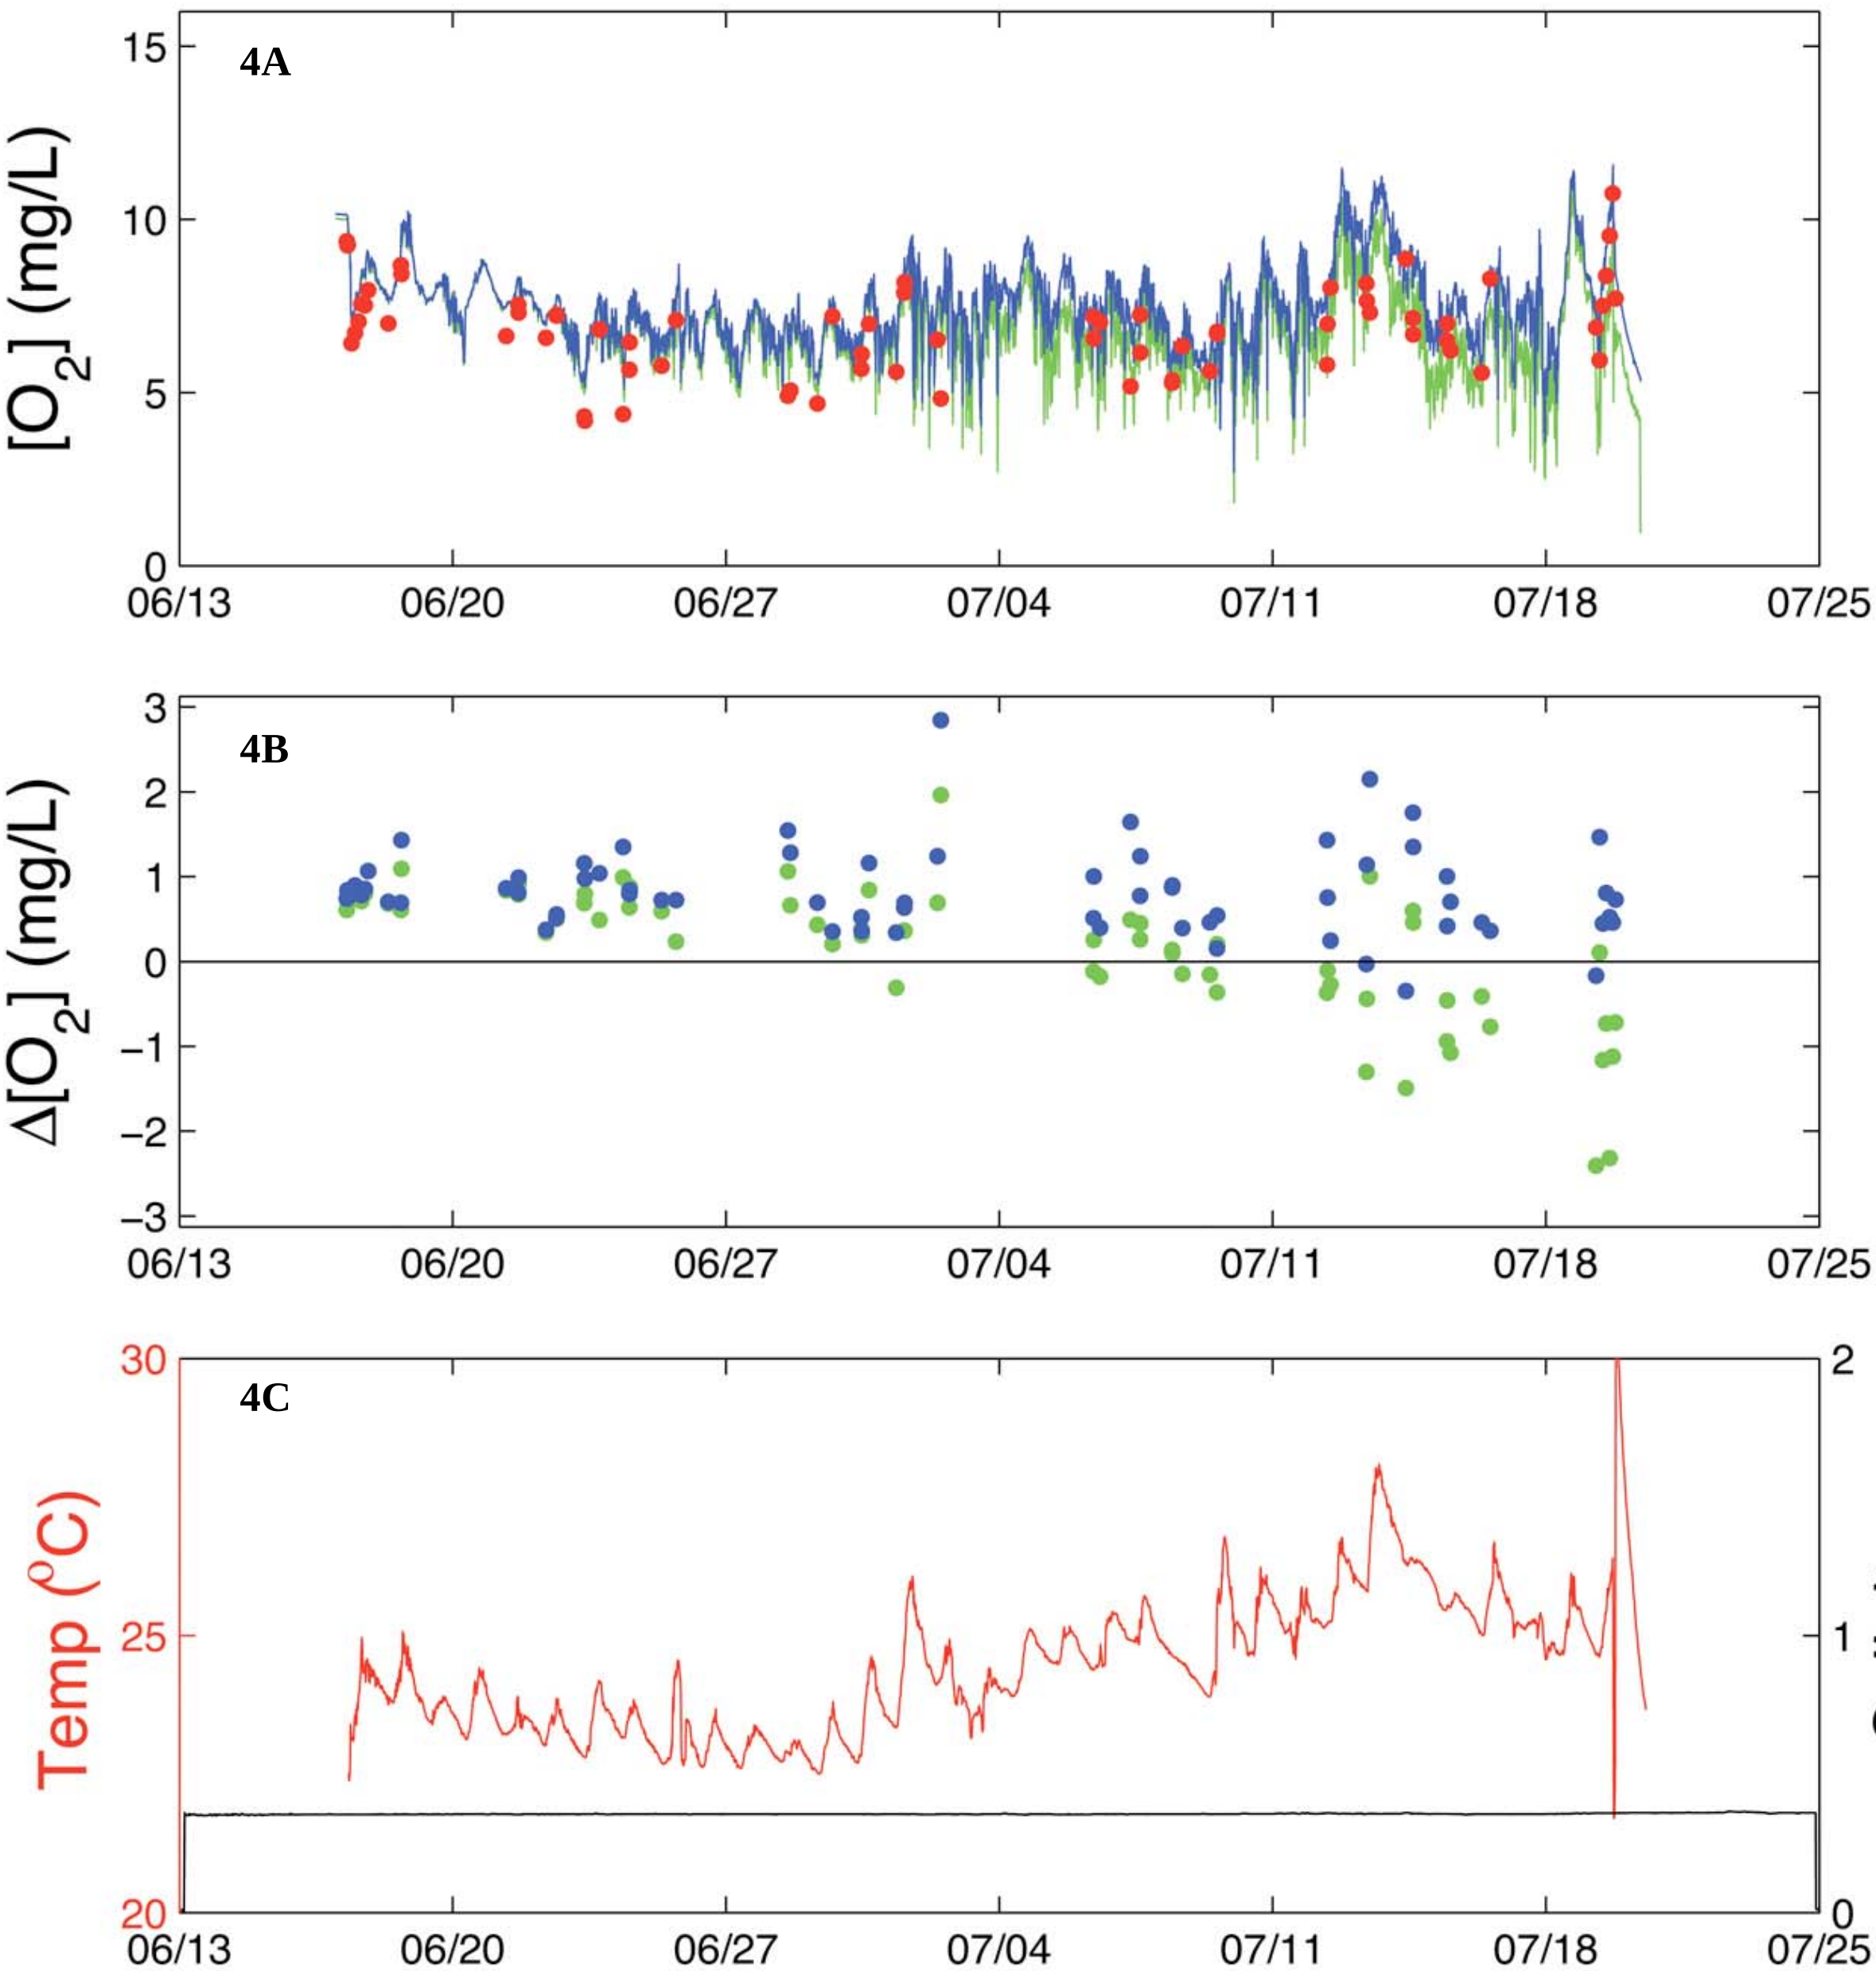
Figures 4A and 4B. Instrument drift at Belleville Lake, MI, 4C (CILER/University of Michigan).

Sensor <u>without</u> the biofouling prevention system after four-week field deployment.

Sensor <u>with</u> the biofouling prevention system after four-week field deployment.

Belleville Lake MI – Both sondes showed a positive offset from all the Winklers in the beginning of the test. The EDS maintained this offset throughout the study. Other deployments done with the same two units do not show the same offsets. The sondes have imbedded QA DO readings that confirm proper calibration.

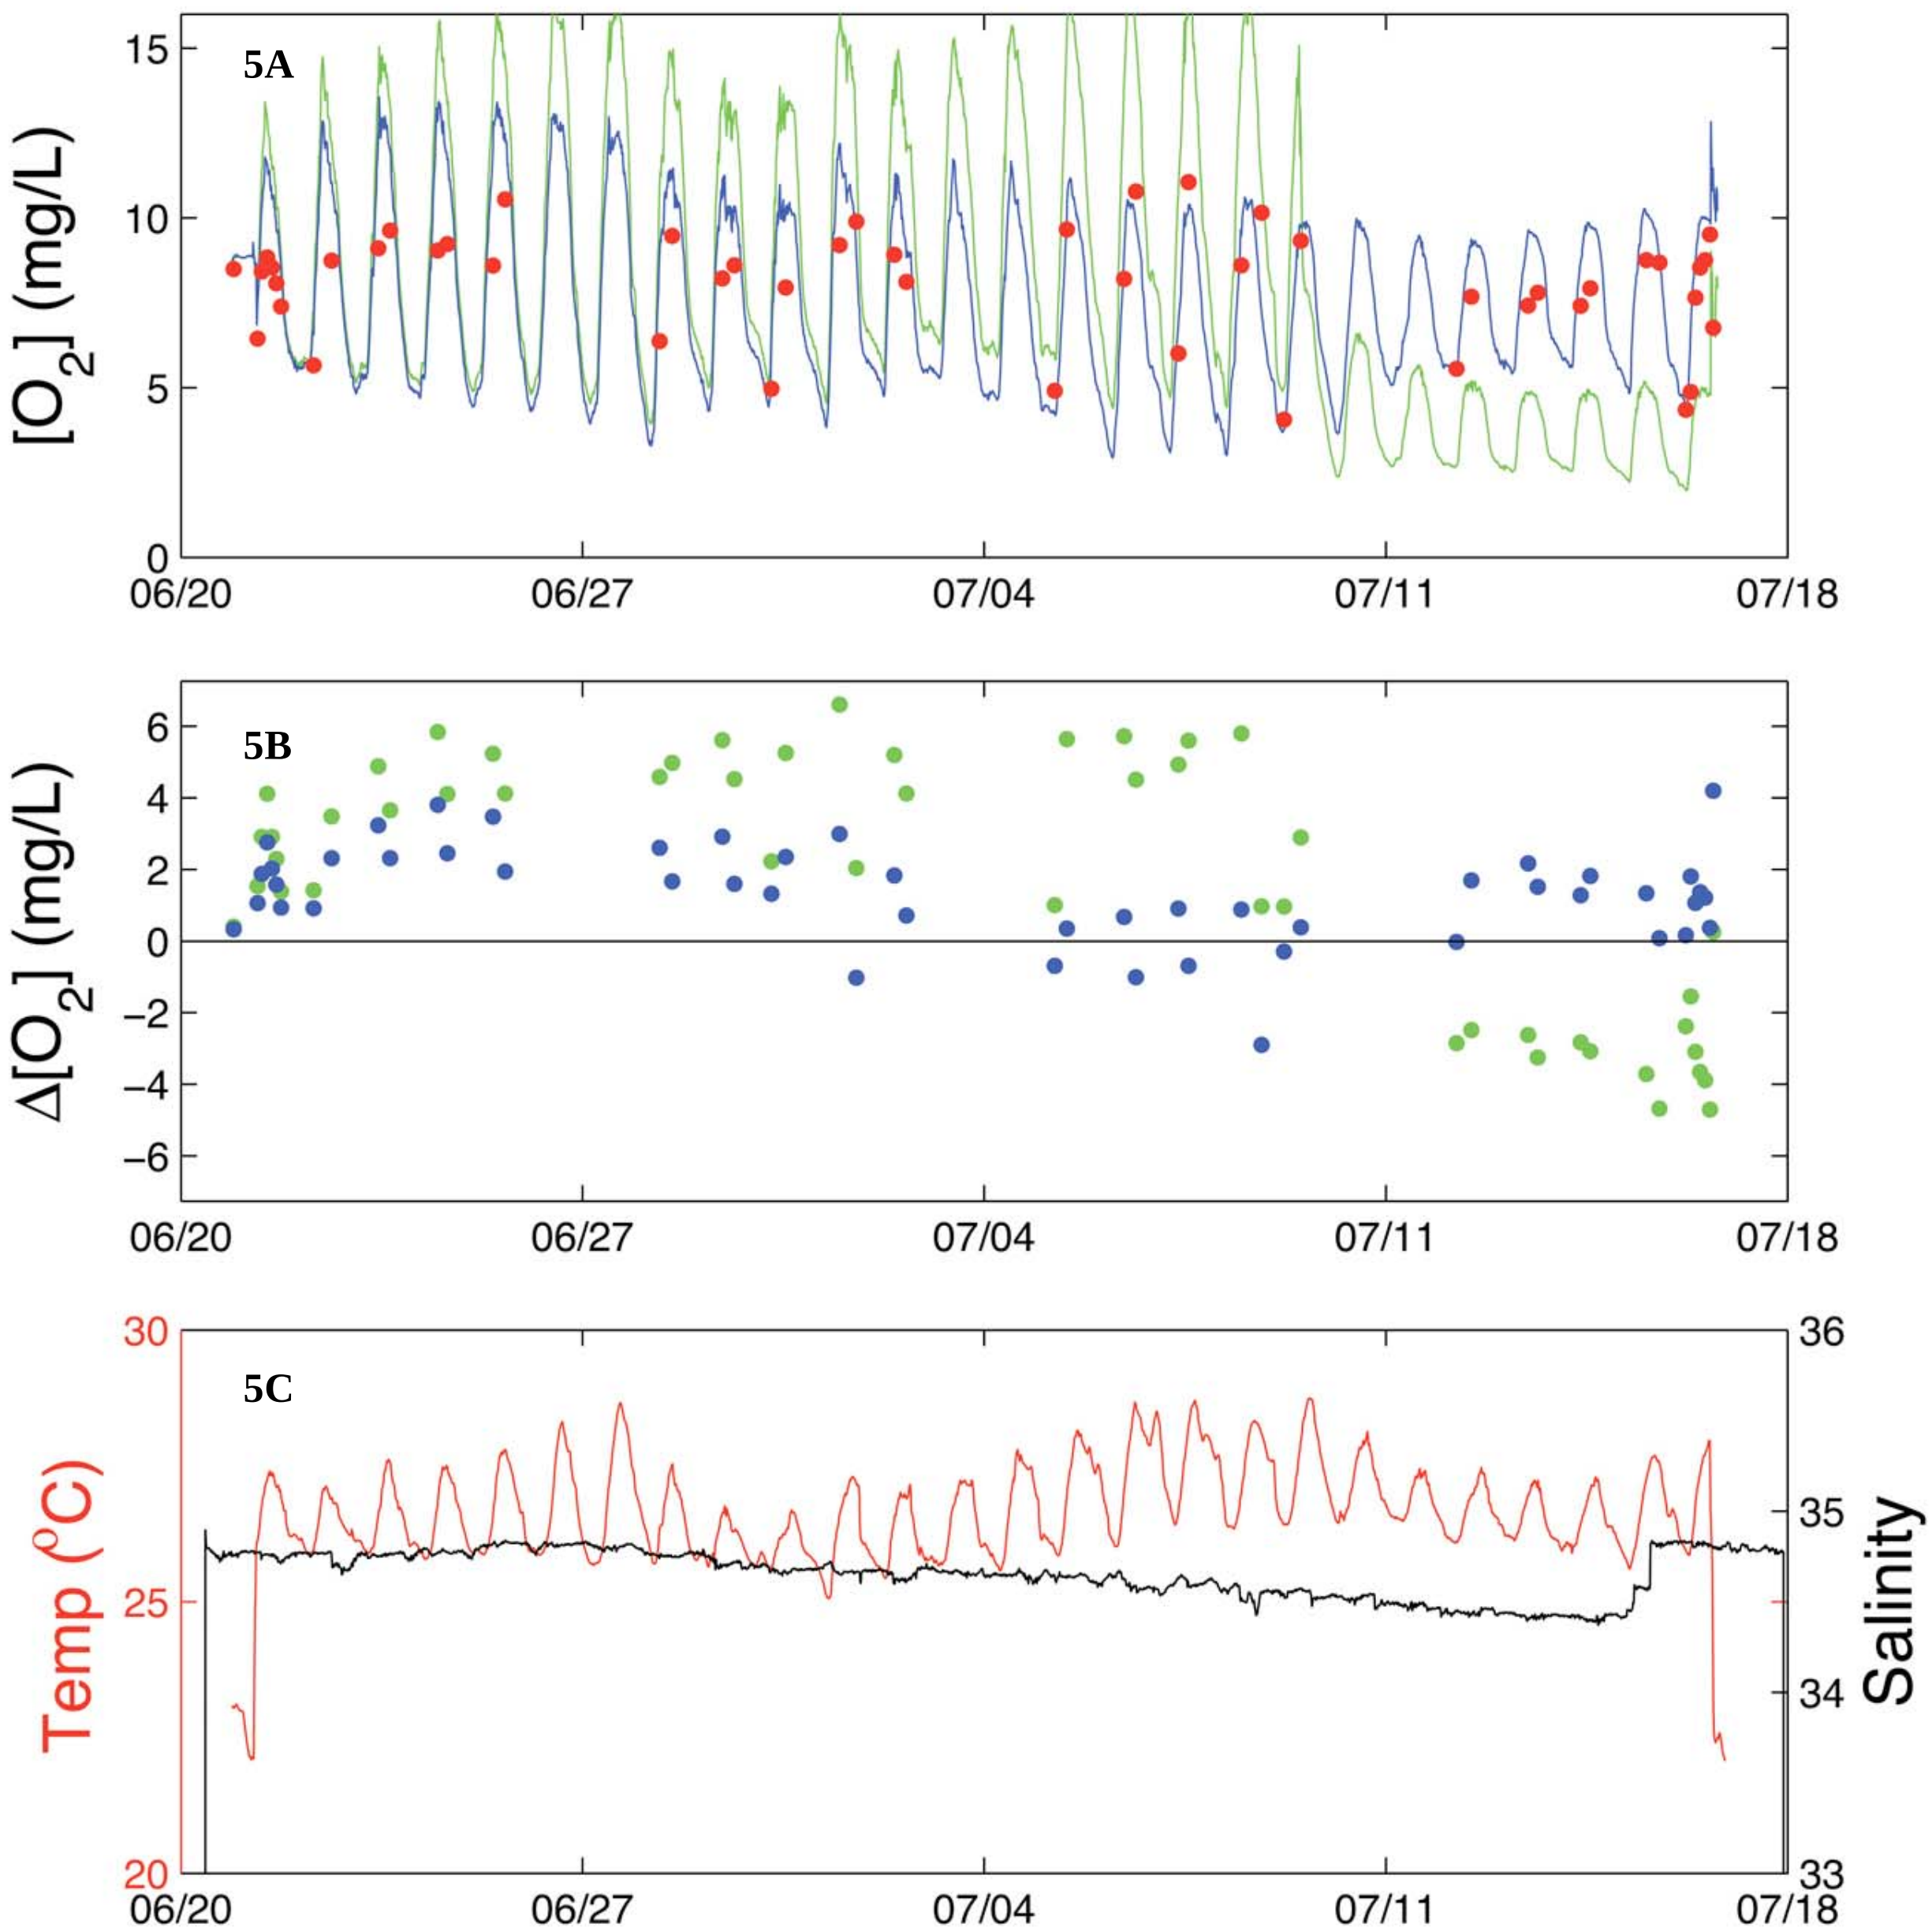
Figures 5A and 5B. Instrument drift at Kaneohe Bay Reef, HI, 5C (University of Hawaii).

Sensor <u>without</u> the biofouling prevention system after four-week field deployment.

Sensor <u>with</u> the biofouling prevention system after four-week field deployment.

Kaneohe Bay Reef, HI – The EDS sonde measured properly, but the standard sonde suffered from a membrane puncture. Variations in the Winkler's are evident.

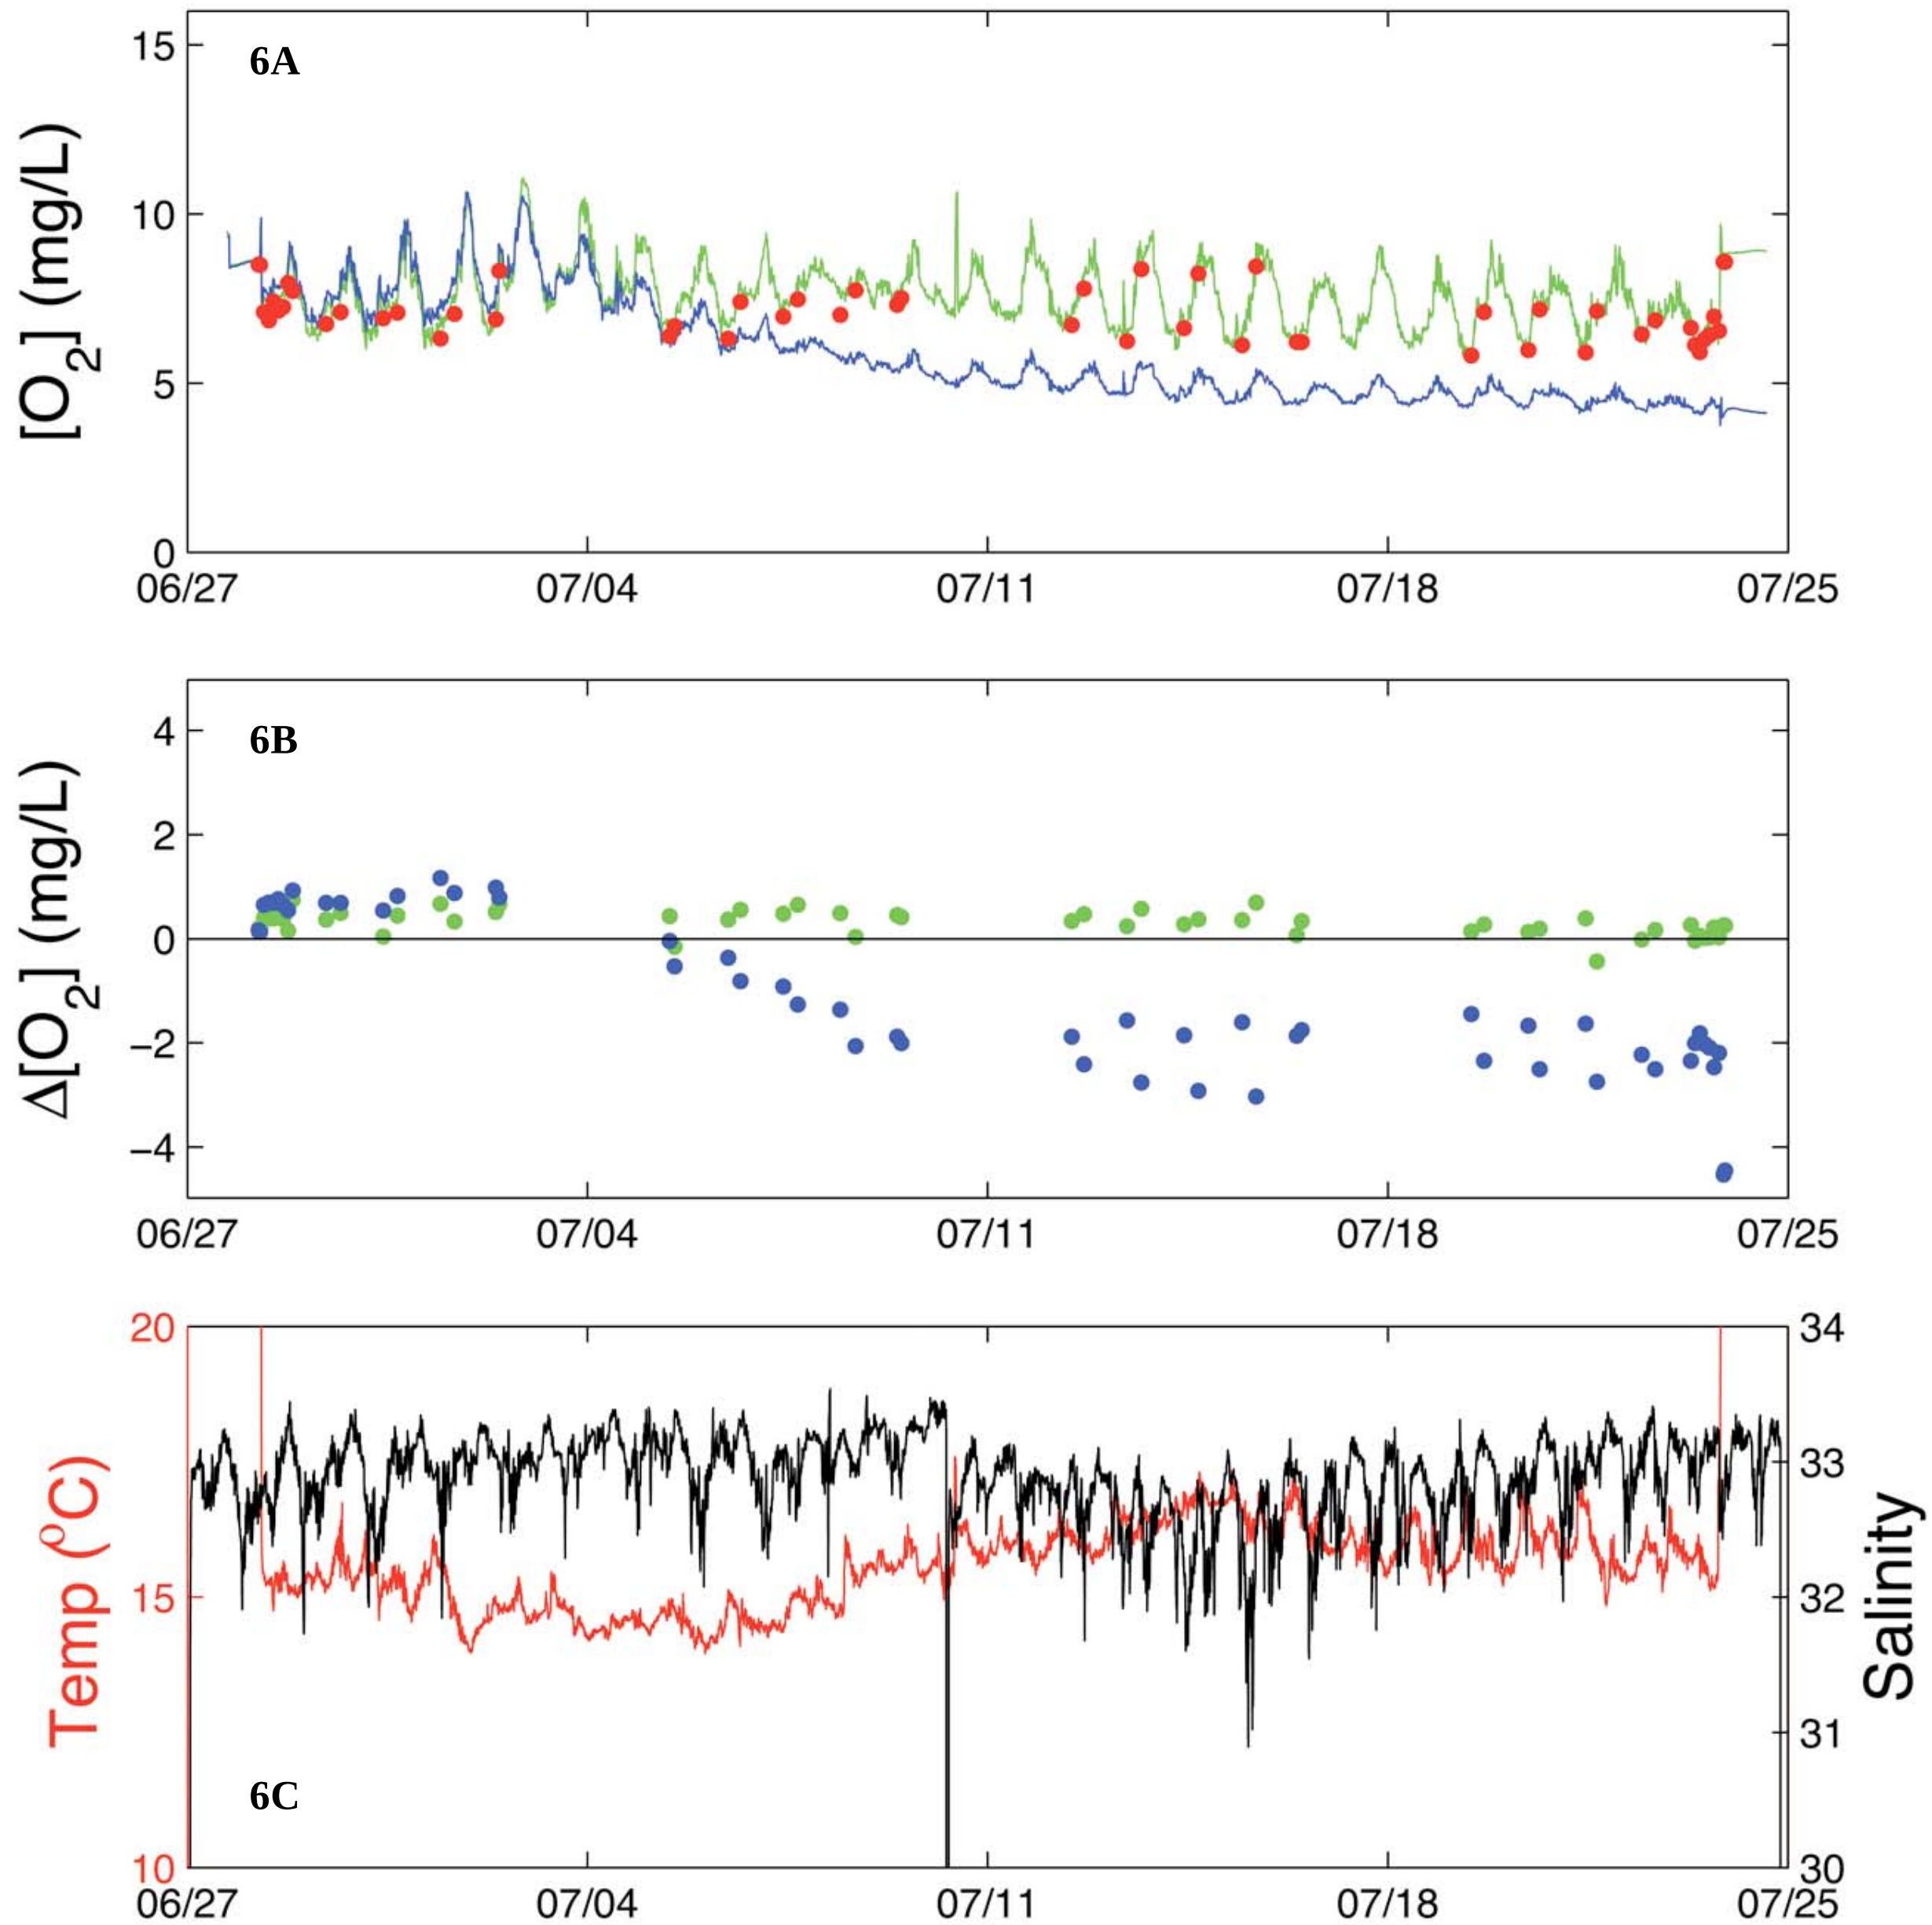
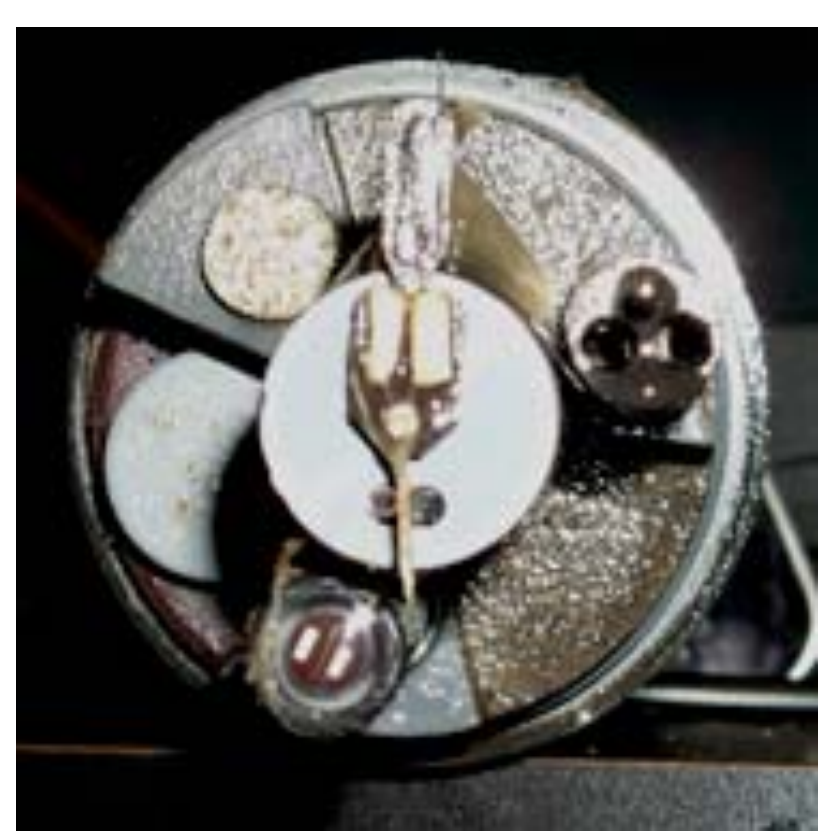
Figures 6A and 6B. Instrument drift at Moss Landing, CA, 6C (MLML).

Sensor <u>without</u> the biofouling prevention system after four-week field deployment.

Sensor <u>with</u> the biofouling prevention system after four-week field deployment.

Moss Landing, CA - The standard sonde worked perfectly and the EDS had an obstruction on the DO membrane that the wiper could not remove.
